INDOOR AIR QUALITY ASSESSMENT

**Massachusetts Department of Recreation and Conservation
Bureau of Forest Fire Control, District 10 Headquarters
Bureau of Forestry
Moore House
7 Military Road
Amherst, Massachusetts**

Prepared by:
Massachusetts Department of Public Health
Center for Environmental Health
Emergency Response/Indoor Air Quality Program
November 2005

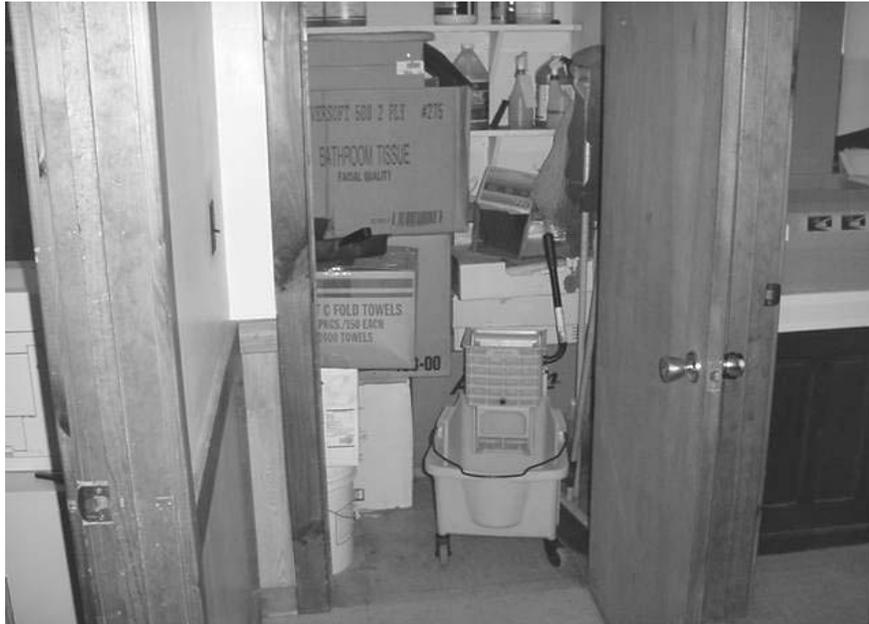
Picture 1

Upon entering the Moore House, a distinct musty odor was detected. The odor was traced to a moldy mop that was stored in a closet with the door closed (Picture 1). Both standing water and wet mops can serve as media for mold growth and associated odors. Mop buckets should be emptied and dried after use. Mop heads should be dried as soon as practicable to prevent mold growth.

Mop and Bucket in Storage Closet

1. Remove moldy mop and mop bucket from the first floor storage closet. Discard moldy mop head.
2. Open windows to provide fresh air.
3. Remove all gasoline-powered equipment from the lower level. Examine the feasibility of providing appropriate storage facilities for the gasoline-powered fire fighting equipment outside.
4. Install a cover over the AHU filter rack.
5. Seal all return ductwork and the AHU cabinet with mastic or HVAC foil tape to prevent air entrainment. The remediation of the AHU and return ductwork will prevent the draw and distribution of basement air and associated odors to occupied floors.

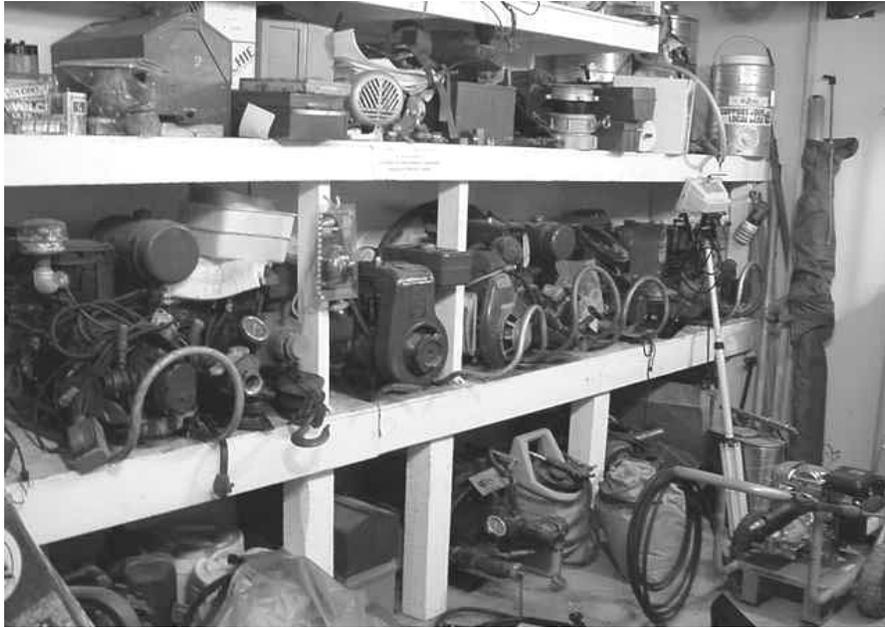
Picture 2

The basement level had a subdivided room that is used to store portable fire fighting equipment (Pictures 2 and 3). Many of these devices use gasoline as a fuel. Gasoline contains a number of VOCs that can rapidly evaporate at room temperature. Each fuel tank for gasoline-powered equipment can release gasoline vapors into the indoor environment, even those drained of fuel. The basement contains no means to exhaust gasoline vapors from the basement storage areas or garage. In an effort to provide some relief, a fan was placed during this assessment to draw air from the basement out through the lower level garage door. After 20 minutes of operating this fan, TVOC measurements dropped to 0.2 ppm in basement areas.

Gasoline-Powered Pumps

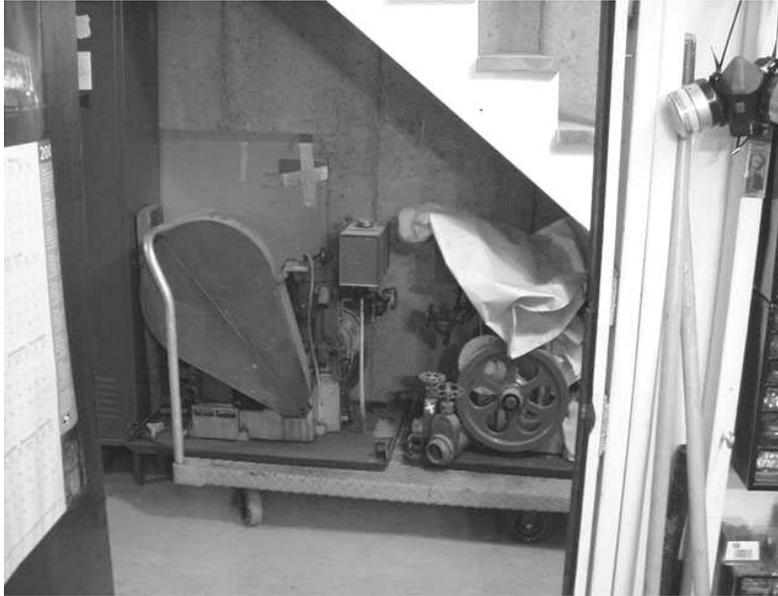
Picture 3

Gasoline Powered Equipment in Lower Level

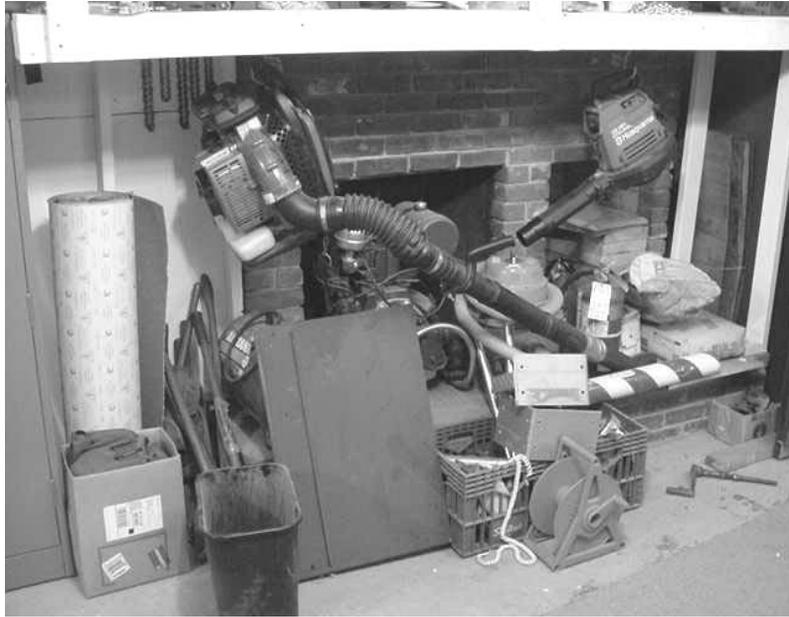
Picture 4

Three likely pathways for migration of TVOCs from the lower level up to the first floor were identified: 1) the stairwell, 2) the chimney (Pictures 4 and 5), and 3) the forced hot air heating system ductwork. Of particular note is the heating system, which uses an

Fireplace on Lower Floor

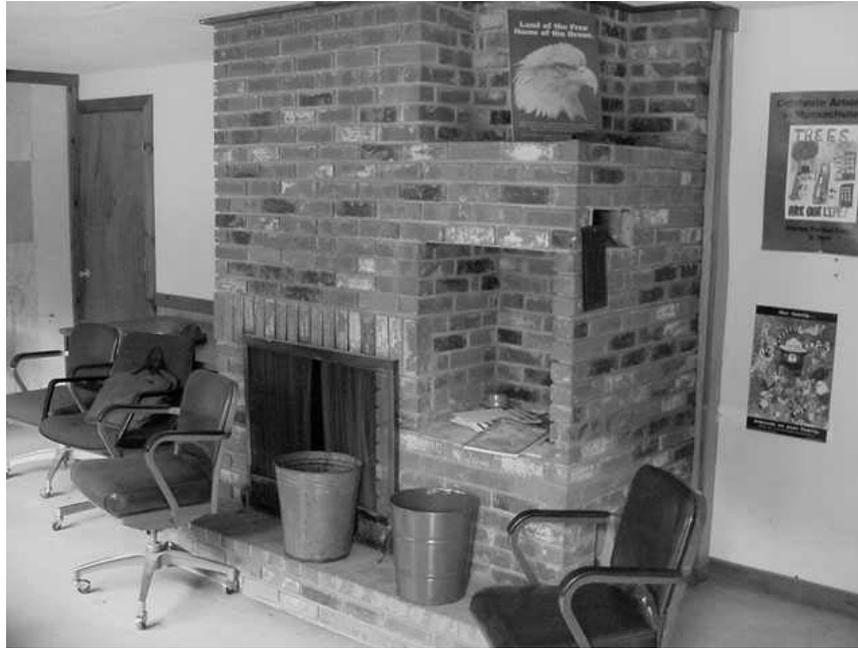
Picture 5

Fireplace on Upper Floor

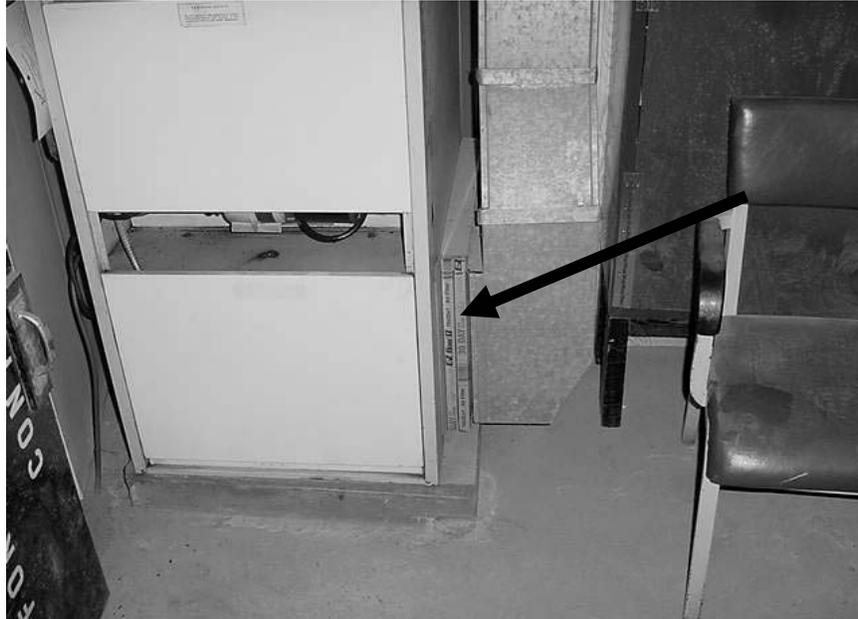
Picture 6

air handling unit (AHU) to deliver heated air and draws return air from the first floor via ductwork. Since the AHU cabinet and return vent are not airtight [e.g., no cover exists over the filter access opening (Picture 6)], air and other pollutants present in the basement can be drawn into the HVAC system and directed to the first floor. Even when deactivated, lower level air and VOCs can migrate upwards into the first floor hallway via the return air vent.

Open Filter Access Panel

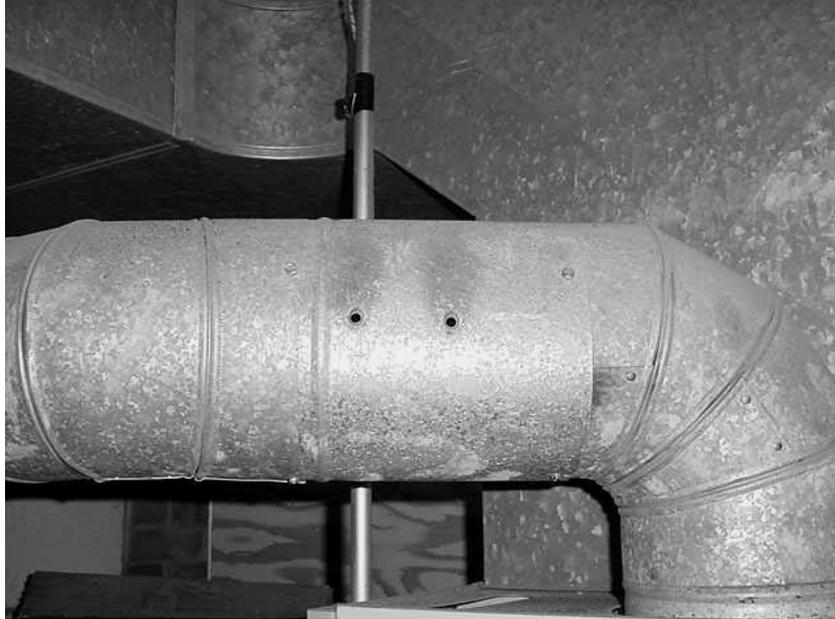
Picture 7

Also found were breaches in the exhaust vent for the AHU in the basement (Picture 7) as well as a hole in the chimney (Picture 8). Under certain conditions, products of combustion from the AHU and/or chimney can be released into the building through these breaches. Exhaust vents and chimneys should be airtight.

Holes in AHU Exhaust Vent

6. Seal all holes in the AHU exhaust duct and chimney.
7. Install weather-stripping and a door sweep to render the door to the lower level garage as airtight as possible.

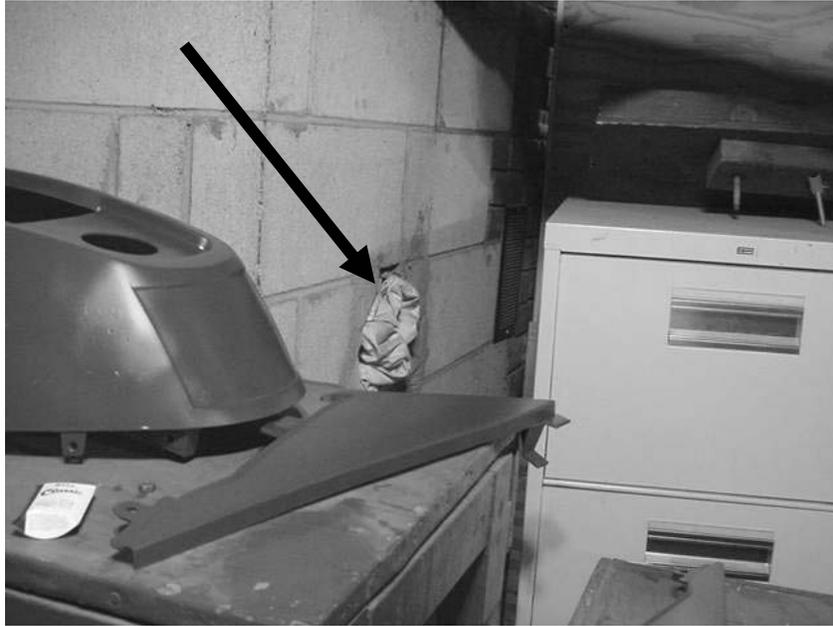
Picture 8

Hole in Chimney, Lower Level
