# **INDOOR AIR QUALITY ASSESSMENT**

**Granite Valley Middle School  
21 Thompson Street  
Monson, Massachusetts 01057**

Prepared by:  
Massachusetts Department of Public Health  
Bureau of Environmental Health  
Indoor Air Quality Program  
May 2009

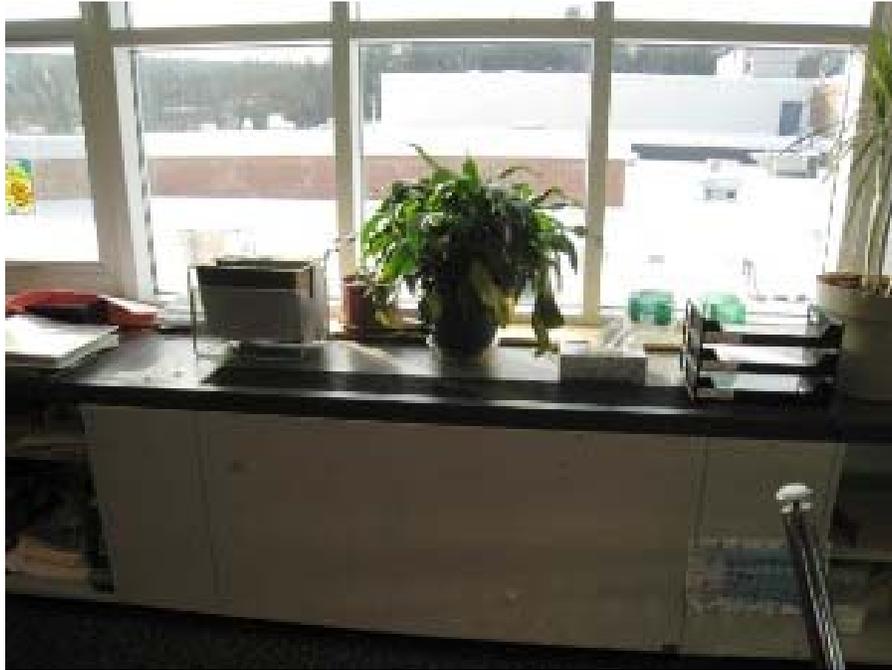
**Picture 1**

Plants were noted throughout the GVMS, located on or near unit ventilators, as well as a hanging over a carpeted area. A planter can be a source of moisture that can chronically moisten carpet and lead to mold growth. Plant soil and drip pans can serve as a source of mold growth. Plants should be properly maintained and be equipped with drip pans. Plants should also be located away from the air stream of mechanical ventilation to prevent aerosolization of dirt, pollen or mold.

**Unit Ventilator  
Note Plant in Air Stream**

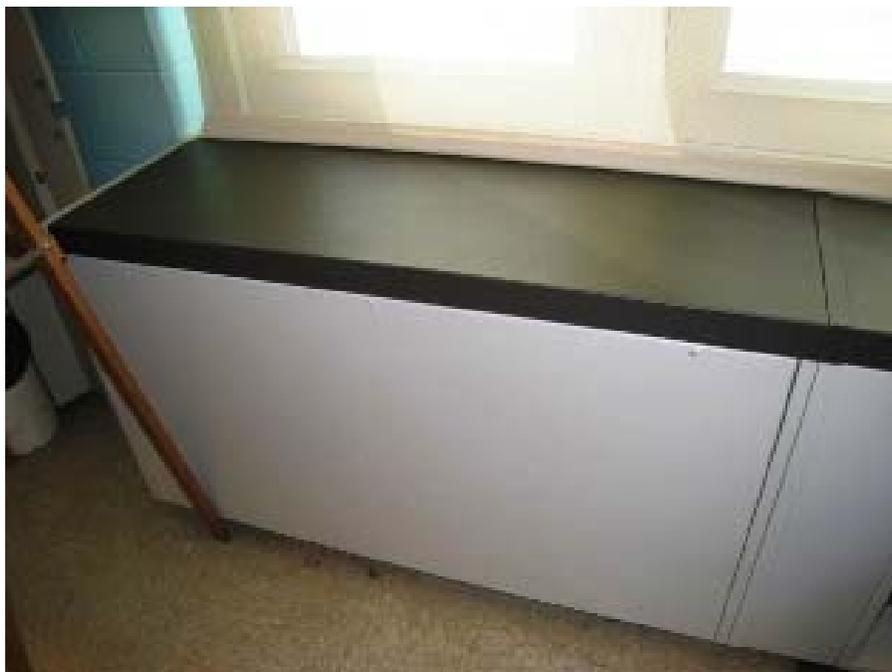
**Picture 2**

**Unit Exhaust**

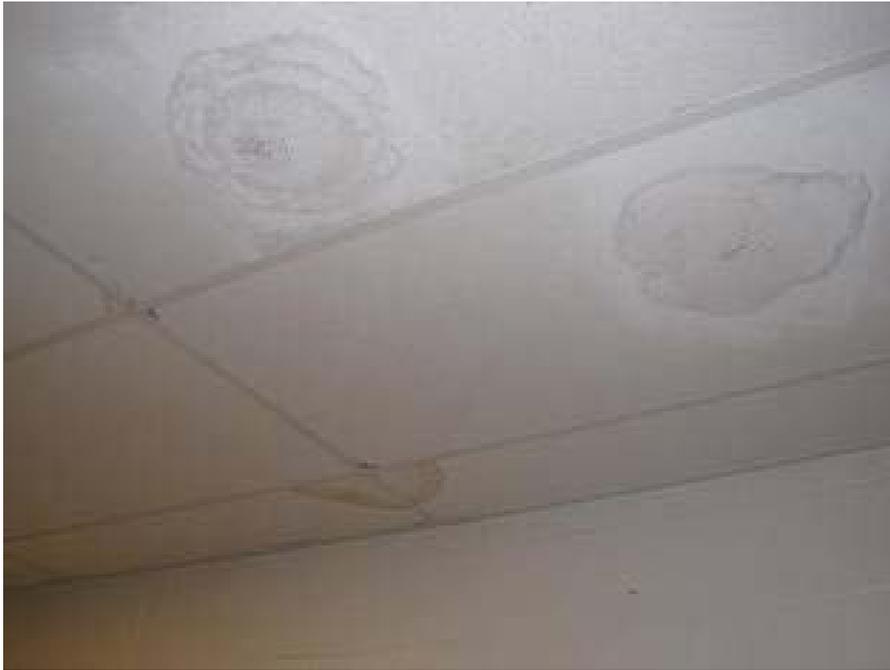
**Picture 3**

Several potential sources of water damage and/or mold growth were observed. Water damaged ceiling tiles were observed in several locations at GVMS. Several areas of water damaged tiles appeared to have been previously painted over rather than replaced (Picture 3). Additionally, in the basement, in the rear storage room, a ceiling area above the Modine heater exhibited extensive water damage (Picture 4). In the same storage room, the surfaces of some wooden furniture exhibited mold colonization. Porous materials exposed to chronic dampness provide the conditions conducive to mold colonization.

**Water Damaged Ceiling Tiles  
Note Painted Areas of Previous Water Damage**

1. Ensure leaks are repaired and replace water damaged ceiling tiles and gypsum wallboard. Examine the area above and around these areas for mold growth. Disinfect areas of water leaks with an appropriate antimicrobial.
2. Obtain Material Safety Data Sheets (MSDS) for all cleaning products used within GVMS and keep them in a central area that is accessible to all individuals during periods of building operations as required by the Massachusetts Right-To-Know Act (MGL, 1983).

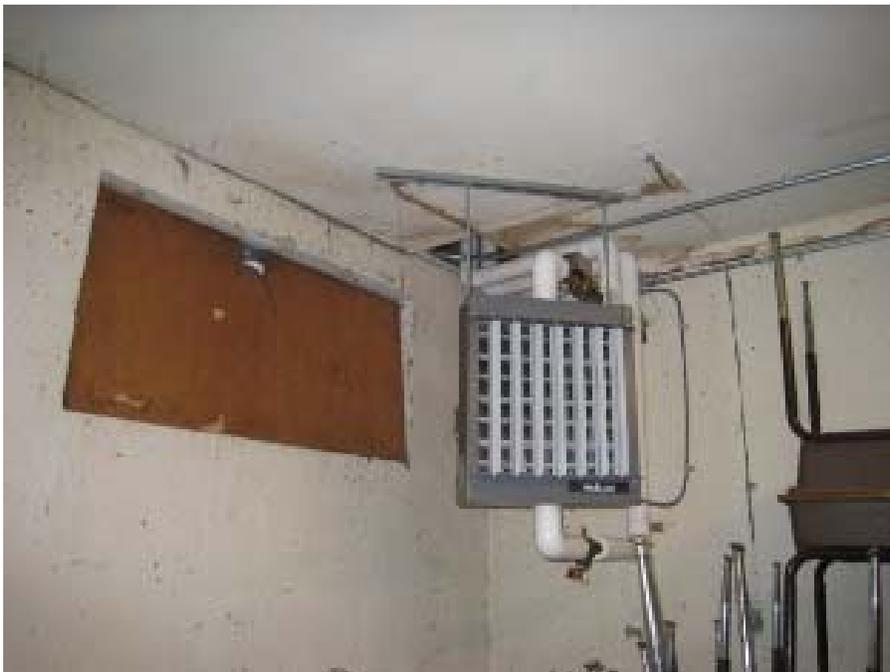
**Picture 4**

**Water Damage Above Modine Heater  
Note large penetration of pipes into ceiling**

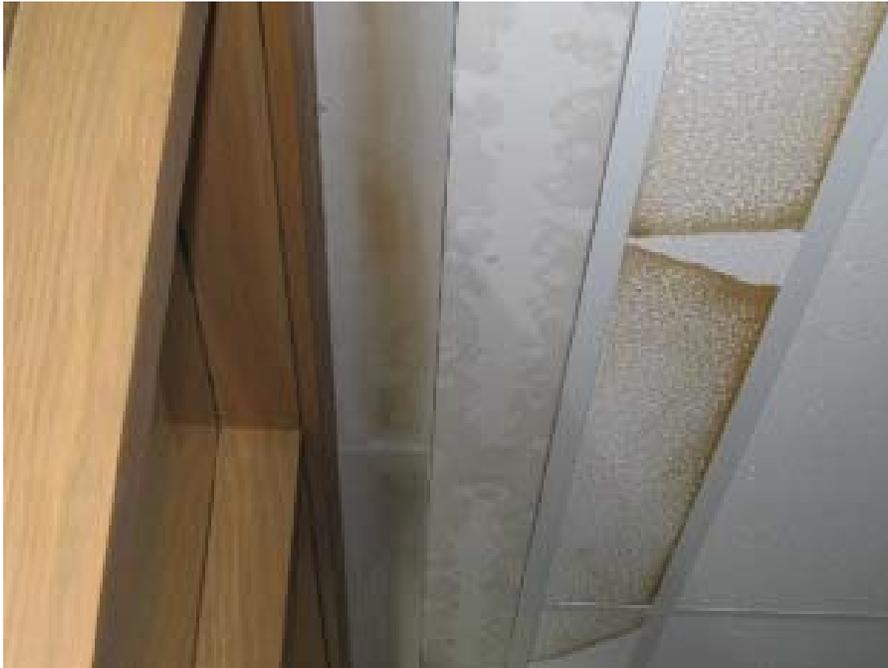
**Picture 5**

In the library, the inner office exhibited extensive water damage to ceiling tiles as well as gypsum wallboard (Picture 5). The former wood shop, which is currently used for storage, exhibits evidence of chronic moisture damage on the wood floor on either side of the overhead door (Picture 6).

**Water Damaged Ceiling Tiles and Drywall in Library**

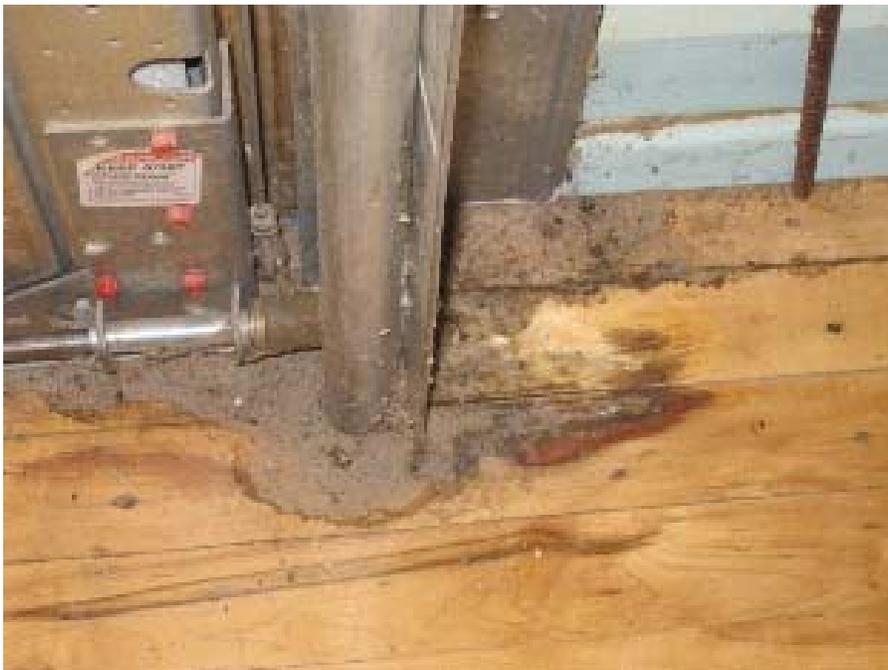
**Picture 6**

**Water Damage to Wooden Floor in Former Shop**

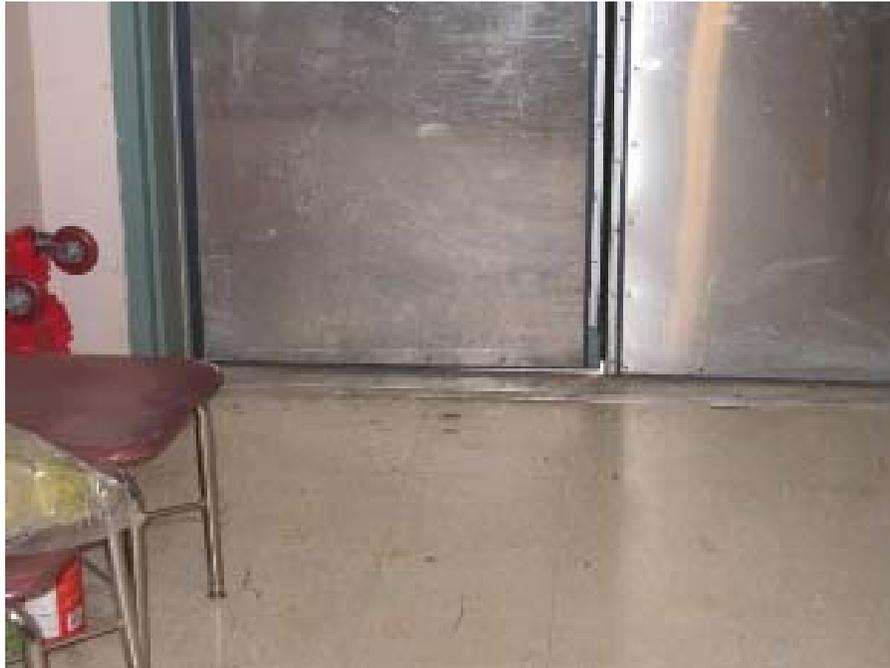
**Picture 7**

- Numerous exterior doors exhibit sizable gaps, including the overhead door in the basement (Picture 7). This can allow moisture, unconditioned air as well as rodents and insects into the building.
- Efflorescence was observed on several portions of the building (Picture 8). Efflorescence is a characteristic sign of water intrusion. As penetrating moisture works its way through mortar and around brick, it leaves behind characteristic mineral deposits.
- Some portions of the brick building lack weep holes. Exterior wall systems should be designed to prevent moisture penetration into the building interior. An exterior wall system should consist of an exterior curtain wall. Behind the curtain wall is an air space that allows for water to drain downward and for the exterior cladding system to dry. In

**Gap in Exterior Door**

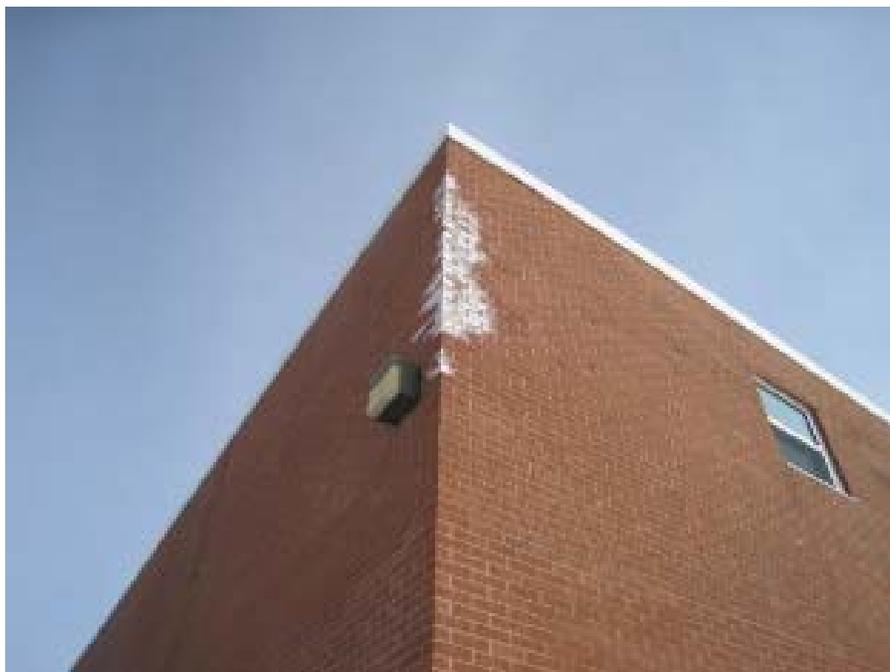
**Picture 8**

**Efflorescence**

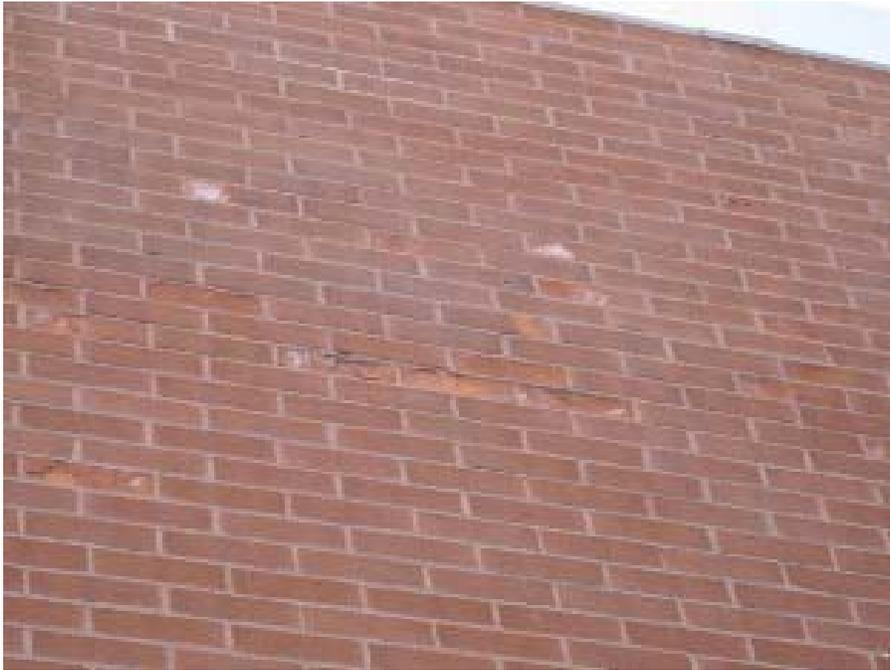
**Picture 9**

- Pieces of the outer layer of brick are flaking and falling off the building, a condition known as spalling (Picture 9). As can be seen in Picture 9, salt crystals are visible on the newly exposed brick surface. This condition is known as subflorescence. Subflorescence is indicative of moisture penetration through masonry. As moisture penetrates the brick surface, mineral salts are deposited on the interior of the brick. In the winter months, through the actions of freezing and thawing, the expansion within the brick creates spalling. Pieces of brick of various sizes were observed at the base of the building. The upper portions of the affected exterior walls appear to be buckling and bulging in response to this condition.

**Section of Bricks Spalling Due To Sub-florescence  
Note Mineral Salts Visible on Exposed Masonry**

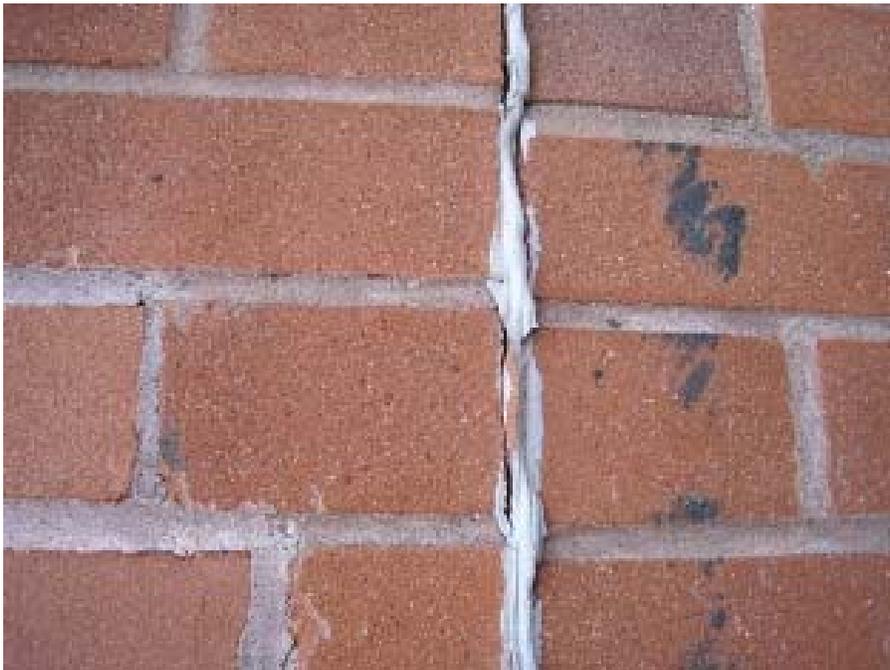
**Picture 10**

- Of note were expansion joints which were cracked and deteriorating (Picture 10).  
Expansion joints must be watertight and airtight, while at the same time, allowing for the joint to expand as necessary (“Accommodating Expansion”). As can be seen in Picture 11, the two sections of exterior walls that are joined at this expansion joint are not in the same plane. One or both of the walls appear to have shifted; therefore, one wall is higher and has moved more forward than the other (Picture 11).

**Deteriorating Sealant on Expansion Joint**

25. Repair missing and broken mortar on the exterior of the building.
26. Repair/replace expansion joint sealant. Repair cracks in concrete as well.
27. Develop a routine cleaning and maintenance program for roof drains in order to prevent rainwater from accumulating on the roof.

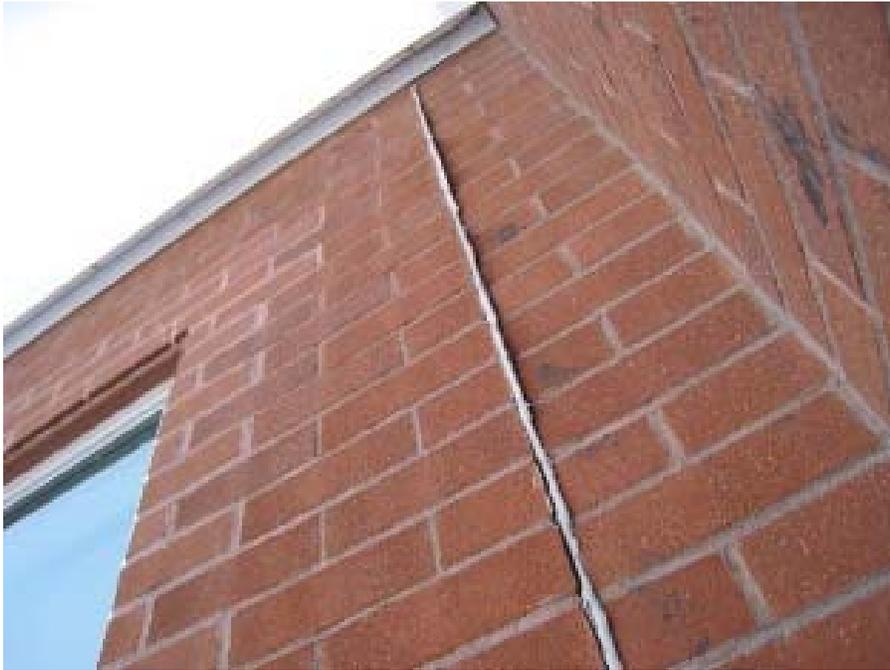
**Picture 11**

**Walls at Expansion Joint In Different Planes**

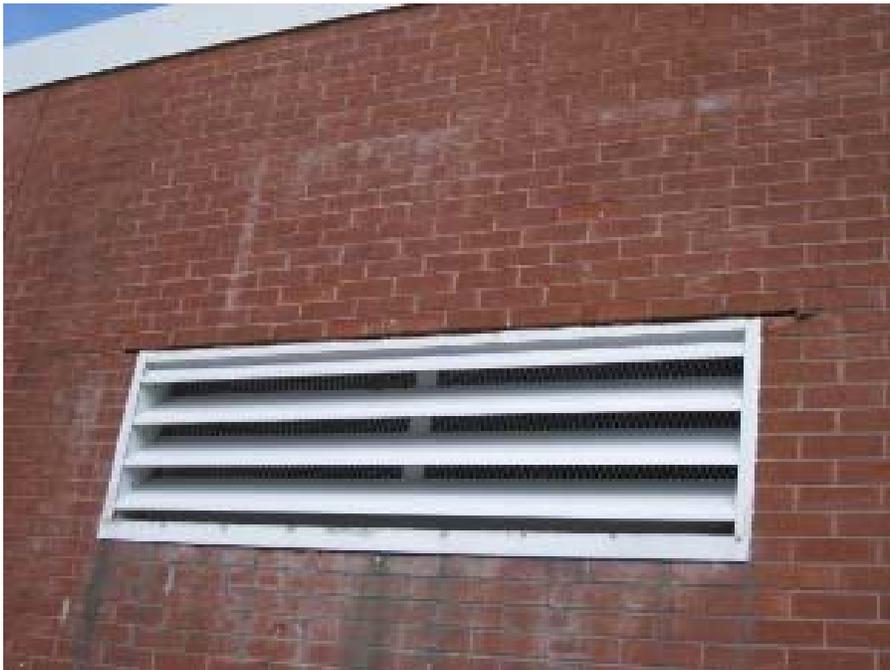
**Picture 12**

- Mortar is cracked and missing in some areas. The missing mortar may allow rainwater, unconditioned air as well as insects to enter the building’s envelope. As water penetrates the interior brick surfaces and is exposed to the elements, particularly the conditions of freezing and thawing, it can further deteriorate the building’s components. On the roof, caulking and mortar were observed to be missing or deteriorated adjacent to windows and fresh air intakes (Picture 12).

**Missing Mortar, Caulking and Water Stains on Masonry**

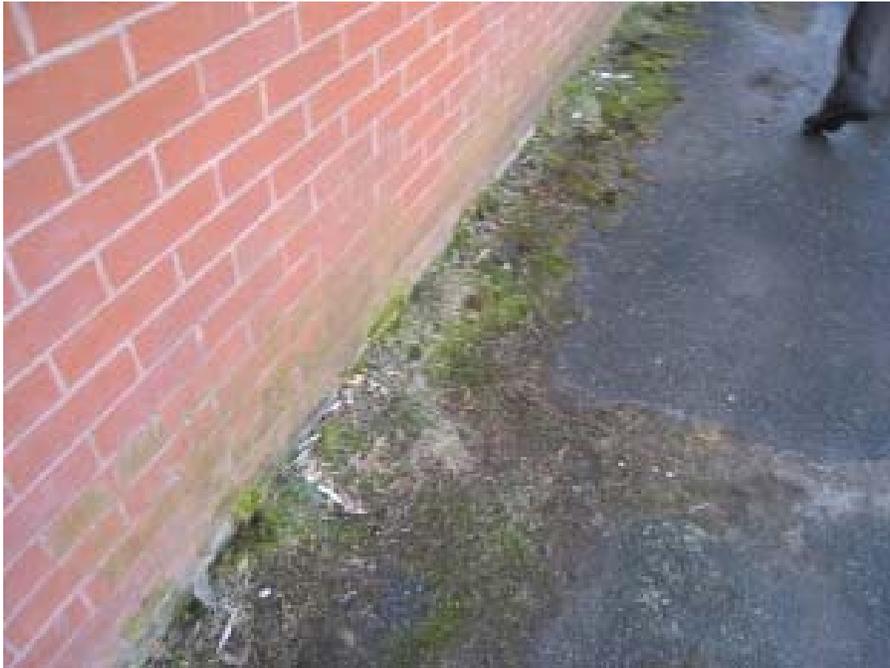
**Picture 13**

- Moss was observed on lower exterior walls, walkways and in the lawn on the north side of the building (Picture 13). The presence of moss on the brick and mortar shown in Picture 13 is indicative of repeated water exposure. The two main requirements of a moss are sufficient moisture and accessible nutrients. For example, the moist environment of a rooftop shaded by trees seems just fine for mosses, [which] prefer to colonize shingles above the eaves, on detritus that builds up in the eaves’ troughs or other depressions. Mosses will be at their best in the winter when there is plenty of water, little light and low temperatures” (OSU, 2000). It is evident from the moisture stains on the exterior brick, (known as mustaching) that the brick has been exposed to moderate to heavy amounts of moisture (Picture 14).

**Moss Growth On Masonry and Asphalt**

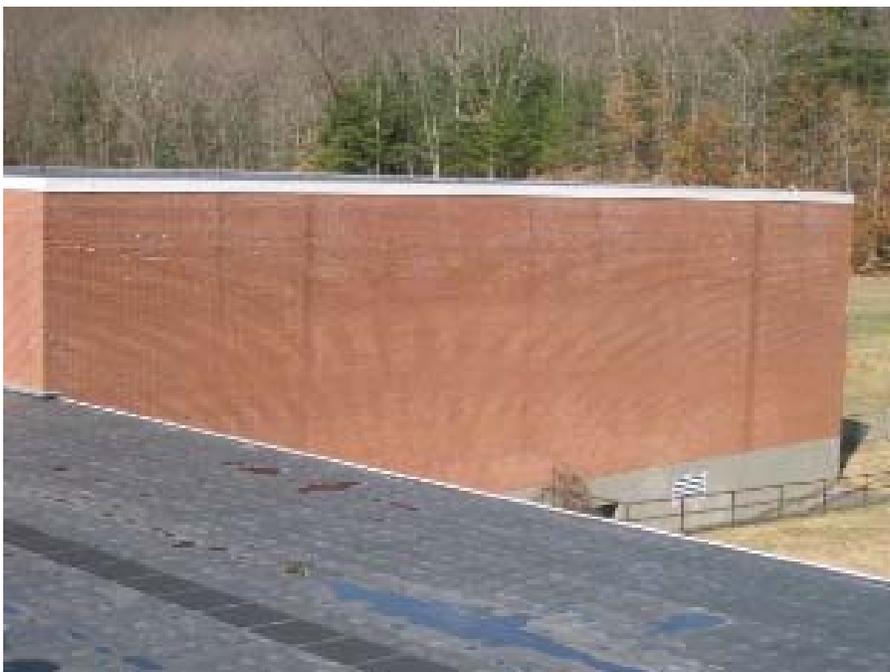
**Picture 14**

**Water Stains on Masonry**

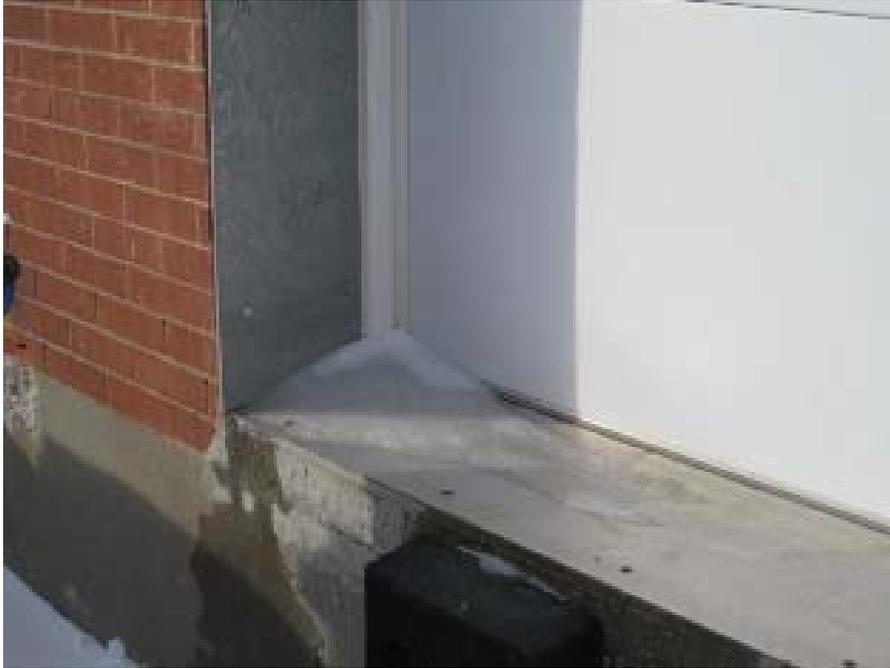
**Picture 15**

- Some egress doors were blocked by snow accumulation at the rear of the building. In addition, snow and ice accumulation was observed on the ledge outside the wood shop's overhead door (Picture 15). This condition may be entirely responsible for the water damage of the interior wooden floor as the snow and ice melt.

**Ice Accumulation on Loading Dock to Wood Shop**

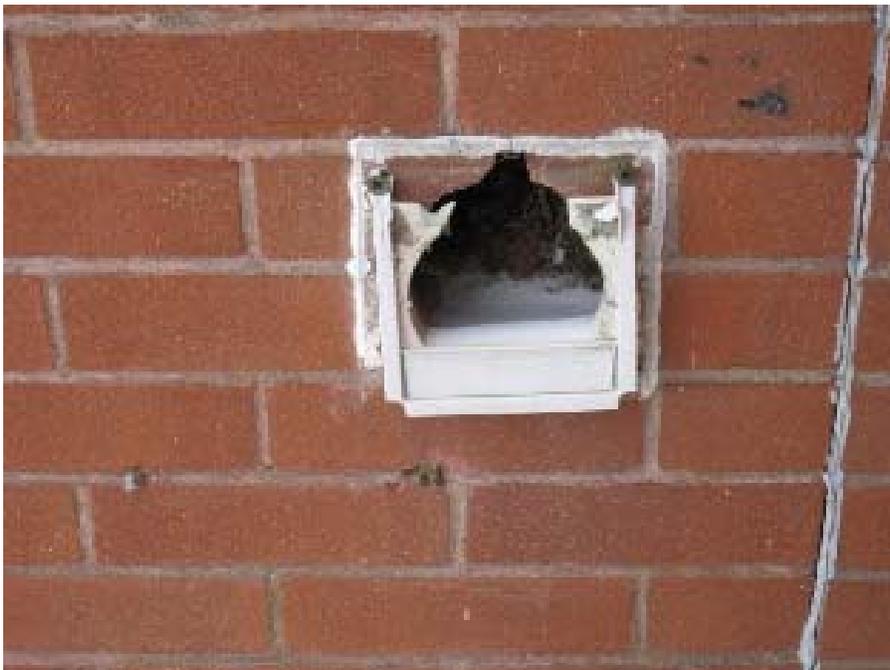
**Picture 16**

- A broken vent was observed on the exterior of the building (Picture 16). The vent appeared to contain an accumulation of snow and leaves. This accumulation could result in mold colonization in the vent.

**Broken Vent Cover Reveals Accumulation of Snow and Organic Debris**

28. Repair/Seal broken vent on the back of the building.
29. Use openable windows in conjunction with mechanical ventilation to facilitate air exchange. Care should be taken to ensure windows are properly closed at night and weekends to avoid the freezing of pipes and potential flooding.

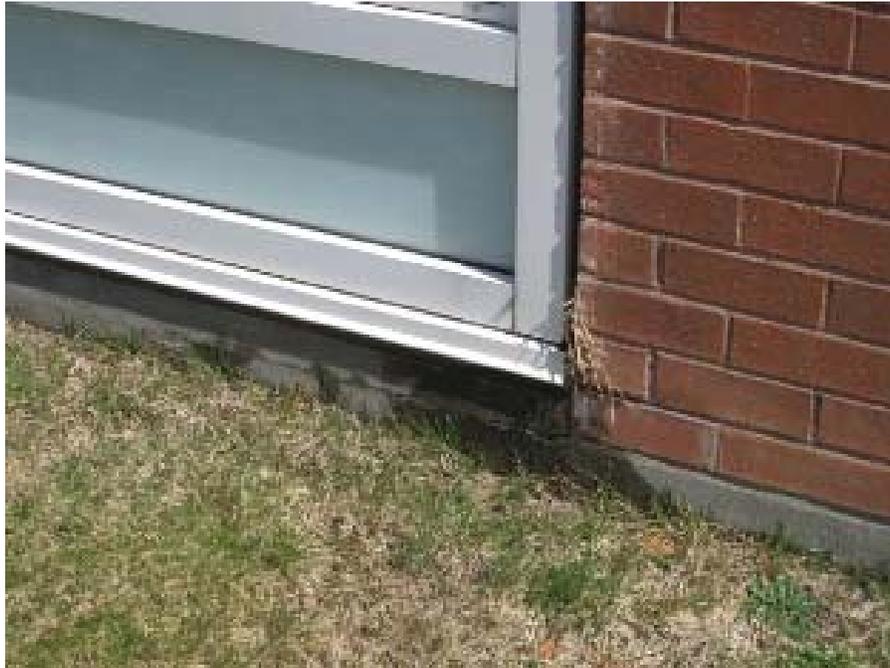
**Picture 17**

- The foundation exhibited cracks in some areas. One area of foundation near a univent exhibited moisture, which may indicate a plumbing leak in the univent (Picture 17). GVMS custodial staff stated they would assess whether a leak has occurred and if so, will arrange for its repair.

**Water Stains Adjacent to Univent**

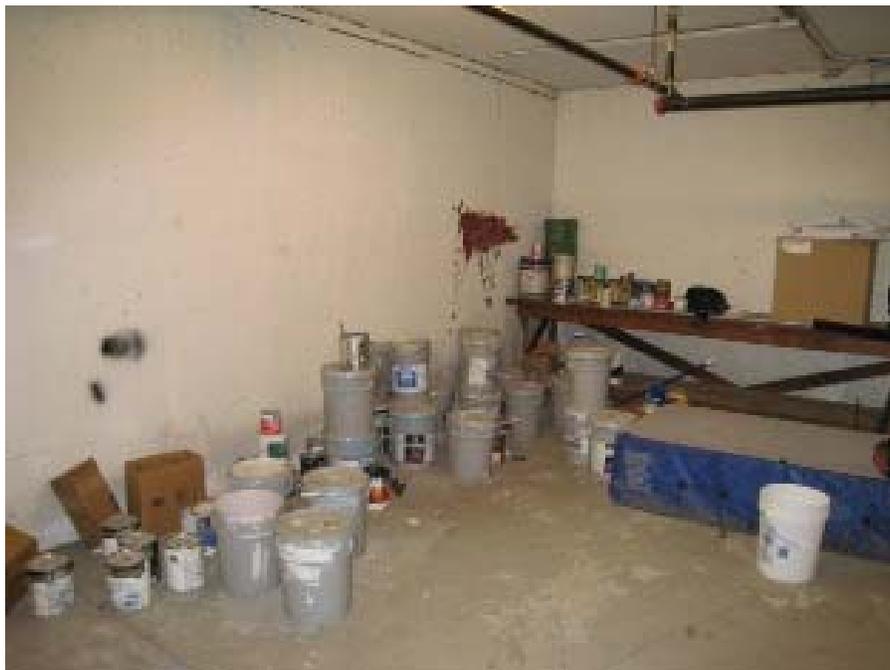
**Picture 18**

Numerous cans of paints and stains were observed in the basement. One can of paint had been left open to the atmosphere and dried around a paintbrush (Pictures 18 and 19). As previously mentioned, paints contain VOCs, which can be irritating to the respiratory system.

**Numerous Paints/Stains Stored in Basement**

12. Discontinue use of dry erase markers. If not feasible, utilize markers with lower VOCs.
13. Ensure all paints are stored with tightly closed lids. Properly dispose of old paints and stains that are no longer being used.

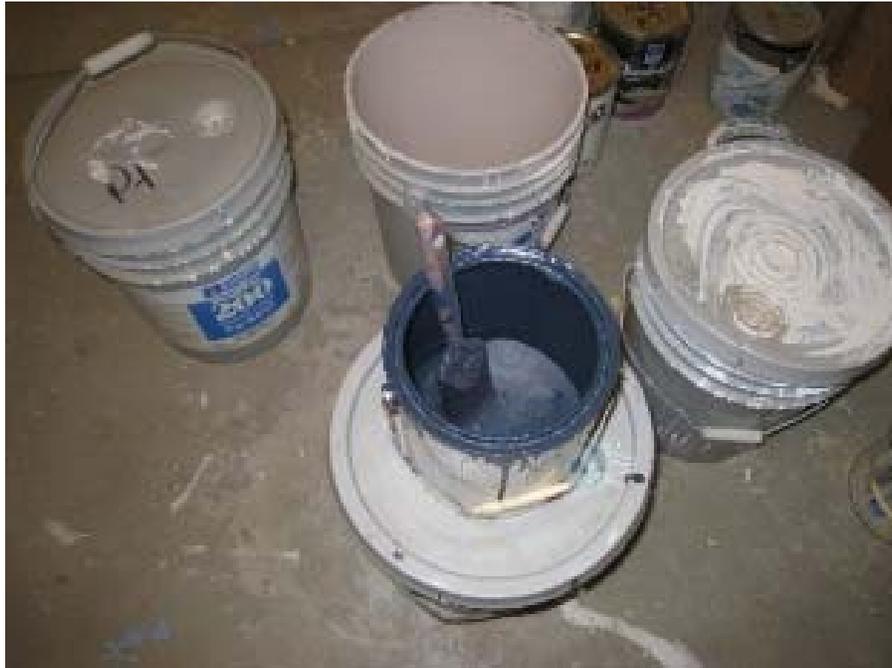
**Picture 19**

**Open Can of Paint**

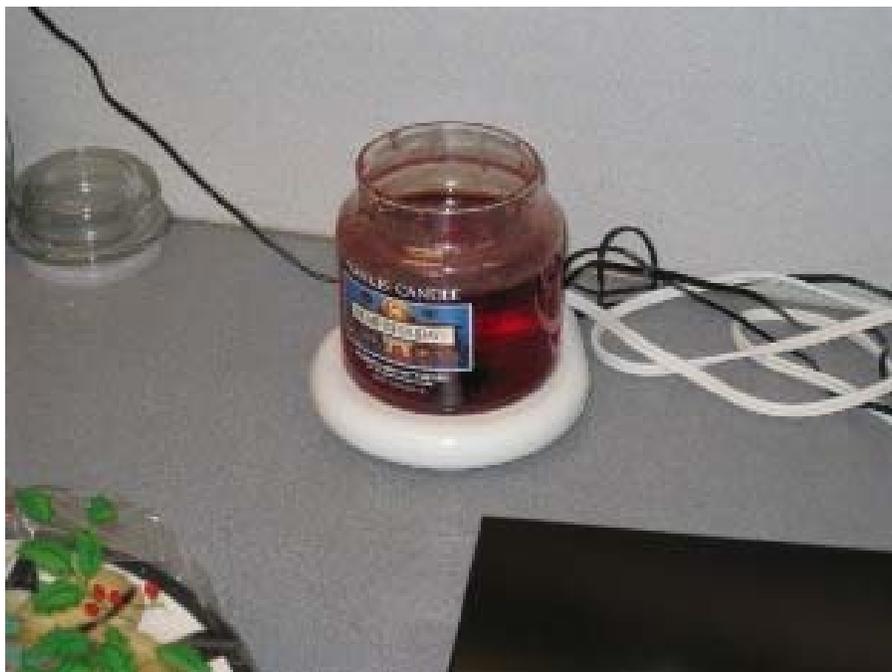
**Picture 20**

Candle warmers, reed diffusers and deodorizing materials were observed in several areas at the GVMS (Picture 20). Air deodorizers contain chemicals that can be irritating to the eyes, nose and throats of sensitive individuals. Many air fresheners contain 1,4-dichlorobenzene, a VOC which may cause reductions in lung function (NIH, 2006). Furthermore, deodorizing agents do not remove materials causing odors, but rather mask odors that may be present in the area. A lawnmower was also observed to be stored in the basement. In addition to being a potential fire hazard, the potential exists for VOC emissions from the gas tank to enter the basement area.

**Candle Warmer**

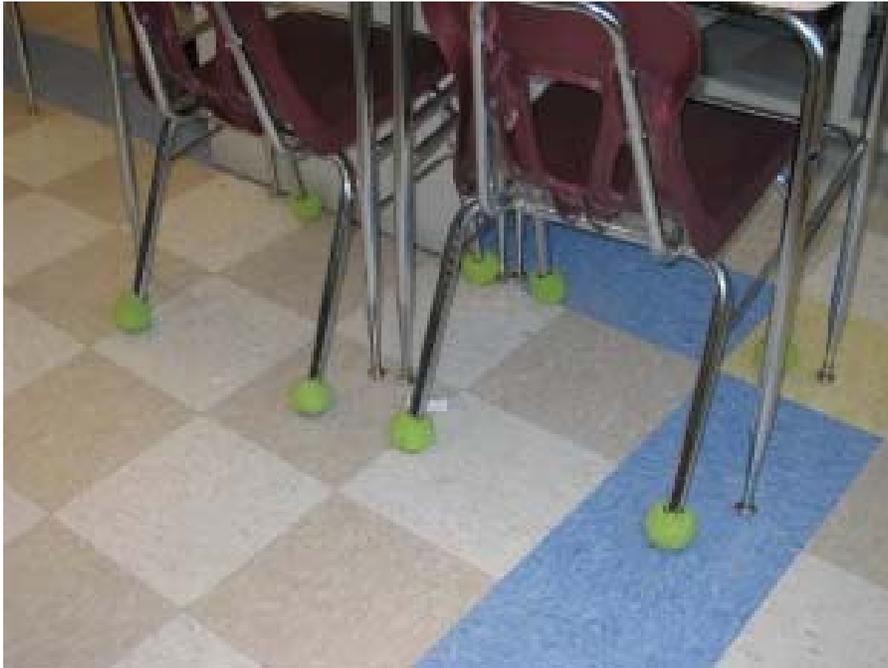
**Picture 21**

In an effort to reduce noise from sliding chairs and tables, tennis balls were sliced open and placed on chair legs in at least one classroom (Picture 21). Tennis balls are made of a number of materials that are a source of respiratory irritants. Constant wearing of tennis balls can produce fibers and off-gas VOCs. Tennis balls are made with a natural rubber latex bladder, which becomes abraded when used as a chair leg pad. Use of tennis balls in this manner may introduce latex dust into the school environment. Some individuals are highly allergic to latex (e.g. spina bifida patients) (SBAA, 2001). It is recommended that the use of materials containing latex be limited in buildings to reduce the likelihood of symptoms in sensitive individuals (NIOSH, 1997). A question and answer sheet concerning latex allergy is attached as [Appendix C](#) (NIOSH, 1998).

**Tennis Balls Used on Chair Legs**

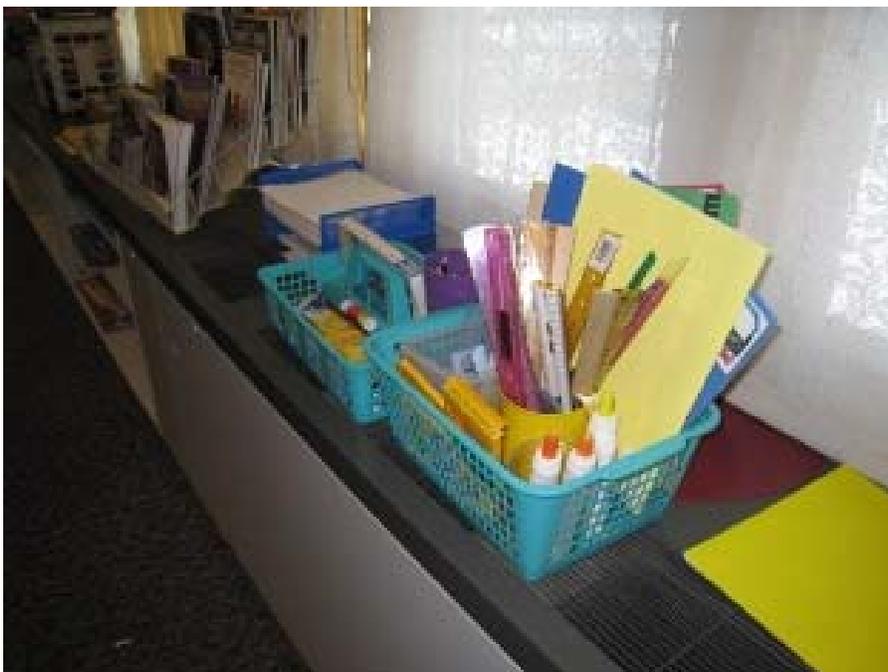
**Picture 22**

**Supplies Stored on Top of Univent**

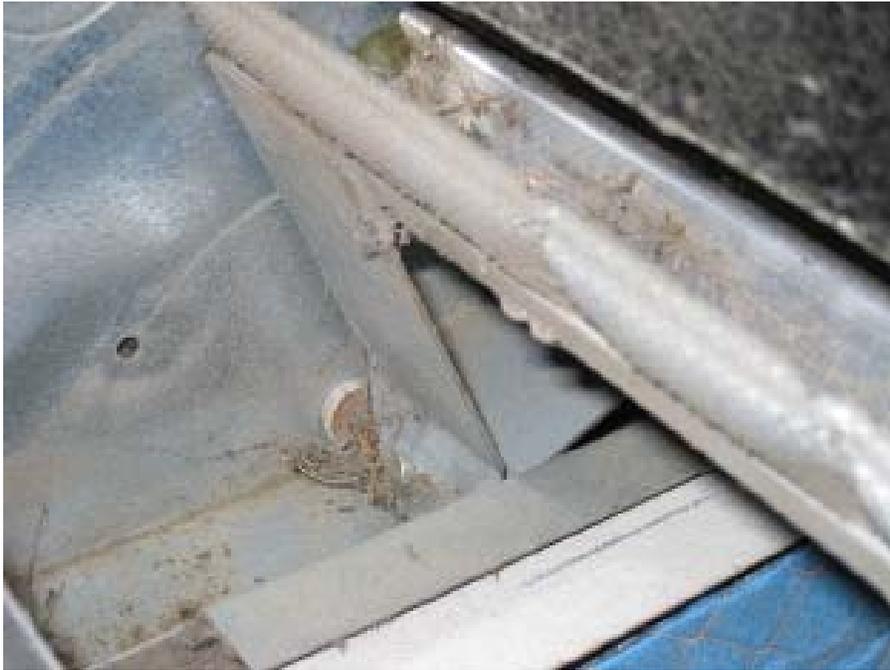
**Picture 23**

**Dust Accumulation on Interior of Univent**

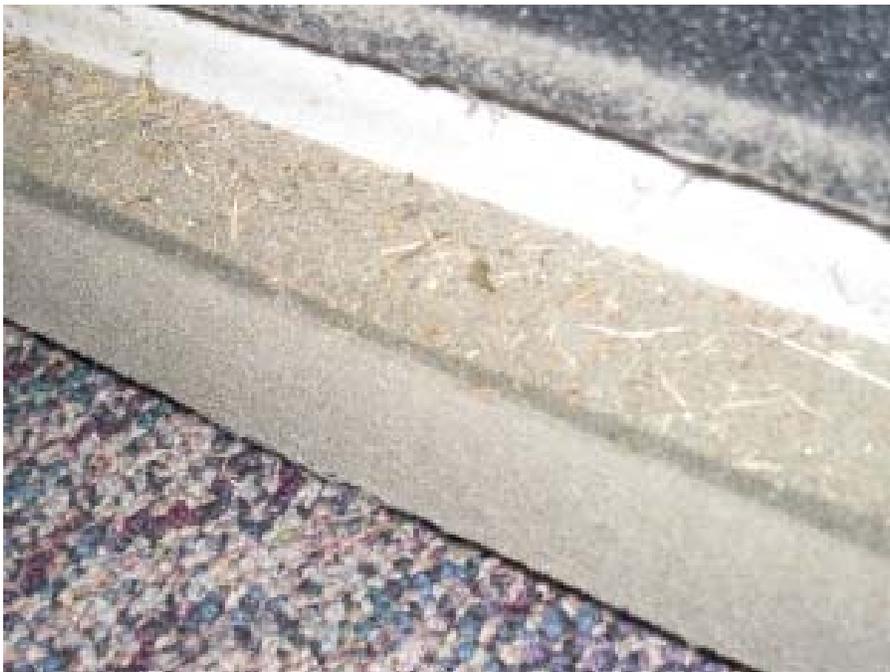
**Picture 24**

**Grass Clippings on Interior Cover of Univent**

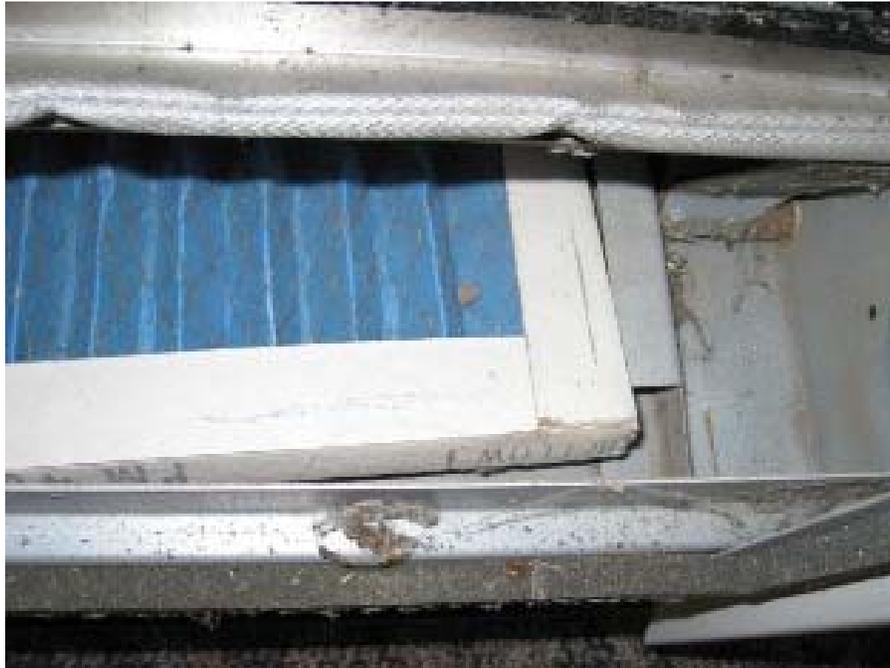
**Picture 25**

**Filter Installation Allows Air to Bypass Filter**

3. Ensure filters for all AHUs and univents fit flush in their racks with no spaces to prevent bypass of unfiltered air.
4. Change filters for air-handling equipment (e.g., univents, AHUs and ACs) as per the manufacturer's instructions or more frequently if needed. Ensure interior as well as exterior portions of the univents (fresh air intakes) and exhaust grates are in a clean condition as well.

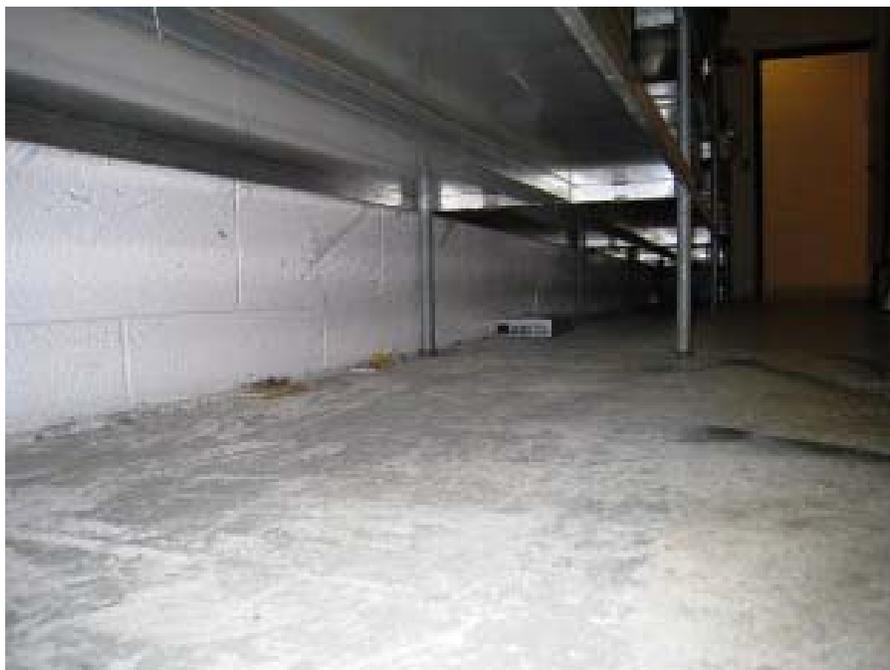
**Picture 26**

A variety of potential allergens were noted at GVMS. Numerous rodent traps were observed in the dry food storage room as well as in the kitchen area (Picture 26). GVMS staff informed BEH that numerous mice had been caught this year in the kitchen/dry storage area. Additionally, a strong odor of decay (most likely a mouse) was detected by BEH staff from within the wall cavity beneath the sink in the copy room. As previously mentioned, several exterior doors exhibit gaps. To penetrate the exterior of a building, rodents require a minimal breach of ¼ inch (MDFA, 1996). Rodent infestation results from easy access to food and water in a building. Rodent infestation can result in indoor air quality related symptoms due to materials in their wastes (i.e., urine). Mouse urine contains a protein that is a known sensitizer (US EPA, 1992). A three-step approach is necessary to eliminate rodent infestation:

**Mousetraps Observed Beneath Shelving in Dry Storage Room**

7. Use the principles of integrated pest management (IPM) to prevent infestation of pests. A copy of the IPM recommendations from the Massachusetts Department of Food and Agriculture (MDFA, 1996) can be obtained at the following website:

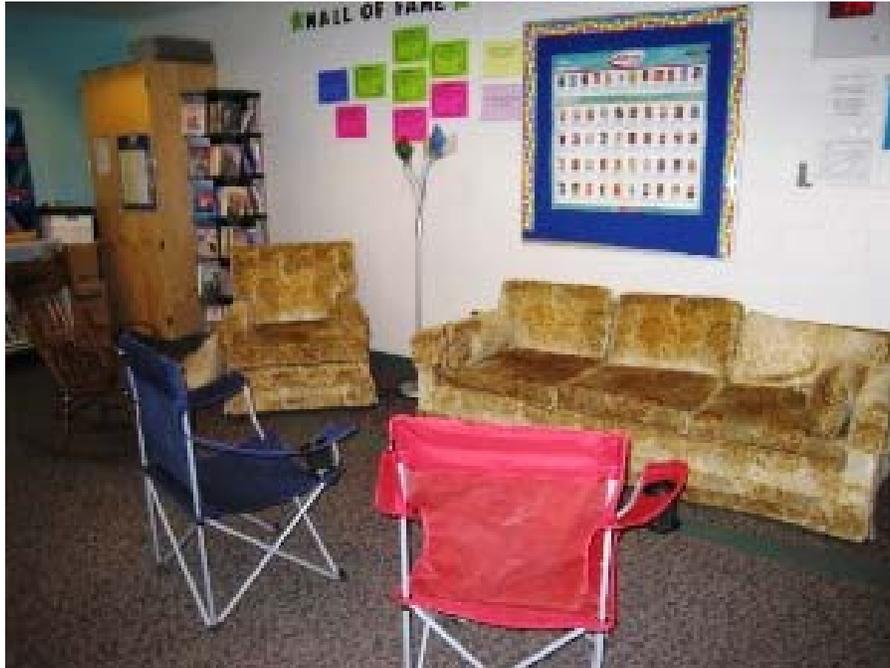
**Picture 27**

A number of classrooms contained upholstered furniture and pillows (Picture 27). Upholstered furniture is covered with fabric that comes into contact with human skin, leaving oils, perspiration, hair and skin cells. Dust mites feed upon human skin cells and excrete waste products that contain allergens. In addition, if relative humidity levels increase above 60 percent, dust mites tend to proliferate (US EPA, 1992). In order to remove dust mites and other pollutants, frequent vacuuming of upholstered furniture is recommended (Berry, 1994). It is also recommended that upholstered furniture (if present in schools), be professionally cleaned on an annual basis. If an excessive dusty environment exists due outdoor conditions or indoor activities (e.g., renovations), cleaning frequency should be increased (every six months) (IICR, 2000). Elevated outdoor levels of airborne particulates can result in increased levels of indoor particulates by entering into the building through open windows, doors and filter bypass.

**Upholstered Furniture in Classroom**

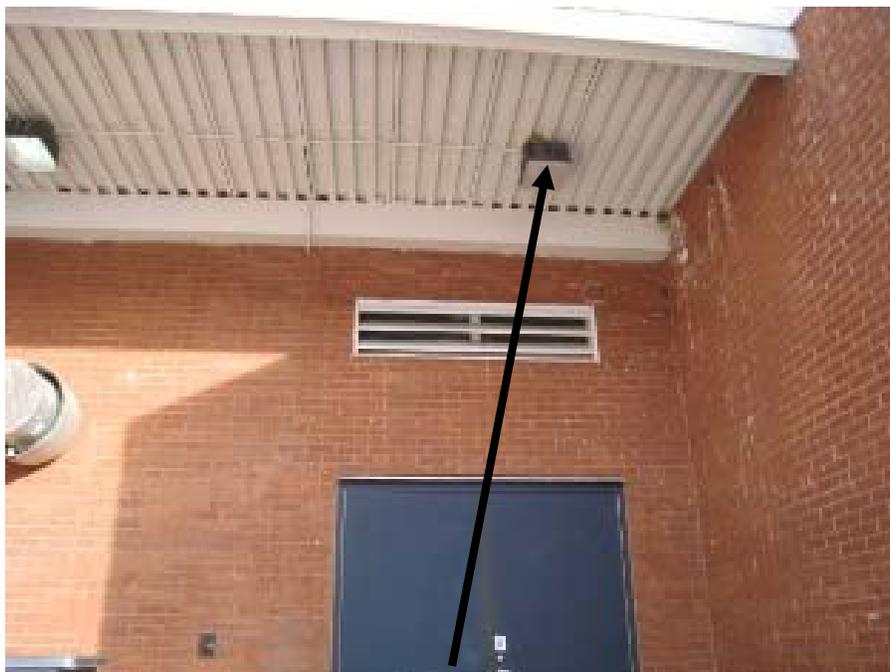
**Picture 28**

Signs of bird roosting and nesting materials were observed in a number of recesses (e.g. within overhangs, above light fixture) around the exterior of the building near a fresh air intake (Pictures 28 and 29). Accumulated bird waste was observed on exterior brick walls. Birds can be a source of disease, and bird wastes and feathers can contain mold and mildew, which can be irritating to the respiratory system. No obvious signs of bird roosting inside the building or in ventilation components were noted by BEH staff or reported by occupants. A few fresh air intakes exhibited hornets' nests. Nests can contain bacteria and may also be a source of allergenic material.

**Bird Nesting Materials in Proximity to Air Intake**

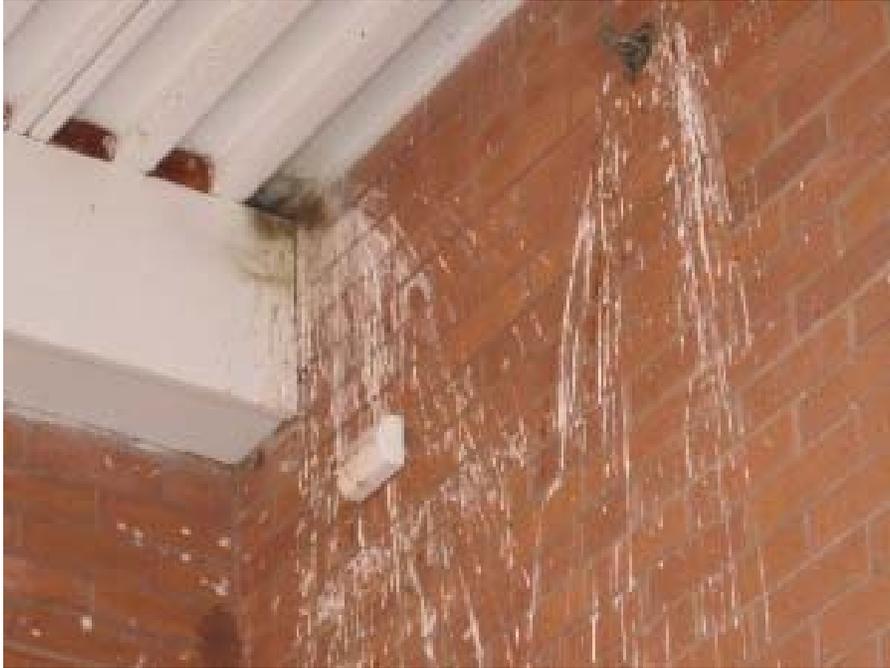
**Picture 29**

**Bird Droppings on Exterior of Building Near Air Intake**

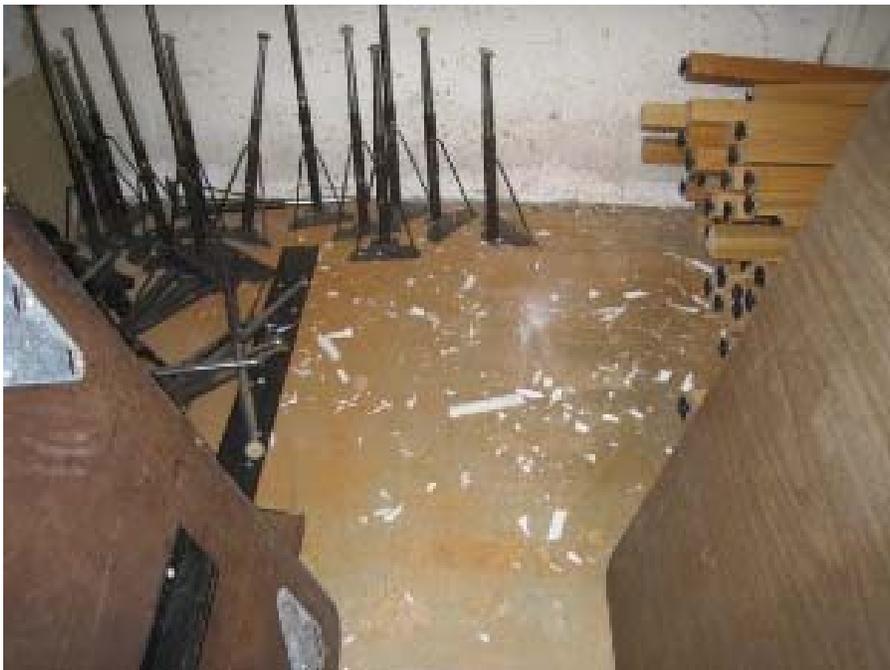
**Picture 30**

Broken fluorescent light bulbs were observed in the basement storage area (Picture 30). These bulbs contain and release mercury when broken, therefore, they must be stored, utilized and disposed of with care. GVMS staff were provided with information regarding cleanup guidelines (Appendix D).

**Broken Fluorescent Light Bulb(s) in Basement**

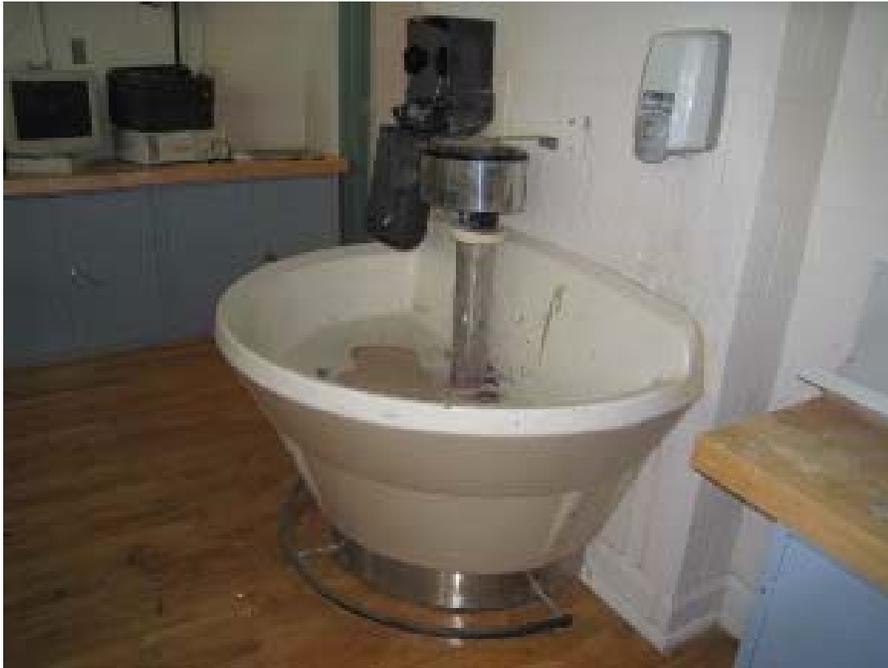
**Picture 31**

**Shop Sink With Dry Drain**
