# **INDOOR AIR QUALITY ASSESSMENT**

**Granite Valley Middle School  
21 Thompson Street  
Monson, Massachusetts 01057**

Prepared by:  
Massachusetts Department of Public Health  
Bureau of Environmental Health  
Indoor Air Quality Program  
May 2009

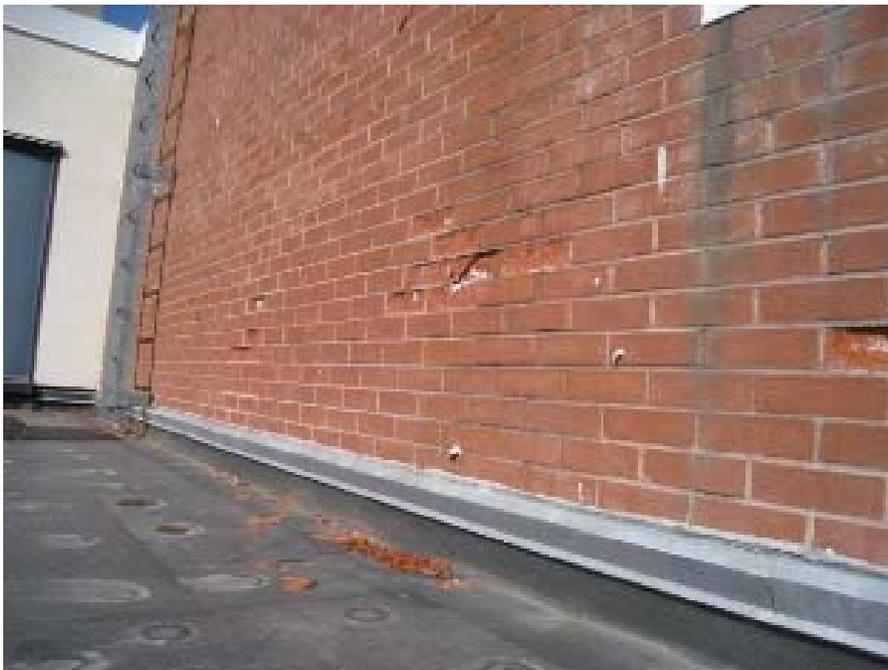
**Picture 32**

**Spalling, Water Stains and Subflorescence on Exterior of Gymnasium**

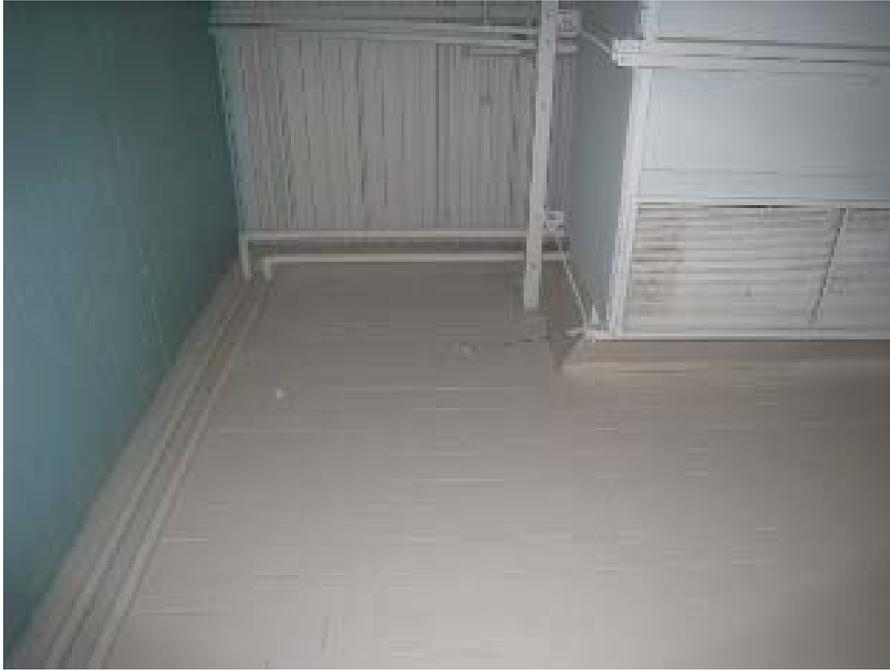
**Picture 33**

**Absence of Water Damage on Interior Gymnasium Walls**
