# **Mold/Water Damage Remediation Assessment**

**Massachusetts Registry of Motor Vehicles  
278 Union Street  
New Bedford, Massachusetts**

**Prepared by:  
Massachusetts Department of Public Health  
Bureau of Environmental Health  
Indoor Air Quality Program  
May 2011**

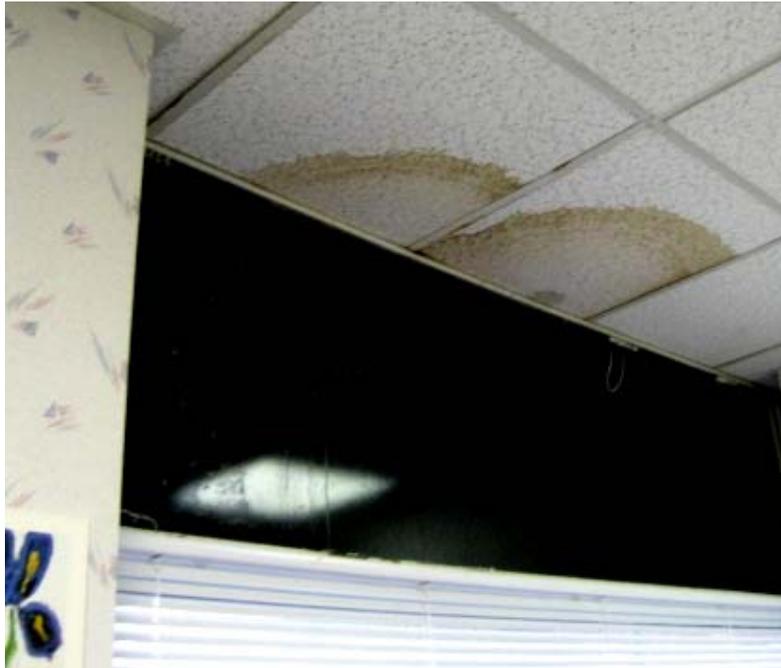
**Picture 1**

Water damaged building materials in the form of stained ceiling tiles, wooden window trim and gypsum wallboard (GW) around the window frame in the breakroom was observed (Pictures 1 through 3). The most likely source of water penetration was missing/damaged exterior caulking/flashing around the window (Picture 4). Elevated moisture content and visible water damage/mold growth was observed on GW beneath vinyl wall covering along the base of the window frame (Picture 3). Vinyl wallpaper is a water impermeable material that can “trap” moisture. Although water-damaged, wooden window trim and ceiling tiles were dry (i.e., low moisture) at the time of the assessment (Table 1).

**Water-Damaged Ceiling Tiles in Breakroom**

1. Make repairs to exterior window caulking/flashing around breakroom window. Use high pressure water to check repairs/identify further leakage.
2. Replace water-damaged ceiling tiles, wooden window trim, and mold-colonized vinyl wallpaper and GW at the base of the breakroom window.
3. Refer to resource manual and other related indoor air quality documents located on the MDPH's website for further building-wide evaluations and advice on maintaining public buildings. These documents are available at: <http://mass.gov/dph/iaq>.

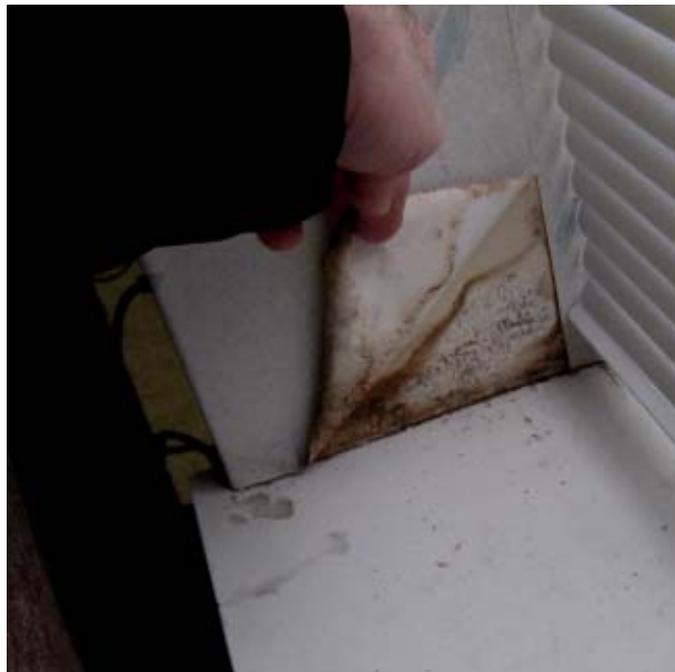
**Picture 2**

**Water-Damaged/Mold Colonized Vinyl Wallpaper and Gypsum Wallboard in Breakroom**

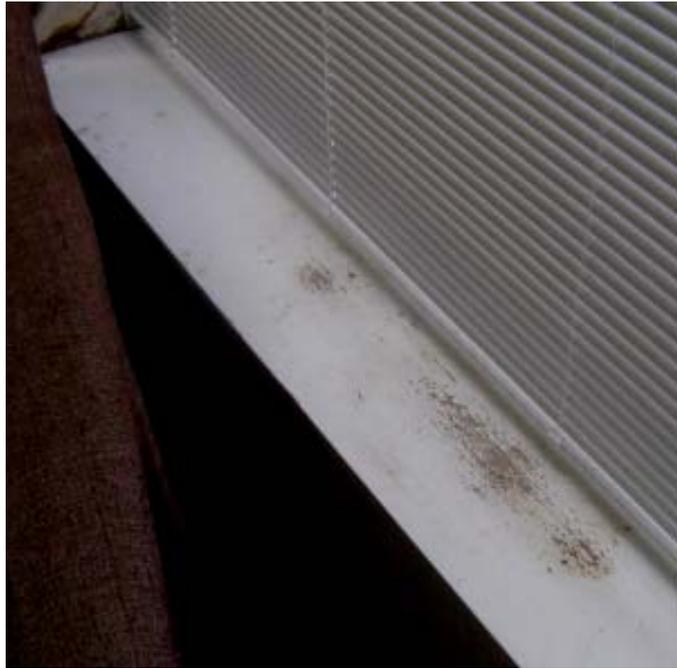
**Picture 3**

**Water-Damaged Wooden Window Trim in Breakroom**

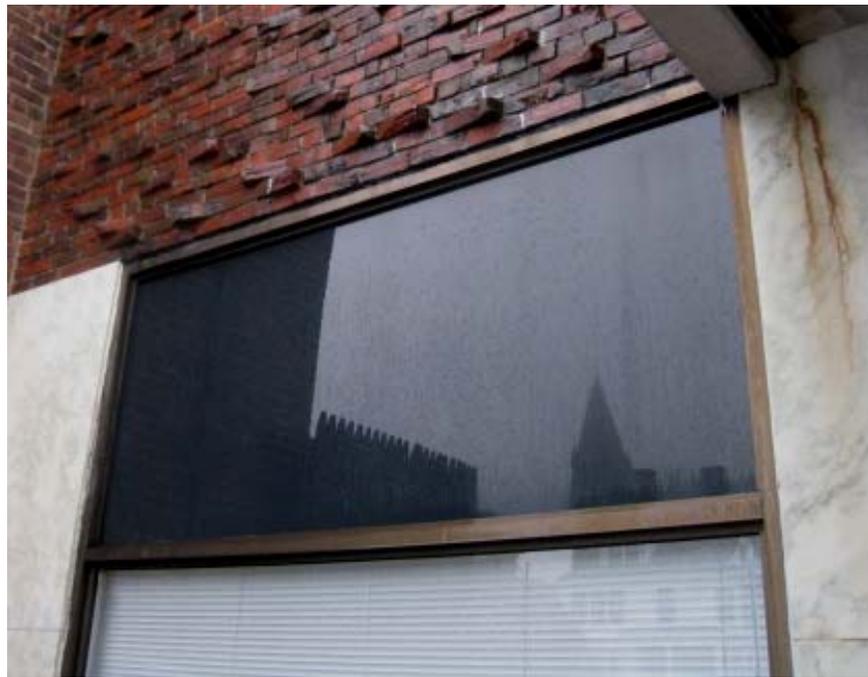
**Picture 4**

**Exterior View of Leaking Breakroom Window**
