INDOOR AIR QUALITY ASSESSMENT

**Massachusetts Commission for the Blind
600 Washington Street, 3rd Floor
Boston, Massachusetts**

Prepared by:
Massachusetts Department of Public Health
Bureau of Environmental Health
Indoor Air Quality Program
March 2013

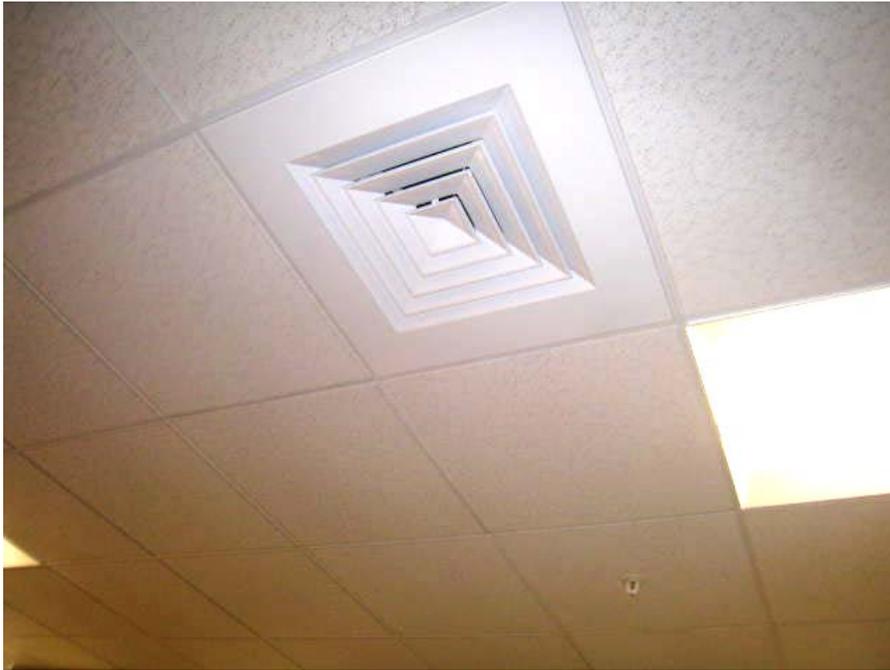
Picture 1

Typical supply vent

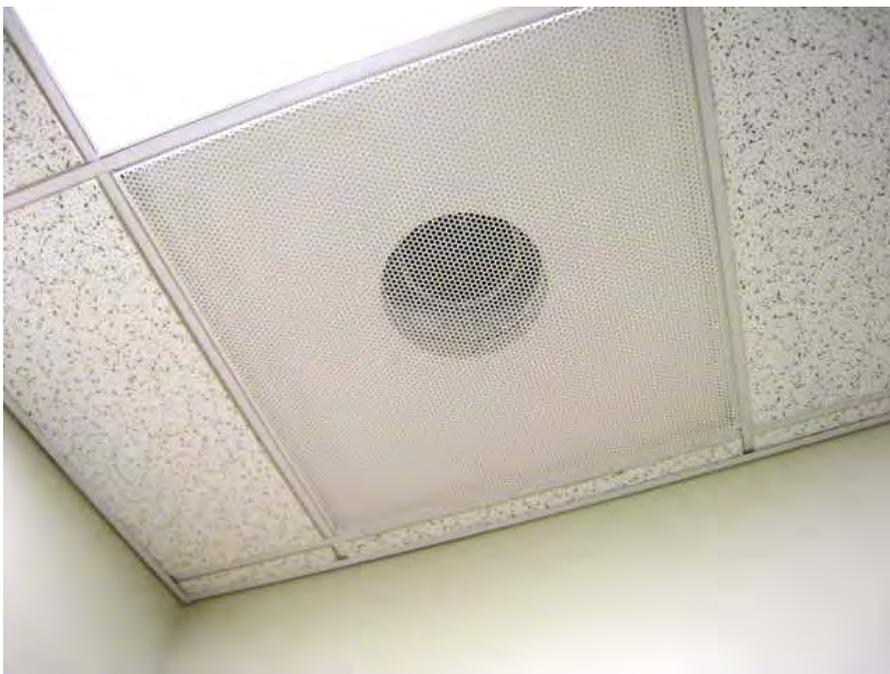
Picture 2

BEH/IAQ staff noted that the arrangement of supply and particularly, exhaust vents in the space may not be in an optimal configuration. In the open cubicle areas, there were significantly more supply vents than exhaust vents noted, and there were typically no exhaust vents located above items such as photocopiers and shredders, which may be a source of waste heat, odors and pollutants. An exhaust vent was noted directly adjacent to the door to the mechanical room (between rooms 3164 and 3165) and the mechanical room door was outfitted with a passive door vent which had been sealed, but not tightly. In this configuration the exhaust vent would tend to draw air from the mechanical room, which would entrain pollutants directly from the mechanical room into the HVAC system.

Typical exhaust vent

6. Remove or relocate the exhaust vent directly adjacent to the mechanical room door.
Consider adding additional exhaust vents in the cubicle areas and if possible rearranging the locations of supply vents to provide occupants of the semi-private offices with both supply and exhaust ventilation and increase exhaust ventilation near the location of copiers.

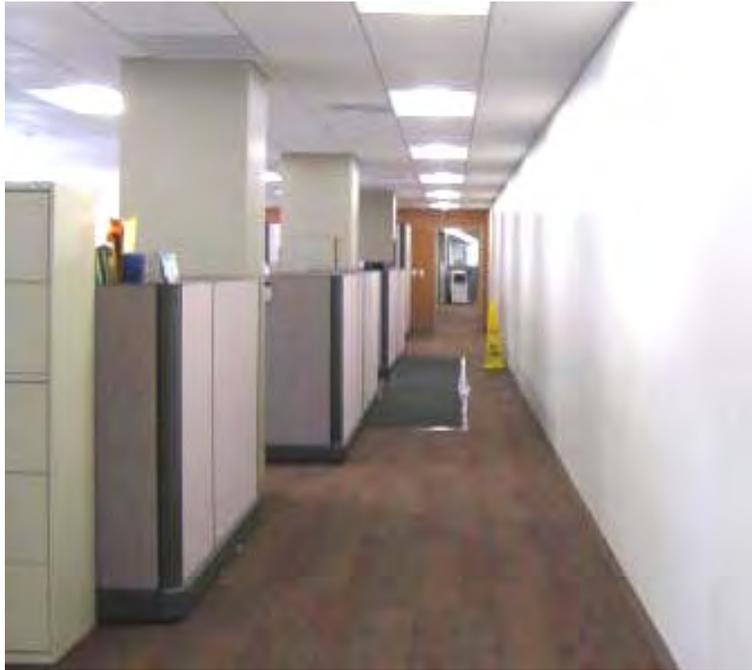
Picture 3

Of particular concern the day of the original assessment (August 30, 2012) was an area of water-damaged flooring located in the wing extending along the southeast side of the floor. An area of carpet tiles that were curling up from the floor was reportedly discovered a few days prior to the assessment. Since a number of employees and visitors to this office have vision problems, it is very important to render the floor as free from obstructions as possible, so this area was covered with a taped-down floor mat (Picture 3). It was determined during the assessment that there was moisture in and underneath the carpet tiles in this area (Pictures 4 and 5). However, the source of water was not identified during that visit. Several potential sources were ruled out at the time based on the location and pattern of moistening, including window or ceiling leaks, leaks from the adjacent space, or a disused theater that could not be accessed at the time of the assessment.

Southeast hallway with taped-down runner

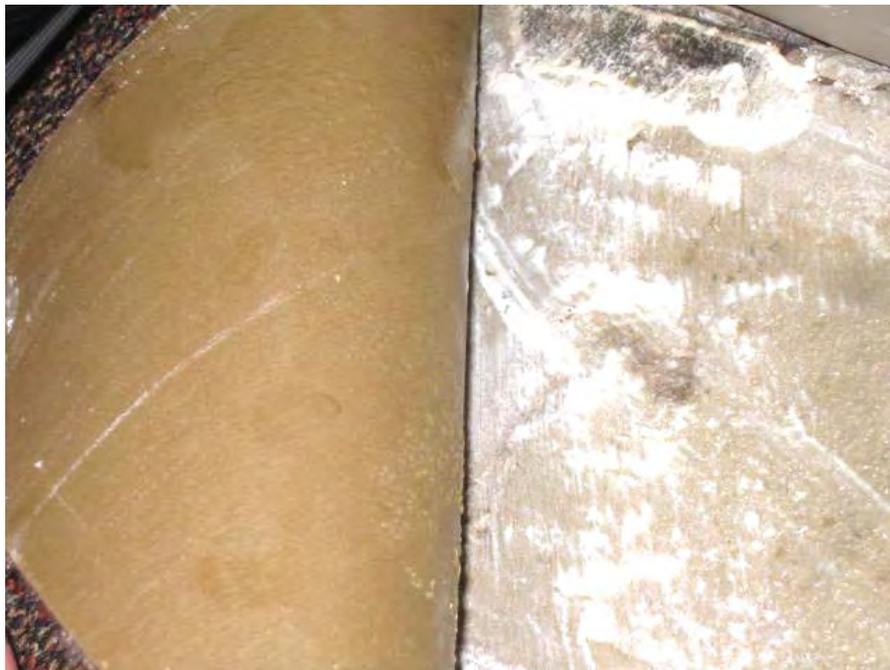
Picture 4

Lifting/loosened carpet tile with moisture underneath

1. Continue to operate fans to dry out flooring.
2. Remove water-damaged flooring to restore the floor to a smooth surface.
3. Ensure that the condensation pump is operational and actively pumping as needed.

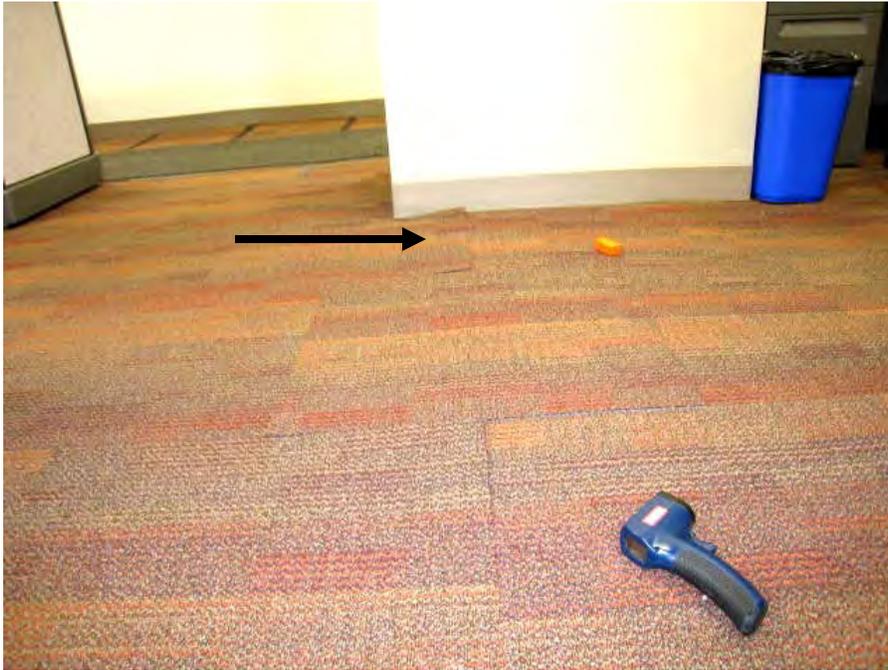
Picture 5

Area with lifting carpet tiles (arrow)

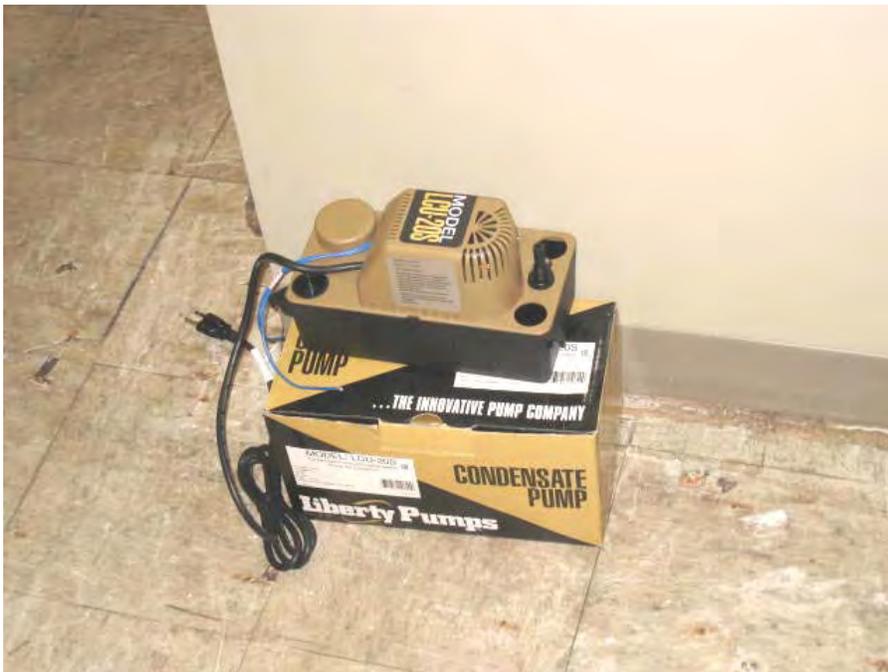
Picture 6

During the September 5, 2012 visit, BEH/IAQ staff were informed that the source of water was a deactivated condensation pump for the AHU (Picture 6) installed in the ceiling plenum. Condensation from the AHU filled the condensation pump, which overflowed wetting carpet/flooring in a 5-foot radius around the pillar (Picture 7). At the time of the September 5, 2012 visit, building/facility maintenance had opened the floor and had used carpet fans to aid in

Condensate pump

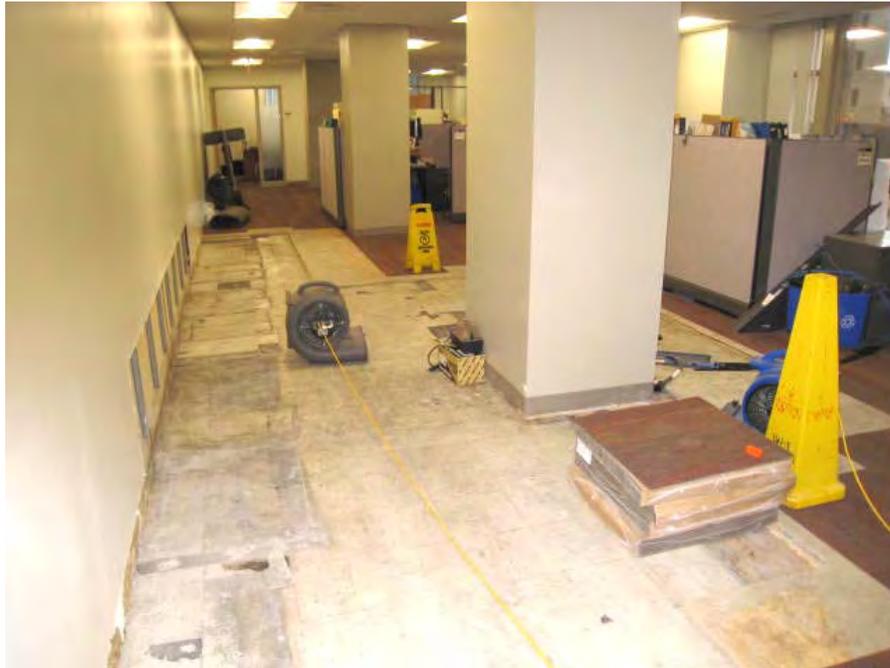
Picture 7

drying the floor materials. No musty or unusual odors were observed in this area by BEH/IAQ staff during the September 5, 2012 visit.

Area of flooring removal

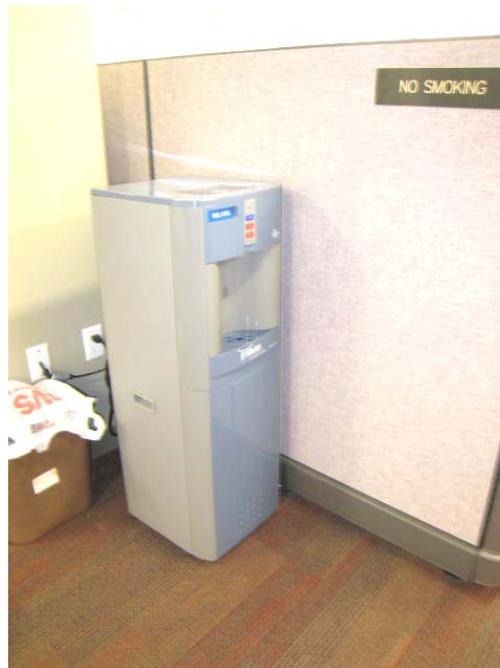
Picture 8

A water-damaged ceiling tile was found in one location. This may indicate an historic plumbing leak. Water-damaged building materials can provide a source of mold and should be replaced after a water leak is discovered and repaired. Water dispensers and mini refrigerators were found located on carpeting (Pictures 8 and 9). Carpeting underneath this equipment is vulnerable to water damage, which can lead to mold growth. These items should be relocated to non-carpeted areas or carpeting under this equipment should be covered by a rubber/plastic mat to prevent moistening.

Water dispenser on carpeting

9. Ensure leaks are repaired and replace water-damaged ceiling tiles.
10. Consider relocating refrigerators to areas with tile floors, or use impermeable mats to contain potential spills or leaks.

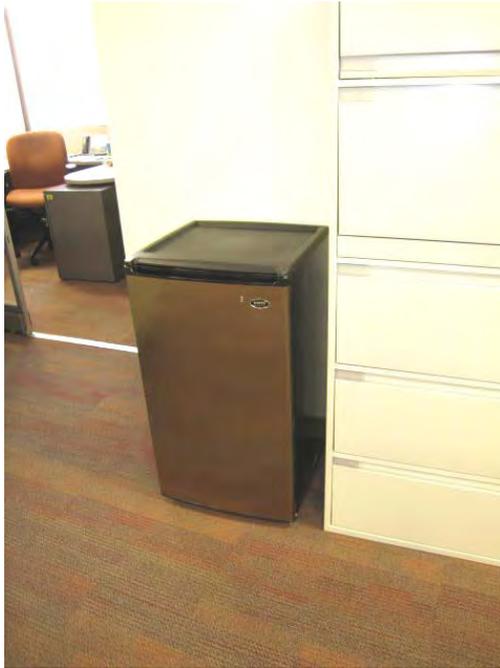
Picture 9

Mini refrigerator on carpeting
