INDOOR AIR QUALITY ASSESSMENT

**Gerard A. Guilmette Elementary and Middle Schools
80 Bodwell Street
Lawrence, MA**

Prepared by:
Massachusetts Department of Public Health
Bureau of Environmental Health
Indoor Air Quality Program
June 2013

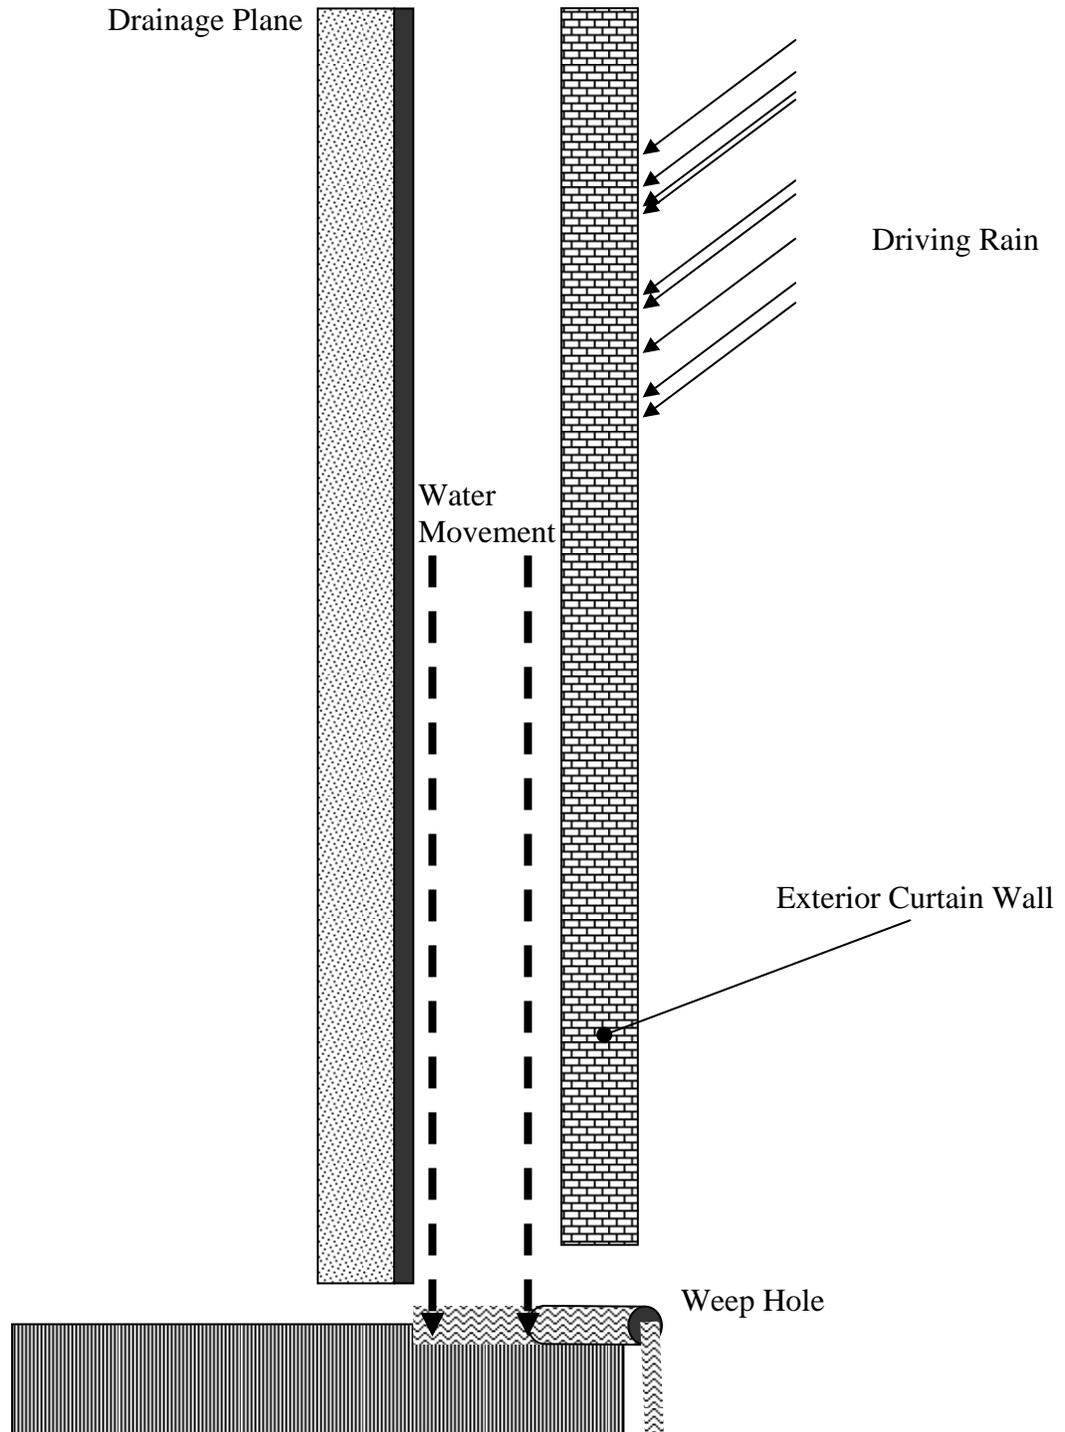
Figure 1

The building is equipped with weep holes along exterior walls to drain away moisture that enters under the façade (Figure 1; Picture 15). These holes were found to be operating correctly in draining moisture; however some of the weep holes appeared to not have any mesh covering and/or were covered by mulch. Without a mesh covering, insects such as bees or wasps may enter through the holes into the interior walls of the building. Covered weep holes can inhibit proper drainage.

Drainage Plane Function: Weep Holes Drain Water from the Wall System to Prevent Moisture Penetration into the Interior

18. Ensure that building weep holes uncovered and are equipped with mesh screens.
19. Seal breaches, seams, and spaces between sink countertops and backsplashes to prevent water damage.

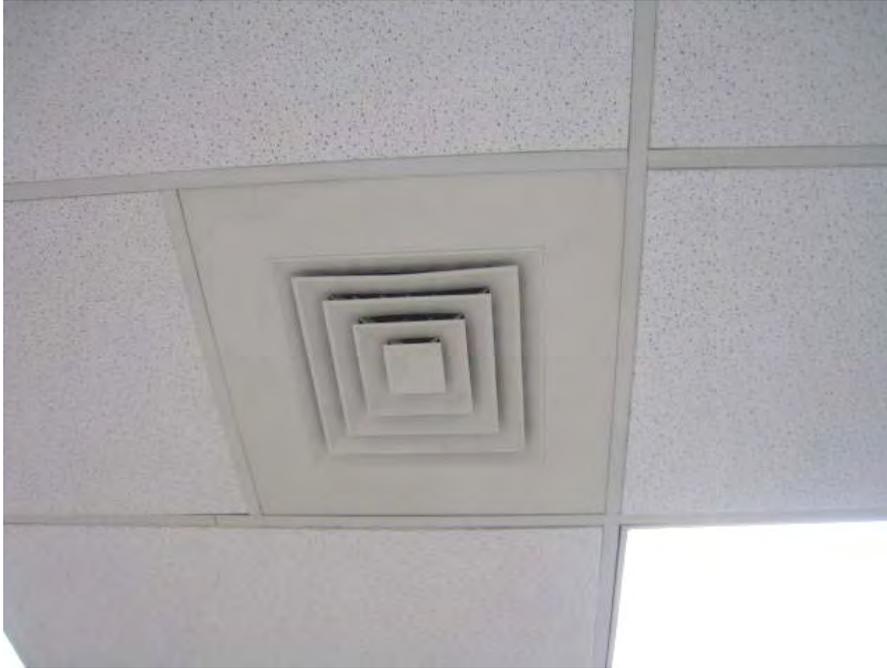
Picture 1

Rooftop air-handling units (AHUs) provide mechanical ventilation to all rooms. Fresh air is ducted to classrooms via ceiling-mounted supply diffusers (Picture 1). Exhaust air is drawn through ceiling-mounted vents and ducted back to the AHUs (Picture 2). In many rooms, airflow from supply and exhaust vents was observed to be low or nonexistent. School maintenance staff is reportedly aware of issues with some of the heating, ventilating and air-conditioning (HVAC) systems, which are in the process of being fixed. The library in particular was reported to have no operating mechanical ventilation at the time of the BEH/IAQ visit. Given that the library windows do not open, there was no source of fresh air for the library at the time of assessment.

Ceiling-mounted fresh air diffuser

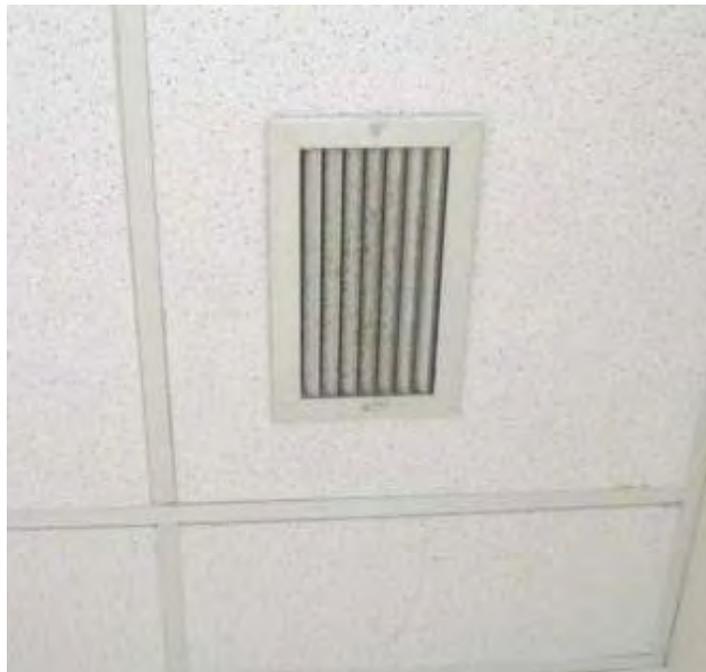
Picture 2

A number of classroom ceiling and FCU vents had accumulated dust/debris. If vents are not operating, back drafting may occur, resulting in re-aerosolization of accumulated dust particles. Personal fans in some rooms were also found to be dusty. Vents and fans should be cleaned periodically to prevent dust/debris accumulation on louvers and fan blades.

Ceiling-mounted exhaust vent, note vent louvers are dusty

33. Replace latex-based tennis balls on chair/table legs with latex-free tennis balls or glides.
34. Clean exhaust/return vents, ceiling fans, and personal fans periodically to prevent excessive dust accumulation.

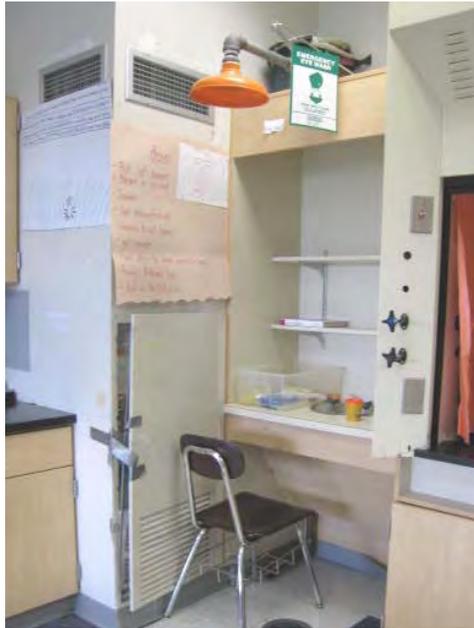
Picture 3

Fan coil units (FCUs) provide auxiliary heating and filtration in most classrooms (Picture 3). Tempered air is provided by wall vents at the top of the unit, and air is returned via a wall

vent at the bottom of the unit. In some rooms, FCUs were found deactivated, ajar, with supply/return vents broken, or blocked by materials (Pictures 3 through 5). In order to operate as designed, units must remain “on” and allowed to operate while rooms are occupied. Importantly, FCUs must remain free of obstructions.

Classroom fan coil unit with cover ajar/taped shut, note emergency shower and drain which is likely to be dry

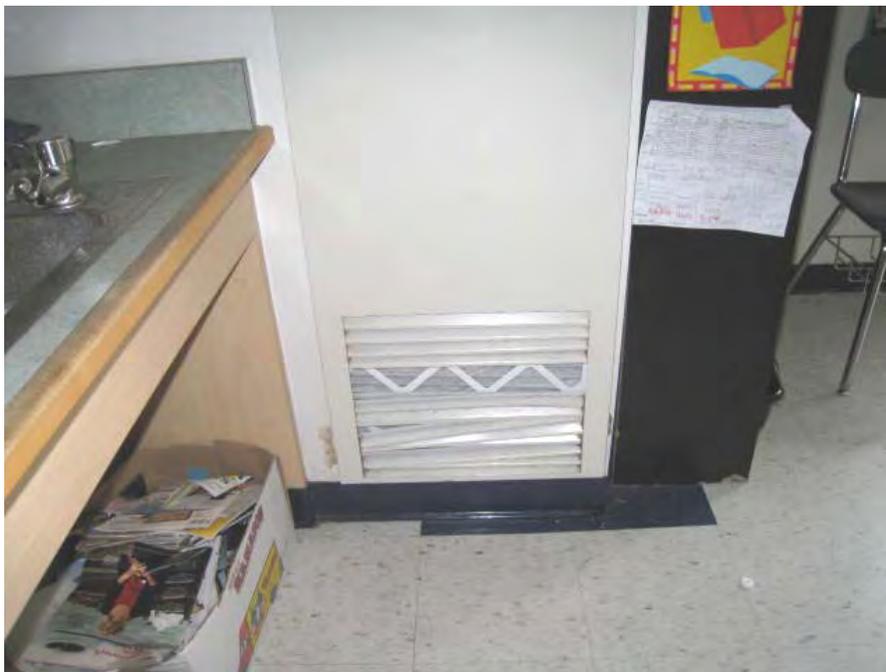
Picture 4

FCUs are designed to operate with a filter to remove particulates from the indoor environment. The FCU filters examined were of a disposable type with an open mesh construction; filters were observed to be placed in the units without any stabilizing clips. Ill-fitting filters can allow unfiltered air to bypass and re-circulate in the room. New clips should be installed to enhance filtering capacity. In order to decrease aerosolized particulates, disposable filters with an increased dust spot efficiency can be installed.

Classroom fan coil unit with broken louvers exposing filter

5. Install filter clip and repair the housing and louvers of classroom FCUs. Ensure that properly-fitted filters are installed.
6. Consider upgrading to a disposable filter with an increased dust spot efficiency in FCUs. Continue to change the filters regularly.

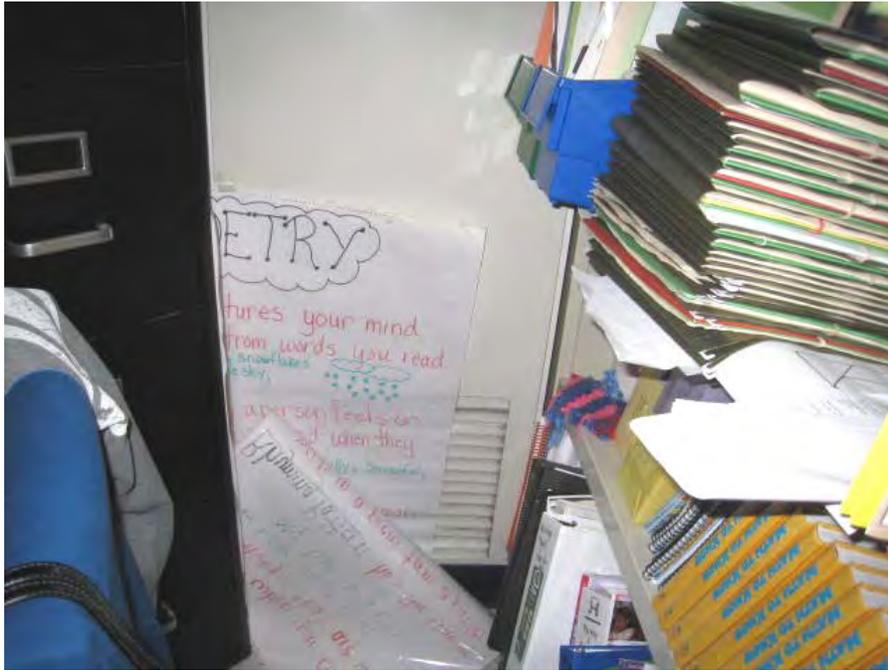
Picture 5

Classroom fan coil unit with return vent blocked by paper

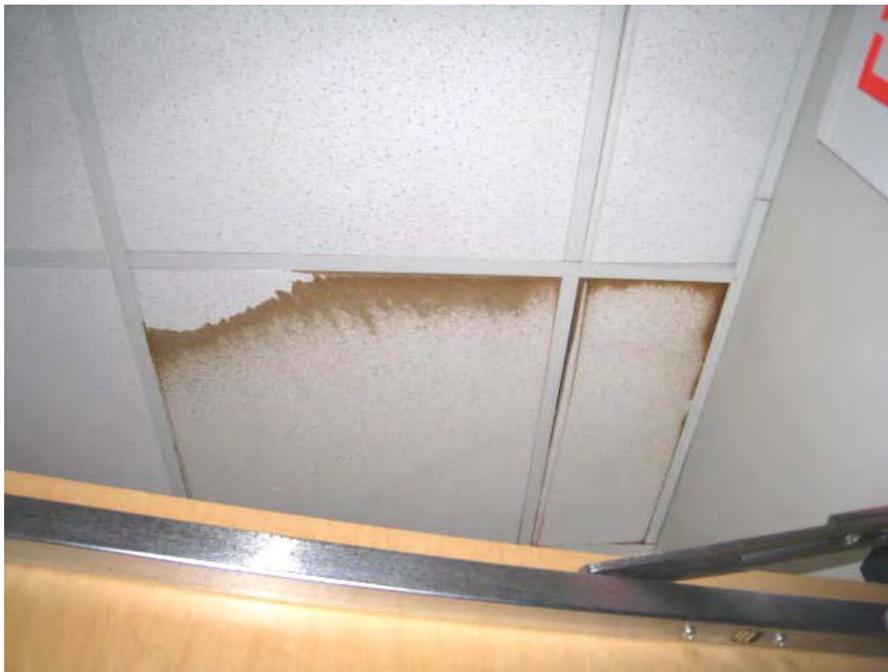
Picture 6

Water-damaged ceiling tiles were observed in some classrooms (Table 1; Picture 6), and a water-damaged windowsill and adjacent wallboard were noted in classroom 319 (Table 1; Picture 7). These appear to be from current and historic roof and/or building envelope leaks. Water-damaged building materials can provide a source of mold and should be replaced after a water leak is discovered and repaired. School maintenance staff reported that a capital project to reseal the building envelope (including all windows) had been put out to bid with work expected to occur over the summer of 2013.

Water-damaged ceiling tile

15. Ensure roof/plumbing leaks are repaired and replace/repair any remaining water-damaged ceiling tiles and building materials. Examine the area above these tiles for mold growth. Disinfect areas of water leaks with an appropriate antimicrobial, as needed. Notify staff prior to ceiling tile replacement to prevent collection of dust on area items.

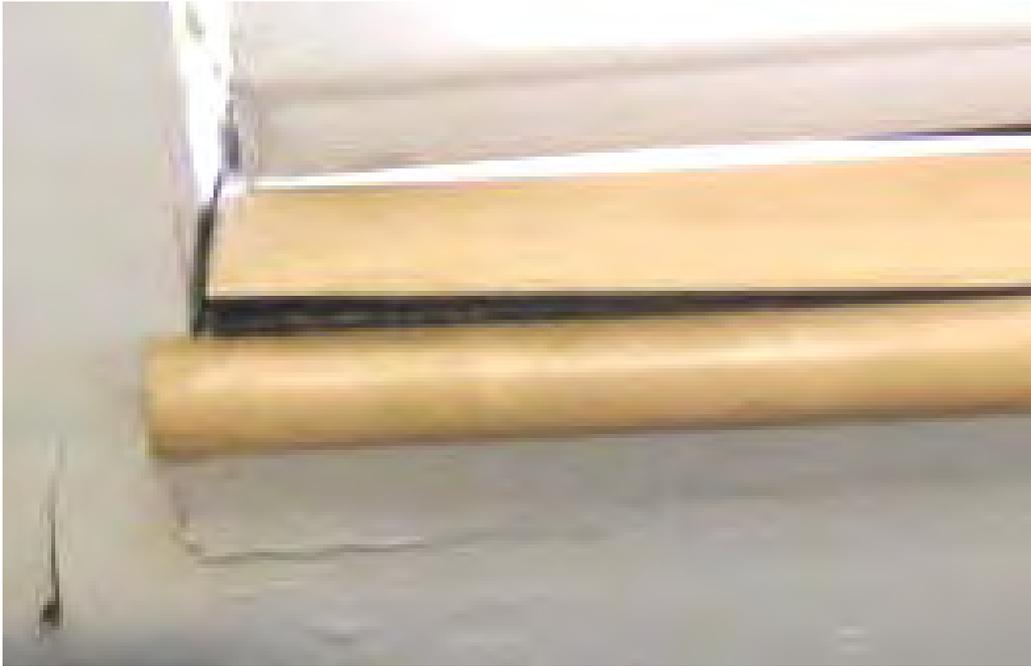
Picture 7

Water-damaged window sill and wall in classroom 319

10. Continue with plans to reseal building envelope/windows over the summer. Particular attention should be made to areas where water infiltration has resulted in water-damaged building materials (e.g., room 319). Once project is completed, make repairs to water-damaged windowsill and wall in room 319 as well as other areas.

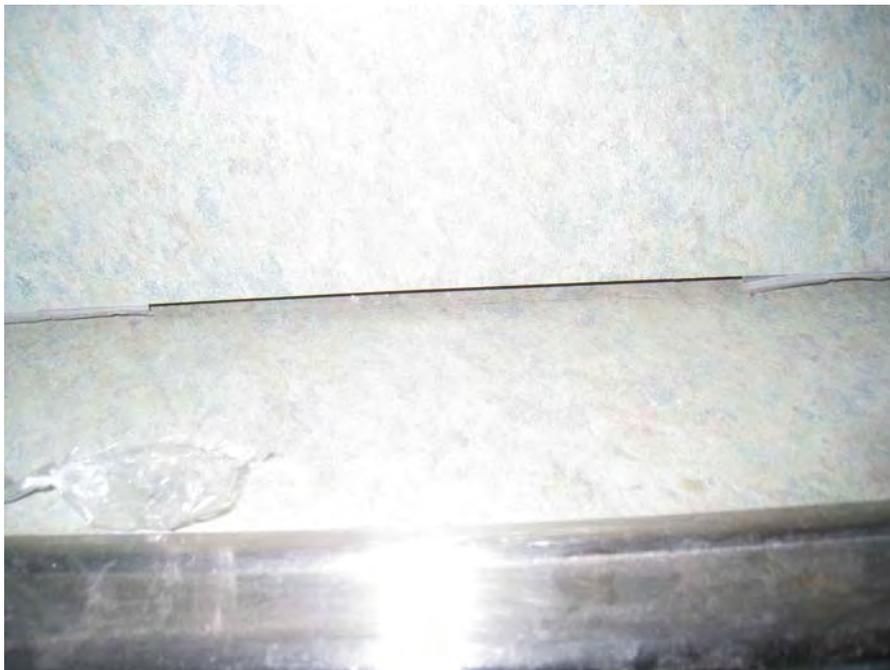
Picture 8

Many classrooms in the school had sinks, and BEH/IAQ staff observed that many of the backsplashes were open or not fully sealed (Table 1; Picture 8). If not watertight, water can penetrate through the seam, causing water damage. Several classrooms were also found to have porous materials (e.g., cardboard, paper, cloth) stored beneath sinks where the materials can be subject to water exposure. Repeated moistening of porous materials can result in mold growth.

Gap in sealant of sink backsplash

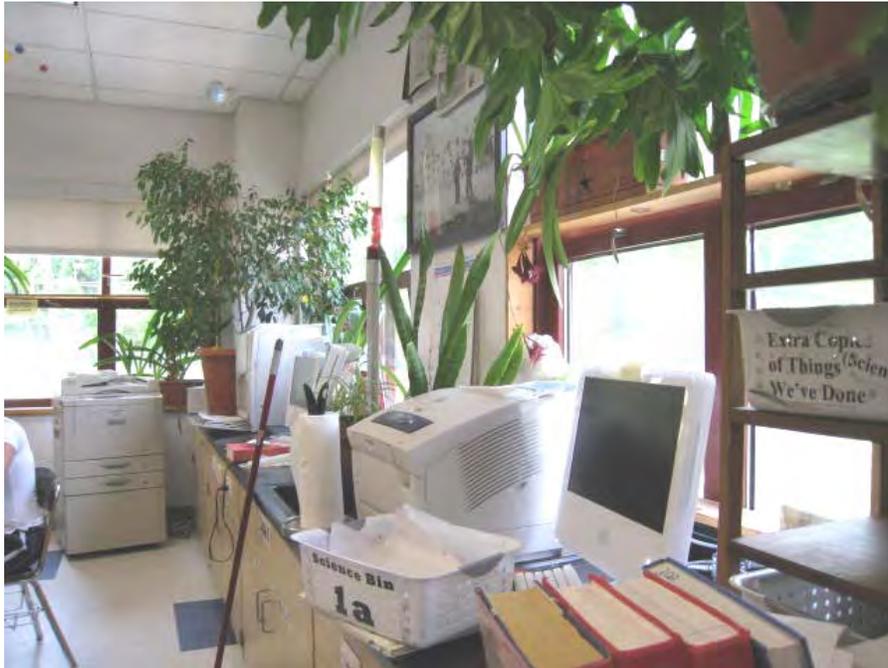
Picture 9

Plants and terrariums were noted in several classrooms (Table 1; Picture 9). In some cases, plants were observed near ventilation sources. Plants, soil and drip pans can serve as sources of mold growth. Plants should be properly maintained, over-watering of plants should be avoided and drip pans should be inspected periodically for mold growth. Plants should also be located away from ventilation sources to prevent aerosolization of dirt, pollen or mold.

Plants in classroom

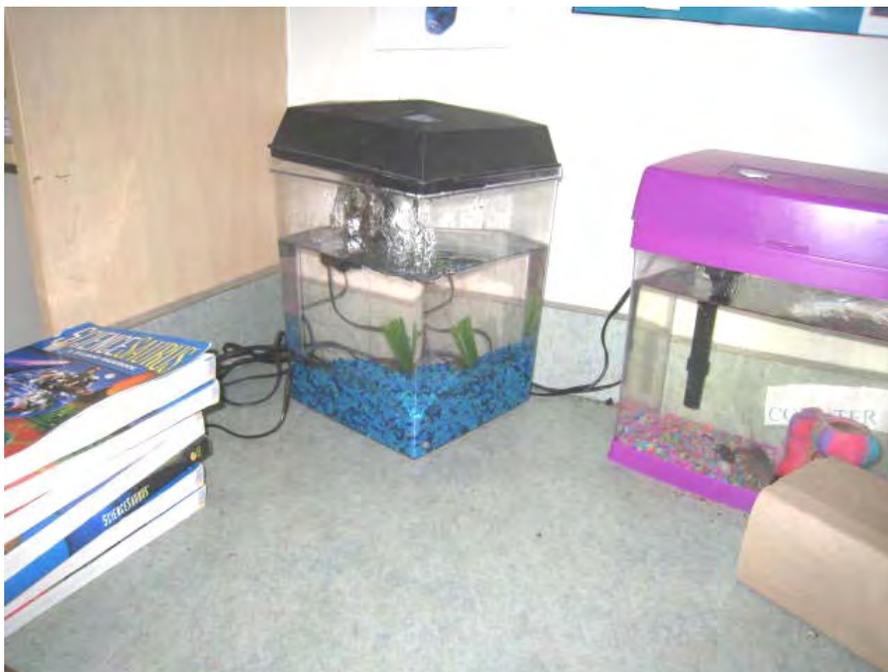
Picture 10

Aquariums were also observed in several classrooms (Table 1; Picture 10). Aquariums can be a source of moisture or spills and, if not cleaned regularly, can emit unpleasant odors.

Aquariums in classroom

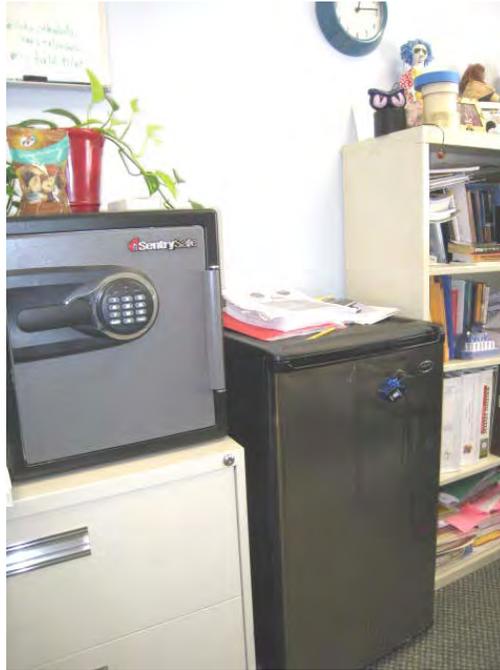
Picture 11

Refrigerators and water dispensing equipment were observed to be located on carpeting (Picture 11). These appliances can leak or spill, which can moisten carpet. It is recommended that these items be located on a non-porous surface.

Food is an attractant to pests, such as rodents. Food and food preparation equipment were found in classrooms and offices (Pictures 11 and 20). Proper food storage is an integral component in maintaining indoor air quality. Food should be properly stored and clearly labeled.

Refrigerator on carpet

21. Consider moving refrigerators and water dispensing equipment to areas with tile floors or place them on waterproof mats to avoid moistening of carpeting.

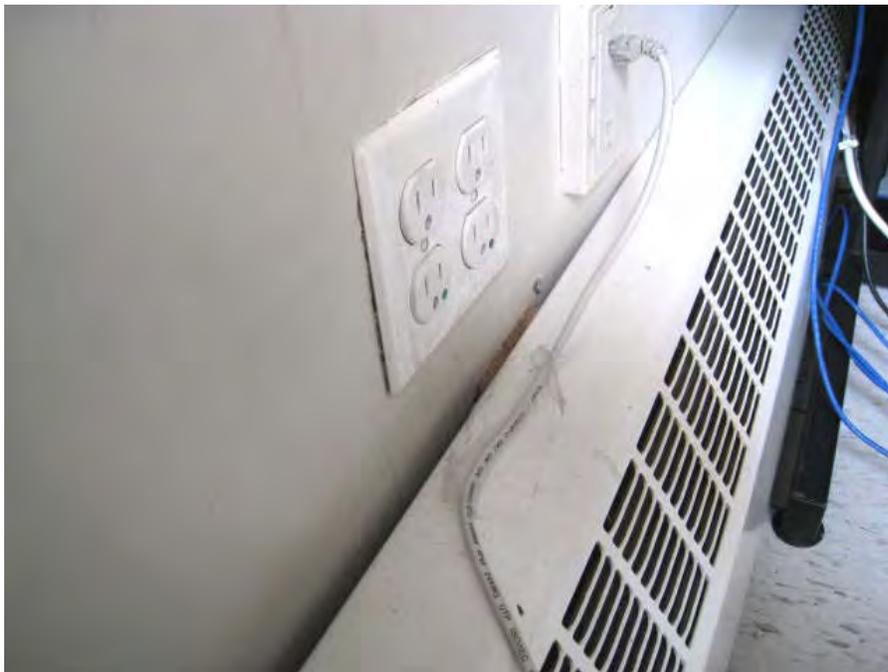
Picture 12

A steel-backed radiator was installed against the wall shared between in room 105 and the adjoining restroom interior wall (Picture 12). If water were to enter the wall cavity, the tile and steel plate of the heater could prevent moisture/water vapor from exiting the wall cavity, resulting extended wetting of the GW. There were signs of water damage to the GW of this wall, including water-damaged ceiling tiles and water stains. In addition, an electrical outlet below the damaged ceiling tile exhibited a pattern of staining that indicated that water may have seeped from the wall cavity into room 105 through the bottom of the socket cover (Pictures 12 and 13). A musty/damp odor was also detected at the base of the radiator. These signs suggest that the wallboard and associated materials along the shared wall may be damp and possibly colonized

with mold. The shared wallboard along this area should be examined, and all water-damaged materials removed and replaced. Water-damaged electrical equipment is also a fire hazard and should be remediated.

Radiator in room 105, note signs of water infiltration around the electrical socket

11. Determine the feasibility of re-grading restroom floors, especially the one adjacent to room 105, to ensure proper drainage of water.
12. Remove and replace any water-damaged wall materials in room 105. Repair the radiator in this room and ensure that no gap into which items can be inserted remains. Relocate the electrical service and socket from this area if it may become wet in the future.

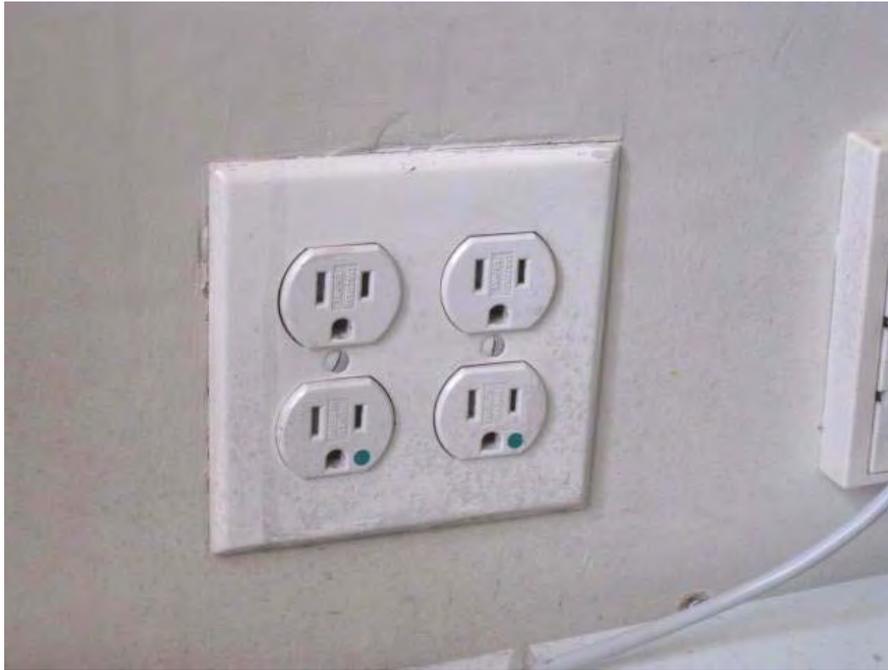
Picture 13

Electrical socket in room 105 with signs of water infiltration

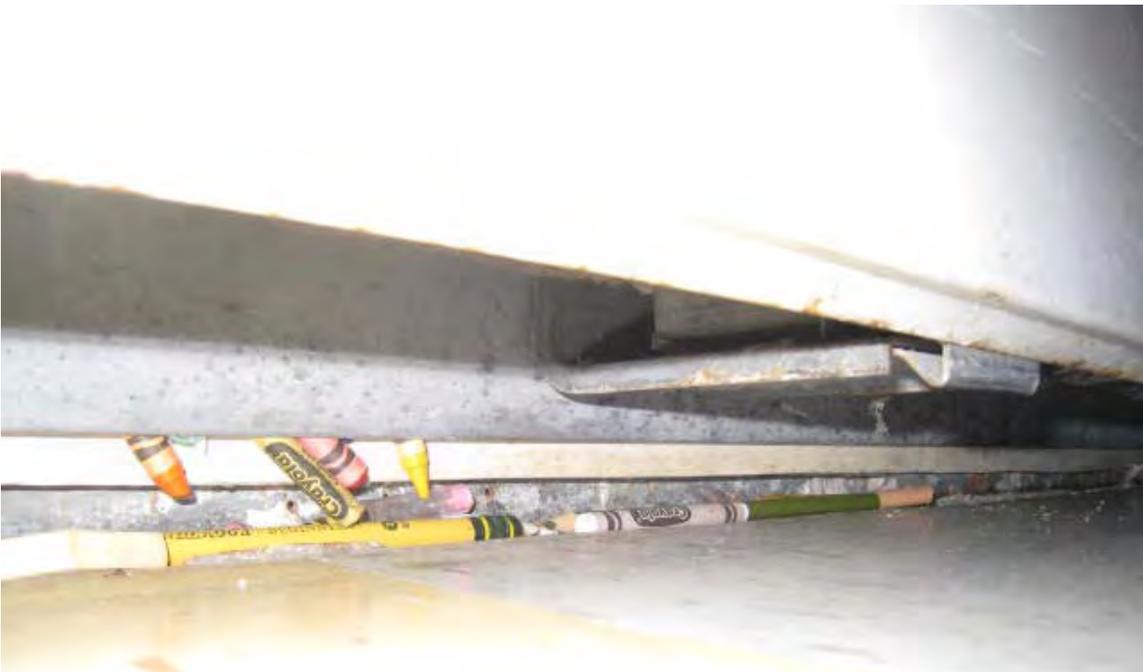
Picture 14

In addition, the radiator in room 105 was not flush with the wall, unlike those installed elsewhere in the building. A number of items, including wax crayons, could be seen in the gap (Picture 14). It is likely that when the radiator is operating (i.e., during the heating season), odors from water-damaged/mold-colonized materials as well as heated crayons and other items inside this gap would result and be distributed throughout the room. This radiator should either be moved or properly sealed to prevent items such as crayons from being inserted into the adjacent gap.

Crayons inside radiator in room 105

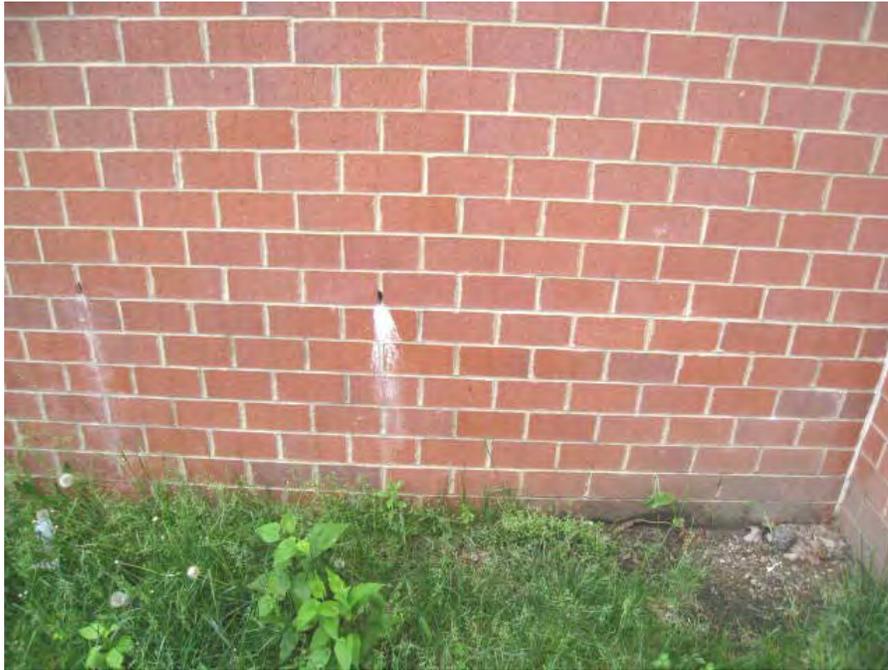
Picture 15

Building weepholes

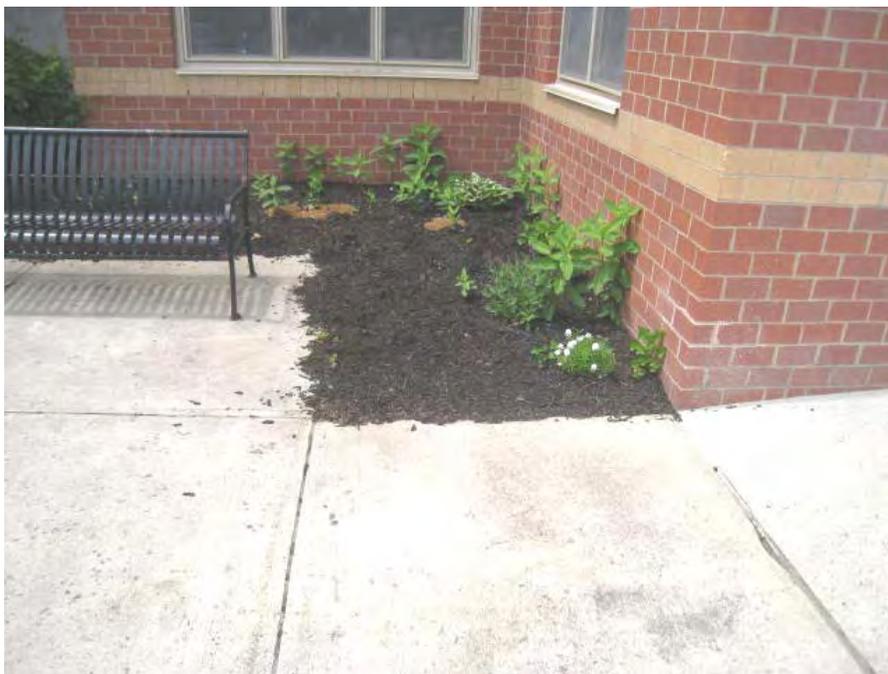
Picture 16

Plants, trees and shrubbery were in close proximity to the building (Picture 16). The growth of roots against exterior walls can bring moisture in contact with the foundation. Plant roots can eventually penetrate, leading to cracks and/or fissures in the sublevel foundation. Over time, this process can undermine the integrity of the building envelope, providing a means of water entry into the building via capillary action through foundation concrete and masonry (Lstiburek & Brennan, 2001).

Plants/soil/mulch against building foundation

25. Trim back plants, trees and shrubs at least five feet away from exterior walls/foundation of the building.
26. For more information on mold consult *Mold Remediation in Schools and Commercial Buildings* published by the US EPA (2001). This document is available from the US EPA website: http://www.epa.gov/mold/mold_remediation.html.

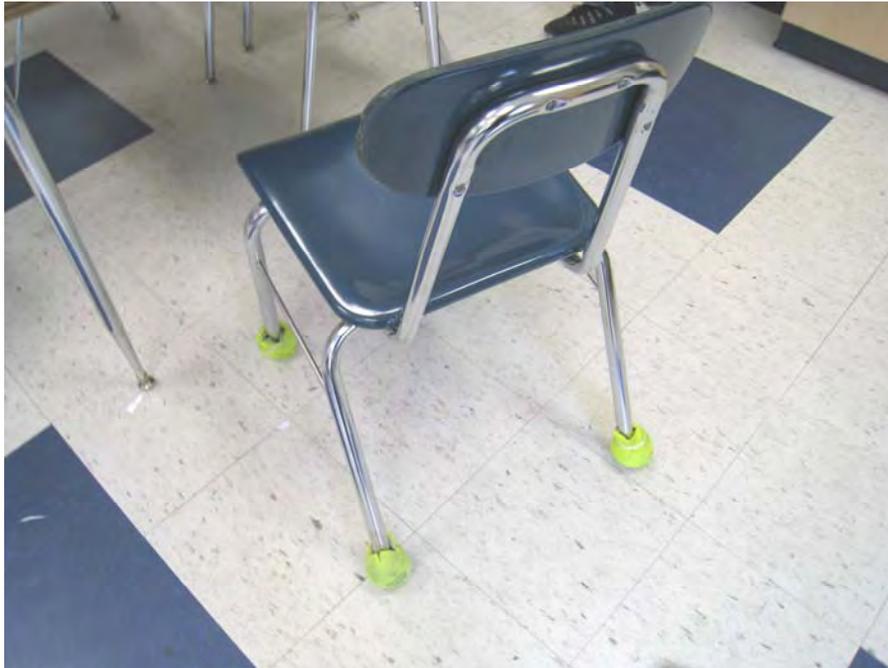
Picture 17

In an effort to reduce noise, tennis balls had been sliced open and placed on the base of desk/chair legs in some classrooms (Picture 17). Tennis balls are made of a number of materials that are a source of respiratory irritants. Constant wearing of tennis balls can produce latex fibers and cause VOCs to off-gas. Tennis balls are made with a natural rubber latex bladder, which becomes abraded when used as a chair leg pad. Use of tennis balls in this manner may introduce latex dust into the school environment. Some individuals are highly allergic to latex (e.g., spina bifida patients) (SBAA, 2001). It is recommended that the use of materials containing latex be limited in buildings to reduce the likelihood of symptoms in sensitive individuals (NIOSH, 1997).

Tennis balls used as glides

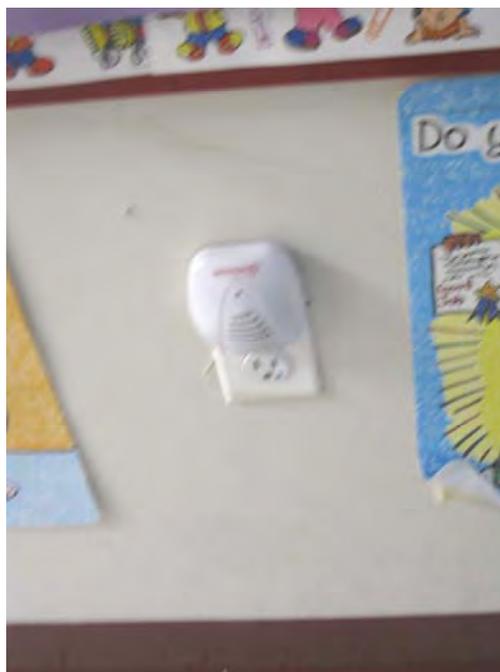
Picture 18

Air fresheners, deodorizing materials and other scented products were observed in some areas (Table 1; Picture 18). Air deodorizers contain chemicals that can be irritating to the eyes, nose and throat of sensitive individuals. Many air fresheners contain 1,4-dichlorobenzene, a

VOC which may cause reductions in lung function (NIH, 2006). Furthermore, deodorizing agents do not remove materials causing odors, but rather mask odors that may be present in the area.

Plug-in air freshener

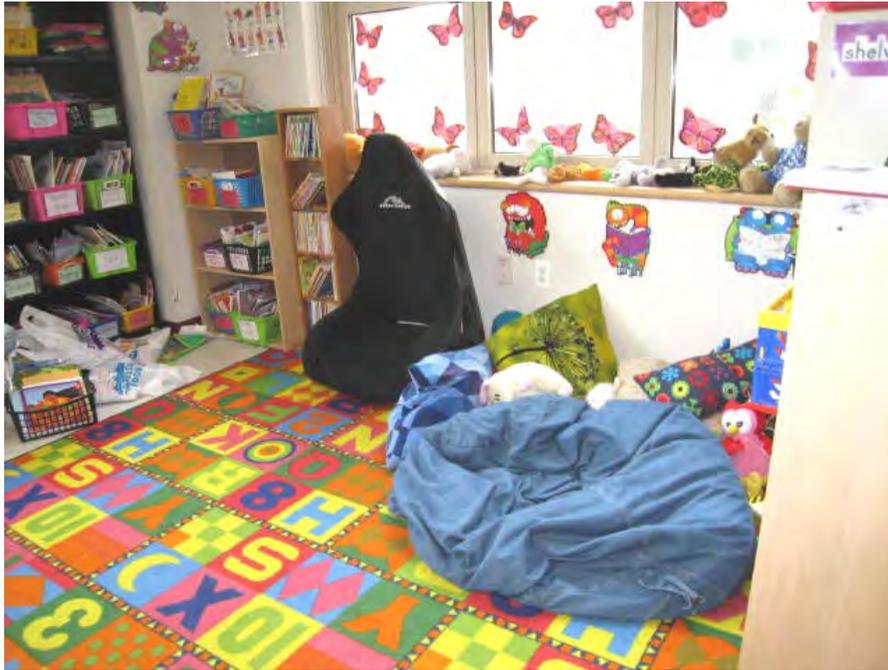
Picture 19

Other conditions that can affect indoor air quality were observed during the assessment. Upholstered furniture, plush toys and area carpets were observed in some classrooms (Table 1; Picture 19). Upholstered furniture is covered with fabrics that are exposed to human skin. This type of contact can leave oils, perspiration, hair and skin cells. Dust mites feed upon human skin cells and excrete waste products that contain allergens. In addition, if relative humidity levels increase above 60 percent, dust mites tend to proliferate (US EPA, 1992). In order to remove dust mites and other pollutants, frequent vacuuming of upholstered furniture is recommended (Berry, 1994). It is also recommended that upholstered furniture in schools be professionally cleaned on an annual basis. Where an excessively dusty environment exists due to outdoor conditions or indoor activities (e.g., renovations), cleaning frequency should be increased (every six months) (IICRC, 2000).

Upholstered items, area rug and plush toys

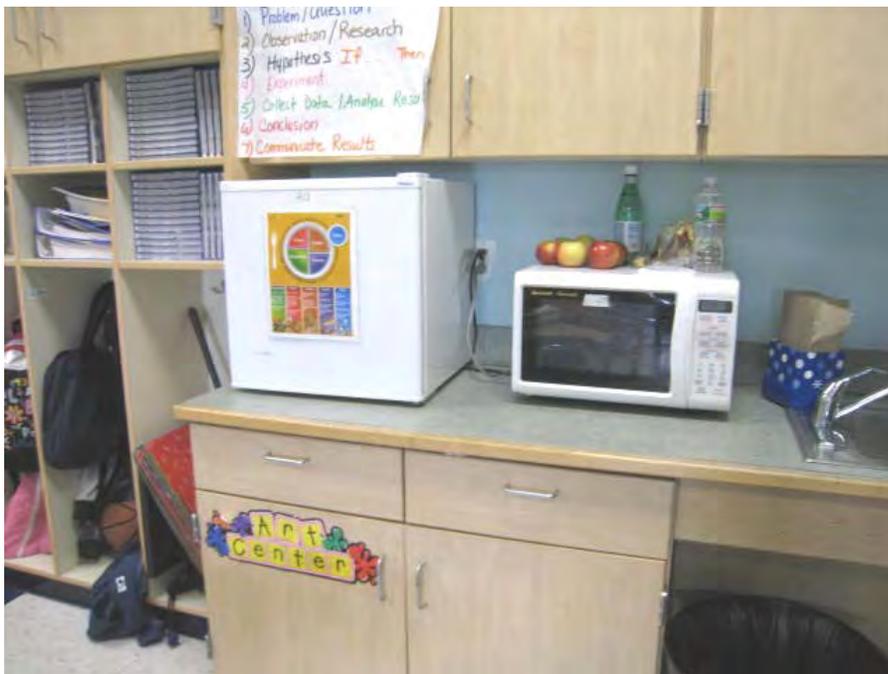
Picture 20

Food preparation area in classroom

29. Ensure food is properly stored and clearly labeled. Reuse of food containers is not recommended since food residue adhering to the container surface may serve to attract pests. Food storage and preparation equipment should be regularly cleaned and maintained or kept in a centralized location. Consideration should be given to centralizing food storage and preparation equipment to reduce the potential for pests.

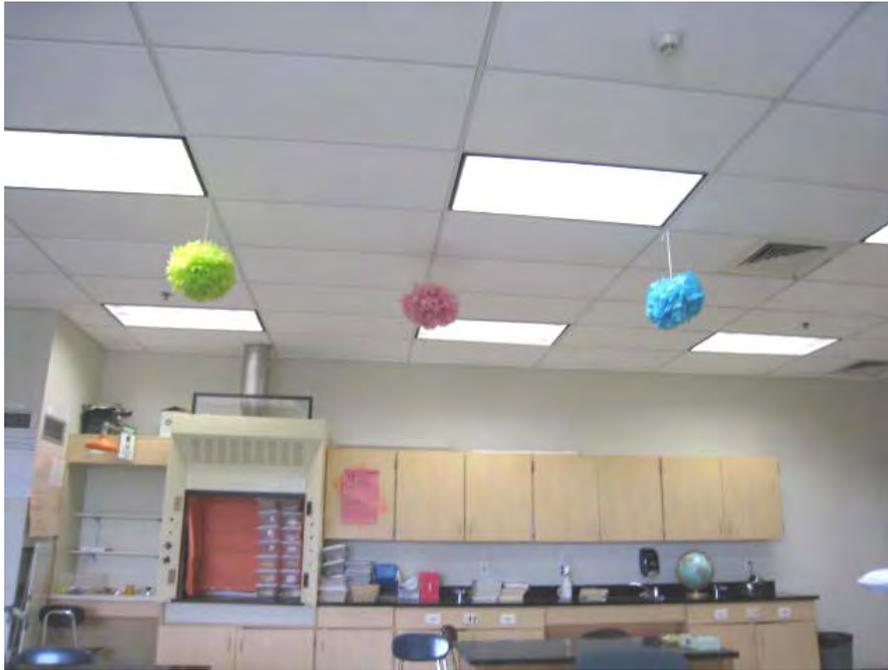
Picture 21

Items hanging from the ceiling
