INDOOR AIR QUALITY ASSESSMENT

**Holyoke City Hall Annex
20 Korean Veterans Plaza
Holyoke, Massachusetts**

Prepared by:
Massachusetts Department of Public Health
Bureau of Environmental Health
Indoor Air Quality Program
October 2014

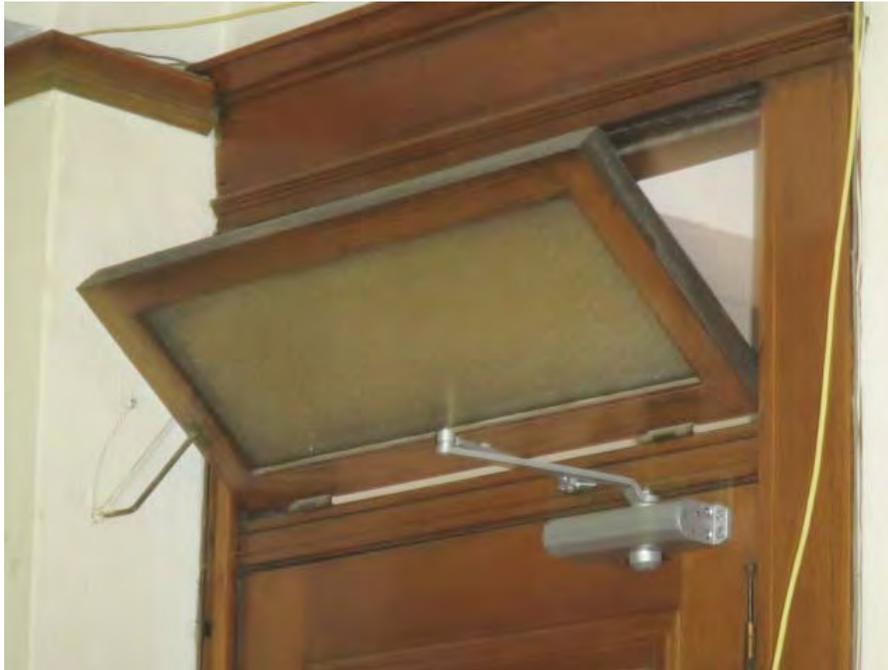
Picture 1

The HCHA is not equipped with a mechanical ventilation system. The building was originally designed with a natural/gravity system heated by steam radiators with fresh air provided through openable windows. In addition to openable windows, the building has hinged windows located above hallway doors. These hinged windows or transoms (Picture 1) enable occupants to close hallway doors while maintaining a pathway for airflow into the rooms. This design allows for airflow to enter an open window, pass through a room, through the open transom to the hallway and subsequently pass through the open transom and window on the

Transom over door

1. Supplement inoperable/non-functioning air conditioning units with window air conditioners to provide cooling during warm months.
2. Open windows (weather permitting) to temper rooms and provide fresh outside air. Care should be taken to ensure windows are properly closed at night and weekends during winter months to avoid the freezing of pipes and potential flooding. In addition, keep windows closed during hot, humid weather to maintain indoor temperatures and to avoid condensation problems when air conditioning is activated.

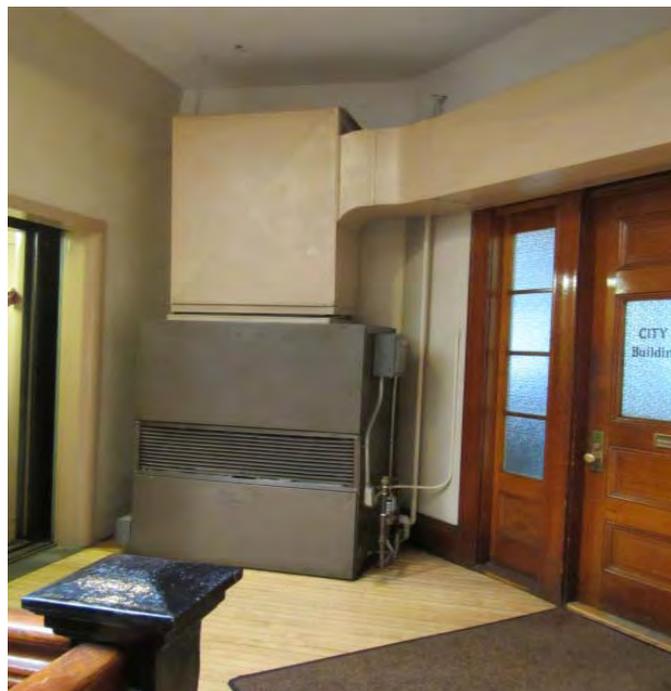
Picture 2

Air-handling units (AHUs) provide cooling during warm months. These AHUs are located in hallways (Picture 2) and are not equipped with fresh air intakes outside the building. The intake vents on the AHUs draw return air from the hallways, cool, and deliver it to occupied spaces via ducted supply vents (Picture 3). The AHU on the third floor was making an atypical noise and weak or nonexistent airflow was detected from supply vents, primarily in south-facing offices on the third floor, indicating either the zones to which they were connected were not calling for air circulation, or that it was in need of maintenance. Of note, the fourth floor AHU that distributes air to the south-facing offices was non-functioning/inoperable. Although the units are cleaned and filters changed regularly, the operational lifespan of this equipment has been exceeded (> 20 years). This system is supplemented by using windows to introduce fresh air and window air conditioning (WAC; Table 1) units.

AHU located in hallway

1. Based on the age, physical deterioration and availability of parts, the MDPH recommends that an HVAC engineering firm evaluate options for providing adequate ventilation building-wide. Such an evaluation is necessary to determine the feasibility of repairing/replacing the existing equipment.

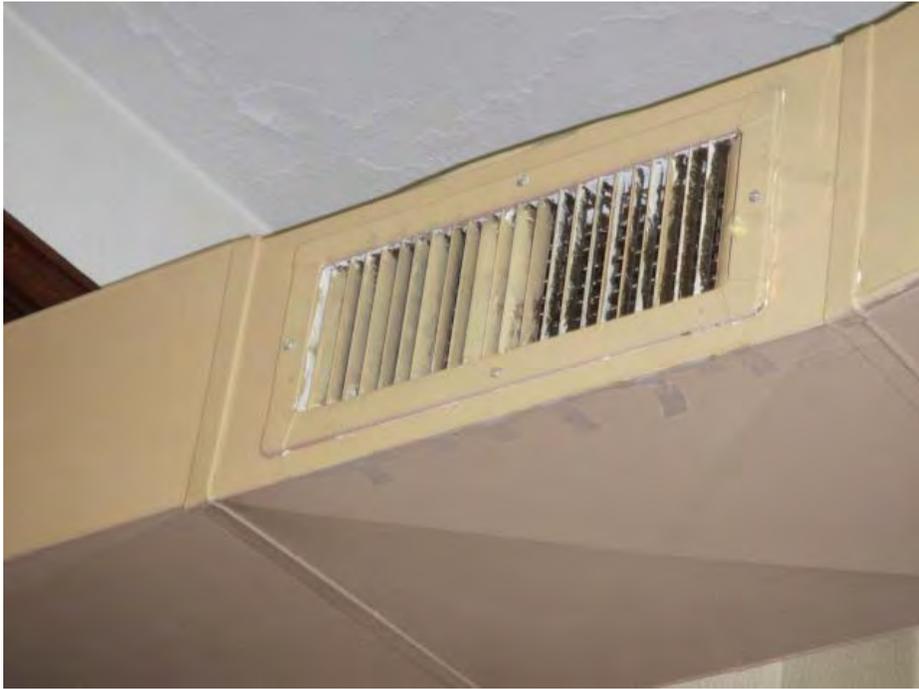
Picture 3

Dust was also observed accumulated on the blades of personal fans and supply vents (Table 1; Picture 3). Vents and fans should be cleaned periodically in order to prevent them from serving as a source of aerosolized particulates.

Ducted supply vent in hallway (note dirt/debris)

14. Refrain from using air fresheners and deodorizers to prevent exposure to VOCs.
15. Clean accumulated dust and debris periodically from supply vents and blades of personal fans.

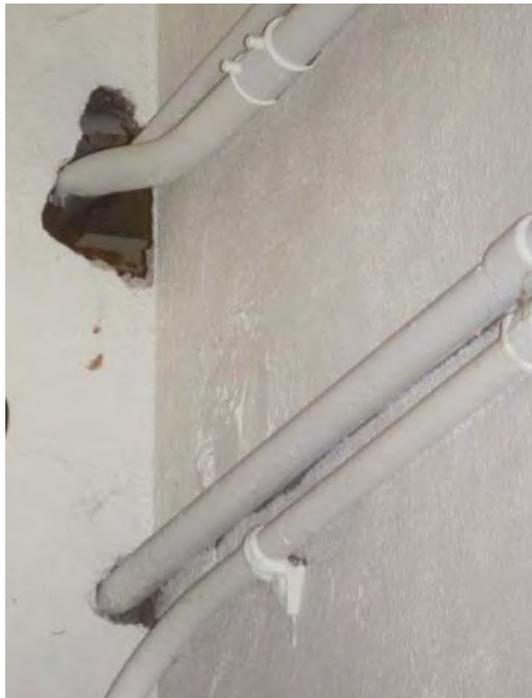
Picture 4

As previously mentioned, the HPD originally occupied the first floor and basement; although unoccupied, conditions exist in the space which can affect IAQ in the building. An open stairwell exists leading from the cell block to the first floor (Pictures 6) allowing odors and associated pollutants to migrate to occupied spaces above via breaches around plumbing/utility

Holes/gaps around utility pipe in basement

pipes. BEH/IAQ staff recommended that facilities staff inspect the basement and all occupied areas of the building for holes/gaps surrounding pipes and seal with a fire-rated sealant foam or other appropriate material.

4. Seal holes/spaces and other penetrations in the ceilings and walls around plumbing and utility pipes throughout the building, particularly in the basement and first floor of the former HPD with an expandable, fire-rated sealing compound.

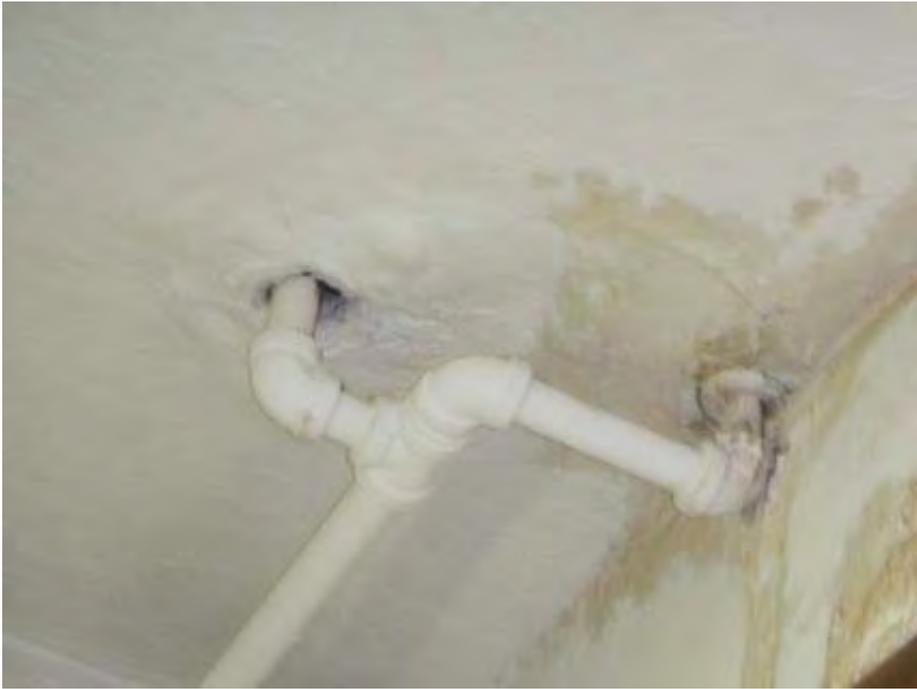
Picture 5

Holes/gaps around utility pipe in cell block (note: water damage)

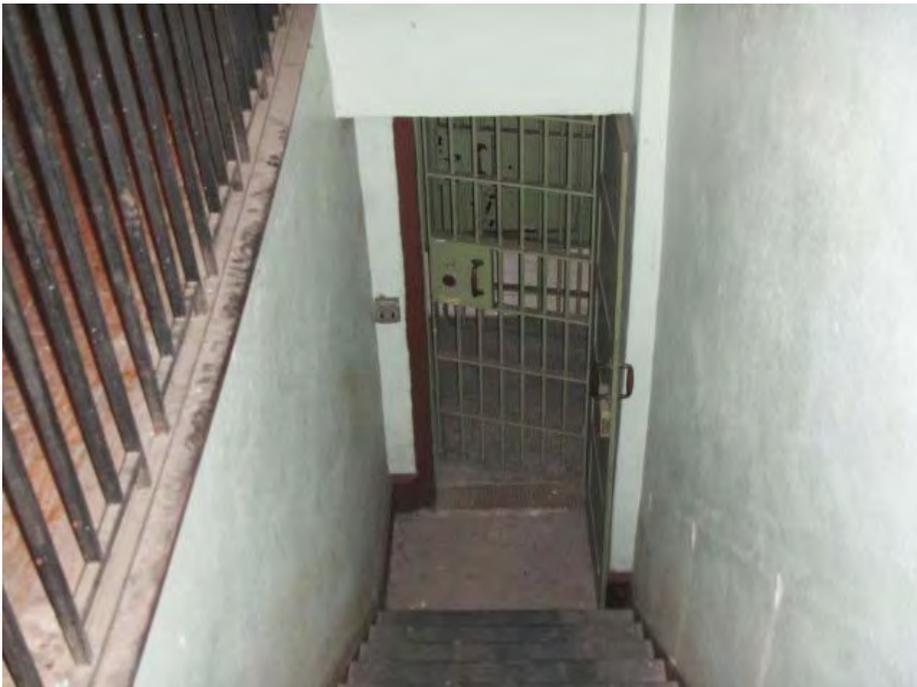
Picture 6

Open stairwell from basement cell block to first floor

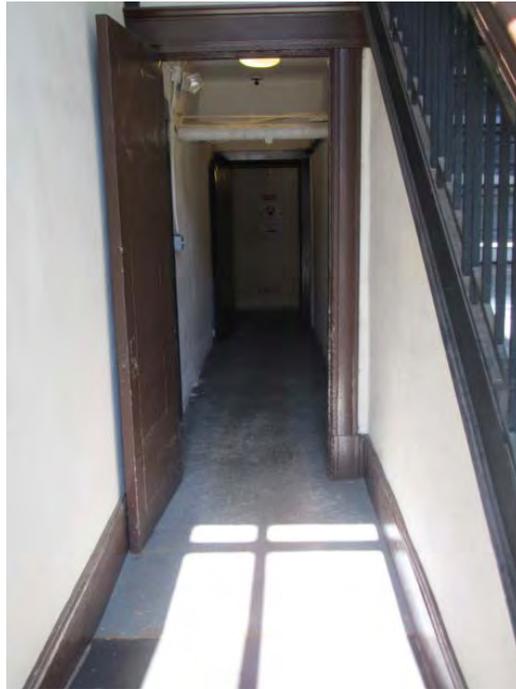
Picture 7

In addition, a ramp exists leading from the basement to the side entrance of the building (Picture 7). It was reported by facilities staff that the access doors at the base and top of the ramp are routinely left open. BEH/IAQ staff noted musty odors at the top of the ramp and found the doors were ill-fitting and did not seal tightly when closed. The door at the base of the ramp should be replaced with an airtight fire-rated door and kept closed to prevent the migration of odors and pollutants to occupied spaces.

Ramp leading from basemen to first floor entrance (note: open door)

5. Install a fire-rated airtight door at the base of the ramp adjacent to the side entrance.
Consider installing an armature if the door is to be used as an access for the public/visitors.

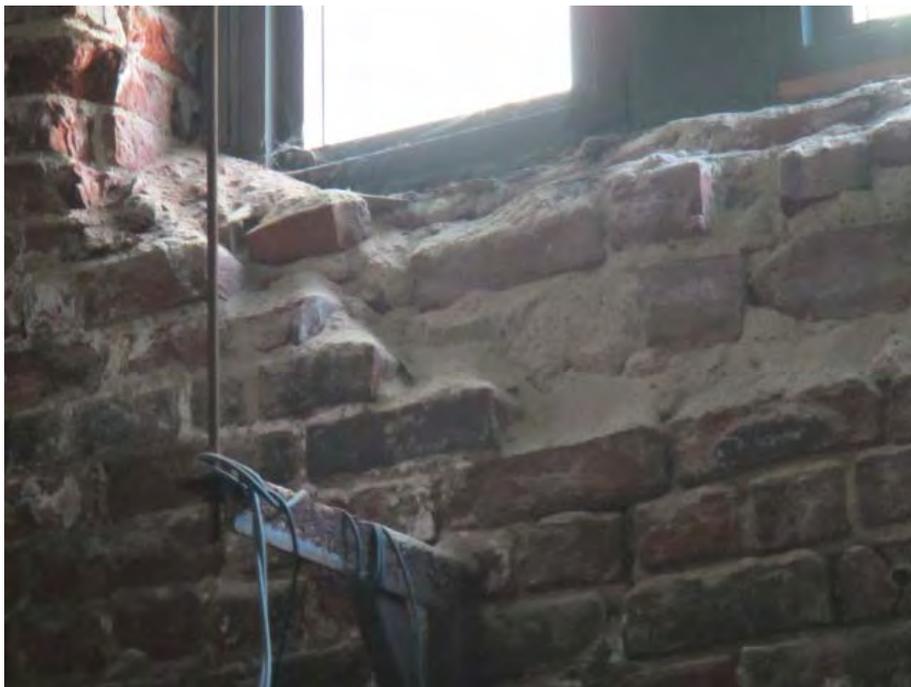
Picture 8

Although no visible mold growth was observed in the basement, several signs of water penetration/damage were identified. The mechanical room had deteriorated/missing brick around the windows (Picture 8). Efflorescence was observed on walls, ceilings, pipes and window frames throughout the space (Picture 9). Efflorescence is a characteristic sign of water damage but it is not mold growth. As the solution moves to the surface of the material, the water evaporates, leaving behind white, powdery mineral deposits. As moisture penetrates and works its way through mortar, brick or plaster, water-soluble compounds dissolve, creating a solution.

Missing/deteriorated brick in mechanical room

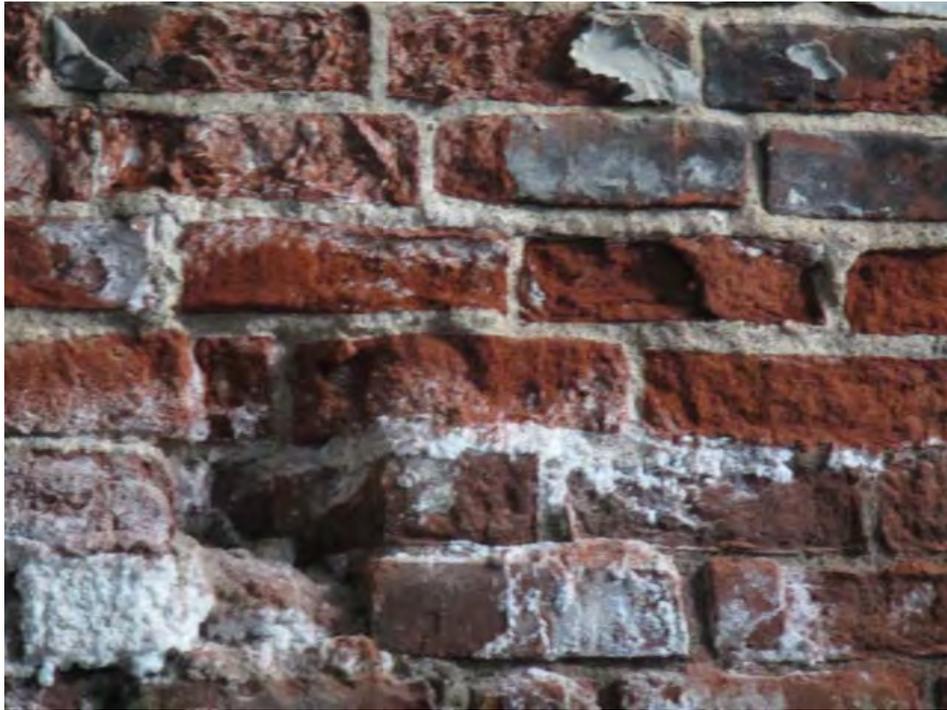
Picture 9

Efflorescence on wall of the mechanical room

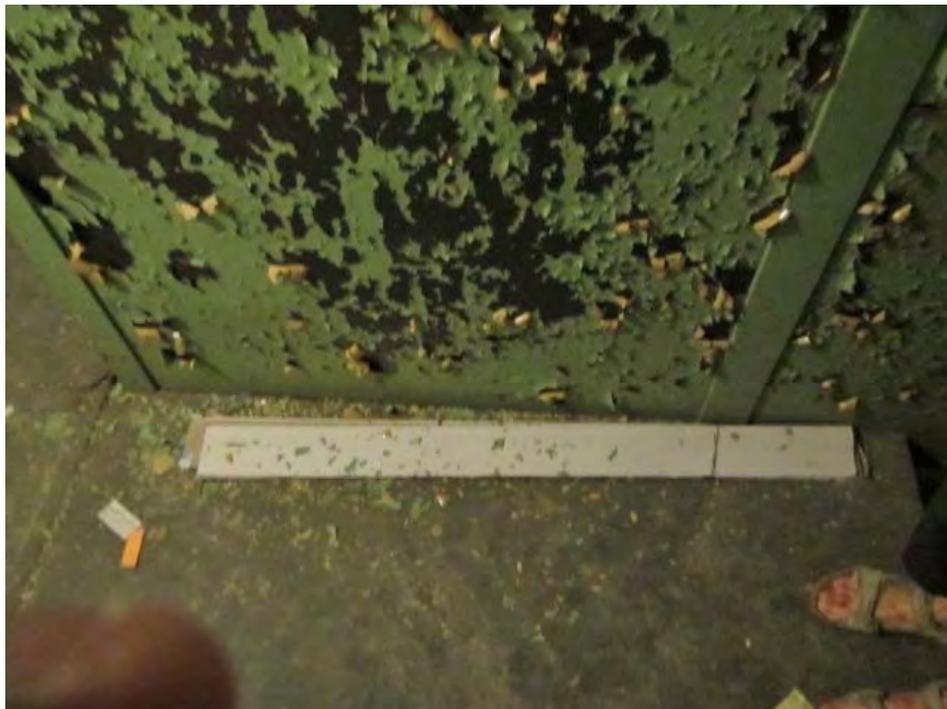
Picture 10

Peeling paint/plaster was observed on ceilings and walls throughout the cell block space (Picture 10), and porous items (e.g., boxes and papers) were observed in the area (Picture 11). Porous materials should not be stored in basements due to chronic moisture and elevated relative humidity. Windows in the cell block, original to the building, were found with cracked/missing panes, and deteriorated/rotted wood frames and sills.

Peeling paint in cell block

9. Repair water-damaged/peeling paint and plaster on walls and ceilings.
10. Reduce the number plants in the building, especially the fourth floor atrium area. Ensure indoor plants are equipped with drip pans. Examine drip pans periodically for mold growth and disinfect with an appropriate antimicrobial, as needed. Move plants away from the air stream of mechanical ventilation equipment.

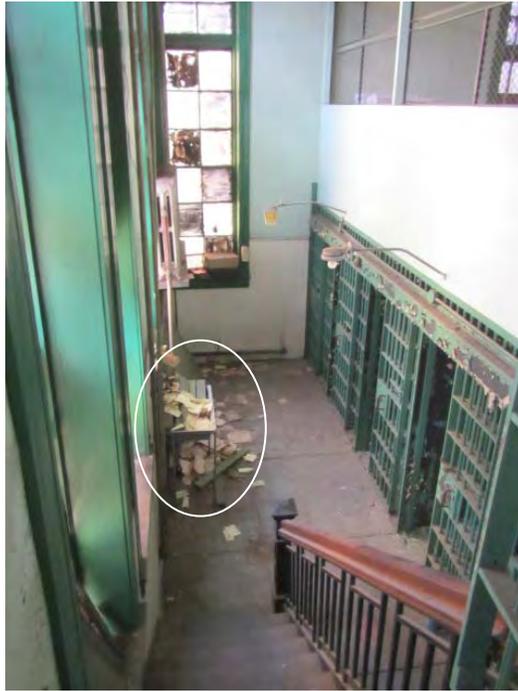
Picture 11

Accumulated water-damaged boxes/papers in cell block

6. Remove all papers and boxes from the cell block space and ensure porous materials are not stored in the basement.
7. Repair/replace missing/broken glass in skylights.

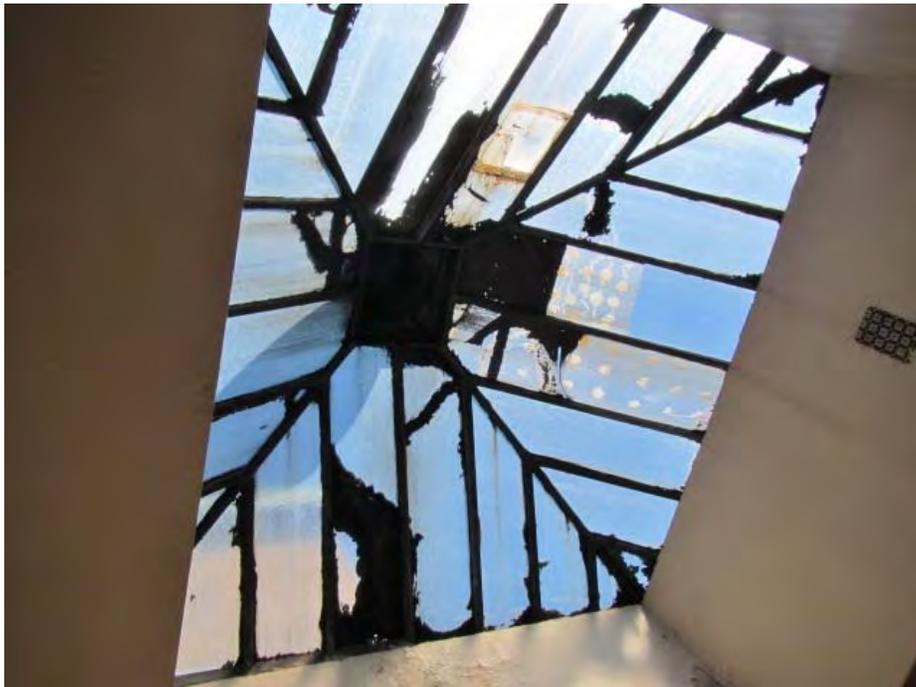
Picture 12

Two skylights in the roof of the building had cracked/missing glass and/or were painted over (Picture 12). Water-damaged walls and ceilings and water staining on wooden floors were

Skylight with cracked/missing/painted over glass

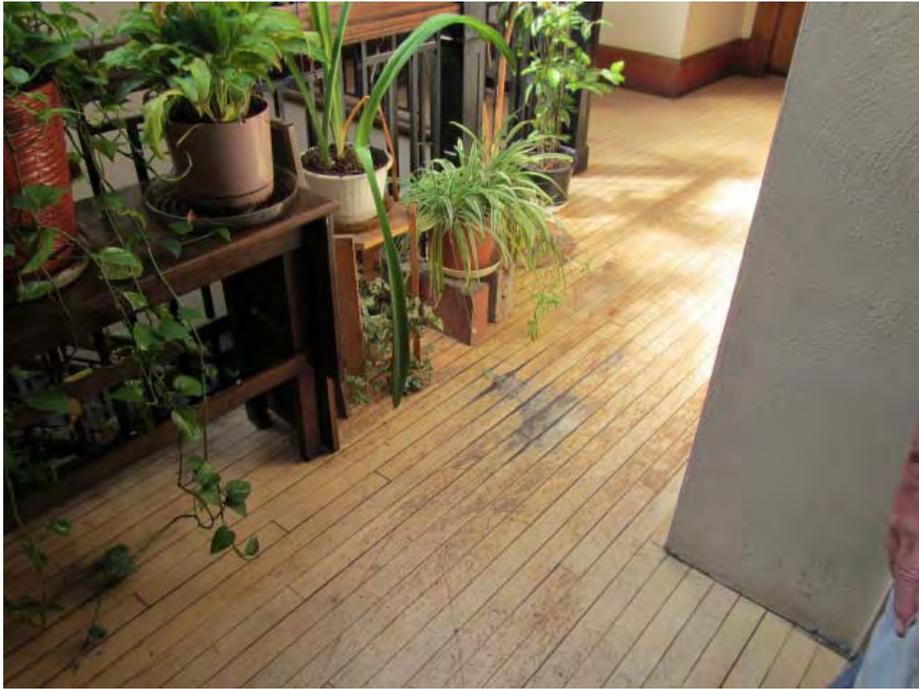
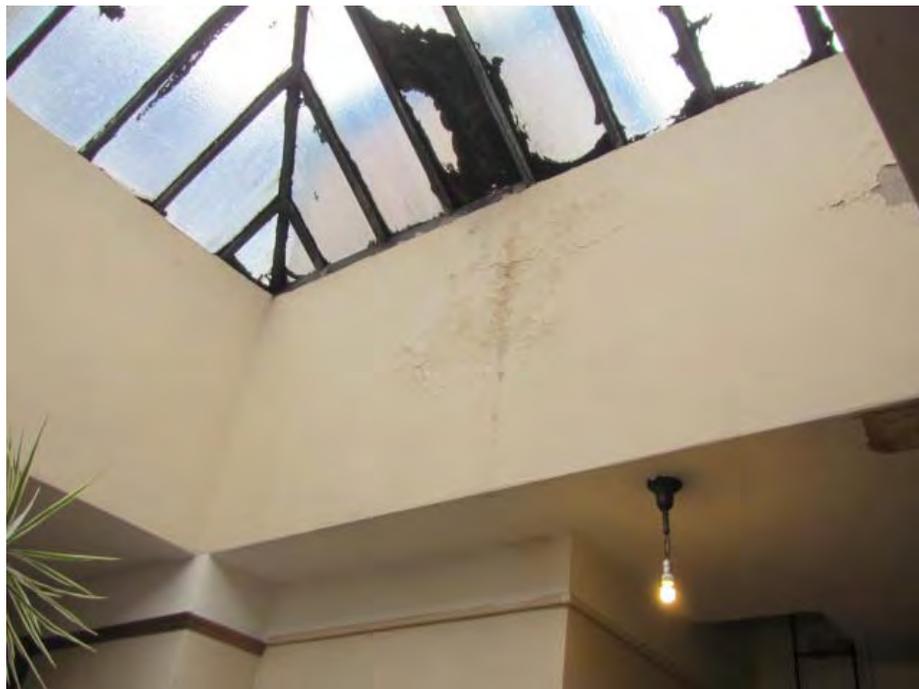
observed on the fourth floor atrium below the skylights, which is indicative of chronic water penetration (Pictures 13 and 14). HCHA staff reported that buckets are routinely used to collect water leakage during/following heavy storms.

Water staining on fourth floor (note: number of plants)

Water-damaged wall plaster in fourth floor atrium

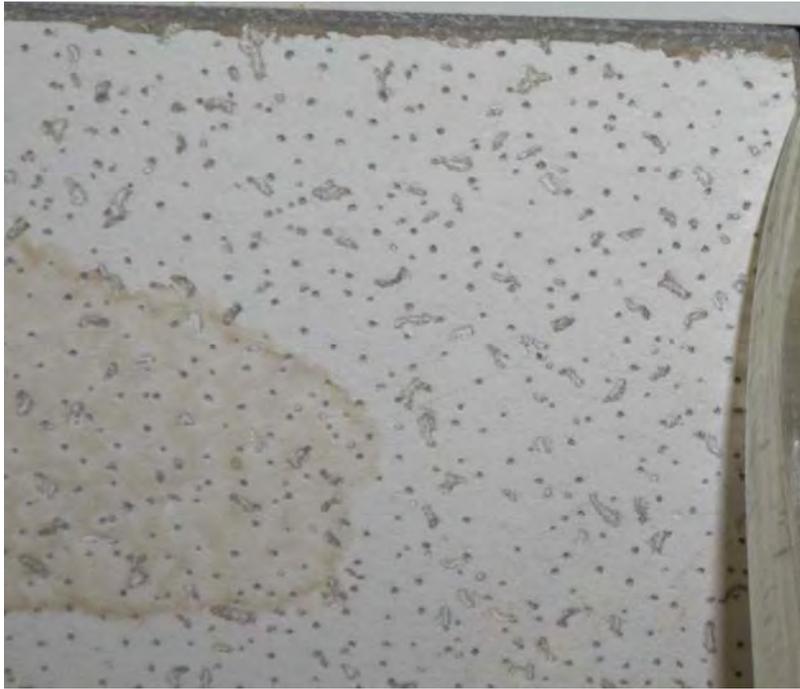
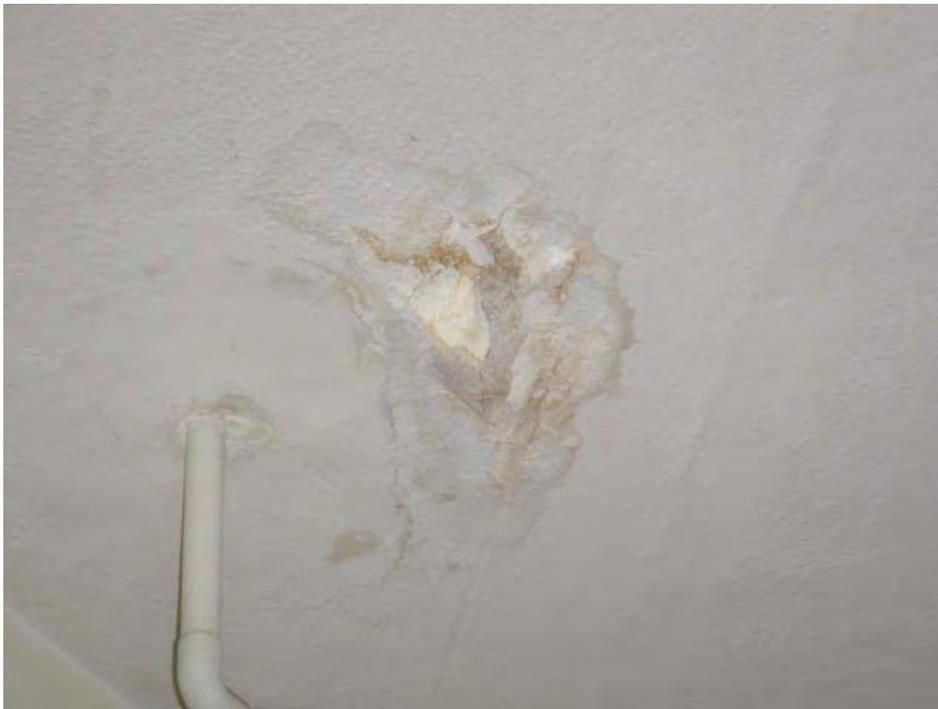
Several rooms in the building had water-damaged ceiling tiles, plaster and peeling paint (Table 1; Pictures 15 and 16), which may stem from roof leaks, plumbing leaks and/or condensation from WAC components. If repeatedly moistened, ceiling tiles can be a mold growth medium. Water-damaged ceiling tiles should be replaced after a water leak is discovered and repaired.

Water-damaged ceiling tile

Water-damaged ceiling plaster

8. Remove water-damaged ceiling tiles and examine for source of water. Monitor for future leaks. After necessary repairs are made, replace any water-damaged ceiling tiles.

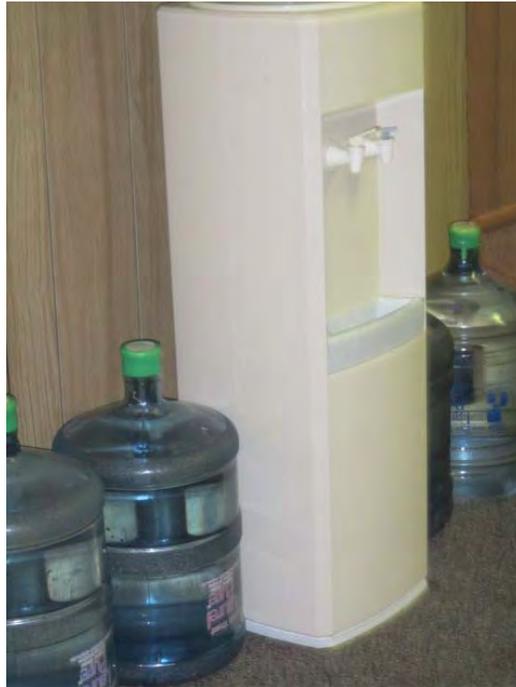
Picture 17

Water dispensers were located in several rooms over carpeting (Table 1; Picture 17). Overflow/spills from water coolers/fountains can moisten carpeting. It is recommended that these dispensers be located on non-porous flooring or a waterproof mat. It is also important that the catch basin of water coolers be cleaned regularly as stagnant water can be a source of odors.

Water dispenser located on carpet

11. Consider moving water dispensing equipment to areas with tiled floors instead of carpeting, or installing waterproof mats to prevent leaks from damaging carpet.

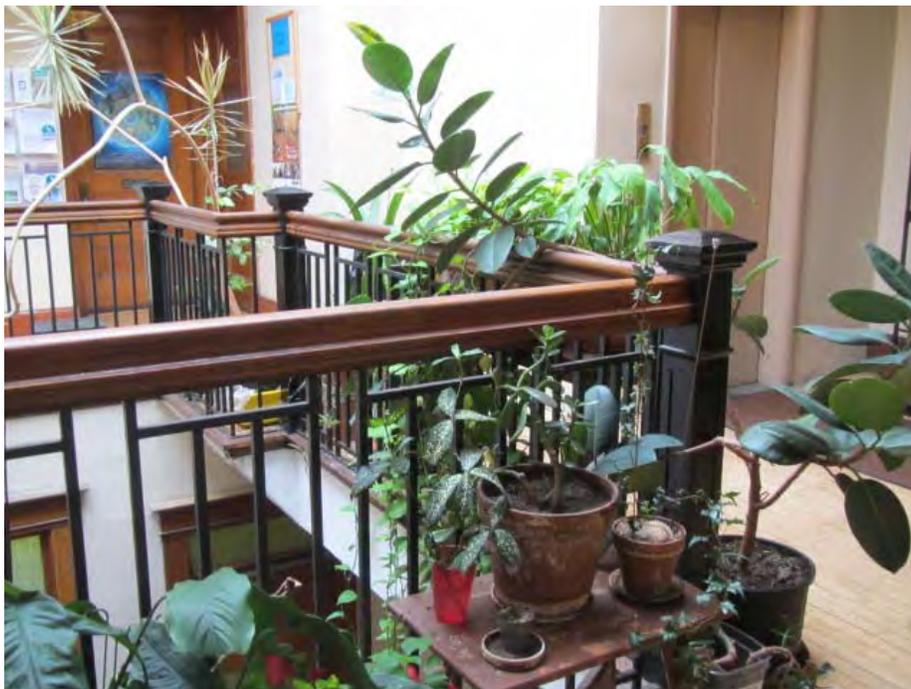
Picture 18

Plants were observed in several offices and numerous plants were located in the fourth floor atrium (Table 1; Picture 18). Plant soil, standing water and drip pans can be potential sources of mold growth. Drip pans should be inspected periodically for mold growth and over watering should be avoided.

Plants in fourth floor atrium

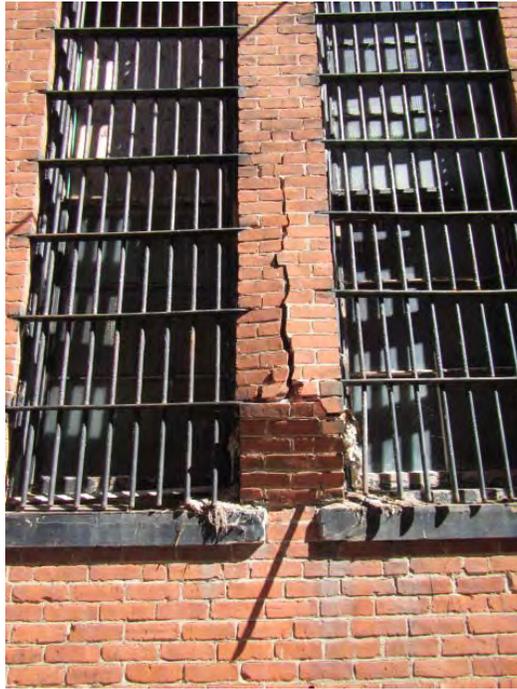
Picture 19

mortar along the south-facing wall of the building had an extensive vertical crack. In addition, the wall was bulging and the bars of the adjacent cell block windows were found dislodged/separated from the damaged wall (Picture 19). Not only are these breaches a source of water penetration to the building interior, the condition of the wall can compromise the structural integrity of the building envelope.

Cracked/damaged brick/mortar on south-facing wall

4. Consider a long-term plan to replace windows (where needed) to prevent air/moisture infiltration.
5. Consult with an architect or masonry engineering firm to develop a plan to address building envelope concerns (e.g., damaged skylights; cracked/ missing brick, stone, and mortar; permeable areas of foundation; and deteriorated interior/exterior walls/foundation) in order to eliminate water infiltration.

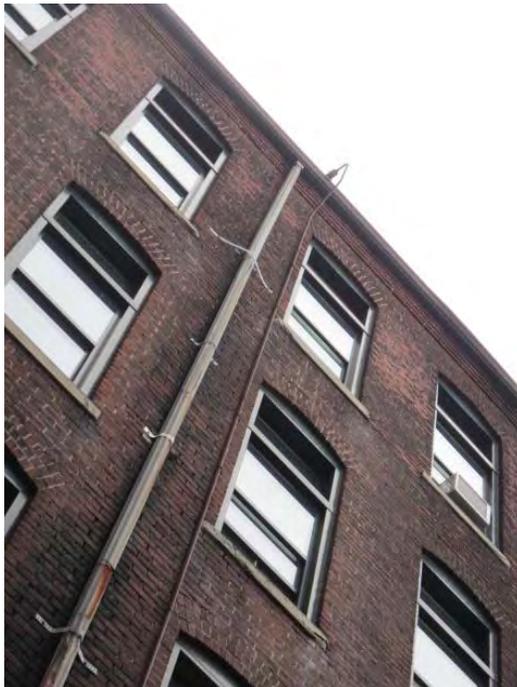
Picture 20

A gutter/downspout exists on the west side (rear) of the building (Picture 20). On the day of the assessment water was observed draining from the center of the gutter indicating that the junction of the gutter/downspout system may be clogged with debris or the gutter has breaches/holes preventing proper drainage. No other areas of the roof had rain gutters/downspouts installed. Without a gutter/downspout system, water can pool at the base of the foundation and penetrate basement walls.

Gutter/downspout attached to the rear of the building

2. Install exhaust ventilation in restrooms to prevent the migration of odors, moisture and pollutants into occupied spaces.
3. Install gutters and downspouts to direct rainwater at least 5 feet away from foundation.

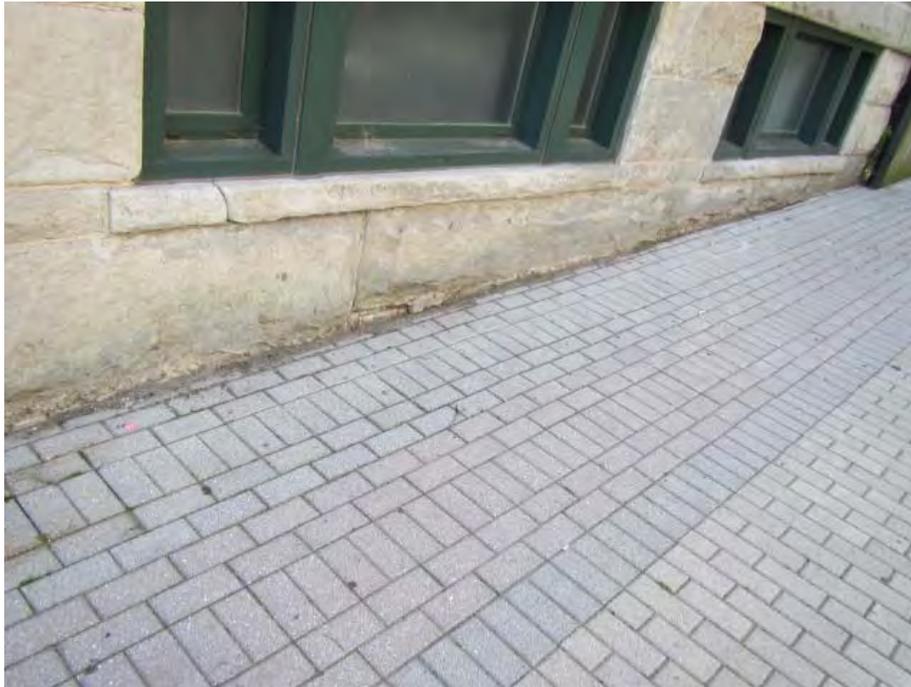
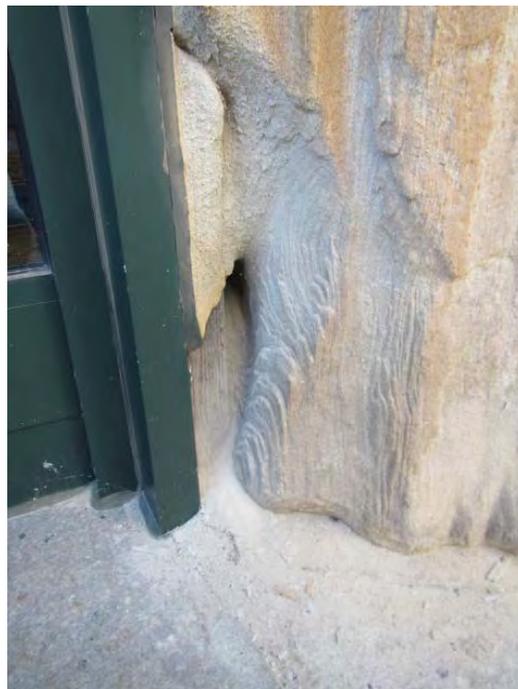
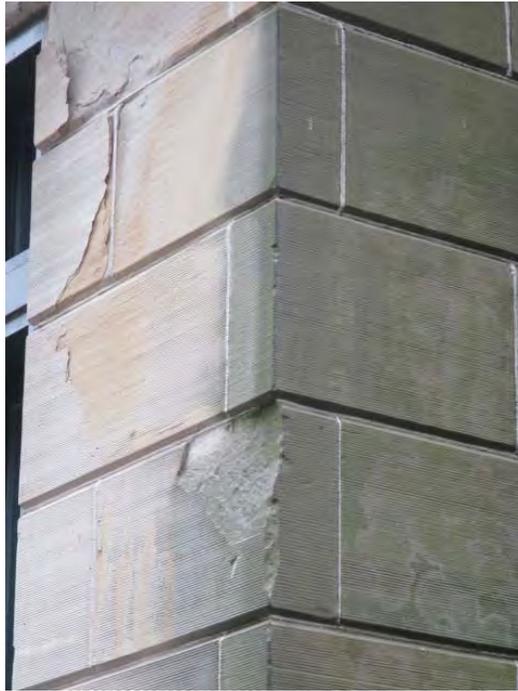
- Cracks/deterioration in the stone foundation, walls and columns likely due to chronic exposure to wind driven rains and water pooling along the foundation (Pictures 21 through 23).
- Missing/damaged brickwork along walls and windows (Pictures 24).
- Damaged flashing along the roofline (Picture 25).
- Plant and grass growth along the foundation in a number of areas (Picture 26). The growth of roots along exterior walls can hold moisture and eventually lead to cracks and/or fissures in the foundation below ground level.
- Deteriorated/rotted wood and cracked/missing glass in windows.

Over time, these conditions can undermine the integrity of the building envelope and provide a means of water entry into the building via capillary action through foundation concrete and masonry (Lstiburek & Brennan, 2001). The freezing and thawing of water during winter months can lead to further damage and subsequent water penetration into the interior of the building. In addition, these breaches can be a pathway for rodents and other pests to enter the building.

Damaged stone foundation along sidewalk

Deteriorated stone column adjacent to side entrance of the building

Cracked/damaged stone on north side of the building

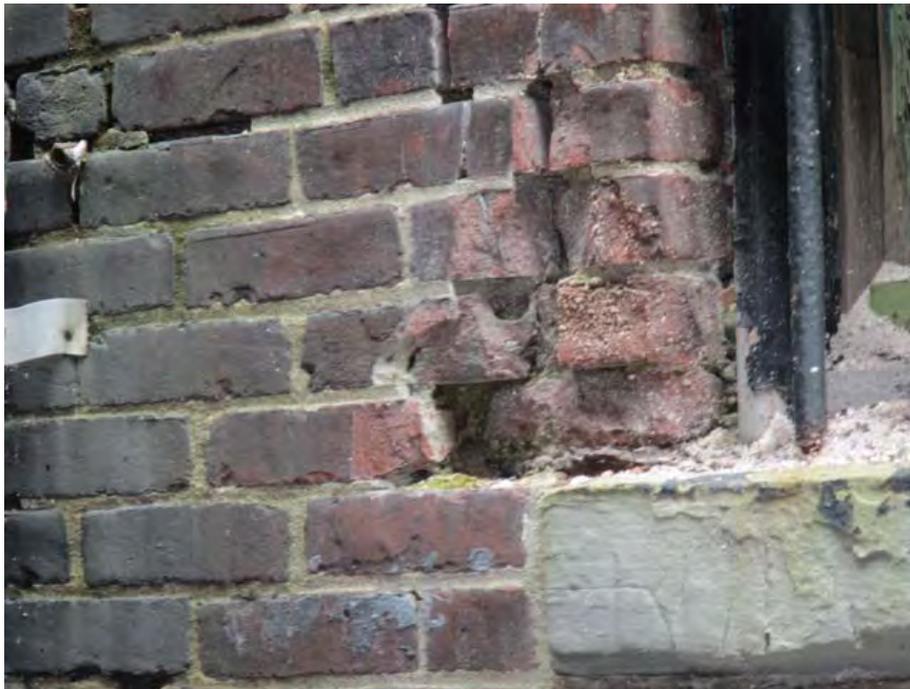
Picture 24

Cracked/damaged brick and mortar

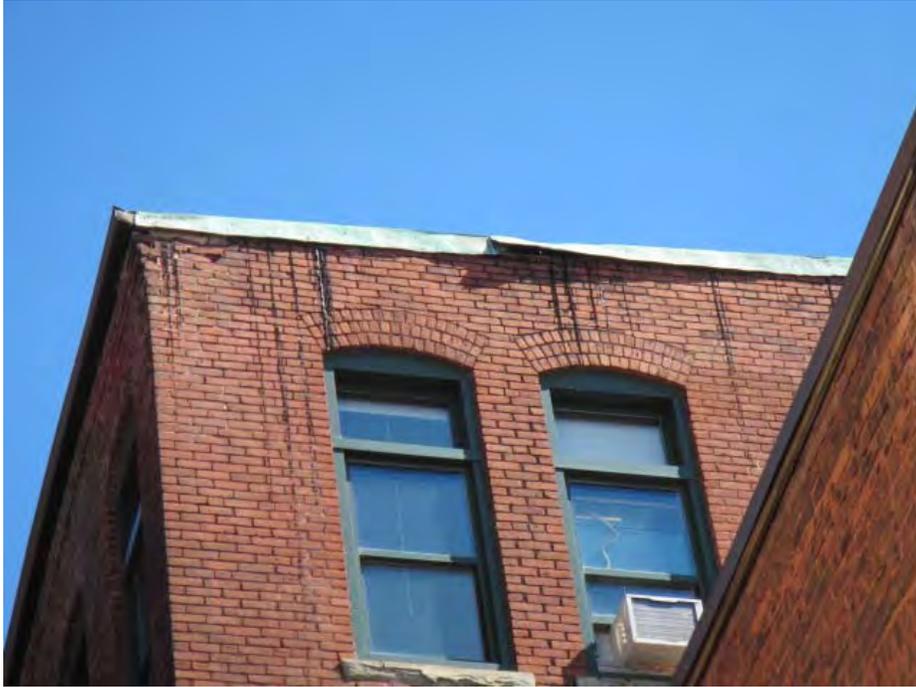
Picture 25

Damaged flashing along the roofline

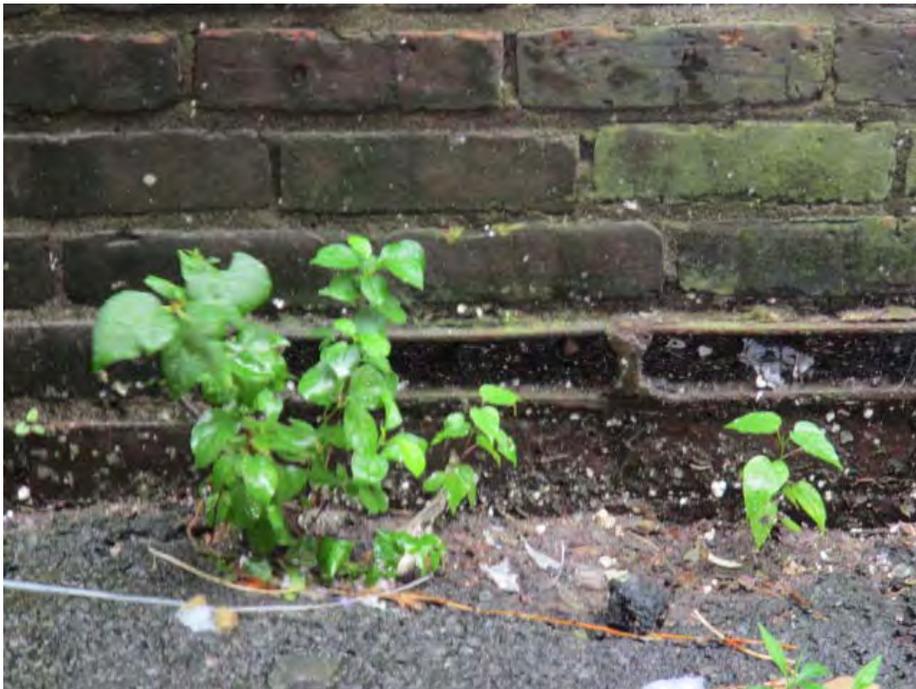
Picture 26

Plants growing along the foundation

12. Remove grass, plants and debris from the exterior wall/foundation of the building to prevent water penetration into basement and crawlspace.
13. Make repairs as needed to the elevator generator to prevent exposures to VOCs.

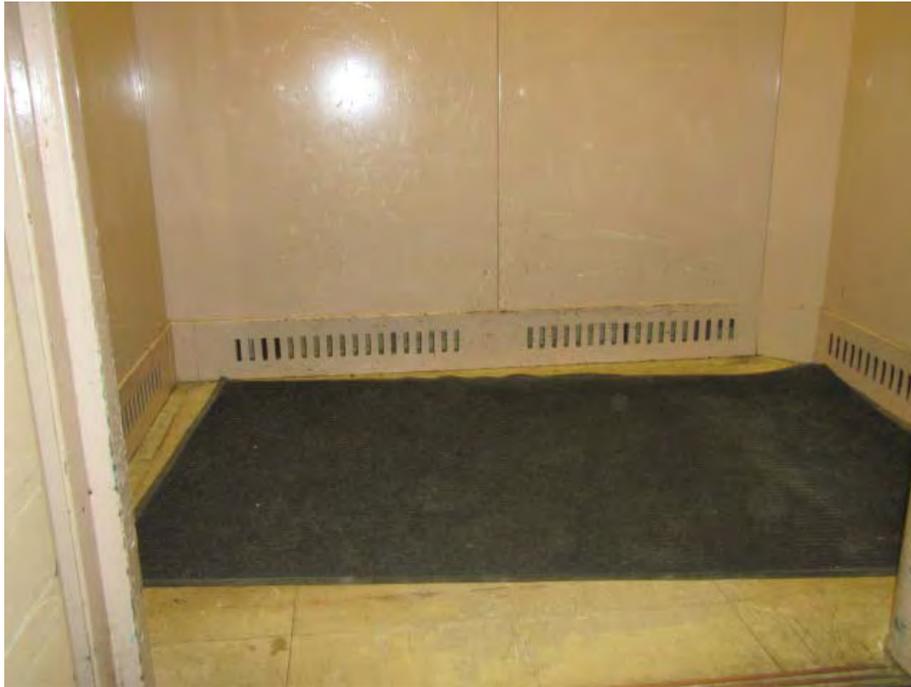
Picture 27

BEH/IAQ staff detected an odor of hydraulic fluid near the elevator. Hydraulic fluid has a distinct odor and contains volatile organic compounds (VOCs), which can be irritating to the eyes, nose and throat. Normally, elevator shafts have a fan to provide ventilation and exhaust odors generated by the hydraulic mechanism. The elevator in the HCHA is configured with passive vents that draw air from the adjacent mechanical room (Picture 27). Upon inspection, BEH/IAQ staff observed the generator was leaking fuel and oil-soaked towels were on the floor of the mechanical room. Facilities staff reported that a firm had been contacted to make needed repairs.

Passive vents located on the interior of the elevator

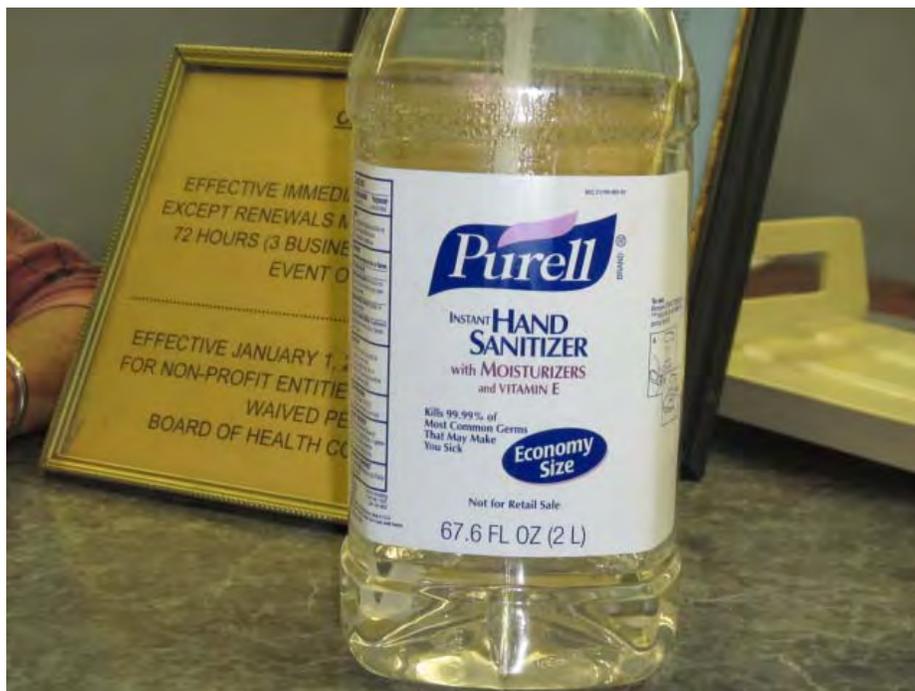
Picture 28

Hand sanitizer was also found in some spaces (Table 1; Picture 28). Hand sanitizer products may contain ethyl alcohol and/or isopropyl alcohol which are highly volatile and may

Hand sanitizer

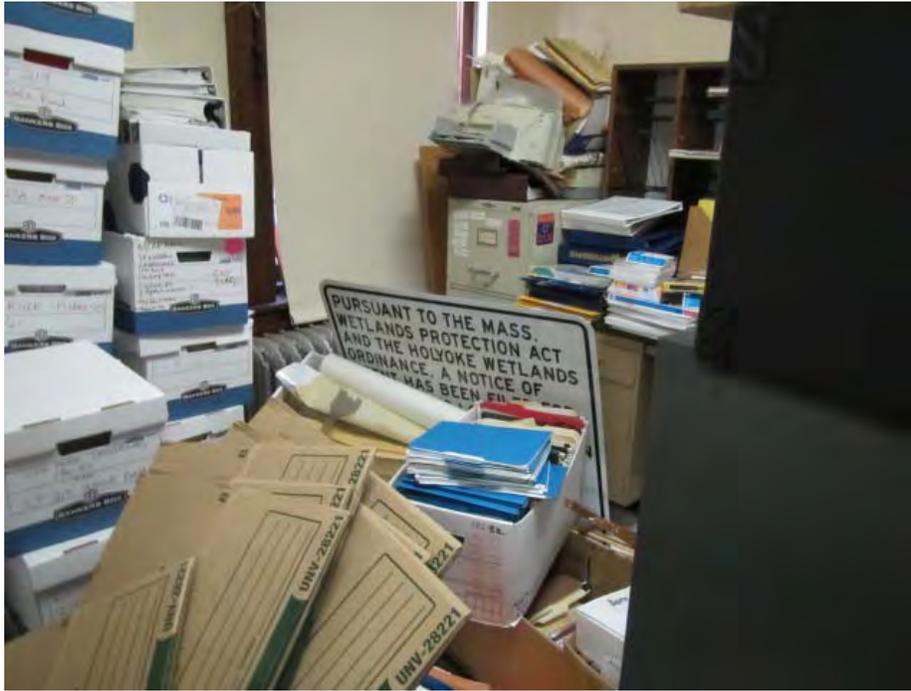
Picture 29

Other conditions which may affect indoor air quality were observed during the assessment. In several rooms, items were observed on the floor, windowsills, tabletops, counters, bookcases and desks (Table 1; Picture 29). The large number of items stored in office spaces provides a source for dust to accumulate. These items (e.g., papers, folders, boxes) make it difficult for custodial staff to clean.

Boxes, paper and clutter in an office space
