INDOOR AIR QUALITY ASSESSMENT

**Department of Fish and Game
Division of Fisheries and Wildlife
Richard Cronin Building
1 Rabbit Hill Road
Westborough, MA**

Prepared by:
Massachusetts Department of Public Health
Bureau of Environmental Health
Indoor Air Quality Program
September 2015

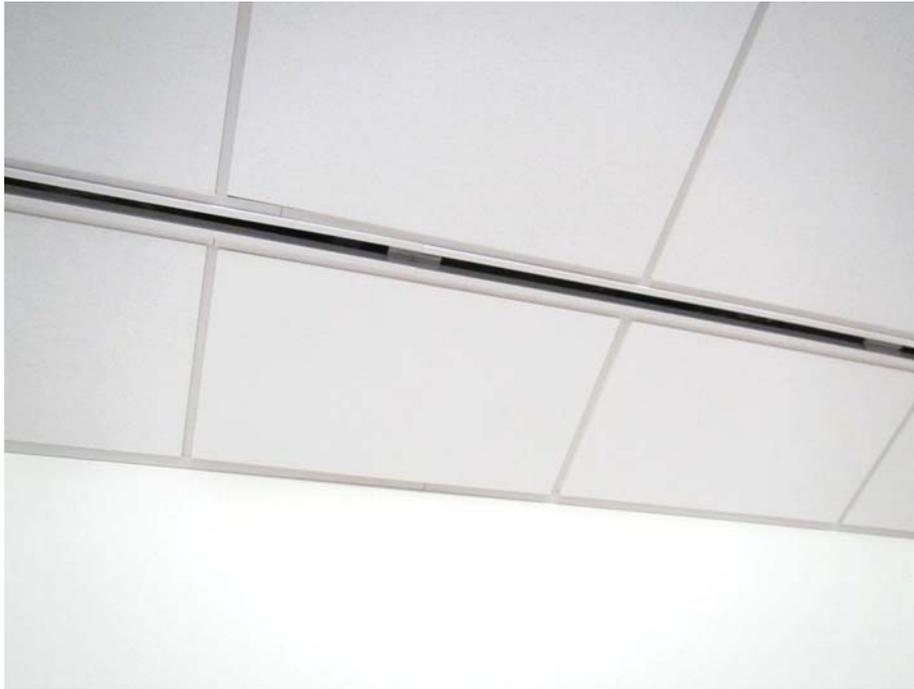
Picture 1

Supply air vent

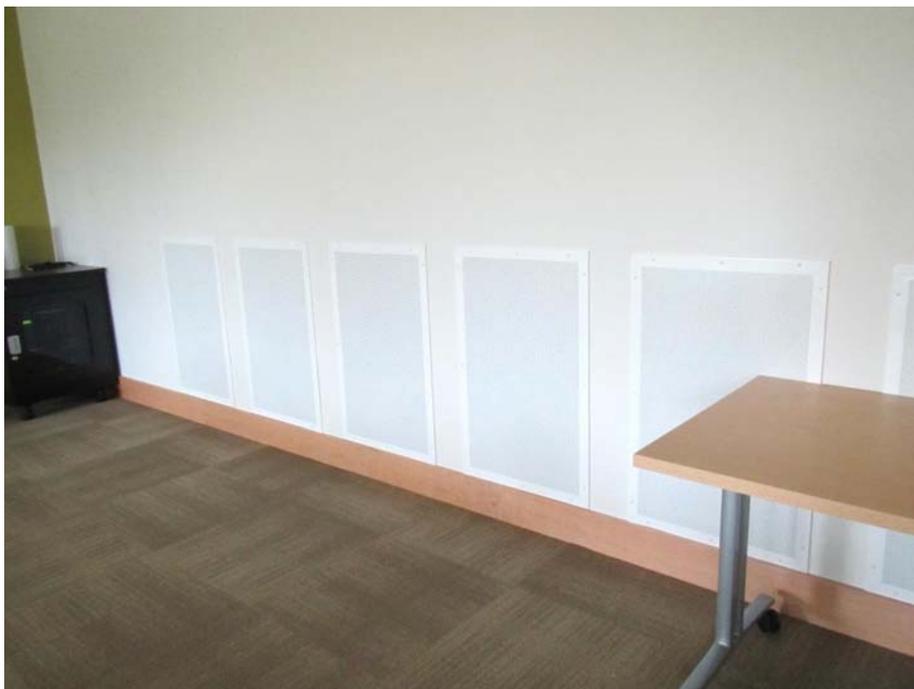
Picture 2

Exhaust vents in conference/meeting room

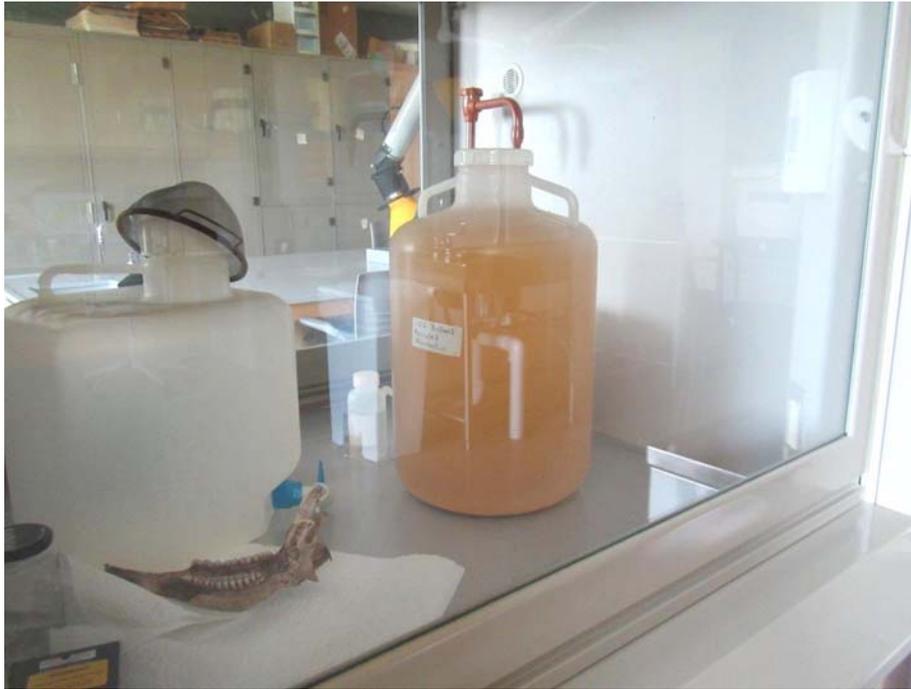
Picture 3

No testing for TVOCs was conducted during the assessment, but several potential sources of VOCs were identified. In the laboratories, a shared hood contained a large vessel of formalin (Picture 3). Formalin is an aqueous solution of formaldehyde gas, often used as a tissue sample preservative or disinfectant. Formaldehyde gas can evaporate from the solution if not kept in a tightly closed container. Formaldehyde has a strong and irritating odor, and is toxic and carcinogenic. It can also cause an allergic reaction in sensitive people (ATSDR, 1999). Use of formaldehyde or other laboratory chemicals should take place in the laboratory hoods whenever possible and the containers should be kept tightly sealed. The laboratory hoods require calibration/certification annually to ensure safe performance.

Exhaust hood in between laboratories

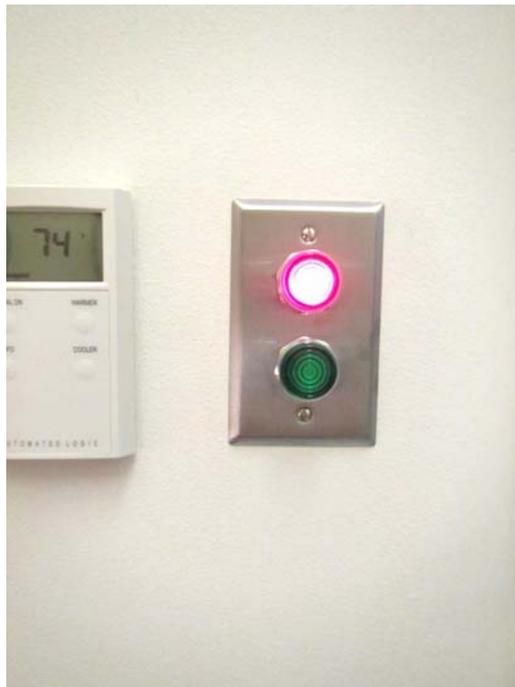
Picture 4

Indicator lights for window opening

4. Ensure occupants are aware of the use of special features of the building, such as the window indicator lights.
5. Ensure proper operation of carbon dioxide sensors in meeting room; calibrate and/or make repairs/replace as necessary. Maintain these systems in accordance with manufacturer’s instructions.

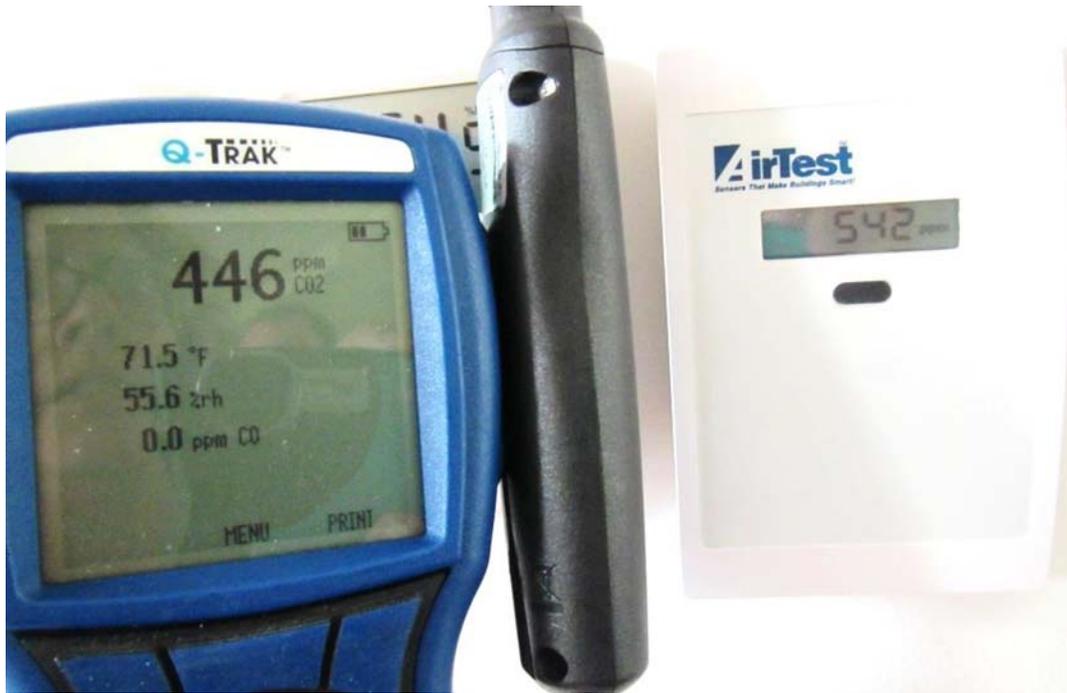
Picture 5

Carbon dioxide sensors are present in the larger conference/meeting rooms. One of these sensors was suspected to be malfunctioning during the June 26, 2015 visit, and comparison with the Q-trak measurement showed that the sensor was inaccurate (Picture 5). Carbon dioxide sensors should be calibrated regularly/as per the manufacturer’s instructions and replaced/repared when not functioning.

Comparison of carbon dioxide readings of Q-trak and building carbon dioxide sensor

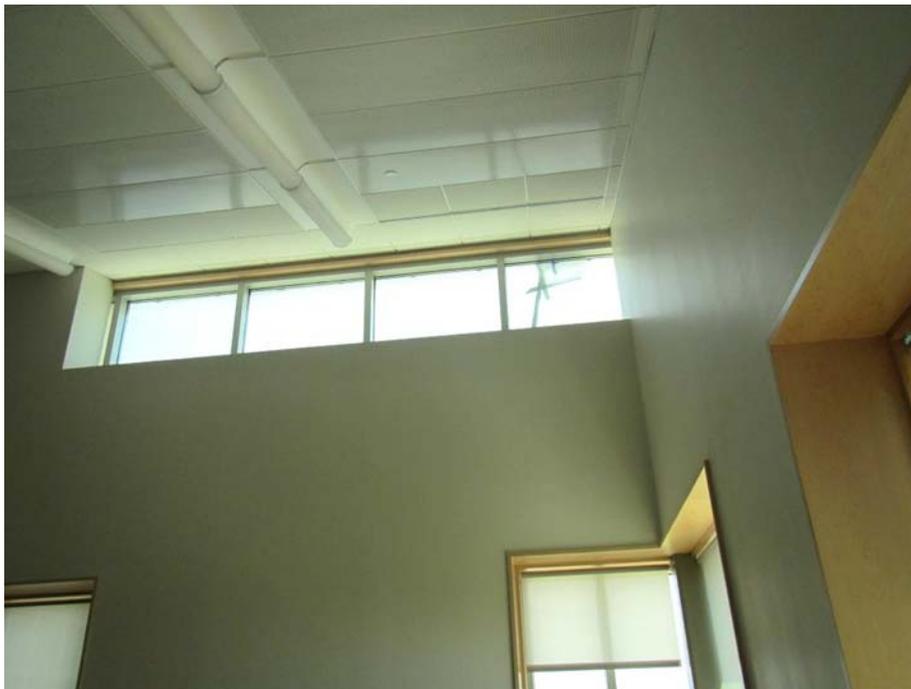
Picture 6

- Windows high up on the second floor along the south side of the building had been reported to leak during heavy rains. While repairs are underway windows are covered in plastic to prevent additional water infiltration (Pictures 6 and 7).
- Condensation from HVAC components were reported by building occupants to have occurred in the past, causing minor moistening of carpeting in a few areas; no moist building materials were observed during the visit.
- Piping for one of the ceiling AHUs on the first floor was wet with condensation. The AHU was equipped with a drip pan, which reportedly drains to the outside. Additional insulation may be needed for cooling pipes.
- A portable air conditioning unit was observed in the data/server room (Picture 8). These units create condensation that must be drained to the exterior. These units

Inside room where upper windows leak

3. Repair leaking windows and remove and discard any water-damaged porous building materials (gypsum wallboard, carpeting, paper-backed insulation, etc.) as necessary in a manner consistent with recommendations found in “Mold Remediation in Schools and Commercial Buildings” published by the US Environmental Protection Agency (US EPA, 2001).

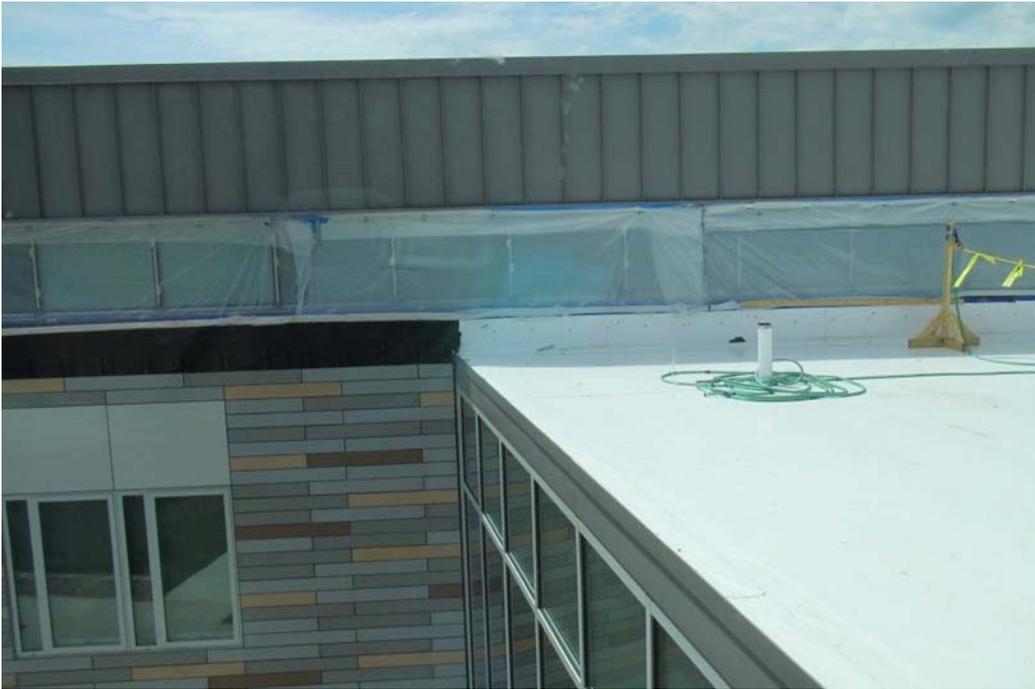
Picture 7

Plastic covering windows from outside

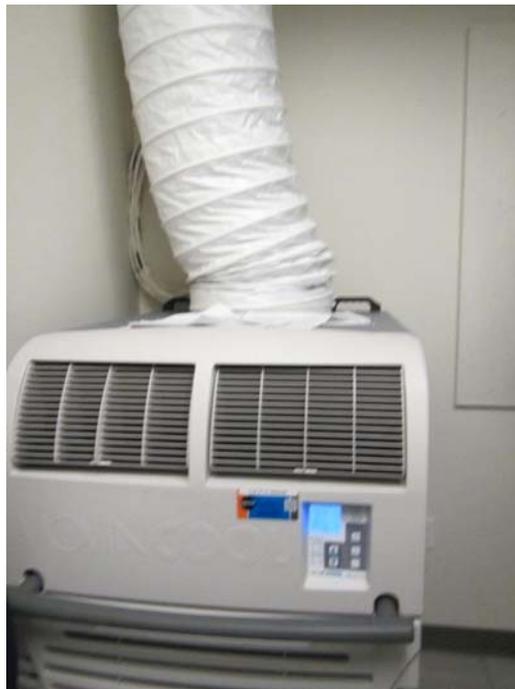
Picture 8

Portable air conditioner

8. Monitor and maintain condensation drip pans in the HVAC system. Consider additional insulation of cooling coils to prevent condensation. Maintain the portable air conditioner in accordance with manufacturer's instructions and monitor for spills/leaks of condensate.

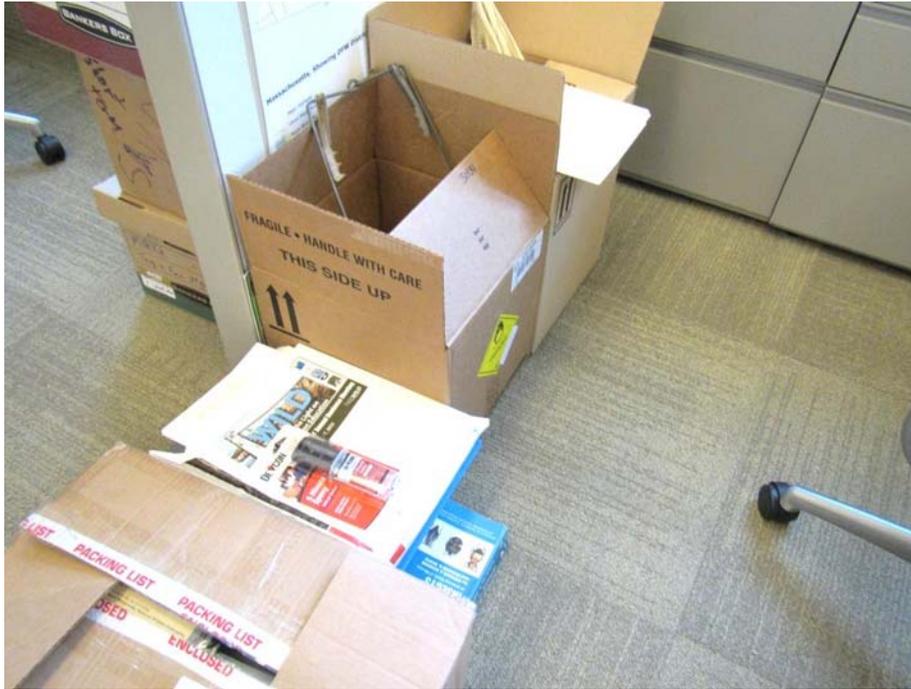
Picture 9

Cardboard and paper on the floor

9. Avoid storing porous items on floors where there is radiant floor cooling and in below-grade/basement areas.
10. Maintain the water feature in the atrium and monitor for water quality, fish health and any odors/other issues.

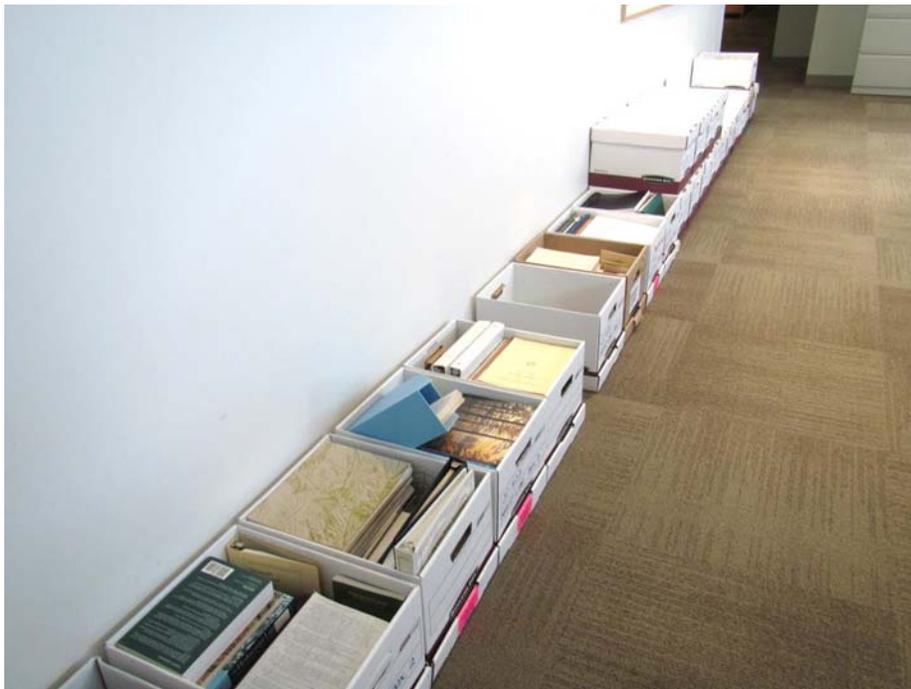
Picture 10

Boxes of books on the floor

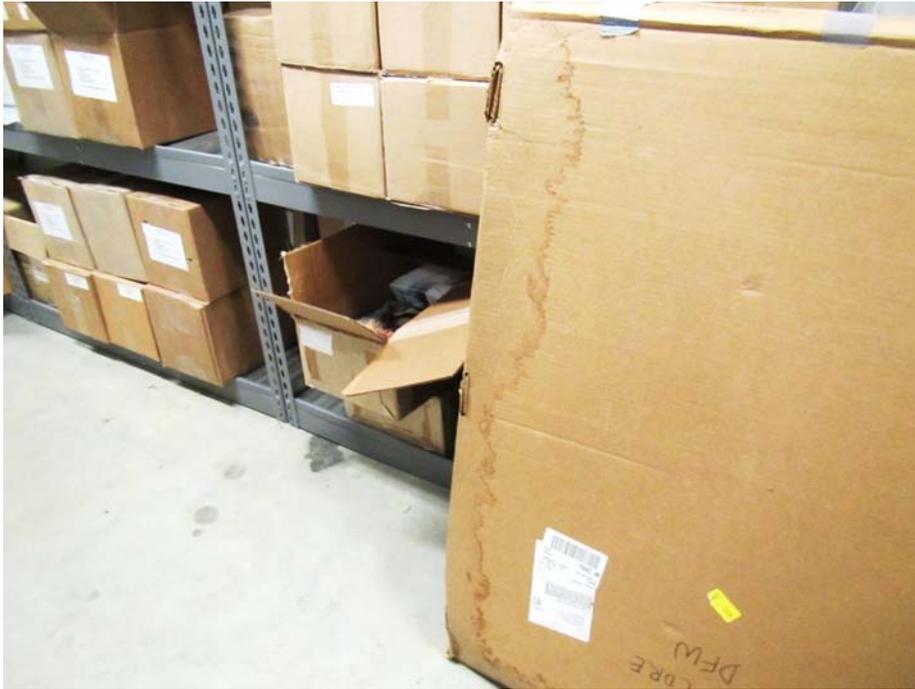
Picture 11

- According to facilities management, the building has radiant floor cooling. Due to this feature, the potential exists for the floors to generate condensation when indoor conditions are humid. Carpeting could become moistened and if moistened for an extended period of time, be a medium for microbial growth. In many areas, cardboard boxes and other porous materials were stored on floors (Pictures 9 and 10), which may be moistened by condensation in humid conditions.
- Porous items on floors in below grade areas such as the basement storeroom (Picture 11) may become water-damaged.

Water-damaged box on floor of basement storeroom

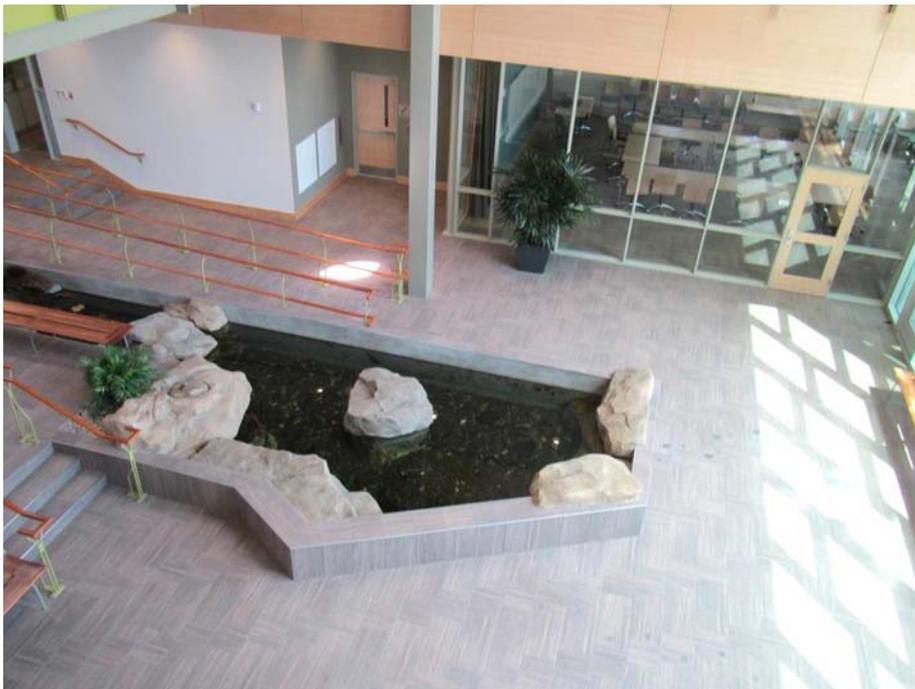
Picture 12

The building atrium has a water feature in the form of a cold-water trout river/pool (Picture 12). This feature appeared to be in good condition during the visit, with clear water and no odors. In addition, it was reported that the fish were breeding and healthy, which indicates that good water quality is being maintained. If this water feature is not properly maintained, odors and microbial growth may occur. Due to the central placement of the water and the open atrium/office area, any unpleasant odors would be easily distributed to other occupied spaces.

Trout pool in atrium view from upper level

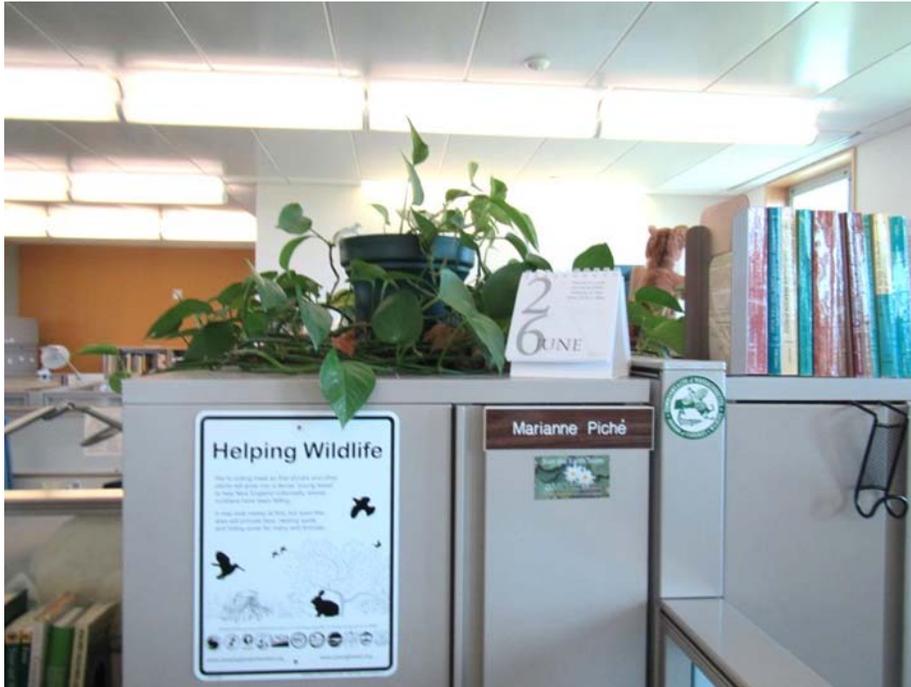
Picture 13

Plants were observed in many open areas, cubicles and offices (Picture 13; Table 1). Plants can be a source of pollen and mold, which can be respiratory irritants to some individuals.

Plants in an office

Plants should be properly maintained, over-watering of plants should be avoided and drip pans should be inspected periodically for mold growth and cleaned or replaced as necessary.

11. Indoor plants should be properly maintained and equipped with drip pans to prevent water damage to porous building materials and be located away from ventilation sources to prevent the aerosolization of dirt, pollen or mold.

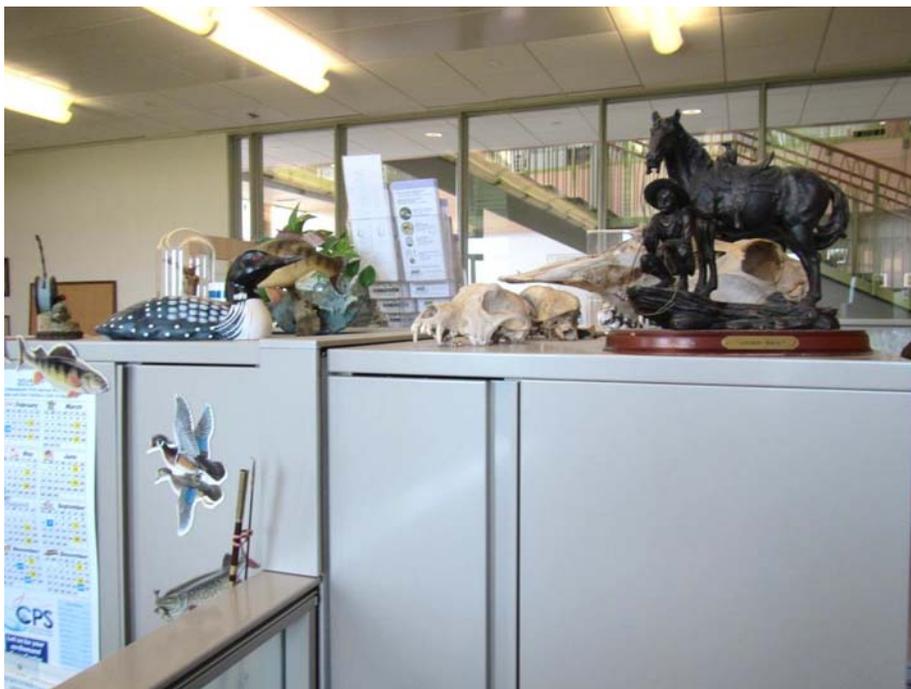
Picture 14

In some areas, accumulations of items were seen on floors, windowsills, tabletops, counters, bookcases and desks, which provide a source for dusts to accumulate. Some of these items included feathers, furs, taxidermy and other organic materials, which may contain allergens (Pictures 14 and 15). In addition, these items may make it difficult for custodial staff to clean. Items should be relocated and/or be cleaned periodically to avoid excessive dust build up.

Items on a file cabinet

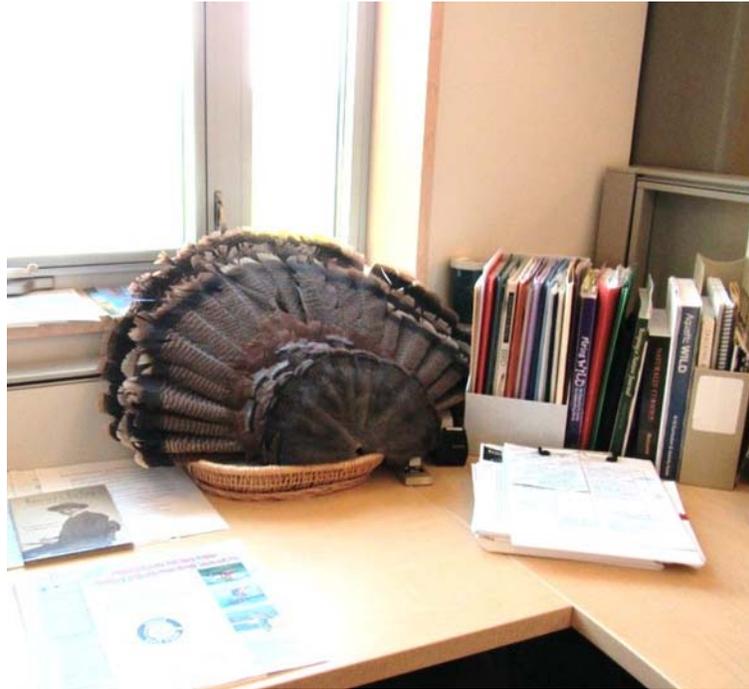
Picture 15

Feathers in an office

16. Reduce the use of hand sanitizing products especially those containing fragrances.
17. Clean items including feathers, furs and taxidermy of accumulated dusts regularly and keep items out of airflow to prevent distributing dusts and allergens.

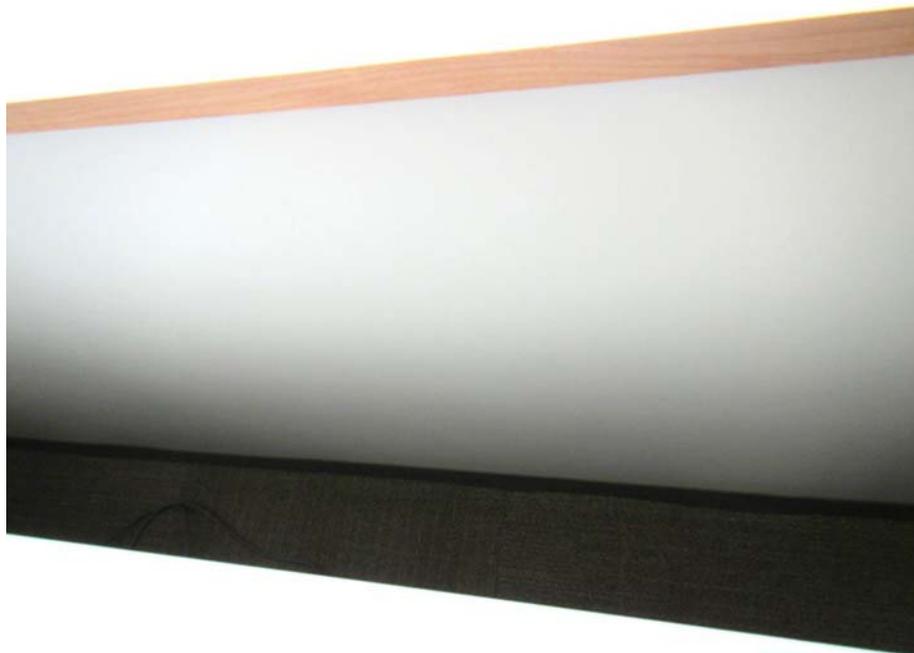
Picture 16

In some areas, a space exists between the cube and building walls (Picture 16). If not cleaned regularly, accumulations of dust and debris in this space can provide food and harborage for pests.

Area between cube and building walls

18. Ensure areas between cube and building walls are cleaned regularly.
19. Vacuum carpet with a high efficiency particulate arrestance (HEPA) filtered vacuum in combination with cleaning carpeting annually or semi-annually in soiled high traffic areas as per the recommendations of the Institute of Inspection, Cleaning and Restoration Certification (IICRC, 2012).

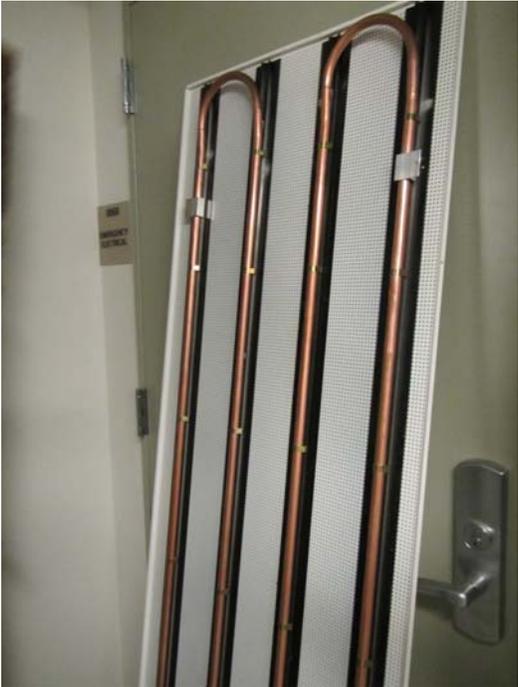
Picture 1

- The ceiling tile system has, from bottom to top, metal ceiling tiles, cooling coils and a layer of insulation (Picture 1).
- At the time of the July 31, 2015 visit, some of the ceiling tiles in the affected offices had visible condensation (Picture 2). Staining on other tiles indicate past condensation as well. In areas where the ceiling tiles were removed, condensation could also be seen on the coils themselves. This condensation can moisten the insulation.
- The use of the radiant ceiling in cooling mode would be more likely over the summer months, thus leading to an increase in problems associated with moistened insulation.

The conditions leading to the odor seem to be related to both the installation of the insulation (a porous material directly on cooling coils) and humidity control issues in the building during hot, humid weather. As a temporary measure to remove the source of the odor, it is recommended that all the insulation that is odorous or in direct contact with moisture above the third-floor ceiling tile system be removed and discarded.

Construction of ceiling tile system with heating/cooling coils

In order to address the ceiling condensation issue, longer term measures should include an investigation of the design functioning of the ceiling tile system, particularly in cooling mode, to determine if another method of insulating the coils is appropriate. Additionally, continue to commission the building's climate control systems with particular emphasis on humidity control.

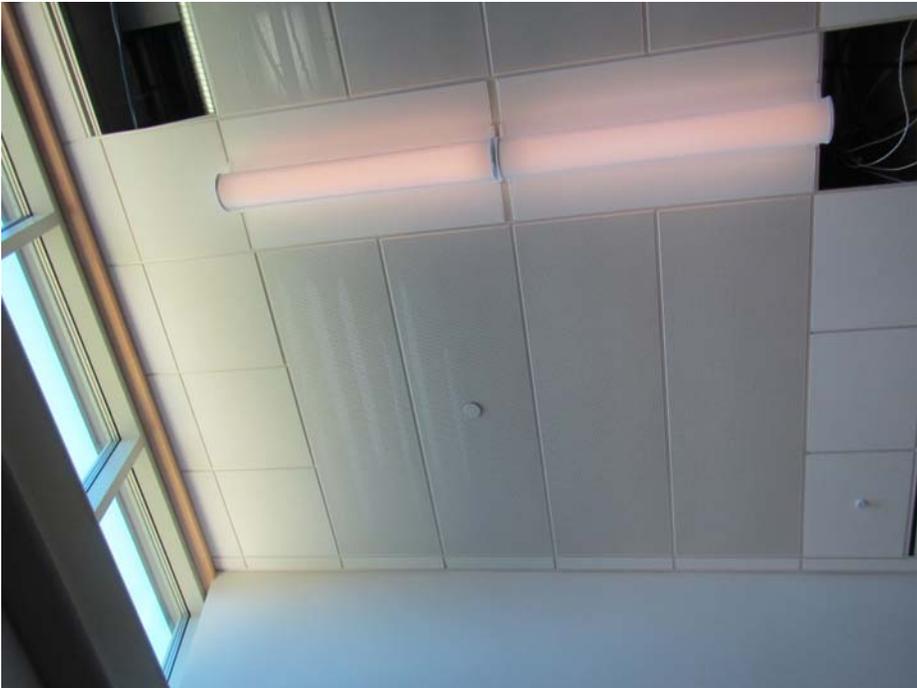
Picture 2

- Other leaks from the ceiling coils may have also occurred in these offices, as reported by Mr. Nicosia and Mr. Tisa.
- A sample of the insulation had been removed from the ceiling in room 310 and placed in a plastic bag for several days. The odor inside this bag matched the odor inside the offices, supporting the insulation as the source of the odor.
- Surface temperatures were measured on ceiling system in the affected offices and nearby areas. At the time of the visit, one of the surface temperature measurements (room 305) was below the dew point and the ceiling was visible wet. In other areas, the surface temperature of the tiles was only a few degrees above the dew point.

Condensation on ceiling tiles
