INDOOR AIR QUALITY ASSESSMENT

**Sheffield Town Hall
21 Depot Square
Sheffield, Massachusetts**

Prepared by:
Massachusetts Department of Public Health
Bureau of Environmental Health
Indoor Air Quality Program
November 2015

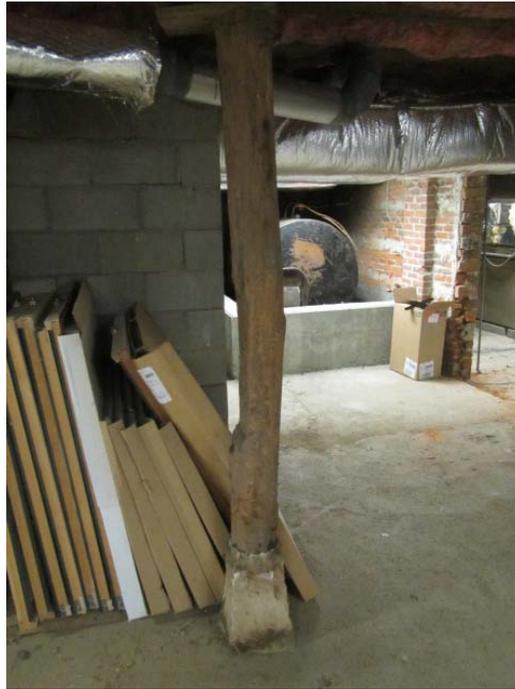
Picture 1

Note that the first floor is supported from the basement with a combination of wood pillars (Picture 1), brick columns (Picture 2), house jacks (Picture 3), and steel I-beams connected to permanent metal columns (Picture 4).

Wooden support pillar in basement

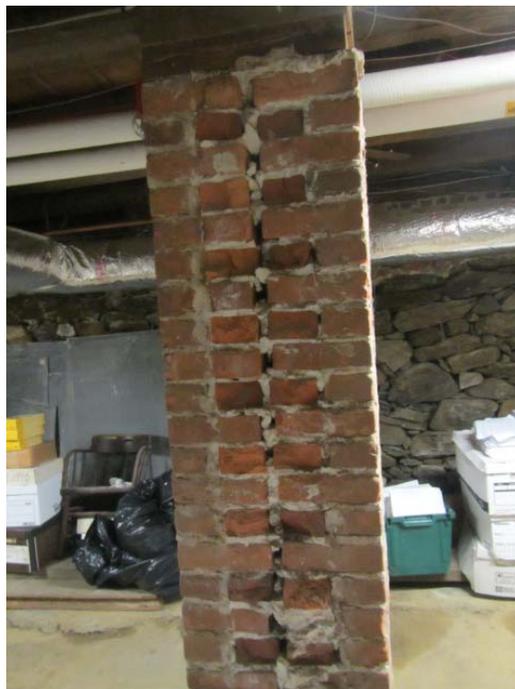
Picture 2

Brick support column

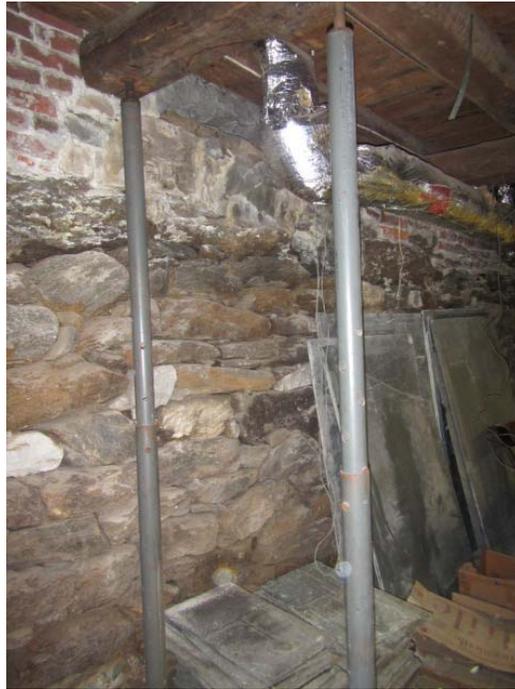
Picture 3

House jack

6. Consult with a building engineer regarding replacing split wood support beams and house jacks with a permanent support system. Additionally, consult about the structural integrity of walls where the brick is significantly deteriorated.

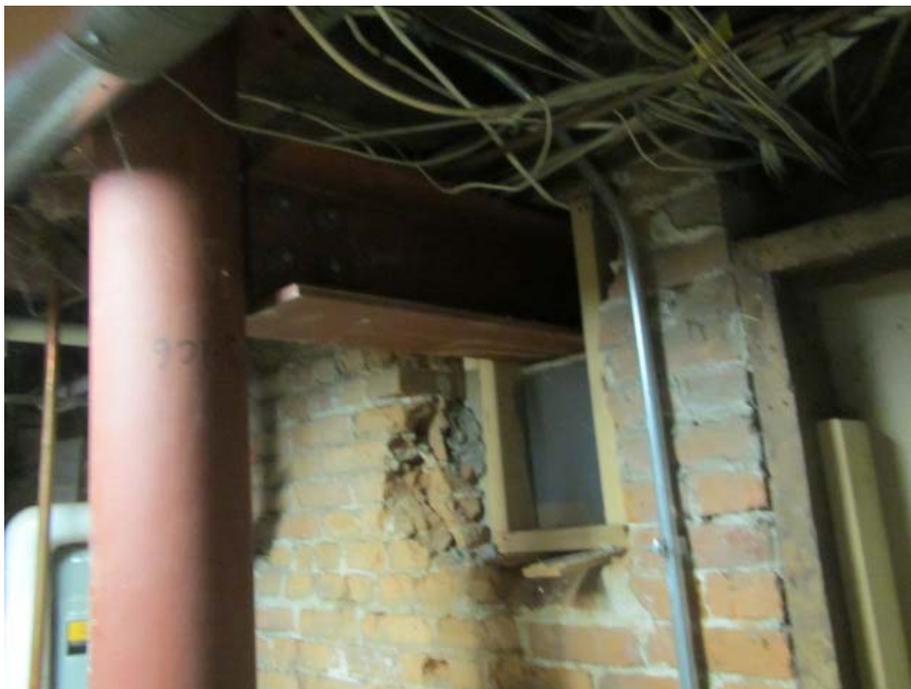
Picture 4

Steel I-beam and permanent metal column

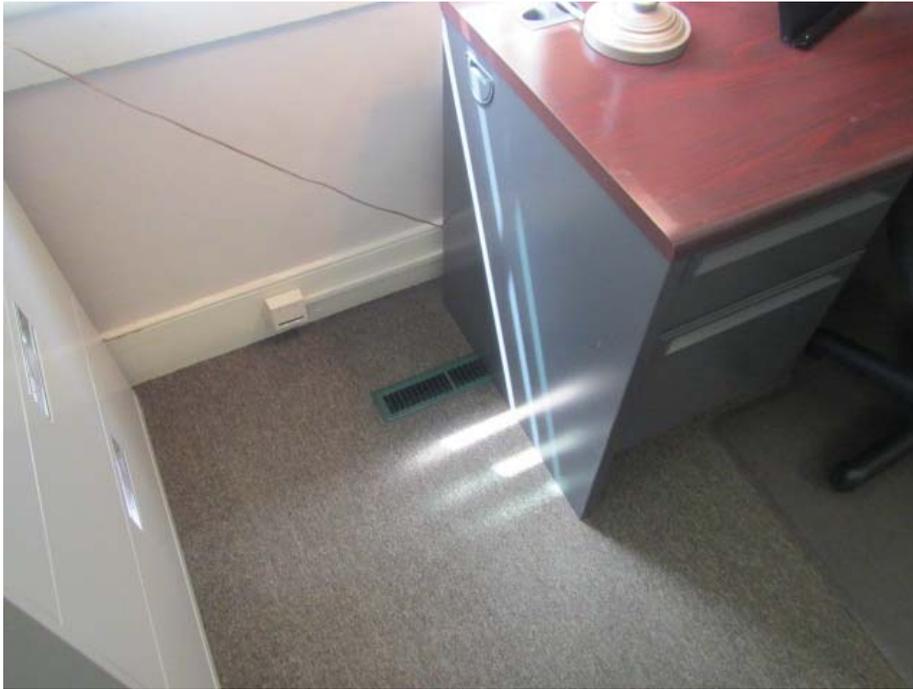
Picture 5

Floor-mounted vent on first floor

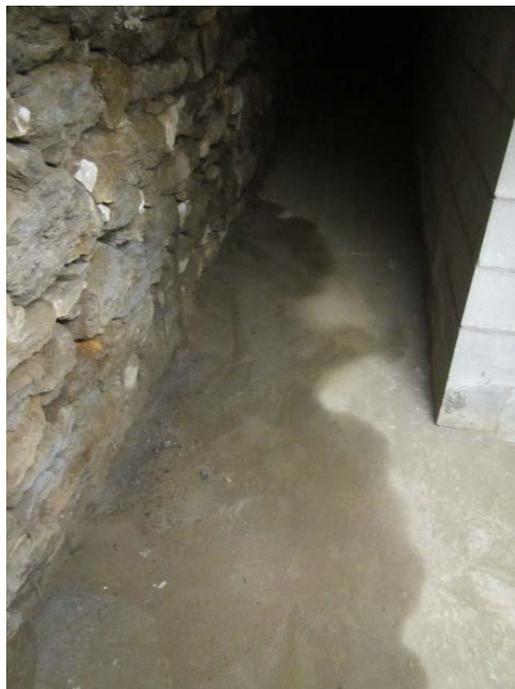
Picture 6

The basement of the STH has signs of significant water penetration through the basement walls. Water was noted on the floor near the front of the east wall (Picture 6). Staining on the floor indicates that water flows from the east wall towards the north wall, passing beneath a wall

Water from foundation wall

4. Replace water-damaged GW with cement board as was done in the elevator stairwell walls.
5. Consult a building engineer as to the best method for preventing or minimizing water penetration through the foundation.

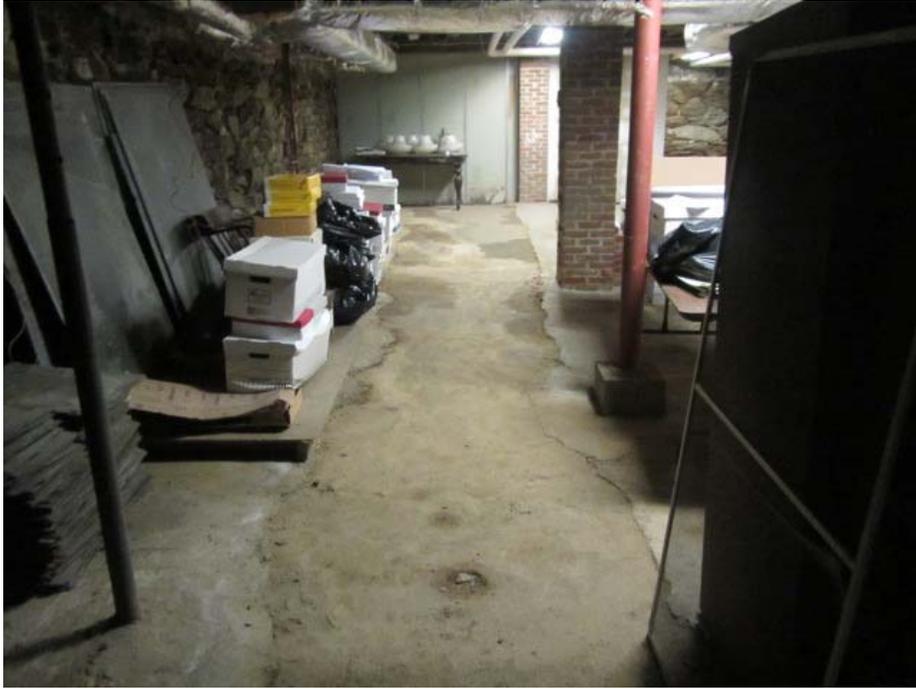
Picture 7

in the rear of the building near the northwest corner (Picture 7). The source of water entering the basement appears to originate from watering of plants in a garden around the front of the building (Picture 8). It is recommended that shrubbery and gardens be located at least five feet from a building's exterior wall. Water from the garden can readily pass through the flagstone foundation, since it generally consists of piled stones with no mortar (Picture 9).

Signs of water flow beneath stored boxes toward northwest corner of basement

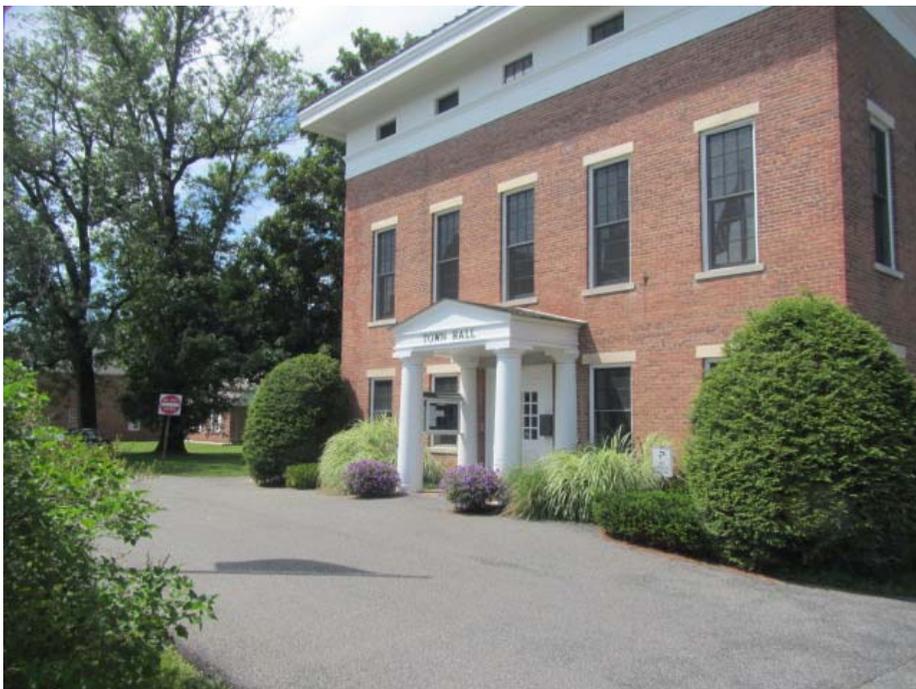
Picture 8

The conditions observed in the STH are somewhat complicated. The installation of a garden along the front of the building creates a condition for water to readily enter the basement, resulting in chronic moistening of GW. This and other water sources noted create conditions for porous materials (e.g., GW, cardboard, paper) to be chronically moistened, resulting in mold growth.

Garden above foundation where water enters the basement

1. Consider if it is feasible to add a fresh air make-up vent to the basement AHU.
2. Consider removing the garden at the front of the building.
3. Consider installing a water impermeable surface over the garden to limit water penetration into the basement. This surface should be sloped to drain away from the building.

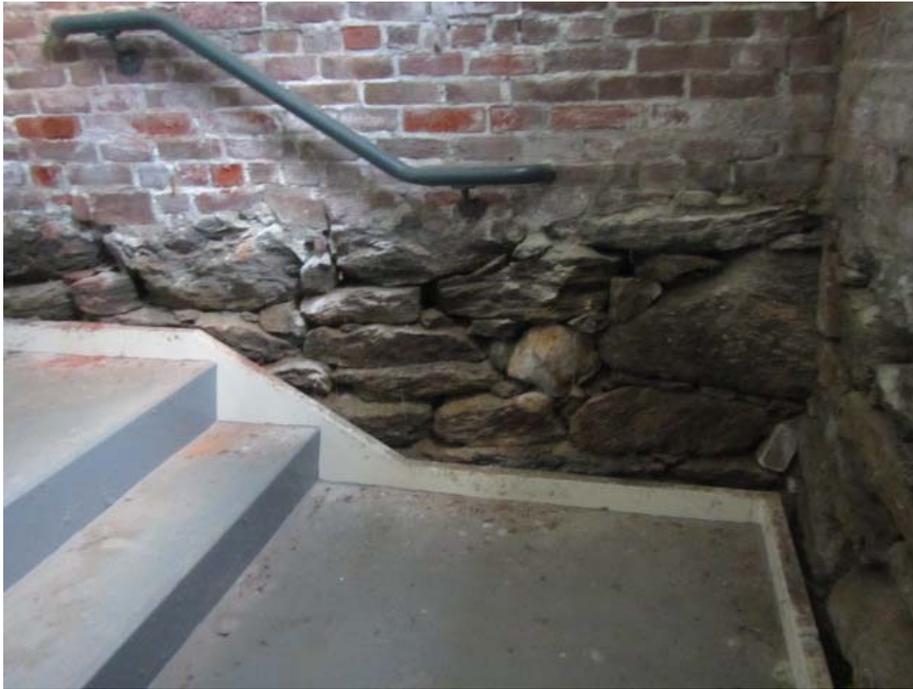
Picture 9

Field stone foundation with no mortar

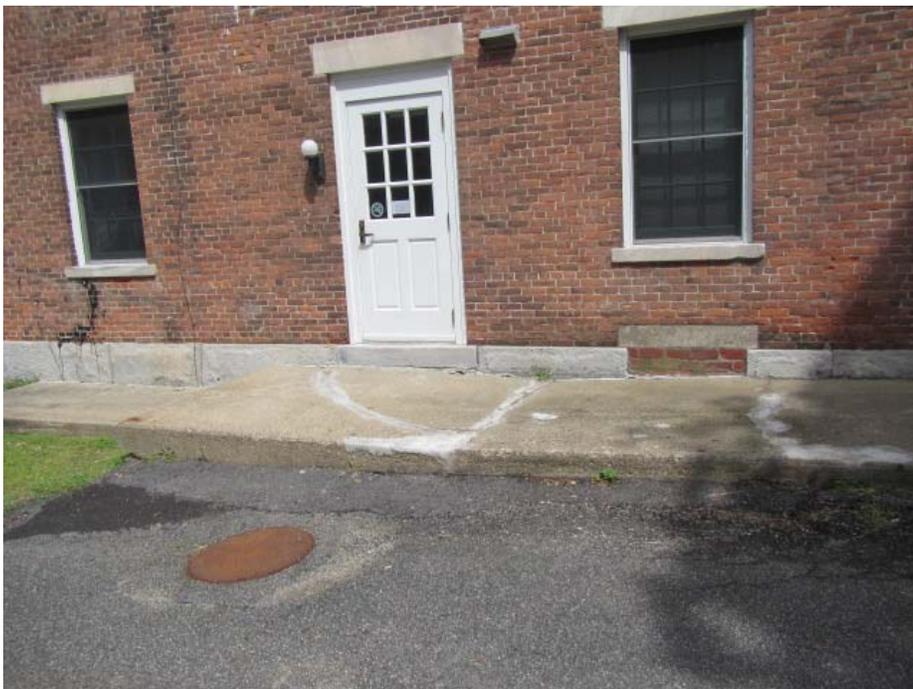
Picture 10

A second location at the base of the rear stairwell, near the elevator, had heavy accumulation of silt. The wall in this area had sunlight streaming in through a large gap near the building sill, corresponding to a cracked cement slab above the exterior south wall of the building (Picture 10). The purpose of the cement slab appears to have included support for a removed fire escape (Picture 11).

Cracked cement slab on exterior of the building

7. Temporarily seal the hole in the exterior wall along the cement slab in the elevator stairwell to prevent water penetration.
8. Clean the door well in Picture 13 as needed to reduce water penetration. Clean the door well drain if one exists.

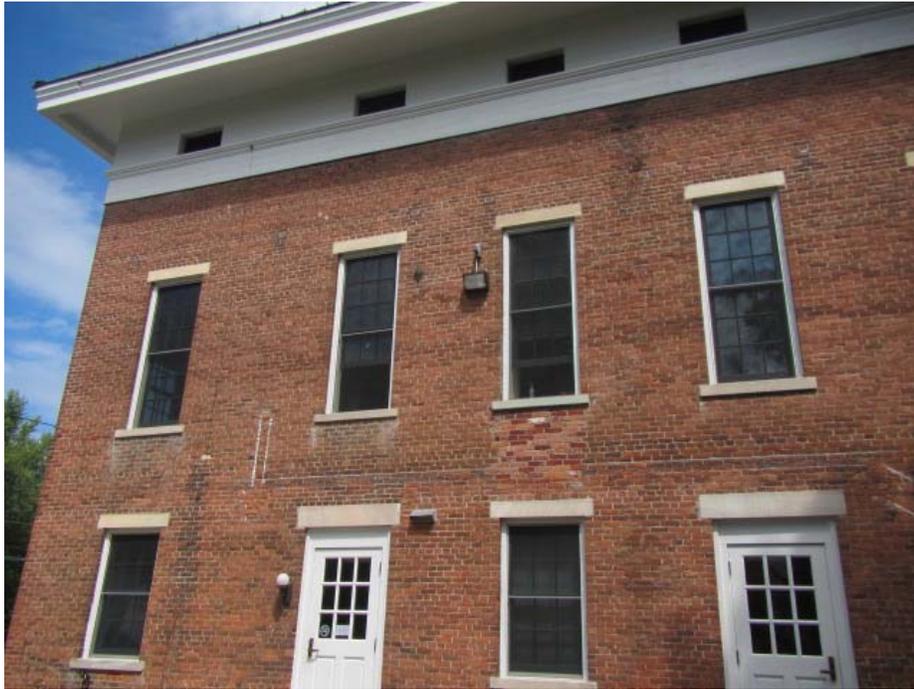
Picture 11

Wall with removed fire escape (Note white lines on wall)

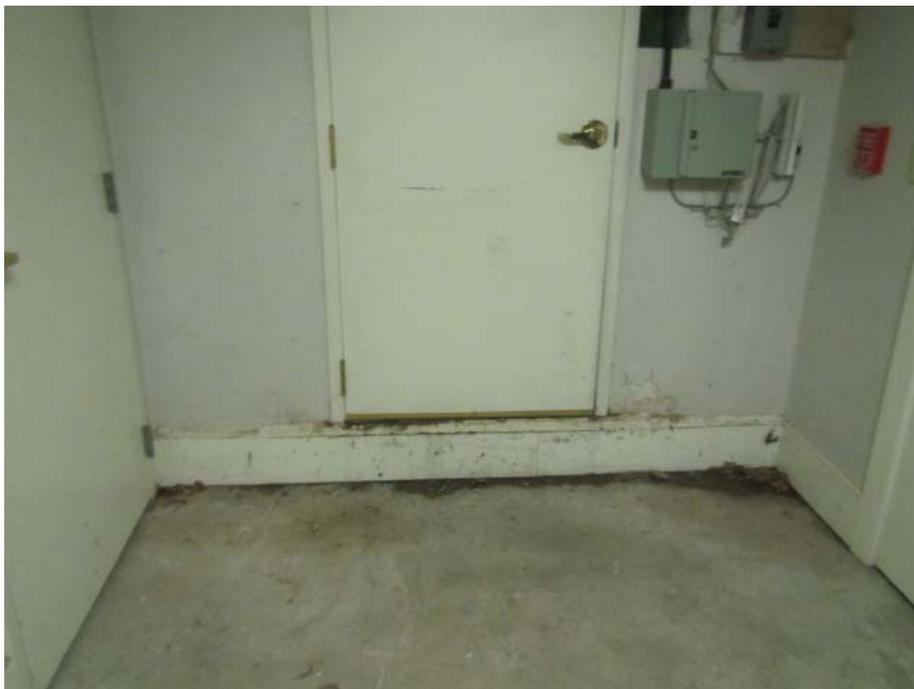
Picture 12

An access door was installed in the rear of the STH, which also appears to have repeated water penetration (Picture 12) due to lack of drainage for the exterior door well (Picture 13).

Water damage on inside of basement access door

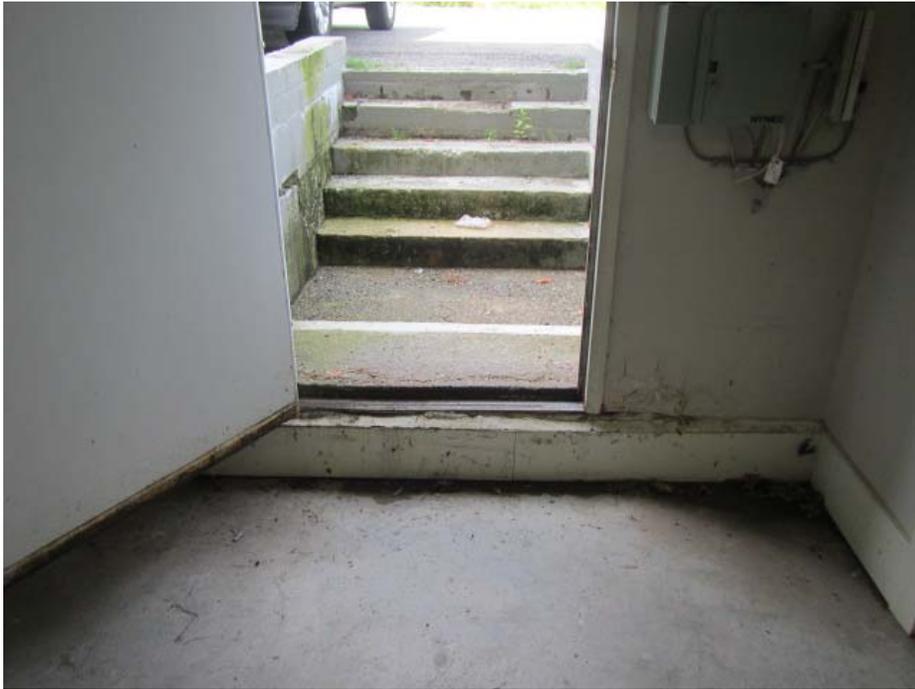
Picture 13

Door well with no drain

7. Examine the feasibility of either installing a drain in the floor of the rear exterior door well or installing a roof over the exterior door to prevent water penetration in the basement.

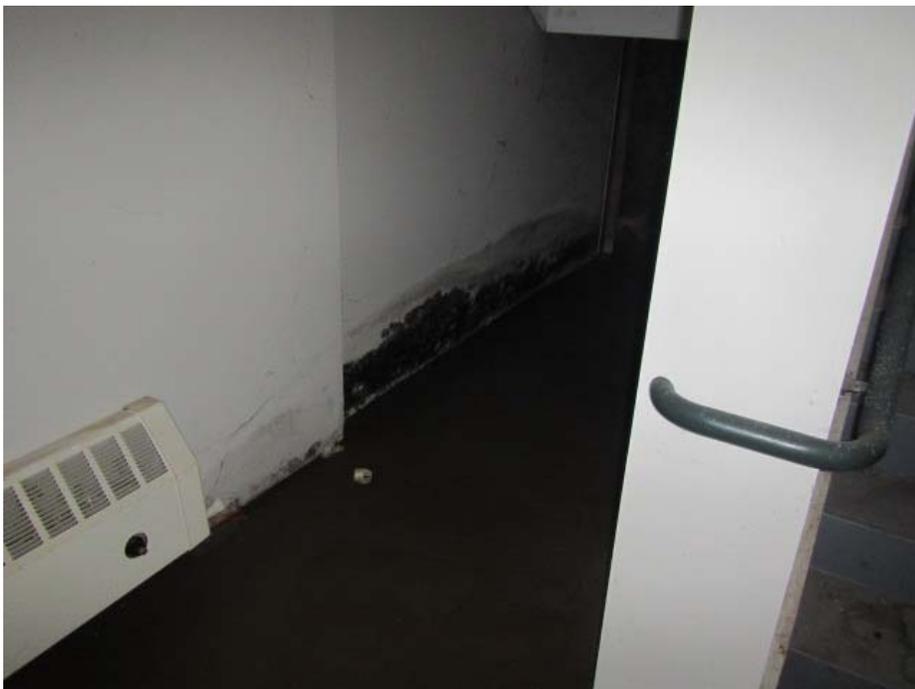
Picture 14

Water penetration has led to extensive water damage to gypsum wallboard that was installed in the basement as part of the 1990s renovation. Heavily mold-contaminated GW is present at the base of the front stairwell (Pictures 14 through 16). In addition, numerous water-damaged boxes containing records were noted on pallets in an area of water penetration (Picture 7). Mold contaminated GW and cardboard/paper cannot be cleaned and must be removed in a manner consistent with the US EPA document "Mold Remediation in Schools and Commercial Buildings" (US EPA, 2001).

Mold colonization from chronic water damage to GW at front stairwell base

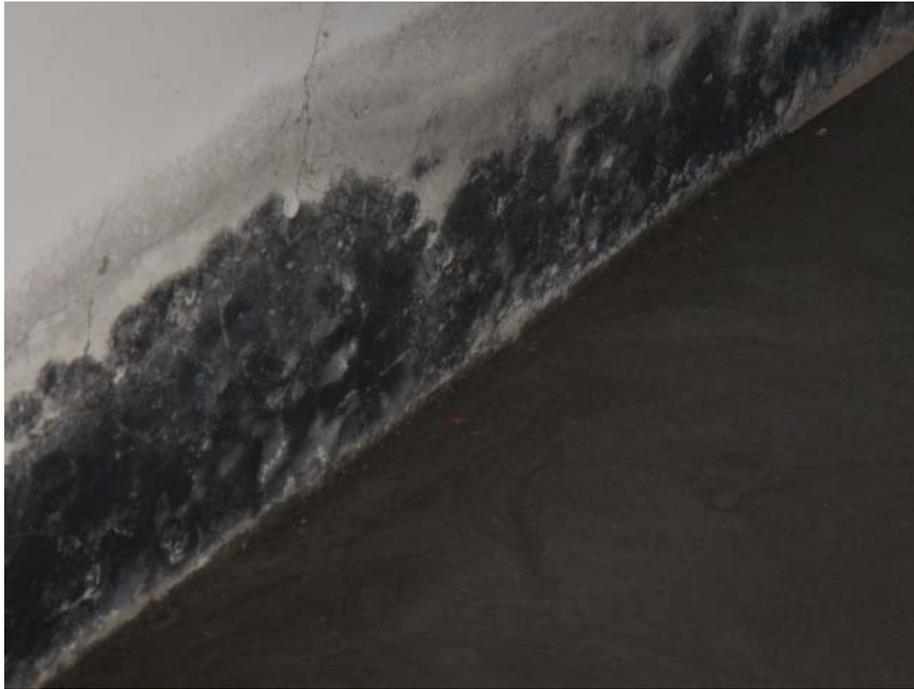
Picture 15

Close-up of GW shown in Picture 14

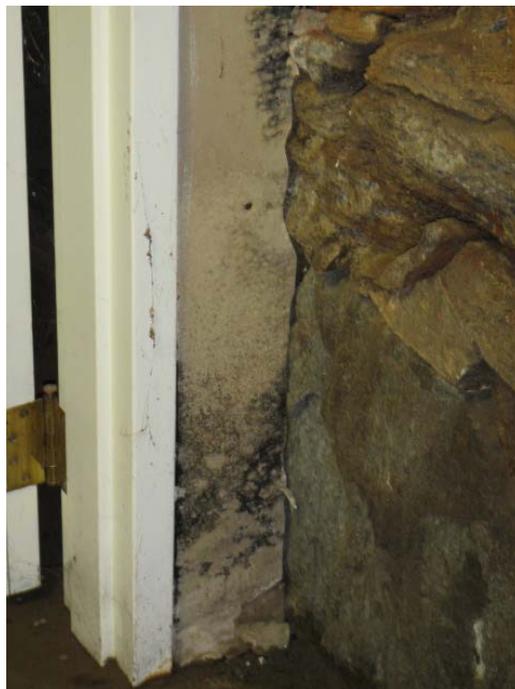
Picture 16

Mold colonized GW

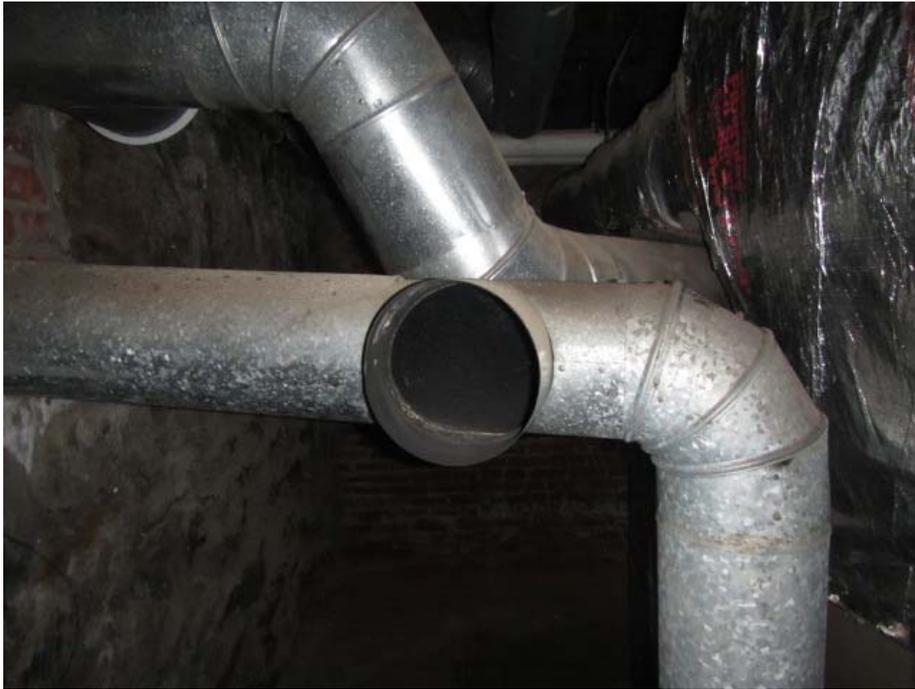
Picture 17

Open flue duct

9. Maintain all indoor plants to prevent accumulations of debris and mold growth.
10. Seal the open flue in the basement with a barometric damper or another appropriate method.

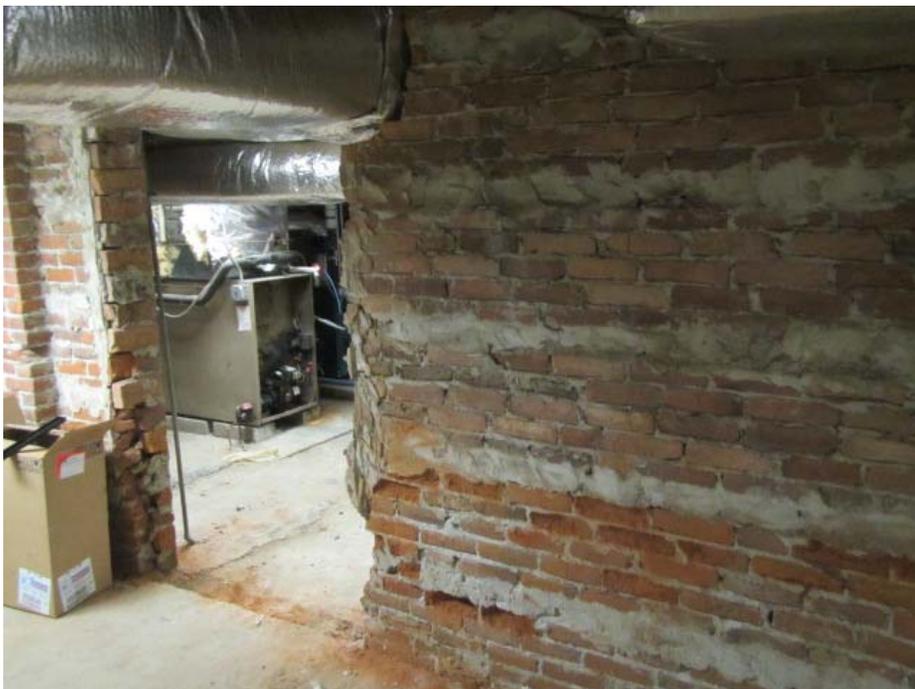
Picture 18

Other conditions that can affect IAQ were observed during the assessment. Of note are the conditions of brick walls and support pillars in the basement, which are part of the original construction on the building. When the AHU system ductwork was installed, bricks were removed from brick support walls to create an opening that accommodates the ductwork; these brick walls supports the first floor (Pictures 18 and 19). At the base of these support walls is a large amount of red brick dust (Picture 20). In the experience of BEH staff, brick deterioration is often attributable to exposure of brick to moisture. Water penetration over time causes both brick and mortar to disintegrate, resulting in the production of mortar and brick chips, red brick and white mortar dust, water staining, and efflorescence. Condensation from chilled air generated by the basement AHU may be contributing to increased moisture. Cold air flowing from open supply vents in the basement was noted during the visit. These supply vents should be closed during summer months to prevent condensation on the floor.

Opening in brick support wall

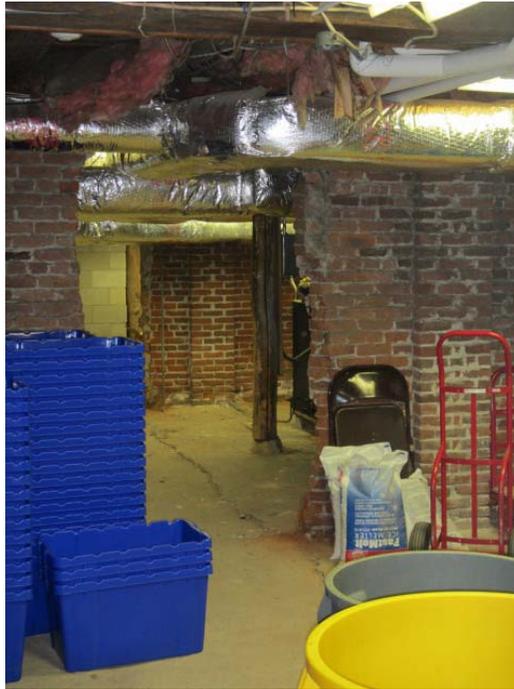
Picture 19

Opening in brick support wall

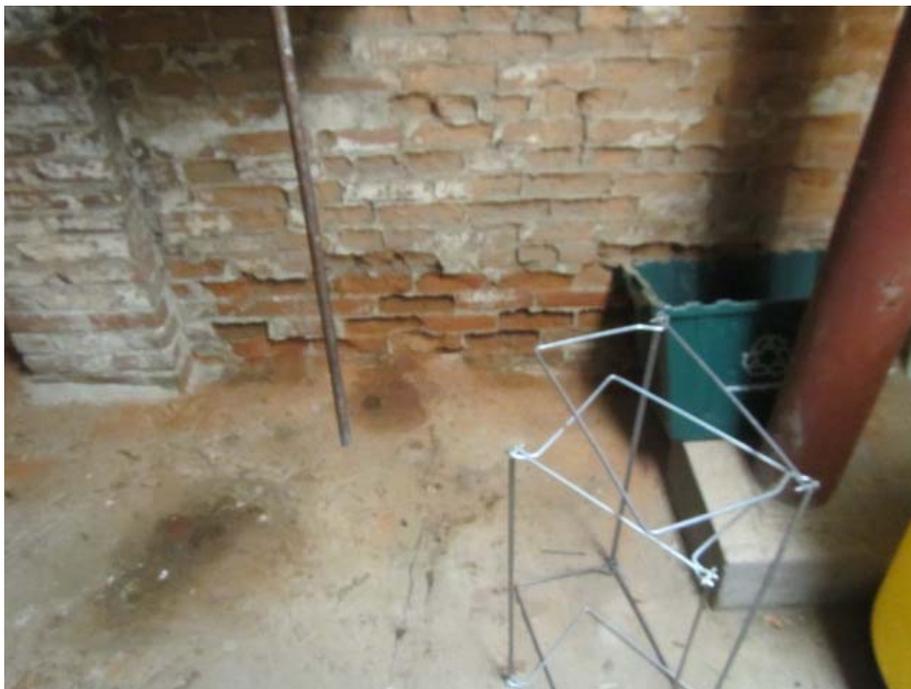
Picture 20

Because this dust appears to be exclusively red brick, forces other than water, such as friction from shifting of weight, is creating this fine brick powder. The openings cut into the brick wall likely created additional stresses on the remaining bricks. As the bricks deteriorate, an additional loss of brick cohesion may result in shifting of load, which may stress the bricks further as well as the support structures. A number of wooden support beams were found split in half (Picture 21), indicating that the supports are under excess stress and that their ability to carry loads has been reduced. The BEH/IAQ recommends that the Sheffield building inspector examine the integrity of these basement structures.

Red dust from bricks (Note brick condition)

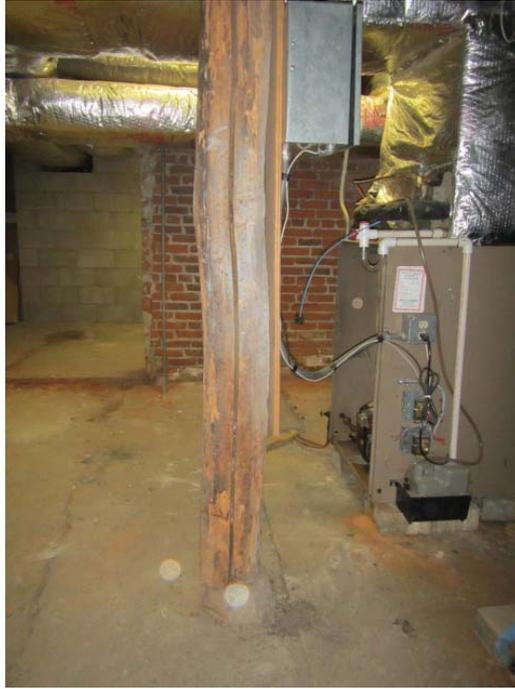
Picture 21

Example of a split wood support pillar

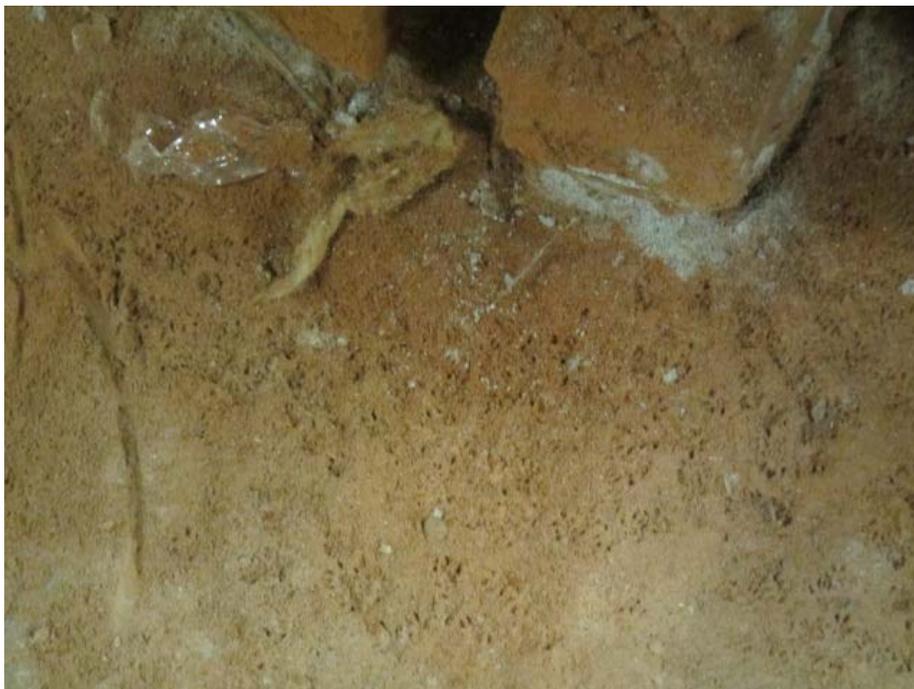
Picture 22

Signs of rodent infestation were observed throughout the STH. Mice footprints were found in red brick dust in the basement (Picture 22). There were holes/gaps around doors and in between fieldstone, which allow for easy access for rodents to enter the building. It is recommended that a comprehensive integrated pest management plan (IPM) be implemented to more effectively control rodents and other pests.

Rodent foot prints in brick dust

12. An integrated Pest Management (IPM) plan should be developed for this building to address rodent issues in the basement.
