INDOOR AIR QUALITY ASSESSMENT

**Egremont Elementary School
84 Egremont Avenue
Pittsfield, MA**

Prepared by:
Massachusetts Department of Public Health
Bureau of Environmental Health
Indoor Air Quality Program
March 2016

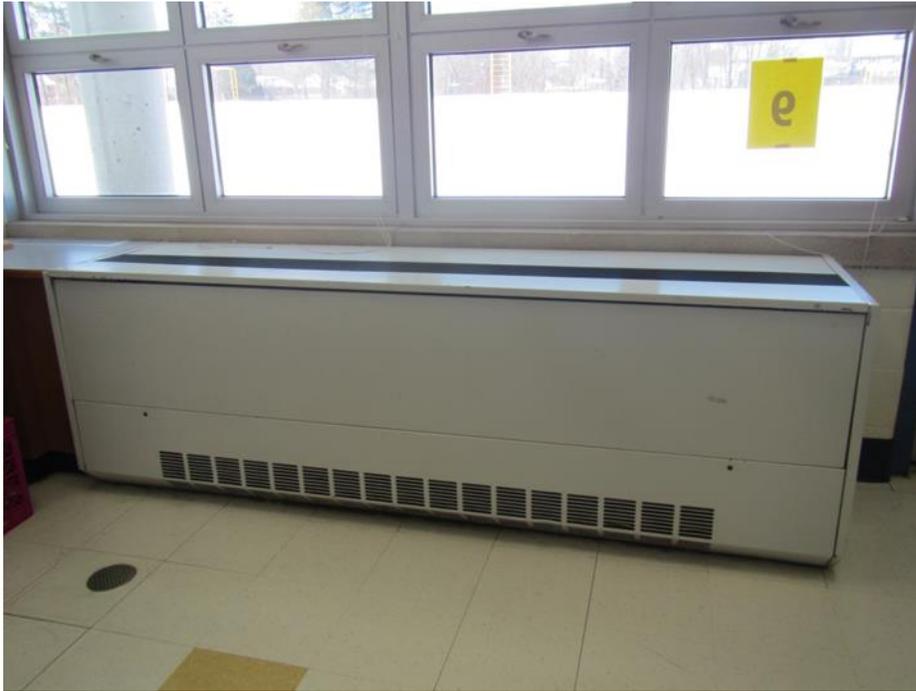
Picture 1

Fresh air is provided by a combination of unit ventilators (univents) located in individual classrooms along the outside wall (Picture 1) and air handling units (AHUs) above the ceiling which serve central areas such as the gym and cafeteria. The unit ventilators draw fresh air through a vent on the outside wall (Picture 2) or the roof. Air is mixed with return air from the room, filtered, heated (if needed) and delivered back to the room (Figure 1). In some locations, univents were found partly obstructed by items on top or in front, which can impair proper operation. Air from the AHUs is filtered, heated and delivered to rooms via ducted supply vents. At least one of these vents was deliberately blocked with a ceiling tile due drafts/noise (Table 1). Exhaust vents are located on the walls of classrooms (Picture 3) and are ducted to fans on the roof. Additional exhaust vents are located in toilet rooms and other areas.

Unit ventilator (univent)

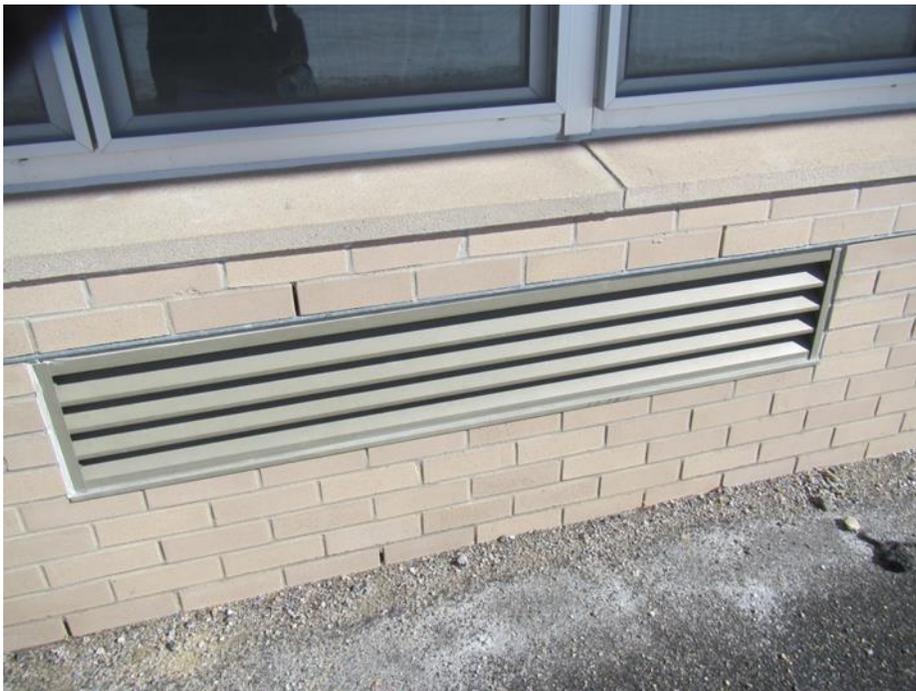
Picture 2

Fresh air intake for univent

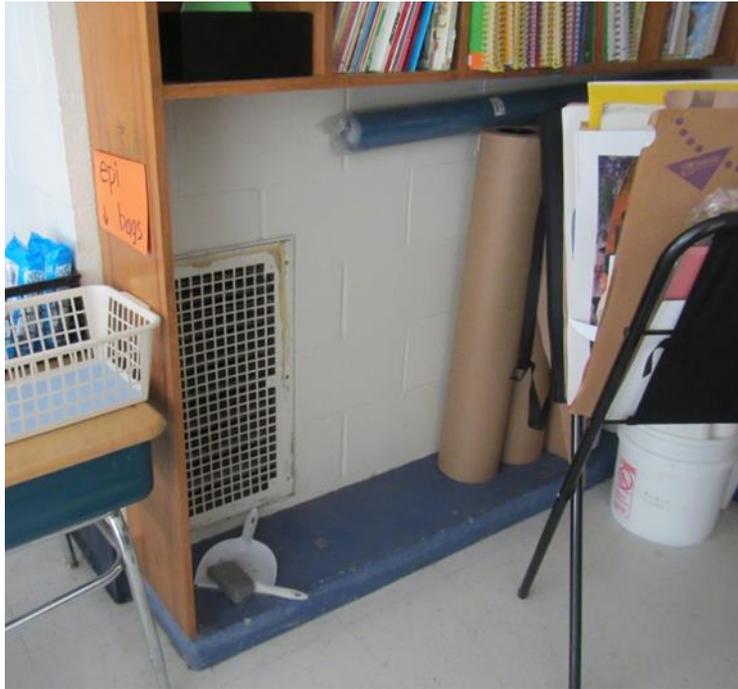
Picture 3

Exhaust vent in classroom

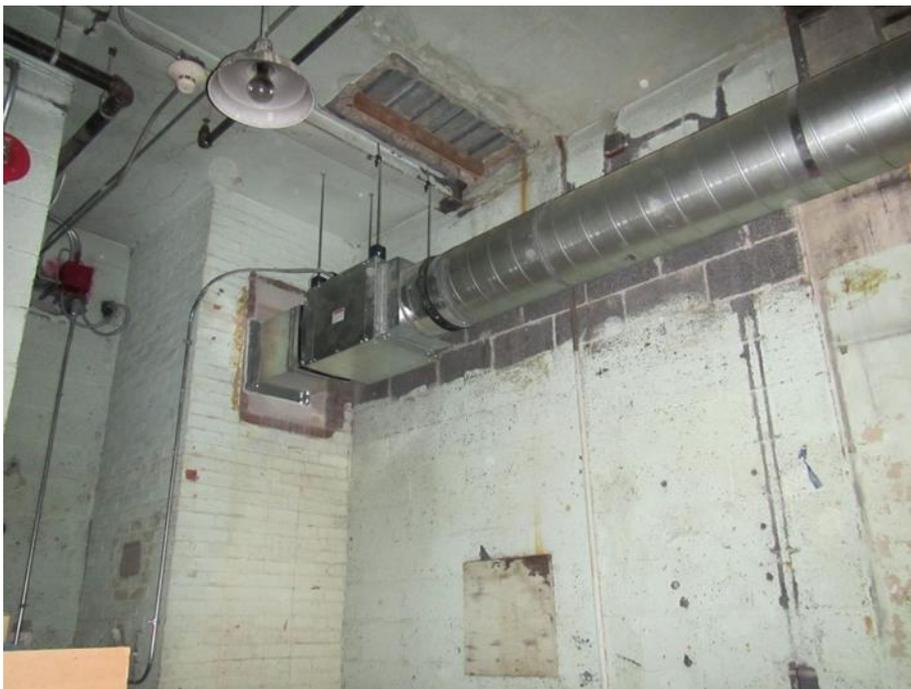
Picture 4

Several modifications were made in the crawlspace to help vent it to the outside and reduce pathways to occupied areas. These included the installation of an active vent system that uses fans to vent crawlspace air to the outside (Pictures 4 and 5), sealing of many holes/breaches between the crawlspace and occupied areas, as well as replacing wax rings beneath toilets in room 25. Facilities staff reported a reduction, but not elimination of the musty odor. Upon further examination, BEH/IAQ staff noted gaps around pipes for the girls restroom inside room 25 (Picture 6).

Active vent system as viewed from the lower basement

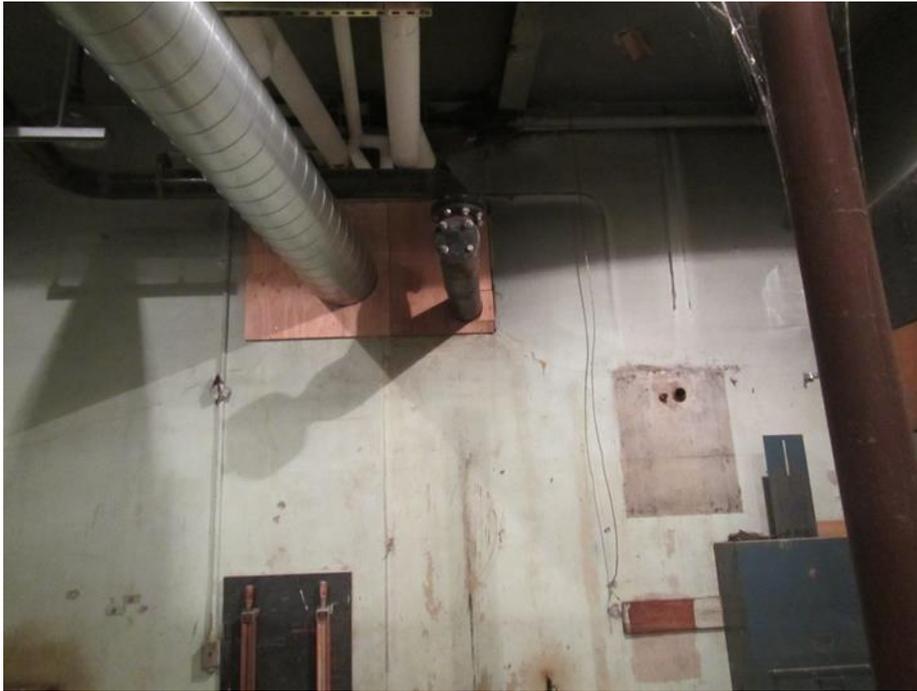
Picture 5

Active vent system as viewed from the lower basement

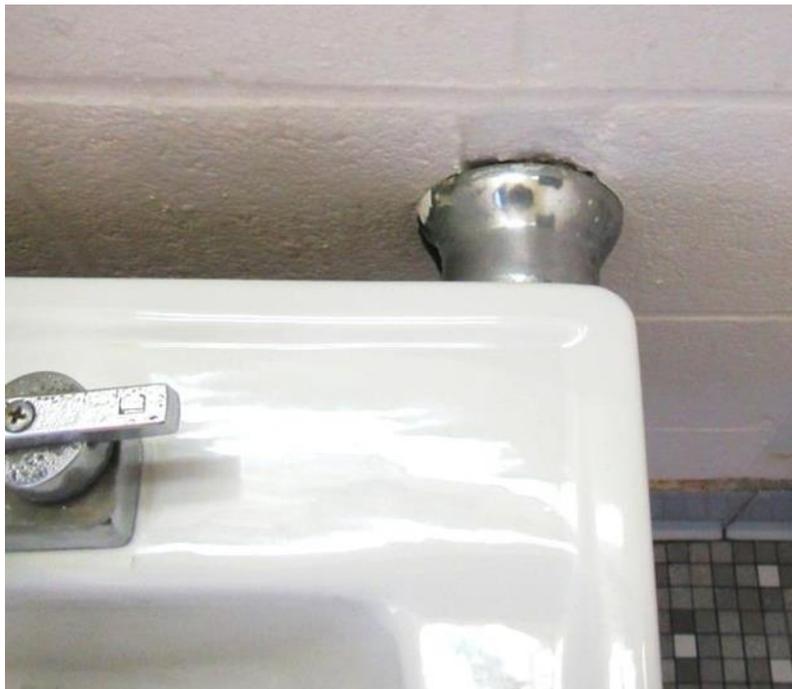
Picture 6

Gap around pipe in restroom inside room 25

6. Continue sealing breaches in the interior walls in the addition restroom to contain crawlspace odors, including those areas identified in Picture 6.

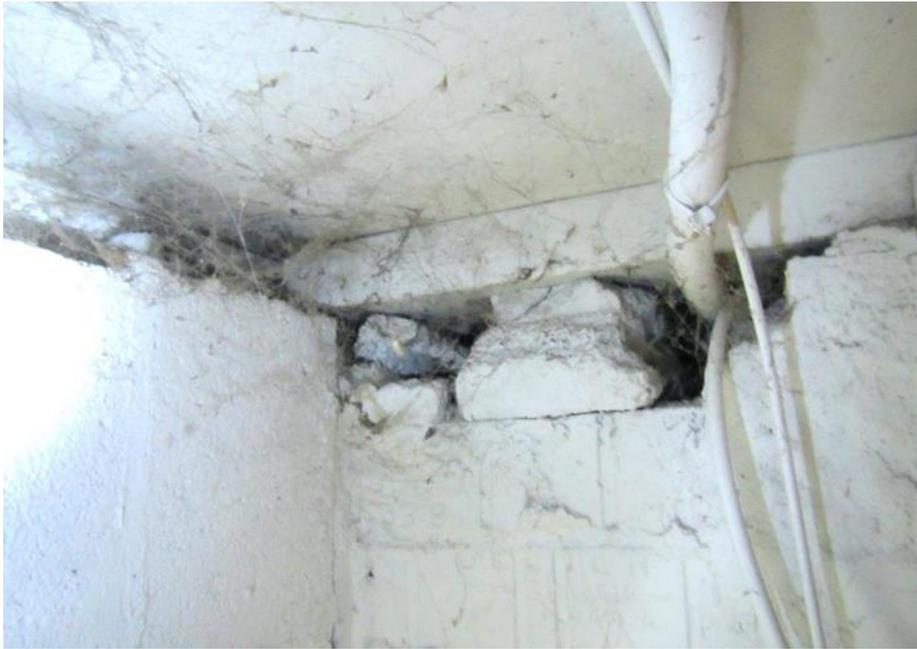
Picture 7

Upon returning to the building in February 2016, BEH/IAQ staff noted that the musty odor seemed to be centralized near the addition’s breezeway doors. The odor was traced to gaps in the ceiling of the custodial closet next to room 25 (Picture 7), some of which appear to be connected to interior wall space that may connect to the basement. Gaps were also identified in the exterior building envelope along the edges of the roof of the addition above the breezeway

Breaches inside janitors closet

1. Examine the wood shown in Picture 8 and replace all rotten wood as needed.
2. Seal the space in the ceiling of the custodial closet shown in Picture 7.
3. Consider turning off the exhaust system for the addition (rooms 25-29) to prevent the creation of negative pressure that draw unconditioned air and odors into occupied areas.

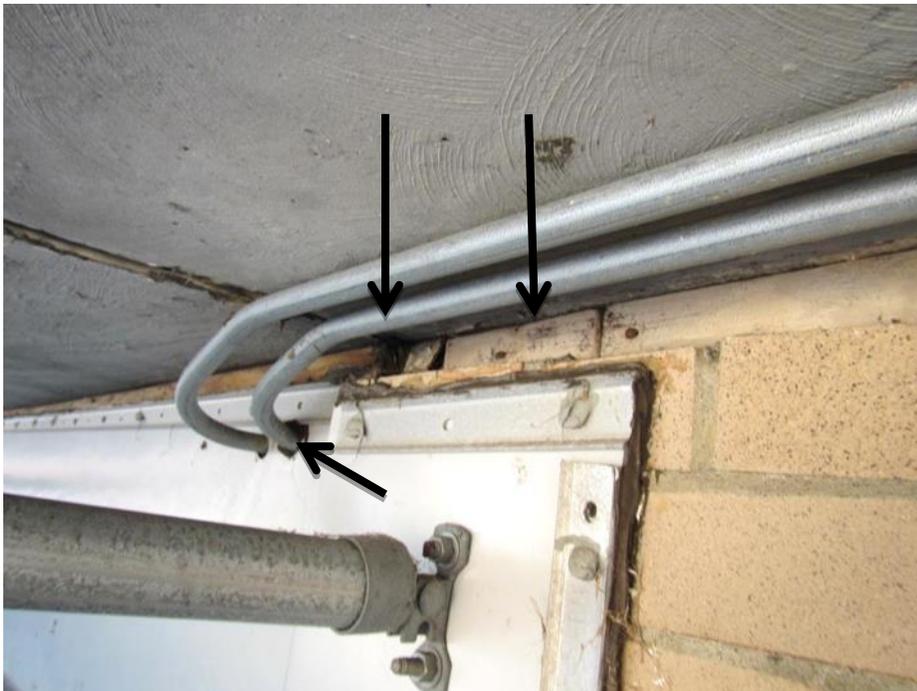
Picture 8

(Picture 8) which may lead to wetting of wood materials inside the wall cavity likely contributing to reported odors.

Openings in exterior wall above breezeway roof allowing for air and moisture to cause wood rot (arrows)

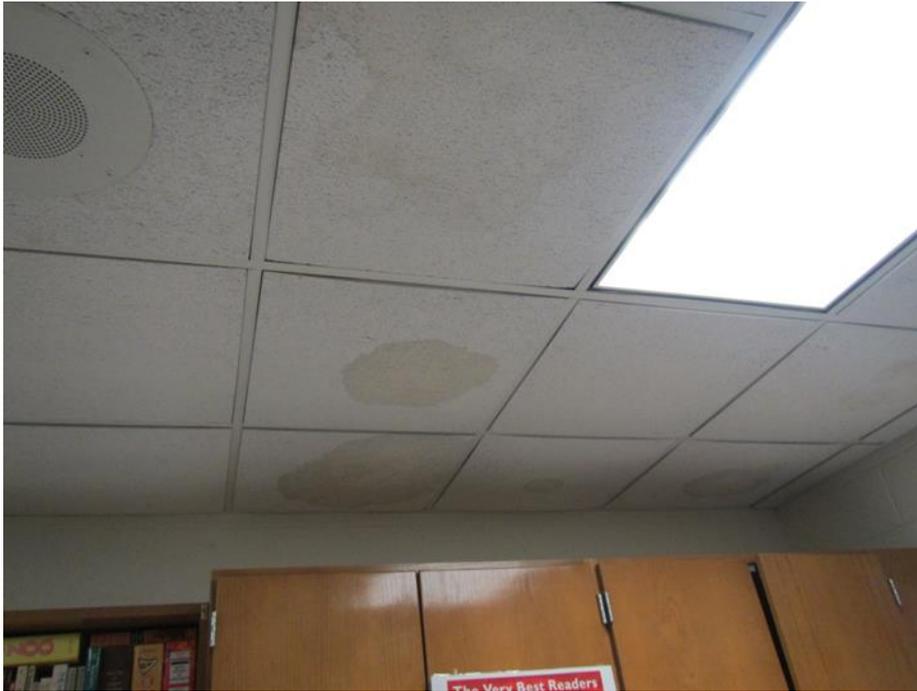
Picture 9

Additional moisture/microbial issues were identified in the building as well. A few stained ceiling tiles were observed in the building (Picture 9) which appear to be due to historic roof or plumbing leaks. Water-damaged ceiling tiles can be a source of mold, and should be replaced once the leaks have been repaired.

Water-damaged ceiling tiles

7. Repair roof/plumbing leaks and replace stained ceiling tiles.
8. Repair sink backsplashes to render them watertight. Refrain from storing porous or significant amounts of materials under sinks.

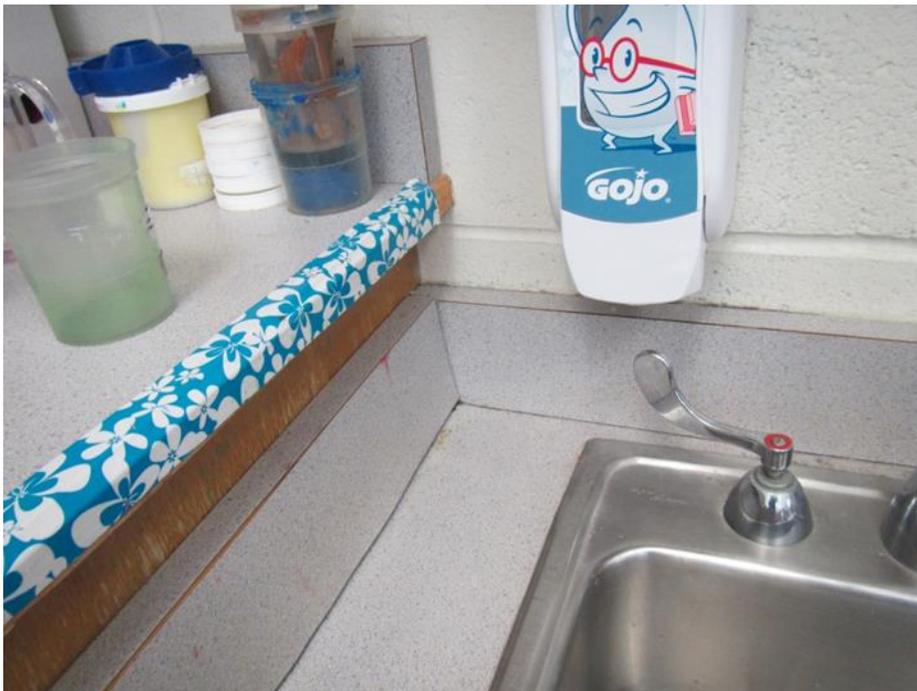
Picture 10

Many of the sinks in classrooms had backsplashes with a gap (Picture 10; Table 1) which can allow for moistening of the wood material and potential microbial growth. A few sinks also had porous items stored beneath them, where they could become damaged due to condensation or leaks. Porous items and large amounts of items should not be stored under sinks.

Unsealed sink backsplash

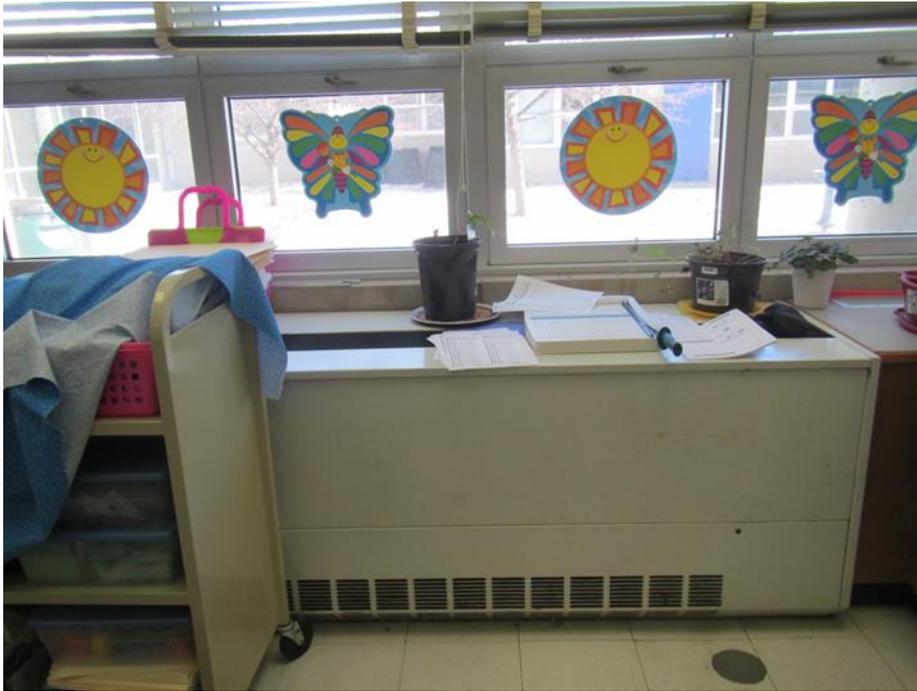
Picture 11

Plants were observed in a few areas, including on top of univents (Picture 11). Plants can be a source of pollen and mold, which can be respiratory irritants to some individuals. Plants should be properly maintained and equipped with drip pans and located away from air diffusers to prevent the aerosolization of dirt, pollen and mold.

Plants on univent

9. Clean refrigerators regularly, including cleaning the gaskets with an antimicrobial solution.
10. Keep plants in good condition, avoid overwatering, and remove from the airstream of univents and other air sources.

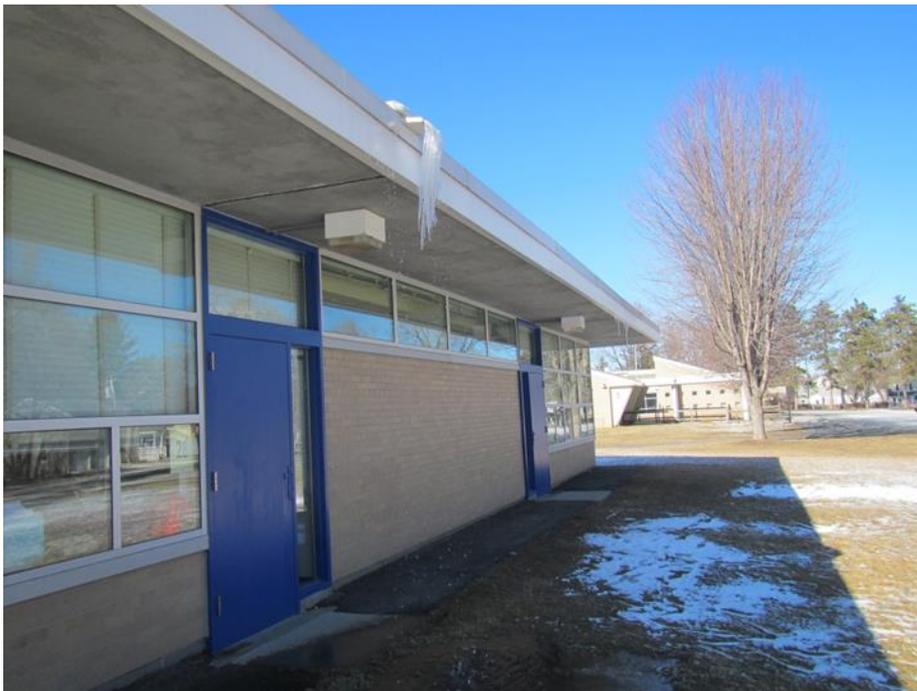
Picture 12

Gutters along the outside of the building had accumulations of ice and were found to be dripping/pouring onto the ground in several locations (Pictures 12 and 13). These conditions can lead to water infiltration along seams at the roofline due to ice dams/broken gutters, and through the foundation due to accumulation of water at the base. The gutter system should be inspected for breaches and repaired once weather permits. The insulation/venting of the roof along the edge may need to be improved to prevent ice damming. And the ground near the foundation may need to be regraded to reduce ponding in areas such as those in Picture 13.

Ice accumulations from gutter

11. Inspect and repair the gutter system once outdoor conditions allow. Inspect insulation and vents along the edge of the roof to minimize the creation of ice dams and allow the gutters to flow freely.

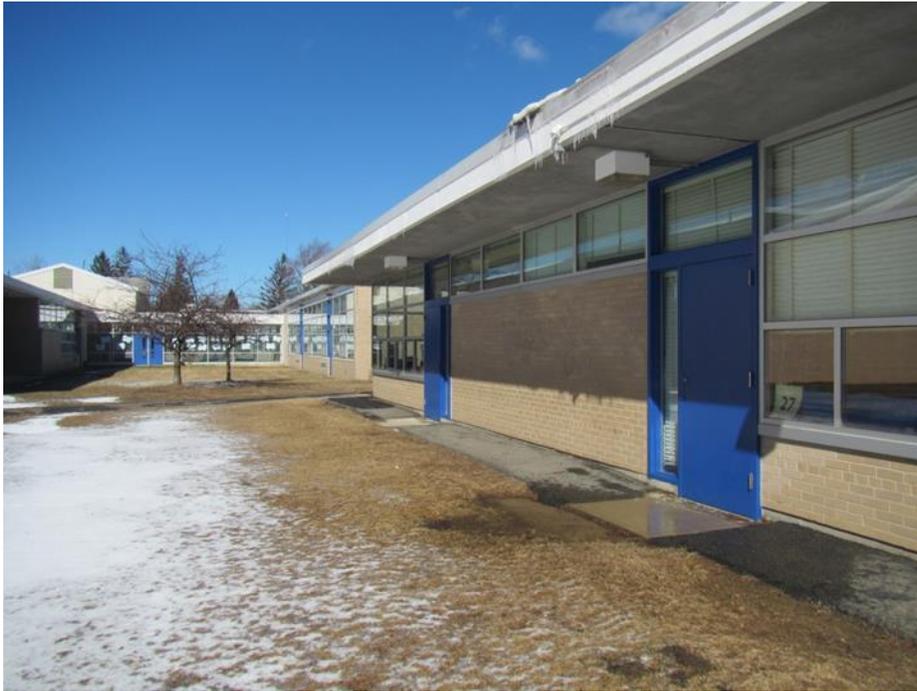
Picture 13

Puddles from dripping gutter

12. Regrade the ground where ponding occurs to direct water away from the building.
13. Repair/replace weather-stripping on doors so that no light or drafts are present.

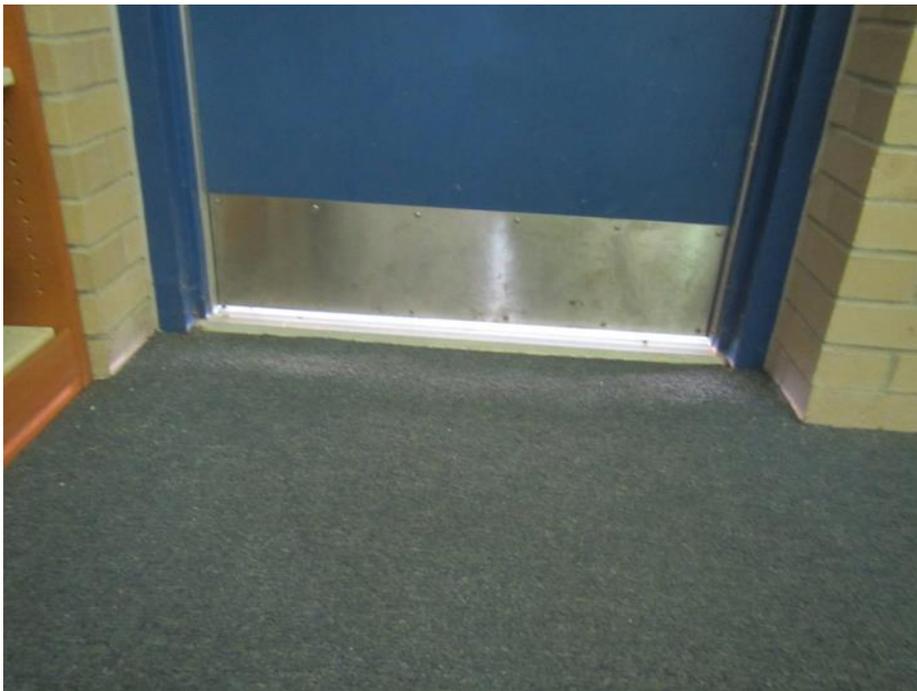
Picture 14

Some of the exterior doors from classrooms and hallways lacked sufficient weather-stripping, as light could be observed beneath them (Picture 14). Weather-stripping should be repaired/replaced to prevent moisture, unconditioned air and pests from entering the building.

Light visible underneath door showing lack of weather-stripping

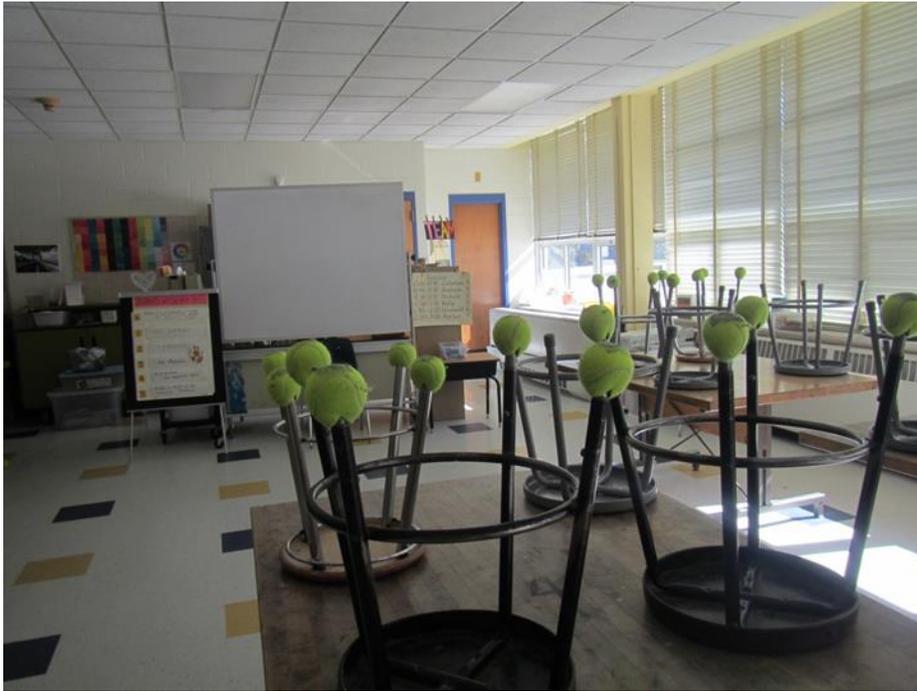
Picture 15

In a few classrooms, tennis balls were found sliced open and placed around chair legs to reduce noise (Picture 15). Tennis balls are made of a number of materials that are a source of respiratory irritants. Constant wearing of tennis balls can produce fibers and off-gas VOCs. Tennis balls are made with a natural rubber latex bladder, which becomes abraded when used as a chair leg pad. Use of tennis balls in this manner may introduce latex dust into the school environment. Some individuals are highly allergic to latex (e.g. spina bifida patients) (SBAA, 2001). It is recommended that the use of materials containing latex be limited to reduce the potential for symptoms in sensitive individuals (NIOSH, 1997). Latex-free glides should be used for this purpose. Some areas of the school already had glides. Tennis and other balls were also found wedged in the vent for the gymnasium, where they may contribute to particulate matter in the interior and obstruct airflow (Picture 16); they should be removed.

Tennis balls on chair legs

14. Replace tennis balls in classrooms with latex-free glides.
15. Remove tennis balls from the gymnasium vent.
16. Change filters regularly in univents (2 to 4 times a year), and vacuum the cabinets of debris each time the filters are changed.

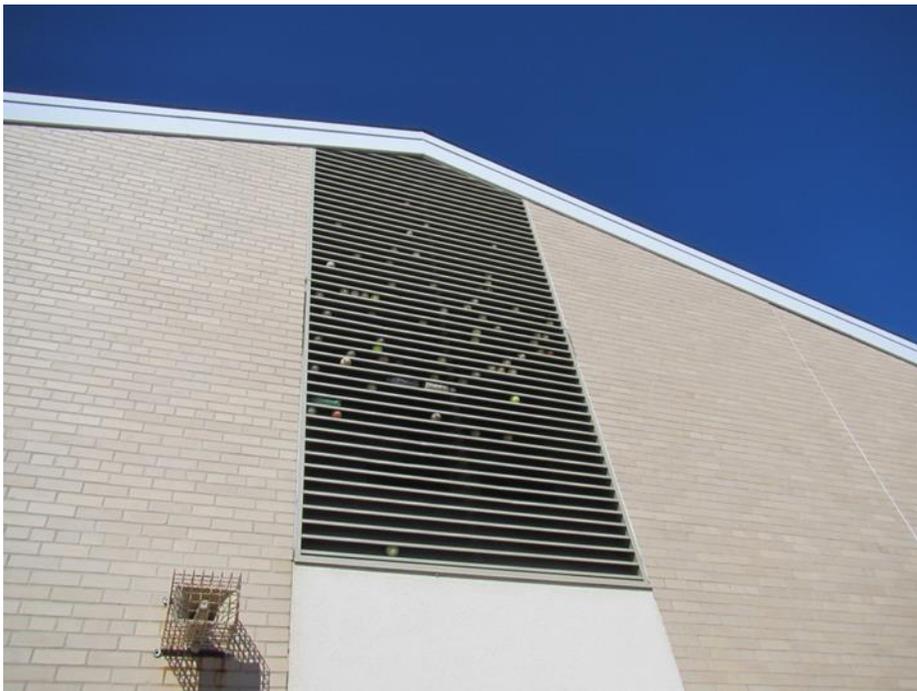
Picture 16

Tennis balls and other items in gymnasium vent

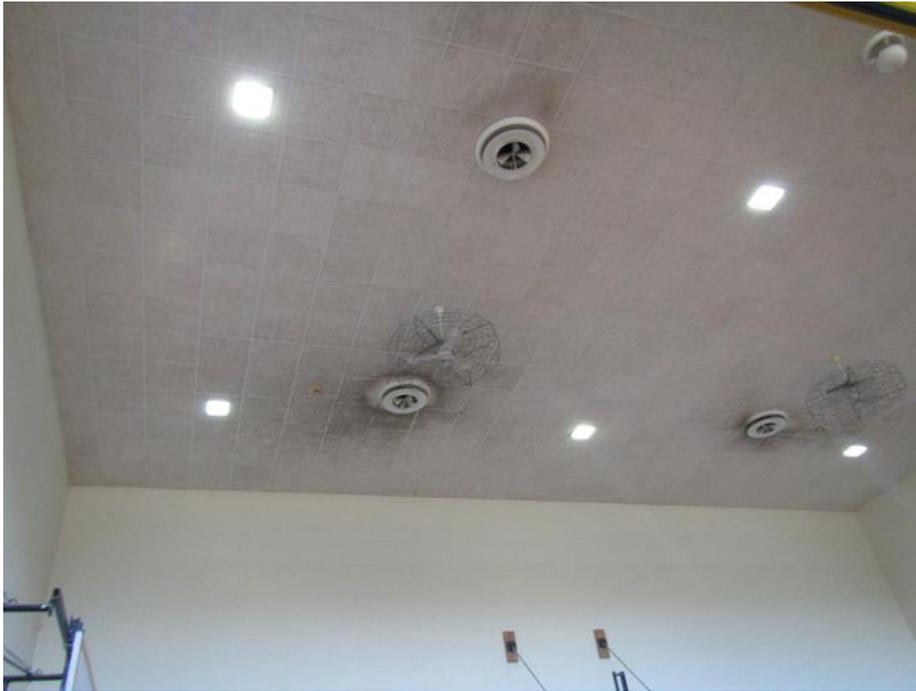
Picture 17

Some personal fans, supply and exhaust vents were observed to be dusty (Picture 17; Table 1). In some areas, items were observed on the floor, windowsills, tabletops, counters, bookcases, and desks (Table 1). Many univent cabinets had dust and debris in them as well.

Dusty supply vents

17. Clean other supply and exhaust vents regularly to prevent aerosolization of debris.
18. Clean carpeting and area rugs regularly and discard those that are worn out or too soiled to be cleaned.

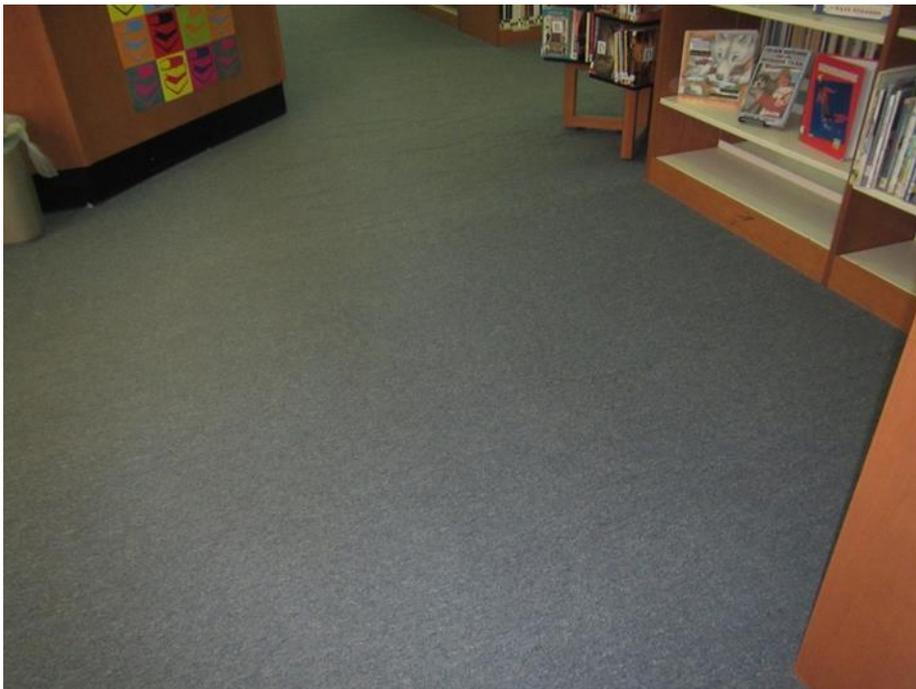
Picture 18

Most classrooms had built-in area rugs, and some other areas were carpeted. Carpeting should be cleaned annually or semi-annually in soiled high traffic areas as per the recommendations of the Institute of Inspection, Cleaning and Restoration Certification (IICRC, 2012). Carpeting in the library was significantly worn and wrinkled (Picture 18) and may be beyond its service life, consideration should be made to replacing.

Wrinkled, worn library carpet
