INDOOR AIR QUALITY ASSESSMENT

**Leominster High School
122 Granite Street
Leominster, Massachusetts**

Prepared by:
Massachusetts Department of Public Health
Bureau of Environmental Health Assessment
January, 2000

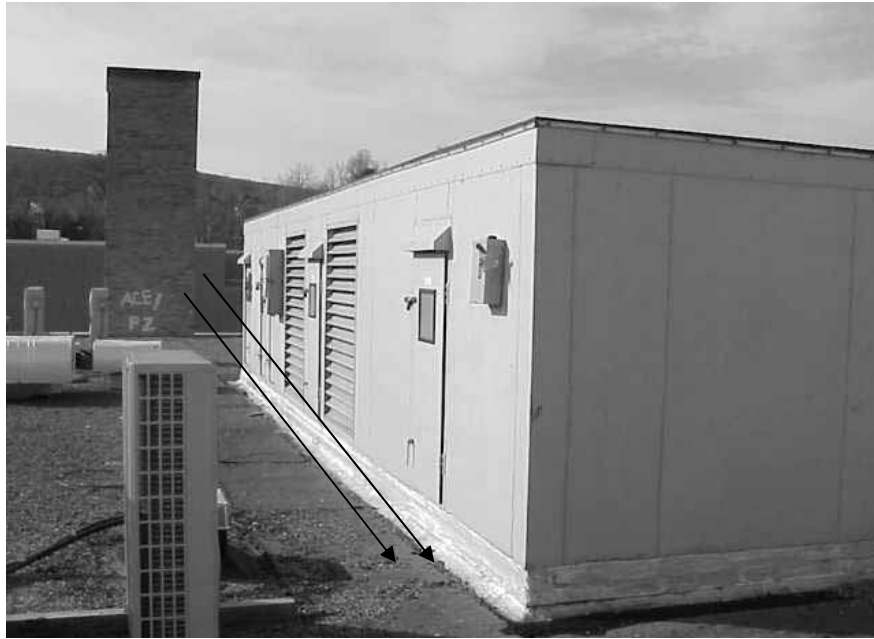
Picture 1

Please note that the interior room fresh air supplies and exhaust vents are connected to the rooftop AHU that appears to recirculate return air. Science areas tend to use materials that generate odors or particulates. It is likely that animal generated wastes and odors noted in the MDLWD report can be drawn into return ductwork and distributed to other internal rooms by the AHU. It is imperative that chemical hoods be maintained to directly exhaust off-gassing materials from the building as recommended in the MDLWD report. In addition, odor-producing materials should be reduced or avoided in the science areas. Several rooms in the science area (A101, A108 and A110) do not have exhaust vents. Without exhaust ventilation, normally occurring indoor pollutants can build up.

Rooftop AHU Servicing The Internal Classrooms Of The A And C Wing

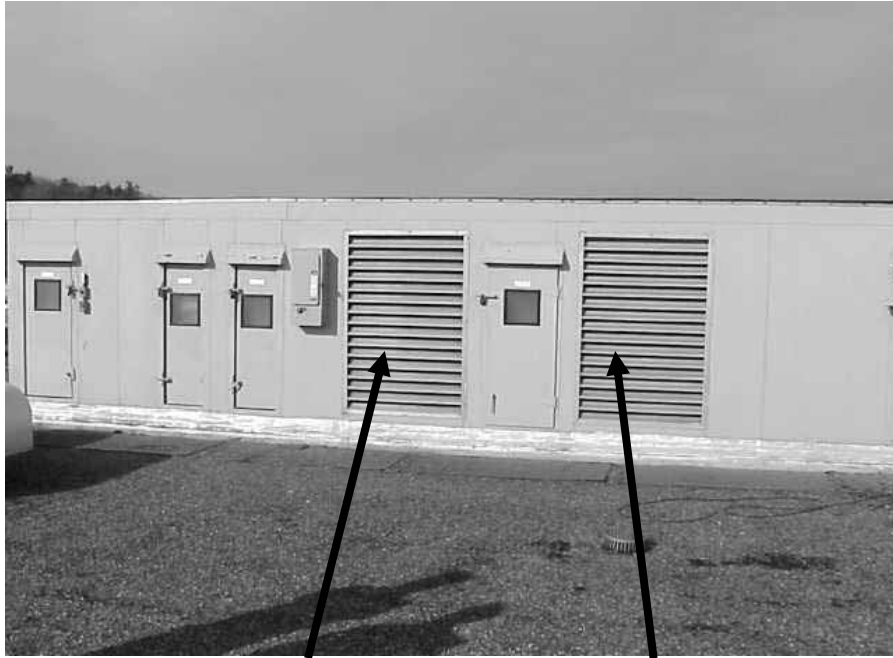
Picture 2

Fresh Air Intake and Exhaust Vents Located within Several Feet of Each Other

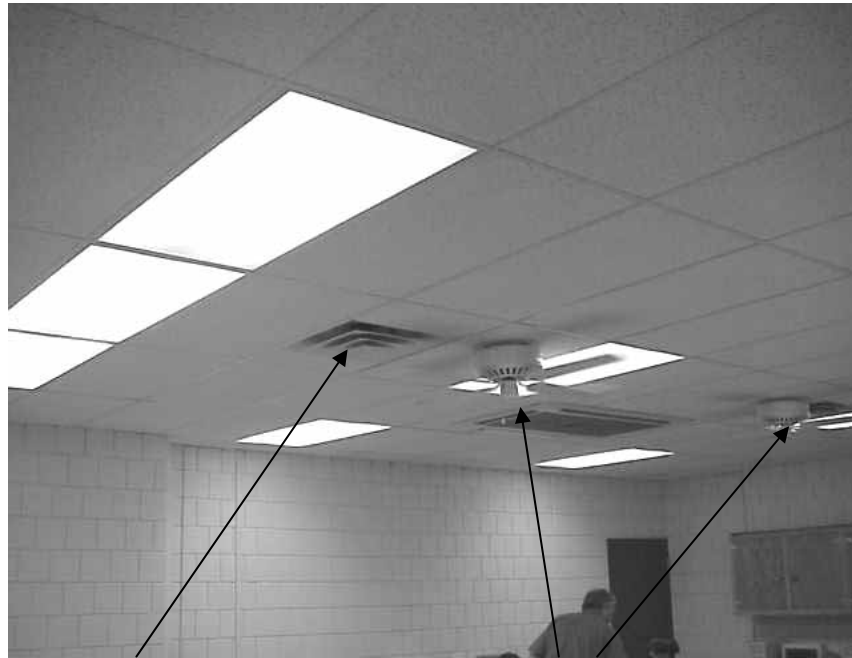
Picture 3

Students using electrical soldering irons were observed in this room. None of the soldering benches in the room had local exhaust ventilation to draw soldering fumes away from students. Electrical solder contains a number of metals, including aluminum, tin, silver and copper. The ACGIH recommends local exhaust ventilation to draw solder fume away from operators at the soldering bench level (ACGIH, 1998).

C201 Computer Room

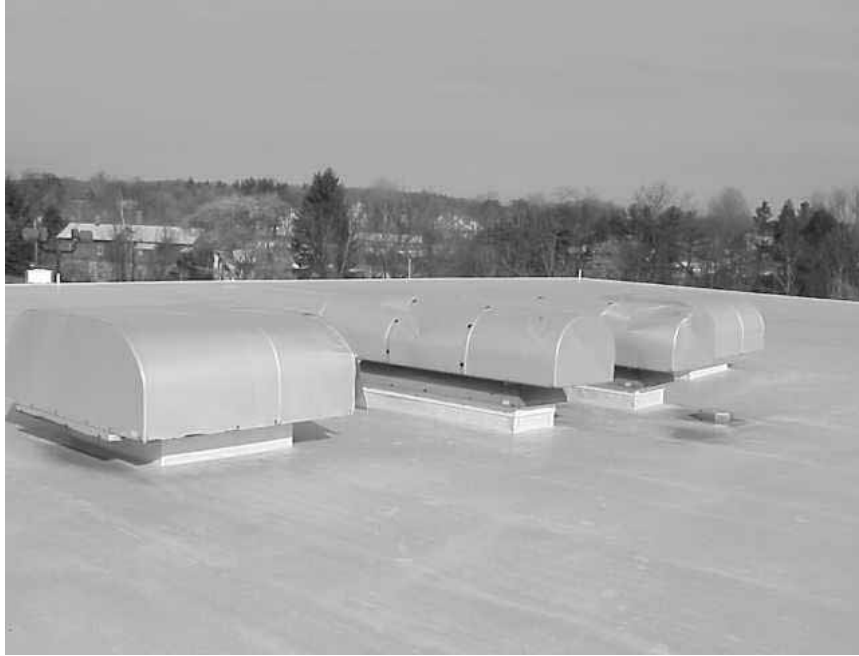
Picture 4

vents. An examination of the rooftop vents during the November 9th assessment found them inoperable.

Fresh Air Intakes and Exhaust Vents for B and D Wings.

7. Repair the rooftop vent equipment above Wings B and D.
8. Inspect exhaust motors and belts for proper function, repair and replace as necessary.
9. Remove all blockages from univents and exhaust vents.

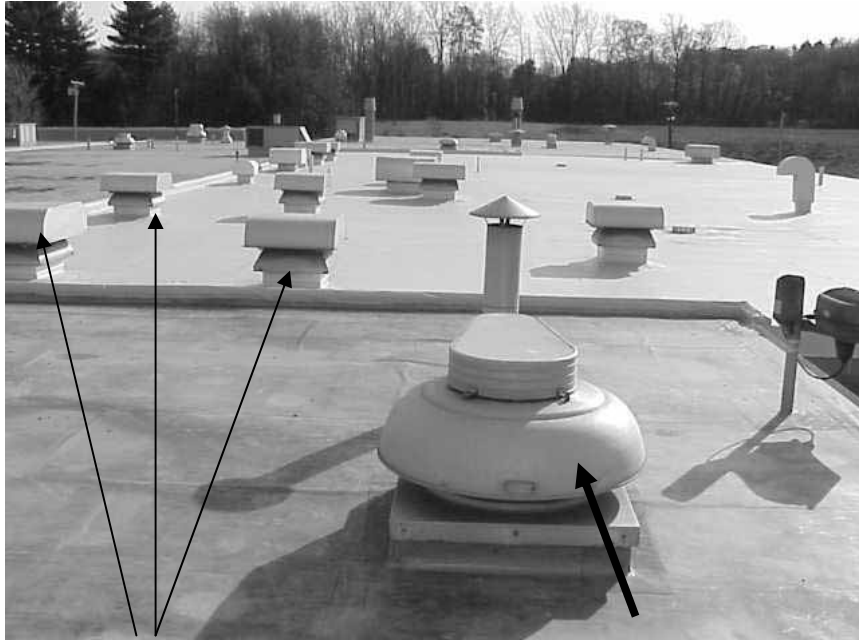
Picture 5

The CTE (F wing) has ceiling mounted univents that draw fresh air through intakes located on the roof (see Picture 5). Exhaust ventilation is provided by a combination of AHUs and single use dedicated exhaust vents. Of the exhaust vents noted in the CTE, the restaurant exhaust vents were not drawing air.

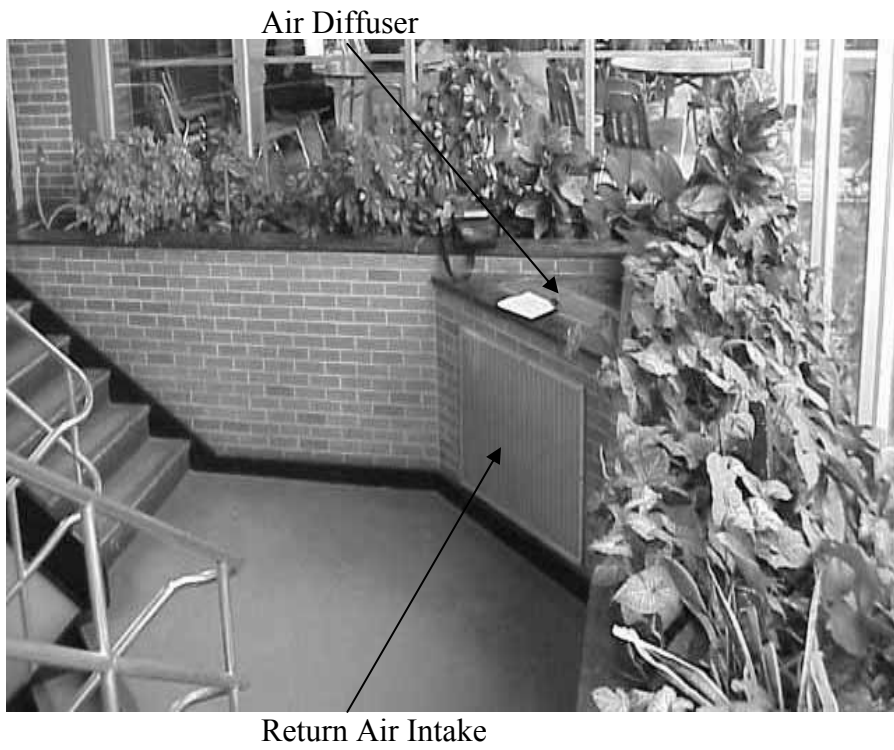
Picture 6

Indoor Garden outside the Cafeteria

14. Remove plants from the indoor planter in the cafeteria hallway and examine the base of the planter for appropriate drainage, water leaks and microbial growth. If microbial growth is present, disinfect non-porous surfaces with an appropriate antimicrobial agent.

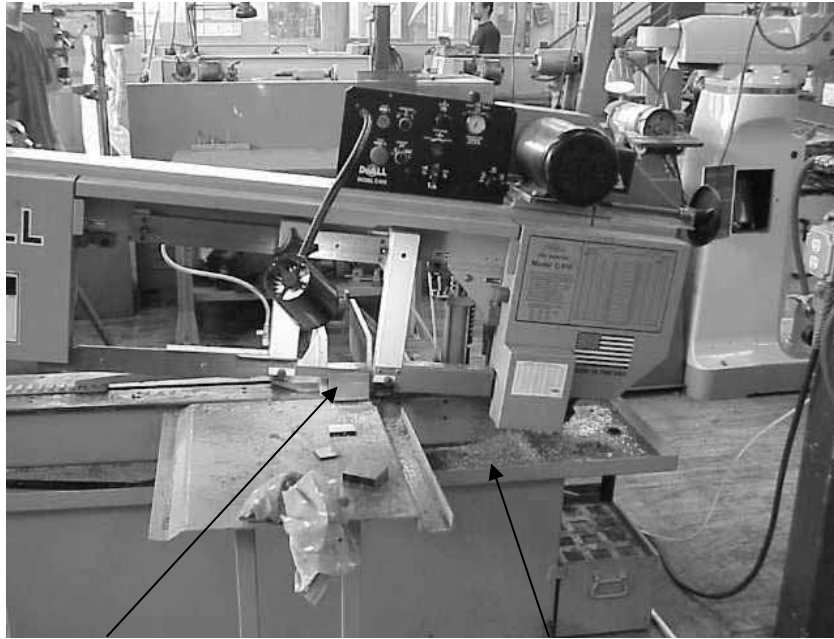
Picture 7

Metal Cutting Saw In Metal Shop

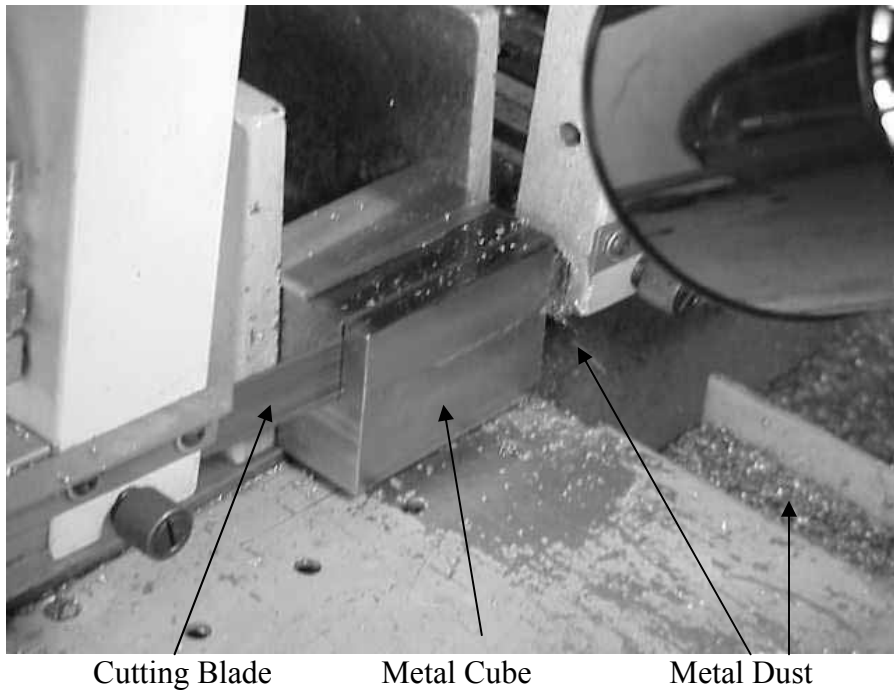
Picture 8

Close-up of Cutting of Metal Cube

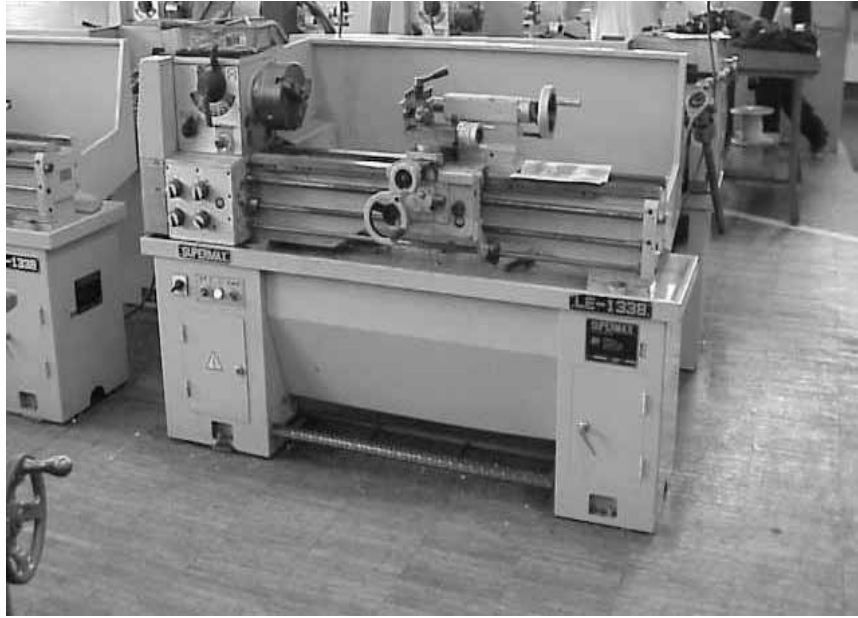
Picture 9

Metal Lathe in Machine Shop

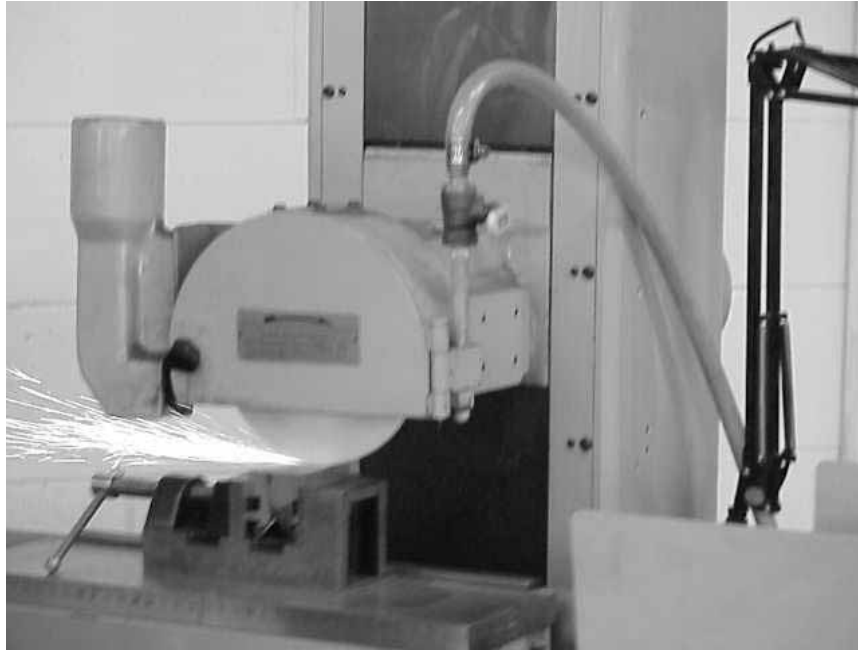
Picture 10

Operating Surface Grinder in Machine Shop, Note No Local Exhaust Ventilation

2. Provide local exhaust ventilation consistent with recommendations of the American Conference of Governmental Industrial Hygienists (ACGIH) for all metal fume producing procedures (e.g., see machine shop, soldering shop, automotive repair) (ACGIH, 1998). The construction of local exhaust ventilation for the machinery in the machine shop and printers in the graphics area are all highly recommended for shop activities to continue. Examine the feasibility of providing local exhaust ventilation for all metal fume producing machinery in the machine shop.

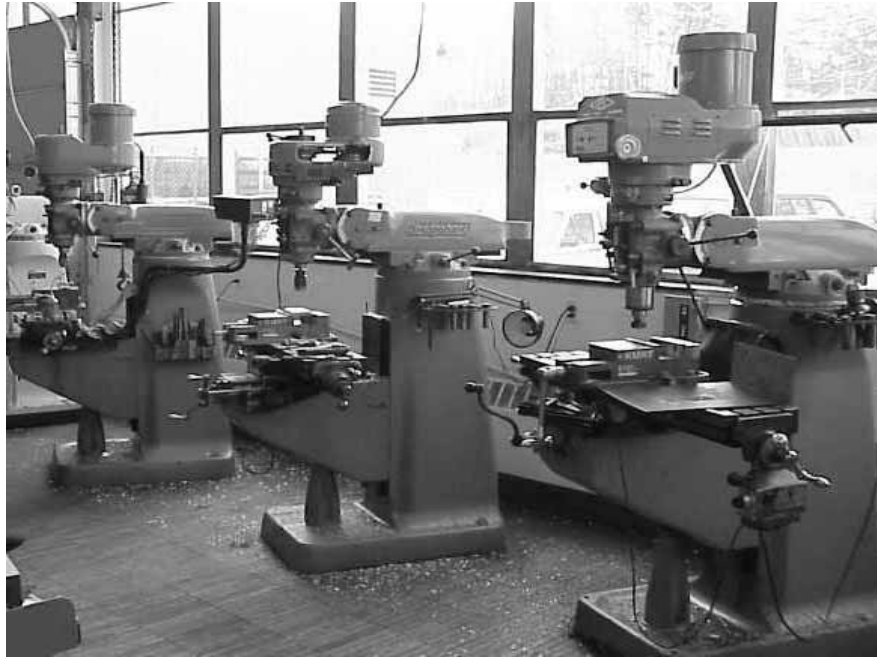
Picture 11

Metal Drills, Note Metal Fragments of Floor

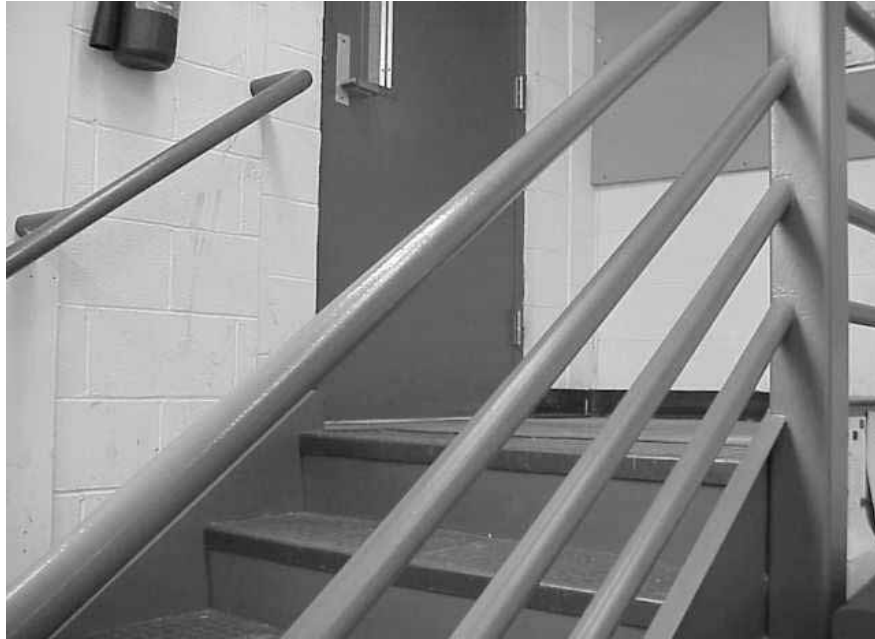
Picture 12

As noted in the metal shop area, spaces exist under each door that directly access shops from the main CTE hallway. Since a number of shops have large exterior doors (e.g., the automotive repair shop) that are left open during school hours, wind or cold air entering the shops can cause over-pressurization, which can result in shop odors and particulates being forced under the door space into hallways.

Space Beneath Machine Shop Hallway Door

2. Install weather-stripping on machine shop hallway door and keep this hallway door closed to minimize metal fume penetration into the hallway.
3. Contact a certified hazardous waste remediation company to examine the leaking oil from the storage tank in the autobody shop. Have spilled materials, including the soaked cardboard in the flameproof cabinet in the organic chemical storeroom, cleaned professionally and dispose of this waste in accordance with Massachusetts's hazardous waste disposal laws.

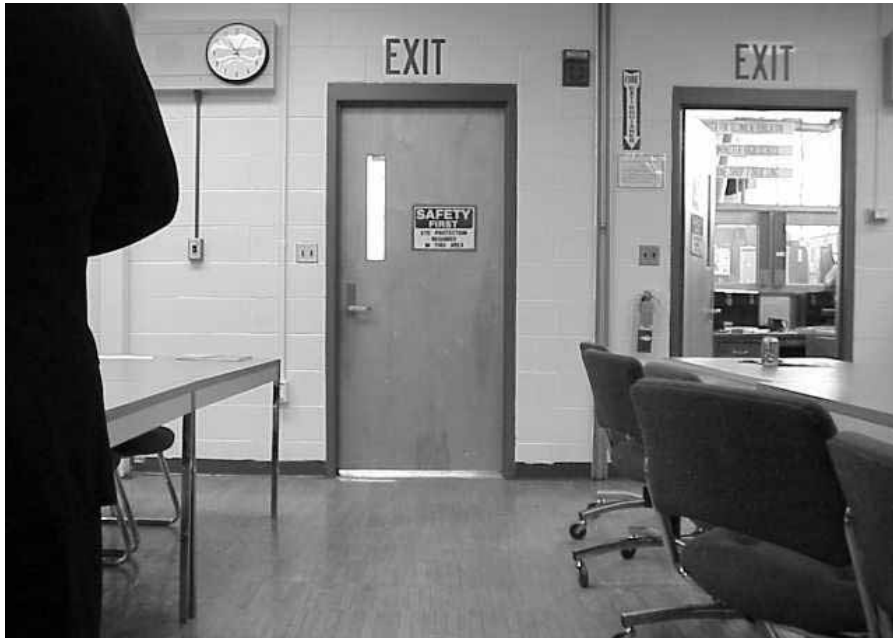
Picture 13

Space Beneath Classroom Door Adjacent To Metal Shop

26. Sweep up sawdust on the floor of the stage.
27. Replace crushed flexible ducts in the wood shop.
28. Install weather-stripping along edges of all doors leading to shops in the CTE to prevent odor/dust migration into classrooms and/or hallways.

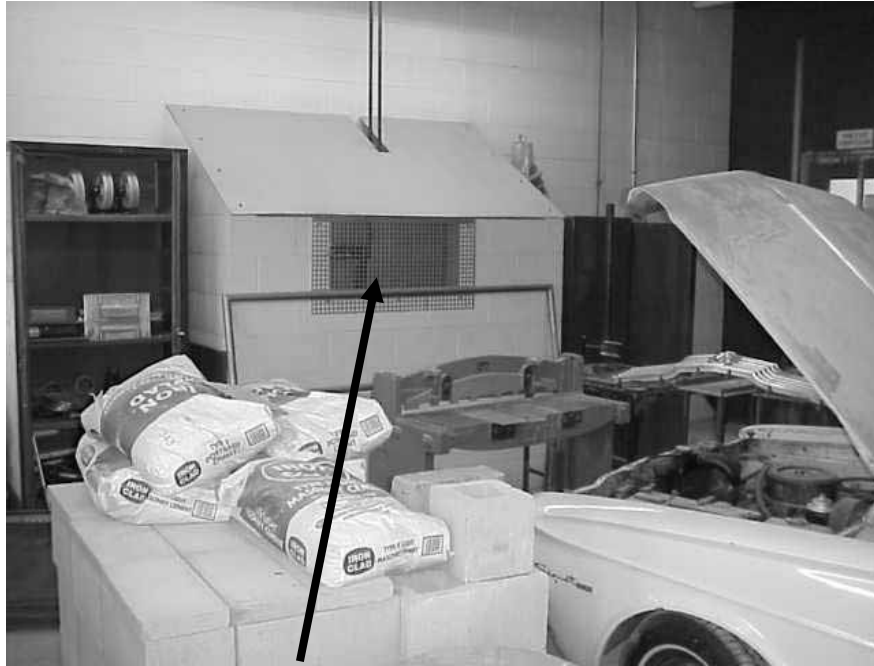
Picture 14

Measurable levels of total volatile organic compounds (TVOCs) were detected in the autobody shop. The source of the TVOCs was traced to the grille of a structure within this area (see Picture 14). Within this structure is an above ground tank used as a fuel supply by a large multiple car spray paint/drying booth located in the autobody shop. This drying booth uses No. 2 fuel oil to supply heat for the paint baking process of the spray booth. Streaks of leaking No. 2 fuel oil were observed on the side of the tank, indicating either oil leakage or overfilling of the vessel. No. 2 fuel oil contains TVOCs, which can be irritating to the eyes, nose, throat and respiratory tract.

Oil Tank in Autobody Shop

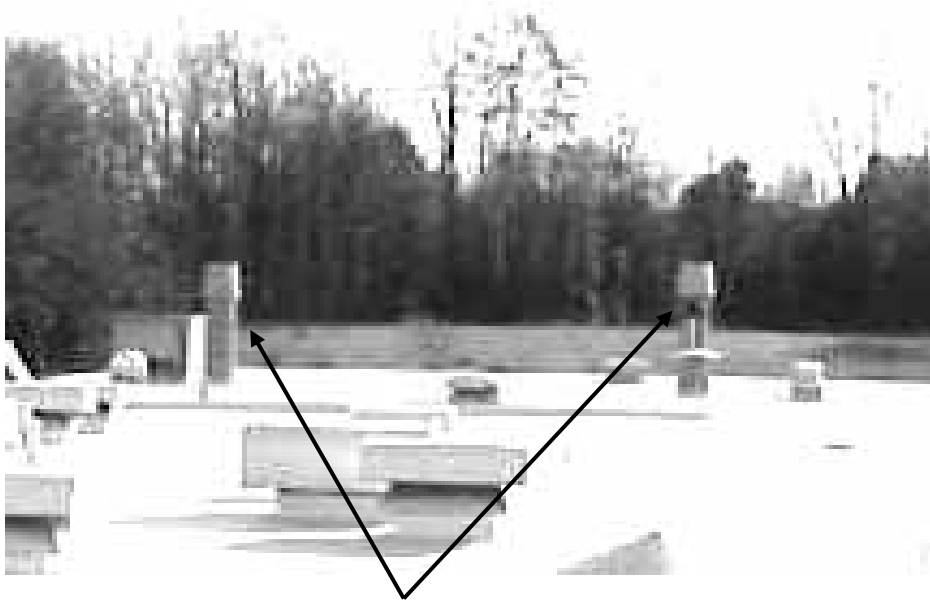
Picture 15

Products of combustion from the paint booth appear to be vented through metal smokestacks located on the CTE roof (see Picture 15). During the course of this assessment, fuel exhaust odors were reported in room F420. It appears that the smokestacks are several feet above the level of the roof. Under certain wind conditions, products of combustion from the smokestacks may be entrained into the building through rooftop fresh air intakes. No. 2 fuel oil combustion products can be irritating to the eyes, nose, throat and respiratory tract.

Smoke Stacks for Autobody Spray Booth

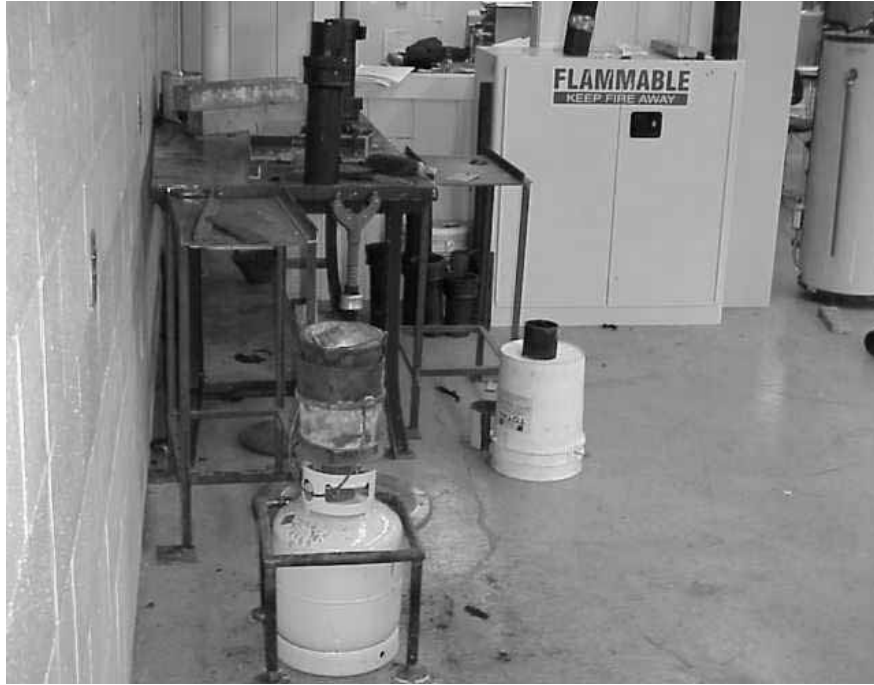
Picture 16

In addition to the use of solder, ingots of flux were being melted in a pan heated by a gas jet from a propane tank. While this operation is located beneath the hood of a local exhaust ventilation system, the presence of a flameproof cabinet within ten feet of the gas jet poses a significant fire hazard (see Picture 16). Frequently, poorly sealed containers of flammable materials will off-gas into the flameproof cabinet, resulting in a release of vapors when the cabinet is opened. With the local exhaust ventilation system

operating, vapors from the cabinet can be drawn to the propane tank jet flame and ignited. It is highly recommended that this flameproof cabinet be moved from this area.

Ingot Melting Using Propane Tank, Note Flameproof Cabinet

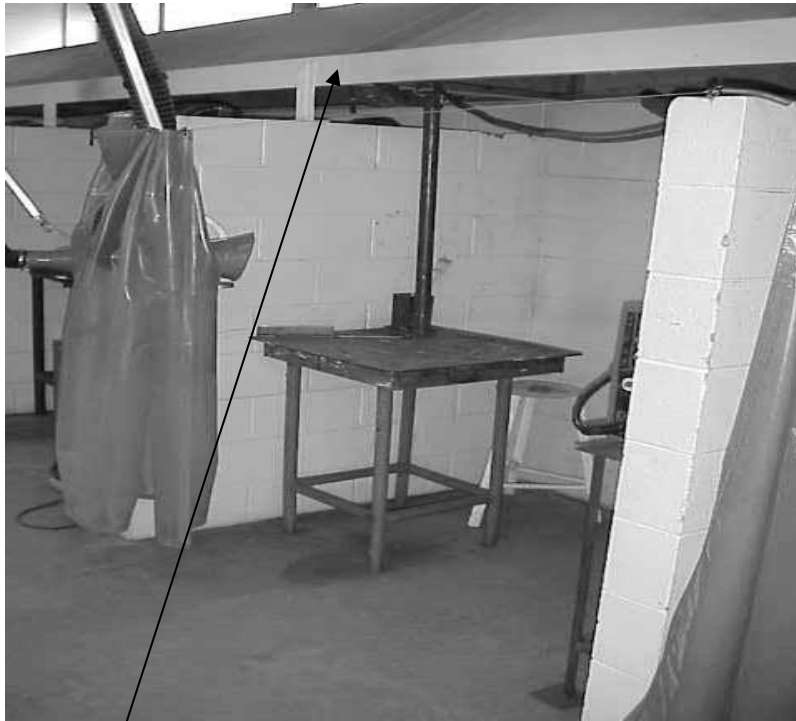
Picture 17

The welding shop was observed with smoke escaping from a welding booth, despite the presence of a local exhaust ventilation system. This escape of smoke from the welding booth is attributed to the welding stand location outside the outer lip of the exhaust hood (see Picture 17). Another factor is the lack of velocity of exhaust ventilation drawn from the elephant trunk vents connected to the exhaust fan (see Picture 18). Each of the elephant trunks was installed with an extra length of flexible hose. The extra length of flexible hose results in a condition that requires exhaust air entering the base of the vent to make an estimated 540° in curves before entering the metal duct above the ceiling. As a general rule, each 90° bend in ducting will reduce the draw of air by 50 percent. In this case, an exhaust hose makes roughly six 90° turns (540°). Assuming that the velocity of the draw of air at the metal ductwork at the top of the flexible hose equals 100 percent, the draw of air at the base of the vent is reduced to roughly 1 percent of the draw because of the six 90° bends in the hose. To increase the draw of air and welding pollutants, the length of flexible hoses should be shortened to reduce the hose length and number of turns exhaust air must travel.

Welding Table outside the Outer Lip of the Exhaust Vent

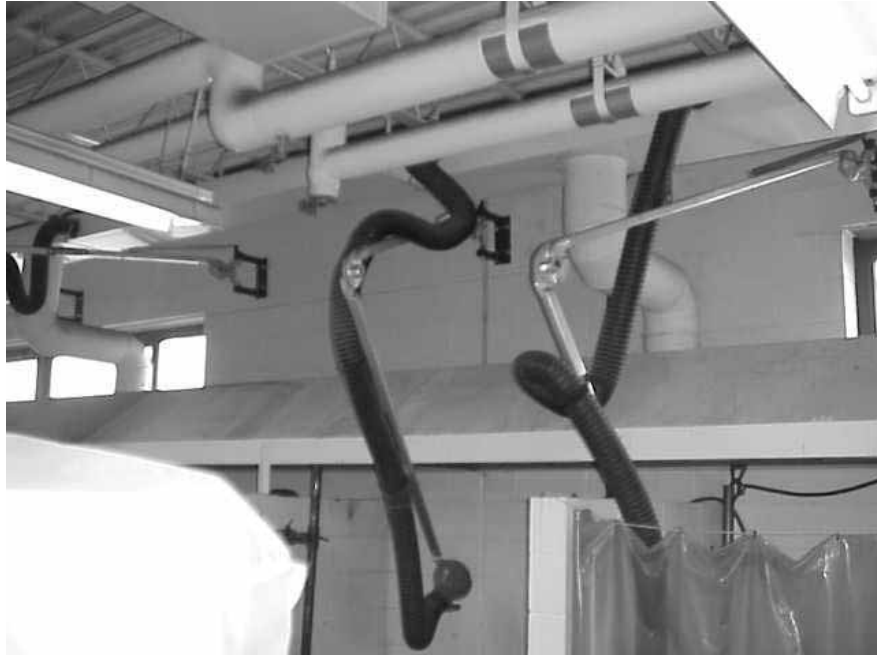
Picture 18

Several local exhaust vents for wood dust generating machinery were found crushed. The reduction in diameter of the ducts can cause a build up of sawdust within the duct, resulting in blockage. Wood dust can be an irritant to the eyes, nose and throat and should be properly vented.

Bent Elephant Trunk Flexible Ducts

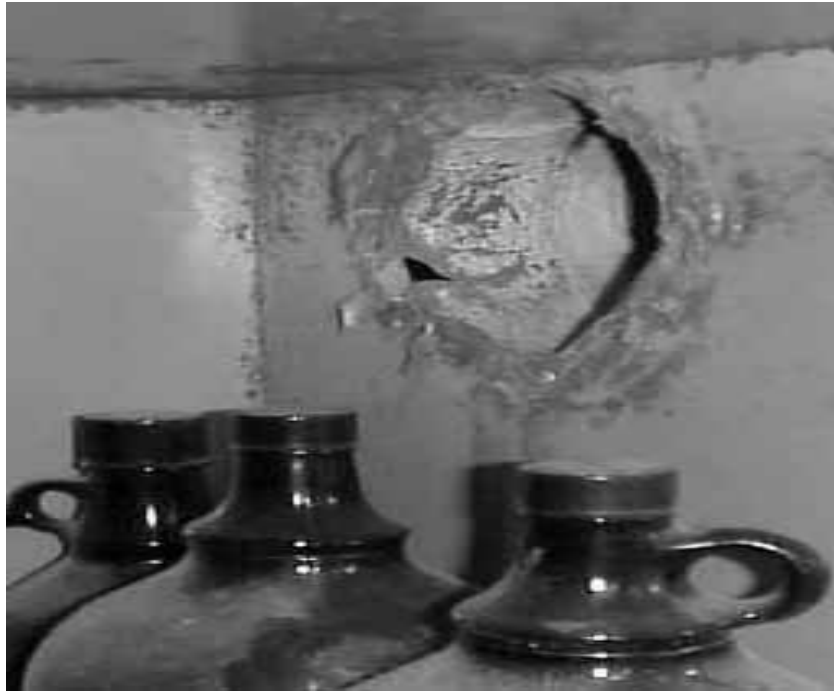
Picture 19

Hole Made By Exhaust Vent Ductwork in Flameproof Cabinet

15. Consolidate chemical storage into a single room.
16. Disconnect the organic storeroom flameproof cabinet from the exhaust ventilation system. Replace the flameproof cabinet.

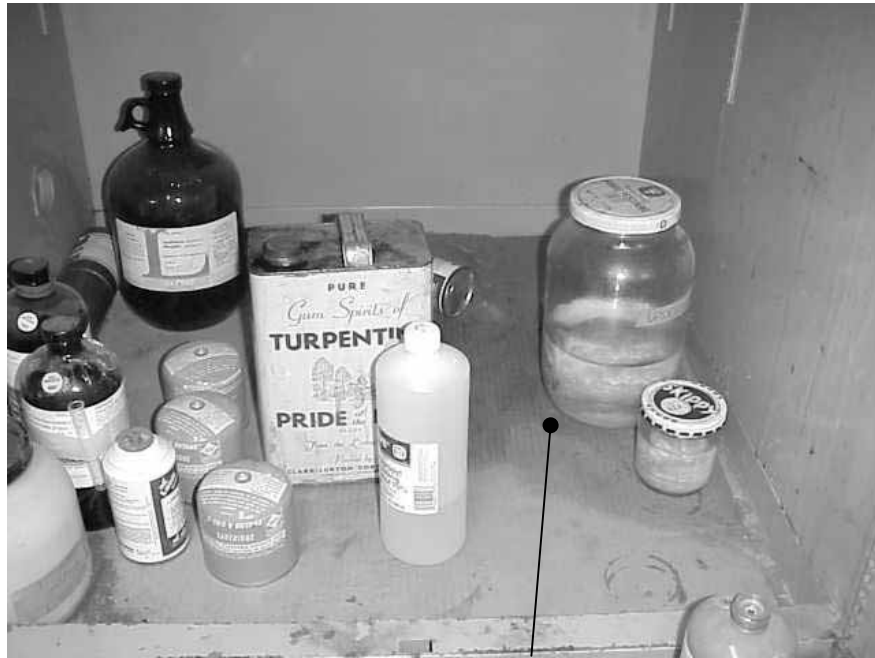
Picture 20

The interior walls underneath the shelves and door of the flammable storage cabinet were heavily corroded, which can indicate off-gassing of chemicals from improperly sealed containers. A piece of cardboard covers the lower shelf and appears to be stained with an oily material (see Picture 20). In the center of the stain are two glass jars containing liquid, in which a substantial amount of silvery metal is stored. Each jar is sealed with a metal lid and is coated with an oily material, which is presumably the same material that saturated the cardboard.

Base Of Flameproof Cabinet Covered with Cardboard, Note Stain

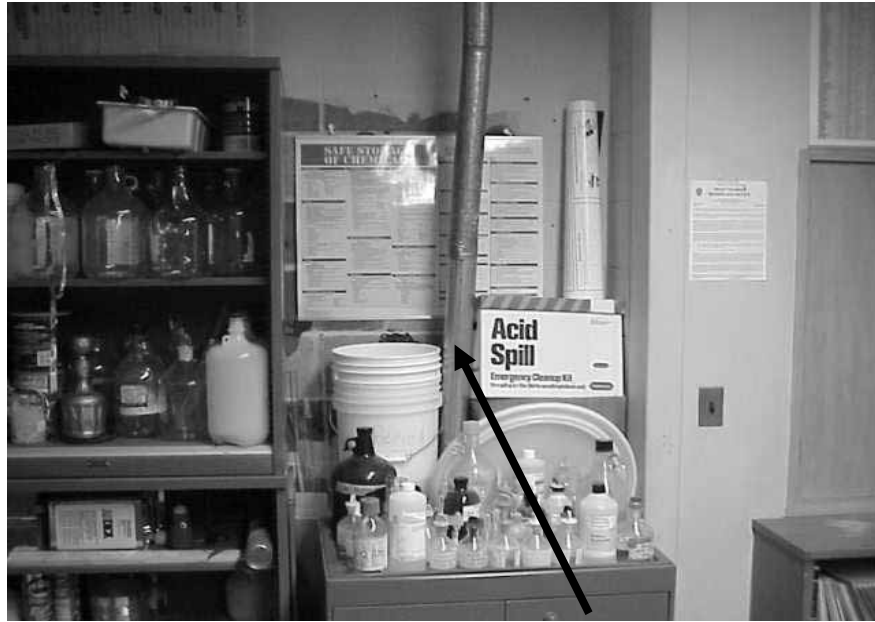
Picture 21

As noted in the MDLWD report, the acid cabinet in the inorganic chemical storage room is vented with galvanized pipe (see Picture 21). The acid cabinet as well as the flameproof cabinet are connected to a *common* single duct that is connected to an exhaust vent motor on the roof. The ductwork that the acid and flameproof cabinets is connected to appears to be the dedicated local exhaust vents that draw air into wall mounted grilles located near classroom access doors. Since the cabinets are connected to a common duct, it is possible that off-gassing VOCs from the flameproof cabinet and evaporating acids from the acid cabinet can mix and react within the ductwork. Acids and VOCs should not be mixed in order to prevent unintended chemical reactions.

Acid Cabinet with Vent

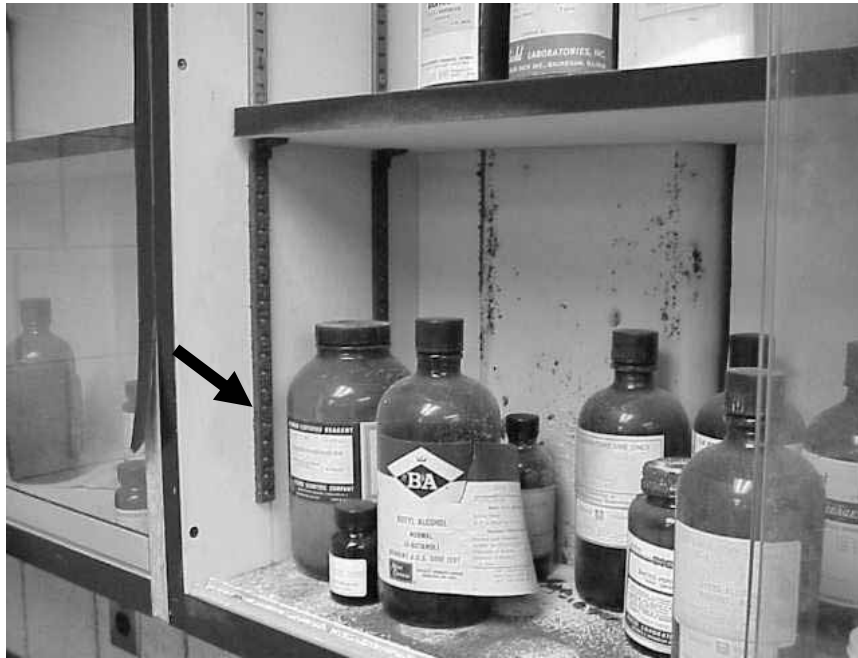
Picture 22

1. Shelves in classrooms outside the chemical storerooms appear to be corroded from off-gassing materials (see Picture 22). Corrosive materials appear to have corroded the metal shelf supports, coating the shelf with oxidized metal. The corroding of the metal shelf supports can lead to the undermining of the structural integrity of the shelves. Materials should be removed from the shelves and relocated.

Corroded Classroom Shelves with Stored Chemicals, Note Corrosion on Shelf Supports

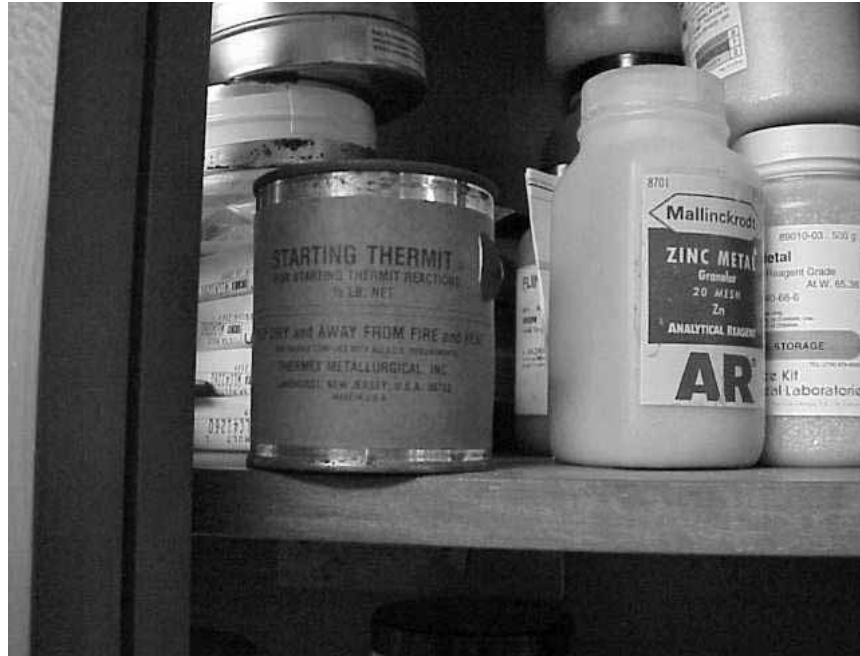
Picture 23

Thermit on Open Shelf

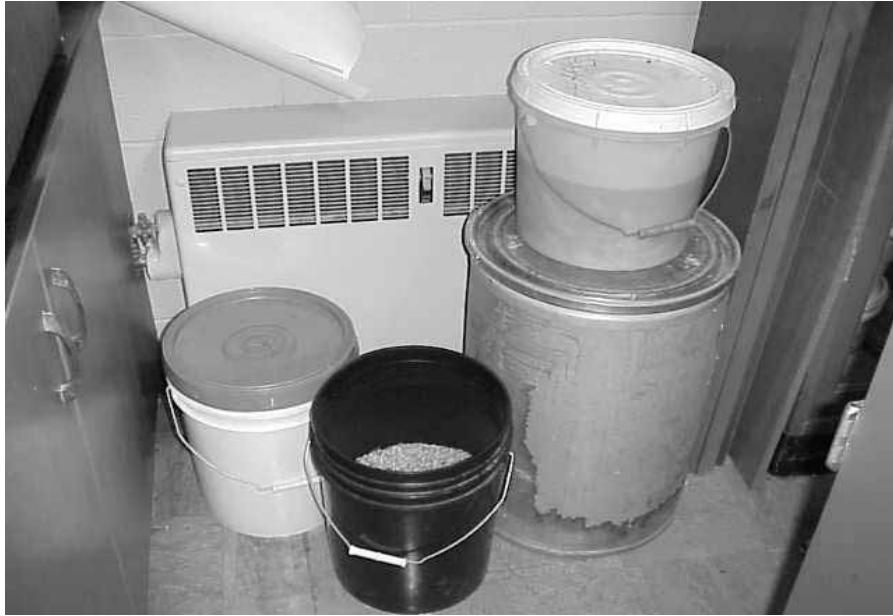
Picture 24

Science Materials Stored Against Heater

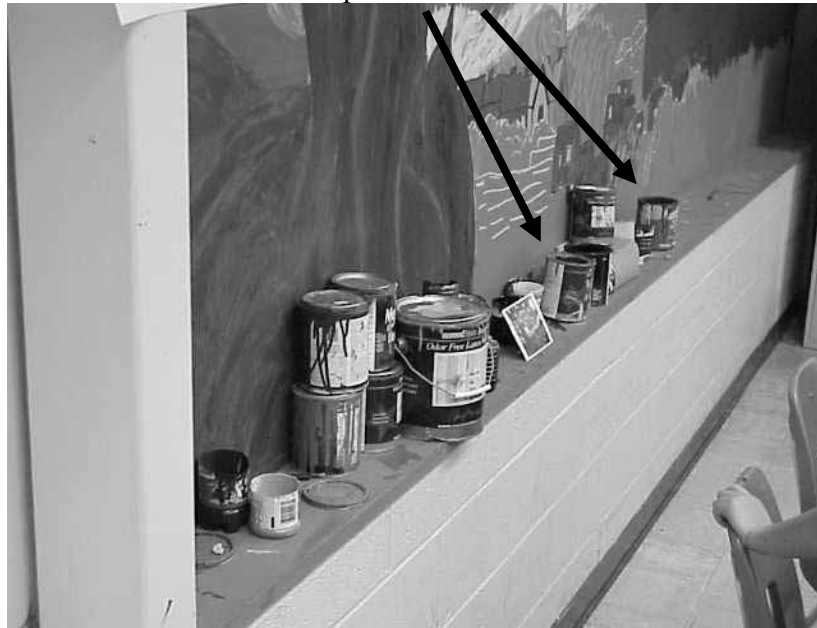
Picture 25

Open Cans of Paint in Classroom C218
