INDOOR AIR QUALITY ASSESSMENT

**Furnace Brook Middle School
500 Furnace Street
Marshfield, Massachusetts**

Prepared by:
Massachusetts Department of Public Health
Bureau of Environmental Health Assessment
January, 2000

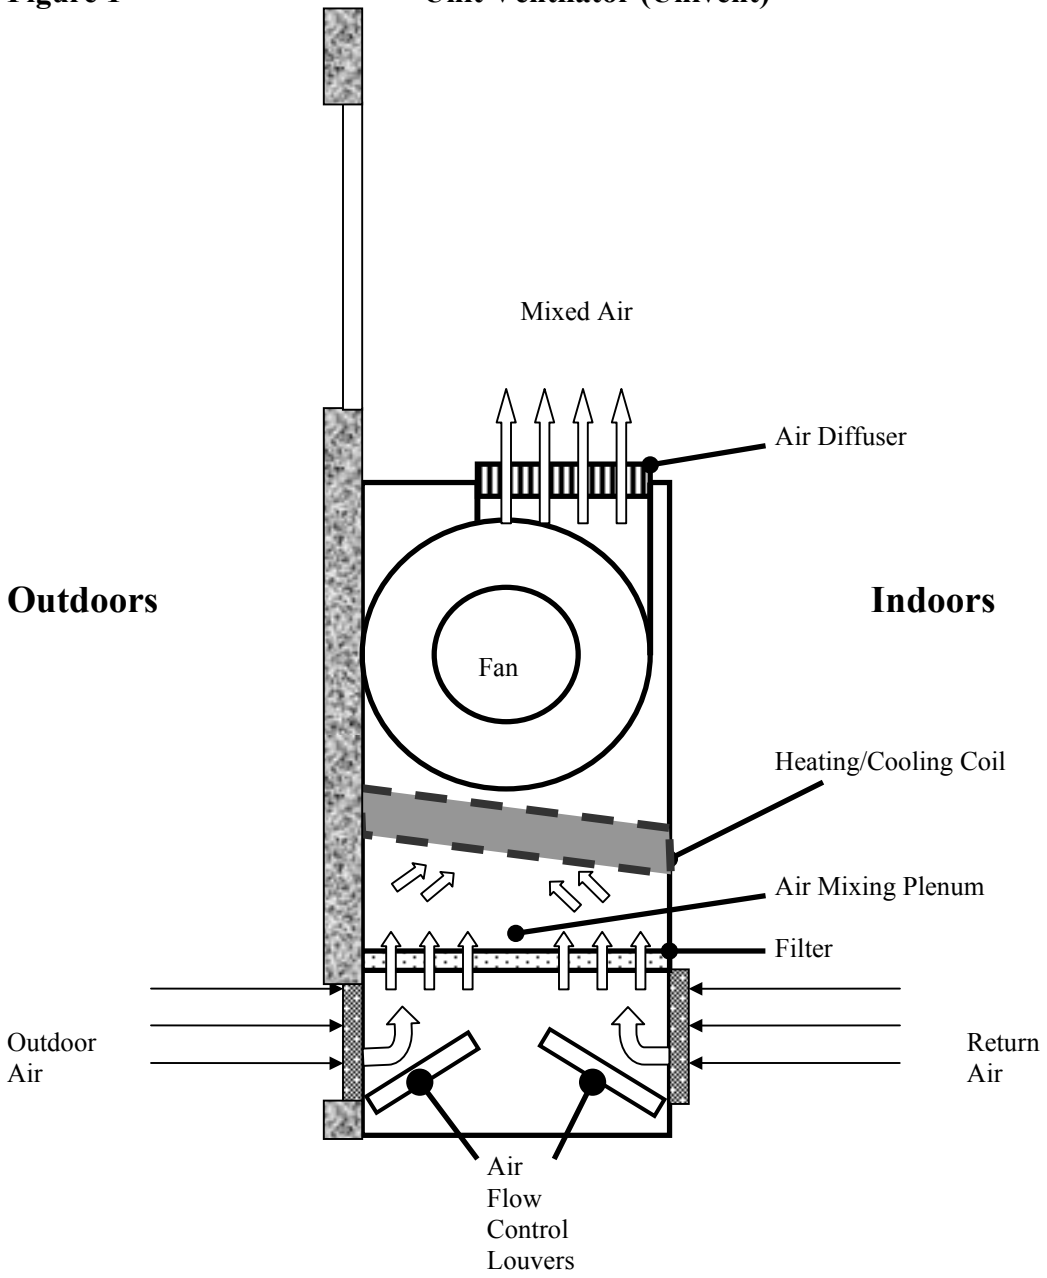
Figure 1

It can be seen from the tables that carbon dioxide levels were elevated above 800 ppm in thirty-five of the forty-two areas surveyed, which is indicative of an overall ventilation problem in the school. However, it is important to note that a number of areas had newly installed ventilation systems that had not been activated and calibrated at the time of the assessment. Of note were the language conference room and the choral room, which had levels of carbon dioxide in excess of 800 ppm without occupancy during the air monitoring, indicating little or no air exchange. It is also noted that areas in which carbon dioxide levels were below 800 ppm had open windows or were sparsely populated during the assessment, which can greatly reduce carbon dioxide levels. Fresh air in classrooms is supplied by a mechanical unit ventilator (univent) system (see Figure 1). The majority of univents in non-renovated classrooms were operating during the assessment.

Unit Ventilator (Univent)
