# **INDOOR AIR QUALITY ASSESSMENT**

**Leicester Middle School  
70 Winslow Avenue  
Leicester, Massachusetts**

Prepared by:  
Massachusetts Department of Public Health  
Bureau of Environmental Health Assessment  
February, 2000

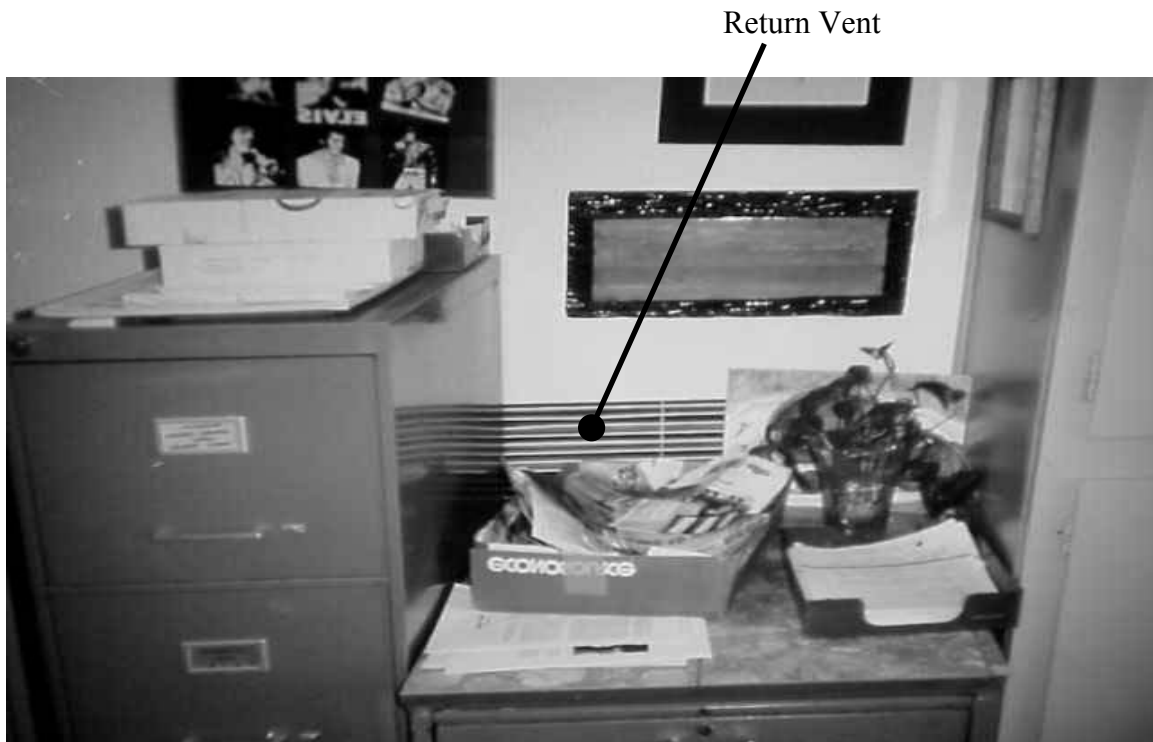
Picture 1

Mechanical ventilation in the art room is provided by an air-handling unit (AHU) located in an adjacent mechanical room. The system was deactivated by request of the occupant, therefore providing no mechanical ventilation. In addition, ventilation grilles were noted to be blocked by various items (see Picture 1). Mr. Suprenant re-activated the system during the assessment, which BEHA staff verified. The door to the mechanical room is equipped with louvers to provide fresh “make-up ” air to the mechanical room. These louvers were blocked with sheet metal which prevents airflow, interfering with the proper function of the system (see Pictures 2 & 3). It is important that the system remains “on” and be allowed to operate un-obstructed to provide mechanical ventilation to the area.

Return Vent Obstructed by Cabinet and Other Items

3. Remove all blockages from univents and exhaust vents. Inspect periodically to ensure these areas remain free from obstructions.
4. Once univents and exhaust ventilation are running properly, the systems should be balanced.

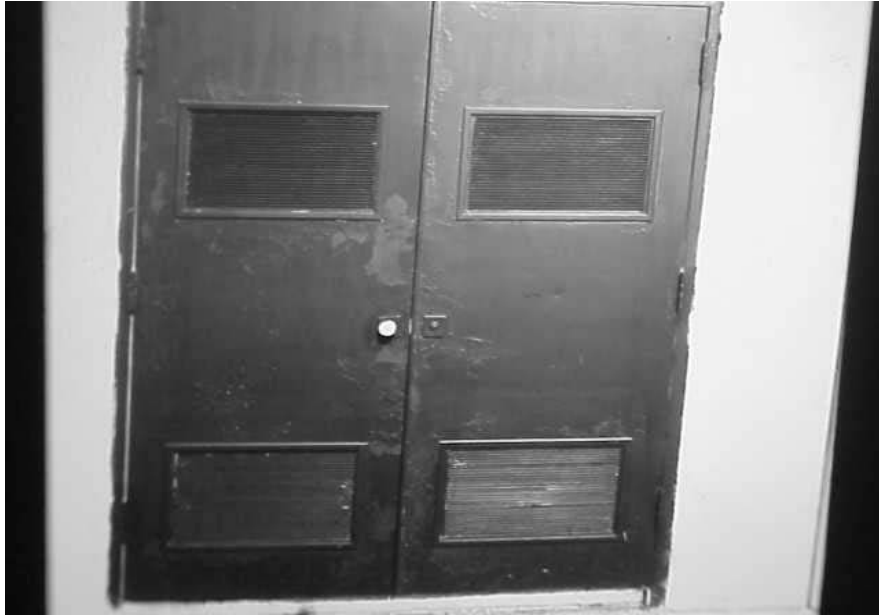
**Picture 2**

Exterior Door to Mechanical Room Containing AHU for the Art Room (Exterior View)  
Note Fresh-air Intake Louvers

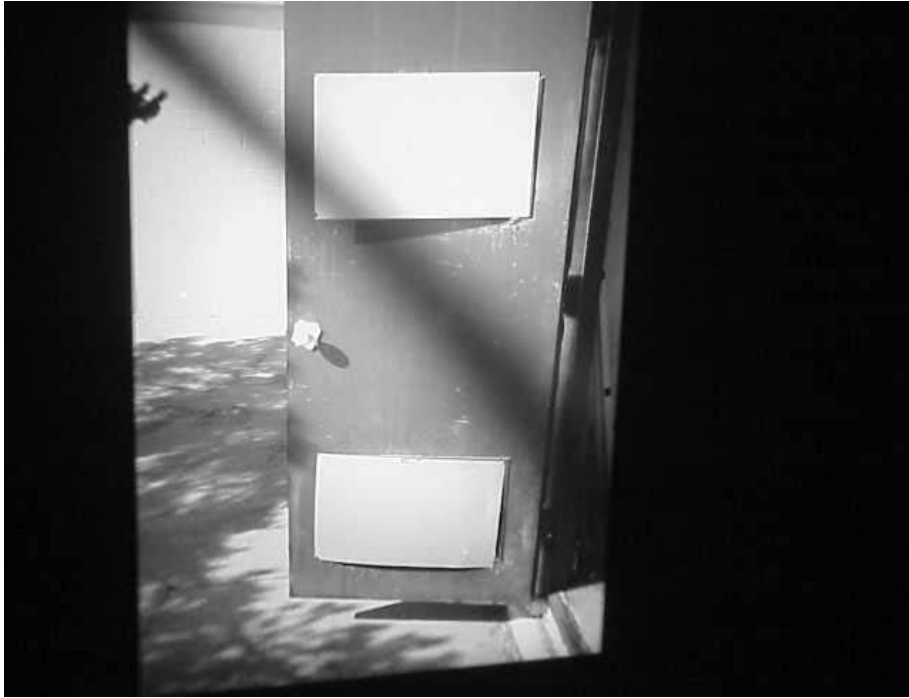
**Picture 3**

Exterior Door to Mechanical Room Containing AHU for the Art Room (Interior View)  
Note Fresh-air Intake Louvers are Covered with Sheet Metal

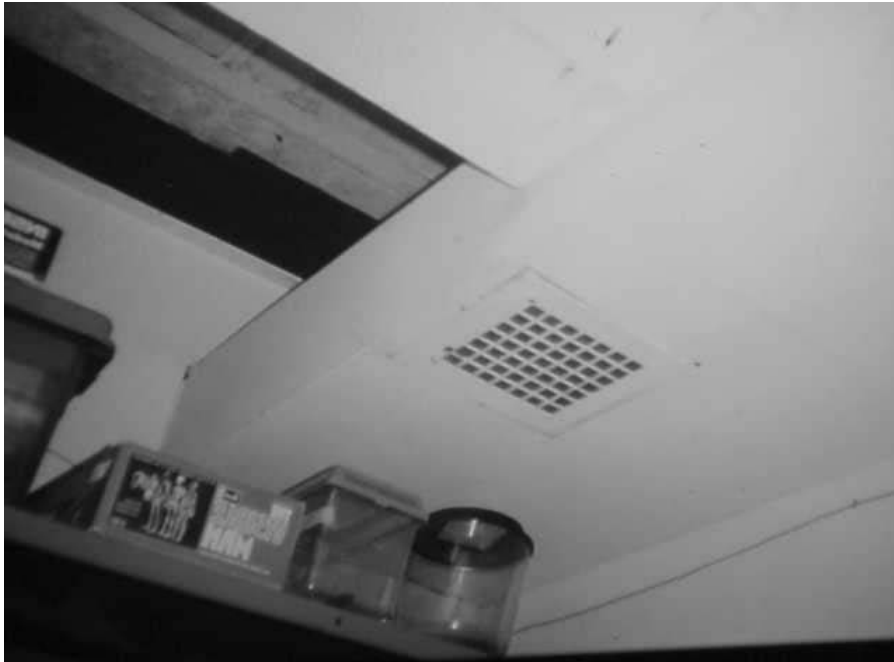
**Picture 4**

Exhaust ventilation for science classrooms 8 and 10 is provided by ceiling-mounted exhaust vents located in a chemical storeroom for each of the science classrooms (see Pictures 4 & 5). Passive grills are mounted on the wall adjacent to the drop ceiling to draw classroom air into the storerooms and out of the building through the exhaust vents (see Picture 6). These systems were not operating during the assessment. Cool air was noted backdrafting through these vents indicating that the system was off or that motors on the roof were inoperable. The assessment occurred on a cold day with moderate wind conditions (10-15 mph). The combination of the inactive ventilation system and wind would explain the occurrence of backdrafting noted on the day of the assessment.

As noted in the previous report, mechanical exhaust ventilation in the chemical storage rooms located in classrooms eight and ten were not operating. Exhaust ventilation should be activated and kept on at all times to prevent the infiltration of chemical odors into occupied areas.

Inactive Ceiling-mounted Exhaust Vent Located in Science Classroom 8 Chemical Storeroom

2. Inspect exhaust system that services the science rooms and chemical storage areas for proper function. Repair and replace motors and belts as necessary. Once operable, run the system continuously to prevent the infiltration of chemical odors into occupied areas.

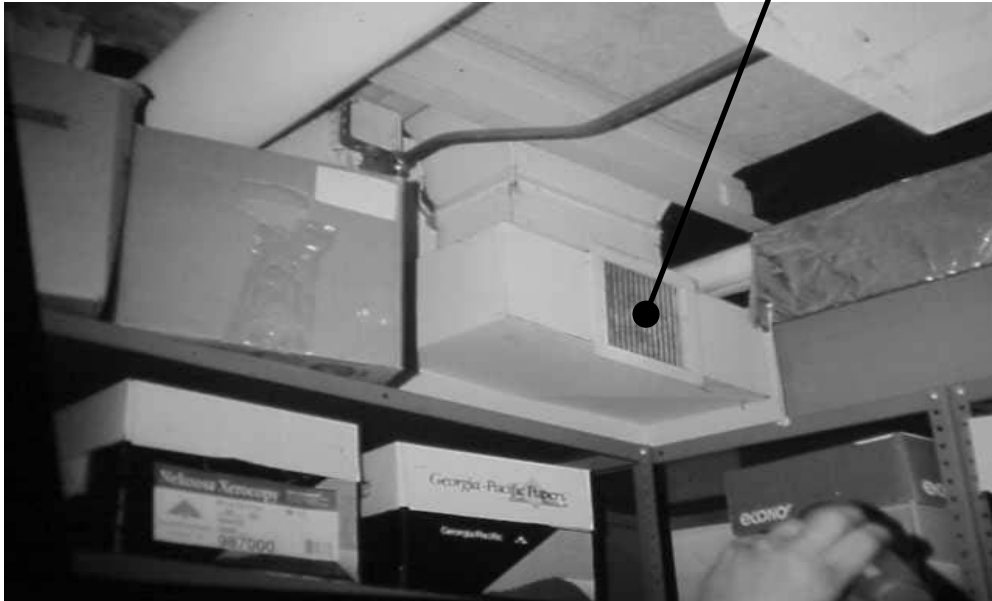
**Picture 5**

Inactive Ceiling-mounted Exhaust Vent Located in Science  
Classroom 10 Chemical Storeroom

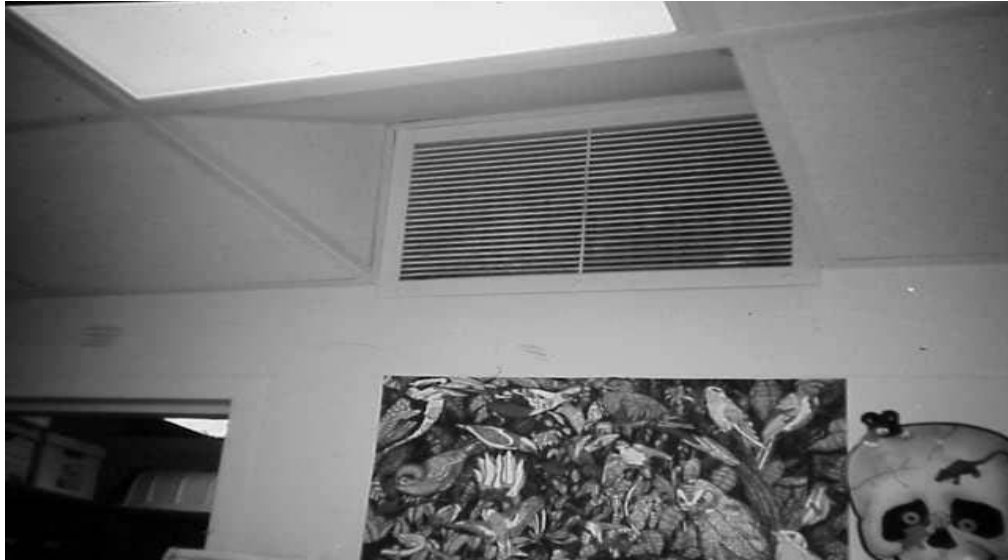
**Picture 6**

Passive Vent Providing Exhaust Ventilation to Science Classrooms

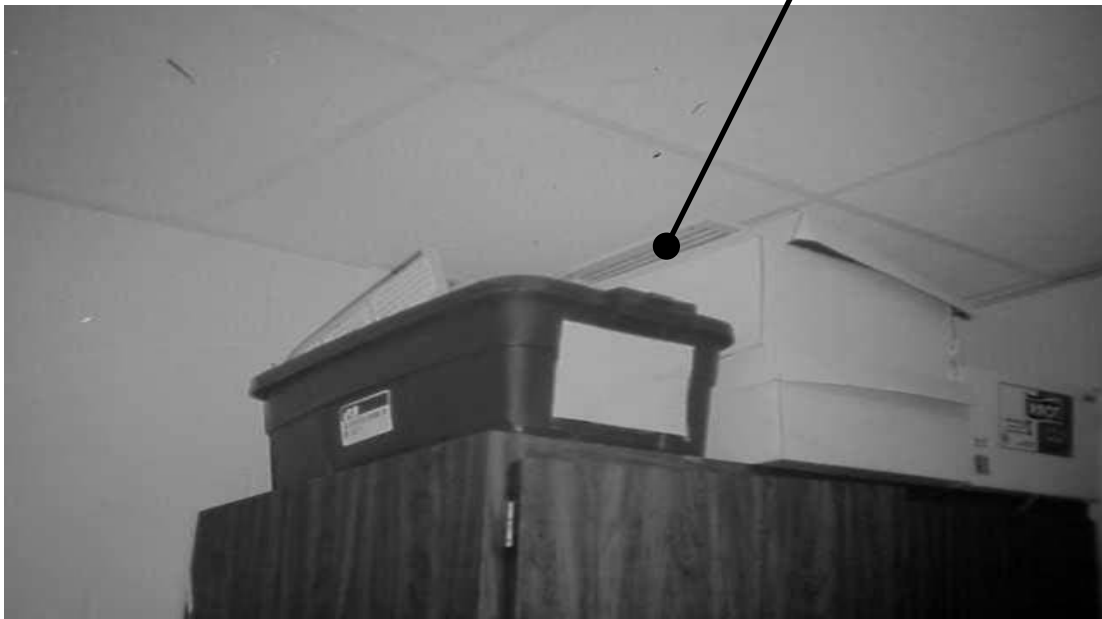
**Picture 7**

Also noted in several classrooms were exhaust vents found obstructed by boxes, crates and other items. Ceiling mounted exhaust vents in the seven new classrooms are located approximately three feet above storage cabinets. Items were seen stored on top of the cabinets in many classrooms, blocking the vents (see Picture 7). As noted in the previous report, care should be taken to avoid the blockage of these vents by items stored on top of cabinets. Exhaust ventilation in the cafeteria was drawing weakly.

Ceiling-mounted Exhaust Vent Obstructed by Boxes

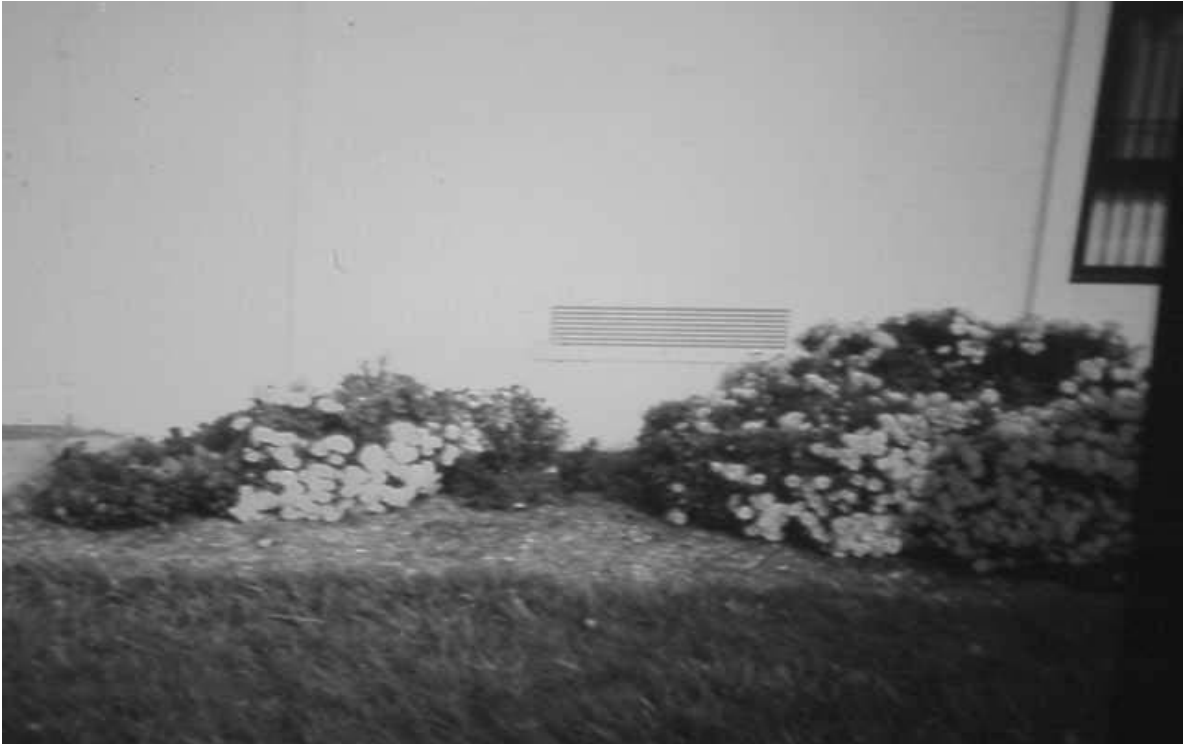
**Picture 8**

Along the perimeter of the building, shrubbery and flowering plants were noted in close proximity to a univent fresh air intake outside of one of the classrooms (see Picture 8). Shrubby and flowering plants can be a source of mold and pollen and should be placed and/or maintained to ensure that fresh air intakes remain clear of obstructions.

Shrubbery and Flowering Plants near Univent Fresh-air Intake

10. Inspect shrubbery along outside perimeter of building periodically; trim away from fresh air intakes as needed.
11. Examine the feasibility of providing air conditioning and/or additional ventilation to computer classroom 24 to remove excess heat generated by computer equipment.
