INDOOR AIR QUALITY ASSESSMENT

**Francis T. Bresnahan Elementary School
333 High Street
Newburyport, Massachusetts**

Prepared by:
Massachusetts Department of Public Health
Bureau of Environmental Health Assessment
February, 2000

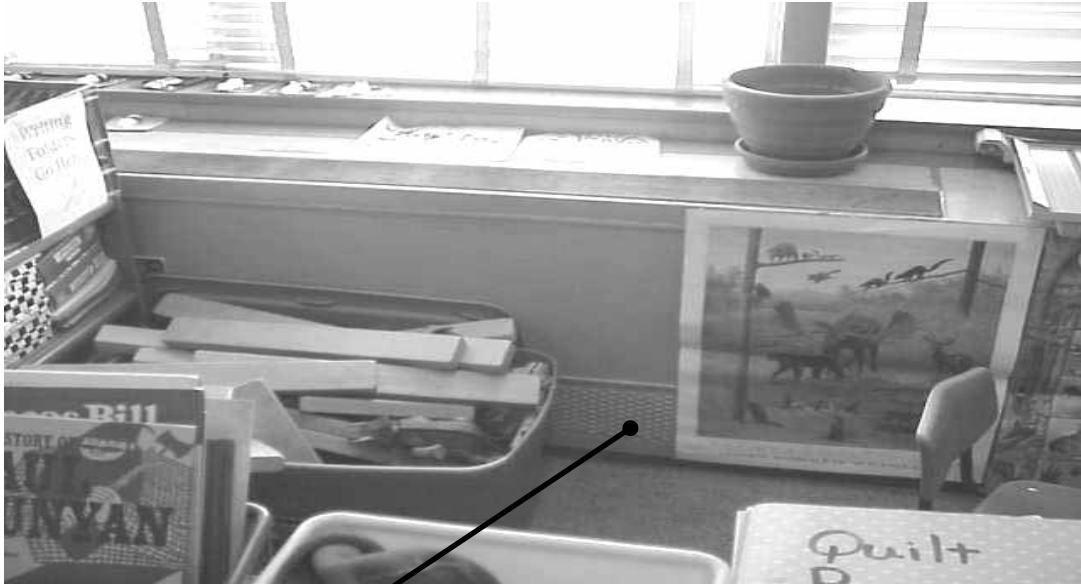
Picture 1

Univent Return Vent Blocked by Storage Bin and Poster

4. Remove all blockages from univents and exhaust vents to ensure adequate airflow.
5. Operate mechanical ventilation in gymnasium and cafeteria during occupancy.

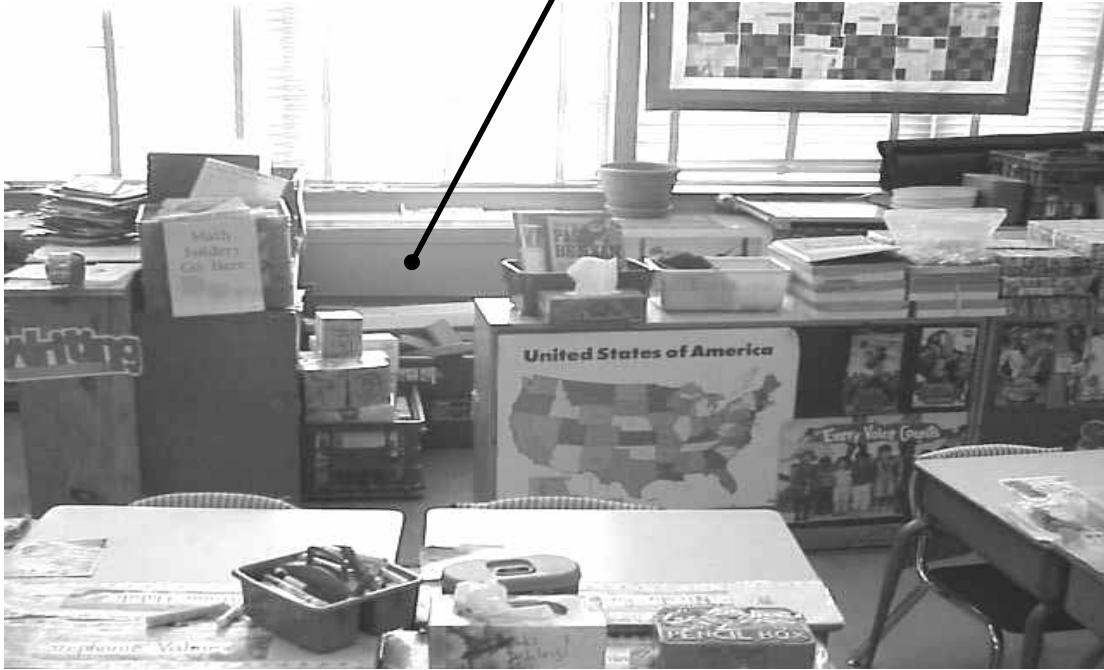
Picture 2

**Classroom Configuration Note Amount of Materials around Univent
Inhibiting Airflow**

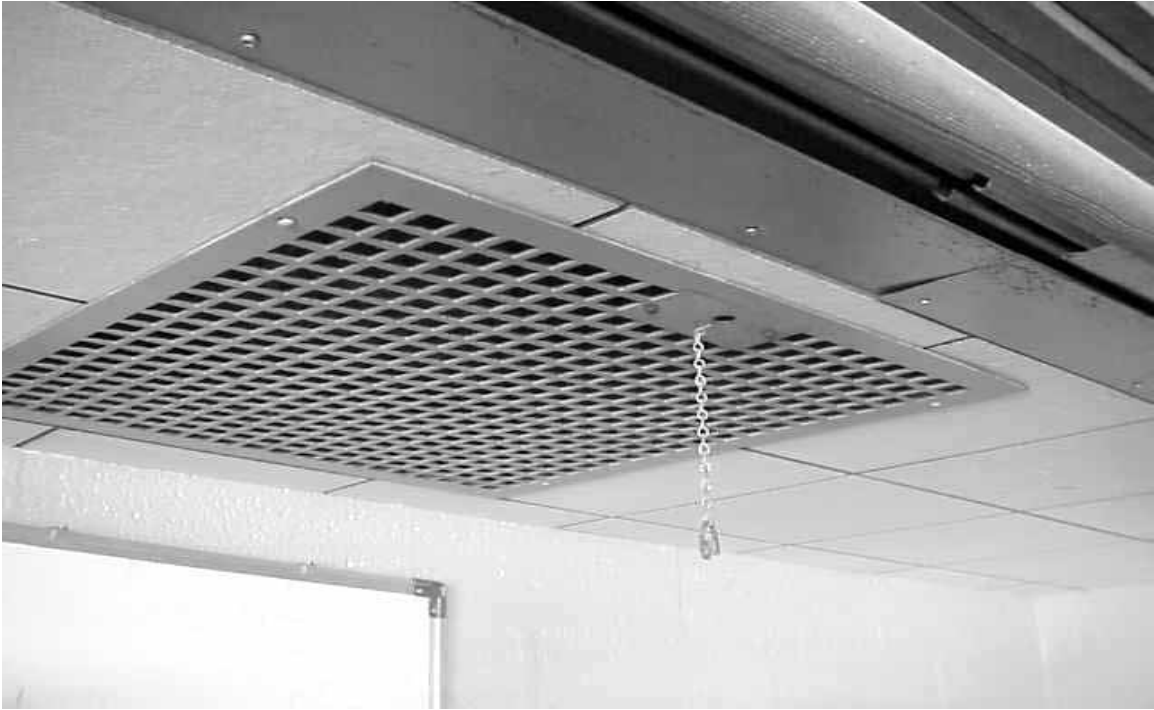
Picture 3

The mechanical exhaust system in classrooms consists of ducted, grated wall vents and/or exhaust vents mounted in the ceiling of coat closets. Coat closet exhaust vents and exhaust vents in the library are equipped with pull chains to adjust a flue located in the ductwork (see Picture 3). Exhaust ventilation was off or drawing weakly in many of the classrooms surveyed. In addition, exhaust vents were missing pull chains, had louvers closed or were obstructed by bookcases, storage bins and other items (see Pictures 4 & 5). As with the univents, exhaust vents must be activated and be allowed to operate free of obstruction in order to function as designed.

**Ceiling-mounted Exhaust Vent in Coat Closet Note Pull Chain
Which Controls Flue inside Duct**

2. Examine exhaust motors for function, increase exhaust if necessary. Operate exhaust ventilation during occupancy. Ensure exhaust flues are opened to facilitate air exchange. Repair and/or replace missing/damaged pull chains.

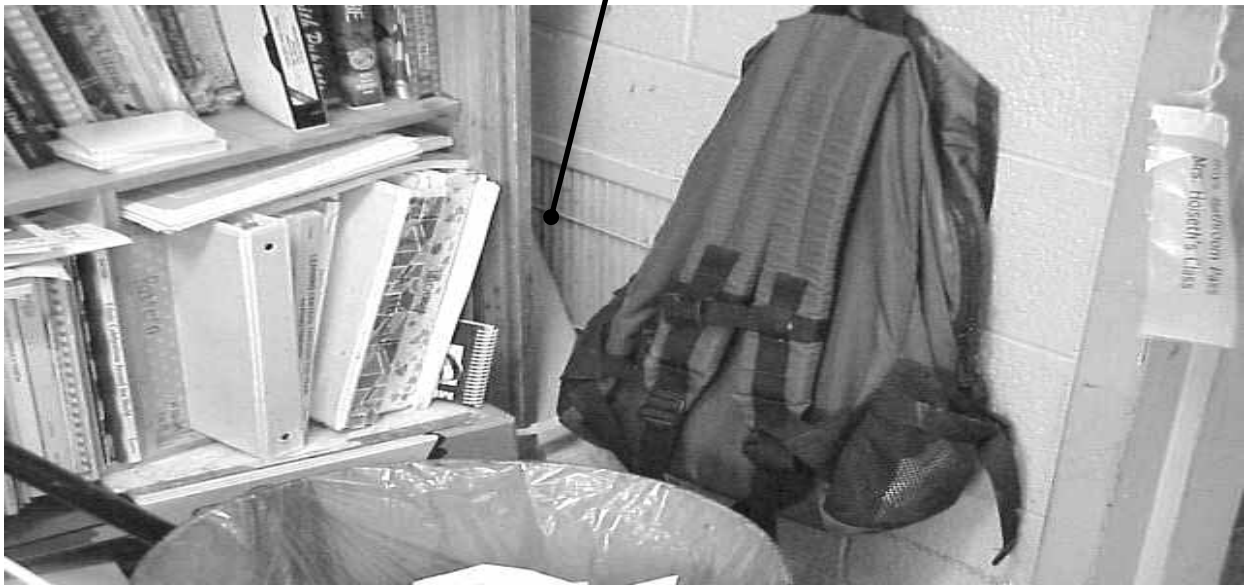
Picture 4

Wall-Mounted Exhaust Vent Obstructed by Bookcase and Bookbag

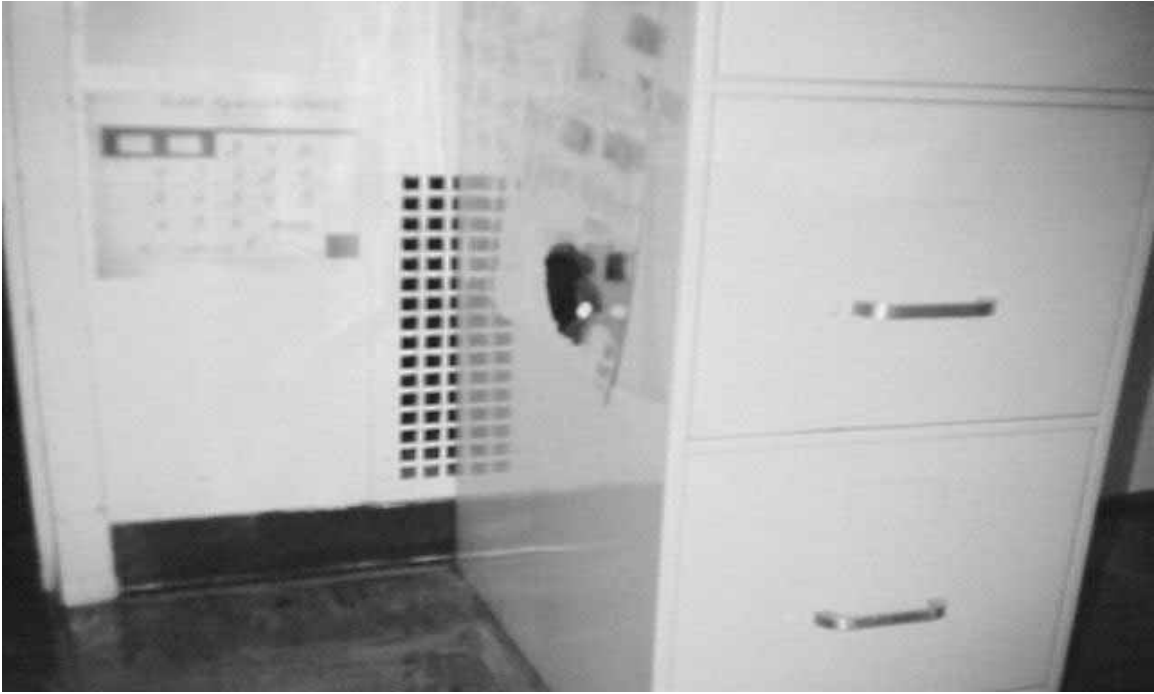
Picture 5

Wall-mounted Exhaust Vent Obstructed by File Cabinet

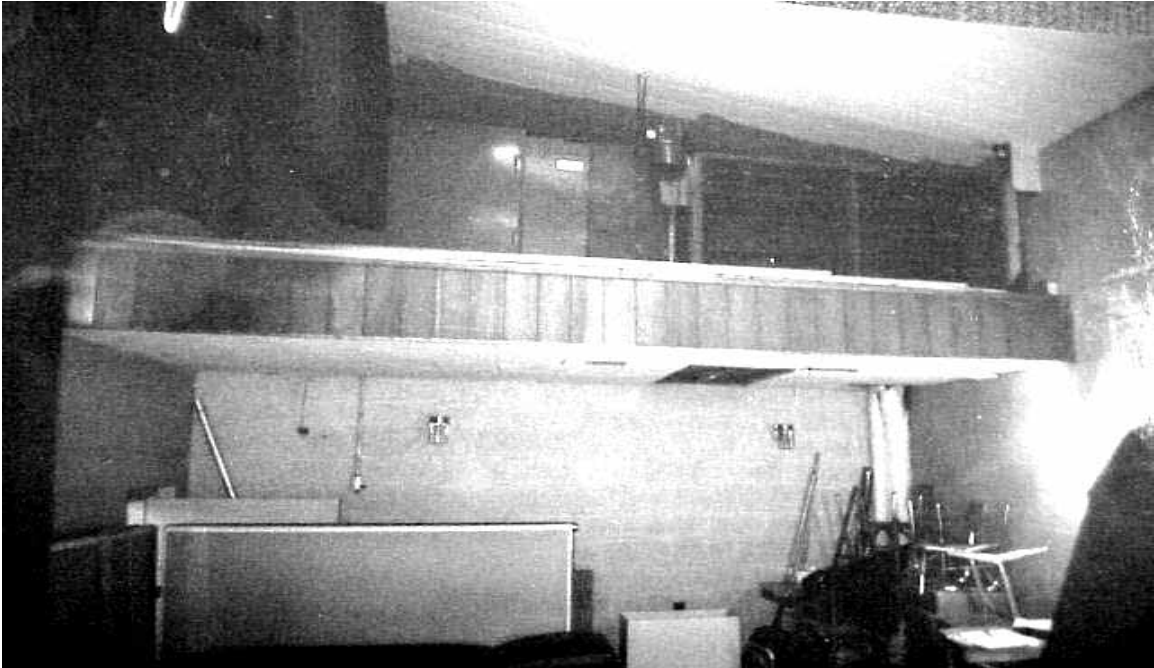
Picture 6

Ventilation complaints were reported in the gymnasium. Fresh air to the gymnasium is provided by an AHU mounted in the stage area at the rear of the gym (see Picture 6). During the assessment a gym class was being conducted, the AHU was not

AHU Servicing Gymnasium Located Behind Stage Area

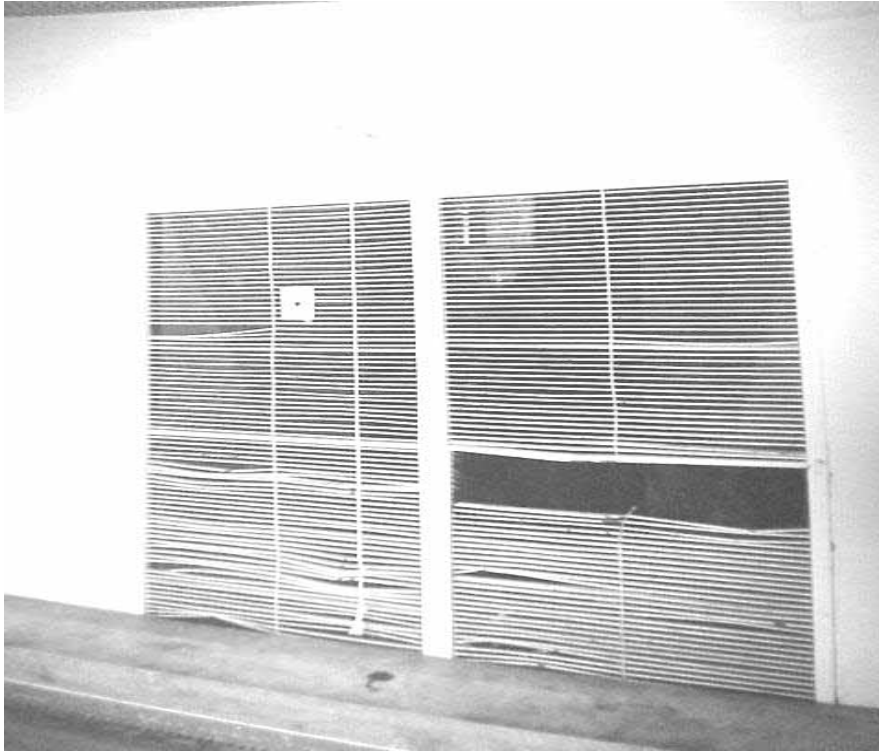
Picture 7

operating and elevated levels of carbon dioxide were recorded (i.e., over 800 ppm). Exhaust ventilation for the gym is provided by a large, wall-mounted exhaust vent. The grille of the exhaust vent was damaged. The system appeared to not have been activated for some time, as evidenced by accumulations of dirt, debris and food noted within the vent (see Pictures 7 & 8). Elevated levels of carbon dioxide were also recorded in the cafeteria during lunch hours. As with the gymnasium, both the supply and exhaust ventilation were deactivated during occupancy.

Damaged Exhaust Grille Noted in Gymnasium

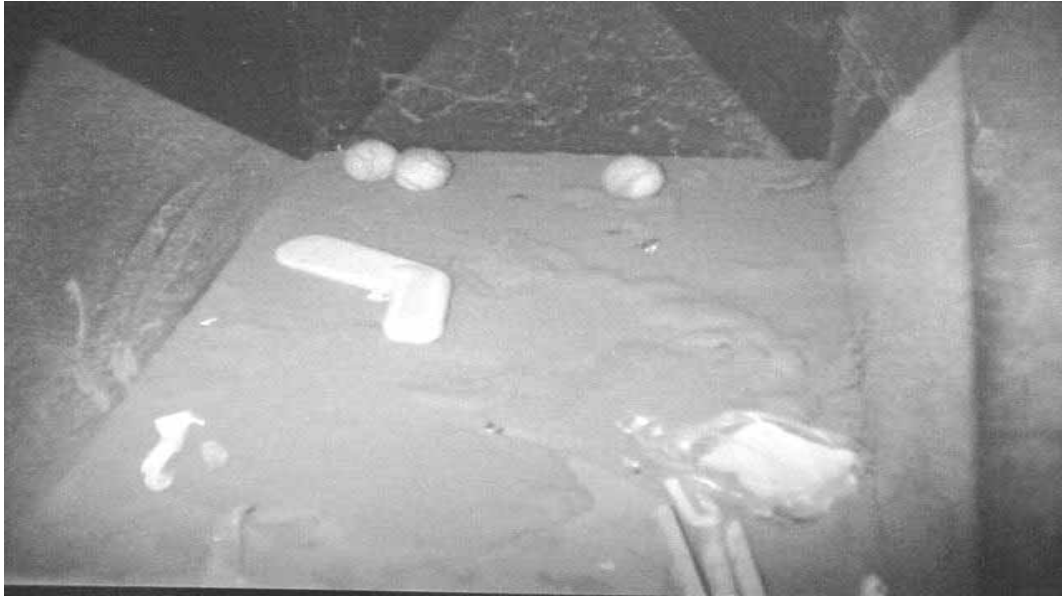
Picture 8

**Accumulated Dirt, Dust and Debris Noted in Inactive Gymnasium Exhaust Vent
Picture Taken through Damaged Exhaust Grille (see above)**

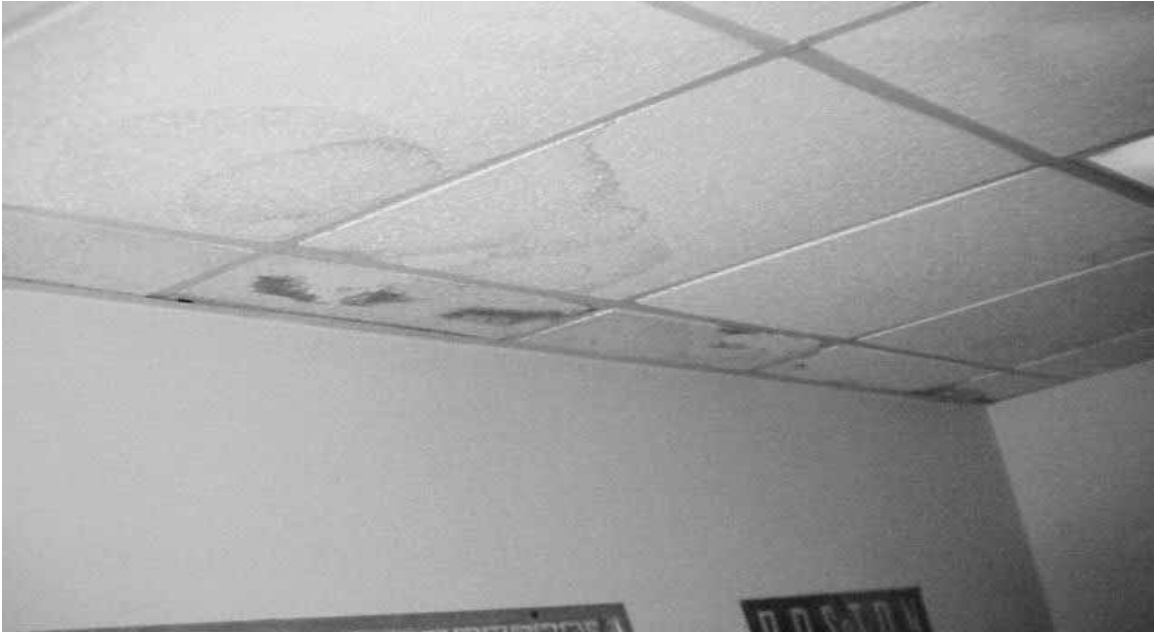
Picture 9

A number of classrooms have water-damaged ceiling tiles which can indicate leaks from either the roof or plumbing system (see Picture 9). Water-damaged tiles can

provide a medium for mold and mildew growth and should be replaced after a water leak is discovered and repaired.

Water-Damaged Ceiling Tiles Noted in Classroom

10. Repair any water leaks and replace any water-stained wall and ceiling tiles.
Examine the area above and behind these tiles for mold growth. Disinfect areas of water leaks with an appropriate antimicrobial where necessary.

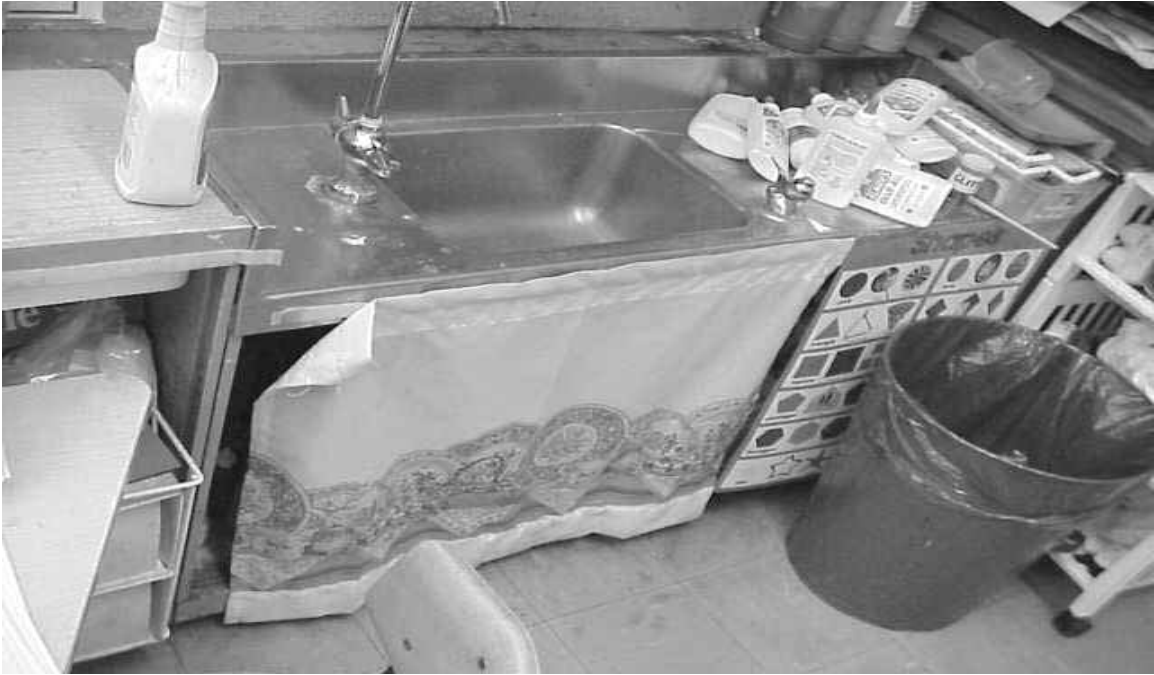
Picture 10

A number of other conditions that can potentially affect indoor air quality were identified at the time of the assessment. Cleaning products and flammable materials were found on countertops and underneath sinks in a number of classrooms. Many of the sinks had cabinet doors open or were missing doors entirely (see Picture 10), allowing easy student access. Cleaning products and flammables contain chemicals such as volatile organic compounds (VOCs), which can be irritating to the eyes, nose and throat. These materials should be stored properly and kept out of reach of students.

**Classroom Cabinet Containing Cleaning Products and Flammable Material
Note Missing Door on Cabinet**

15. Properly store chemicals and cleaning products and keep out of the reach of students. Consider replacing cabinets or installing lockable doors on existing cabinets.

16. Store flammable materials in flameproof cabinets consistent with local and state fire codes.
17. Consider installing local exhaust ventilation in the mailroom to help reduce odors, pollutants and excess heat.

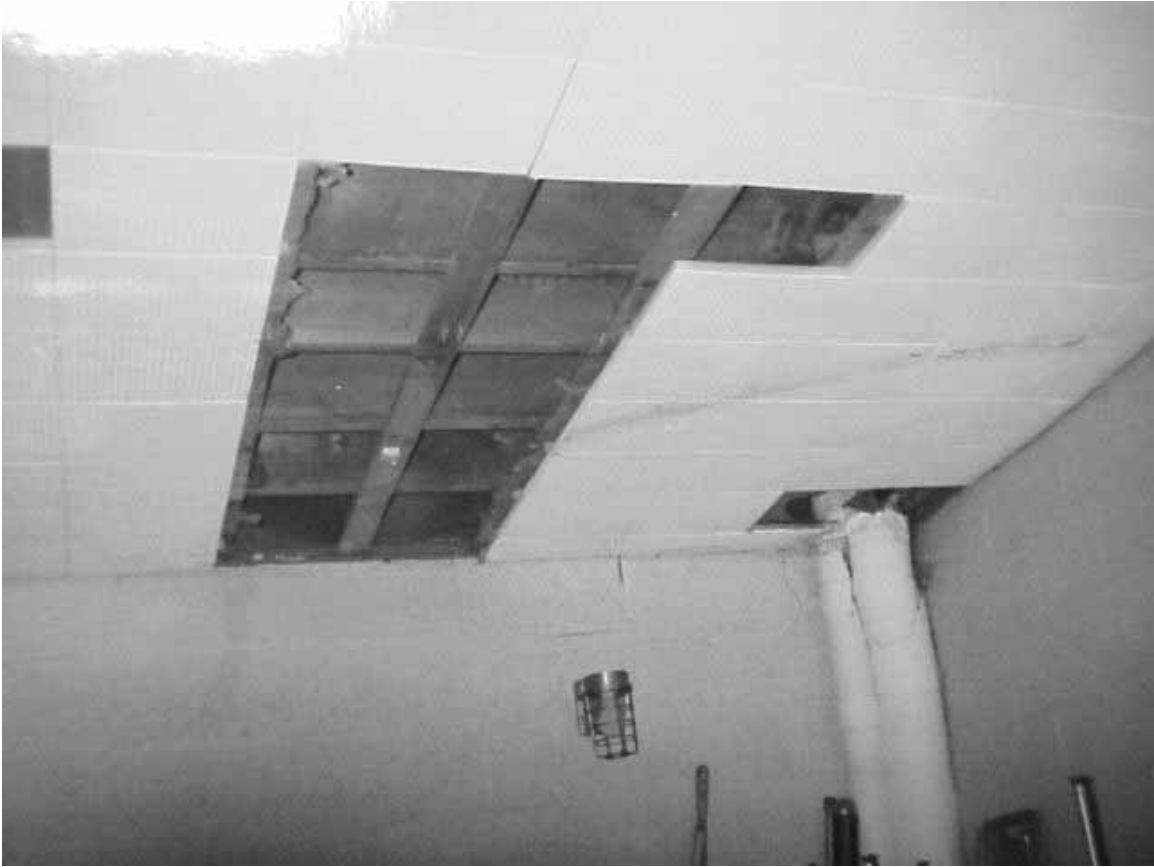
Picture 11

Missing Ceiling Tiles Noted behind Stage in Occupational Therapy Area

19. Change/clean filters for window-mounted air conditioners and portable air purifiers as per the manufacturer's instructions to prevent the re-aerosolization of dirt, dust and particulate matter.
20. Clean chalk boards and chalk trays regularly to avoid the excessive build-up of chalk dust.
21. Replace missing ceiling tiles in occupational therapy area.
