The Commonwealth of Massachusetts
Executive Office of Health and Human Services
Department of Public Health
Bureau of Environmental Health Assessment
250 Washington Street, Boston, MA 02108-4619

February 22, 2000

At your request, the Bureau of Environmental Health Assessment (BEHA) conducted an evaluation of the indoor air quality at the Hanover Middle School on February 4, 2000. Michael Feeney, Chief of Emergency Response/Indoor Air Quality (ER/IAQ), BEHA, conducted this inspection. Concerns about pollutants generated by renovation efforts and the potential impact on occupied classrooms in this building prompted this request.

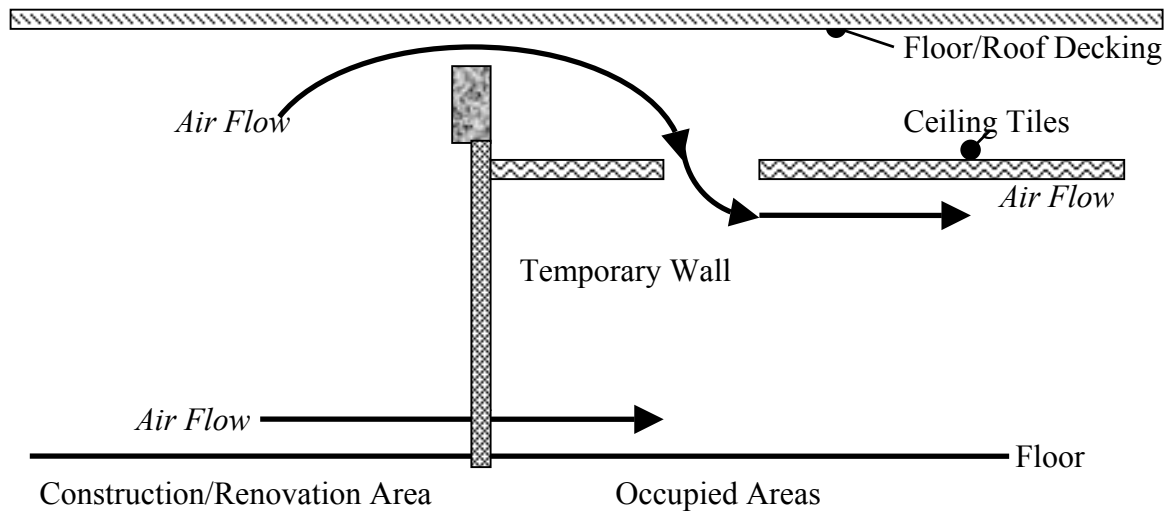
Figure 1

Ceiling tiles in the hallway have been removed on the occupied side of the temporary wall as part of the renovations. None of the open spaces created by the lack of ceiling tiles have been sealed to prevent air movement above the ceiling tiles (see Figure 1). Dust and debris can move with drafts from the unoccupied construction section to occupied areas.

8. Seal utility holes, spaces in roof decking and temporary walls to eliminate pollutant paths of migration. Seal holes created by missing tiles in ceiling temporarily to prevent renovation pollutant migration.

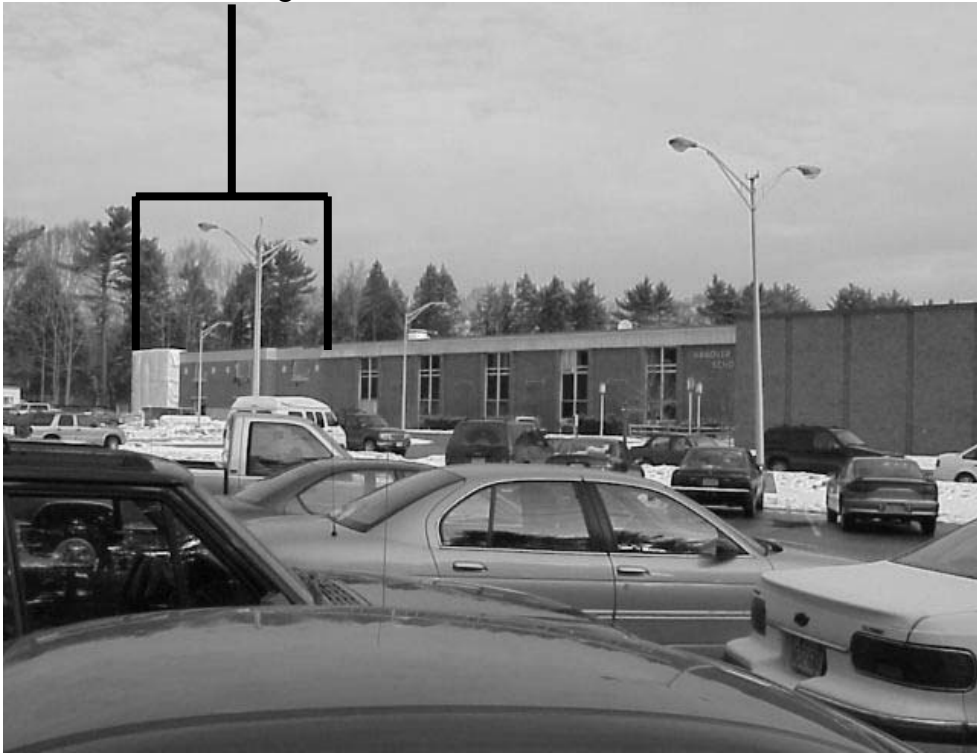
Picture 1

The school is currently under renovation while occupied by students, teachers and school staff. The planned renovations are to the gymnasium and the addition of a wing at the north end of the building (see Picture 1) as well as renovations to a former shop area in the south end of the building. During the assessment, a paint odor was noted in the second floor hallway in close proximity to renovation work. A building committee member confirmed that contractors were applying paint to doors in the new wing during the assessment. In addition, paint odors were also detected on the roof at the junction between the old building and the new wing.

New Wing Added To North Wall Of School

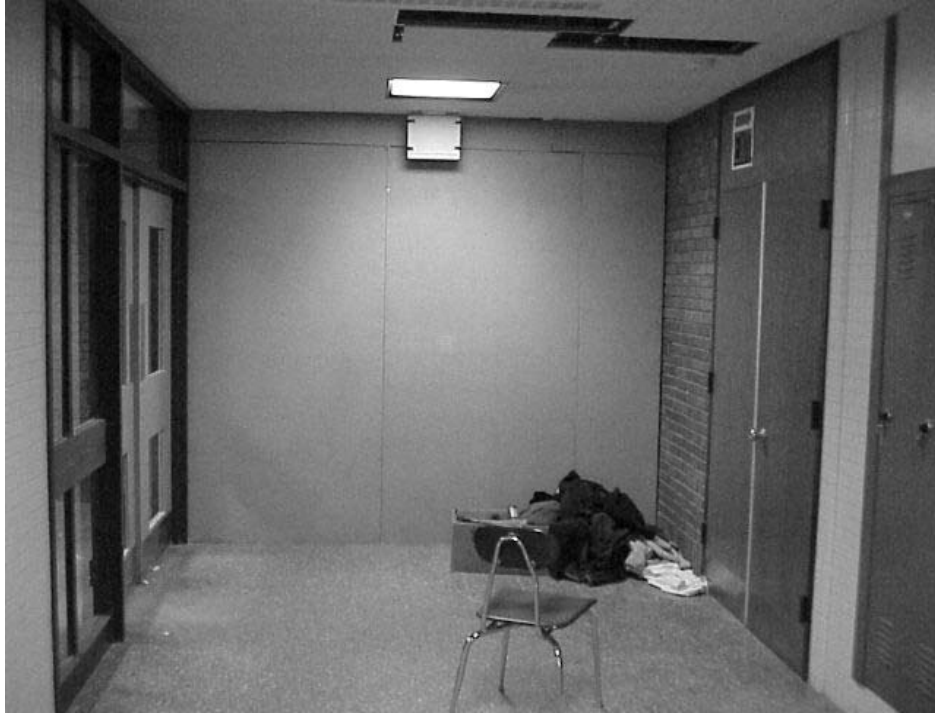
Picture 2

Spaces in the temporary wall were observed. It is important to note that pollutants from renovation work could travel (see Pictures 2 and 3) through these spaces. Above the ceiling, spaces also exist between the decking and interior wall (see Picture 4) as well as in the shared old building/new wing wall where utility holes pass (see Picture 5). The light noted above the ceiling in Picture 4 indicates that no barrier exists to prevent odor migration.

Temporary Wall Sealing Renovations From Occupied Area Of School

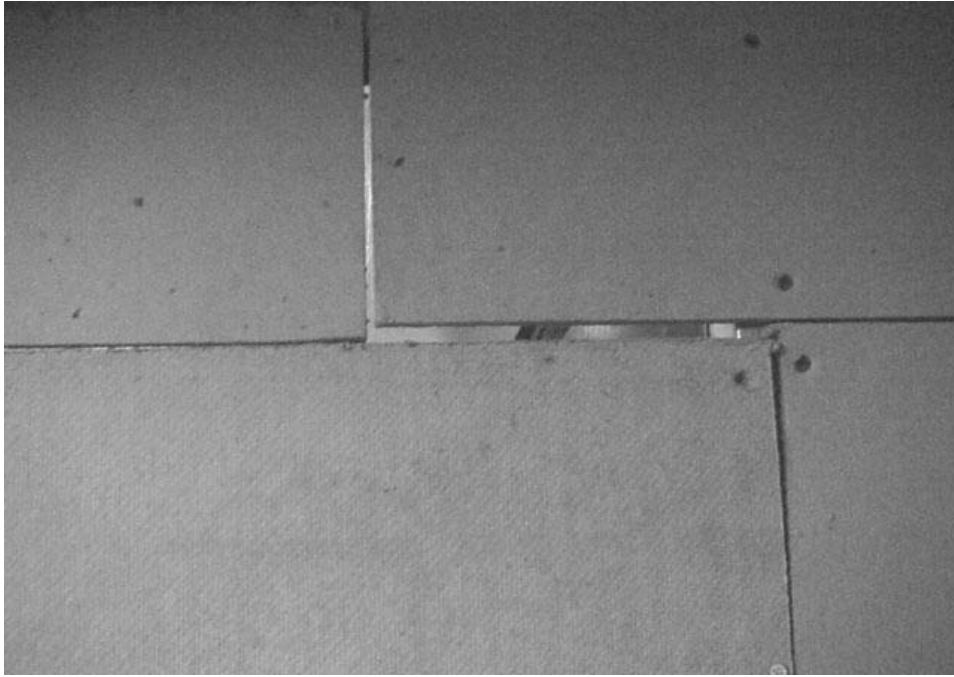
Picture 3

Spaces In Temporary Wall That Are Not Sealed

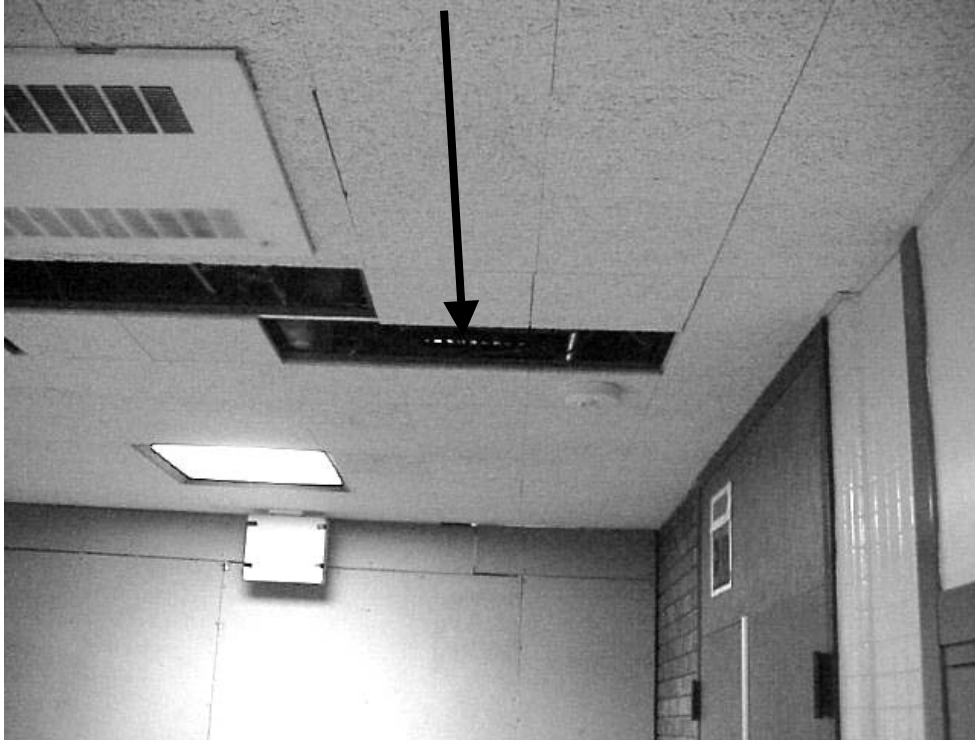
Picture 4

Spaces In Decking And Interior Wall, Note Light Above Ceiling Tiles

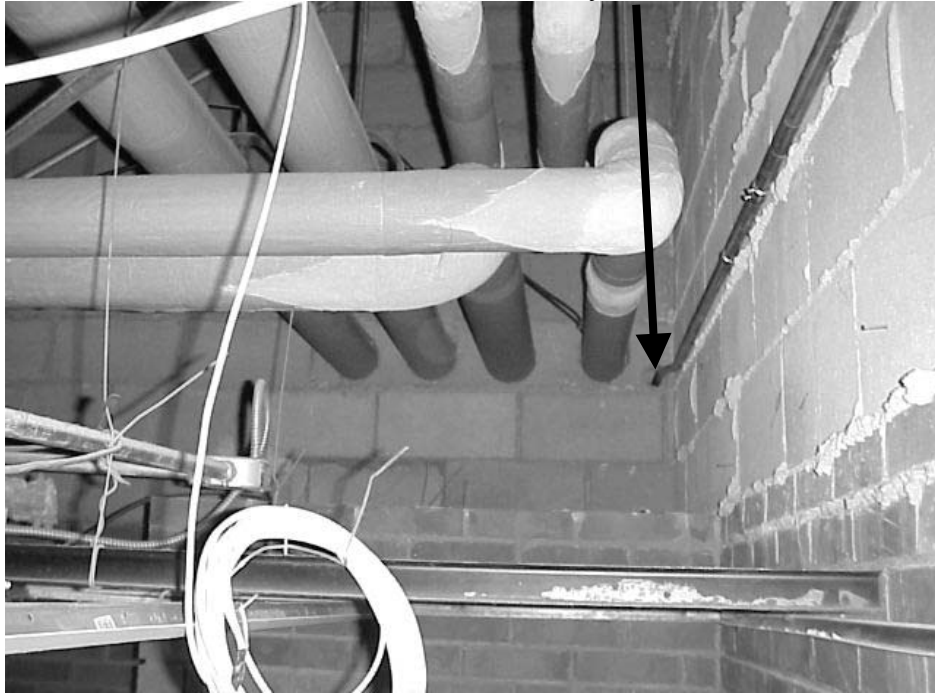
Picture 5

Utility Holes In Wall Through Which Odors May Pass

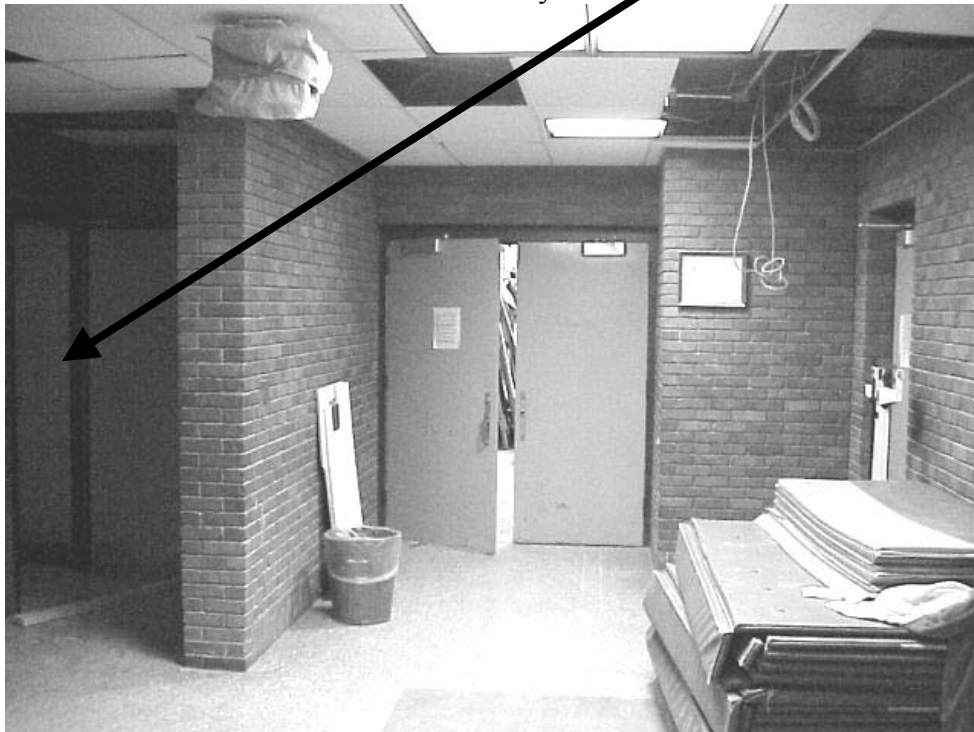
Picture 6

Access to the renovation area near the gymnasium can be gained through a hallway door (see Picture 6) and locker room door (see Picture 7). Access to the former shop area can be gained through a hallway door (see Picture 8). In each of these instances, areas of access were not sealed to prevent the migration of pollutants from the newly constructed wing into occupied areas of the school.

**Hallway Door To Gymnasium Under Renovations Left Ajar,
Note No Containment**

9. Seal hallway doors with polyethylene plastic and duct tape. Consider creating an air lock of a second door inside the renovation space to reduce migration.

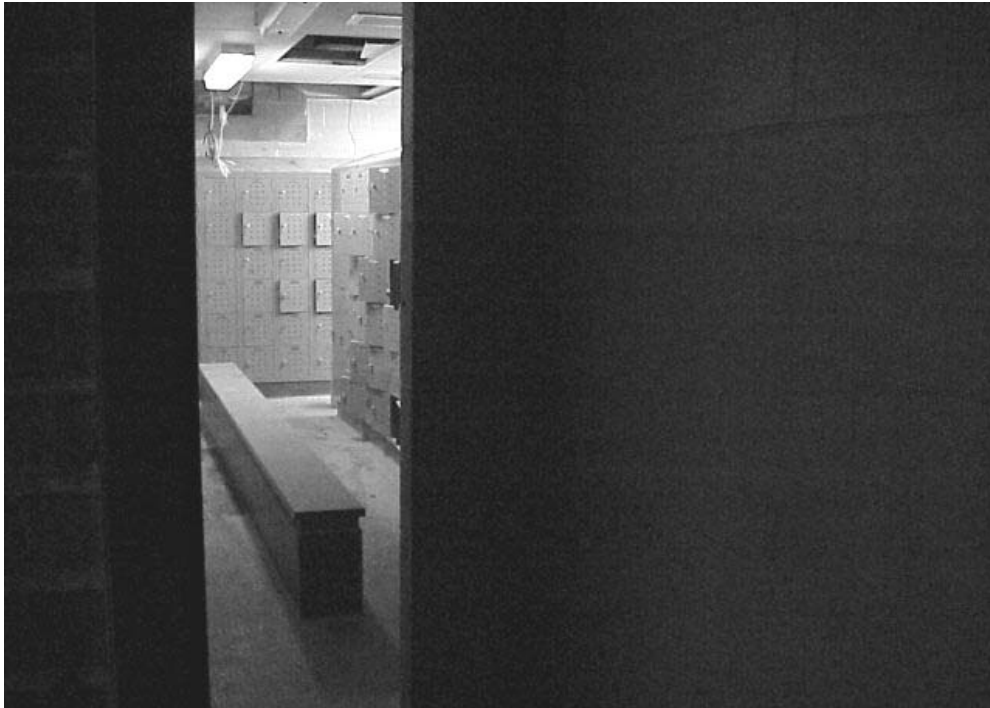
Picture 7

Hallway Door To Locker Room Under Renovation, Note No Containment

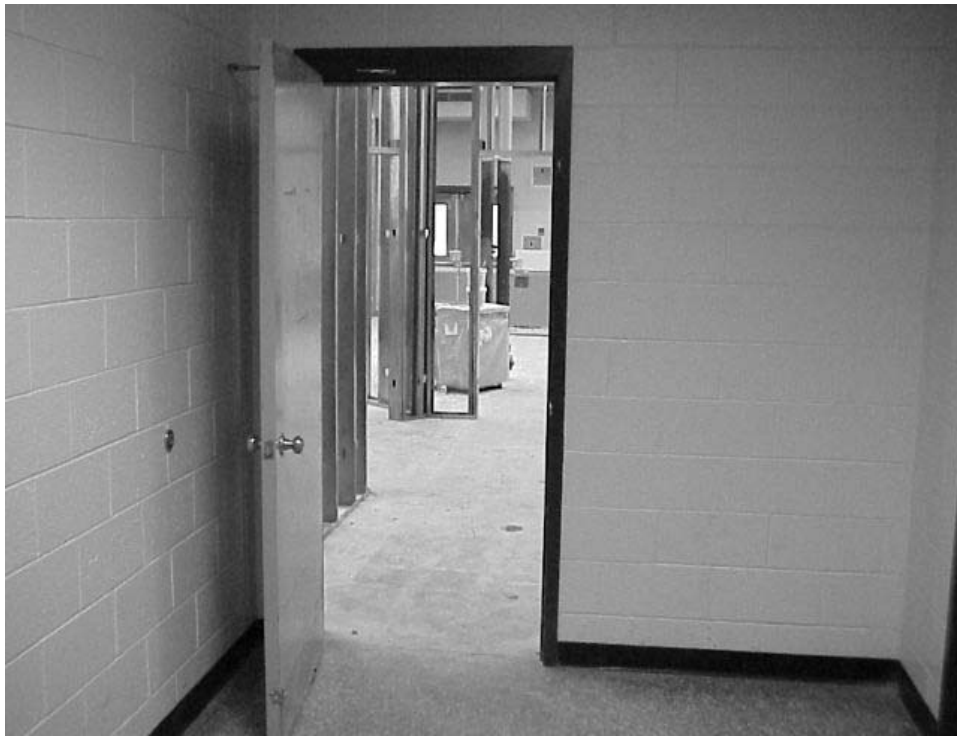
Picture 8

Hallway Door To Former Wood Shop With No Containment

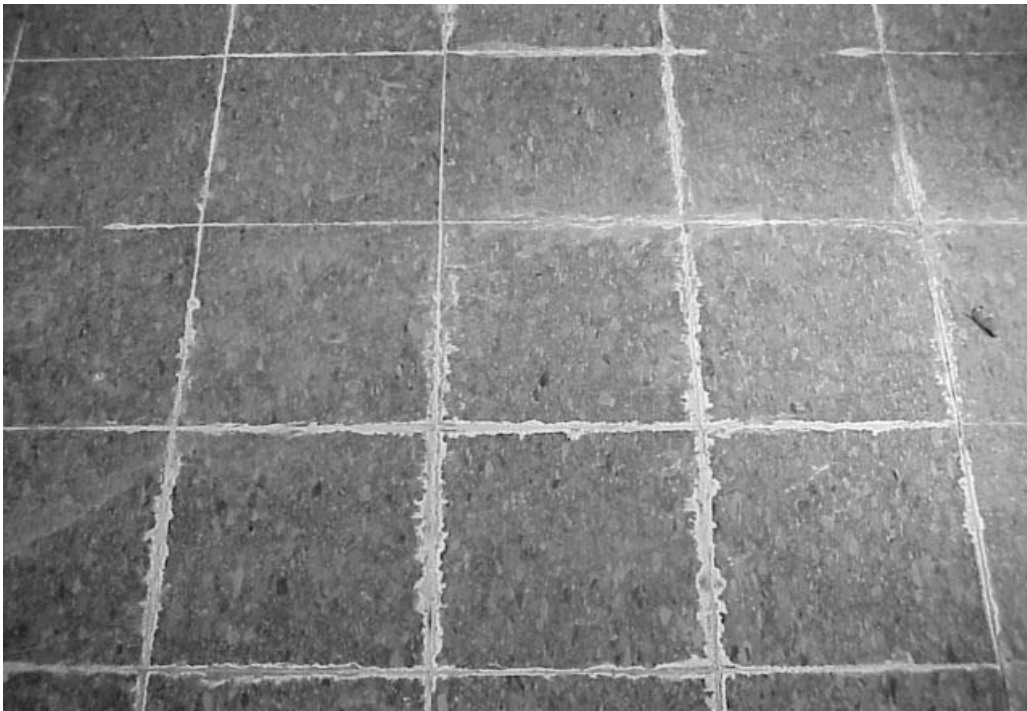
Picture 9

In addition to pollutants caused by renovation, there are several signs of the existence of mold growth in the school that may be attributable to the introduction of moisture into the building by the heating, ventilating and air conditioning (HVAC) system during warm months. A musty odor was detected in the main office of the school, which may indicate mold growth. In addition, signs of moisture accumulation (see Picture 9) were noted in the seams of hallway floor tiles. This type of water damage may occur by the introduction of moist air into this building through the non-air-conditioned exterior classroom windows and unit ventilators into areas that may be chilled by the air-conditioning system in the central core classrooms. If moisture was introduced into this building, mold growth in porous materials (such as carpeting and ceiling tiles) could result from repeated wetting by condensation. If this is the case, the plan to contract an environmental consulting firm to test for the presence of mold in this building is appropriate.

Signs of Dried Moisture in Hallway Floor Tiles near Gymnasium Locker Room

12. Consider continuing with the plan to contract with an environmental consultant to conduct mold tests in the school.
