INDOOR AIR QUALITY ASSESSMENT

**Sandwich High School
365 Quaker Mtg. House Road
E. Sandwich, Massachusetts**

Prepared by:
Massachusetts Department of Public Health
Bureau of Environmental Health Assessment
March, 2000

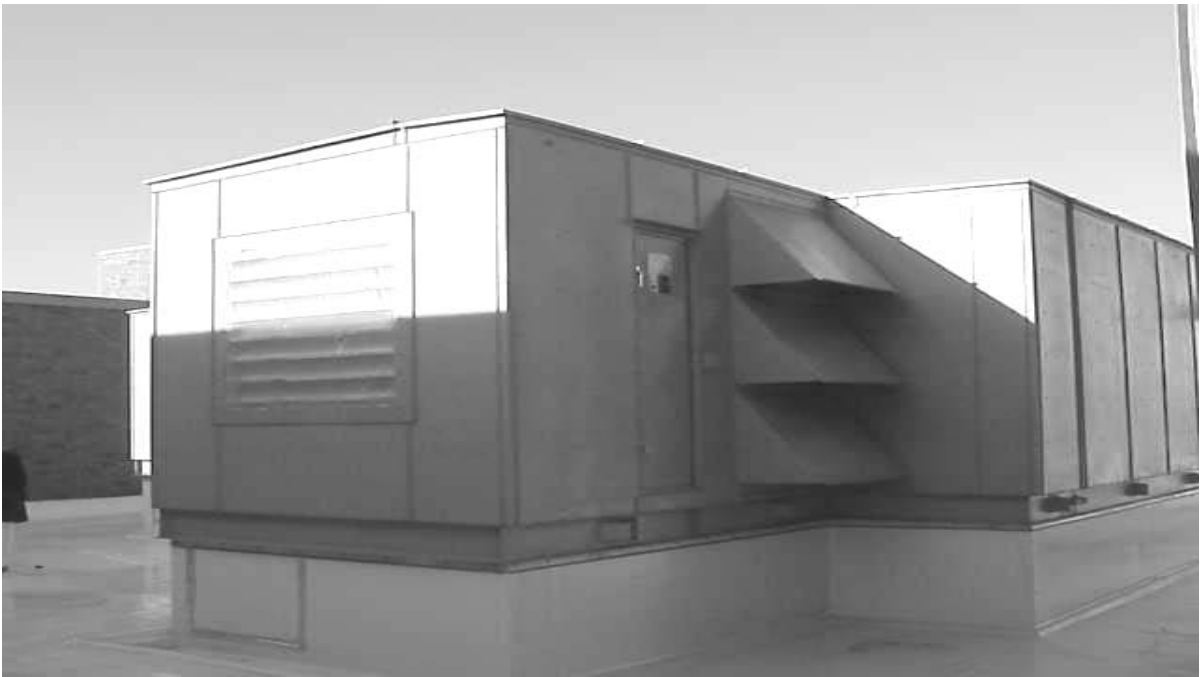
Picture 1

The new addition at SHS has a centralized HVAC system consisting of two roof-mounted air-handling units (AHUs), one used for heating and one for cooling (see Picture 1). Fresh heated or cooled air is provided by the AHUs to classrooms and common areas via ceiling-mounted air diffusers connected to ductwork. According to Mr. McDonald, the AHUs are set to provide 30 percent fresh air. Each classroom is provided with a return vent connected to ductwork back to the AHU. In addition, each classroom has two fan-coil units mounted on the exterior wall that facilitate airflow. A high-pitched noise in the rooftop ventilation system was reported by an occupant of room A312, which may indicate a mechanical problem or malfunction.

Air-Handling Unit for the New Addition, Sandwich H.S.

1. Continue with plans to calibrate and balance the HVAC system in the new addition. Consider increasing the percentage of fresh air intake.
2. Until existing AHUs servicing the old building are replaced, consider contacting an HVAC engineer to examine the fresh air intakes for repair and increase the percentage of fresh air intake if possible.
3. Remove all obstructions from fan-coil unit air diffusers and return vents to facilitate airflow.

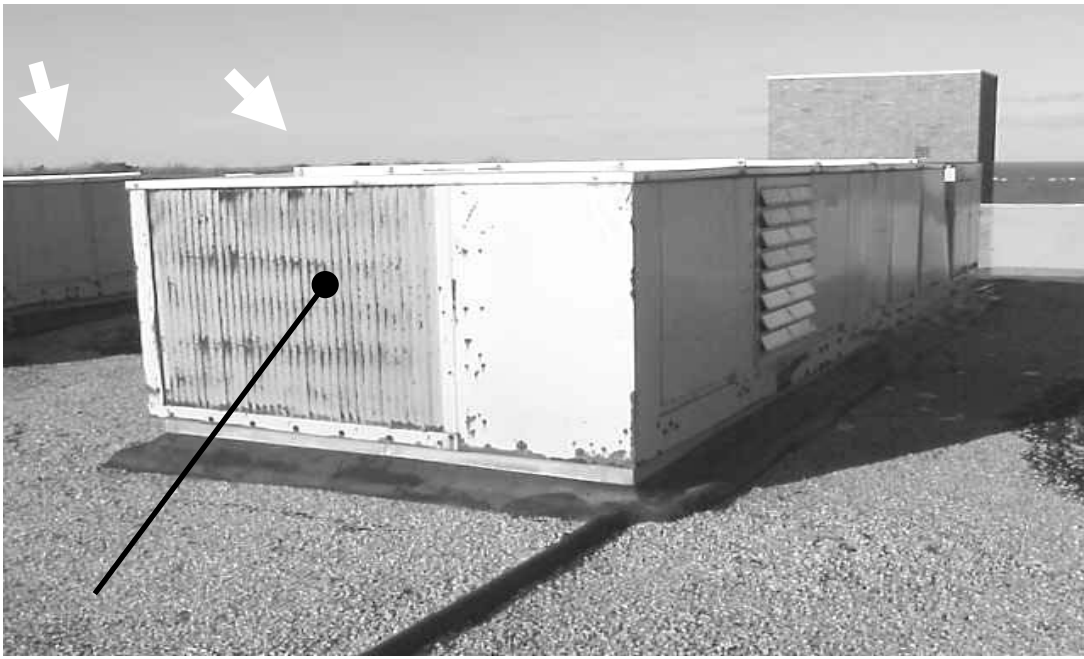
Picture 2

Elevated carbon dioxide levels were found in all second floor classrooms tested in the old wing. BEHA staff examined rooftop AHUs providing ventilation to this area and found the fresh air intakes closed (see Picture 2). According to several school sources, on extremely cold days members of the school maintenance staff physically close fresh air intakes on the units to conserve heat. Reportedly, when fresh air intakes are left open this area experiences numerous complaints of cold temperatures. Each classroom is also provided with a return vent that is ducted back to the AHU. These AHUs are tentatively scheduled for replacement during subsequent phases of the renovation.

fresh air intake noted shut

Air-Handling Units (AHUs) for the Old Building, Sandwich H.S. Scheduled for Replacement Spring 2,000

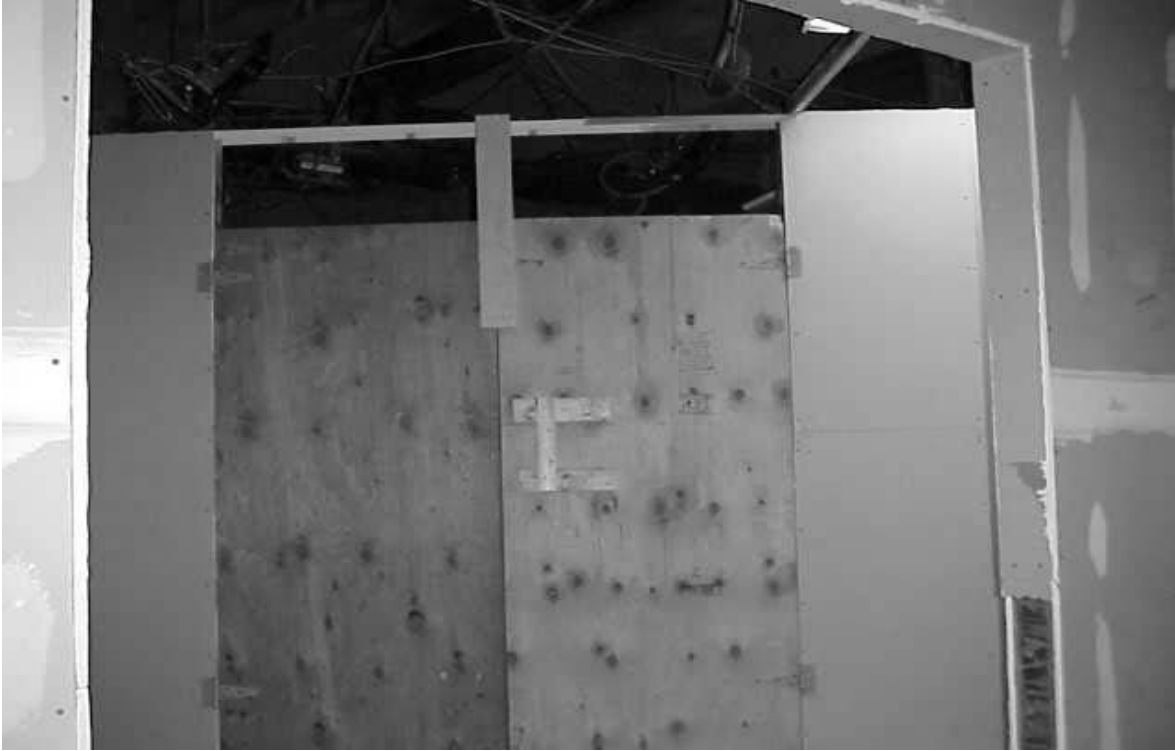
Picture 3

While containment walls have been erected in several areas, the sealing of these areas was not complete (see Pictures 3 & 4). BEHA staff recommended the installation of plastic sheeting on both sheet-rock barriers separating the construction zone from occupied areas on the first and second floors of D-wing. These barriers should be made as airtight as possible to prevent the migration of construction-generated dusts and odors into occupied

areas recommended to be sealed with plastic

**Containment Barrier Separating Construction Zone from Occupied Areas
Note Removed Ceiling Tiles and Spaces above Containment Wall**

areas. BEHA staff also recommended that weather-stripping or foam insulation be installed to seal spaces around containment wall access doors. Other precautions would be to close internal doors inside the construction zone (see Picture 5) and/or the strategic placement of fans to direct renovation pollutants away from occupied areas. Also located in the construction zone on the second floor was a door providing entry into the auditorium (see Picture 6). BEHA staff recommended that the door be sealed on both the construction side as well as the auditorium side with plastic sheeting and duct tape to provide a dual barrier. In all of these cases, the complete sealing of construction barriers, the closing of internal doors and the placement of fans in renovation areas should be done to prevent construction-related pollutants from penetrating into occupied areas.

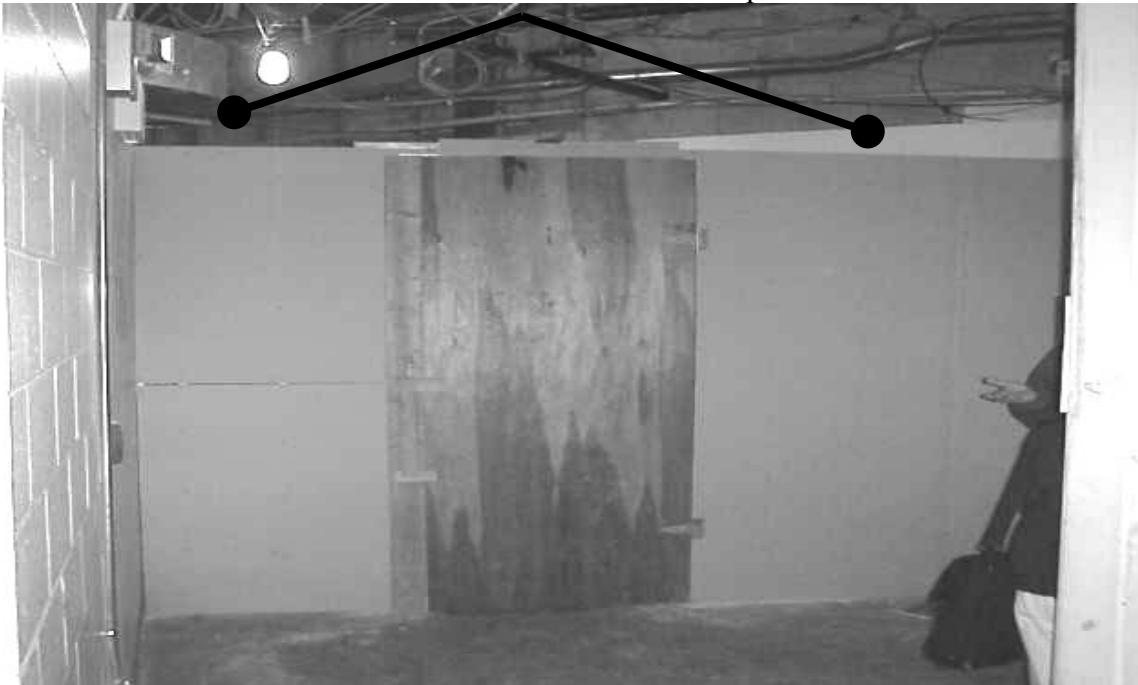
Picture 4

area recommended to be sealed with plastic

**Containment Barrier Separating Construction Zone from Occupied Areas
Note Removed Ceiling Tiles and Spaces above Containment Wall**

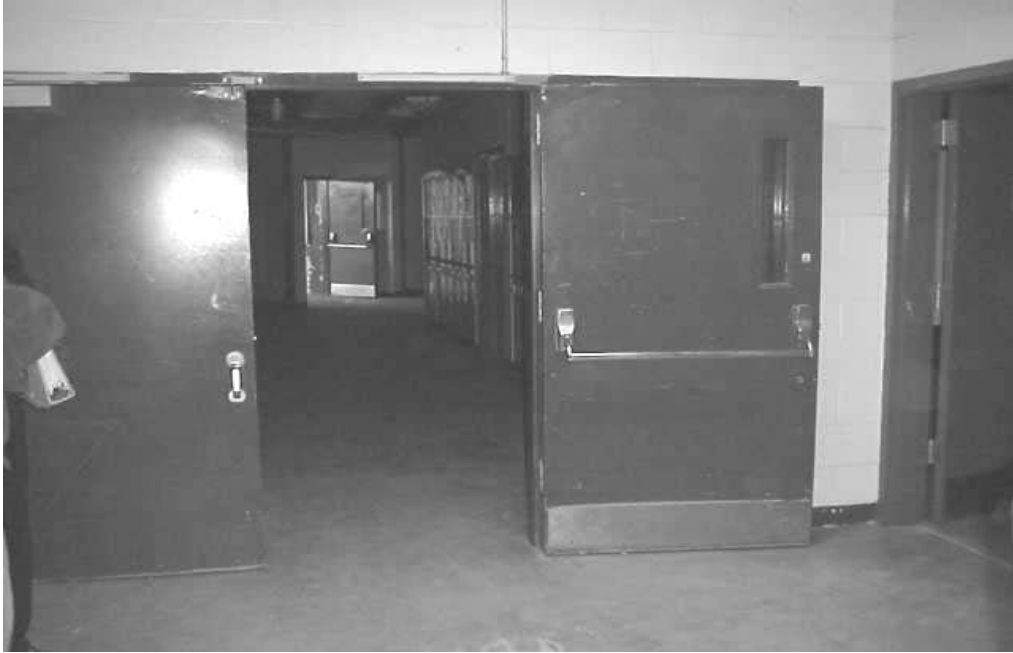
Picture 5

Interior Doors Located In Construction Zone

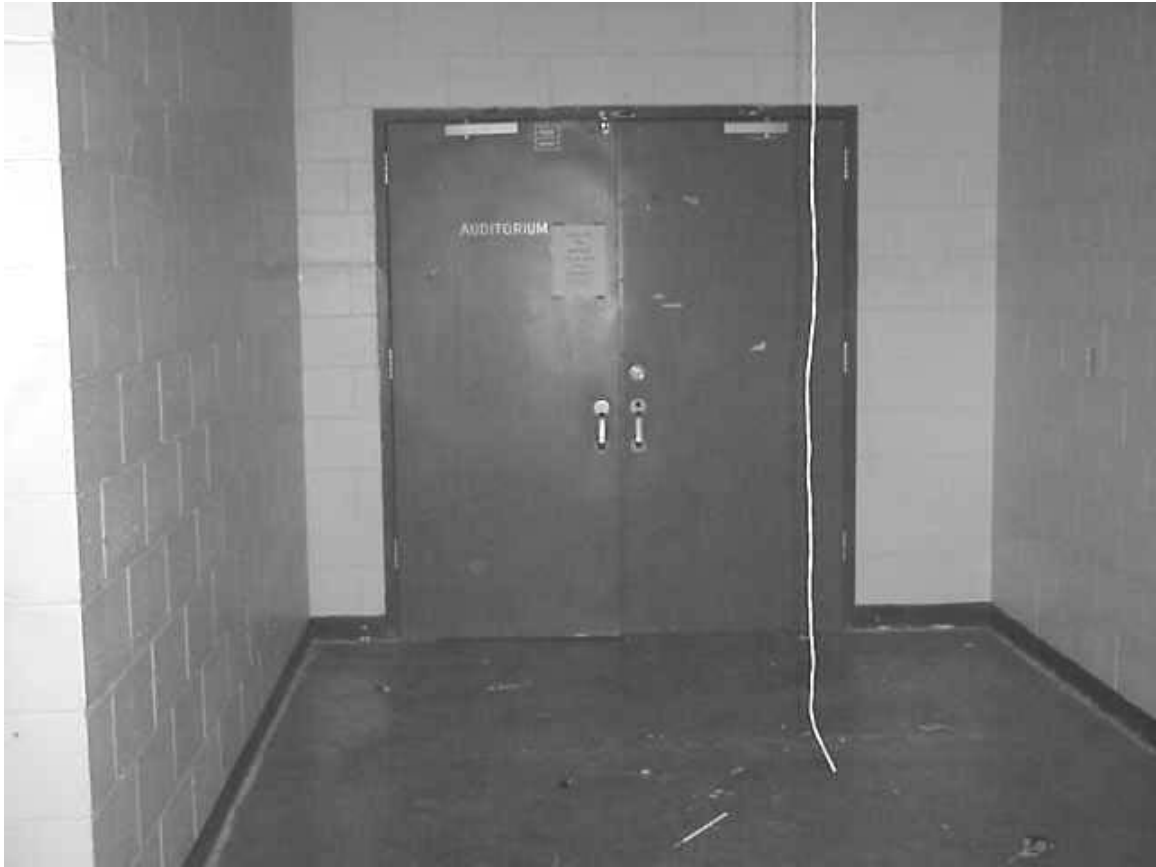
Picture 6

Auditorium Doors Noted in Construction Zone on 2nd Floor of D-wing
