INDOOR AIR QUALITY REASSESSMENT

**Wilbraham Middle School
Hampden-Wilbraham School District
Stony Hill Road
Wilbraham, Massachusetts**

Prepared by:
Massachusetts Department of Public Health
Bureau of Environmental Health Assessment
March, 2000

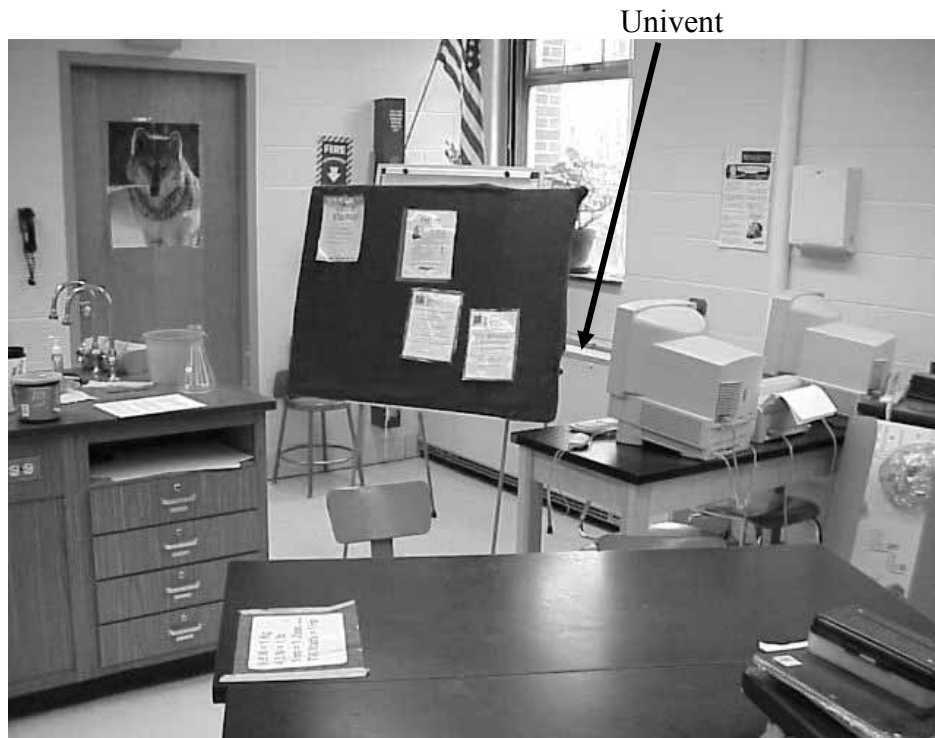
1. All univents were repaired and functioning.
2. Most exhaust vents in the building were functioning.
3. Blockages of airflow to univents (see Picture 1 for an example) and univent exhaust vents (see Picture 2 for an example) continue to exist in classrooms.

Univent Blocked with Free-Standing Bulletin Board

3. As noted in our previous report, all blockages from univents and exhaust ventilators must be removed to ensure adequate airflow.
4. In order to increase thermal comfort, move teachers' desks away from the air stream of HVAC equipment.

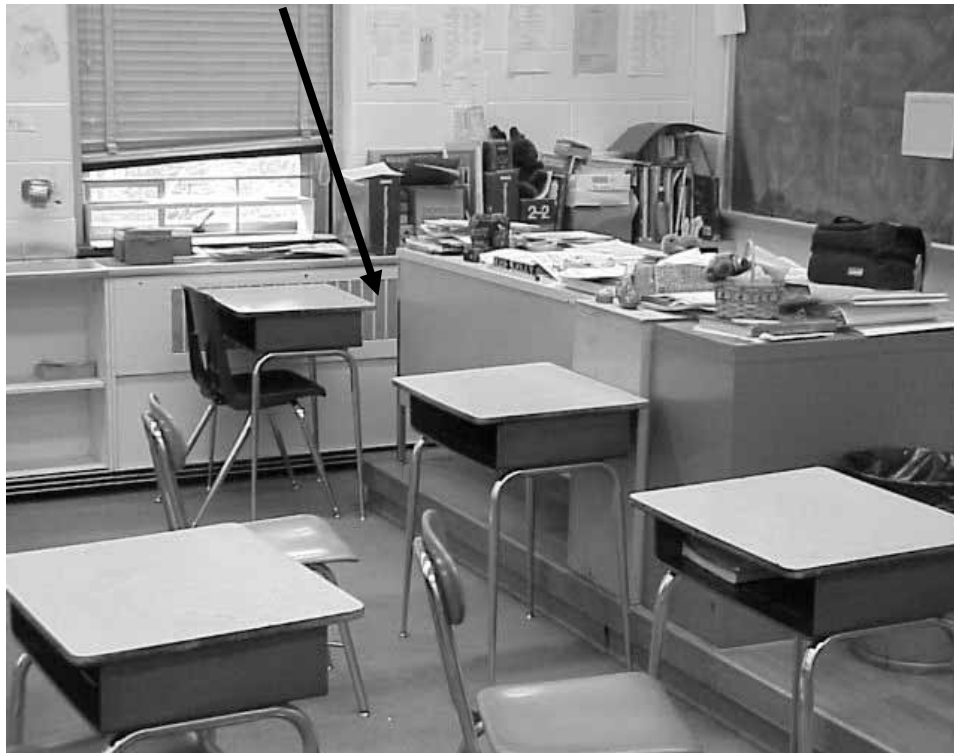
Picture 2

Return Vent of Unit Exhaust Ventilator Blocked with Student Desk

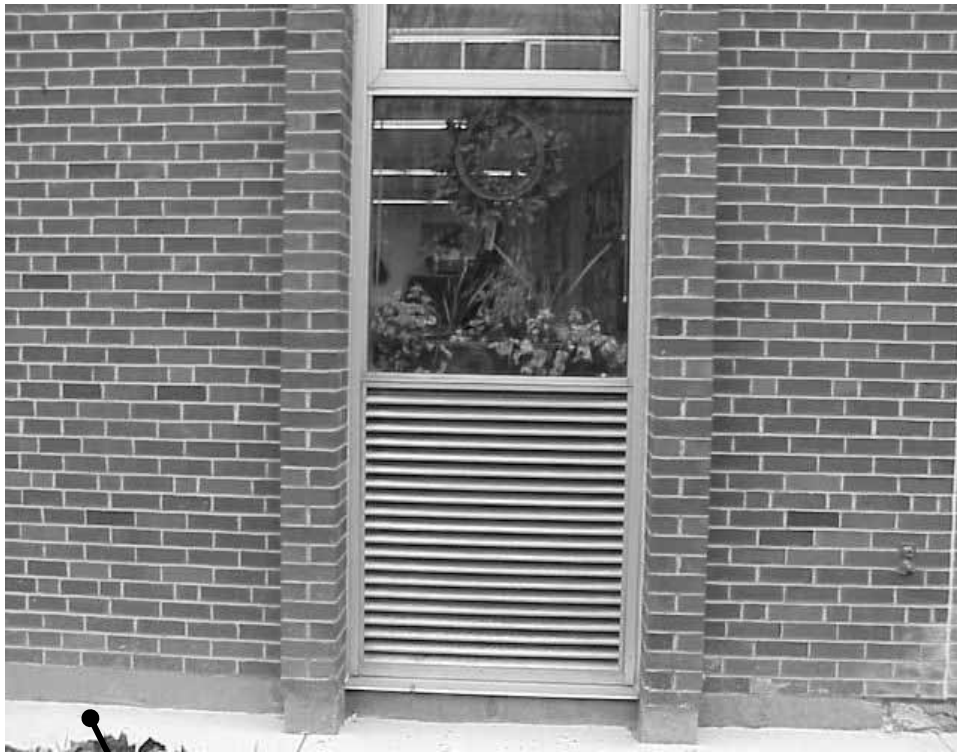
Picture 3

4. A concrete pad and drain system was installed beneath the concrete platforms and around the perimeter of the building to draw pooling water away from the base of the building (see Pictures 3 and 3A).

Concrete Pad Installed around the Perimeter of the Lower Wing

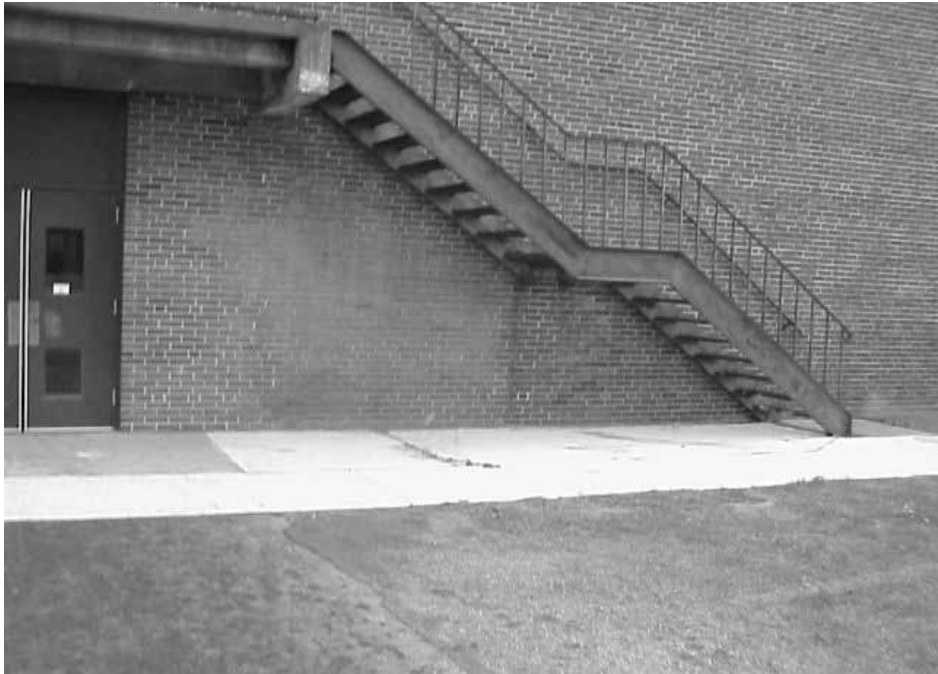
Picture 3A

Concrete Pad Installed beneath the Concrete Platform

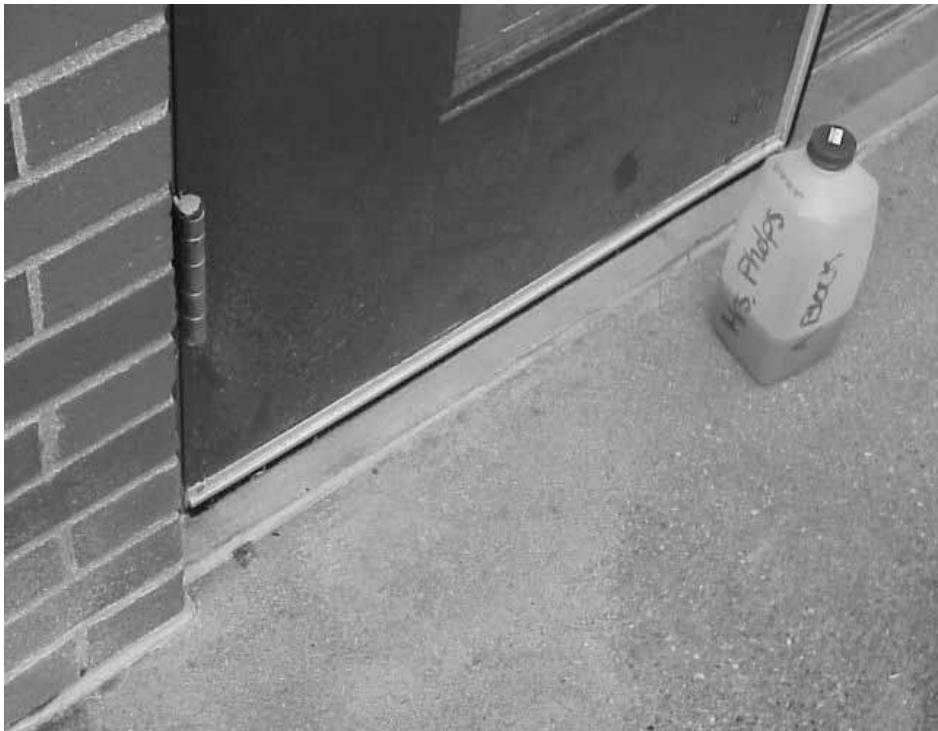
Picture 4

5. Work orders to rebuild the thresholds of the fire escape were commissioned. A caulking material was installed along the concrete slab and exterior wall junction (see Picture 4). A waterproofing compound was applied to the exterior of the brick wall.

Sealant Applied To Door Threshold, Concrete Slab and Exterior Wall Junction

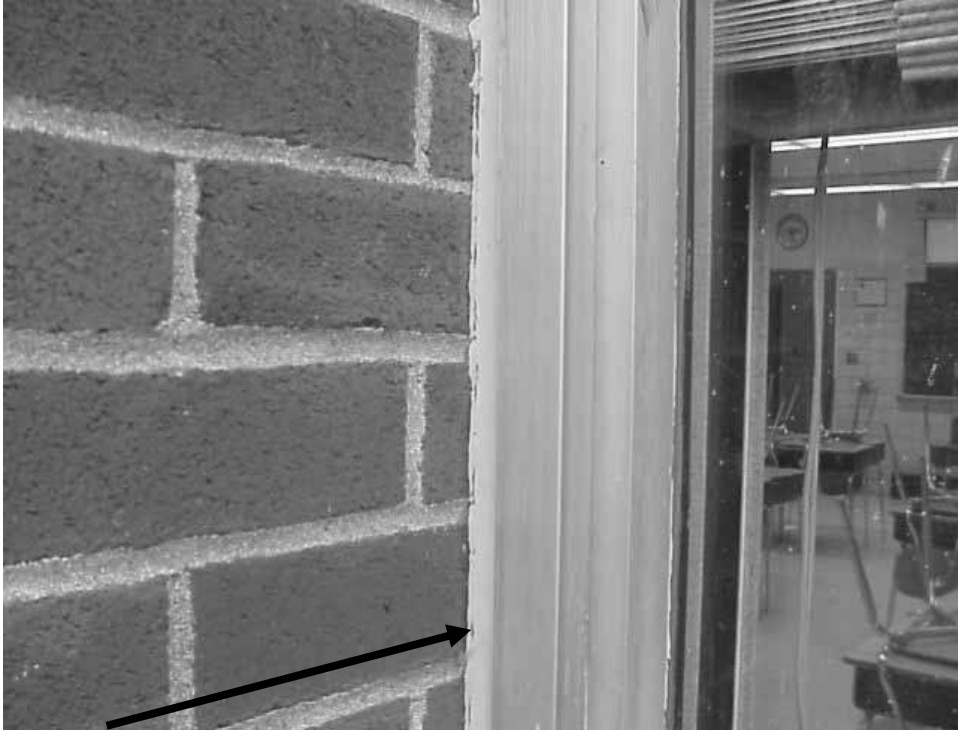
Picture 5

8. The exterior of window systems throughout the school was sealed with a sealing compound (see Pictures 5 and 6).
9. Front hallway windows were repaired.

Example of Caulking Applied to Exterior Wall/Window Frame Seam

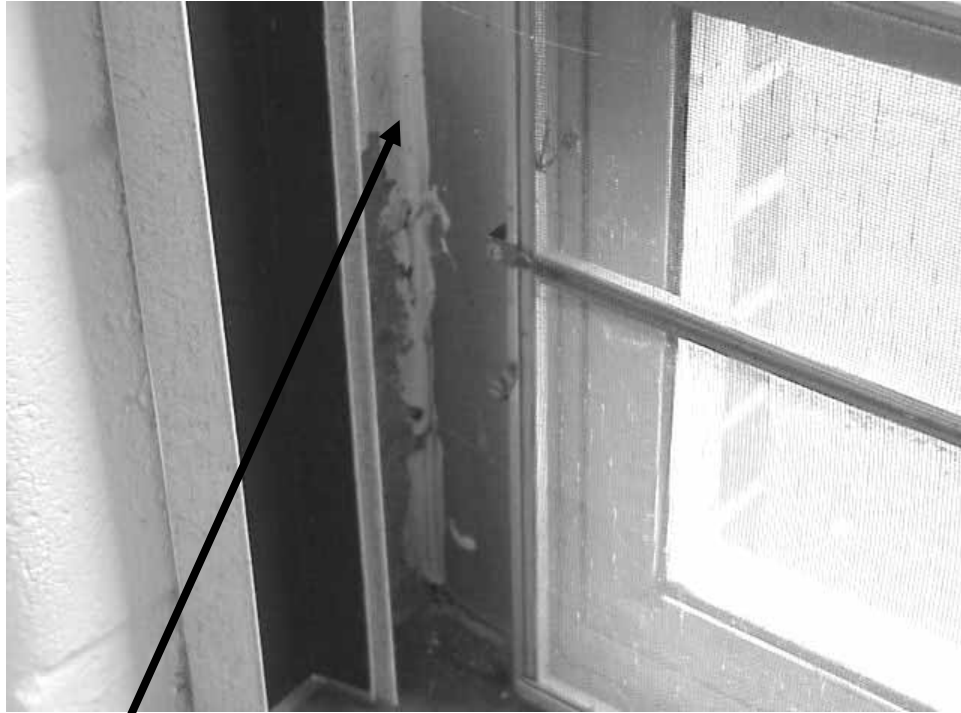
Picture 6

Example of Caulking Applied to Interior Wall/Window Frame Seam

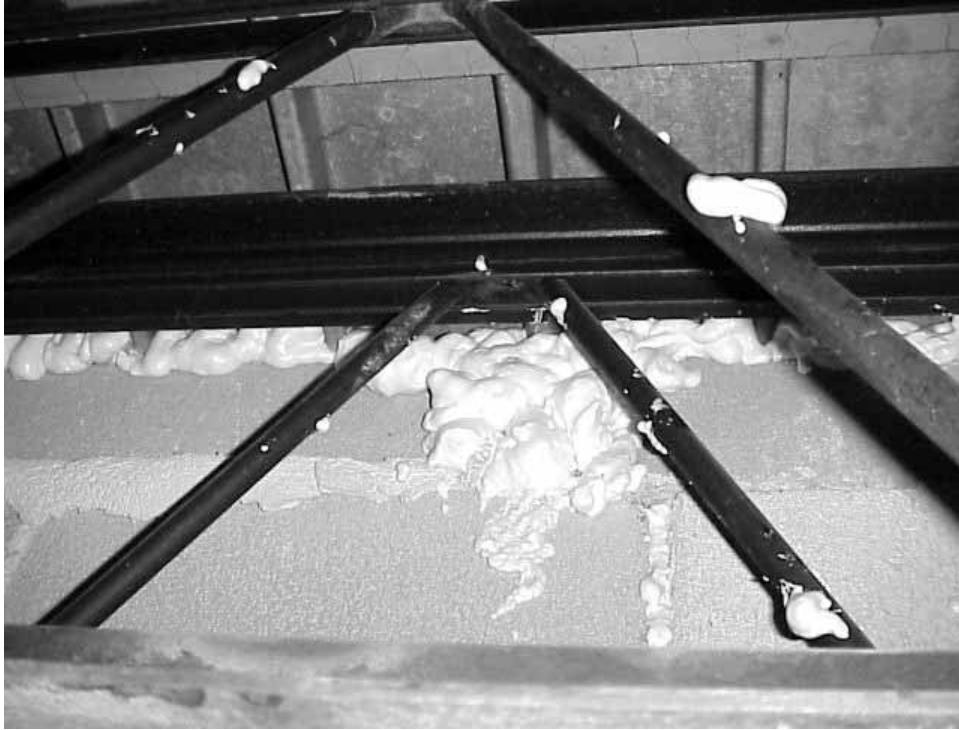
Picture 7

12. The interior wall/roof-decking joint above the art room ceiling was sealed with a foam material to prevent migration of odors from the boiler room (see Picture 7).
13. Shrubbery was removed from the fresh air intake for classroom 6 (formerly classroom 15) (see Picture 8). The vanes of the fresh air intake need to be cleaned with an appropriate antimicrobial.
14. The thermostat controlling the main room of the library was moved from the back office to the main room. Occupants report improved temperature control in the main room of the library.
15. Plants remain above univents in a number of classrooms. These plants should be removed from the close proximity of univents to prevent the aerosolization of particulates.
16. Chemicals were removed from the school.
17. No flammable materials were noted stored outside flameproof cabinets.

Foam Sealant Applied to Roof Decking/Wall Junction of Shared Wall of Art Room and Boiler Room

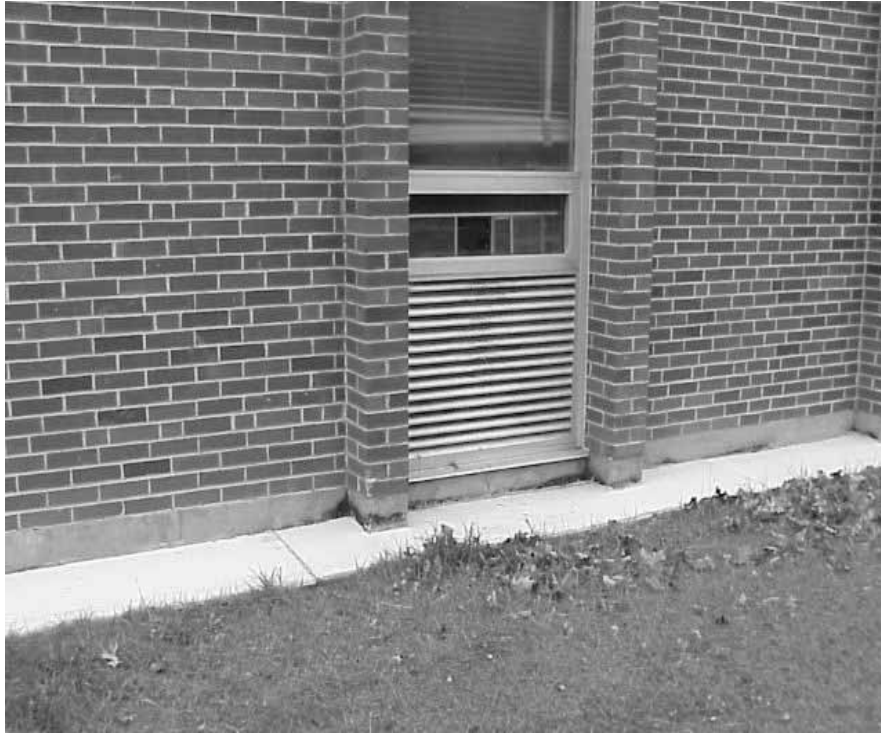
Picture 8

As recommended, shrubbery around the fresh air intake of classroom 6 (formerly 15) was removed. In order to ascertain the condition of fresh air intakes, the fresh air intake grille (see Picture 14) was removed. The interior of this vent contained leaves, dirt and other normal outdoor debris (see Picture 15). No unusual contamination was noted on the inside of this univent. Univents are equipped with filters that strain particulates from airflow. In order to decrease aerosolized particulates, disposable filters with an increased dust spot efficiency can be installed in univents. The dust spot efficiency is the ability of a filter to remove particulates of a certain diameter from air passing through the filter. Filters that have been determined by ASHRAE to meet its standard for dust spot efficiency of a minimum of 40 percent would be sufficient to reduce airborne particulates (ASHRAE, 1989). Note that increased filtration can reduce airflow produced by the univent by increasing resistance. Prior to any increase of filtration, each univent should be evaluated by a ventilation engineer as to whether the univent can maintain function with more efficient filters.

Shrubbery Was Removed From The Fresh Air Intake For Classroom 6 (Formerly Classroom 15)

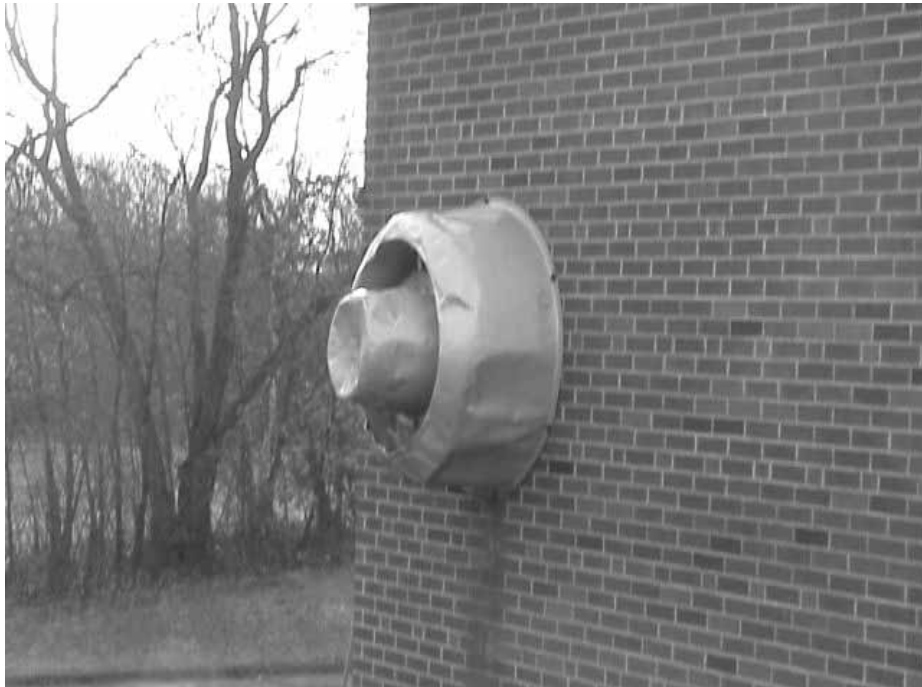
Picture 9

As reported by Wilbraham School Department officials, the exhaust vent for the large gymnasium is inoperable. The exterior casing of the exhaust vent appears to be heavily vandalized (see Picture 9). The exhaust vent is located on the gymnasium's exterior wall, over twenty feet off the ground. It is planned to have this vent repaired.

Vandalized Gymnasium Exhaust Vent Cover

9. Continue with plans to repair the large gymnasium exhaust vent.
10. Seal abandoned drains in science classrooms.

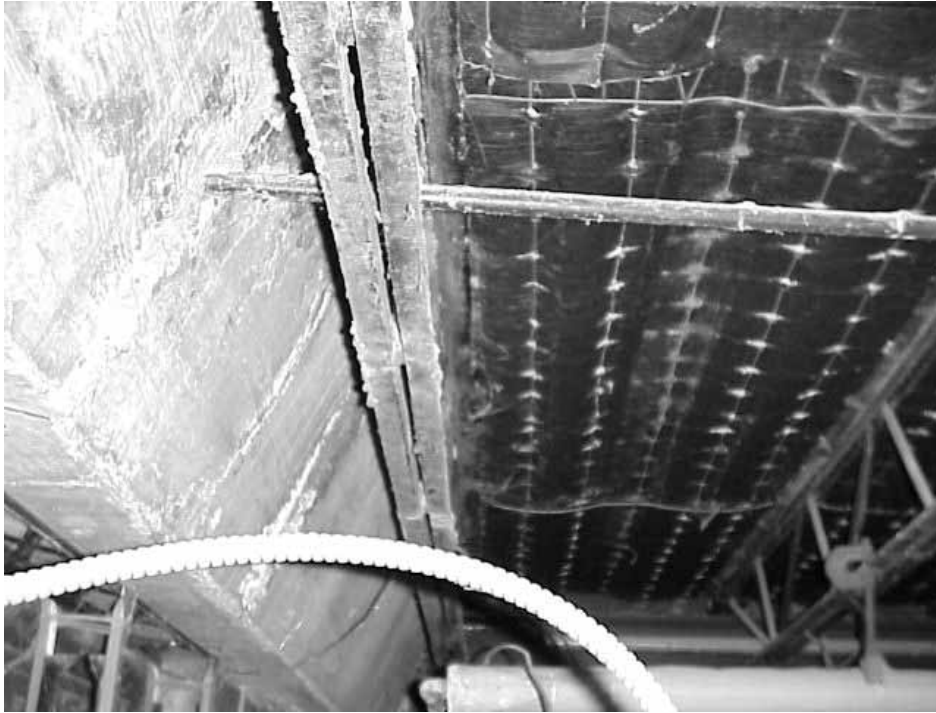
Picture 10

Water damaged ceiling tiles were noted in classrooms that are immediately adjacent to the cement platforms at each end of the back wing. Each of these platforms are supported by steel I-beams that project from the interior of the building through the exterior wall. The corrosion of steel on these beams indicates that water is penetrating to the interior of the building along these beams (see Picture 10). As water moves along beams, water droplets form, which moisten the ceiling tiles. Water also appears to be penetrating through the door threshold at the cement slab. Steel joists beneath the threshold were also corroded, indicating water penetration.

Corrosion of Steel Beams from Water Penetration through Seams around Concrete Platforms

5. Examine methods to eliminate water penetration through exterior walls along steel I-beams and the door threshold of the cement platforms. Examine the paper material adhered to the floor decking above the ceiling beneath the cement platform door threshold. Remove moldy materials. Examine nonporous materials beneath the paper material and disinfect with an antimicrobial agent. Replace water damaged ceiling tiles.

6. As suggested by Mr. Trevallion, consider installing a canopy over the cement platform to direct rainwater away from the base of the platform.
7. Clean the efflorescence in classrooms 15 and 16 (formerly 24 and 25) from brickwork. Monitor this wall after rainstorms for the development of new deposits of efflorescence.

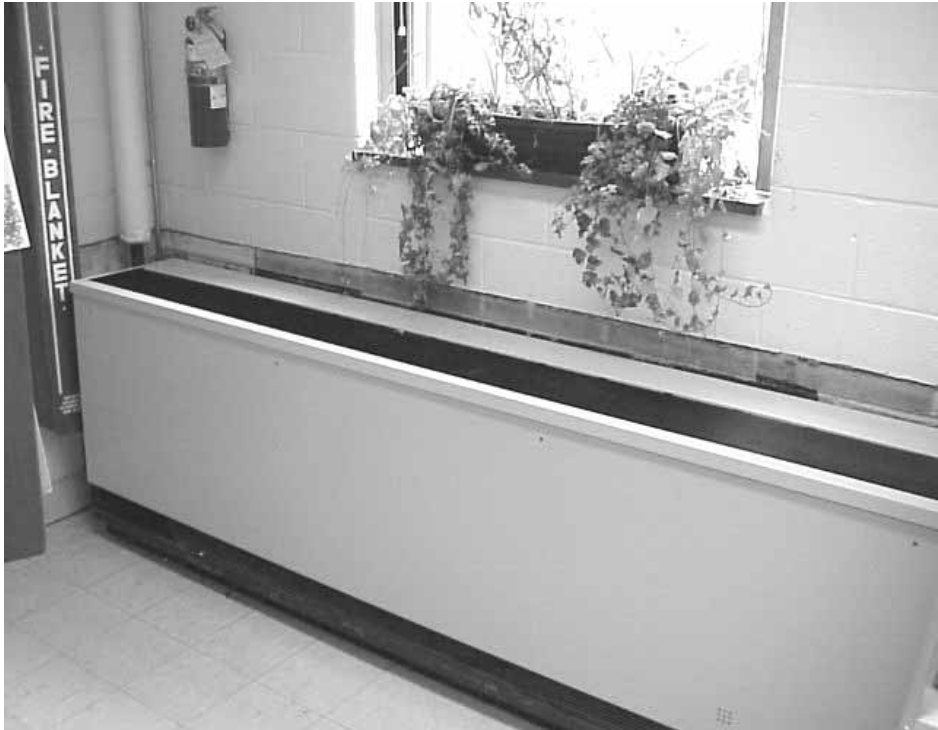
Picture 11

Some classrooms continue to have plants located over univent fresh air diffusers or over heating registers (see Picture 11). Airflow created by the ventilation/heating system can result in the aerosolization of pollen, dust, dirt, spores or other particulates. Moistened plant soil and drip pans can serve as a source of mold growth. A mold odor was traced to carpet squares and cloth beanbags in the corner of a classroom (see Picture 12). The American Conference of Governmental Industrial Hygienists (ACGIH) recommends that porous materials (e.g., carpeting) be dried with fans and heating within 24 hours of becoming wet (ACGIH, 1989). If carpets are not dried within this time frame, mold growth may occur. Water-damaged carpeting cannot be adequately cleaned to remove mold growth.

Plants Over Univent Air Diffuser

13. Move plants away from univents and heat registers in classrooms. Examine drip pans for mold growth and disinfect with an appropriate antimicrobial where necessary. Consider reducing the number of plants in certain areas.

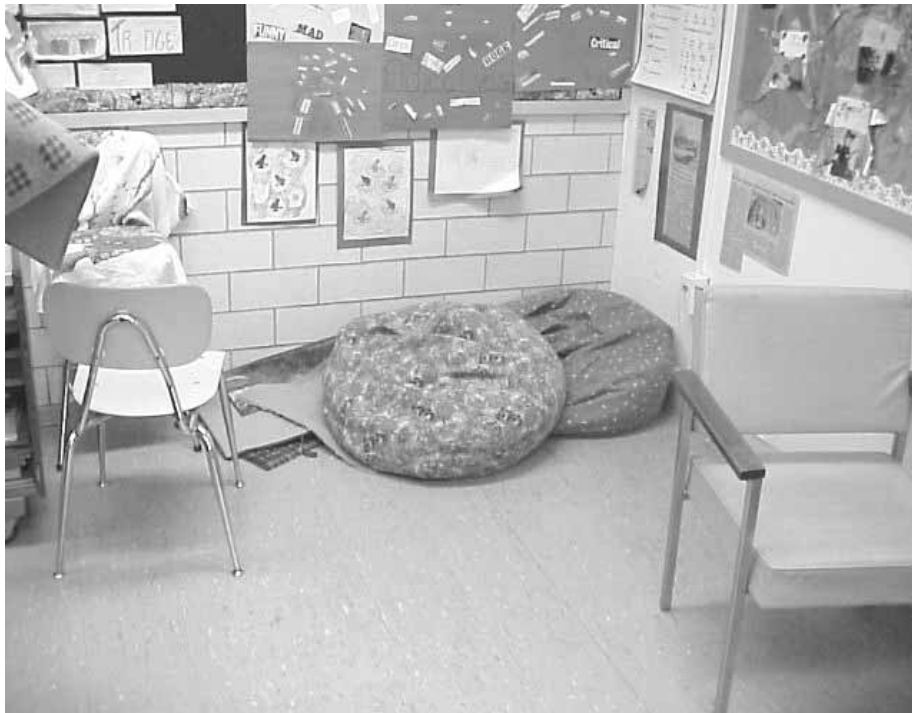
Picture 12

Carpet Squares and Bean Bags With Musty Odor

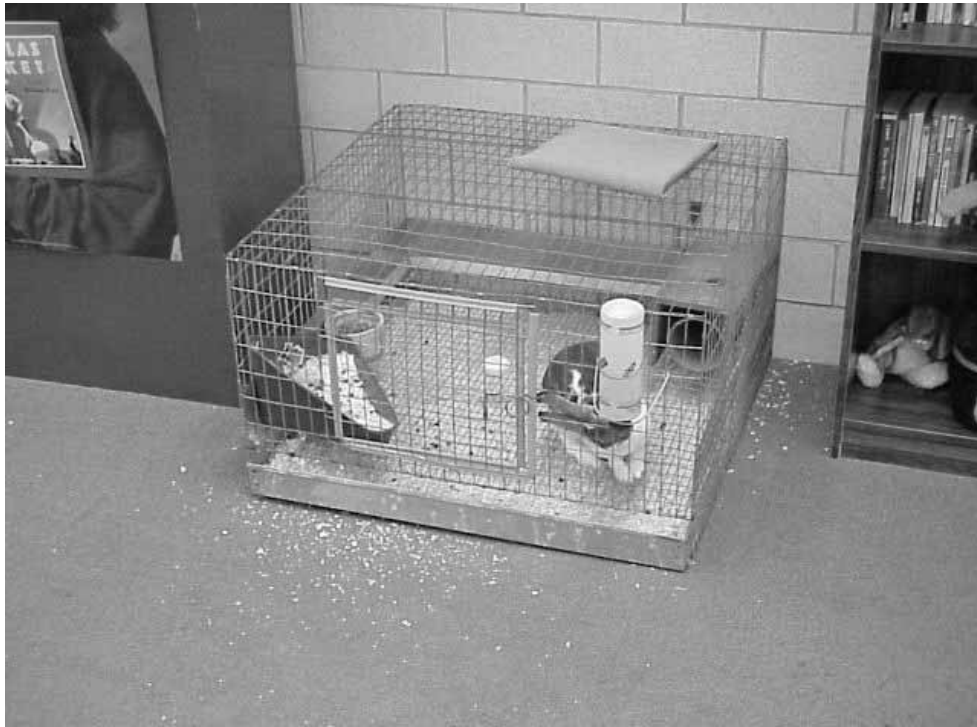
Picture 13

Classroom 20 (formerly classroom 2) has an animal cage containing a rabbit placed on the carpeted floor. While the rabbit cage is well maintained, wood shavings from the cage were found on the carpet outside the cage (see Picture 13). Carpeting can

absorb animal wastes and can be a reservoir for mold and bacterial growth. Animal dander, fur and wastes can all be sources of respiratory irritants.

Shavings from Rabbit Cage on Carpeting

11. Move the rabbit cage to a room with a water impermeable surface that can be easily cleaned.
12. Extend the height of the sewer vent pipe on the roof to prevent odor entrainment.

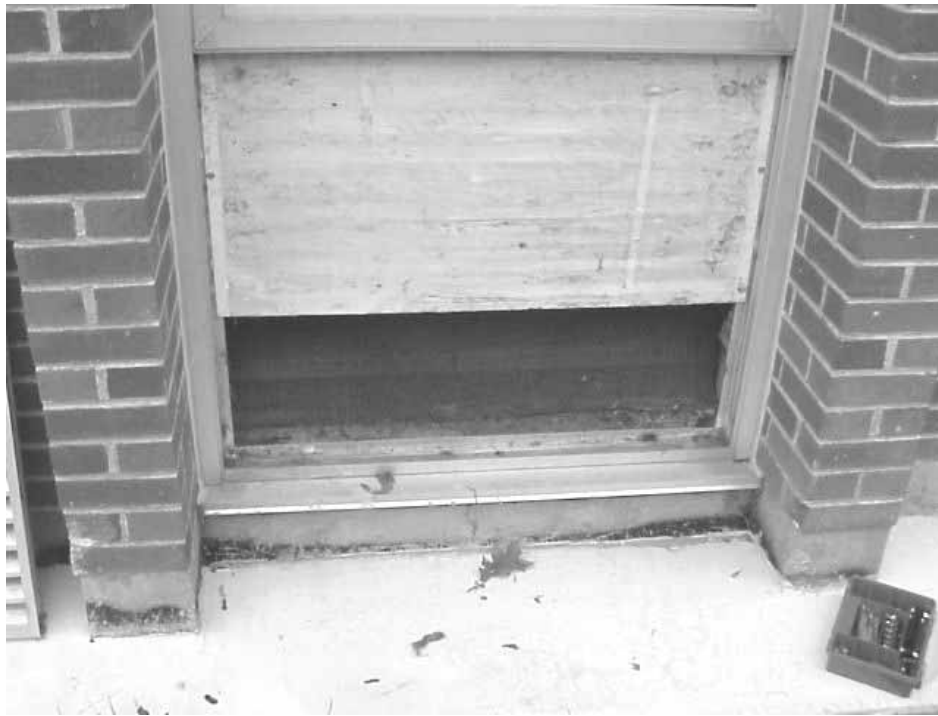
Picture 14

The Fresh Air Intake Grille (See Picture 14) Was Removed From Exterior Of Classroom 6 (Formerly Classroom 15)

8. Remove debris from the interior of univent fresh air intakes. Each of these vents should be examined periodically and cleaned of debris. Clean vanes of fresh air intake for classroom 6 with an appropriate antimicrobial.

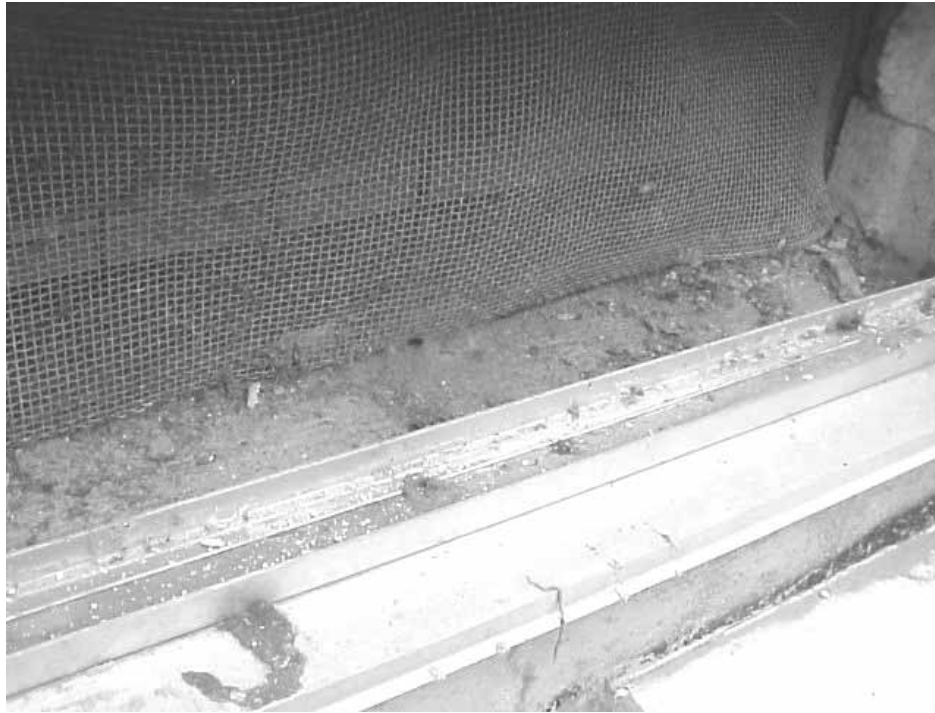
Picture 15

Leaves, Dirt and Other Normal Outdoor Debris behind Fresh Air Intake Louver Of Classroom 6 (Formerly Classroom 15)

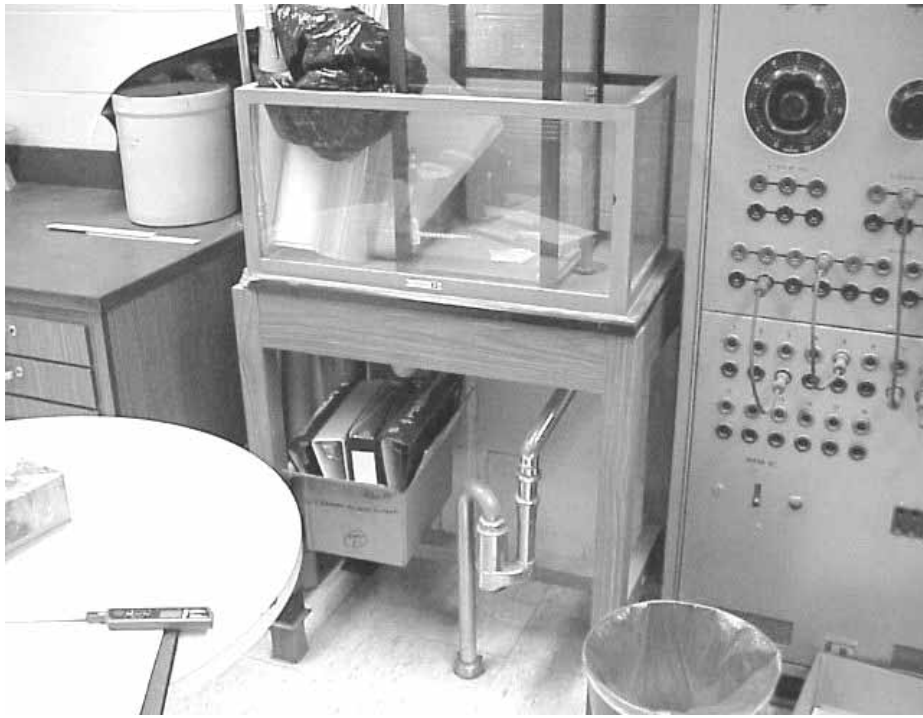
Picture 16

A number of the science classrooms have aquarium-like equipment attached to drains with traps (see Picture 16). It is likely that these drains have dry traps, which can allow for sewer gas to back up into classrooms. A sewer gas vent pipe located on the roof was found in close proximity to a fresh air intake. Sewer gas vent pipes should be located away from or extended above air handlers to avoid entrainment of sewer gas odors into fresh air intakes. The building code requires that exhaust vents be located at a minimum 10 feet away from or 2 feet above a fresh air intake (SBBRS, 1997; BOCA, 1993). Sewer gas can be an eye, nose and respiratory irritant.

Aquarium-Like Equipment Attached To Drains with Traps
