INDOOR AIR QUALITY ASSESSMENT

**Cedar Elementary School
Hanover School District
265 Cedar Street
Hanover, Massachusetts**

Prepared by:
Massachusetts Department of Public Health
Bureau of Environmental Health Assessment
April, 2000

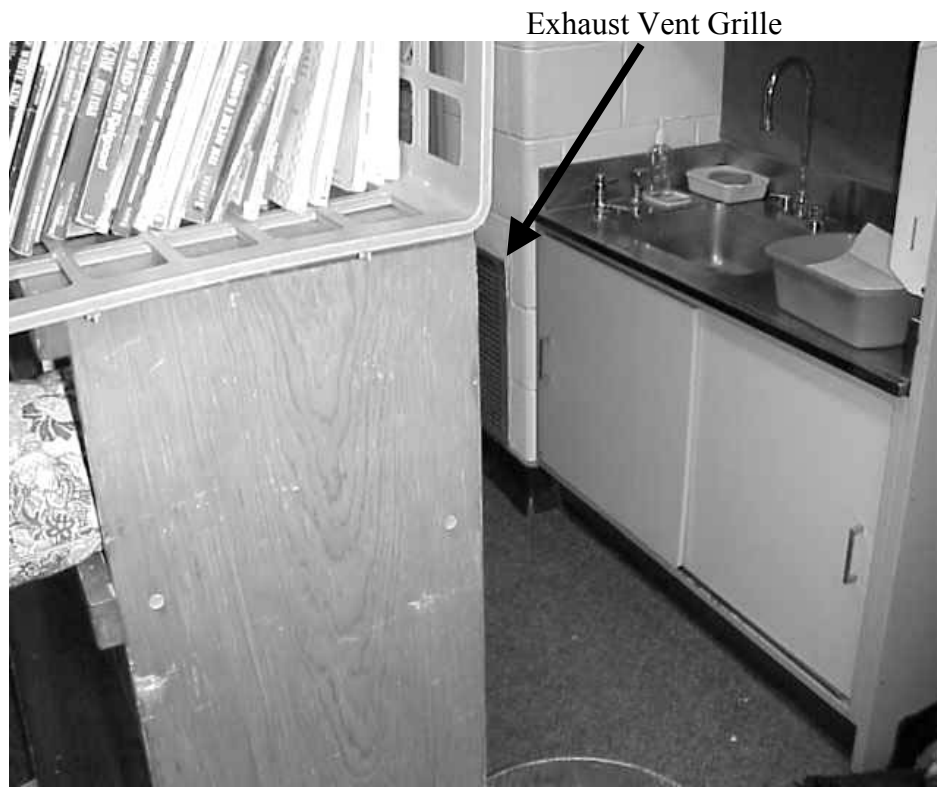
Picture 1

Exhaust ventilation in exterior classrooms is provided by a mechanical system. The exhaust ventilation in classrooms consists of wall-mounted, ducted vents (see Picture 1). These exhaust vents were functioning in the eastern wing of the building, as noted by the dry roof rock ballast beneath the rooftop exhaust vent motors (see Picture 2). Exhaust vents in the western wing were not drawing air, with the exception of the local exhaust vents in restrooms. All rooftop exhaust vent motors above the western wing of the building were deactivated. Please note that the roof rock ballast remained wet (see Picture 3), indicting no air movement from this equipment. Exhaust ventilation is necessary to remove environmental pollutants from classrooms. Without exhaust ventilation, environmental pollutants that exist in a building can accumulate and cause irritant symptoms. A number of exhaust vents throughout the school were blocked by shelves and other items. Exhaust vents must remain clear of obstructions in order to function appropriately.

Wall-Mounted Exhaust Vent Obscured by Shelf

6. Remove all blockages from univents and exhaust vents to ensure adequate airflow.
7. Once both the fresh air supply and the exhaust ventilation are functioning, the ventilation system should be balanced by an HVAC engineer.

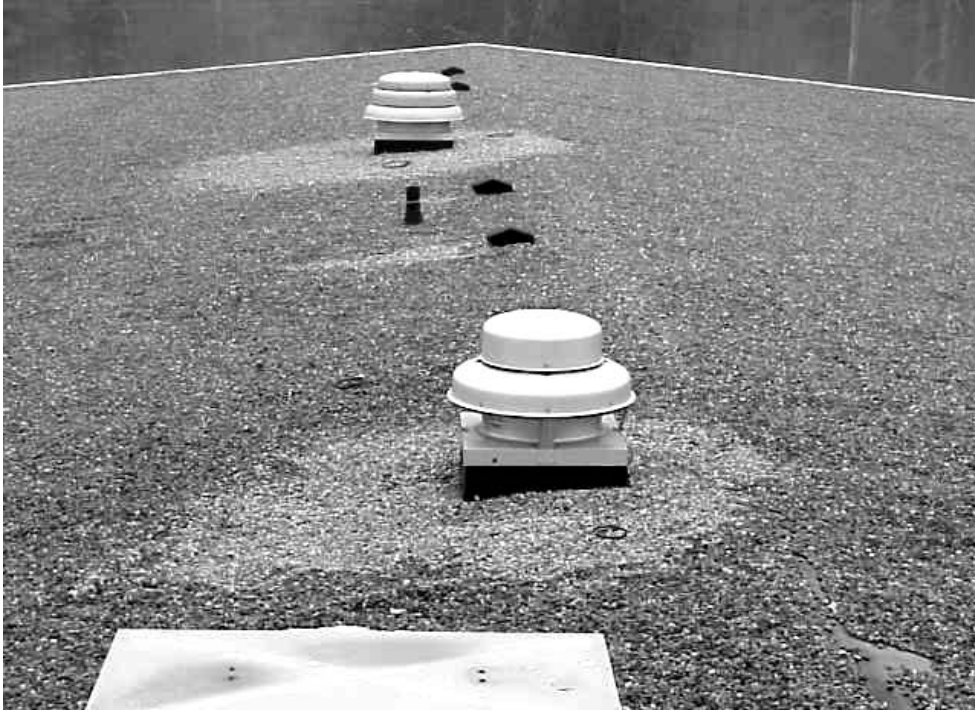
Picture 2

**Exhaust Vents above the Eastern Wing, Note Dry Roof Rock Ballast
Dried By Exhaust Air from These Vents**

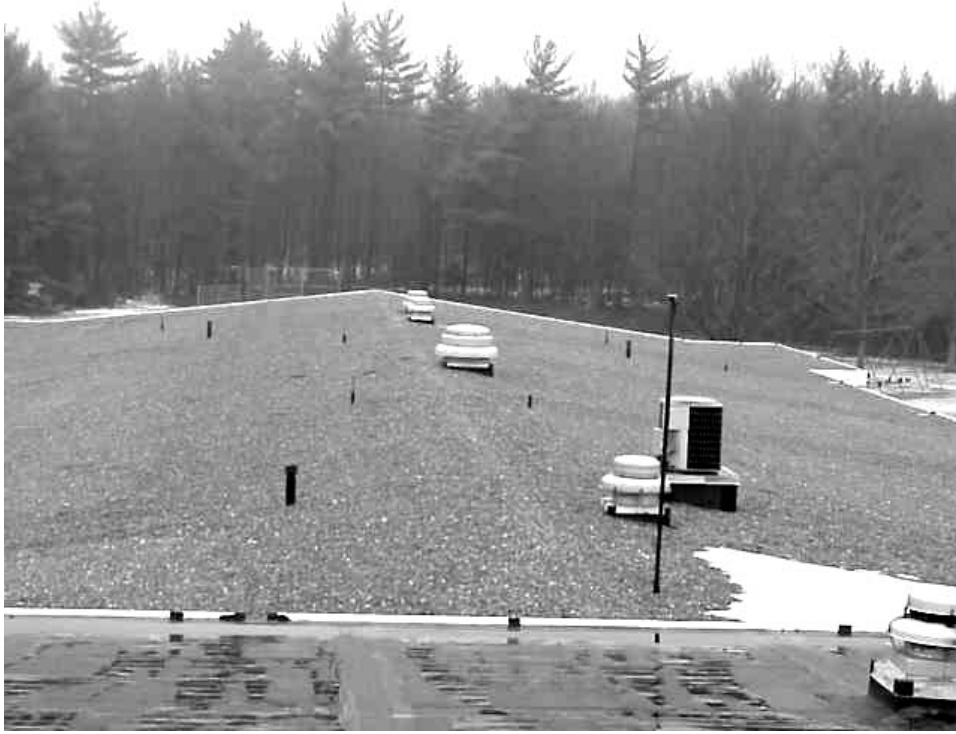
Picture 3

Exhaust Vents Above The West Wing, Note Wet Roof Rock Ballast Around Vents

2. Ascertain whether the exhaust vent motors over the west wing are operable. If operable, activate these motors to provide exhaust ventilation for these classrooms. Repair the exhaust vent motors if necessary.

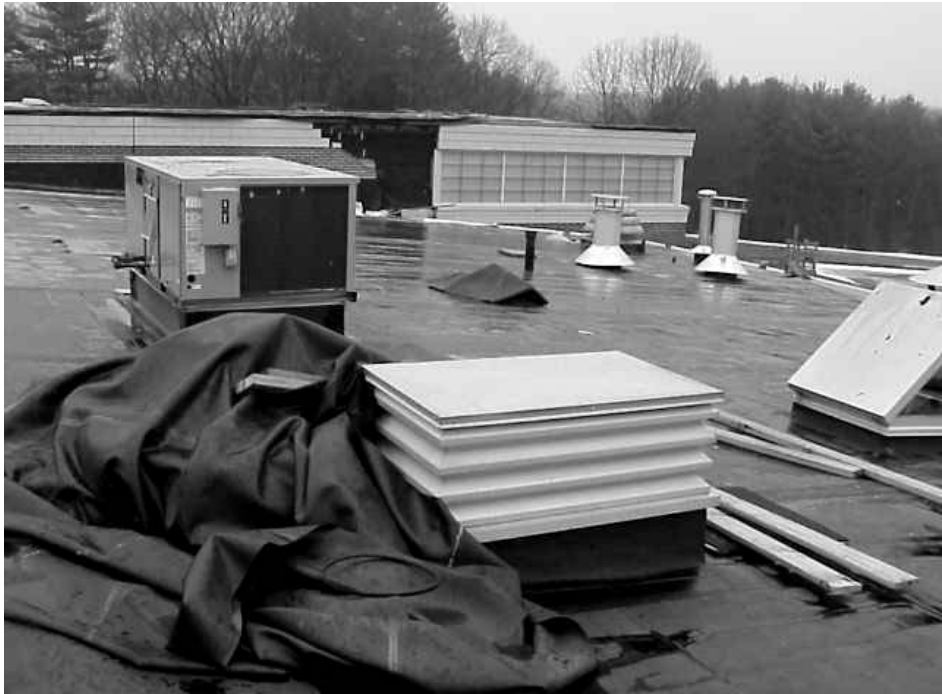
Picture 4

A roof top fresh air intake that services the kitchen and teacher's lunchroom is located on the roof above the kitchen (see Picture 4). Fresh air is distributed to the kitchen and teacher's room by ceiling-mounted air diffusers. A combination of wall and ceiling-mounted return vents is connected by ductwork to the AHU. Both supply and return vents were operating during the assessment. The conference room, learning center, guidance counselor's office and the upstairs storage room do not have fresh air supplies or exhaust vents.

Fresh Air Intake above Kitchen

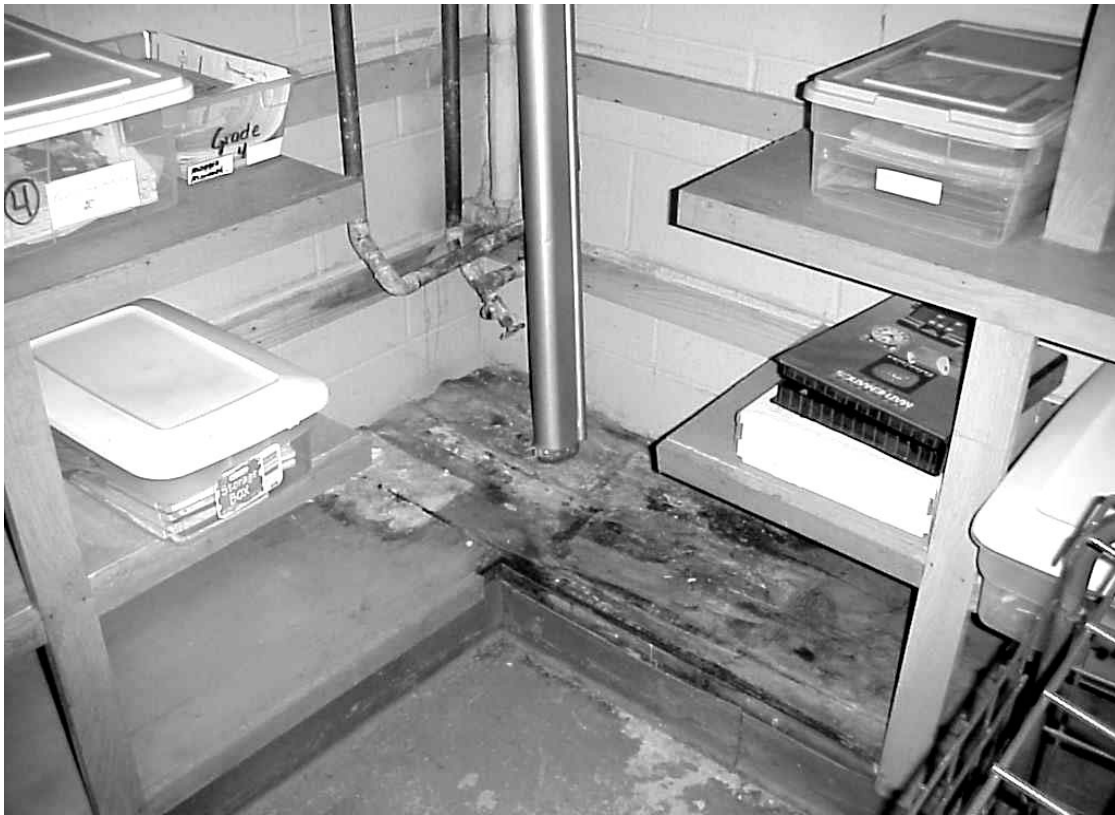
Picture 5

A book storeroom near the boy's restroom in the west wing had heavily water damaged shelving. It appears a water leak from a pipe in this room moistened this shelf, which resulted in mold colonization of the wood (see Picture 5). Water penetration into plywood and particleboard of the cabinet can cause these materials to swell and serve as a growth medium for mold.

Mold Colonized Wood Shelves in Book Storeroom near Boy's Restroom in West Wing

9. Remove moldy shelving from storeroom in Picture 5. Identify the source of water leaking from the pipe above this water damage and repair. Examine areas beneath for mold growth and disinfect nonporous materials with an appropriate antimicrobial agent.

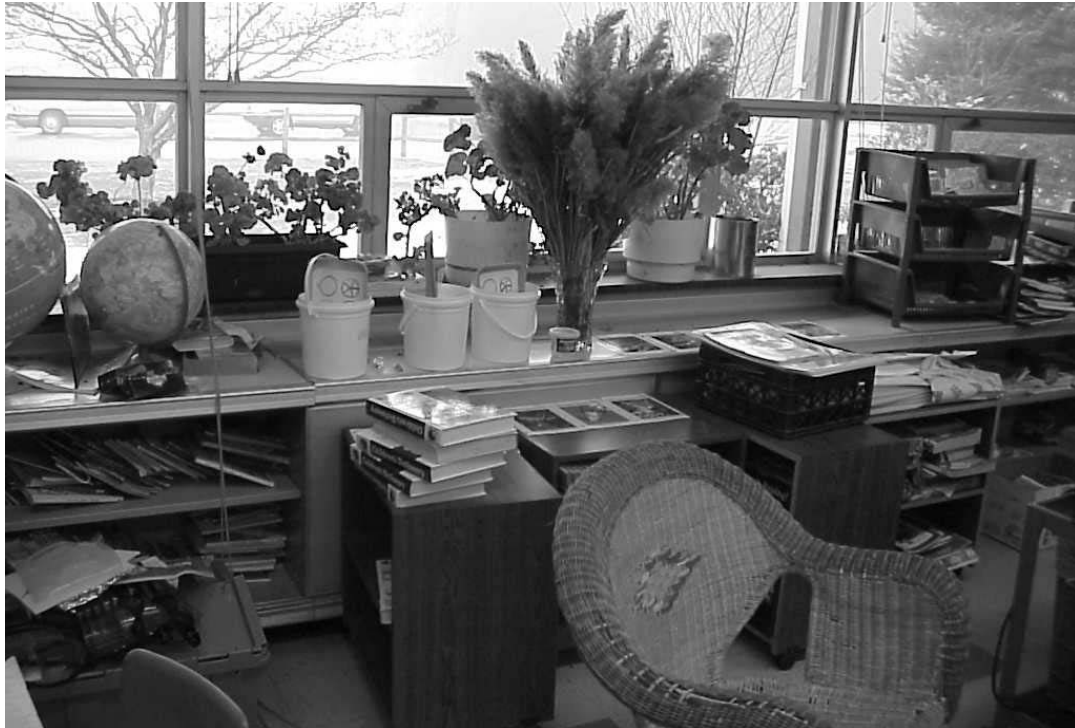
Picture 6

Several classrooms had a number of plants (see Picture 6). In some classrooms flowering plants were observed on univent air diffusers. Several classrooms contained plants in window

planters without drip pans. Window planters are designed to be mounted on the outside of windows and therefore do not have drip pans. The lack of drip pans can lead to water pooling and mold growth on windowsills when used indoors. Moistened plant soil, drip pans and standing water can serve as a source of mold growth. Plants should be equipped with drip pans and over watering should be avoided. In addition, plants should be located away from univents to prevent aerosolization of dirt, pollen or mold.

Plants over Air Diffusers of This Classroom's Univent

13. Move plants away from univents in classrooms. Examine drip pans for mold growth and disinfect with an appropriate antimicrobial where necessary. Consider reducing the number of plants in certain areas.

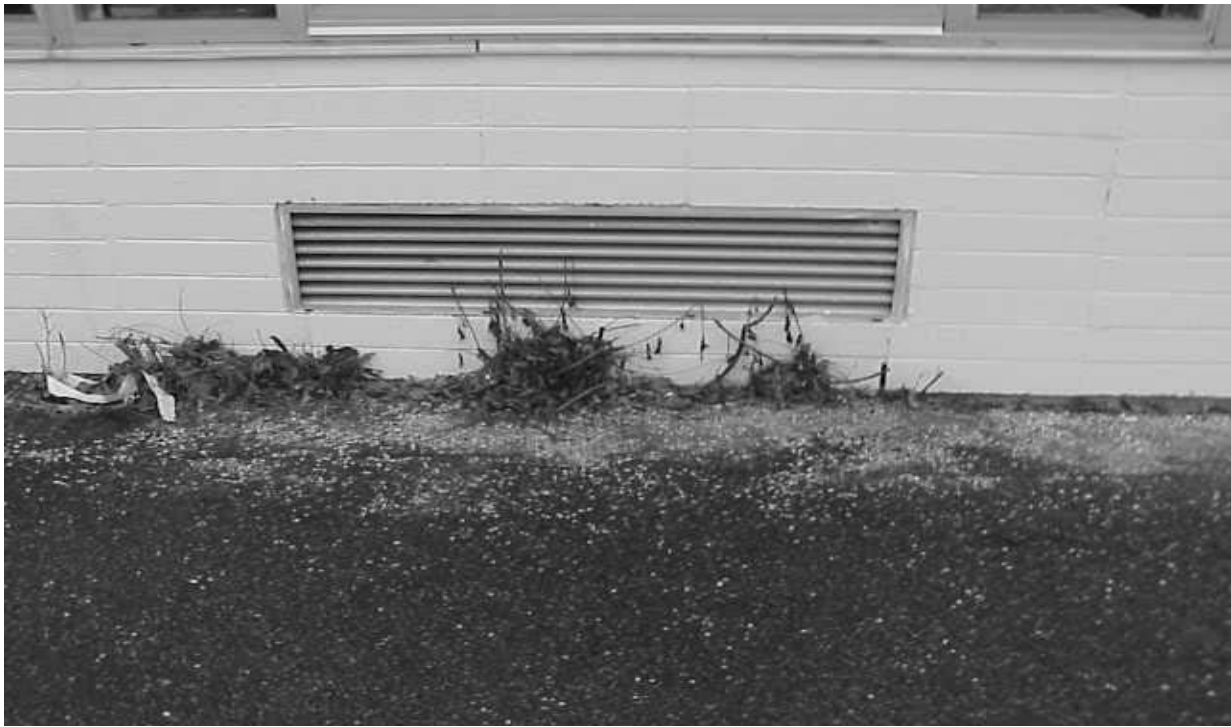
Picture 7

Plants were noted growing in the junction between the exterior wall and tarmac outside classrooms 7 through 10 (see Picture 7). Water can gather in the wall/tarmac seam where these plants are growing. Freezing and thawing of gathered water can result in damage to the exterior wall, which can result in water penetration into the building. Plants growing near fresh air intakes can result in pollen and other plant related particulates being entrained by the univent and distributed into classrooms.

Plants Growing in the Exterior Wall/Tarmac Junction outside Classrooms 7-10

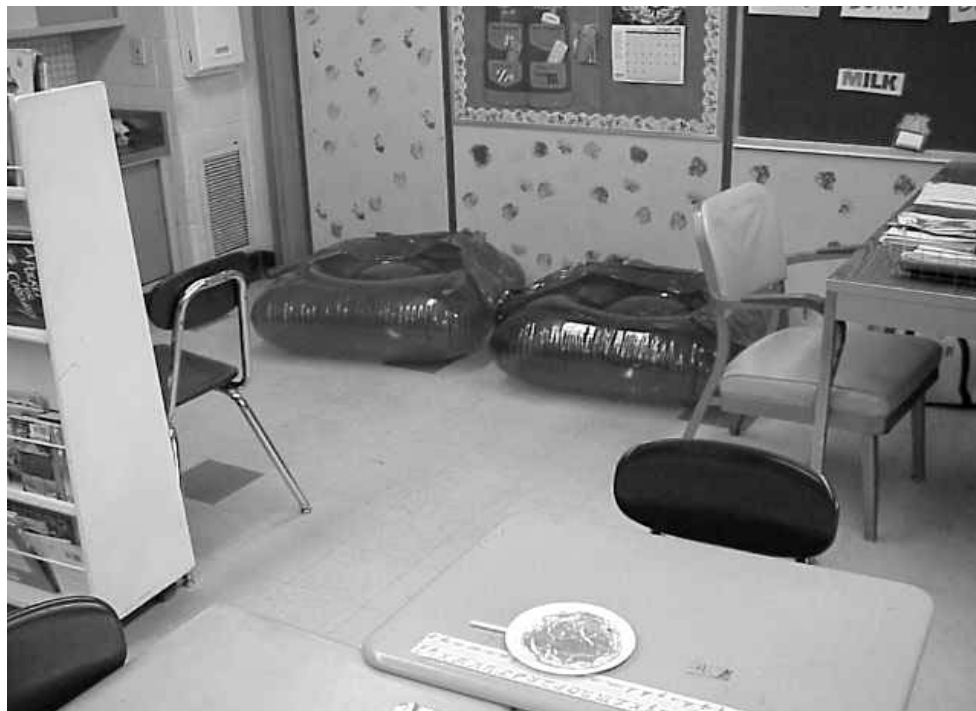
Picture 8

Classrooms 8 and 9 had a detectable odor, which was traced to inflatable furniture that exists in these classrooms (Picture 8). The odor was noted in the west wing near classroom 3 after students returned to these rooms. Teachers opened windows upon returning to these

classrooms after lunch. The opening of these windows created airflow into the classrooms, which flowed into the hallway through open hallway doors. Plastic can have unpleasant odors, which can be irritating to the eyes, nose and throat.

Odorous Inflatable Plastic Furniture Noted In Classroom 8

3. Remove inflatable furniture from classrooms 8 and 9.
4. Remove roofing products from fresh air intake on roof.
5. Examine each univent for function. Survey classrooms for univent function to ascertain if an adequate air supply exists for each room. Operate univents while classrooms are occupied. Consider consulting a heating, ventilation and air conditioning (HVAC) engineer concerning the calibration of univent fresh air control dampers school-wide. If univent dampers cannot be readily adjusted, consider using windows to supplement fresh air in classrooms.

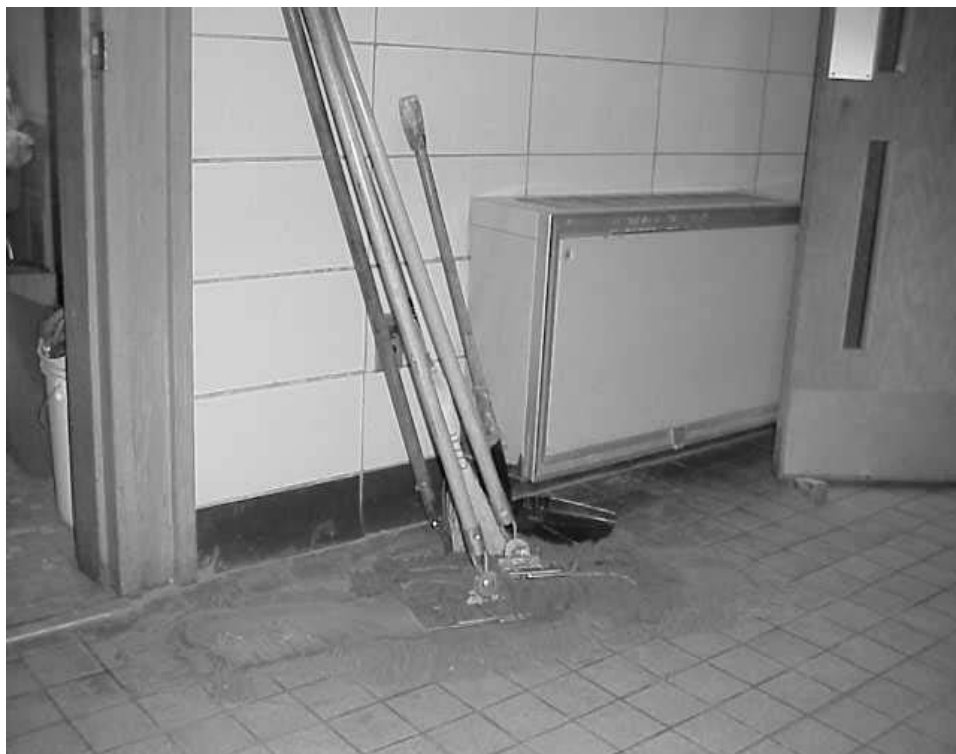
Picture 9

A pretreated floor mop was noted in the hallway beneath a fan coil unit (see Picture 9). The fan coil unit has a return air vent through which hallway air is drawn, heated and distributed through the air diffusers of this unit. Any odors or dusts from the mop can be drawn into the return air vent and aerosolized by the fan coil unit.

Floor Mops beneath Fan Coil Unit in West Wing

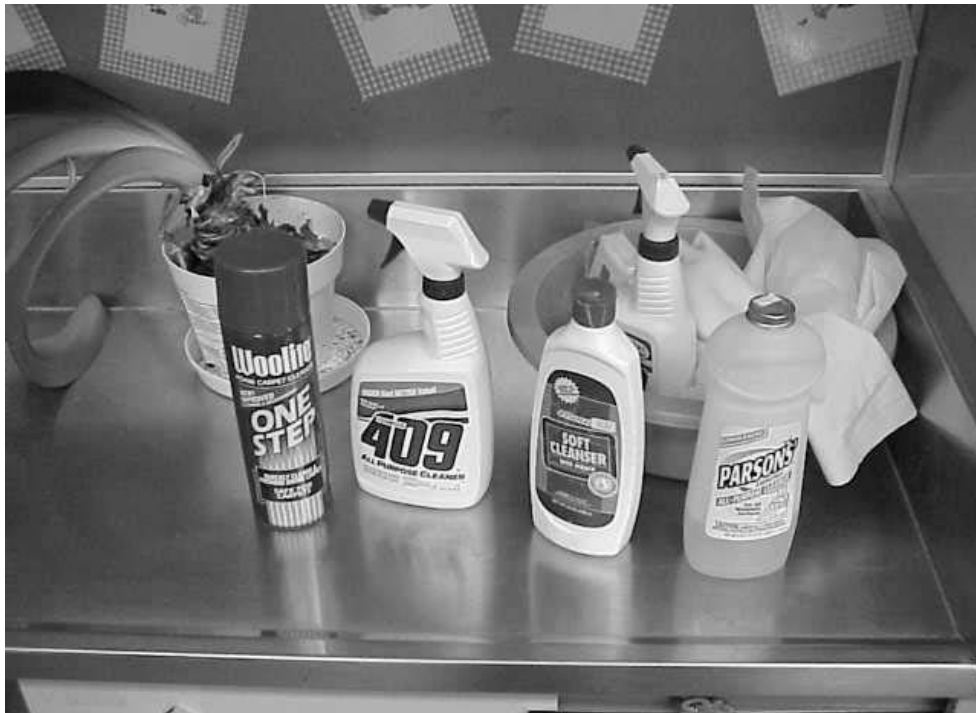
Picture 10

Of note is the prolific use of cleaning materials in this building by teachers (see Picture 10). Cleaning materials frequently contain ammonium compounds or sodium hypochlorite (bleach-products), which are alkaline materials. It was also reported that the custodial staff used ammonia to clean hallway floors in order to remove accumulated salt stains from student traffic. Ammonium containing materials in spray cans were reportedly used to disinfect telephone receivers. The use of disinfectants in this manner can expose an individual to ammonium compound vapors, which can lead to irritation of the eyes, nose or respiratory tract.

An Example of Cleaning Products Found in Classrooms

8. Reduce the use of cleaning materials that contain respiratory irritants (ammonia related compounds) on floors and in classrooms. Do not use these materials to disinfect equipment that comes into close contact with the respiratory system (e.g., telephones). Substitute plain soap and hot water for ammonia related cleaning products. Only use ammonia related cleaning products where necessary. If ammonia containing cleaning products are used, rinse the area of application with water to remove residue.

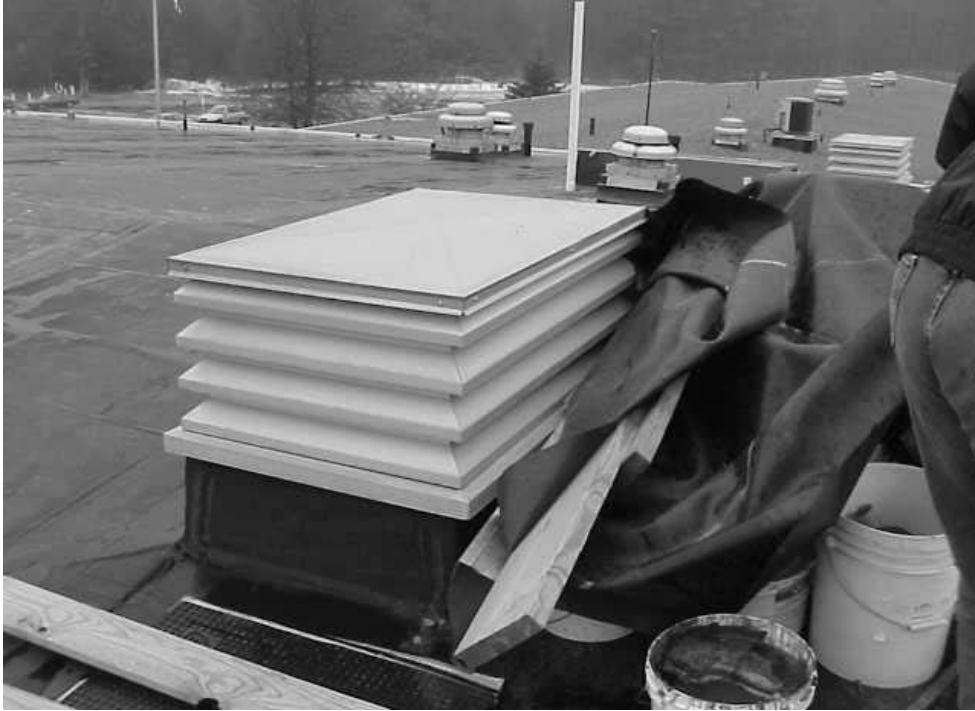
Picture 11

The air intake for the teacher's room was partially covered with a tarpaulin. Stored beneath this tarpaulin were roofing materials, including adhesives that contain volatile organic compounds (VOC) (see Picture 11). VOCs can readily evaporate and can be irritating to the eyes, nose and throat. Entrainment of VOCs and roofing material odors should be avoided.

Open Containers of Roofing Materials beneath Tarpaulin next to Rooftop Fresh Air Intake

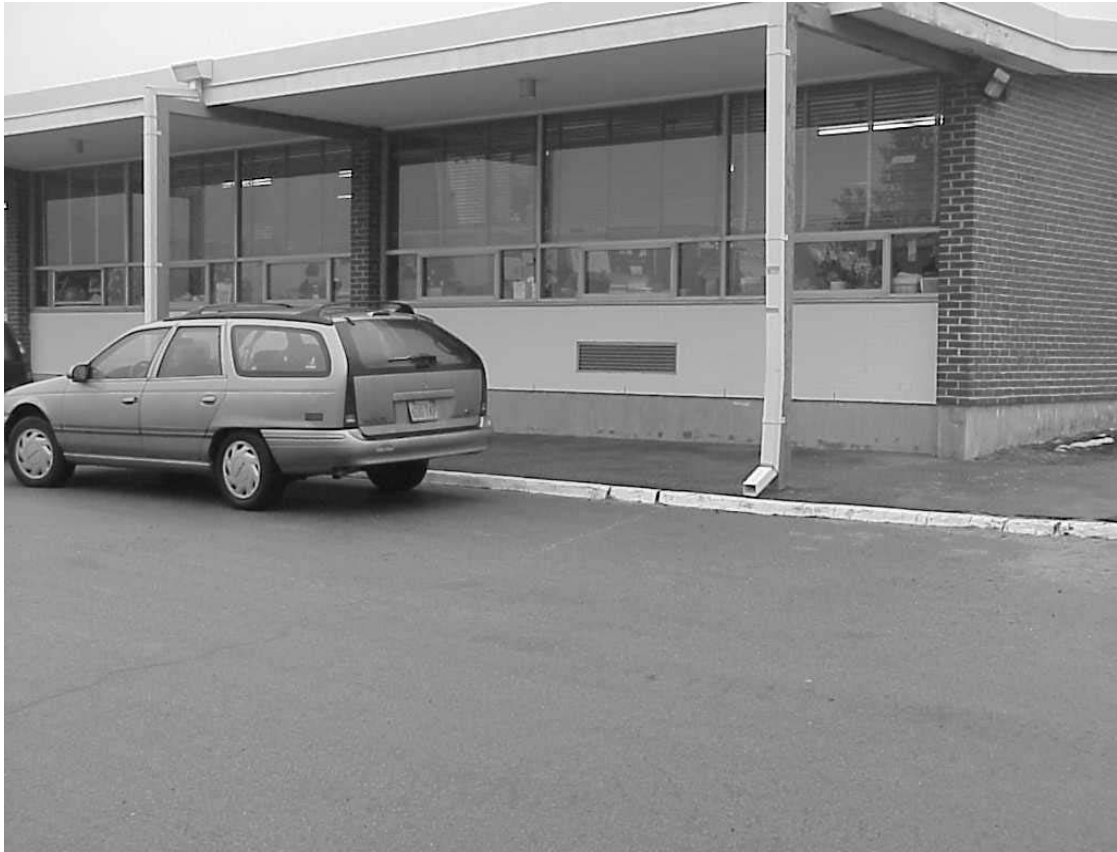
Picture 12

Automobiles parked in close proximity to univent fresh air intakes were noted along the front classrooms of the east wing (see Picture 12), which can result in the entrainment of vehicle exhaust into the building, which may, in turn, provide opportunities for exposure to compounds such as carbon monoxide. M.G.L. chapter 90 section 16A prohibits the unnecessary operation of the engine of a motor vehicle for a foreseeable time in excess of five minutes (MGL, 1996).

East Wing Fresh Air Intake near Parked Cars

14. Prevent parking of cars along the front of the east wing to prevent vehicle exhaust entrainment by univents.
15. Clean chalkboards and chalk trays regularly to prevent the build-up of excessive chalk dust.
