INDOOR AIR QUALITY ASSESSMENT

**Garfield Magnet School
168 Garfield Ave
Revere, Massachusetts**

Prepared by:
Massachusetts Department of Public Health
Bureau of Environmental Health Assessment
April, 2000

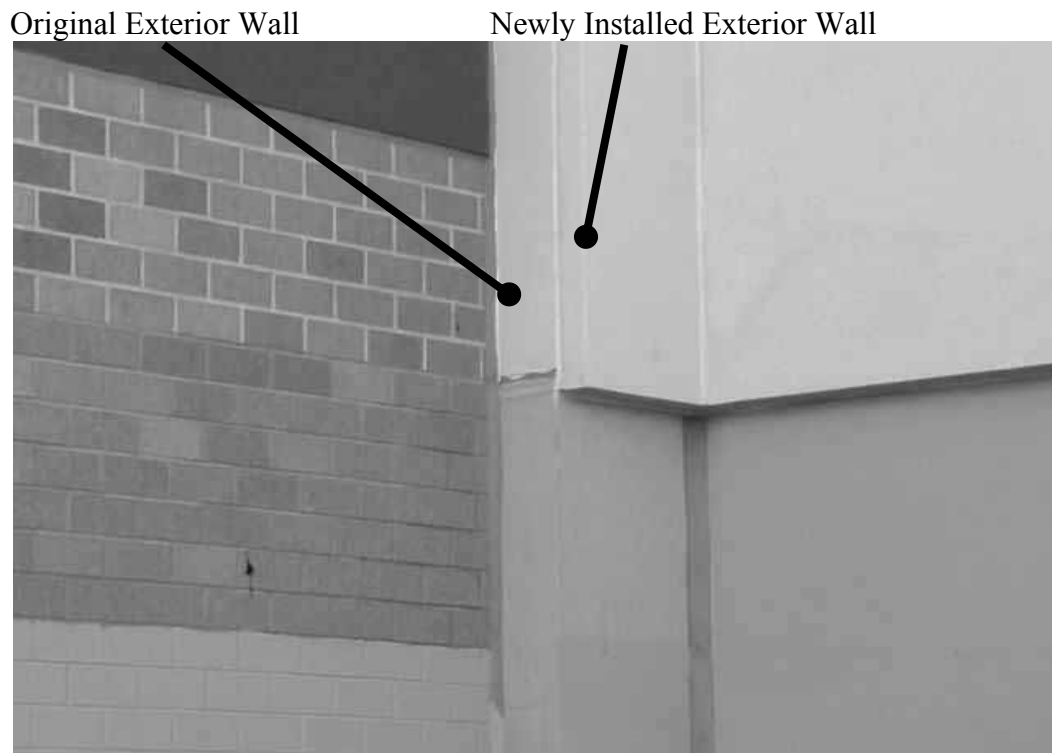
Picture 1

Seaward exterior wall of school that was retrofitted with a new exterior skin

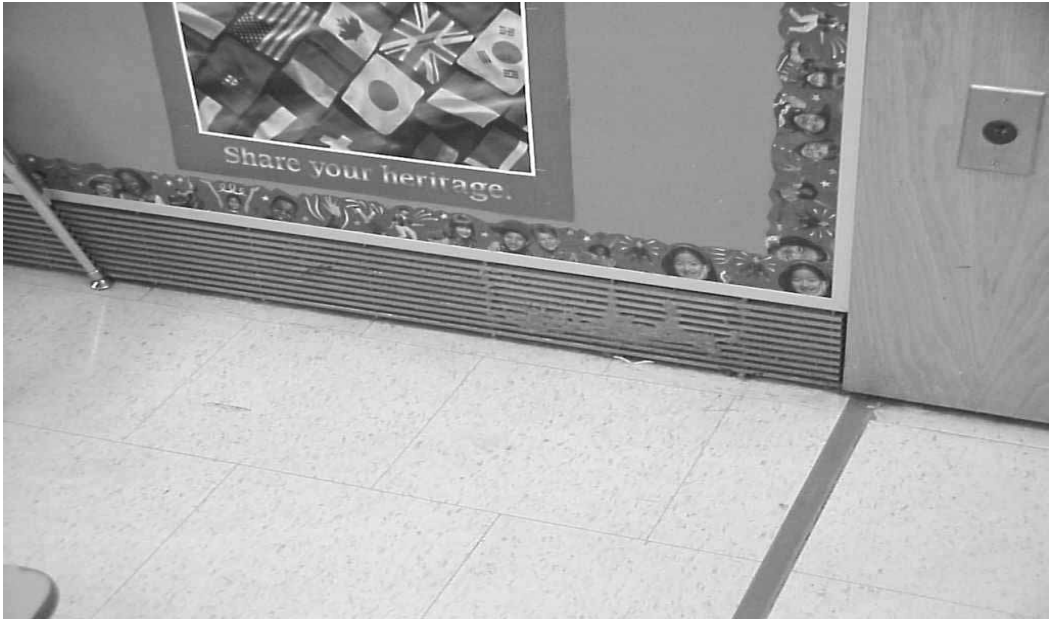
Picture 2

Exhaust ventilation in classrooms is provided by a mechanical exhaust system. The exhaust vents are located on the walls at floor level (see Picture 2). This design allows for the vents to be easily blocked by stored materials and occluded by floor dust. In a number of classrooms, these vents were blocked with books, book bags, boxes and other obstructions. In several areas, exhaust vents were not operating; indicating the motor is turned off or non-functional. BEHA staff examined exhaust motors on the roof. Mr. Mitten reported that several exhaust motors were not functioning. The school department has reportedly placed orders for parts to repair exhaust fan motors EF-14, EF-32, the library exhaust fan and one unlabelled fan. As with the univents, in order to function properly these vents must be activated, cleared of obstructions and allowed to operate.

Exhaust Vent Located at Floor Level in Classroom

3. Install weather stripping around the trash dumpster room hallway doors. Consider increasing the number of trash removals weekly to reduce odor.
4. Activate exhaust ventilation in occupied areas. Repair and/or replace exhaust ventilation motors where necessary.

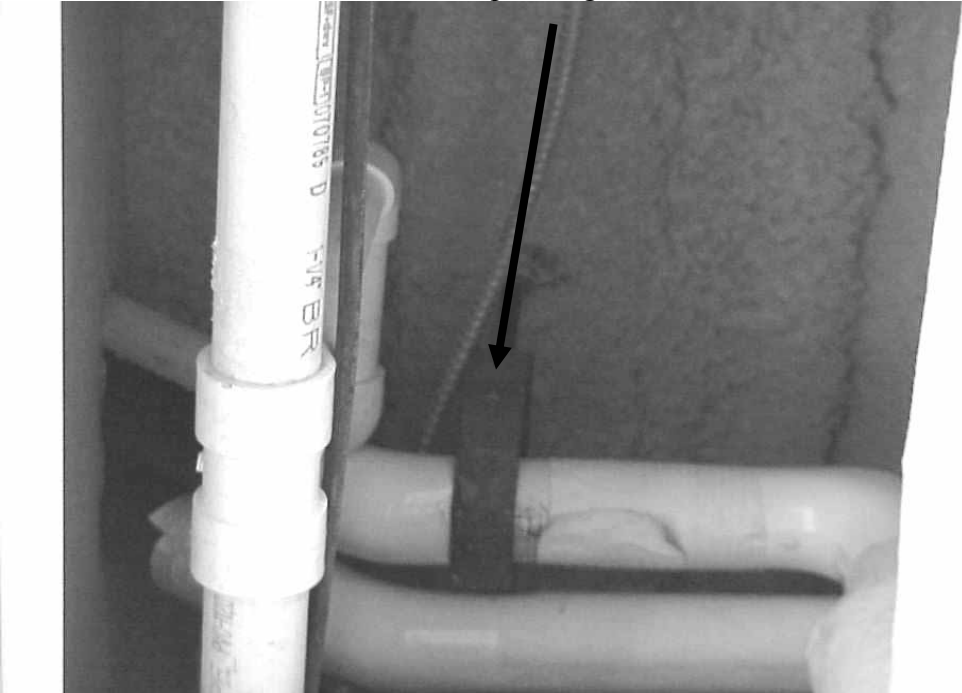
Picture 3

A number of classrooms had water damaged ceiling tiles around the exterior windows. Several of these ceiling tiles were removed, which revealed rusted pipe hangers (see Picture 3). This condition can be a sign that moisture is being introduced into the building resulting in condensate on metal fixtures in the unconditioned ceiling plenum.

Rusted Pipe Hanger

8. Repair any water leaks and replace any remaining water-stained or missing ceiling tiles. Examine the areas above and behind these tiles for mold growth. Disinfect areas of water leaks with an appropriate antimicrobial.

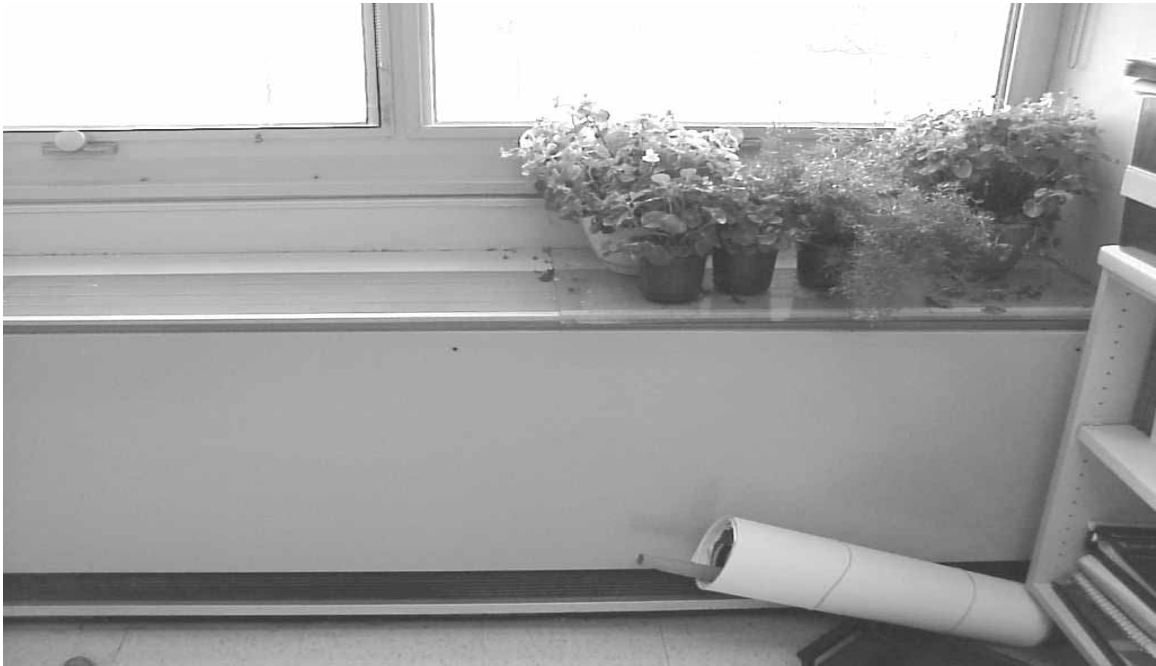
Picture 4

noted on top of univents (see Picture 4). Plants should be properly maintained and equipped with drip pans. Plants should also be located away from univents to prevent the aerosolization of dirt, pollen or mold.

Plants Noted on Classroom Univent Air Diffuser

10. Repair broken windows and replace missing or damaged window caulking to prevent water penetration.
11. Keep plants away from univents in classrooms. Ensure plants have drip pans and examine drip pans for mold growth. Disinfect areas with an appropriate antimicrobial where necessary.

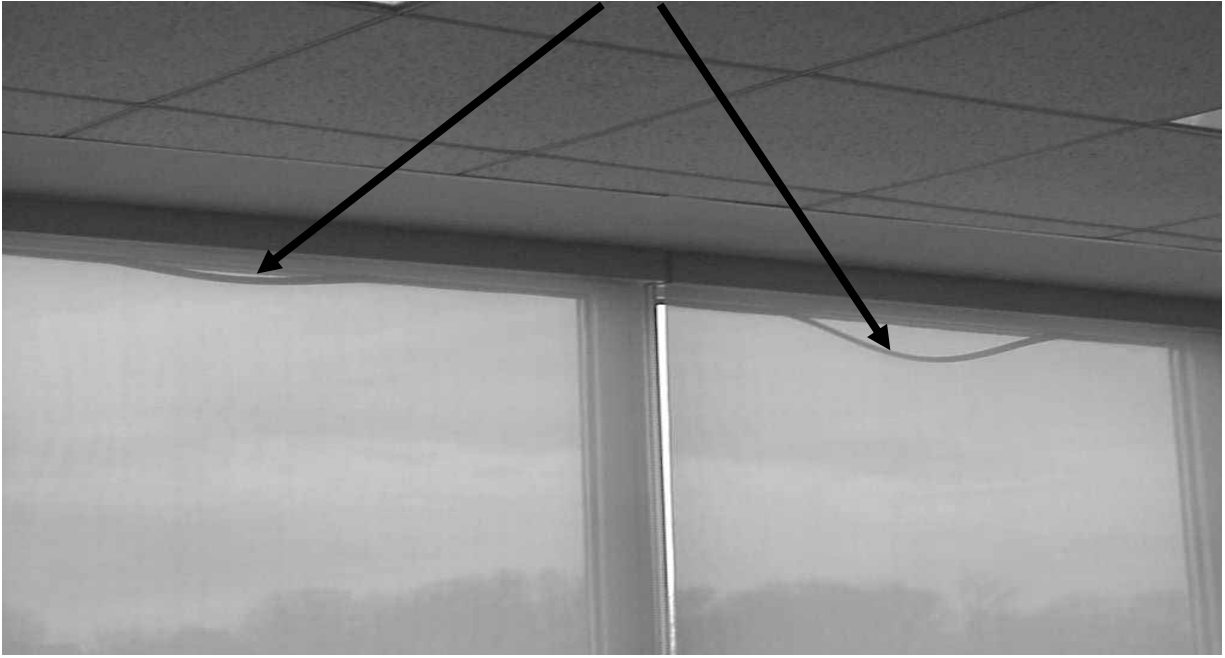
Picture 5

Throughout the school, windowpanes were cracked or broken and air infiltration was noted around windows. In several rooms the window seals appeared to be failing (see Picture 5). Repairs of window leaks are necessary to prevent water penetration. Water penetration through window frames can lead to mold growth under certain conditions. Repeated water damage can result in mold colonization of window frames, curtains and items stored on or near windowsills.

Failing Caulking Noted around Classroom Window

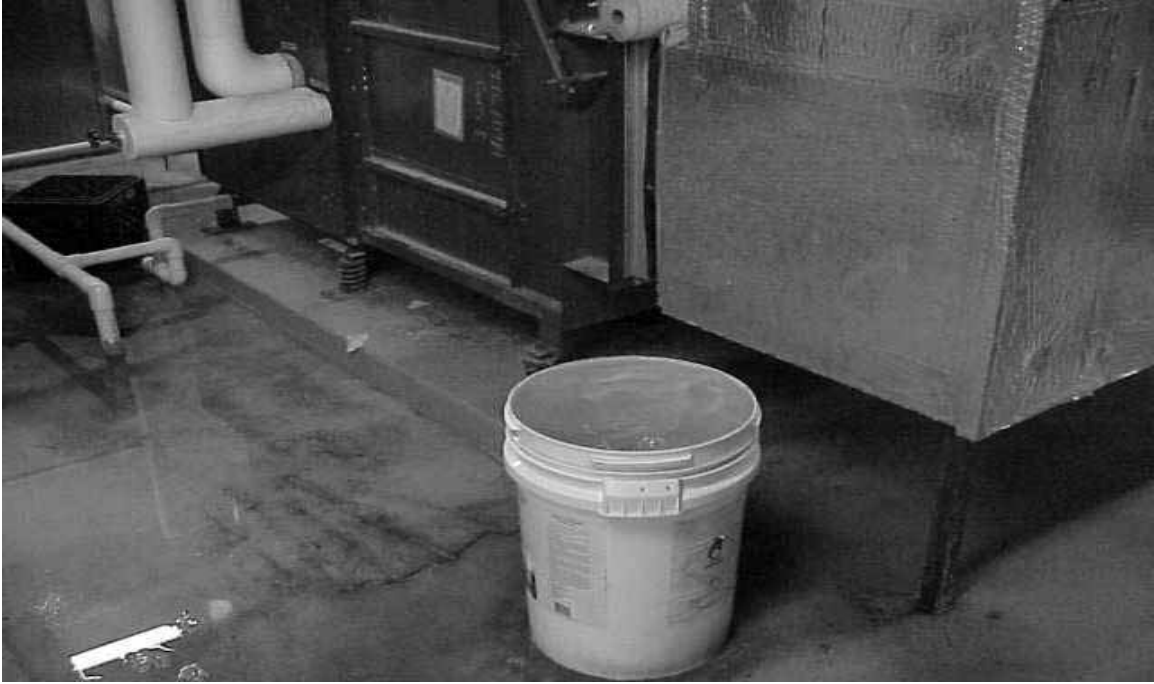
Picture 6

A bucket overflowing with water was noted in the HVAC penthouse (see Picture 6). The bucket was placed beneath a water leak from the HVAC equipment. If left unattended, overflow can spill onto the floor of the penthouse and saturate porous materials, which can lead to potential mold growth. In addition, standing water can become stagnant and provide a medium for bacteria, mold and unpleasant odors. A cup of standing water was noted on the univent in classroom 220. The cup appeared to be stationed on top of the univent to provide added moisture to the air. Although no odors were detected, the water had a cloudy, white- milky appearance. A pungent odor was noted upon entry into the 236 mechanical room. Water-damaged ceiling tiles and cardboard boxes were noted on the floor. These materials should be removed and discarded. A humidifier was noted in classroom 119. Humidifiers should be emptied and cleaned as per the manufacturer's instructions to prevent bacterial and mold growth. The American Conference of Governmental Industrial Hygienists (ACGIH) recommends that porous materials be dried with fans and heating within 24 hours of becoming wet (ACGIH, 1989). If porous materials are not dried within this time frame, mold growth

**Bucket Stationed below Leak in HVAC Penthouse
Note Overflow on Floor**

12. Repair HVAC pipe leak in penthouse to prevent water damage and potential mold growth of stored/building materials.
13. Discard milky water in cup on the univent in classroom 220.

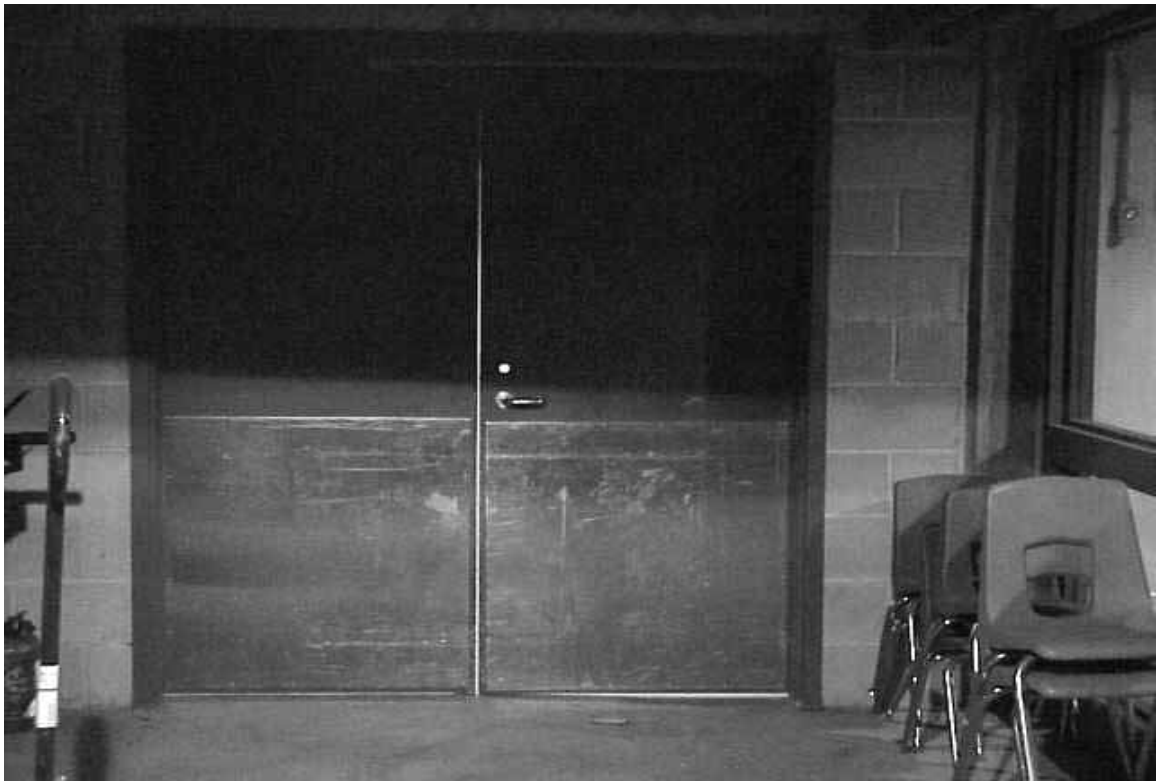
Picture 7

A number of other conditions were noted during this assessment which can effect indoor air quality. A pungent garbage odor was noted in elevators. The elevators terminate in the basement, in a hallway that is connected to a garage area where the school's trash dumpsters are located. When closed, the hallway doors to the trash dumpster room have spaces through which air and odors can freely pass (see Pictures 7 and 8). These doors should be rendered air tight to prevent trash and vehicle exhaust emissions from entering the elevator lobby. Once in the basement hallway, odors can be drawn from the basement and distributed to the occupied areas of the school by the operations of the elevator. This piston effect can serve to place the lobby area under negative pressure as cars move upwards, which can then enhance the penetration of odors into occupied areas. In addition the garage door to the dumpster room should remain shut to avoid over-pressurization, which can also force trash odors into the elevator lobby.

**Double Doors Leading to Dumpster Room Note Spaces
between and beneath Doors**

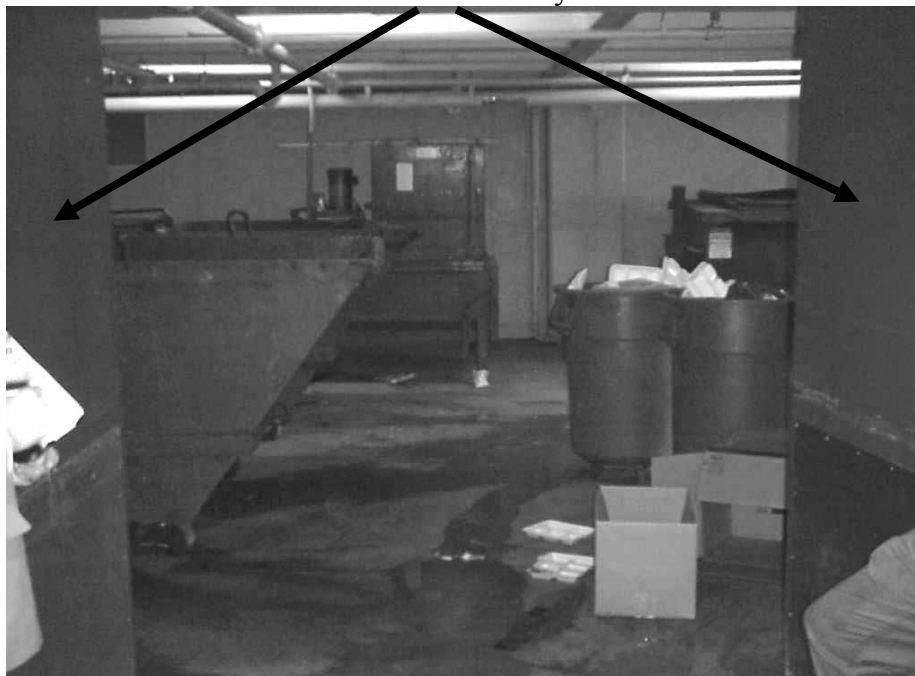
Picture 8

Trash Dumpster Store Room

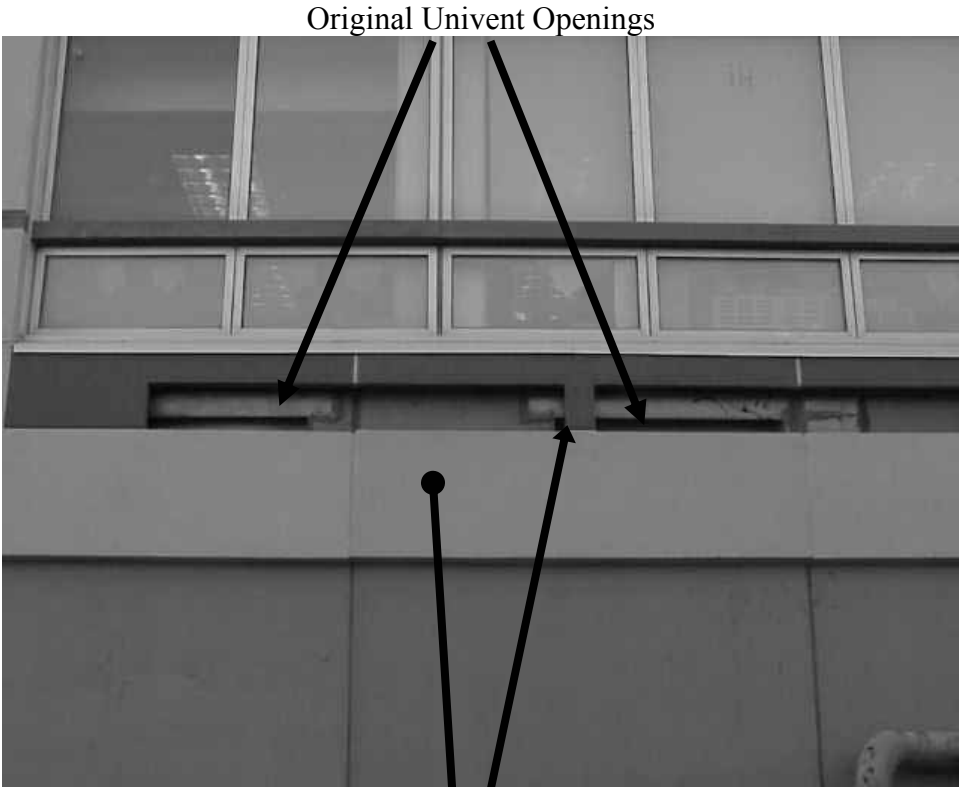
Picture 9

The installation of the exterior wall over the original seaward-facing surface of the school required the removal of the original univent fresh air supply vent exterior louvers. A number of these louvers were installed, but a number of the openings to the univents remain open to the air. The vents that remain open appear to have sections of the new interior wall installed over the fresh air intake vents (see Picture 9). This installation resulted in reduction of the size of openings to some univents, over an estimated 50 percent in one case (see Picture 10). These univents were designed to have the entire fresh air intake vent free of obstruction, except for the fresh air intake louver.

Exterior Wall Installed over Sections of Classroom Univent Fresh Air Intake Vents

2. Consider consulting a ventilation engineer concerning the best option available to ensure appropriate operation of univents with new exterior wall-obstructed fresh air intake vents.

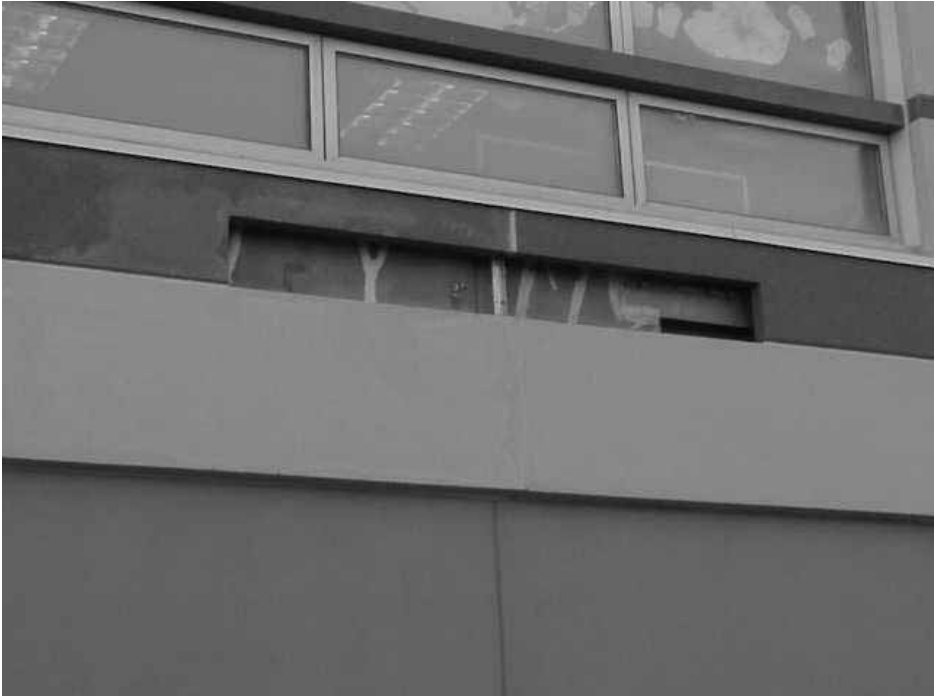
Picture 10

The obstructions may reduce the ability of univents to provide fresh air for classrooms on the seaward side of the building. The alteration of these vents may require that the univents fresh air louvers be opened to a wider fresh air intake setting than other univents in the building to overcome the resistance to airflow the new exterior wall may have created.

Exterior Wall Sealing over Fifty Percent of a Classroom Univent Fresh Air Intake Vents

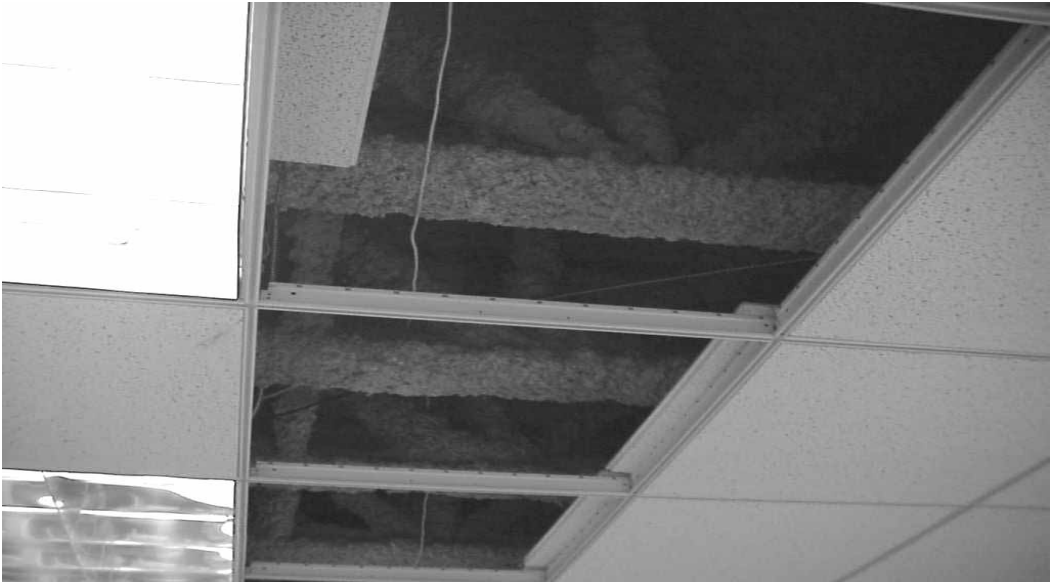
Picture 11

Accumulated chalk dust was noted in several classrooms. Several rooms had missing and/or dislodged ceiling tiles (see Picture 11). Missing ceiling tiles can provide a pathway for the movement of drafts, dusts and particulate matter between rooms and floors. Chalk dust is a fine particulate, which can be easily aerosolized and is an eye and respiratory irritant.

Missing Ceiling Tiles

18. Replace missing or dislodged ceiling tiles to prevent the egress of particulate matter into classrooms.
