INDOOR AIR QUALITY ASSESSMENT

**Augustine Belmonte Middle School
25 Dow Street
Saugus, Massachusetts**

Prepared by:
Massachusetts Department of Public Health
Bureau of Environmental Health Assessment
March, 2000

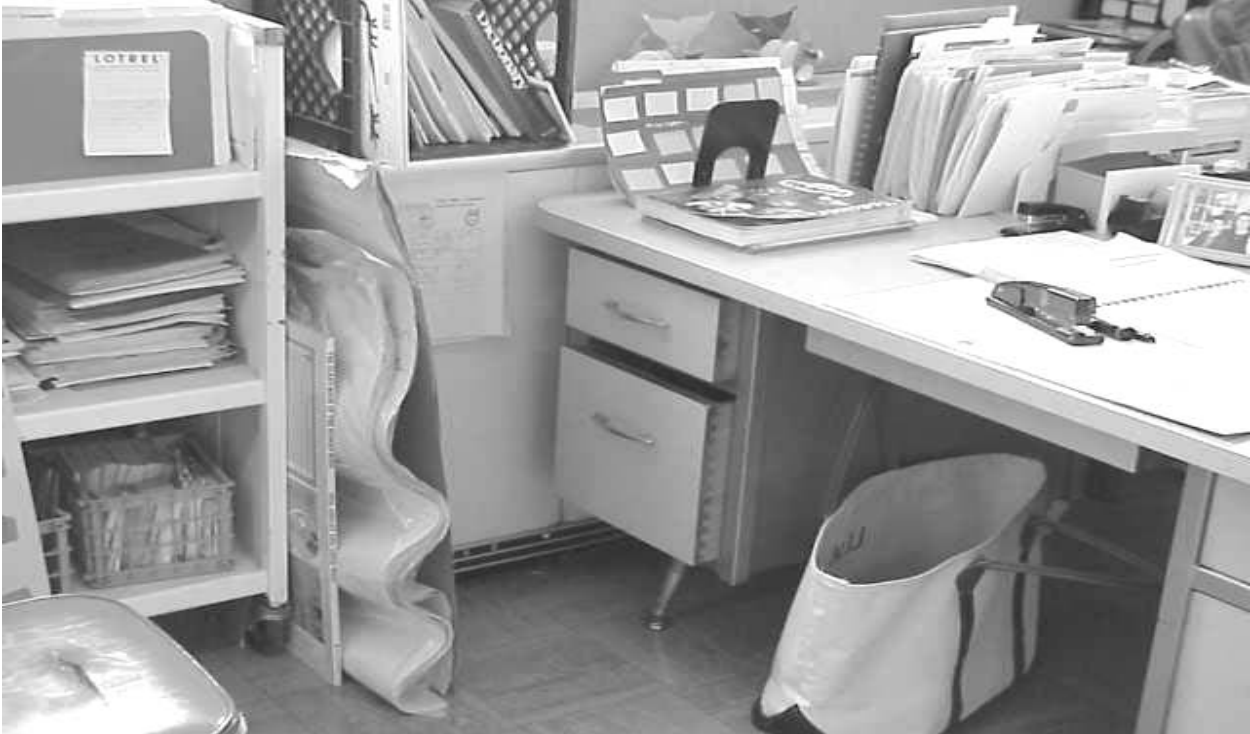
Picture 1

Exhaust ventilation in classrooms is provided by unit exhaust ventilators. Exhaust ventilators were not operating in areas surveyed, with the exception of classroom 107. Blockages to exhaust air intake vents were also noted in several areas. Exhaust ventilation in the library is provided by two wall-mounted exhaust fans located on either side of the room. These fans direct air from the library to the hallways. The library exhaust fans were not operating at the time of the assessment. As with the univents, in

Univent Return Vent Obstructed by Desk

3. Remove all blockages from univents and exhaust ventilators to ensure adequate airflow.
4. Once both the fresh air supply and exhaust ventilation are functioning, the systems should be balanced by a ventilation engineer.

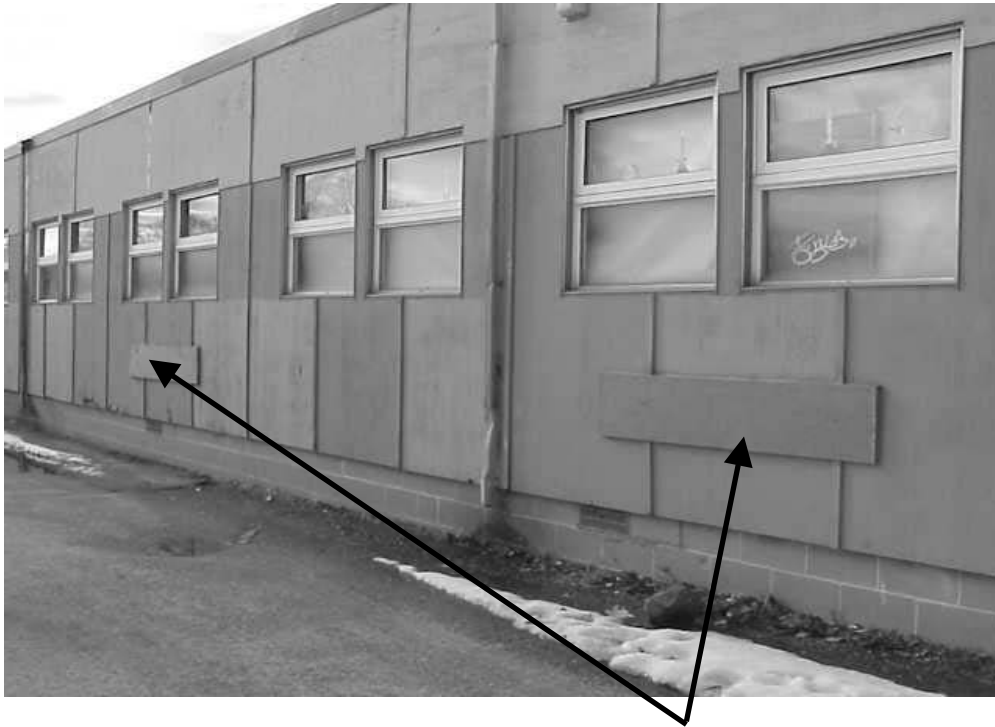
Picture 2

Modular classrooms on the south wing had no mechanical ventilation system. Reportedly, mechanical exhaust vents and univents were removed as a result of energy conservation measures. Spaces formerly occupied by air intakes and exhaust vents were sealed with plywood and sheet metal (see Pictures 2 and 3). Carbon dioxide levels were above 800 ppm in all modular classrooms (see Tables).

**Modular Classrooms –Note Sealed Air Intake Vents and
Downspout Ends Approximately 1-1 1/2 Feet above Ground**

3. Consider consulting a ventilation engineer concerning the installation of mechanical ventilation for modular classrooms.

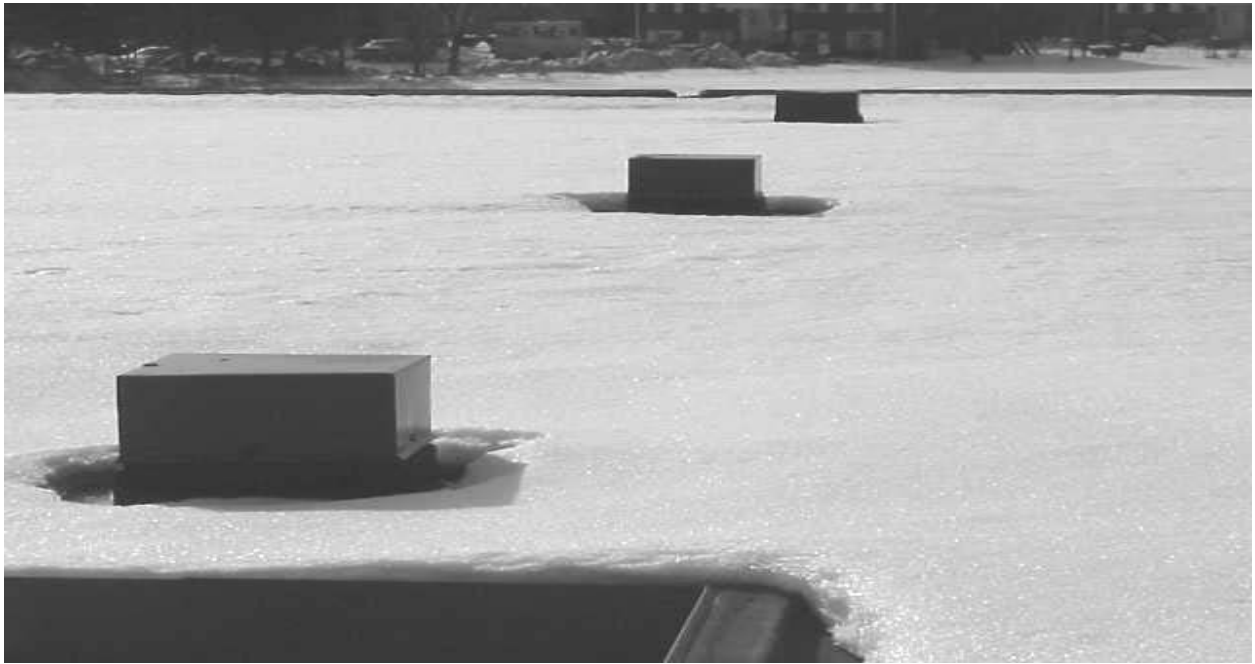
Picture 3

Former Exhaust Ventilation Ducts Sealed with Sheet-Metal

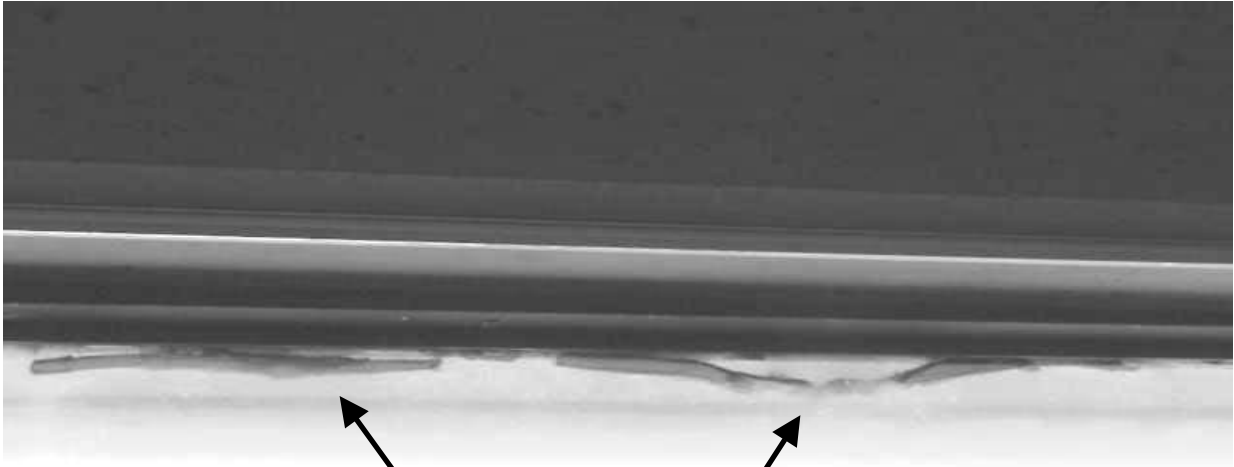
Picture 4

Throughout the school, caulking around the interior and exterior windowpanes was crumbling, missing or damaged (see Picture 4). Several rooms contained loose fitting windowpanes and/or cracked or broken windows. Air infiltration was noted around windows. Many of the metal window frames were corroded and/or water-damaged, which can result in chronic water penetration through improperly sealed windows (see Picture 5). Water penetration through window frames can lead to mold growth under certain conditions. Repairs of window leaks are necessary to prevent further water penetration. Repeated water damage can result in mold colonization of window frames, curtains and items stored on or near windowsills.

Damaged/Missing Window Caulking

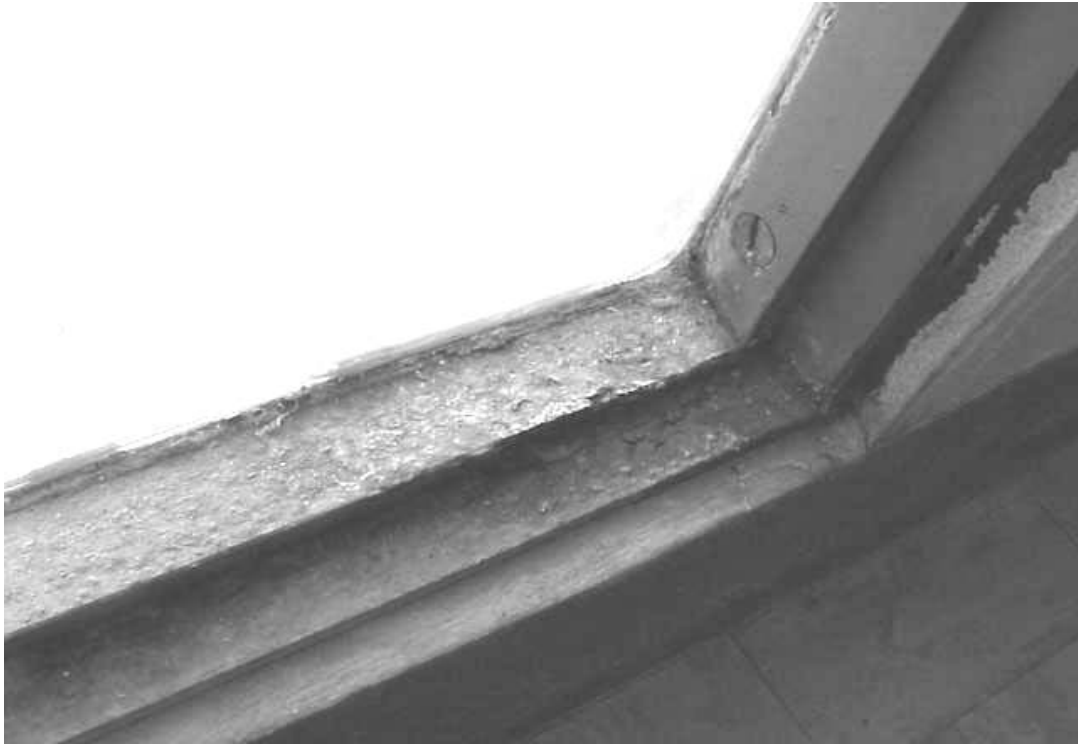
Picture 5

Water Damaged Window Frame

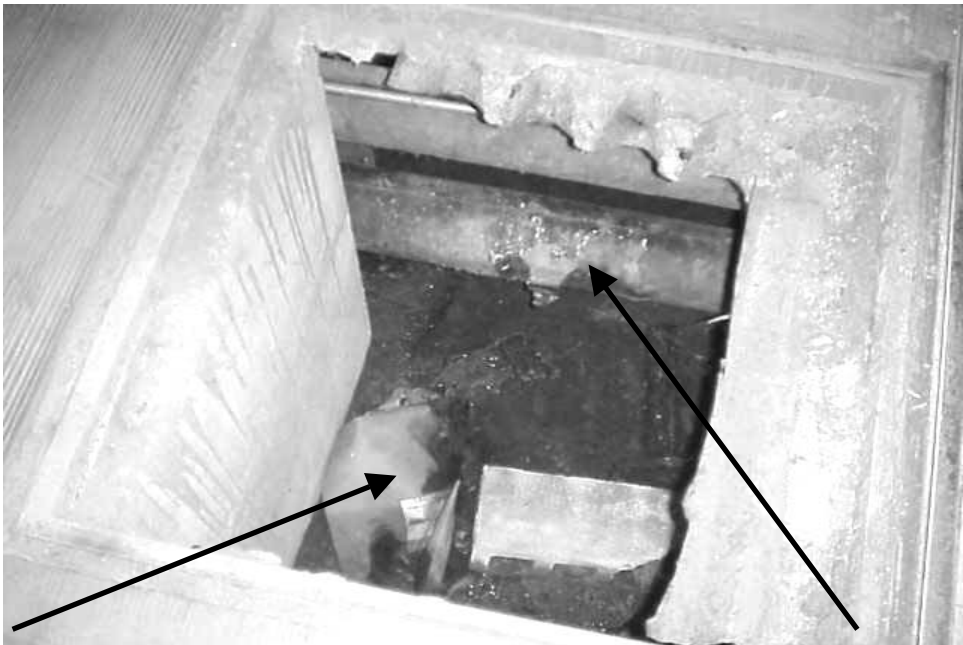
Picture 6

The crawlspace at the far south side of the building was examined. Several inches of water was found on the floor of this space. Fiberglass pipe insulation was severely water damaged and showed signs of possible mold growth (see Picture 6). Also within the crawlspace were saturated cardboard boxes and other debris that showed signs of possible mold growth. Although no odors from mold growth in the crawlspace were noted at the time of the assessment, the potential for odors exists. Standing water can become stagnant, which can lead to mold, bacterial, or other microbial growth that can be a source of unpleasant odors.

Crawlspace Containing Standing Water –Note Water-Damaged Pipe Insulation/ Debris

6. Remove cardboard boxes and debris from crawlspace.

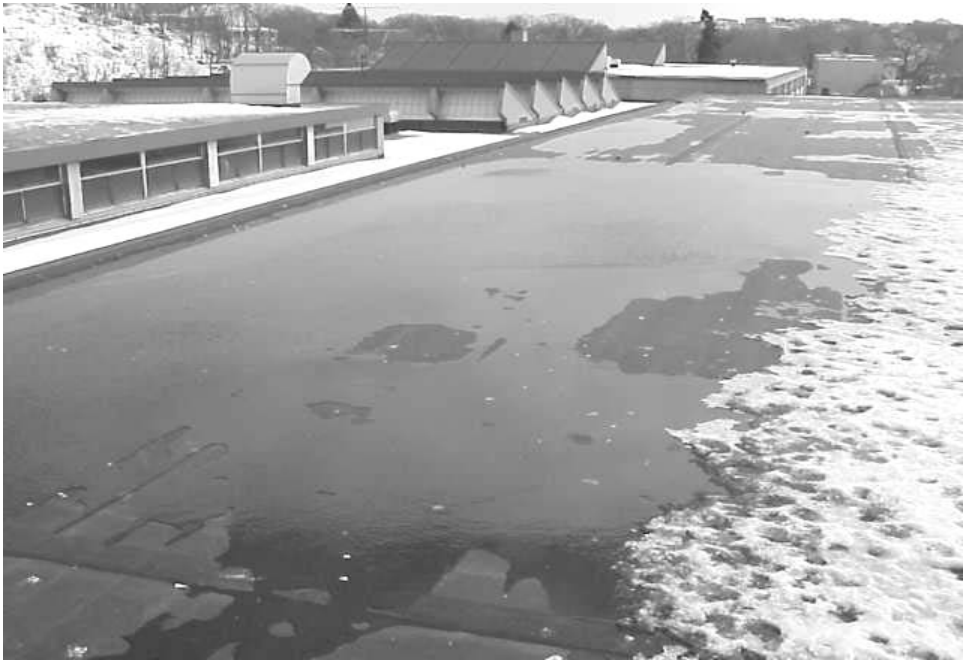
Picture 7

Pooling water was also noted on a number of areas on the roof (see Picture 7). Roof sections over the cafeteria and gymnasium were elevated above the main roof. Draining rainwater from these elevated sections of the roof is directed onto the main roof via downspouts (see Picture 8). The pooling of water and the subsequent freezing and thawing during winter months can lead to roof leaks and water penetration into the interior of the building.

Water Pooling on Roof

8. Inspect roof for proper drainage; examine periodically for standing water.
9. Move plants away from univents in classrooms. Examine drip pans for mold growth and disinfect areas of water leaks with an appropriate antimicrobial where necessary.

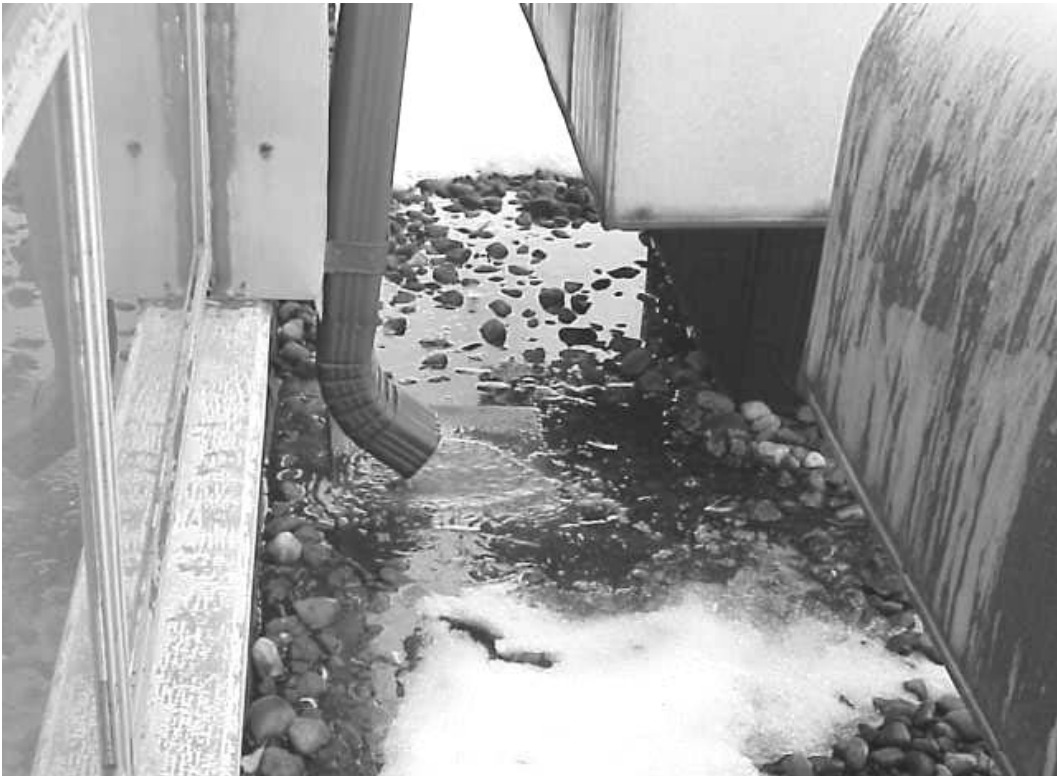
Picture 8

Water Accumulation on Roof

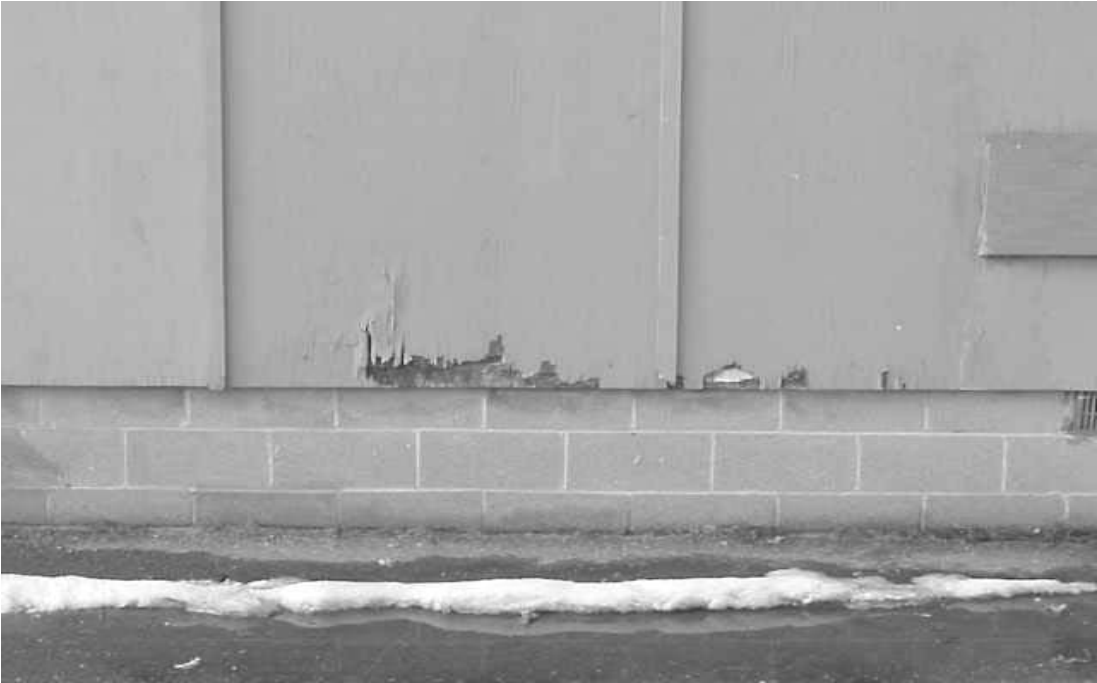
Picture 9

Wood siding of the modular classrooms was damaged and warped from moisture exposure (see Picture 9). Exterior walls of these classrooms should be inspected periodically and repaired and/or replaced to prevent water penetration into interior areas behind wooden planks.

Water Damaged Siding on Modular Classrooms

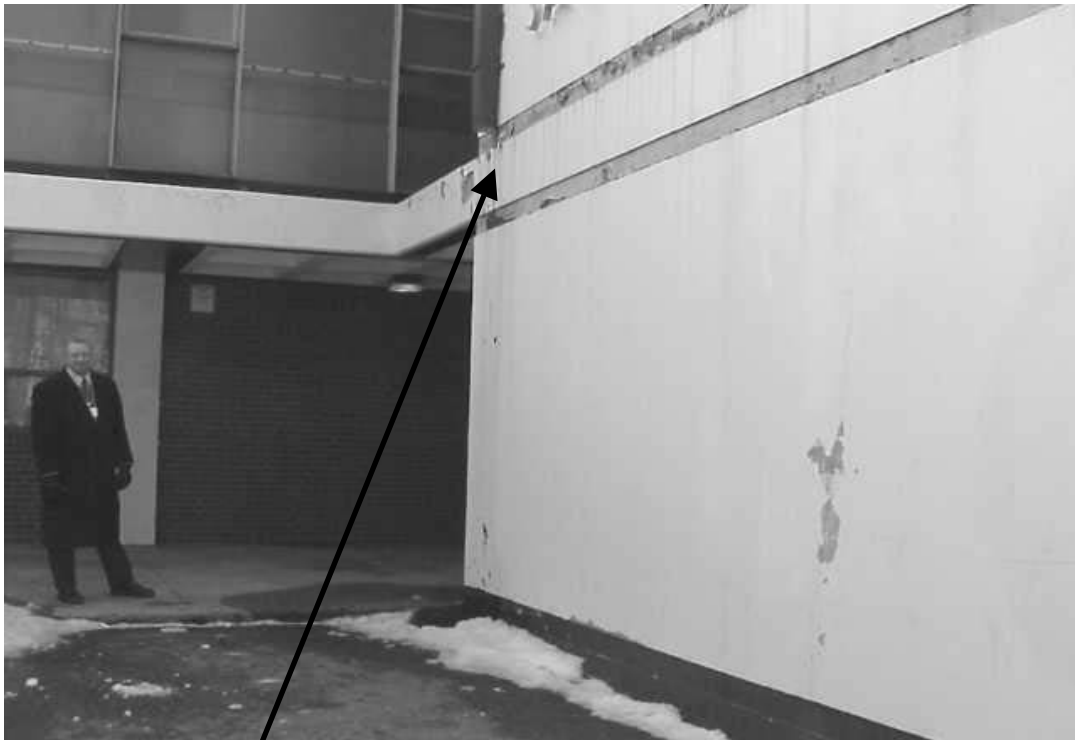
The perimeter also has several problems with drainage. The roof is outfitted with a drainage system that is connected to downspouts. The downspout shown in Picture 10 ends approximately 10 feet above ground, which allows back-splashing rainwater to pool and splash on the ground below and chronically wet the exterior wall. Downspouts should be designed to direct rainwater away from the base of the building to prevent

water pooling and subsequent penetration through exterior walls that can result in damaged building materials and/or mold growth.

Drain-spout Ending Several Feet above Ground Level

10. Examine the feasibility of extending downspouts to ground level and directing water away from the base of the exterior wall.
11. Replace missing ceiling tiles and fill utility holes and wall cracks to prevent the egress of dirt, dust and particulate matter between rooms and floors. Particular attention should be applied to sealing utility holes on the first floor to prevent potential crawlspace odors from entering occupied areas.

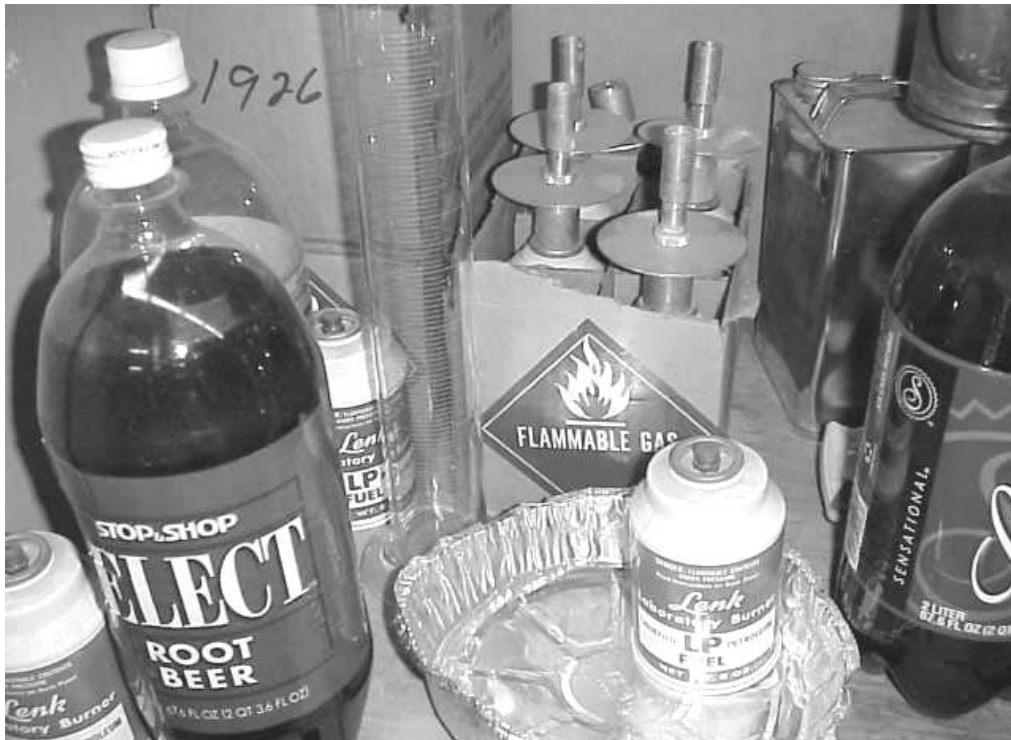
Picture 11

Science room 309 had flammable materials, including methanol, isopropyl alcohol, and numerous containers of liquid propane fuel, stored in cabinets under the sink and other areas (see Picture 11). The woodshop storage area contained flammables on open shelves. Flammable materials should be stored in flammable storage cabinets that meet the specifications of the National Fire Protection Association (NFPA) (NFPA, 1996). The woodshop storage area also had items that appeared to be of significant age.

Flammable Materials under Sink in Room 309

16. Change filters in window-mounted air conditioners as per the manufacturer's instructions to prevent the re-aerosolization of dirt, dust and particulate matter.
17. Consider obtaining flameproof cabinets that meet NFPA requirements. Store flammable materials in the flameproof cabinets in a manner consistent with state and local fire codes.
18. Remove birds' nests from fresh air intake vents.
19. Examine the feasibility of increasing/improving local exhaust ventilation for wood cutting/sanding machinery in shop areas.

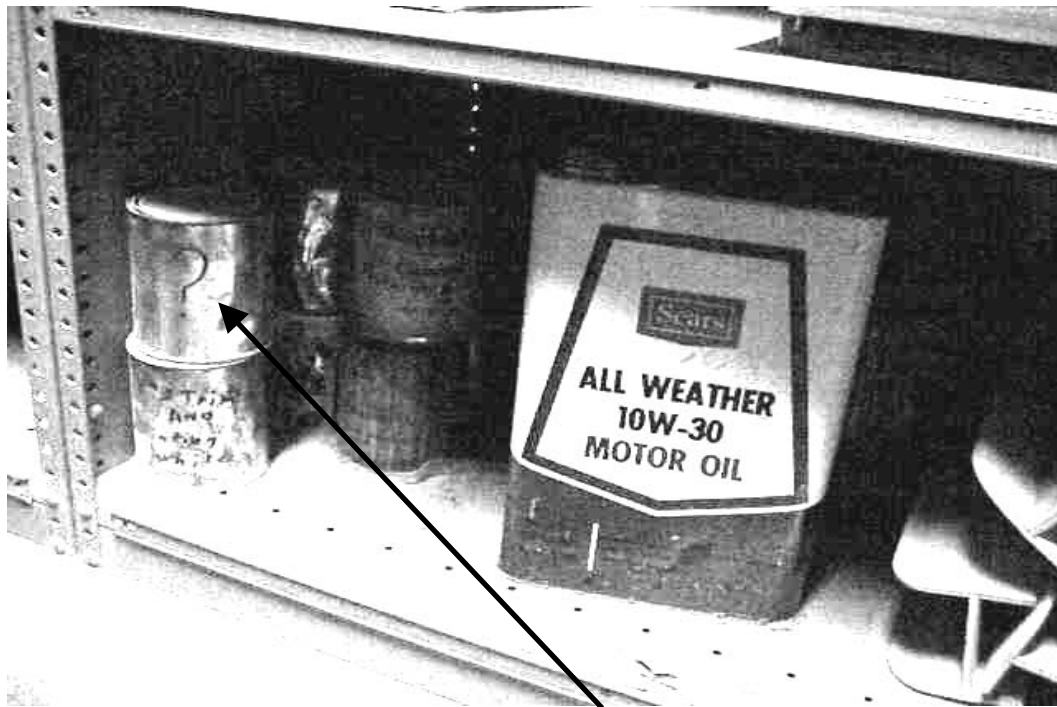
Picture 12

One container was labeled with a question mark (see Picture 12). It is recommended that a thorough inventory of woodshop and science materials be done to assess storage and/or disposal in an appropriate manner consistent with Massachusetts hazardous waste laws.

Note question mark on unlabelled container

Materials in Woodshop Storage Area-Bottom Shelf

14. Re-activate wall-mounted exhaust vent in reading room 233 to help remove excess heat and odors generated by computer mainframe equipment.
15. Have a complete inventory done in all storage areas and classrooms. Discard hazardous materials or empty containers of hazardous materials in a manner consistent with environmental statutes and regulations. Follow proper procedures for storing and securing hazardous materials. Obtain Material Safety Data Sheets

(MSDS') for chemicals from manufacturers or suppliers. Be sure all materials are labeled clearly.

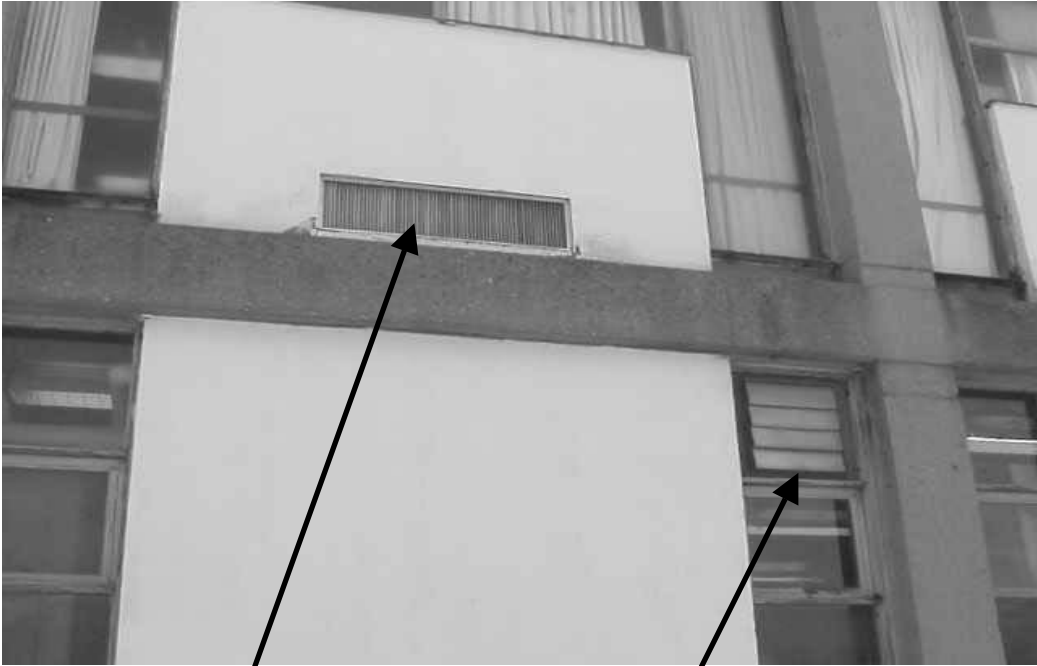
Picture 13

Air Intake in Close Proximity to Exhaust Vent

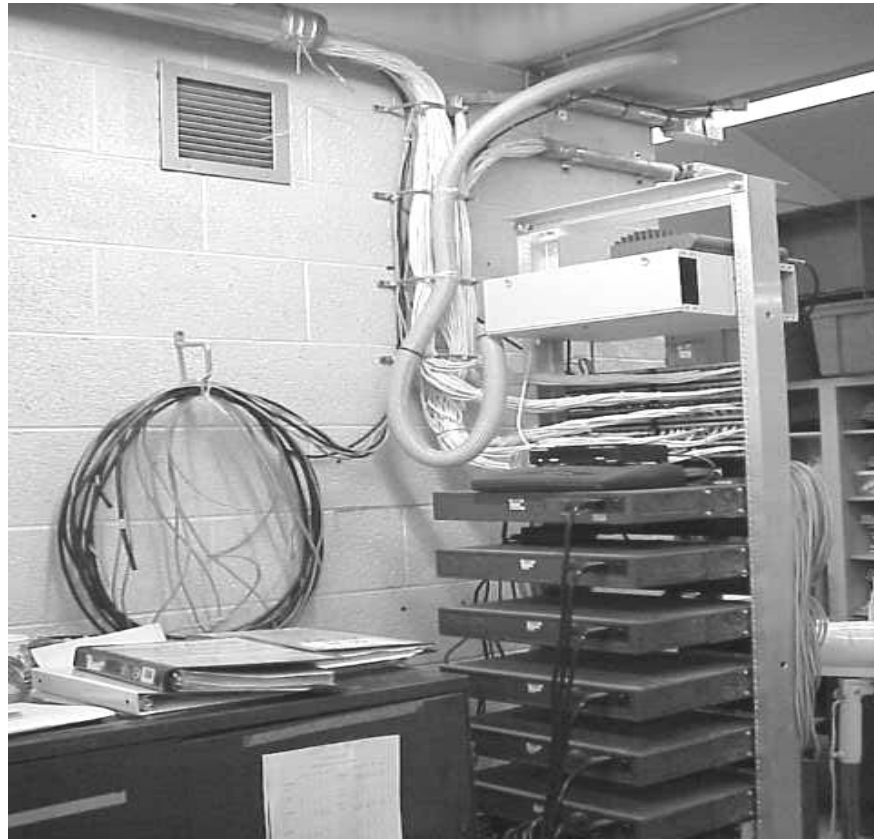
Picture 14

Reading room 233 contained the computer mainframe located near an exhaust vent (see Picture 14). This vent was not operating at the time of the assessment. Faculty lounges in the south wing contained photocopiers. Volatile organic compounds (VOCs) and ozone can be produced by photocopiers, particularly if the equipment is older and in frequent use. Ozone is a respiratory irritant (Schmidt Etkin, D., 1992). Photocopiers and computer equipment also give off excess heat. Without active mechanical exhaust ventilation, pollutants produced by office equipment can build up. School personnel

Computer Main Frame Located beneath Inactive Exhaust Vent in Reading Room 233

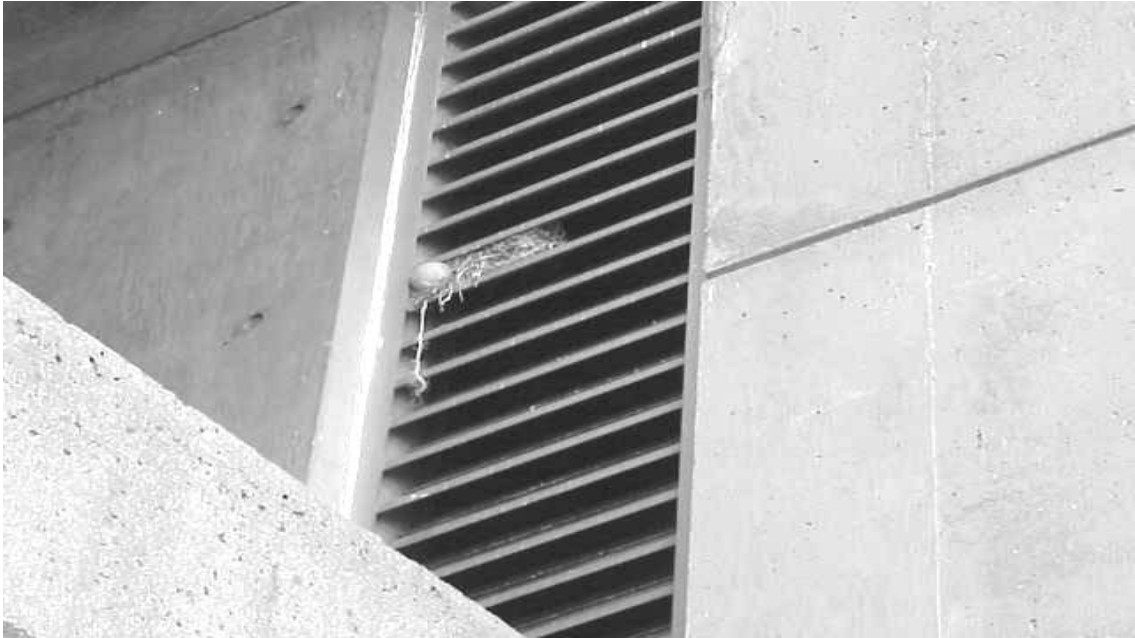
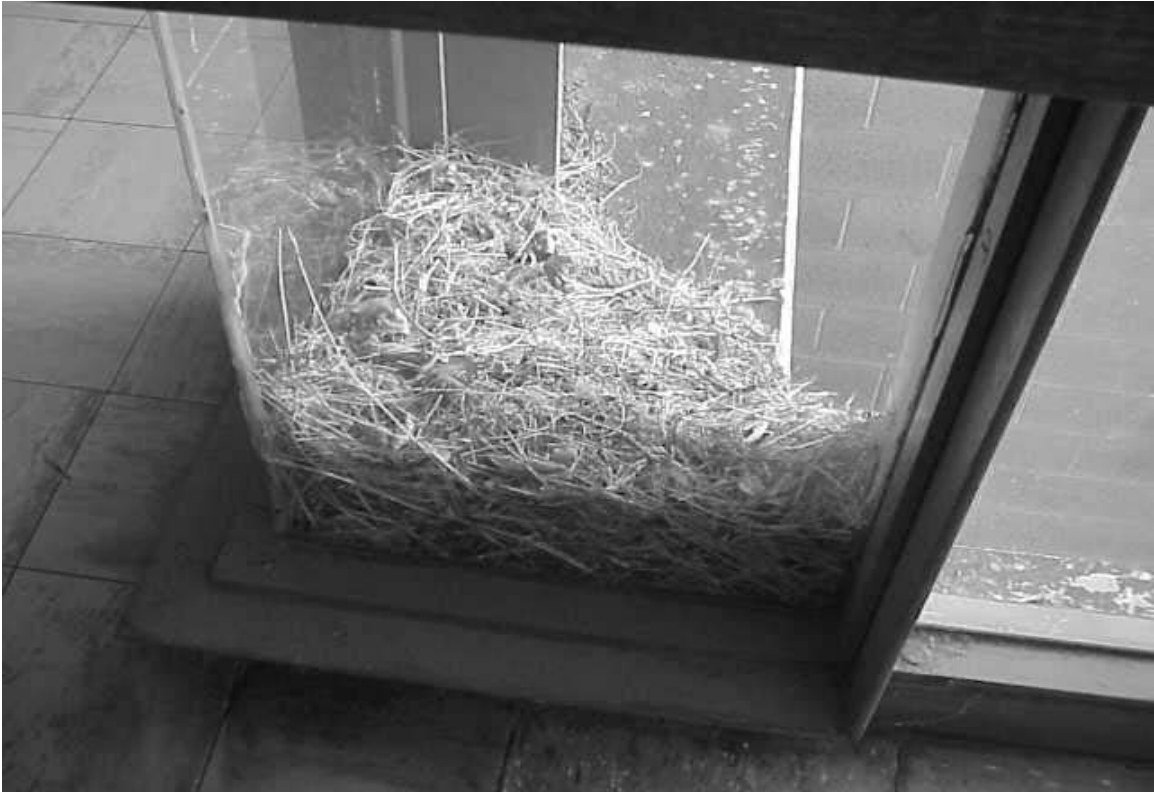
Birds' nests were noted around the building, one of which was located in a fresh-air intake vent (see Pictures 15 & 16). Birds can be a source of disease and bird wastes and feathers can contain mold and mildew, which can be irritating to the respiratory system. If this vent is in use, these materials can be introduced into the building.

Bird Nest in Air Intake Vent

Bird Nest (taken from inside building) On Front Ledge of Second Floor
