INDOOR AIR QUALITY ASSESSMENT

**Upton Town Library
1 Main Street
Upton, Massachusetts**

Prepared by:
Massachusetts Department of Public Health
Bureau of Environmental Health Assessment
May, 2000

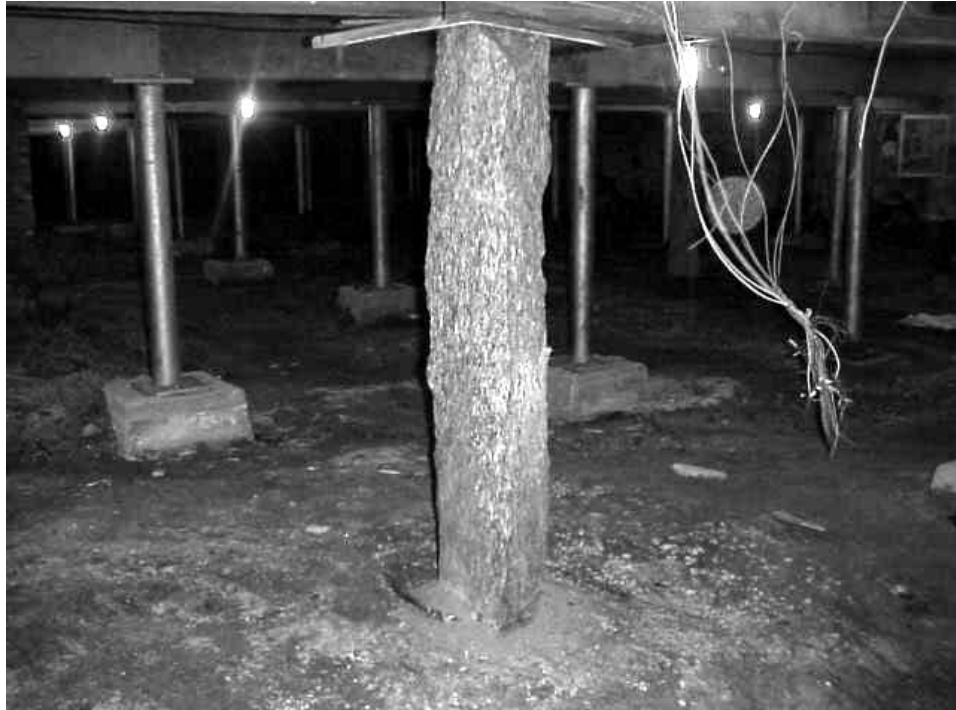
Picture 1

The Upton Library is a wood frame, two-story building originally constructed as a church in the early 1800's. The building was converted into offices for the Town of Upton in the 1970's by students from a local vocational school. The exterior of the building is clad with aluminum siding. The attic of the building is used for storage. The second floor contains offices for the Upton Historical Society and vacant office space. The first floor contains the library, which has an office and meeting room. The basement has a dirt floor with a gas-fueled furnace. The foundation of the basement consists of stacked flagstone. Several of the original floor joist support pillars are granite (see Picture 1), which indicates that the building may be nearly 200 years old. Windows in the building are openable.

**Granite Floor Support Pillar, Note Steel Tube Floor Supports
in Background That Indicate Renovations**

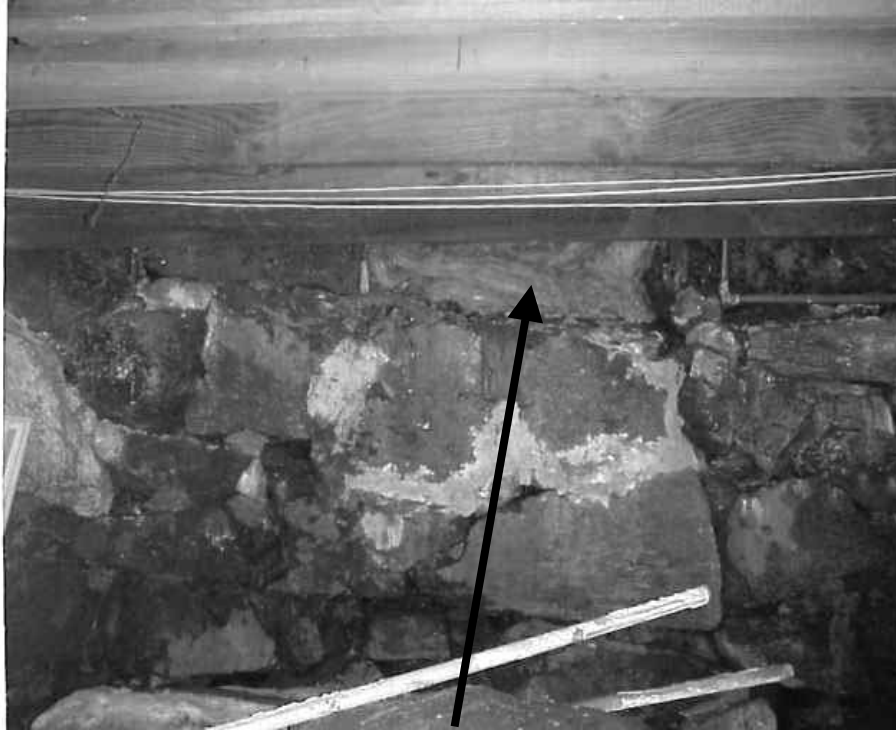
Picture 2

Enhancing the ability of rainwater to penetrate into the basement is the existence of former window casings on the flagstone foundation (see Picture 2). Each window opened into a pit along the exterior of the foundation. Each of these pits was plugged with fiberglass insulation (see Picture 3). The exterior opening for each pit was sealed with a wooden plug (see Picture 4). Since these plugs are not watertight, rainwater impacting along the foundation can readily penetrate into the basement.

Former Basement Window Casing in Basement, Sealed with Fiberglass Insulation

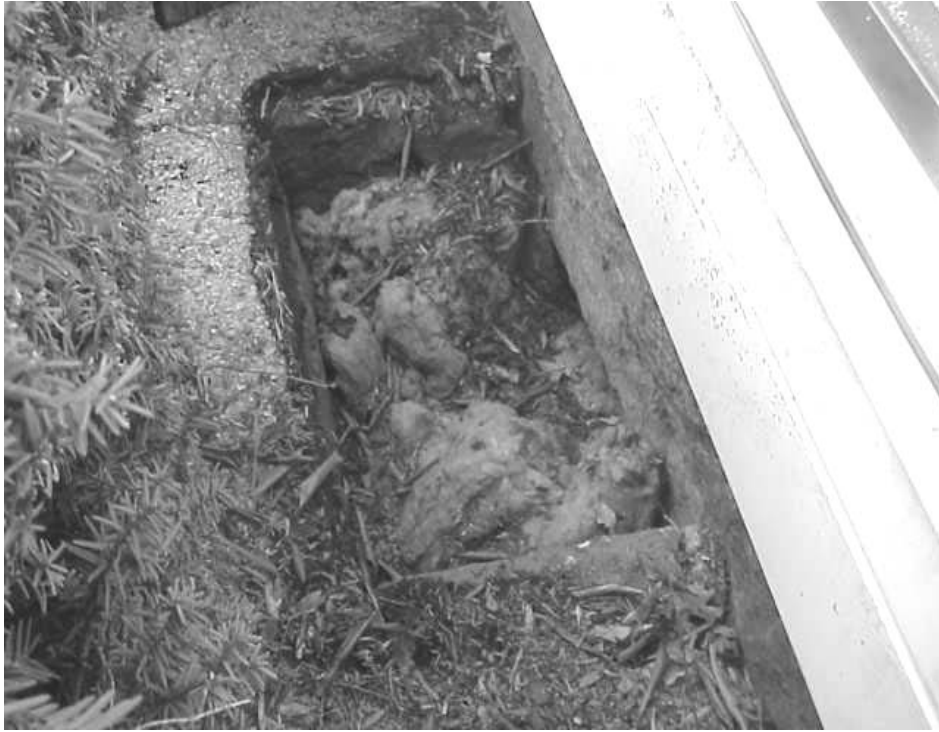
Picture 3

Exterior Shot of Window Casing Sealed with Fiberglass Insulation

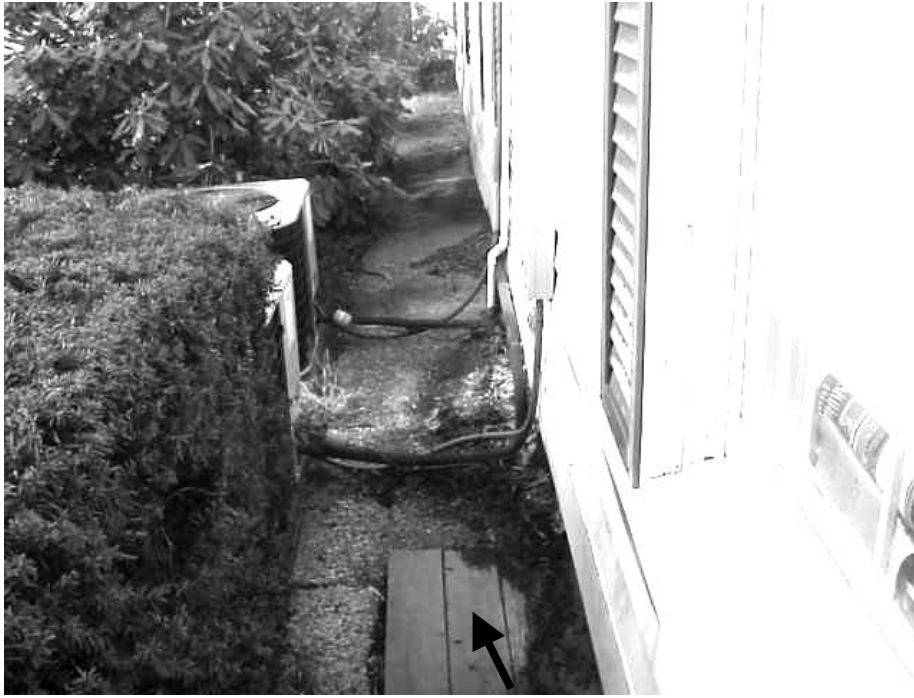
Picture 4

Wooden Plug Sealing Window Casing of Picture 3

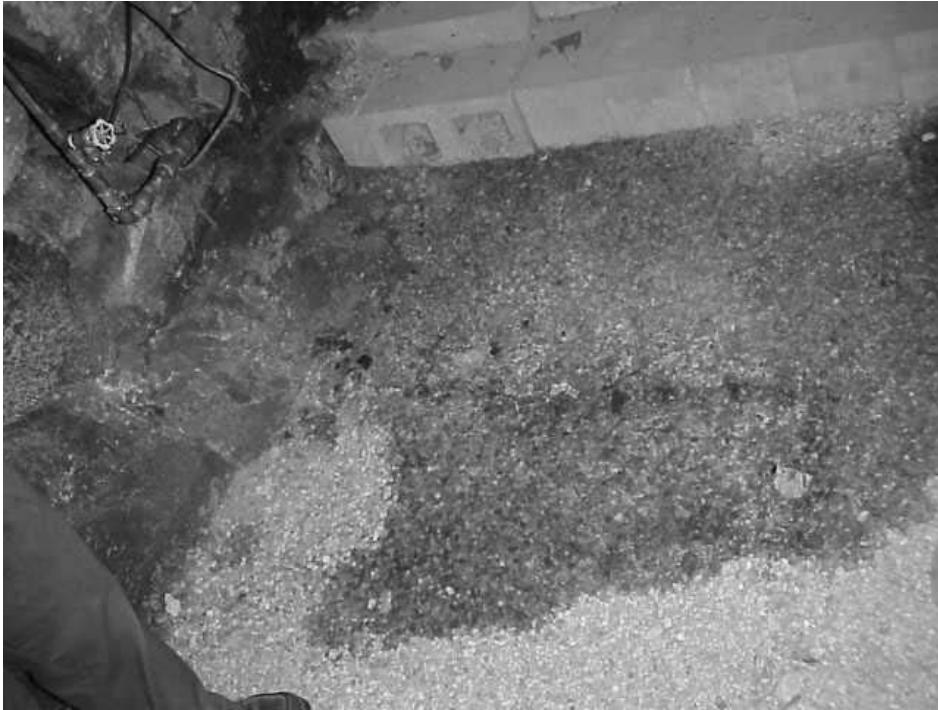
Picture 5

Pooling water was noted in the basement (see Picture 5). The source of water appears to be condensation and/or a leak from the water meter (see Picture 6). This active source of water can serve as a constant generator of mold growth in the basement.

Standing Water in Basement

1. Eliminate pooling water by installing/restoring the roof gutter/down spout system to direct rainwater away from the base of the building.
2. Consider installing insulation beneath the first floor floorboards to create a vapor barrier to limit air movement from the basement into the library. Render all utility pipes holes in the first floor airtight.
3. Consider reactivating fan heaters in the basement. Operate these systems continuously to reduce relative humidity in the basement. If this option is chosen, the installation of mechanical exhaust fans in the basement to equalize air pressure in the basement while exhausting odors should be considered. This system may be installed using the abandoned foundation windows to provide exhaust ventilation.
4. Examine the feasibility of installing a mechanical ventilation system for second floor office space.

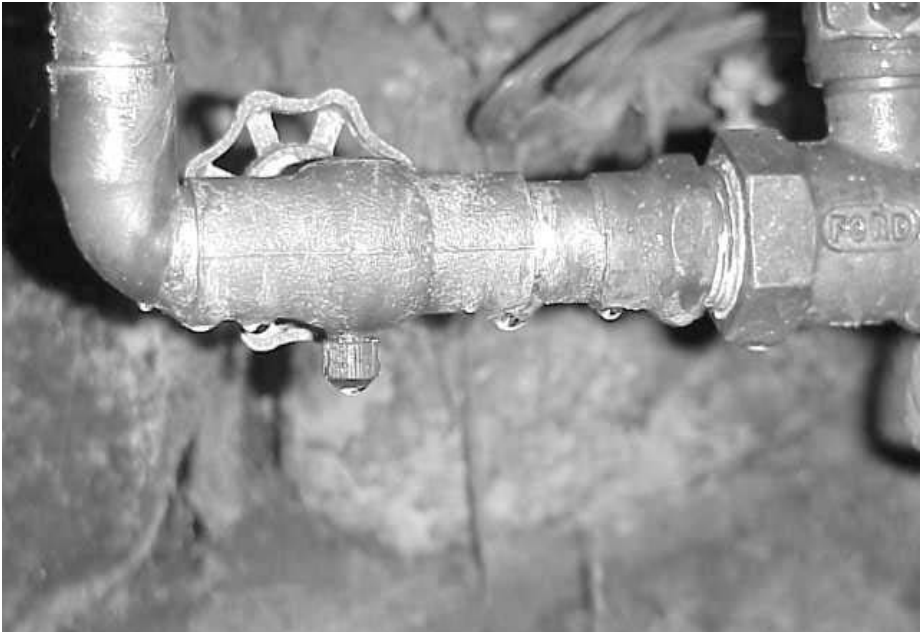
Picture 6

Condensation on Water Pipes

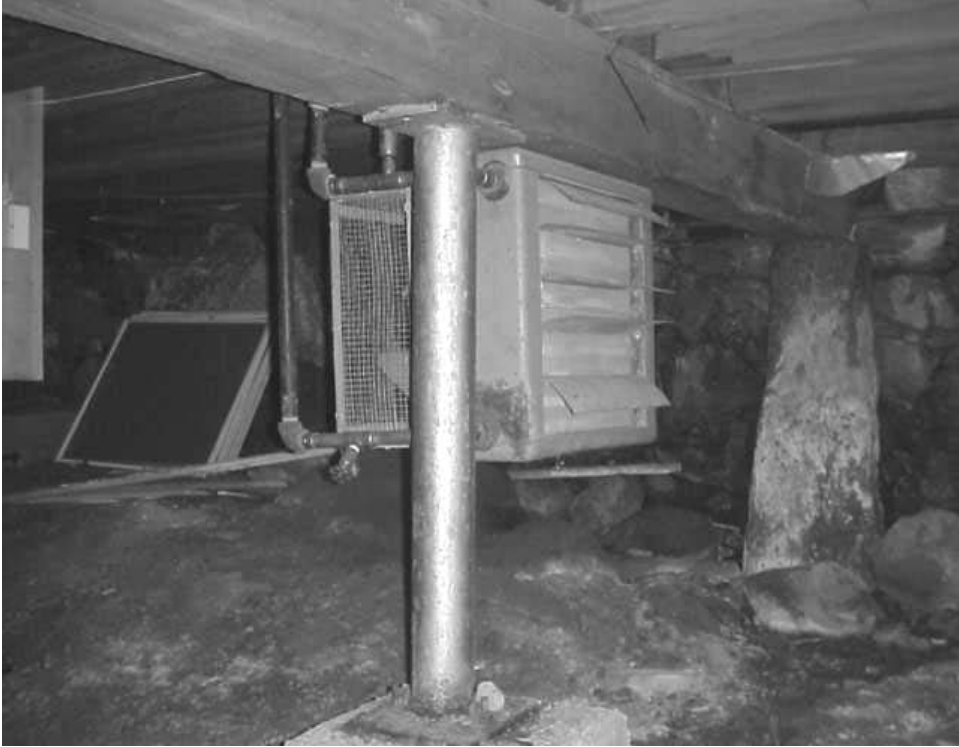
Picture 7

In order to control mold growth, water penetration into the basement area must be minimized. Control of water penetration through the foundation can be limited by installing gutters and permanently rendering watertight the former window frames in the basement. A second method would be to control the relative humidity within these areas by the application of heat. The basement has two heater/fan combination units installed to direct heated air into the dirt floor area of the basement (see Picture 7). It appears that a previous method used to control moisture in these areas was to provide heat from these units to reduce relative humidity. As air is heated, its volume expands and the relative humidity will decrease. With these units operating on a regular basis, relative humidity would be decreased and mold growth controlled or at least minimized. None of these units were operating during the assessment.

The use of these fans to reduce relative humidity in the basement may not be advisable at this time. Since musty odors already exist in the basement, the operation of these fans may create positive pressure in the basement. Positive pressure may serve to

force mold spores into the occupied areas of the building through spaces in walls or ceiling tiles. Until water penetration is controlled, these fans should not be operated.

Fan Heating Unit in Basement

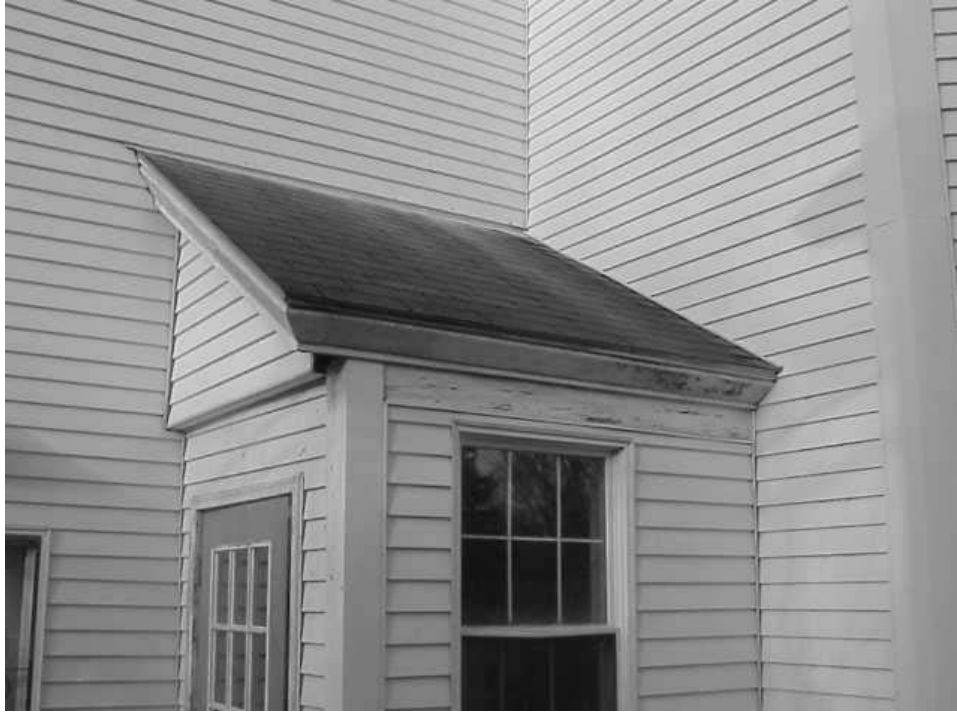
Picture 8

Water damaged ceiling plaster was noted in the rear stairwell near the exterior door of the building, which indicates water leaks through the roof. This leak is most likely through the seam where a small roof meets the exterior wall of the building (see Picture 8).

Wall/Roof Junction above Stairwell Water Damaged Plaster

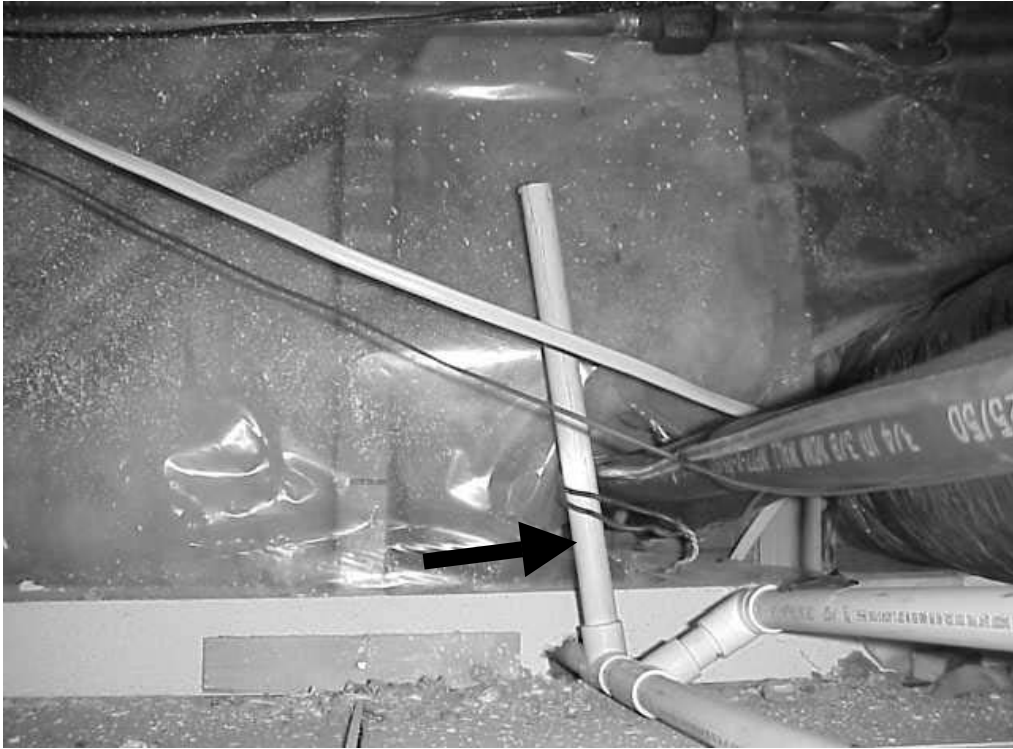
Picture 9

The AHUs have the capacity to provide air-conditioning during warm weather. The provision of air-conditioning produces condensation from the operation of cooling coils in each AHU, which requires each unit to have a drain. PVC pipe is connected to each unit and serves as a drain, which empties at the base of the building outdoors. A pipe joint with an open length of PVC pipe exists above the suspended ceiling (see Picture 9). This open pipe can serve as a source for moisture to penetrate into the occupied areas of the library.

Open PVC pipe of AHU Condensation Drain

1. Consider consulting a ventilation engineer to evaluate the library AHUs. Open fresh air dampers to increase the quantity of air circulated by the AHUs.
2. Replace AHU filters regularly as per the manufacture's instructions.
3. Render the former basement windows watertight.
4. Seal the condensation pipe in Picture 9.
5. Repair the leaking water pipe in the basement.
6. Consider insulating water utility pipes to reduce the potential for condensation.
7. Examine the feasibility of installing mechanical exhaust ventilation in restrooms.
8. Examine the junction between the lower roof and exterior wall for water penetration and reseal if necessary. Repair water damaged wall materials in the rear stairwell.
9. Install weather stripping along the edges of the basement door to limit air movement through the doorframe.
