# **INDOOR AIR QUALITY ASSESSMENT**

**Boylston Elementary School  
at the  
Boylston Town Offices Building  
221 Main Street  
Boylston, Massachusetts**

Prepared by:  
Massachusetts Department of Public Health  
Bureau of Environmental Health Assessment  
June, 2000

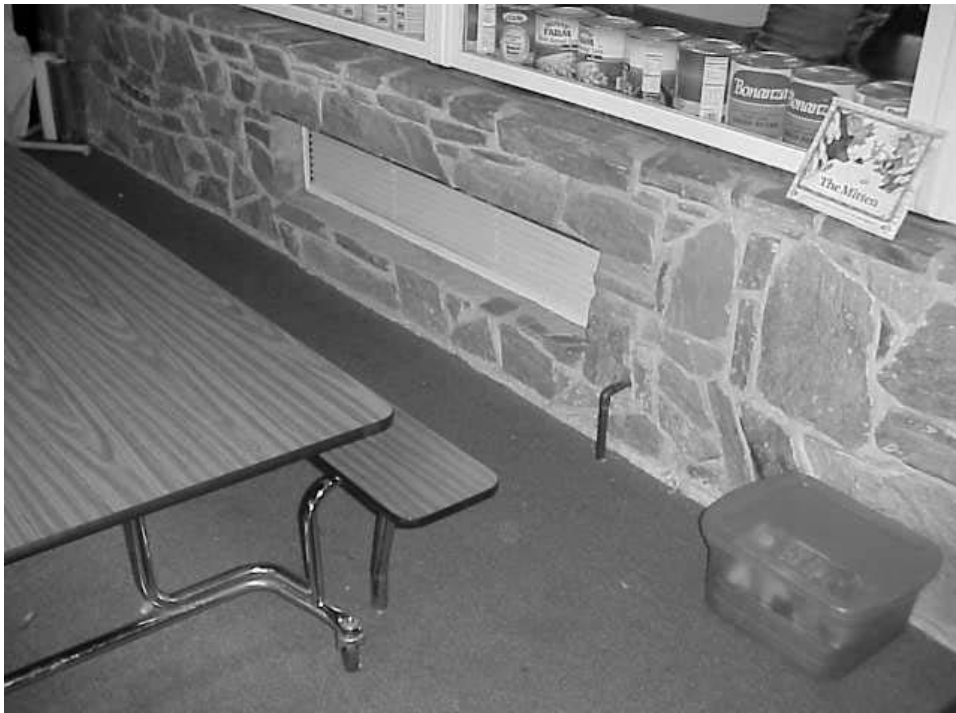
**Picture 1**

Fresh air in the cafeteria/kitchen area is provided by univents as well. It appears that the original structure of the building included the kitchen and inner cafeteria, which had univents beneath a large former exterior wall ([see Picture 1](#)). Subsequent renovations added the outer cafeteria area, which enclosed the original cafeteria/kitchen univent fresh air intakes indoors (see Picture 2). As a result, the cafeteria/kitchen does not appear to have a fresh air supply. The outer cafeteria has six univents with fresh air intakes (see Picture 3). It appears that the operation of these univents is inadequate to provide sufficient fresh air for the student population noted in this area (90+ students and staff), since carbon dioxide levels exceeded 800 ppm.

**Kitchen/Cafeteria Univent Fresh Air Supply Vent Sealed Indoor  
by Outer Cafeteria, Note Stone of Former Exterior Wall**

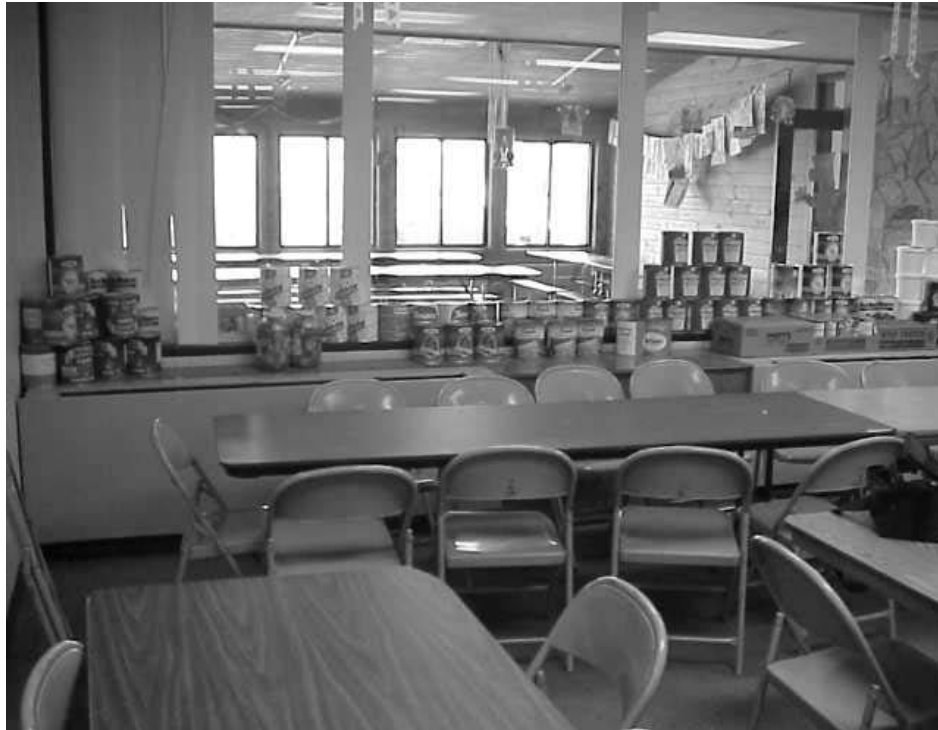
**Picture 2**

**Interior View of Kitchen/Cafeteria, Univalent Fresh Air Intakes Sealed Indoors Are Located below Windows**

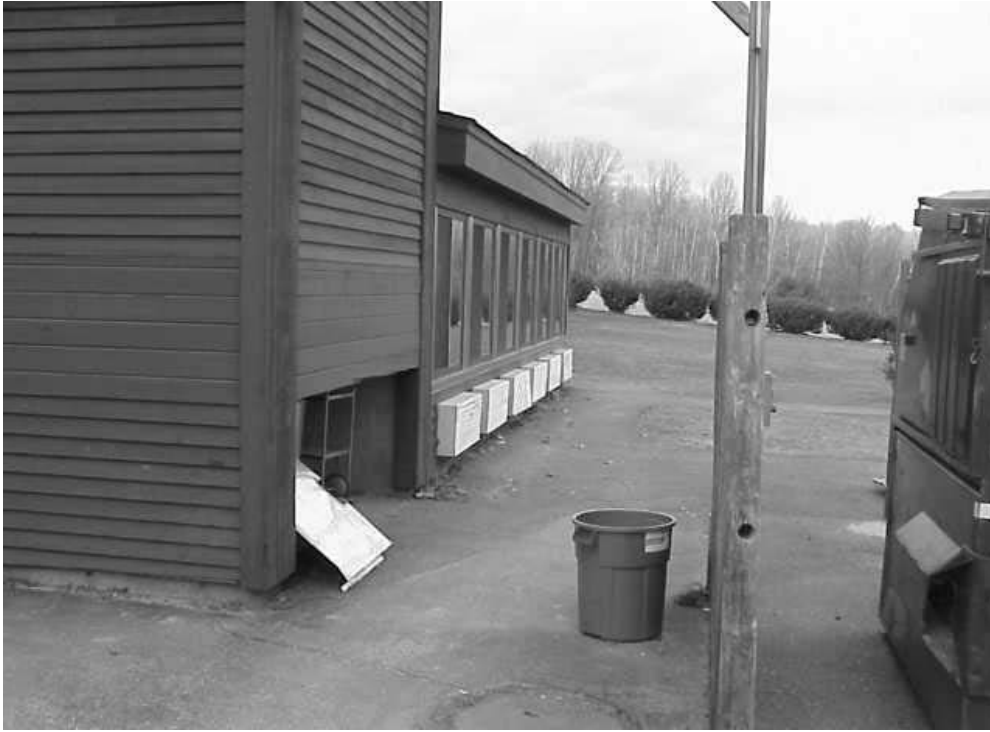
**Picture 3**

**Outer Cafeteria Fresh Air Intakes**

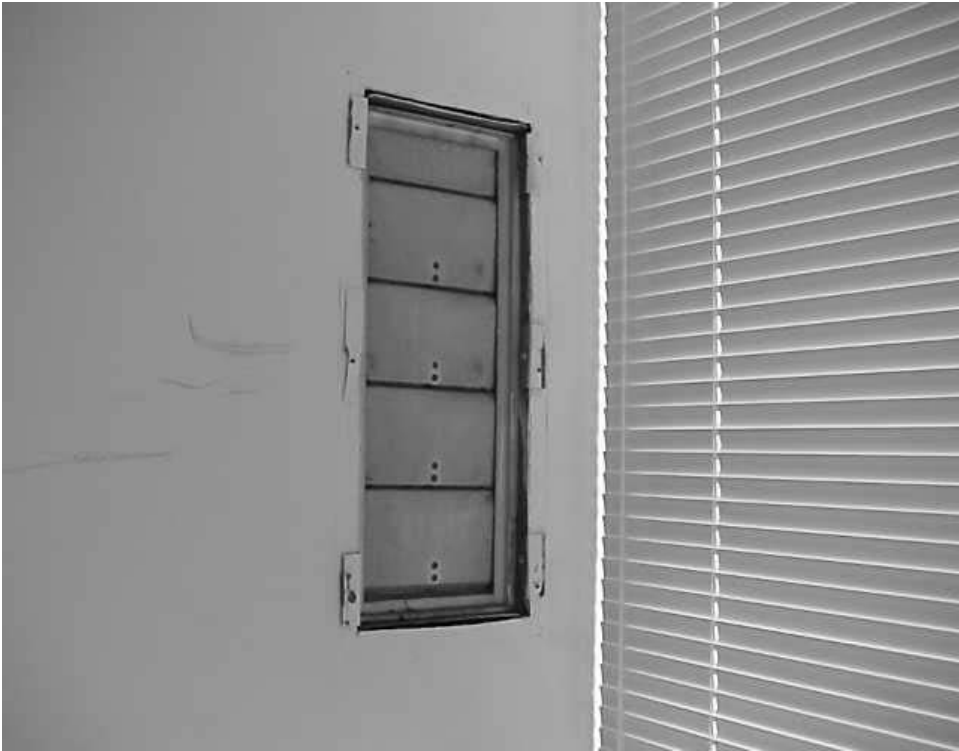
Picture 4

With the exception of restrooms, no mechanical exhaust ventilation system exists in the building. First floor classrooms have a passive non-mechanical exhaust vent (see Picture 4). In order to function, this ventilation system relies on positive pressure created by the univent to force air out of the passive vent. As the univent operates, air pressure increases and additional fresh air is introduced into the classroom (called positive pressure). As positive pressure increases, air is forced out of the room through wall and door spaces. The passive vent is designed to allow for slow release of air from classrooms by increasing positive pressure created by the univent. Each vent contains metal louvers on hinges, which should open to release air from the room through a vent on the exterior of the building (see Picture 5). The design of these exhaust vents requires that classroom hallway doors remain

**Louvered Exhaust Vent with Grille Cover Removed**

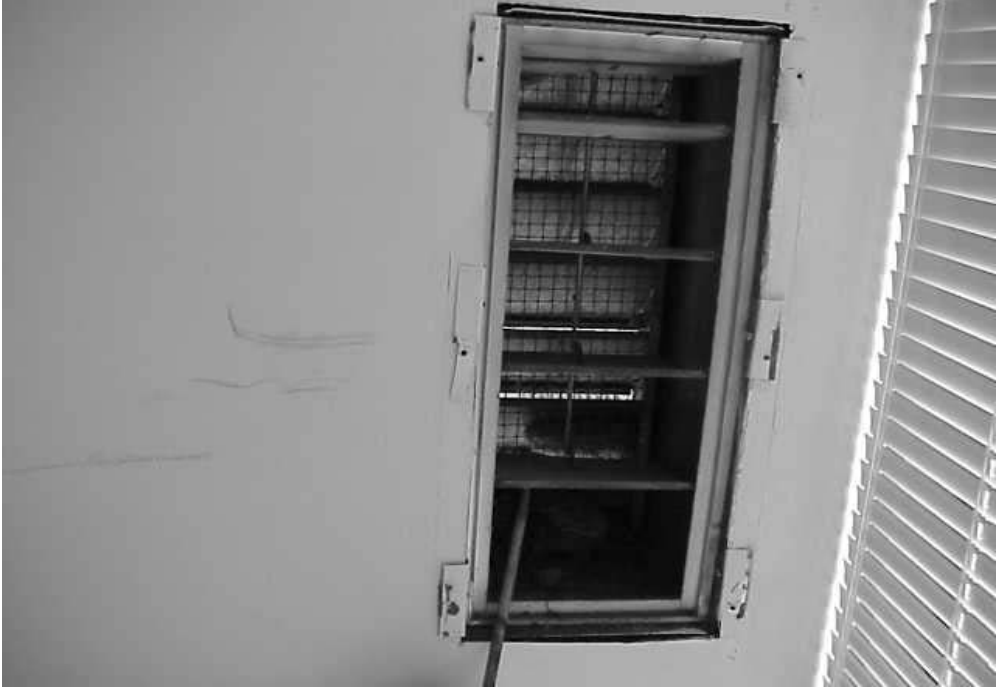
Picture 5

closed as much as practical in order to maintain positive pressure. With hallway doors open, classroom air would be forced into hallways. In addition, several of these passive vents were examined and noted to be backdrafting cold air into classrooms. Previous BEHA experience indicates that these types of systems tend to backdraft cold air during winter months. Without a mechanical system, these vents may not function to provide exhaust ventilation and can be a source of cold air during winter months. An examination of these vents reveals that the louvers are in various states of disrepair. In order for these vents to operate, routine cleaning and lubrication of the louvers would be necessary so that the louvers will readily rotate with minimum positive pressure in the classroom. With the absence of active mechanical exhaust ventilation, pollutants generated during building occupancy will tend to linger in classrooms.

**Exhaust Vent with Louvers Fully Opened**

1. Operate univents while classrooms are occupied.
2. Remove all blockages from univents.
3. Repair/replace the exhaust vent louvers. Remove wasp nests from these vents in a manner as to not introduce insects or chemical agents into the school via the ventilation system.
4. Examine the feasibility of replacing drip pans in univents.
5. Replace water damaged pipe insulation.
6. Replace water damaged plasterboard in the ceiling of restrooms.
7. For buildings in New England, periods of low relative humidity during the winter are often unavoidable. Therefore, scrupulous cleaning practices should be adopted to minimize common indoor air contaminants whose irritant effects can be enhanced when relative humidity is low. An increase in filter efficiency in the HVAC system

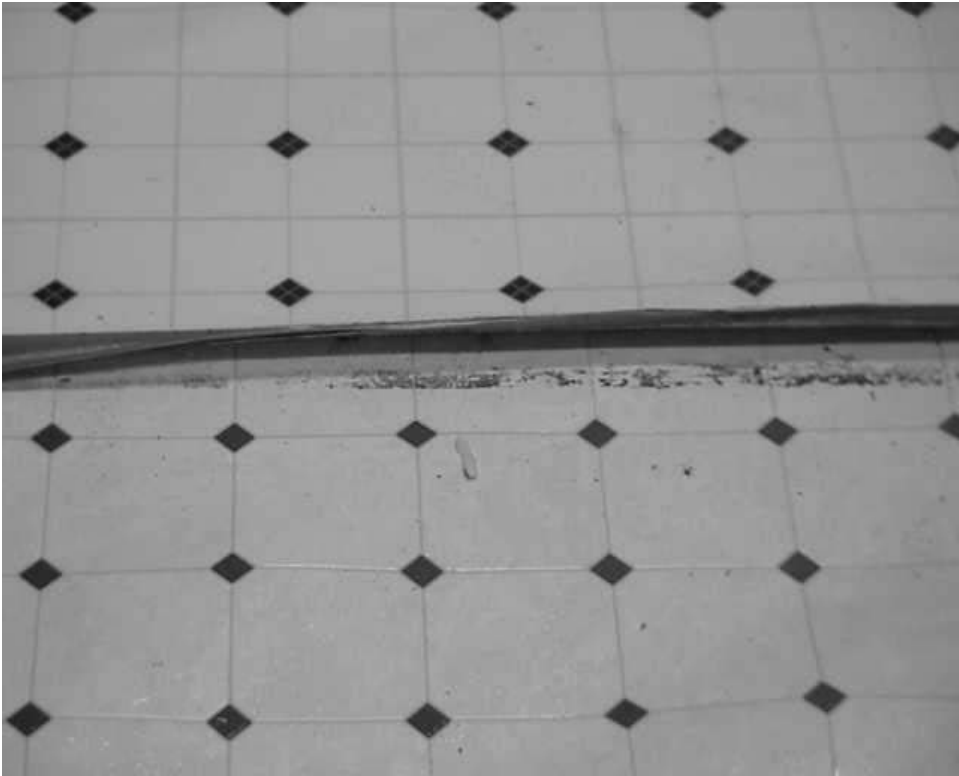
**Picture 6**

Of concern to school officials, are linoleum sheets that were laid down over existing carpeting in several classrooms. Sheets of linoleum were affixed to the floor using duct tape (see Picture 6). This measure was employed to provide a physical barrier to carpet related pollutants. This measure appears to be of limited effectiveness, since the duct tape did not adhere to the existing carpeting to create an airtight seal. The linoleum created bubbles, which would expel air from beneath this barrier when compressed. This action can result in carpet-related pollutants being aerosolized. Of note was the absence of mold odors in these classrooms. A musty odor was noted in the foyer of the building. The exterior of the front door has carpet laid outdoors. This carpet can lead to water gathering near the door threshold, which can cross the threshold to moisten the interior carpet.

**Linoleum with Peeling Duct Tape**

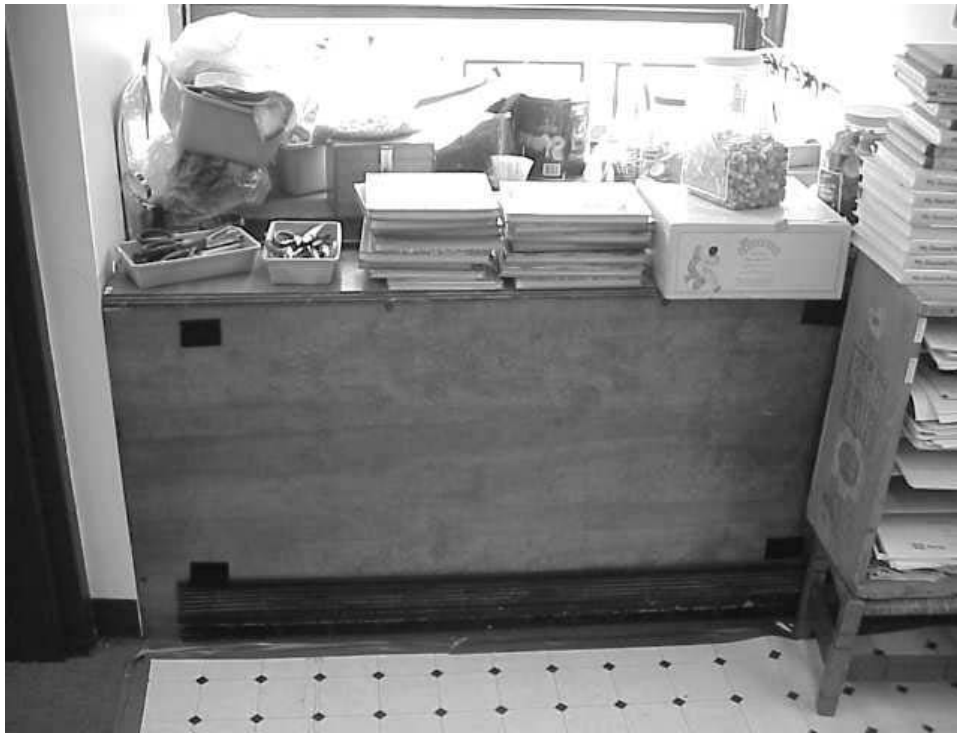
**Picture 7**

Of note is the condition of the univents. Instead of installing univents as a complete metal case (see Picture 7 for a typical univent installation), it appears that the internal workings of a univent were encased in specially designed wooden cabinets. Within these cabinets are pipes clad with fiberglass insulation (See Picture 8). Since these univents can provide chilled air during warm months, moist air introduced into these wooden cabinets can result in the wetting of the insulation paper. It appears that mold may have colonized the insulation paper (see Picture 9). This colonization may be a source of spores and other mold-related particulates, which can be aerosolized by the univent. Other sources of mold

**Univent in Wooden Casing**

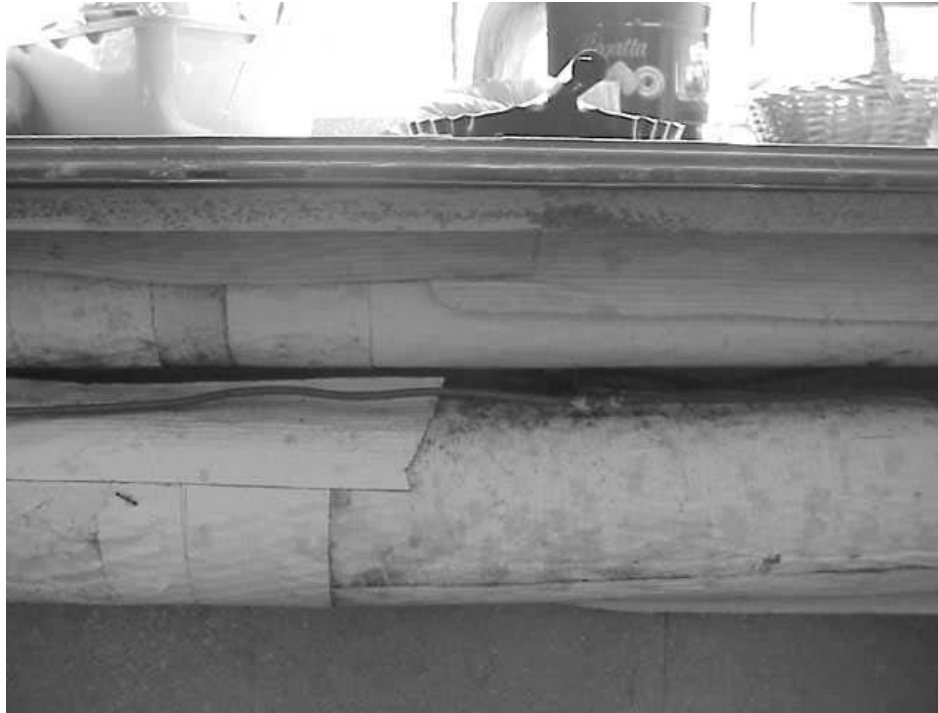
**Picture 8**

**Insulated pipes in Wooden Univent Cabinet, Note Stains/Possible Mold Growth**

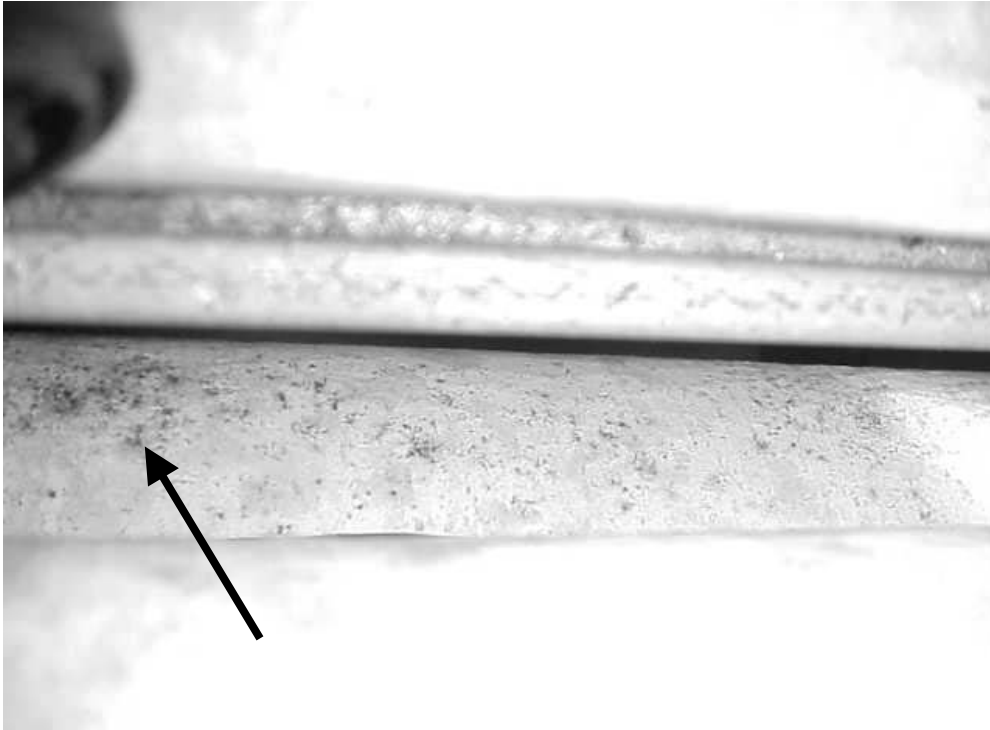
**Picture 9**

**Paper of Pipe Insulation, Note Possible Mold Colonies**

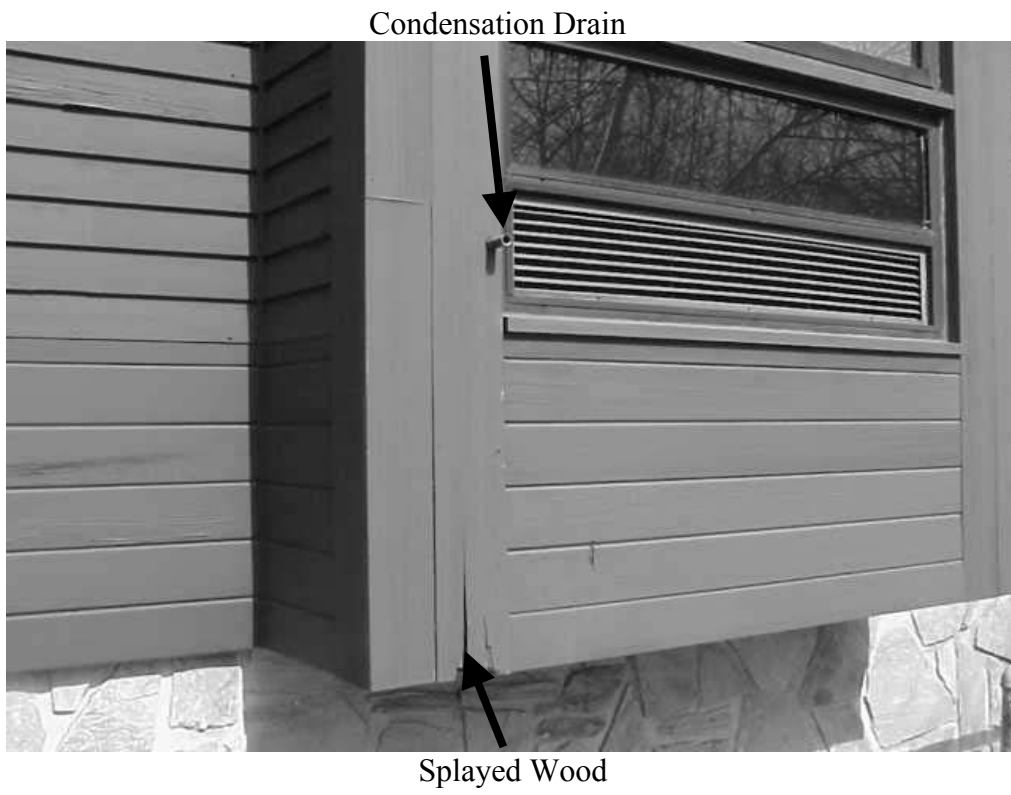
**Picture 10**

Each univent condensation drain terminates through the exterior wall of the building several feet above the ground (see Picture 10). This configuration exposes the wood of the exterior surface of the building. In one case, dripping condensation appears to have caused splaying of wood. Repeated water exposure from these drains can result in further damage to the exterior of the building. In addition, a leaking spigot at the rear of the building had moistened the exterior wall of the building (see Picture 11).

**Condensation Drain, Note Splayed Wood Immediately below Drain**

8. Consider extending the condensation drains to prevent water damage to the exterior wall of the building.
9. Consider removing the carpet installed outside of the front door of the building. Examine the carpet around the front door for mold growth and remove where necessary. Disinfect the nonporous surface and clean the area beneath the carpet.
10. Remove the carpet section beneath the fish tank.
11. Examine the feasibility of installing exhaust ventilation in the outer cafeteria.
12. Examine the feasibility to improve fresh air to the cafeteria/kitchen.
13. Inspect restroom exhaust motors for proper function, make repairs as necessary. Consider increasing restroom exhaust capabilities to remove moisture and/or odors.

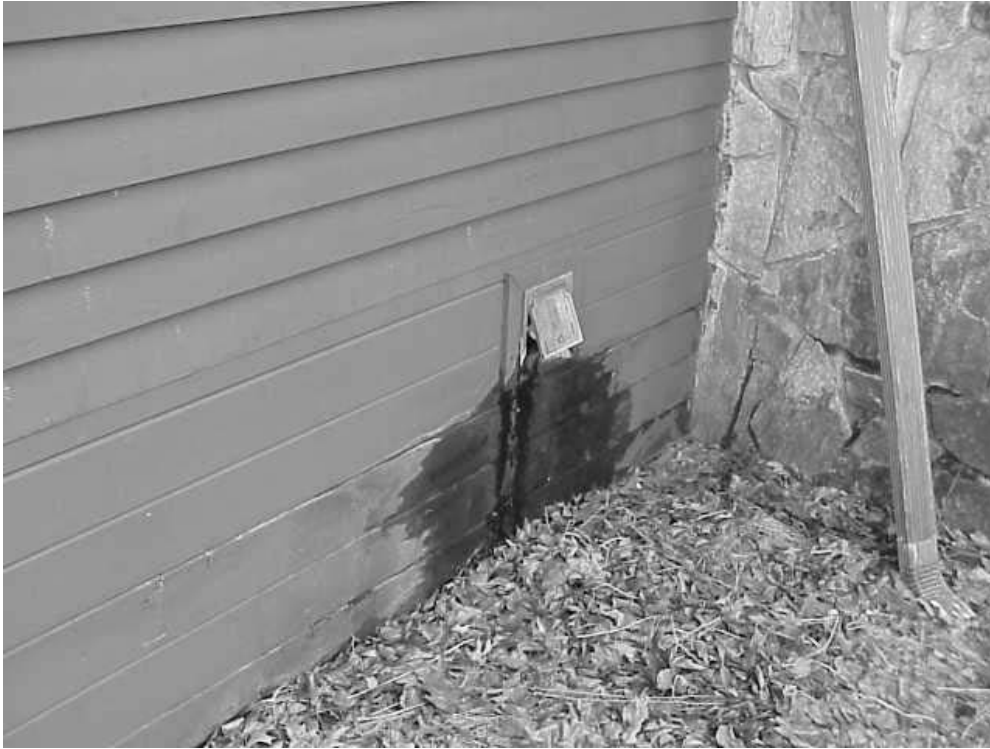
**Picture 11**

**Exterior Wall Water Damaged by Dripping Spigot**

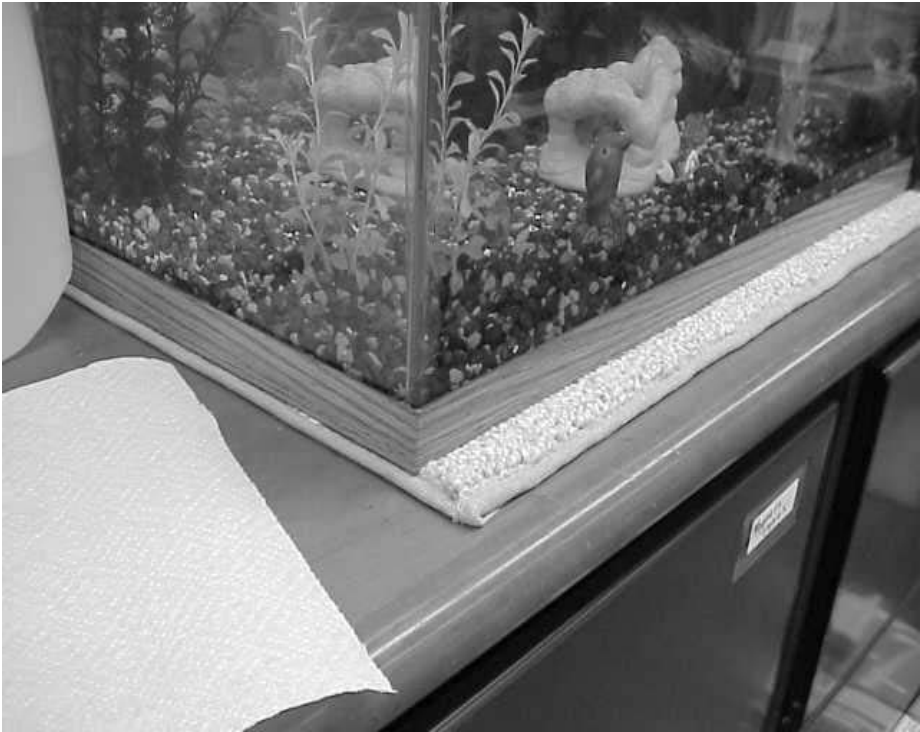
Picture 12

One classroom was noted to have a section of carpet beneath a fish tank (see Picture 12). Fish tanks can generate condensation under certain conditions. Under such conditions, the carpet section can become repeatedly moistened and serve as a medium for mold growth.

**Carpet beneath Fish Tank**

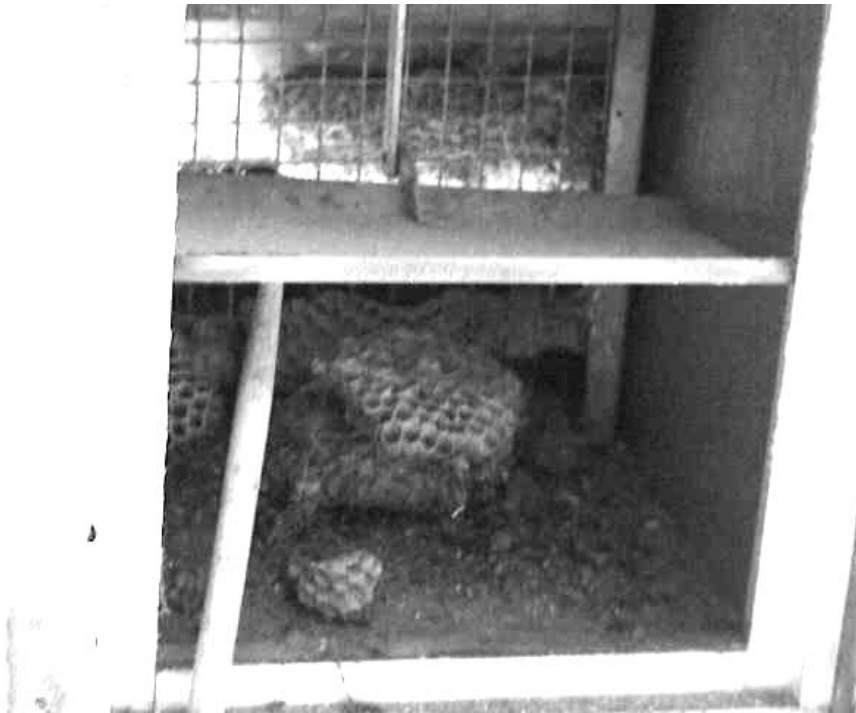
**Picture 13**

Wasp nests were found in the interior of the passive exhaust vents (see Picture 13). It is recommended that they be removed as soon as possible in a manner as to not introduce insects or chemical agents into the school via the ventilation system.

**Wasp Nests in Exhaust Vent**
