The Commonwealth of Massachusetts  
Executive Office of Health and Human Services  
Department of Public Health  
Bureau of Environmental Health Assessment  
250 Washington Street, Boston, MA 02108-4619

April 20, 2000

At your request, an indoor air quality assessment was done at the Winthrop Town Hall, Winthrop, MA. This assessment was conducted by the Massachusetts Department of Public Health (MDPH), Bureau of Environmental Health Assessment (BEHA). On March 21, 2000, a visit was made to this building by Michael Feeney, Chief of the Emergency Response/Indoor Air Quality (ER/IAQ) Program, BEHA. Accompanying Mr. Feeney and you during the assessment were Cory Holmes, Environmental Analyst for BEHA's ER/IAQ program, Tim Lesile, Job Superintendent and Leo Schiavuzzo, Public Facilities Coordinator. Concerns about pollutants generated by renovation efforts and the potential impact on occupied areas in the building prompted this request.

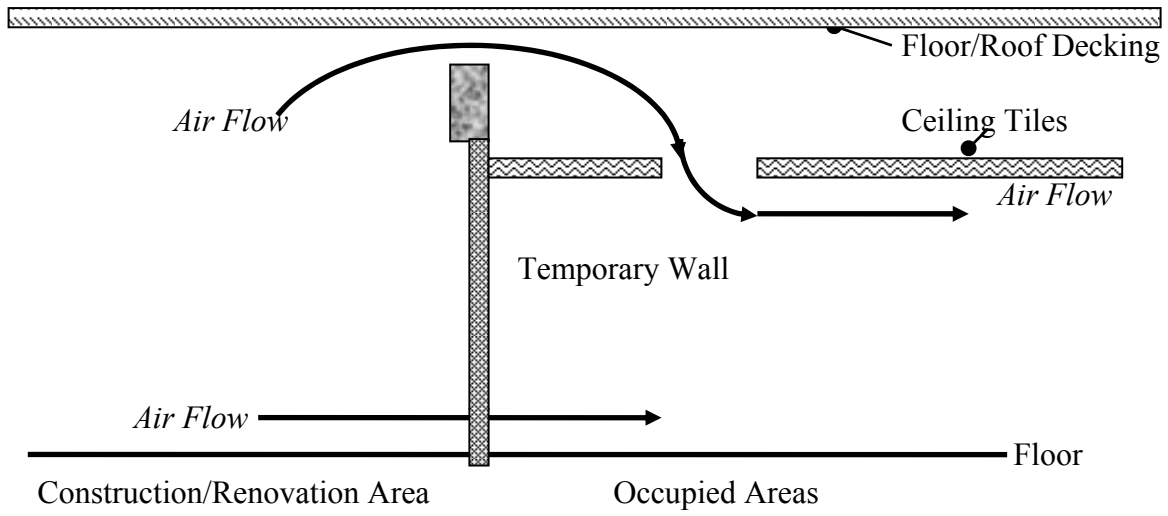
**Figure 1**

Missing ceiling tiles were also noted in several areas, providing spaces between the decking and wall (see Picture 2) which can provide a means of egress for renovation generated pollutants to enter occupied areas. None of the open spaces created by the lack of ceiling tiles have been sealed to prevent air movement above the ceiling tiles (see Figure 1). Dust and debris can move with drafts from the unoccupied construction section to occupied areas.

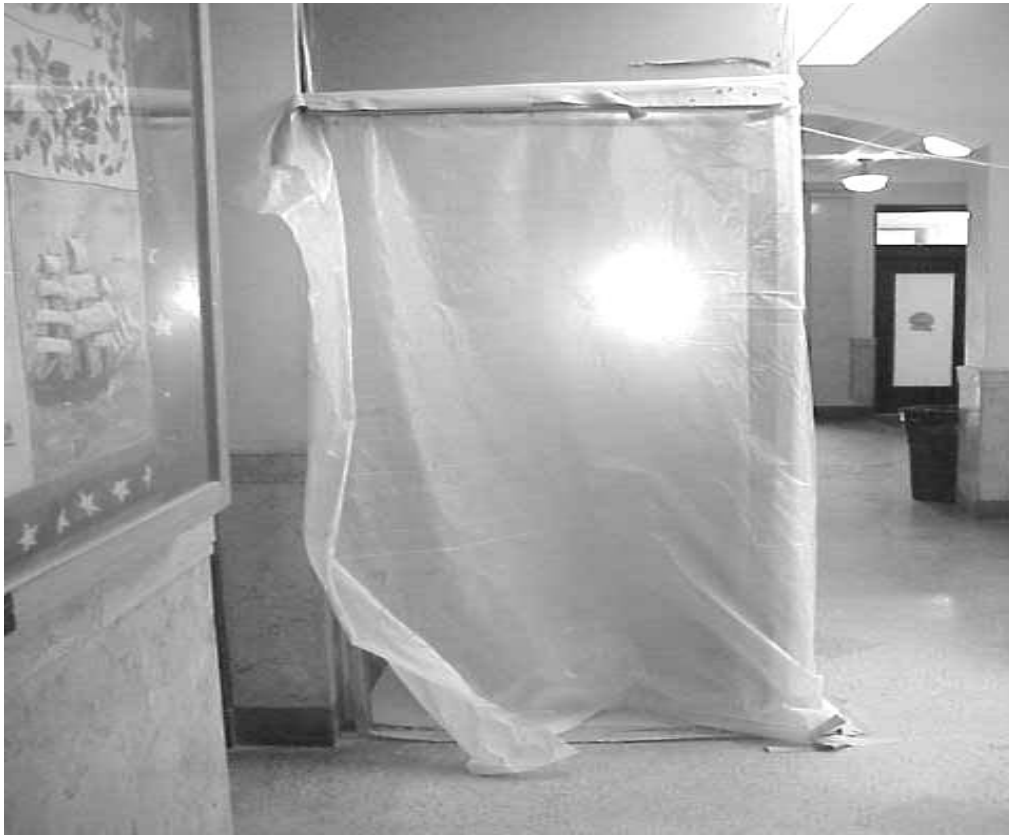
**Picture 1**

Spaces in temporary walls were observed and were noted to Mr. Schiavuzzo & Mr. Lesile by BEHA staff. It is important to note that pollutants from renovation work could travel through these spaces (see Picture 1). BEHA staff recommended that spaces around containment walls be sealed with duct tape. BEHA staff also recommended that containment walls be covered with plastic sheeting and duct tape to provide a secondary barrier.

**Unsecured Containment Barrier around Restroom Renovations  
Note the Only Means of Egress is through This Barrier**

9. Seal construction barriers with polyethylene plastic and duct tape to create a secondary barrier to prevent migration of renovation generated pollutants into occupied areas.

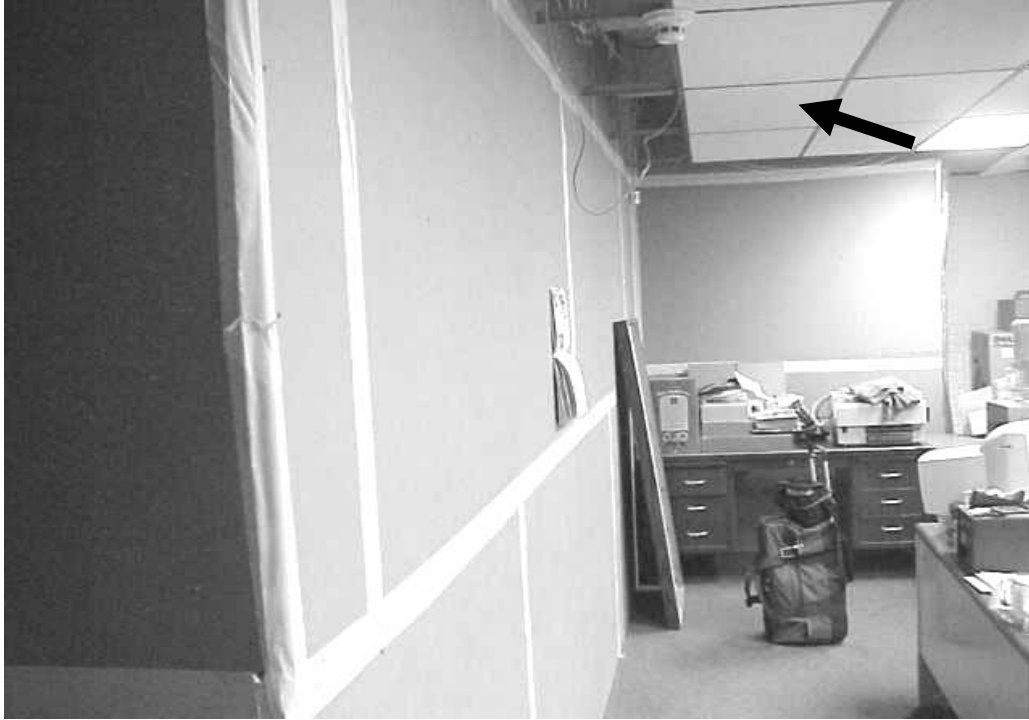
**Picture 2**

**Missing Ceiling Tiles Noted in Office Area Adjacent to the Construction Zone**

8. Seal utility holes, spaces in roof decking and temporary walls to eliminate pollutant paths of migration. Seal holes created by missing tiles in ceiling temporarily to prevent renovation pollutant migration.
