INDOOR AIR QUALITY ASSESSMENT

**Federal Street Elementary School
125 Federal Street
Greenfield, Massachusetts**

Prepared by:
Massachusetts Department of Public Health
Bureau of Environmental Health Assessment
July, 2000

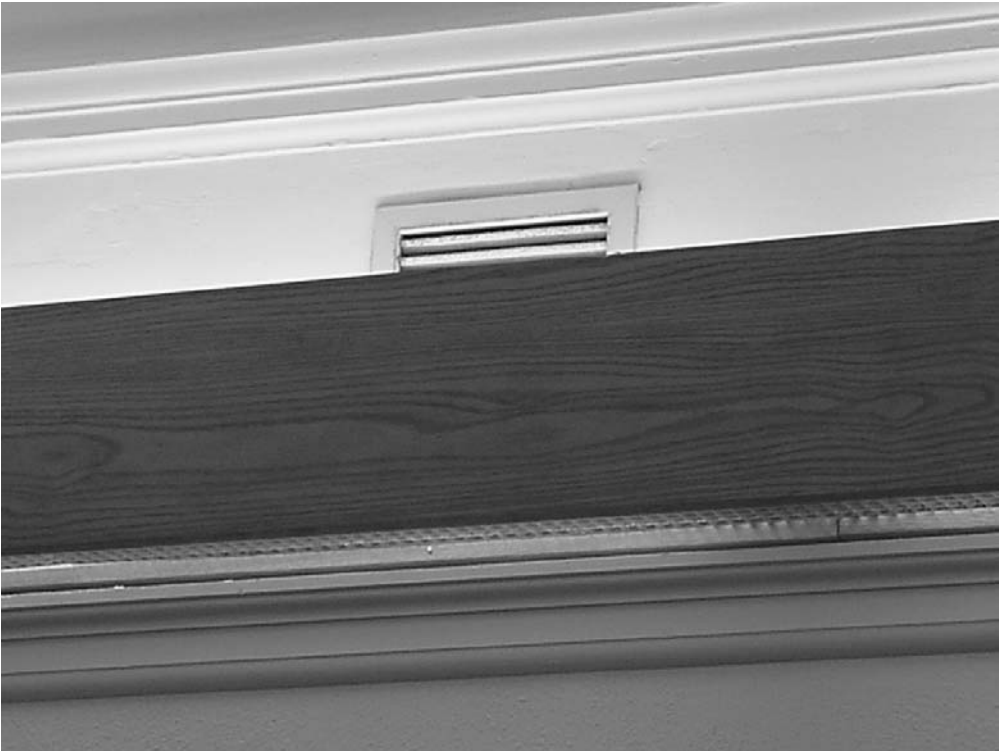
Picture 3

Exhaust ventilation is provided by wall-mounted exhaust vents. As with the univents, exhaust vents were not operating, indicating that the exhaust vent motors are deactivated or broken. Decreasing the efficiency of this system in some classrooms is the location of vents behind wall molding that shields florescent lights (see Picture 3). Without a functional exhaust system, normally occurring environmental pollutants can build-up and lead to indoor air quality complaints.

Exhaust Vent behind Wood Molding

5. Consider cutting spaces into wood molding blocking exhaust vents in classrooms.

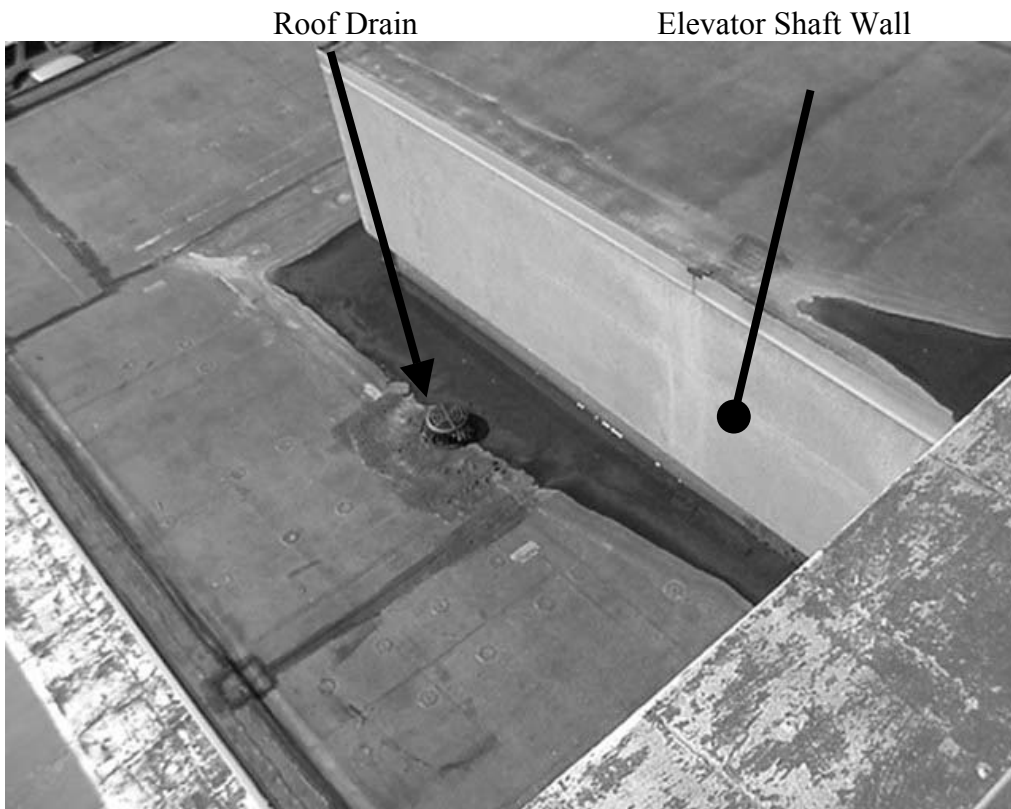
Picture 4

A number of areas, particularly in and around the elevator shaft of the north wing, have water-damaged ceiling tiles and wall plaster which can indicate leaks from the roof, windows or plumbing system. The roof of the north wing had accumulated water against brickwork of the elevator shaft (see Picture 4). It appears that this section of the roof is sloped *towards* the wall *instead of* toward the roof drain. Chronic pooling of this nature can lead to both moisture penetration through exterior brick and damage to the roofing material due to the freezing and thawing of water during winter weather. Water-damaged

Water Pooling on Roof Several Days after Rain, Note Roof Drain

5. Repair roof and replace/repair any water-stained ceiling tiles and wall plaster.
Examine the area above and around these areas for mold growth. Disinfect areas of water leaks with an appropriate antimicrobial if necessary.
6. Examine the feasibility of installing local exhaust ventilation in teacher's room to vent pollutants from photocopying and other activities out of the building.

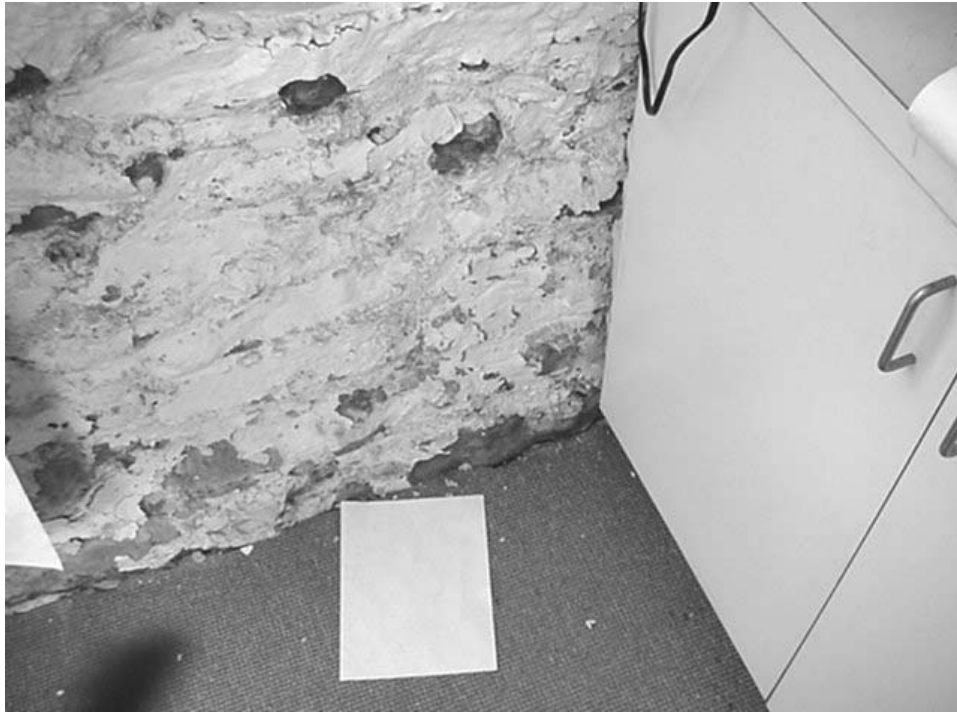
Picture 5

The reading recovery room in the south wing, Bull basement north wing, the art room basement north wing and Madder basement north wing all have musty odors. These odors can be attributed to water penetration through either exterior wall brick or interior brickwork of exhaust ventilation shafts. Walls in the basements of both wings show signs of brick deterioration and efflorescence (i.e., mineral deposits), which indicates water penetration. Efflorescence is a characteristic sign of water intrusion. As moisture penetrates and works its way through mortar around brick it leaves behind these characteristic mineral deposits. With moisture entering the basement, porous materials can become wet and serve as growth media for mold. Each of these areas has carpeting that is in contact with exterior brick that is deteriorating (see Picture 5). The American Conference of Governmental Industrial Hygienists (ACGIH) recommends that carpeting be dried with fans and heating within 24 hours of becoming wet (ACGIH, 1989). If carpets are not dried within this time frame, mold growth may occur. Water-damaged carpeting cannot be adequately cleaned to remove mold growth.

Water Intrusion and Powdered Brick on Carpeting, Note the Proximity of Carpet to Wall

1. Remove water damaged carpeting from the basement classrooms. Disinfect non-porous surfaces with an appropriate antimicrobial compound. After disinfection, clean non-porous surfaces with a soap and water.

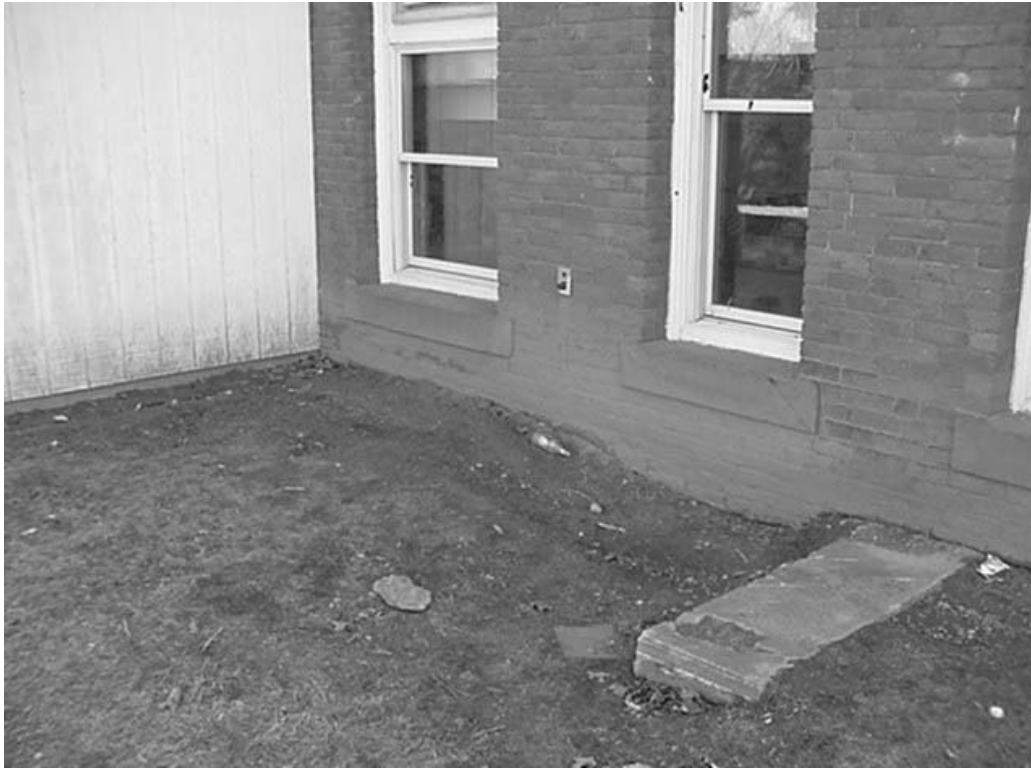
Picture 6

Several sources of moisture penetration into the basement were identified. The primary source of moisture penetration into the basement area would appear to be inadequate damage of rainwater runoff from exterior walls. A trough was noted in the ground along the north wall of the north wing in the grass. This condition can lead to water pooling at the base of the wall. Lack of grass and mud discoloring the wall

indicated that water pools and splashes on the exterior wall to a height over one foot in this area (see Picture 6). A second source of water penetration along the north wall appears to be from the addition of a wooden roofed structure to the side of the building. Flashing to the wood structure lies flush against the exterior wall (see Picture 7), instead of cut into the brick and sealed. The purpose of roof flashing is to direct rainwater from one flat exterior surface to a generally perpendicular surface (usually a roof) while preventing water penetration at the seam. In general, a seam is ground into brick into which the flashing is inserted and sealed with a waterproof compound (see Figure 2). This configuration prevents water from penetrating into the exterior brickwork or the interior area under the roof. With the existing configuration, rainwater rolling down the exterior wall can penetrate into the building.

**North Wall of North Wing with Mud Spattering and Discoloration,
Note the Trough in Soil against the Wall**

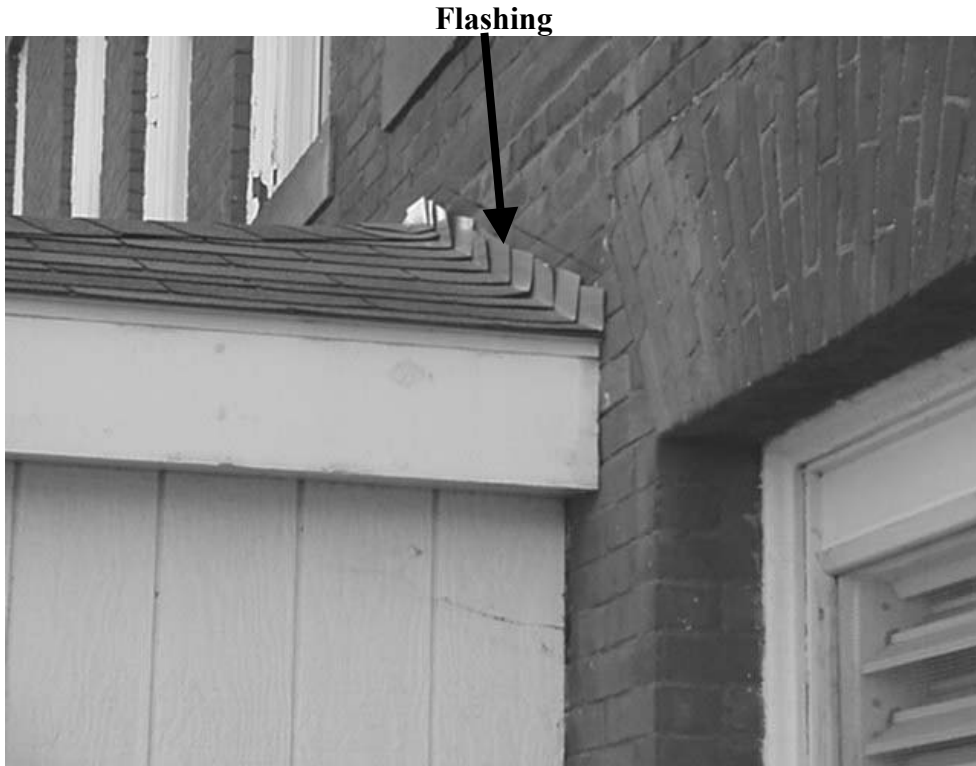
Picture 7

Roof Flashing Laying Flush on Exterior Brick of North Wall

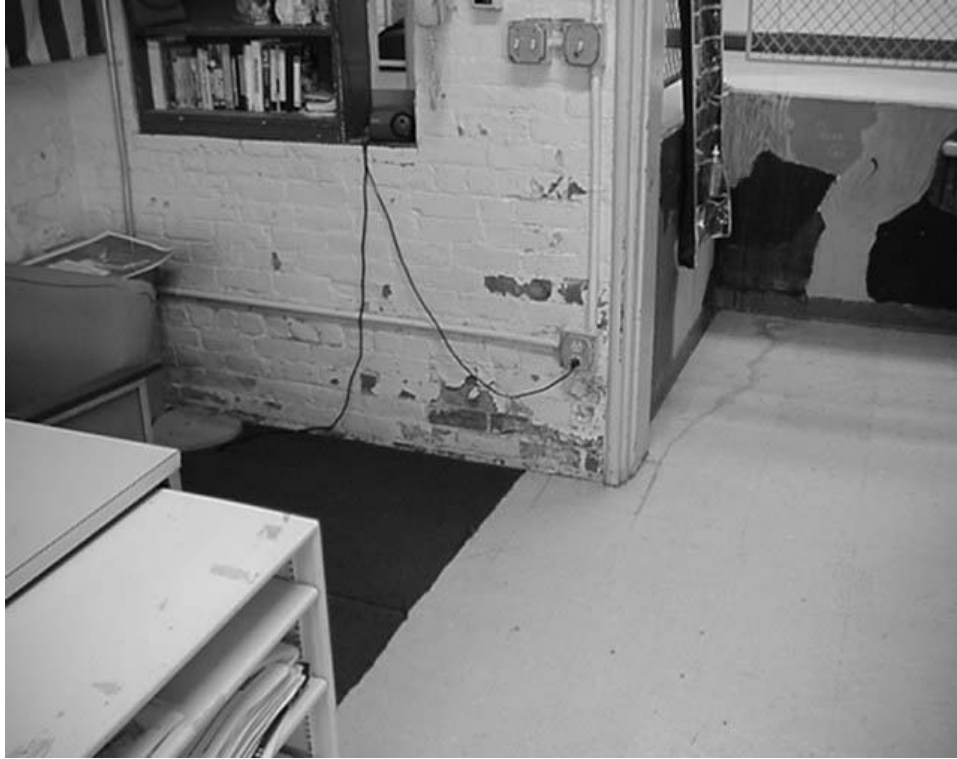
Picture 8

The final source of rainwater penetrating into the basement appears to be at the base of brick airshafts that formerly served as part of the exhaust ventilation system. The floor/wall junction of an *interior* wall of the art room also showed signs of efflorescence (see Picture 8) adjacent to carpeting, which indicates water damage to the airshaft. Although these airshafts have chimney caps to prevent water intrusion (see Picture 9), it appears as though they may be failing or are inadequate as evident by the accumulation of brick and mortar debris at the base of the vent shafts.

Carpet in Close Proximity to Interior Wall with Signs of Water Intrusion in Art Room

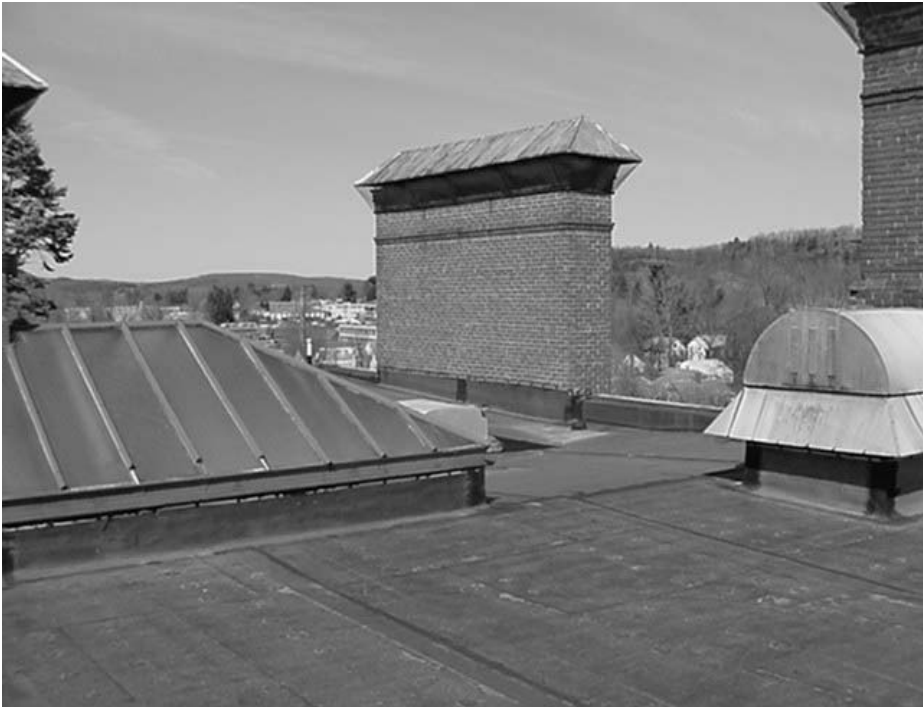
Picture 9

Capped Air Shaft on North Wing Roof

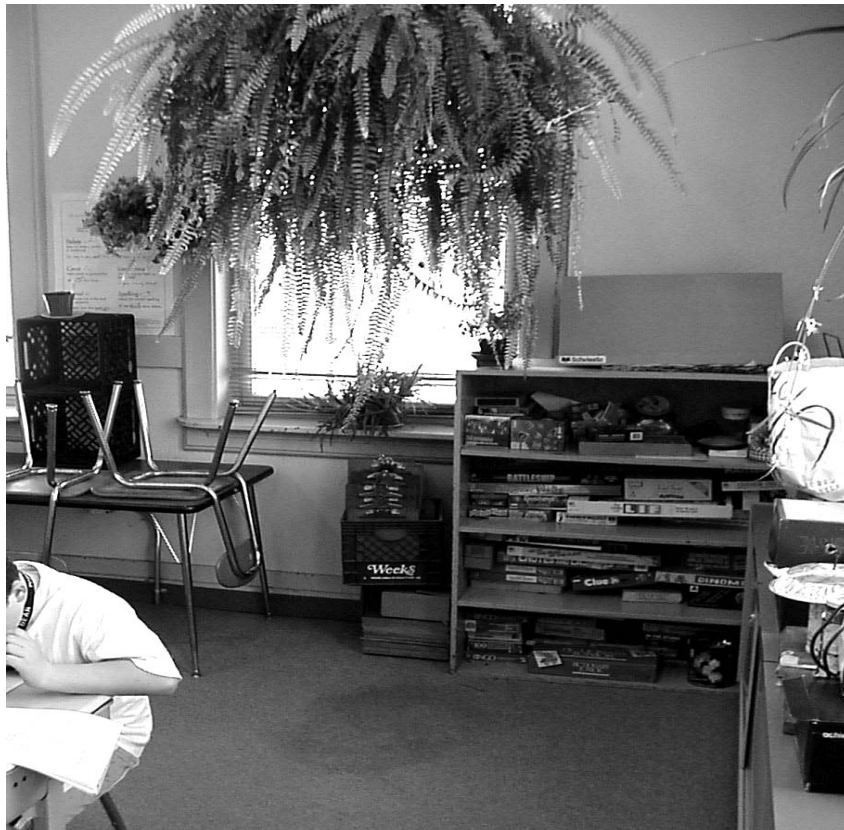
Picture 10

Several classrooms also had a number of plants. Plant soil and drip pans can serve as source of mold growth. In one case, chronic leakage from a hanging plant resulted in water staining of carpeting (see Picture 10). A number of plants did not have drip pans. The lack of drip pans can lead to water pooling and mold growth on windowsills when used indoors. Wooden sills can be colonized by mold growth and serve as a source of mold odor. Plants should also be located away from univents to prevent the aerosolization of dirt, pollen or mold.

Plant in Classroom, Note Water Stain on Carpet beneath Plant

8. Remove carpeting beneath hanging plant in Picture 10. Disinfect non-porous surfaces with an appropriate antimicrobial compound. After disinfection, clean non-porous surfaces with a soap and water.

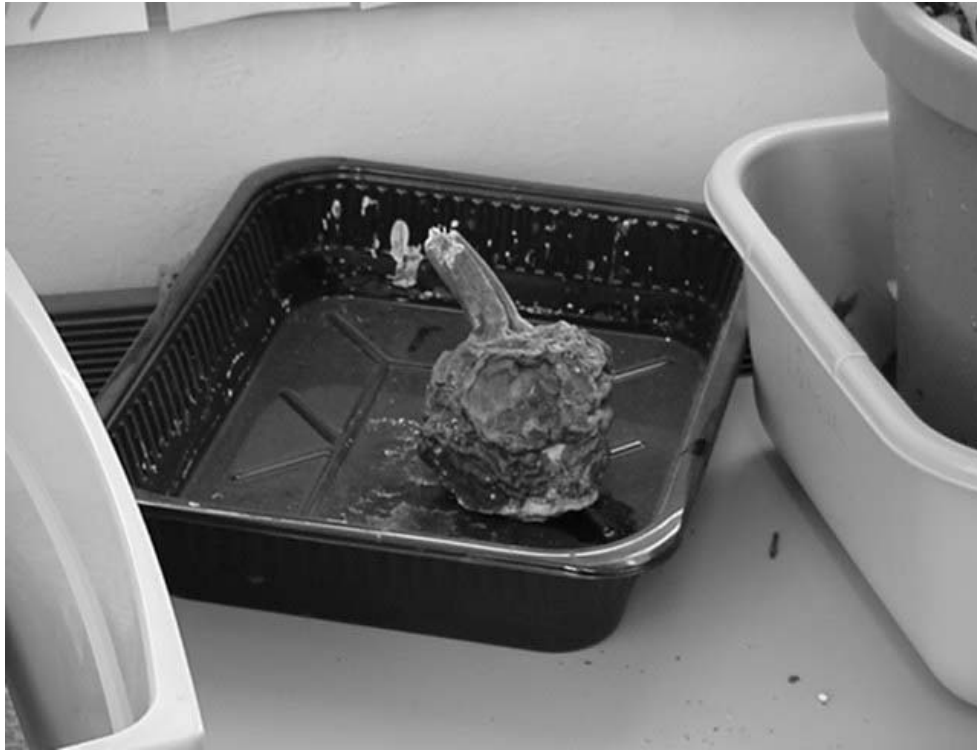
Picture 11

One classroom had decaying fruit (see Picture 11). Another classroom contained an aquarium that appeared to be green with algae growth. Aquariums should be maintained to prevent mold/bacterial growth and/or unpleasant odors. Decaying food items can also grow mold and give off unpleasant odors. In addition, decaying fruit can serve as an attraction to pests (insects and rodents). The art room contained a dehumidifier. Dehumidifiers should be emptied and cleaned as per the manufacturer's instructions to prevent bacterial and mold growth.

Decaying Fruit in Classroom

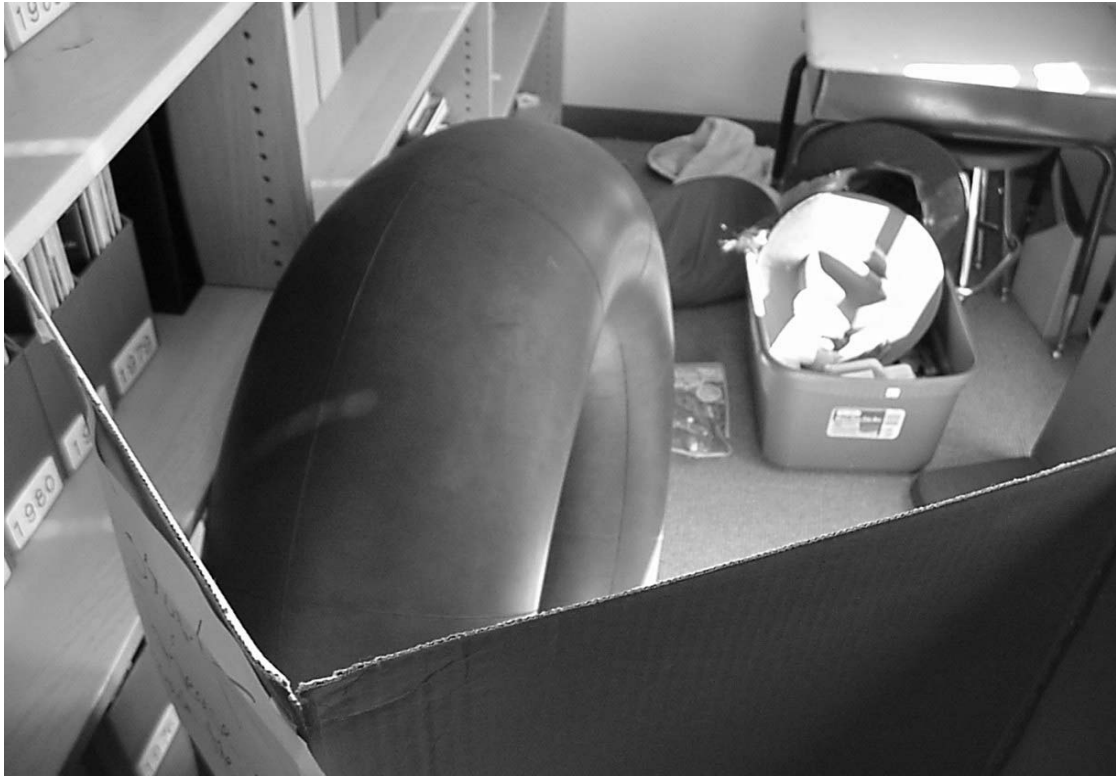
Picture 12

An acrid odor was detected in the library. The odor was traced to an inner tube found in direct sunlight beneath an exterior window (see Picture 12). Rubber materials can emit unpleasant odors, which can be enhanced by heating.

Rubber Inner Tube in Sunlight in the Library

15. Clean chalkboards and trays regularly to prevent the build-up of excessive chalk dust.
16. Relocate or consider reducing the amount of materials stored in classrooms to allow for more thorough cleaning of classrooms. Clean items regularly with a wet cloth or sponge to prevent excessive dust build-up.
17. Remove the tire inner tube from the library and store in a cool place.
