INDOOR AIR QUALITY ASSESSMENT

**Greenfield Town Hall
14 Court Square
Greenfield, Massachusetts**

Prepared by:
Massachusetts Department of Public Health
Bureau of Environmental Health Assessment
July, 2000

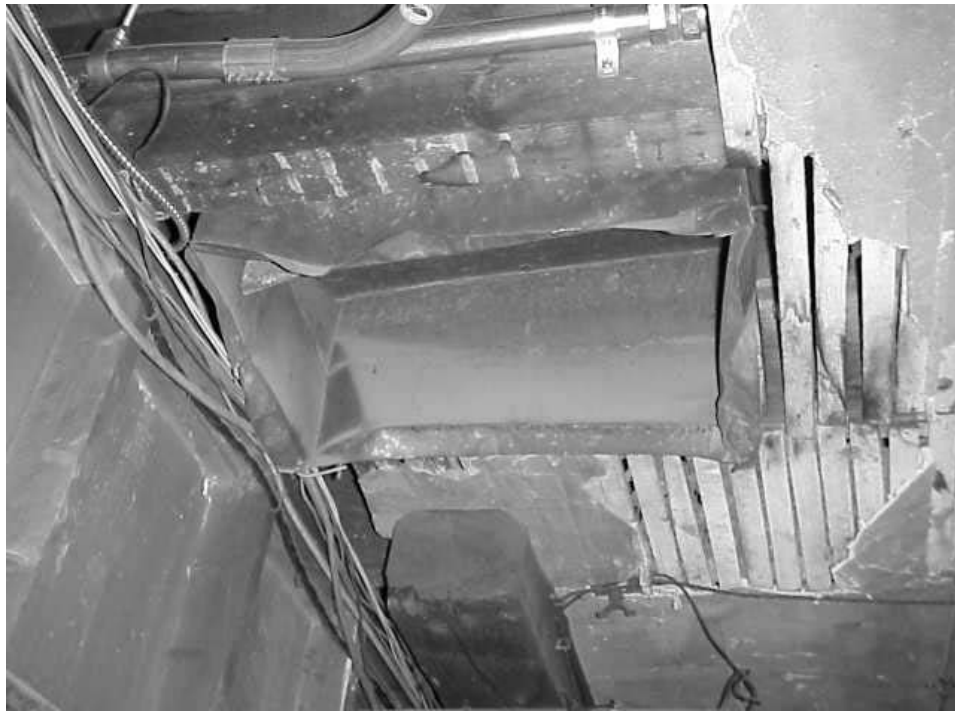
Picture 1

**Abandoned Ductwork in Basement Ceiling below Board of Health Office,
No Corresponding Vent in the first floor Was Located**

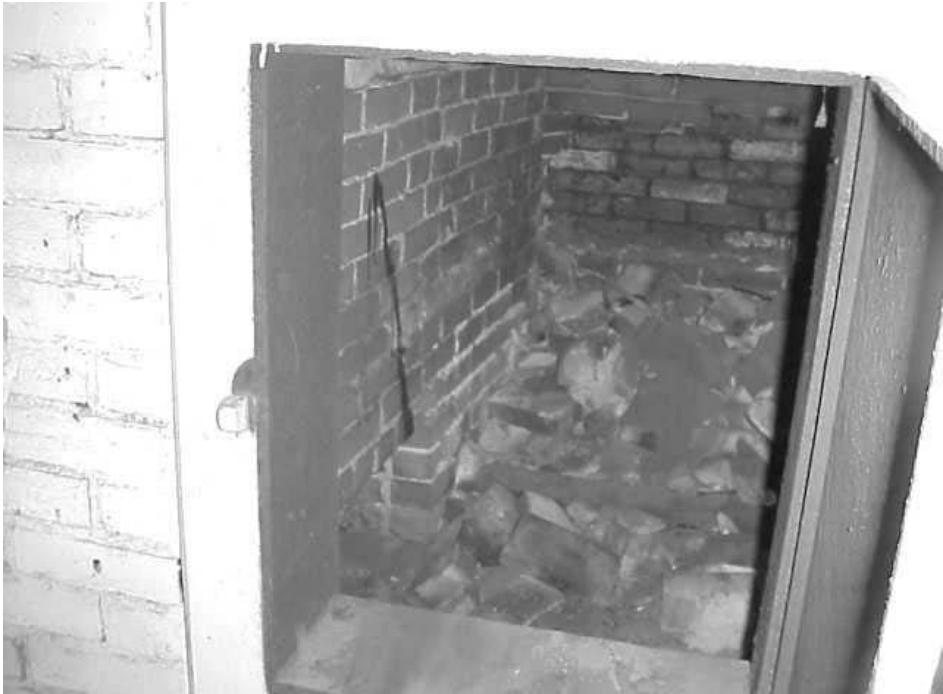
Picture 2

Exhaust Vent in Basement Sealed by Steel Door

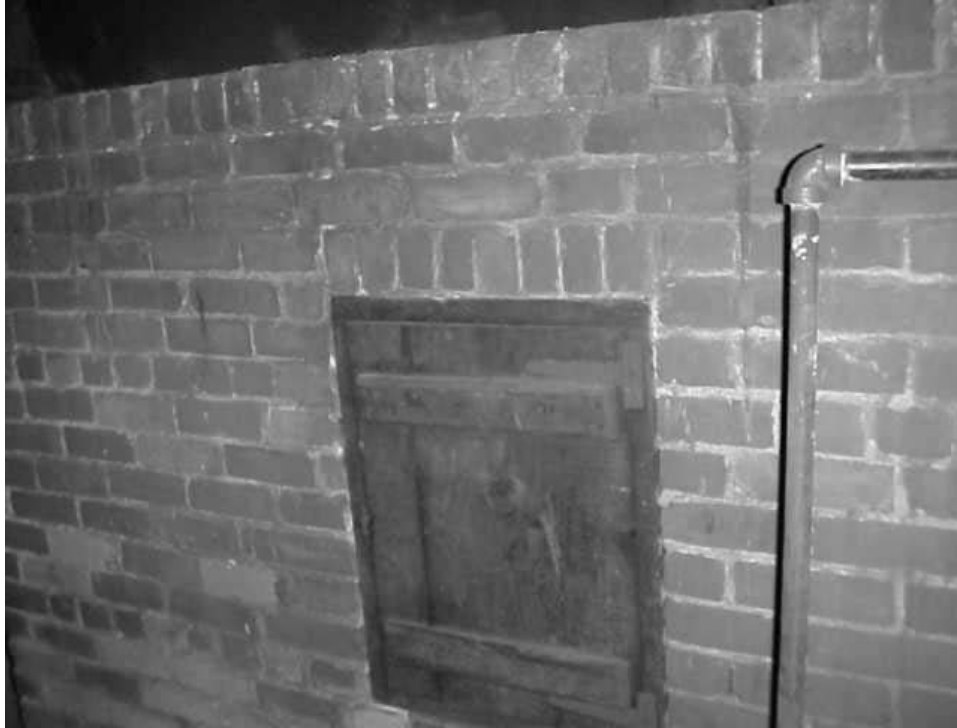
Picture 3

Exhaust Vent in Basement Sealed by Wooden Door in the 1848 Section

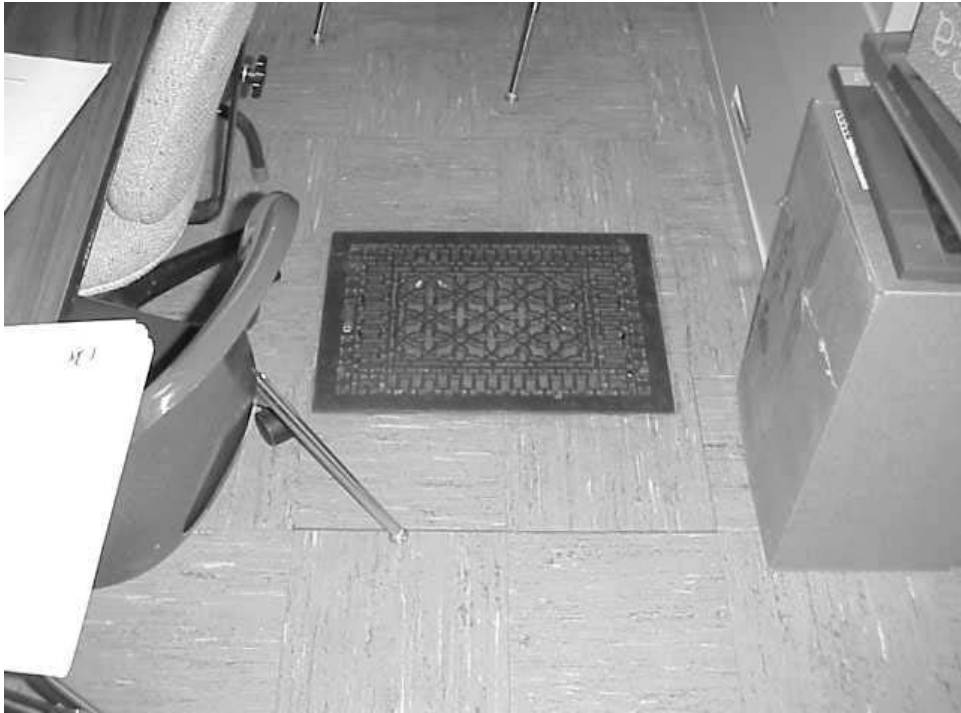
Picture 4

Air movement is provided by the stack effect. The heating elements warm the air, which rises up the hot air ventilation shafts. As the heated air rises, negative pressure is created, which draws cold air from the basement area and fresh air (see Picture 4) into the heating elements.

Supply Vent in Floor

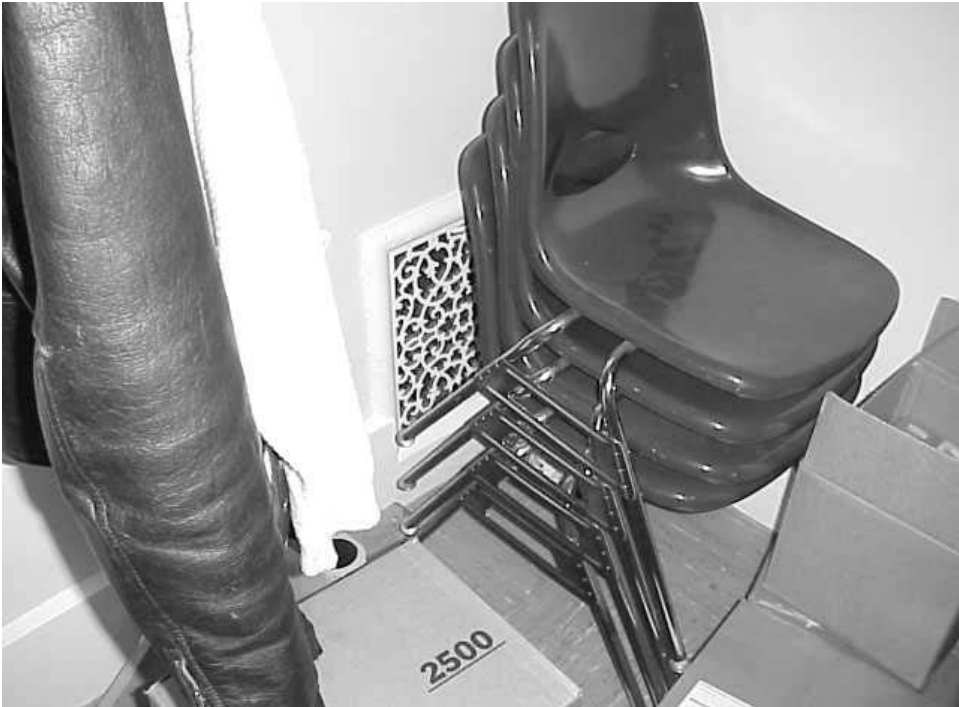
Picture 5

The air vents near the floor (see Picture 5) provide exhaust ventilation. As the heated air enters the airshaft, it rises. Negative pressure is created in these shafts, which

Wall Mounted Exhaust Vent

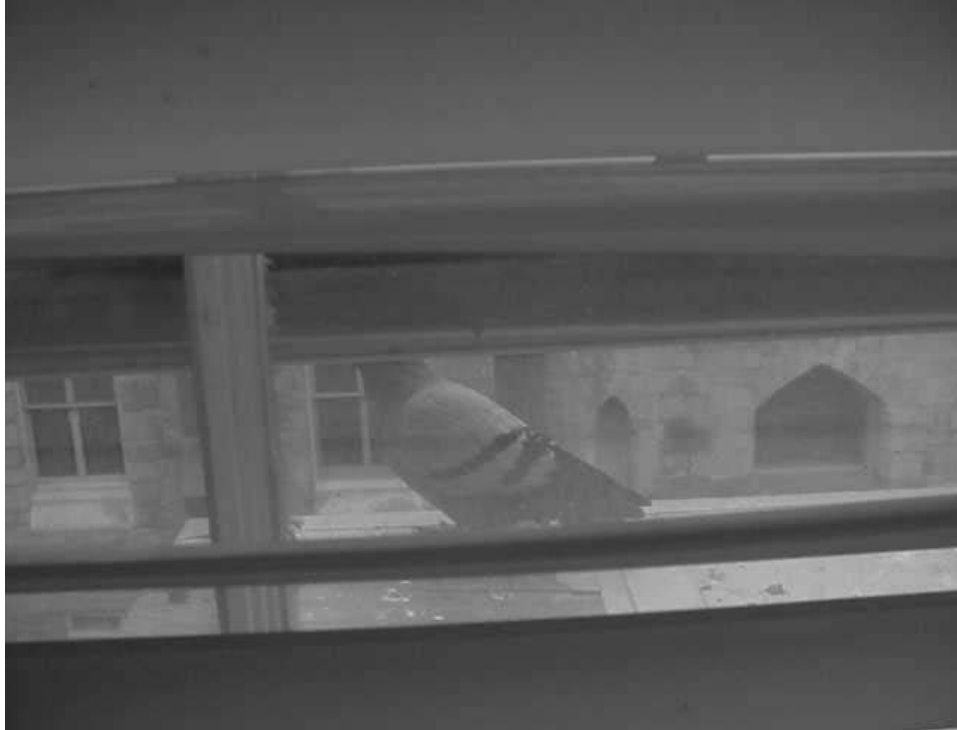
Picture 6

Several other conditions were noted during the assessment which can effect indoor air quality. Examination of the interior of the building found no visible signs of bird infestation. Pigeons were seen perching on top of and under a window-mounted air conditioner on the second floor (see Picture 6). The air conditioner services the DPW Engineer's Office. During the assessment of the public works office, cooing pigeons could be heard at this air conditioner. The top of the exterior surface of the air conditioner had bird wastes (see Picture 7). While the bird wastes are on the exterior of the building, this air conditioner has the ability to introduce fresh air from outdoors. As air is drawn into the air conditioner, bird waste particulate can be entrained into the airstream and introduced into the interior of the building. Bird wastes in a building raise

**View from Indoors of Pigeon on Top of the DPW Engineer's Office
Window-Mounted Air Conditioner Casings**

1. Clean bird wastes from contaminated materials around the air conditioner.
Remove accumulated bird wastes from flat, non-porous surfaces and disinfect with an appropriate antimicrobial agent. Once disinfected, each treated area should be cleaned to ensure the removal of residual bird waste and cleaning materials. Removal of contaminated porous materials (e.g., insulation) may be the only appropriate measure to remove bird wastes from these materials. A copy of an issue of the Centers for Disease Control *Morbidity and Mortality Weekly Report* for July 10, 1998 (see Appendix A), which covers the clinical aspects as well as clean up associated with bird waste has been provided for reference.
Dependent on the scale and scope of the contamination,

3. Examine all other window-mounted air conditioners and disinfect in a manner consistent with the previous recommendations.
4. Install anti-roosting spikes on the top surface of all air conditioners as well as on window ledges.

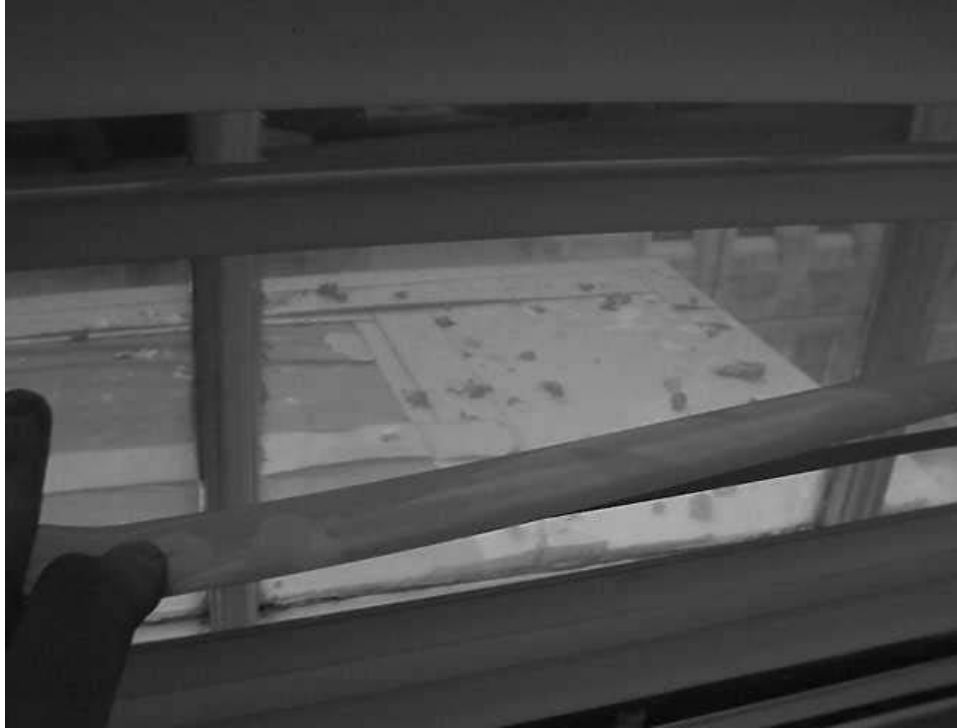
Picture 7

**Pigeon Waste on the DPW Engineer's Office
Window-Mounted Air Conditioner Casings**

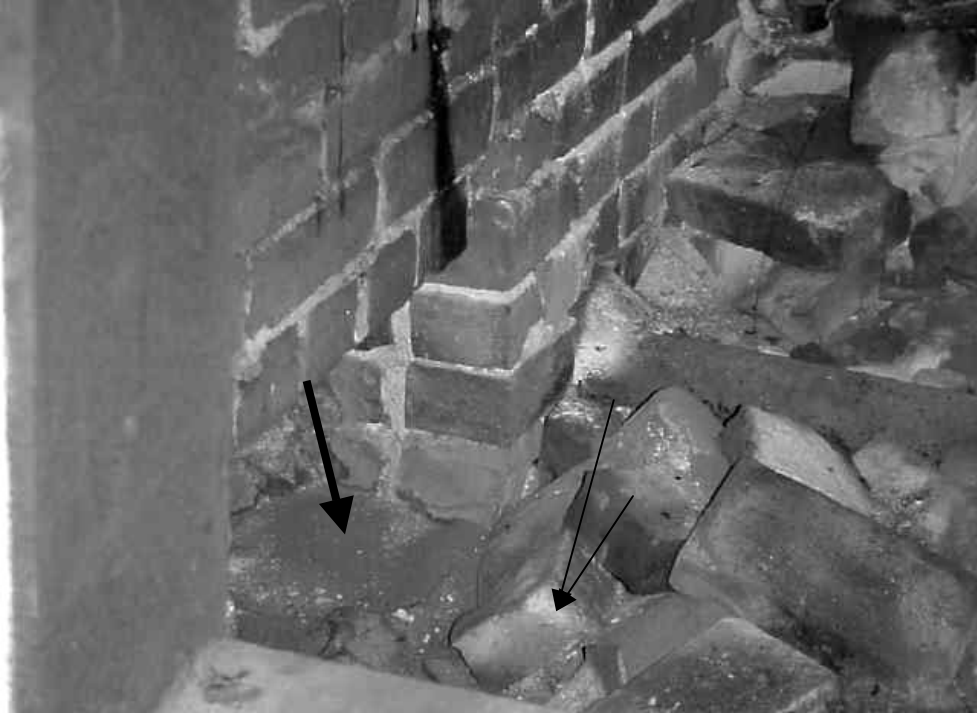
Picture 8

Of note are the condition of bricks at the base of each exhaust airshaft (see Pictures 8 through 10). This dust appears to consist of red brick only. In the experience of BEHA staff, brick deterioration is usually attributable to water penetration into the interior of the airshaft. Water penetration over time causes both brick and mortar to

disintegrate, resulting in the production of mortar and brick chips; red brick and white mortar dust; water staining and efflorescence. This dust appears to be exclusively red brick, which may indicate a mechanical source (weight shift) that is powdering this brick. Settling/shifting is evidenced by a distinct tilt in the floor of the second floor meeting room. Round objects were found to roll toward the northwest corner of this room when placed on the floor. Also of note is that it appears that at least one weight bearing floor beam in the basement had been cut during a wire installation (see Picture 11). Settling/shifting in a brick building can result in the creation of cracks and spaces in the roof and exterior wall. The development of cracks in these building systems (called the building envelope) can result in water penetration into the building. It is suggested that the Greenfield building inspector examine the integrity of these basement structures.

Crumbled Brick inside Exhaust Vent Shaft

1. Consider consulting a ventilation-engineering consultant to examine options for the installation of a mechanical ventilation system.
2. Consider consulting a building engineer to analyze the integrity of the building after consulting with the Greenfield building inspector.

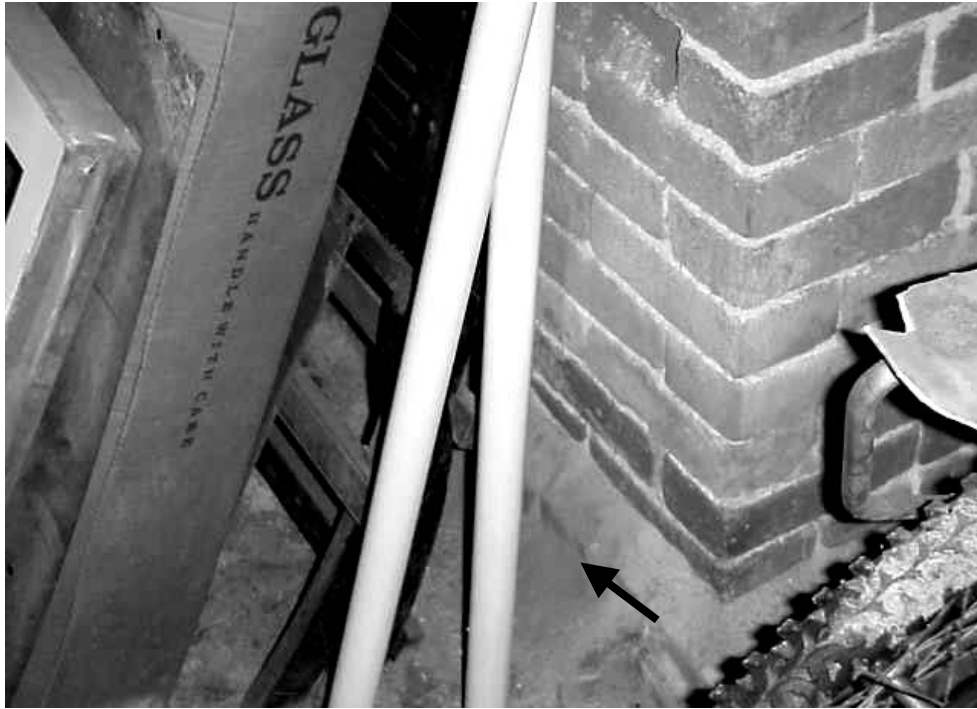
Picture 9

Crumbled Brick and Dust on the Outside of an Exhaust Vent Shaft

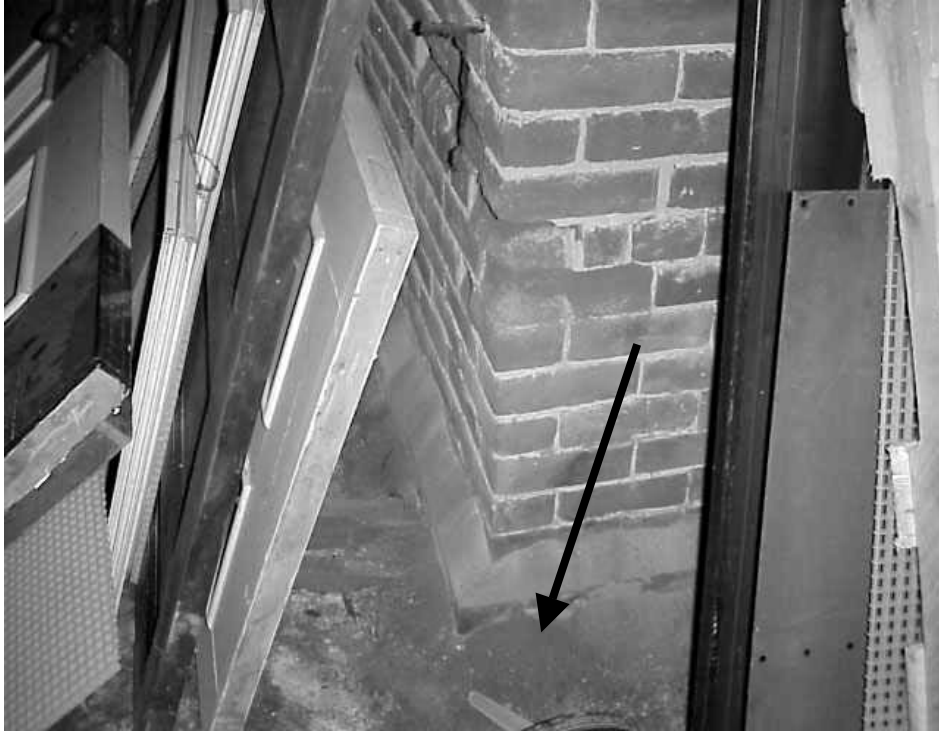
Picture 10

Crumbled Brick and Dust on the Outside of an Exhaust Vent Shaft

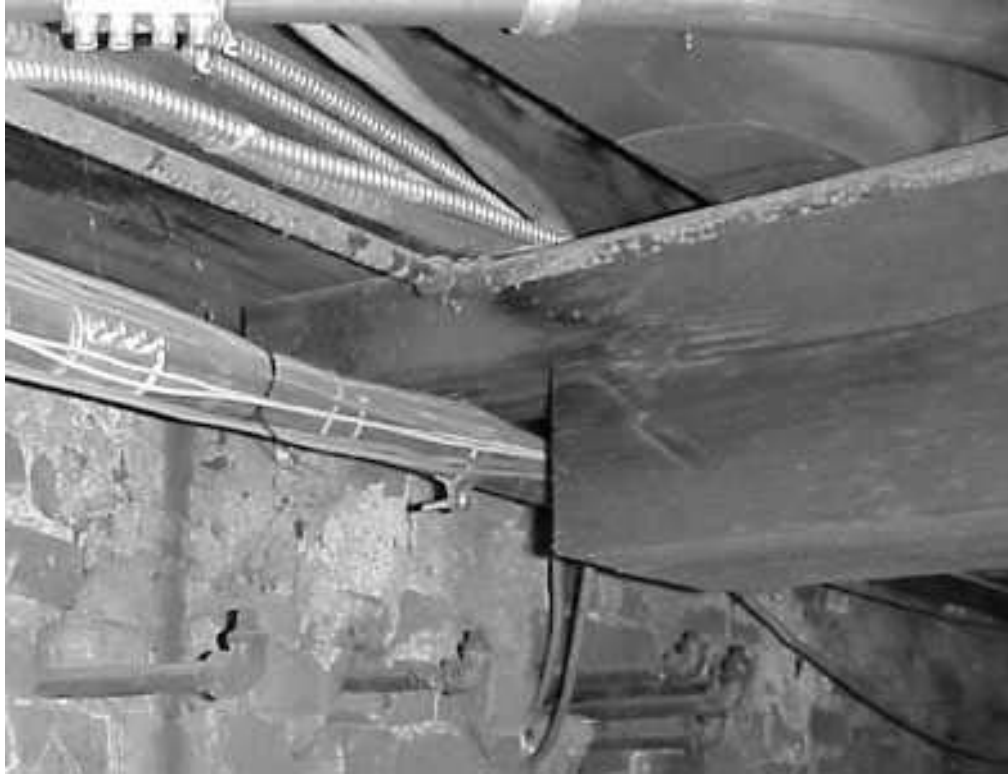
Picture 11

Floor Support Beam with a Cut Removing 2/3 of Wood
