INDOOR AIR QUALITY ASSESSMENT

**Aborn Elementary School
309 Eastern Ave.
Lynn, Massachusetts**

Prepared by:
Massachusetts Department of Public Health
Bureau of Environmental Health Assessment
June, 2000

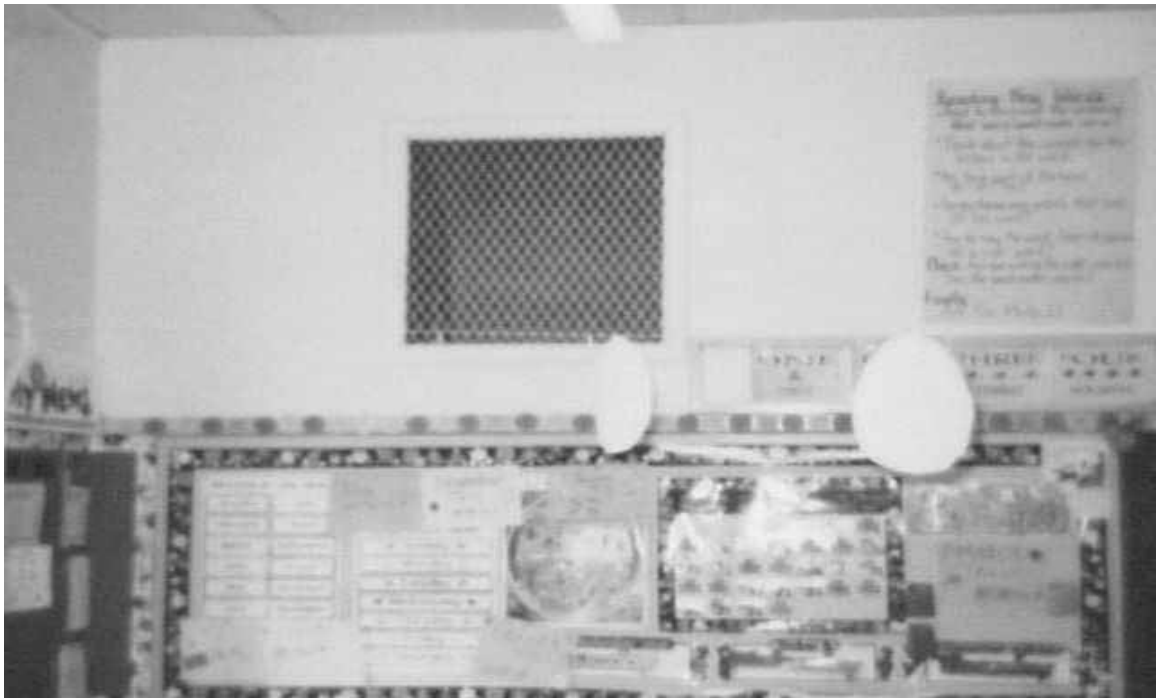
Picture 1

to classrooms in combination with openable windows. Ventilation is provided by a series of louvered vents. Each classroom has an approximately 3' x 3' grated air vent in the center of an interior wall near the ceiling (see Picture 1) which is connected by a ventilation shaft to a vault-like room in the basement (see Picture 2). A corresponding 3' x 3' vent exists in each room near the classroom doorway that is connected to an exhaust ventilation shaft that runs from the roof to the basement. Some of these vents were sealed with plywood, reportedly to prevent reoccurring odors from entering occupied areas. Most vents are not sealed (see Picture 3). Some classrooms and hallway areas contain open floor vents that are also connected to the ventilation shaft in the basement (see Picture 4). Classrooms were constructed around these shafts to provide exhaust ventilation.

Classroom Natural Gravity Feed Supply/Heat Vent Note Vent Is Not Sealed

2. Consider consulting a ventilation engineer concerning the feasibility of restoring the original gravity feed ventilation system. This may entail repair or replacement of heating elements located in ventilation shafts; repair of broken or missing warm air and cool air pulley chain/louver door systems to provide ventilation in this building as designed; repair of the hinged-pulley system and/or installation of openable windows in basement area to provide fresh air to classrooms.

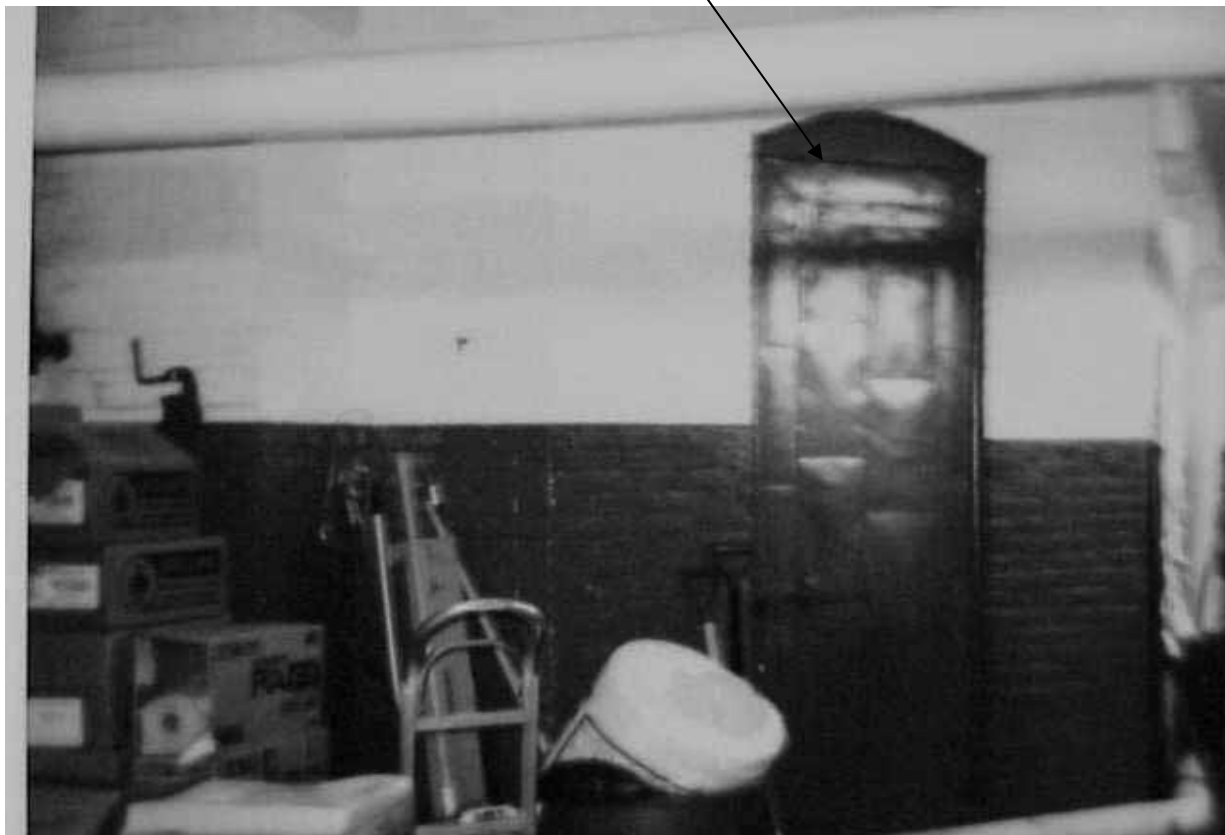
Picture 2

Doorway to Ventilation Room (Vault) in Basement

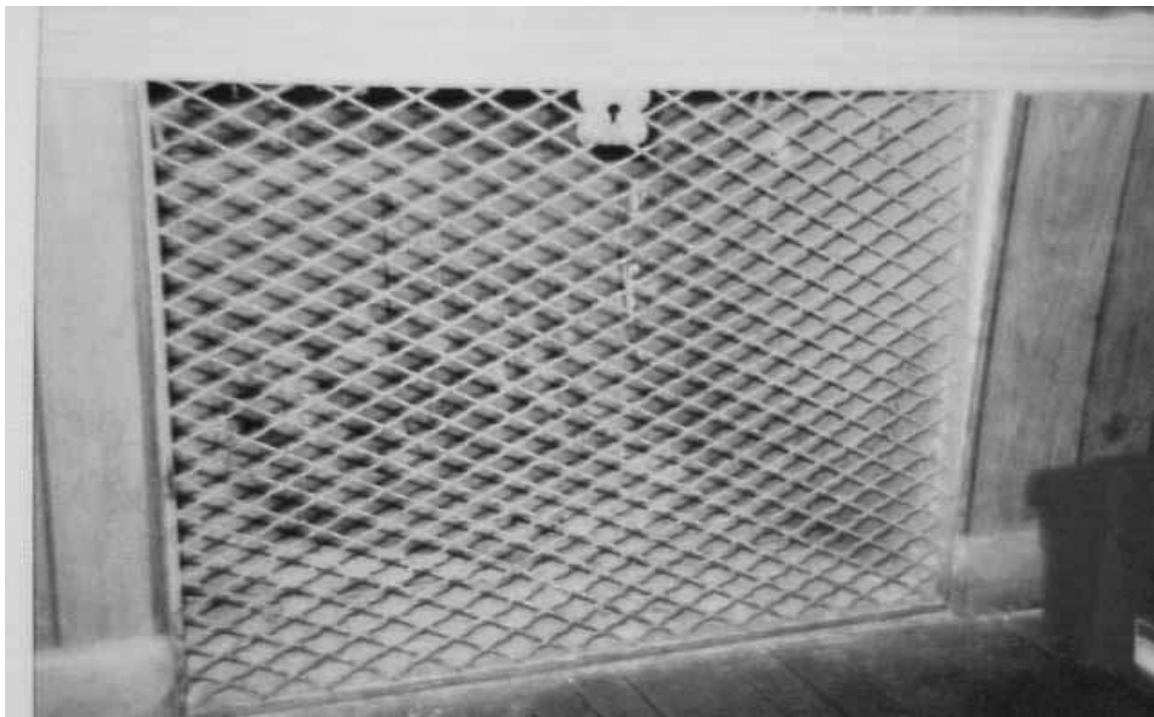
Picture 3

into the hot air ducts, return air is drawn from the “hearths” at the bottom of the exhaust ventilation shafts. Negative pressure is created in these shafts, which in turn draw air into the exhaust vents of each classroom. The draw of air into these cool air vents is controlled by a draw chain pulley system. As mentioned previously, some of these vents were sealed in classrooms, therefore no means of exhaust ventilation exists.

Unsealed Classroom Natural Gravity Feed Exhaust Vent

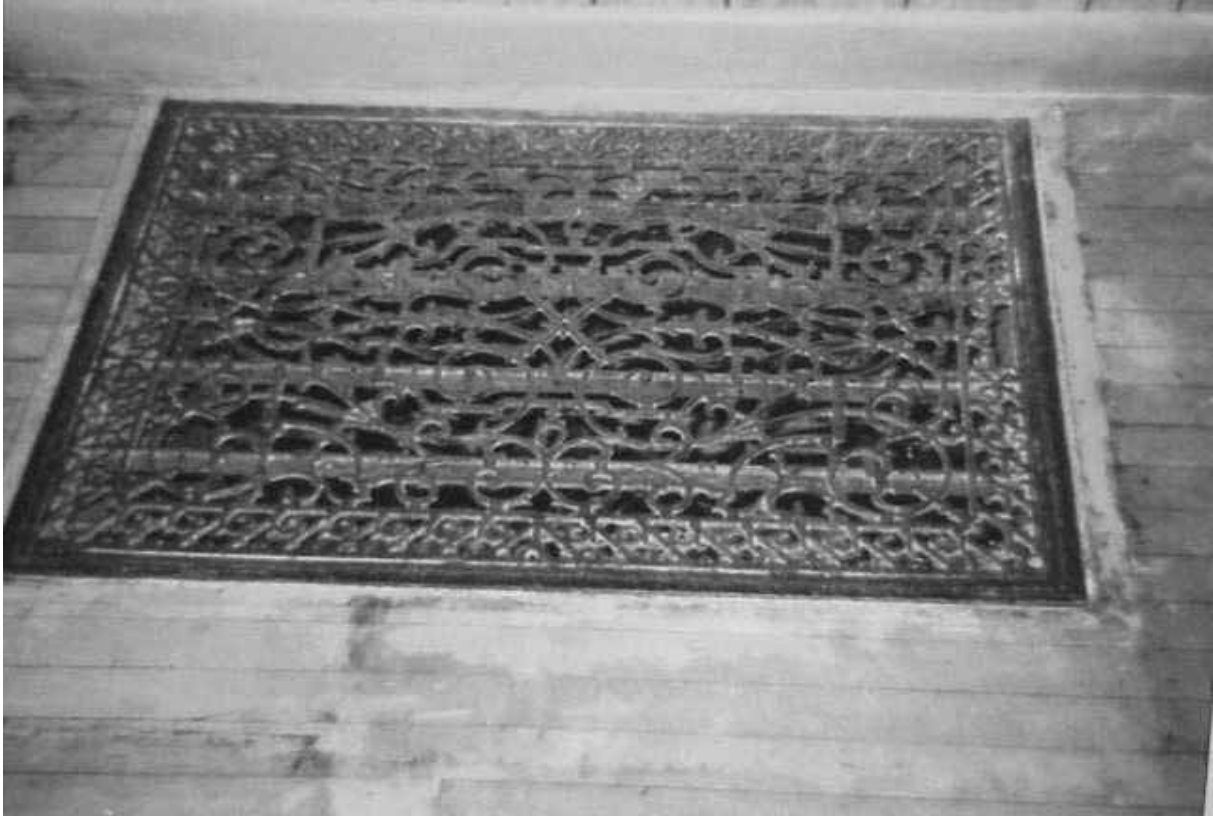
Picture 4

Natural Gravity Feed Supply/Heat Floor Vent

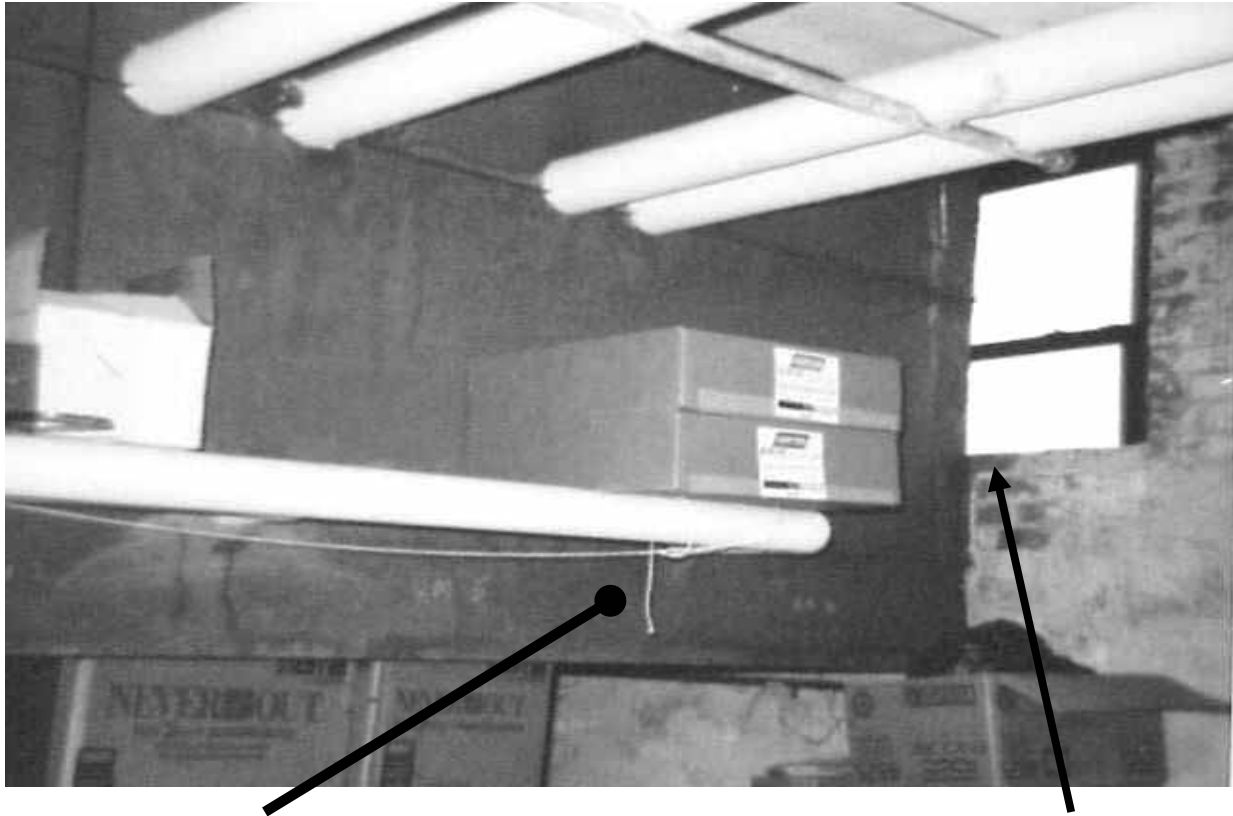
Picture 5

Air movement is provided by the stack effect. Heating elements located in the base of the ventilation shaft (see Picture 5) warm the air, which rises up the hot air ventilation shafts. As the heated air rises, negative pressure is created, which draws cold air from the basement area into the heating elements. This system was designed to draw air from two sources in the basement: fresh air from a hinged window-pulley system on the exterior wall of the building (see Picture 5) and return air from the exhaust ventilation shafts. These sources of air mix in the vault prior to being drawn into the heating elements. The percentage of fresh air to return air is controlled by the hinged window-pulley system. The chains of the pulley system were designed to be set to lock the hinged window at a desired angle to limit fresh air intake. The remains of the chain and pulley system were noted in the ventilation vault. Non-openable windows have replaced the hinged window-pulley system; therefore no fresh, cool air can be introduced into the system.

Heating Element/Radiator in Ventilation Room (Vault) in Basement Note Window Originally Designed to Introduce Fresh Air into the System

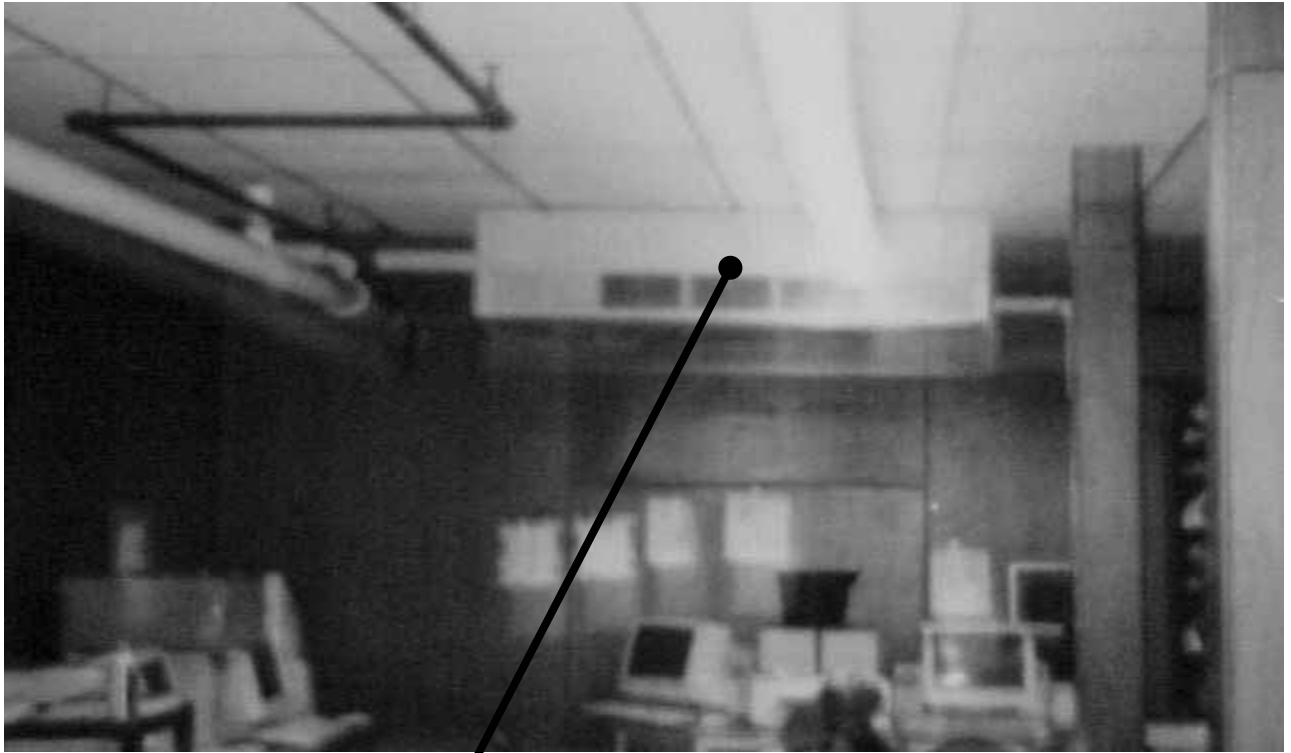
Picture 6

Basement classroom 13 contained a ceiling-mounted unit ventilator (univent), which was not operating during the inspection (see Picture 6). A univent draws fresh air from a vent on the exterior of the building and air from the classroom (called return air) through a vent in the base of the unit (see [Figure 1](#)). Fresh air and return air are mixed, filtered, heated and expelled into the classroom through a fresh air diffuser located in the top of the unit. To function as designed, univents must be activated to provide a mechanical means of fresh air. No mechanical exhaust ventilation was noted in this area.

Ceiling-Mounted Univent Noted in Classroom 13

3. Examine univent in classroom 13 for proper function, ensure fresh air intake louvers are operable, repair/replace as needed. Operate univent during periods of school occupancy.

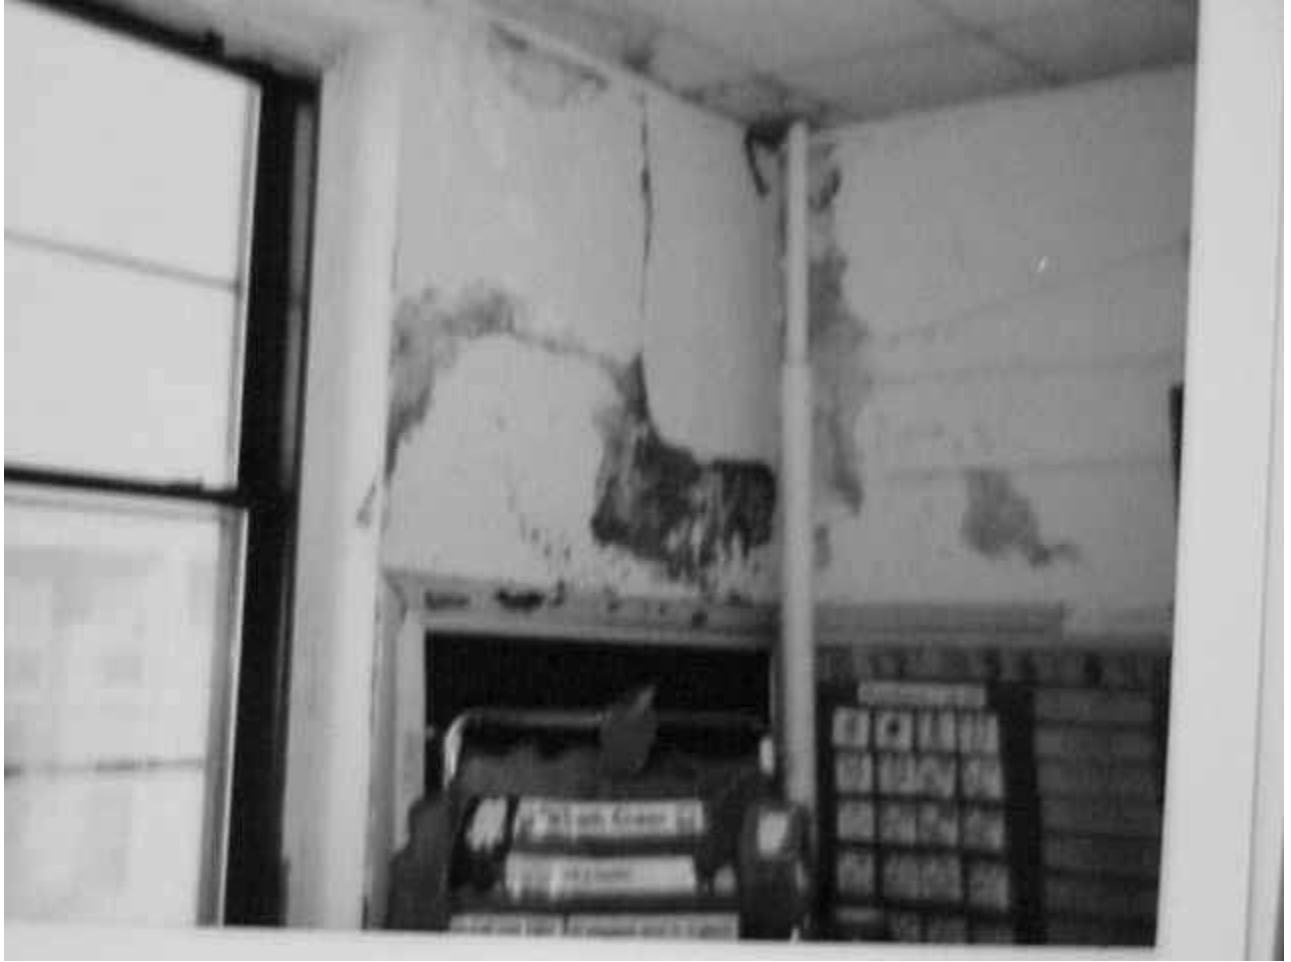
Picture 7

Several classrooms had water-damaged ceiling tiles, which can indicate leaks from either the roof or plumbing system. Water-damaged ceiling tiles can provide a medium for mold and mildew growth and should be replaced after a water leak is discovered and repaired.

Water-damaged wall plaster was also noted on walls and windows in a number of areas in the building (see Tables), which may be evidence of a current or historic roof or plumbing leak. Water intrusion was evident by the presence of efflorescence (e.g., mineral deposits) and water-damaged plaster. Efflorescence is a characteristic sign of water damage to brick and mortar, but it is not mold growth. As moisture penetrates and works its way through mortar around brick, water-soluble compounds in bricks and mortar dissolve, creating a solution. As this solution moves to the surface of the brick or mortar, the water evaporates, leaving behind white, powdery mineral deposits. Water-damaged wall plaster, if wetted repeatedly, can be a medium for mold growth. Water damage was especially prevalent in the northeast corner of the building (see Picture 7). A perimeter inspection of the exterior of the building also revealed missing, damaged and crumbling mortar around brickwork. These conditions are breaches of the building envelope and provide a means for water entry into the building.

Water-Damaged Ceiling Tiles and Wall Plaster Noted in Northeast Classroom

6. Consider having exterior brick repointed and waterproofed to prevent further water intrusion. Repair water damaged ceilings, walls and wall-plaster as necessary.

7. Repair any existing water leaks and replace any remaining water-stained ceiling tiles, wooden flooring and wood trim. Examine the areas above and around these tiles for mold growth. Disinfect areas of water leaks with an appropriate antimicrobial as needed.
