INDOOR AIR QUALITY ASSESSMENT

**New Bedford Water Department
Administration Building
1105 Shawmut Avenue
New Bedford, Massachusetts**

Prepared by:
Massachusetts Department of Public Health
Bureau of Environmental Health Assessment
July, 2000

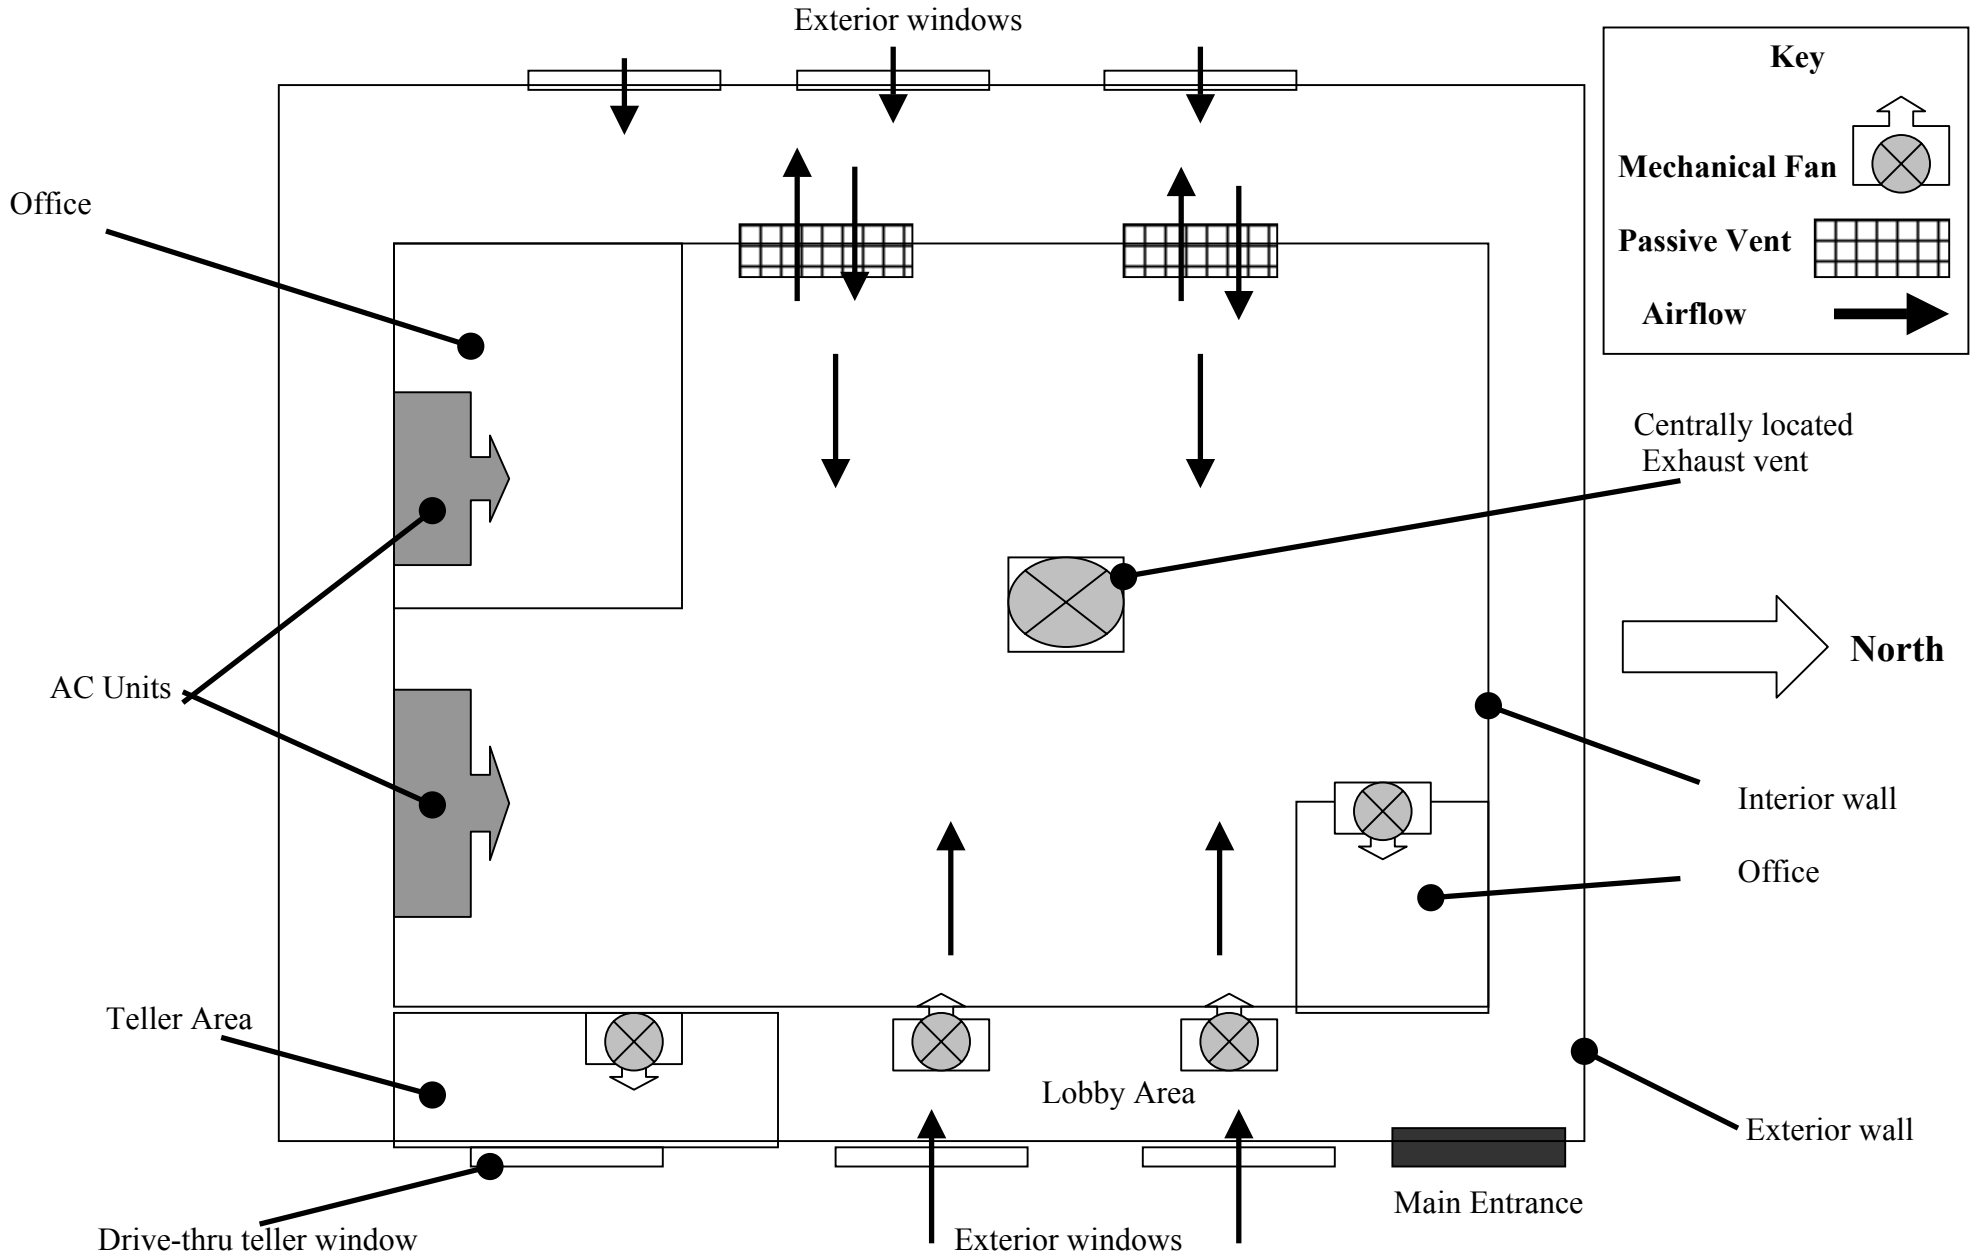
Figure 1
Physical Layout of New Bedford Water Department
Billing Area

Office space and common areas in the building are not equipped with mechanical supply ventilation, but use wall-mounted mechanical fans and passive vents in combination with openable windows to circulate air (see Pictures 1-3). When the building was converted to office space in 1995, interior walls were constructed which prohibited access to windows on the exterior walls. In an effort to provide fresh air, wall-mounted mechanical fans were installed along the east wall and passive vents were installed in the west wall to facilitate airflow (see Figure 1). Also noted in the main

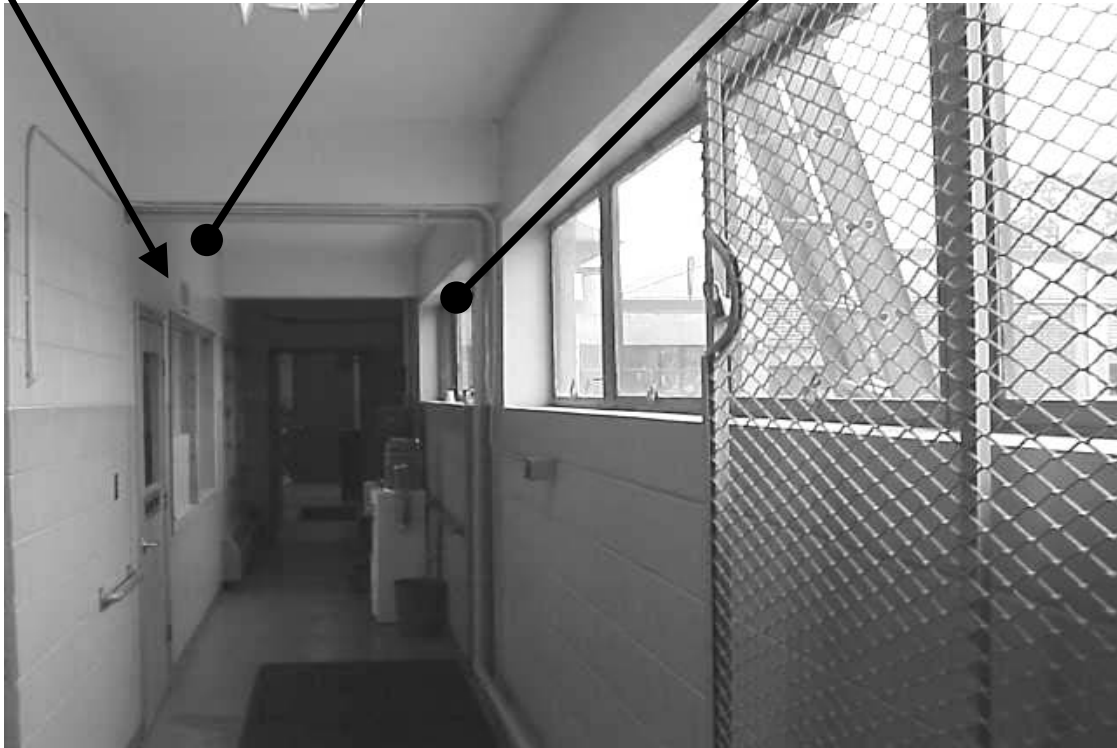
Picture 1

A number of complaints of stale air and poor ventilation were expressed to BEHA staff. Although efforts were made to facilitate airflow into the main office area, the configuration of the building with the construction of interior walls obstructs direct access to openable windows. In addition, most of the windows were closed and a number of the fans were deactivated during the assessment. Without a mechanical supply ventilation system, the sole source of ventilation in the building is openable windows.

**Openable Windows on Exterior Wall of Water Department Administration Building
Note Windows are Separated from Occupied Billing Area by Interior Wall**

1. To maximize air infiltration/circulation, open windows and utilize mechanical fans during periods of occupancy.
2. Consider consulting a heating, ventilating and air-conditioning (HVAC) engineer regarding the installation of a mechanical ventilation system to provide fresh air to the interior of the building.

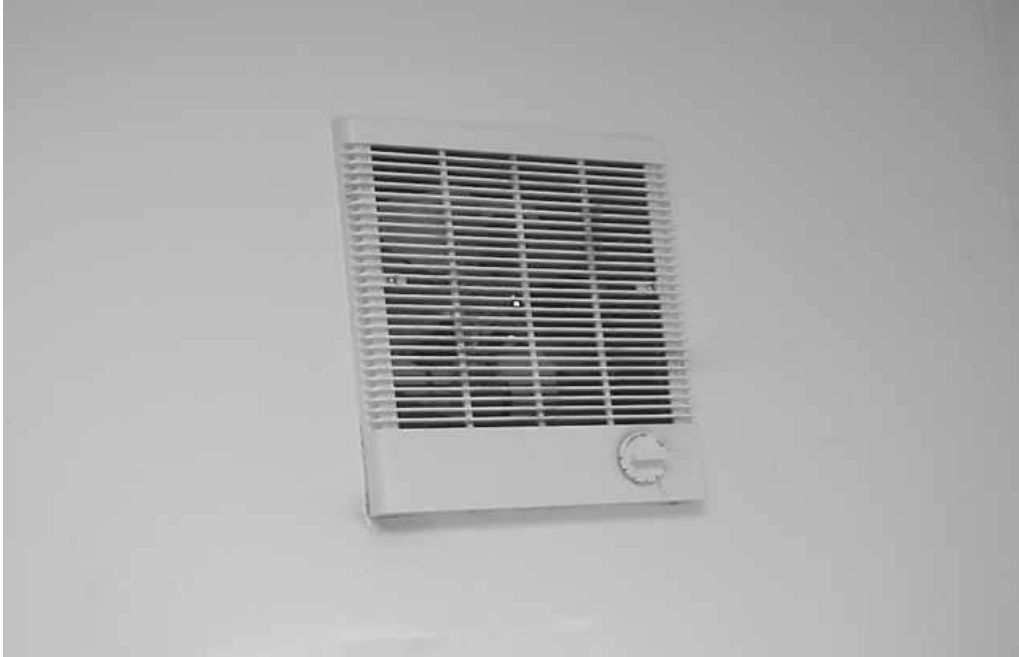
Picture 2

Example of Wall-Mounted Fan Installed in Main Office Area to Facilitate Airflow

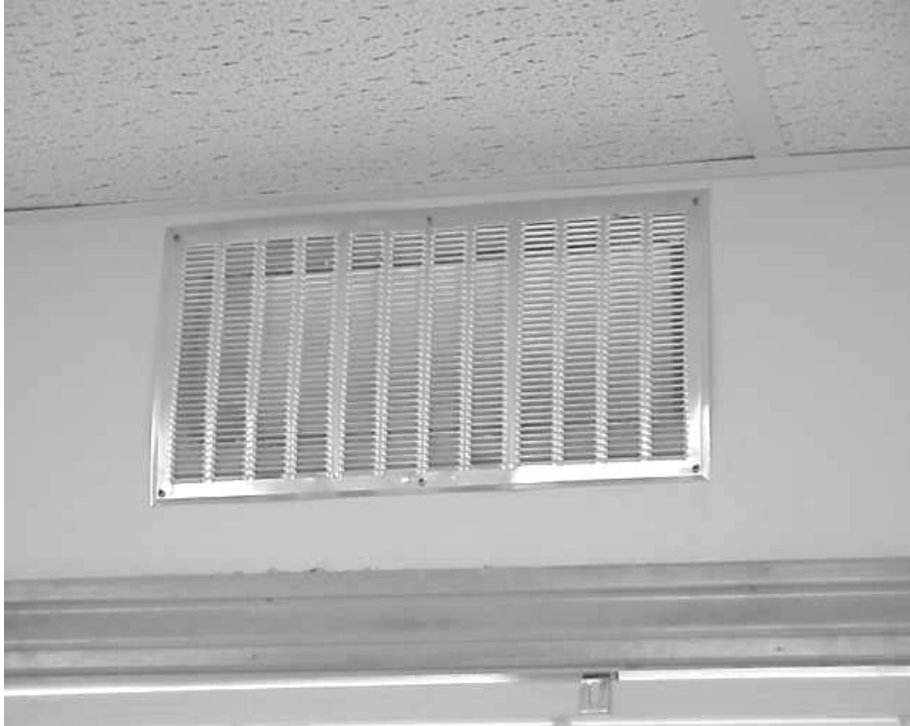
Picture 3

Example of Passive Wall Vent Installed in Main Office Area to Facilitate Airflow

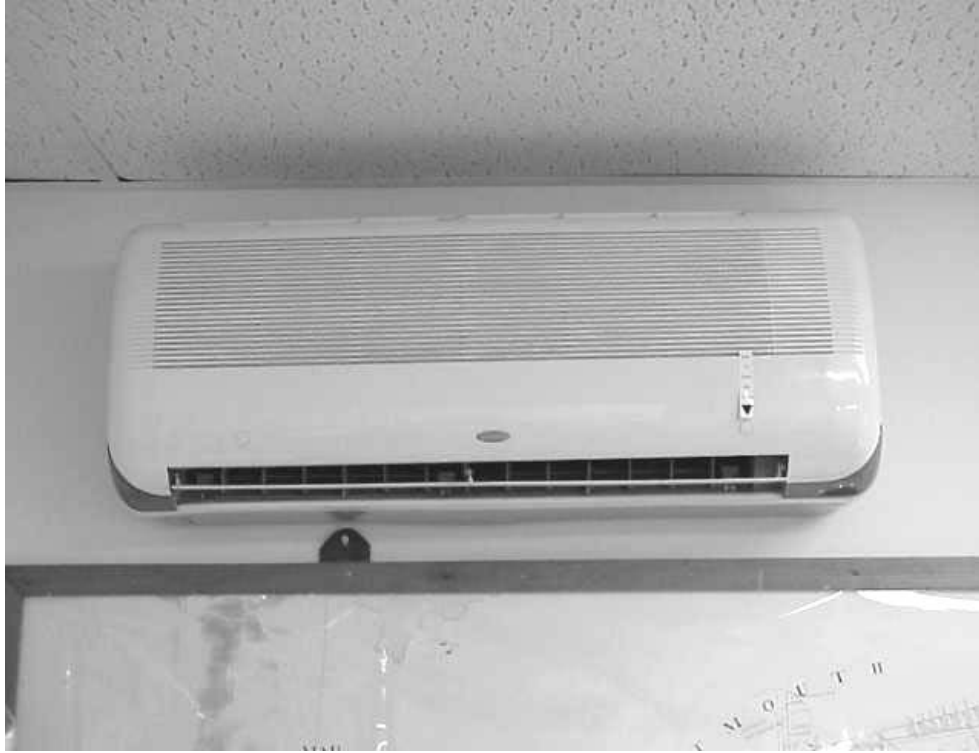
Picture 4

office area are several wall-mounted air-conditioning (A/C) units. Chilled water for the system is provided by rooftop chillers (see Pictures 4 & 5). These A/C units provide no fresh air and recirculate only.

**Example of Wall-Mounted Air-Conditioning (A/C) Unit
Note A/C Units do not Provide Fresh Air but Recirculate Only**

3. Continue to operate mechanical exhaust ventilation during periods of occupancy.
4. Operate wall-mounted air-conditioning units in conjunction with wall fans to provide for the comfort of occupants.

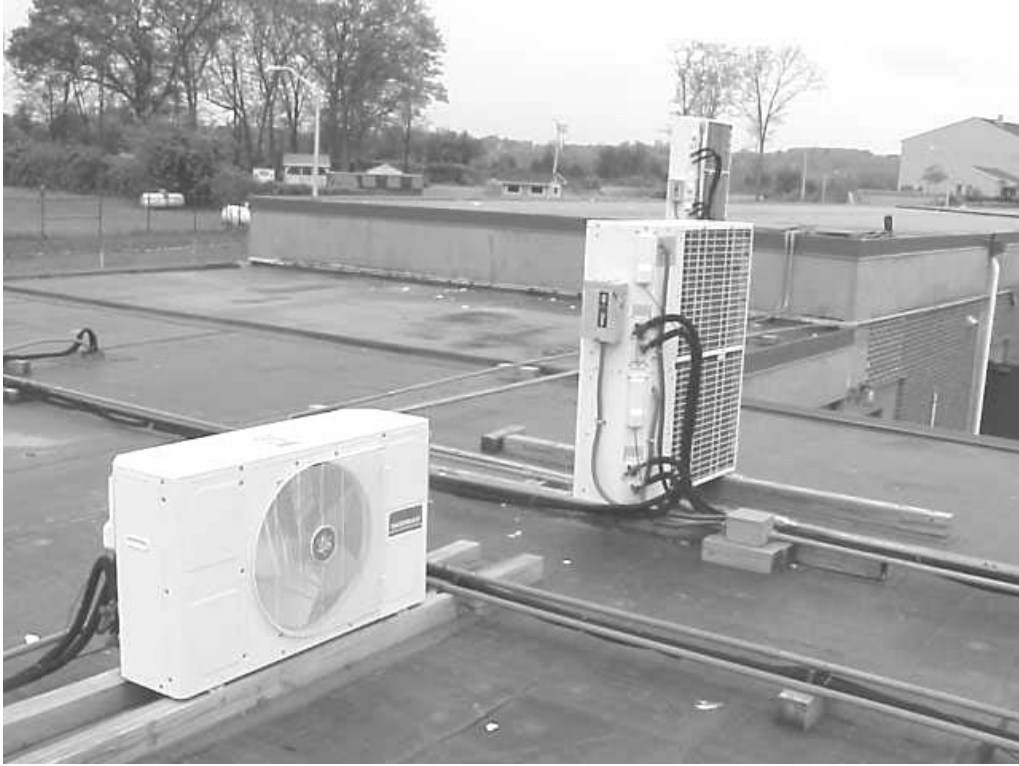
Picture 5

Rooftop Units Providing Chilled Water for A/C Units

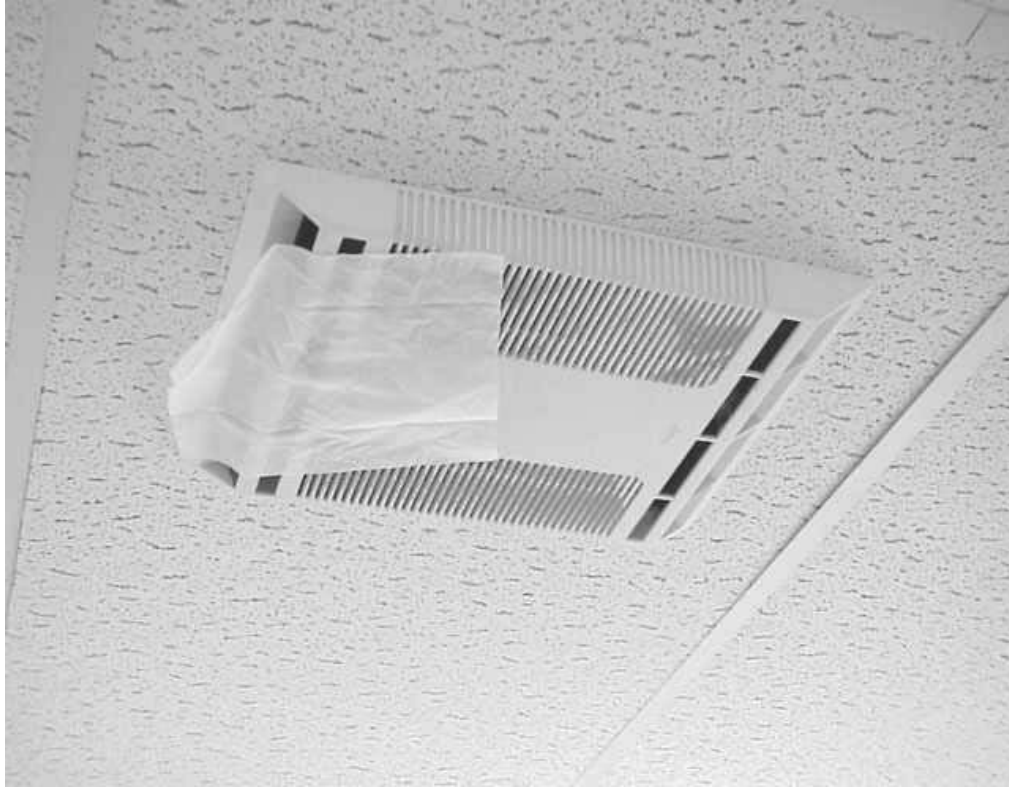
Picture 6

Mechanical exhaust ventilation is provided by ceiling-mounted intake grills connected to ductwork. All exhaust vents were functioning throughout the building (see Pictures 6-8). Restrooms also have mechanical exhaust ventilation to help remove excess moisture and/or odors.

**Ceiling-Mounted Exhaust Vent Noted in Billing Office Area
Note Tissue Indicating Draw of Air**

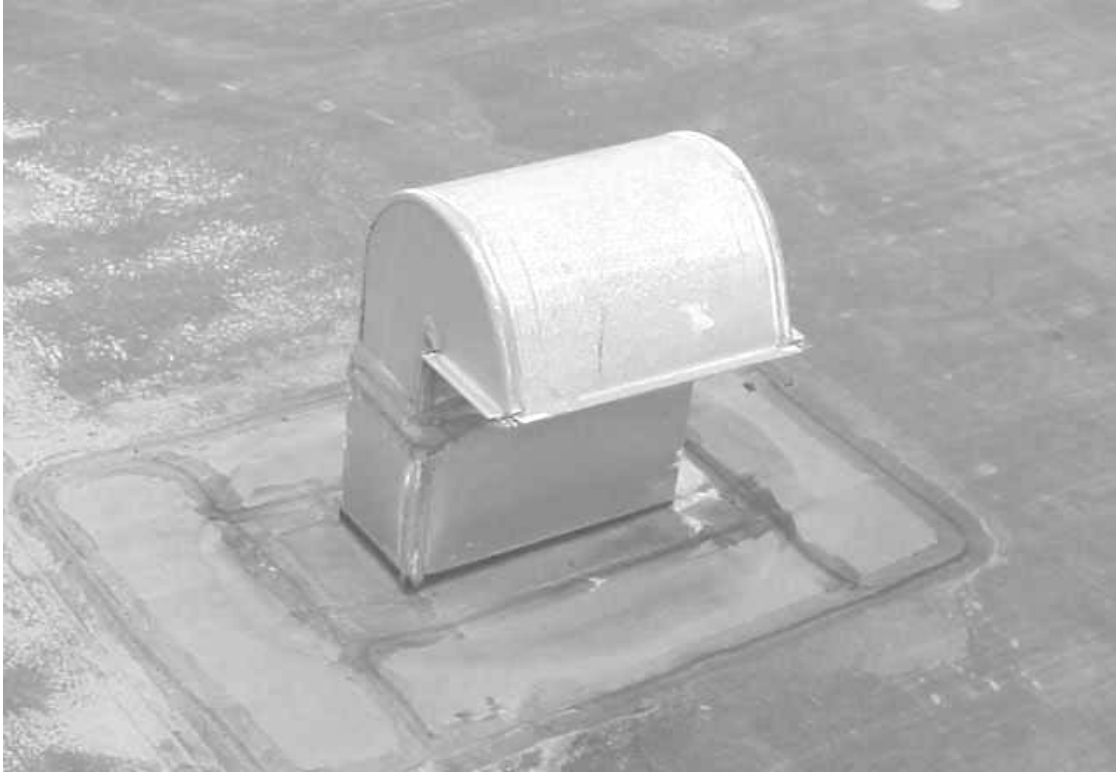
Picture 7

Rooftop Exhaust Ductwork for Main Office Area

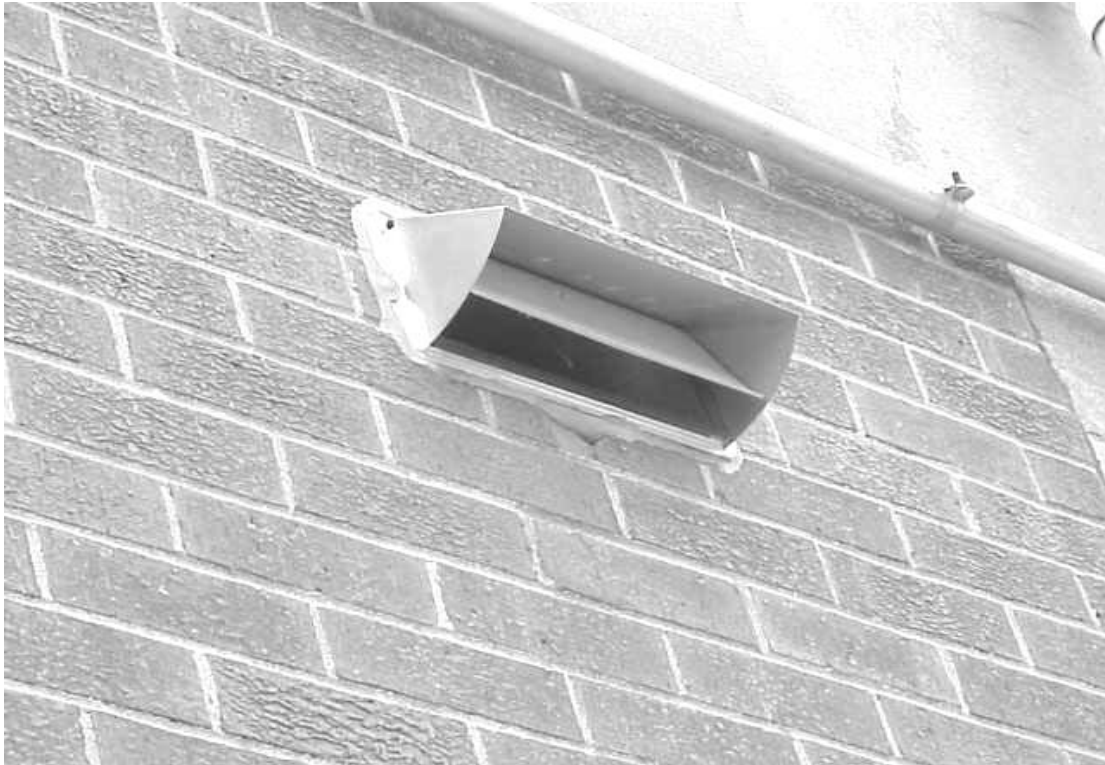
Picture 8

Exhaust Ductwork for Conference Room Noted on West Exterior Wall

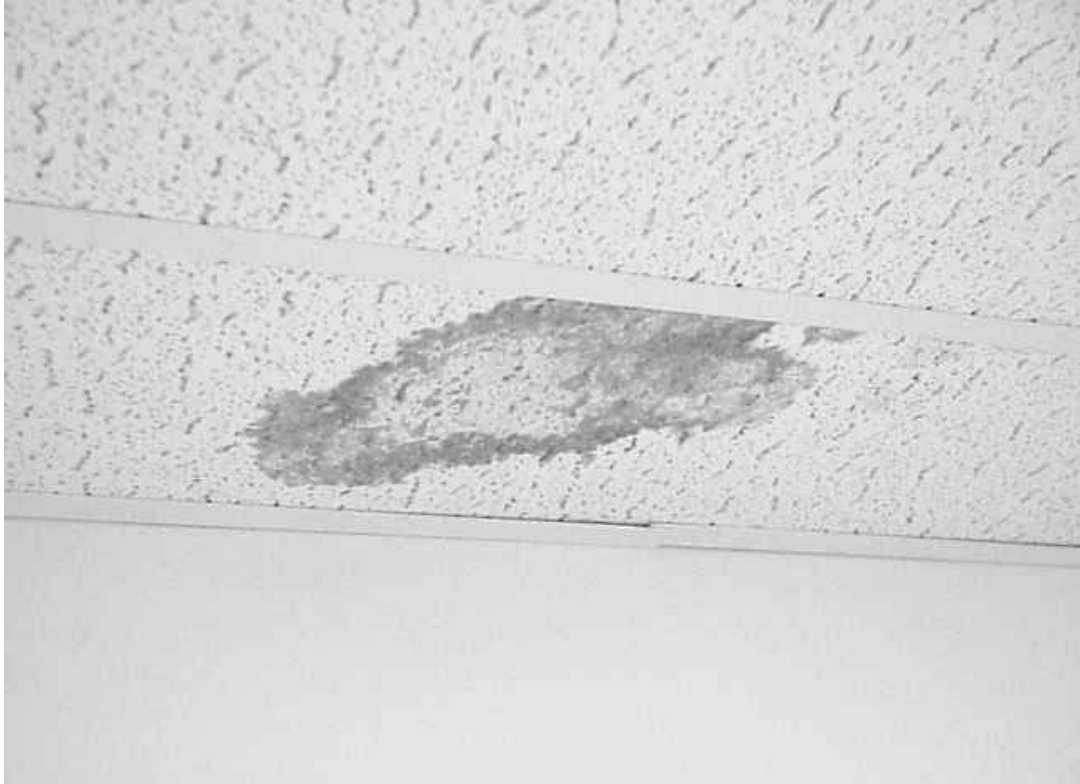
Picture 9

A number of areas had water-stained ceiling tiles, which are evidence of roof and/or plumbing leaks (see Picture 9). Water-damaged ceiling tiles can provide a source of mold and mildew growth, especially if they are moistened repeatedly. These tiles should be replaced after a water leak is discovered and repaired. The most likely source of water penetration appears to be around the chilled water pipes, connected to the rooftop chillers (see Picture 10). Holes around utility pipes are breaches of the building envelope and can provide a source of water penetration. In addition, chilled water pipes

Water-Stained Ceiling Tile

7. Remove clinging plants on brickwork to avoid damage to mortar and brickwork and subsequent water penetration.
8. Repair any existing water leaks and replace any remaining water-stained ceiling tiles. Examine the areas above these tiles for mold growth. Disinfect areas of water leaks with an appropriate antimicrobial as needed.

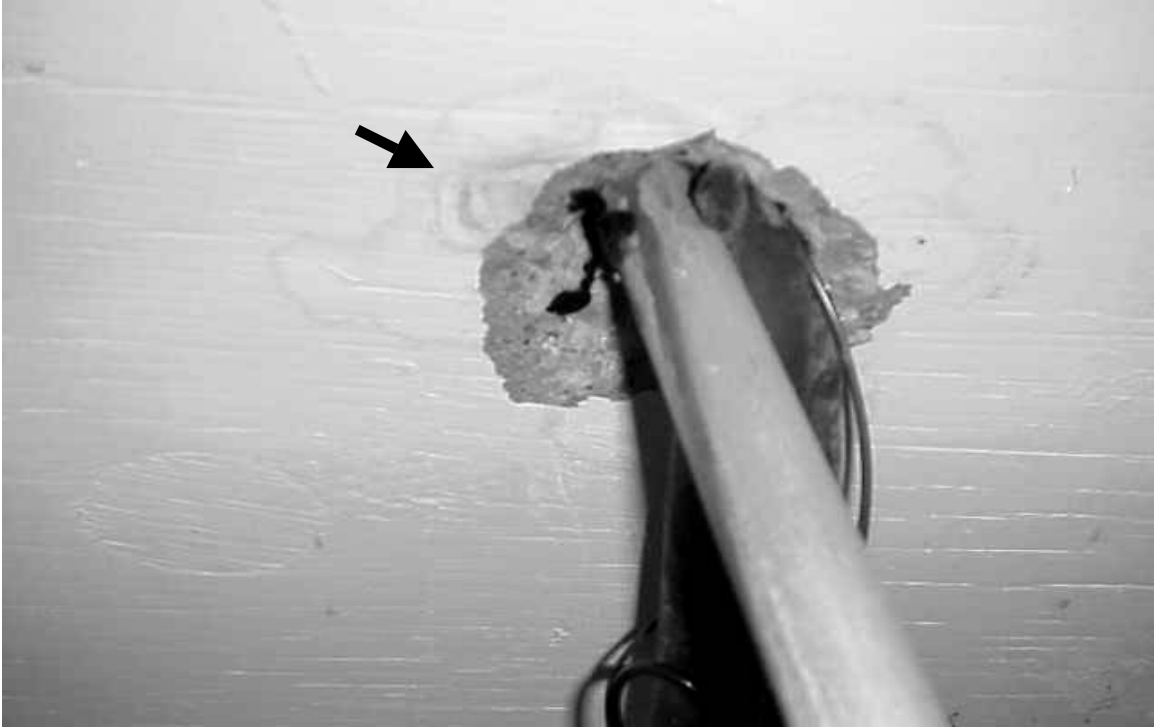
Picture 10

should be insulated to avoid condensation build-up and the subsequent wetting of ceiling tiles from dripping pipes. When warm, moist air passes over a surface that is colder than the air; water condensation can collect on the cold surface of the pipes. Over time, water droplets can form, which can then drip from a suspended surface. The cool temperature of the metal piping would make them prone to generating condensation. Dripping condensation can lead to mold growth on porous materials (i.e., ceiling tiles).

**Utility Hole for Pipe Penetration through Roof Noted above Ceiling Tiles
Note Water Stained Pipes and Ceiling Plaster Indicating Water Penetration**

9. Seal holes around utility pipes to avoid water penetration from the roof. Consider insulating water pipes to avoid condensation and the subsequent wetting of ceiling tiles from dripping pipes.

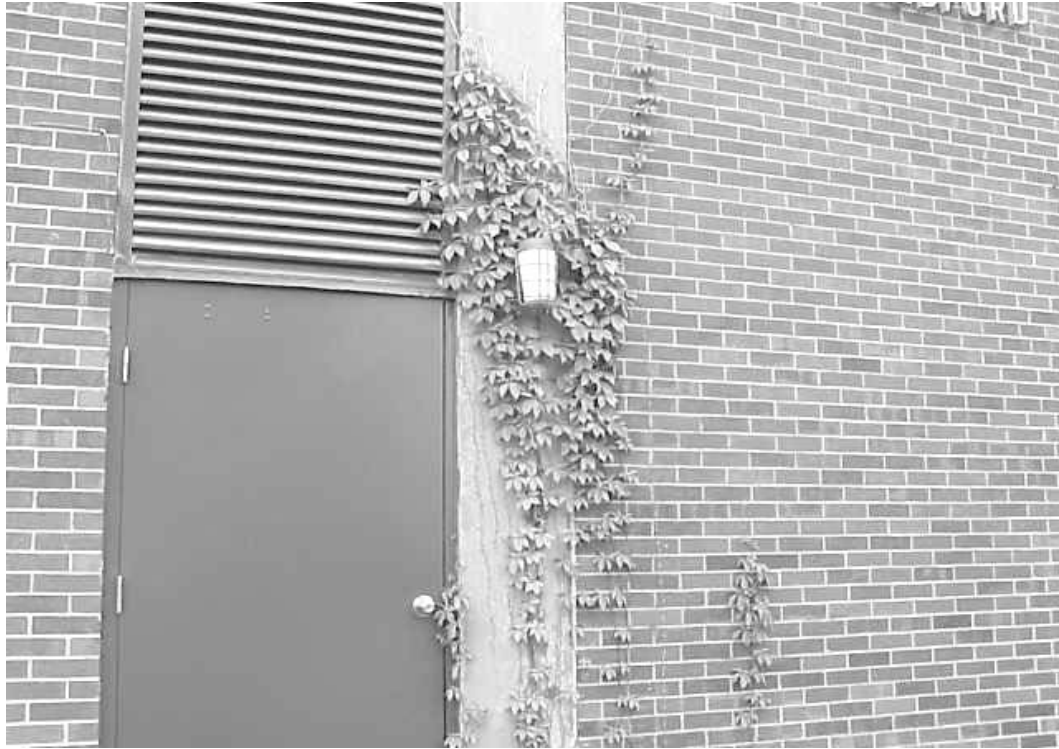
Picture 11

Vine growth was noted on the exterior walls of the building (see Picture 11). Clinging plants can cause water damage to brickwork by inserting tendrils into brick and mortar. Water can penetrate into the brick along the tendrils, which can subsequently freeze and thaw during the winter. This freezing/thawing action can weaken bricks and mortar, resulting in damage to the wall. In order to avoid this problem, clinging plants on brickwork should be removed.

Vine Growth Noted on Exterior Brick

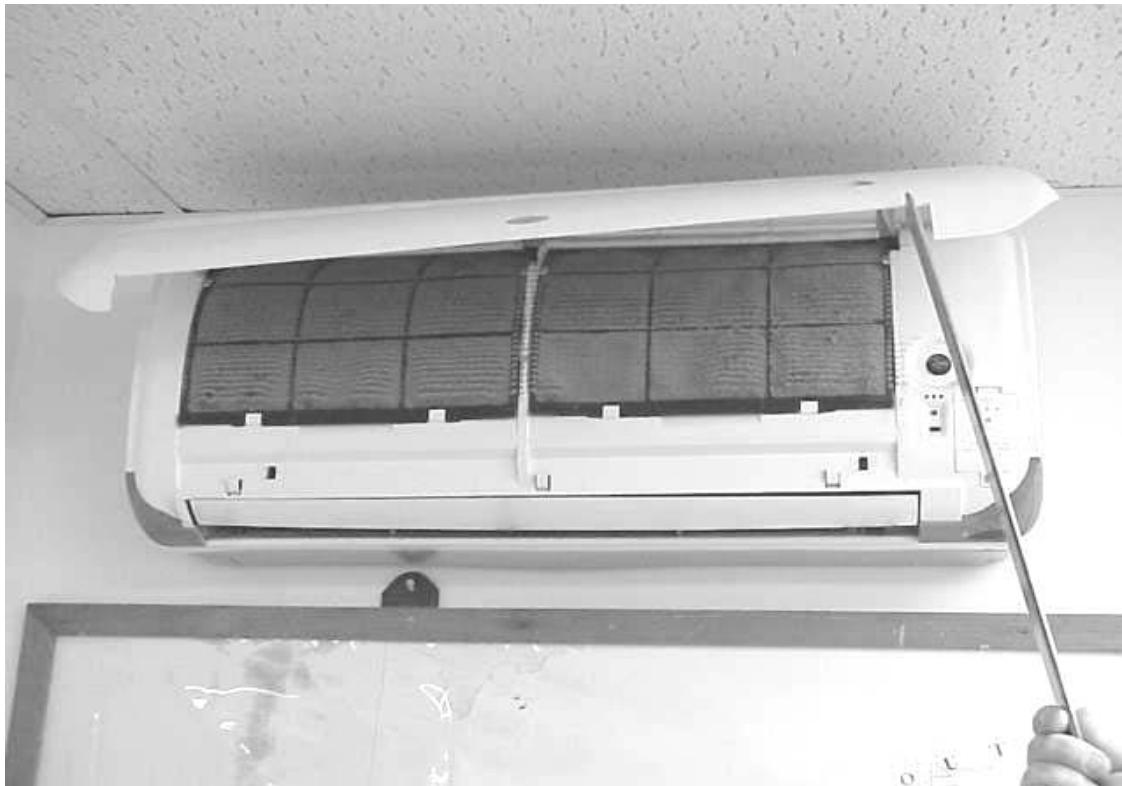
Picture 12

Several other conditions that can potentially affect indoor air quality were also observed. As previously mentioned, many areas contained wall-mounted air conditioners. These units are equipped with filters, which should be changed as per the manufacturer's instructions to avoid the build up and re-aerosolization of dirt, dust and particulate matter (see Picture 12). The filter of the unit in the main office area was inspected by BEHA staff and had heavy dust accumulation (see Picture 13). A number of these units are equipped with indicator lights informing operators of filter status. The indicator light for this unit was red at the time of the assessment; presumably meaning it needed to be changed (see Picture 14).

Wall-Mounted A/C Unit Opened to Expose Filter

10. Change filters for A/C units as per the manufacturer's instructions, or more frequently if needed. Clean and vacuum interior of units prior to operation to avoid the re-aerosolization of accumulated dirt, dust and debris.

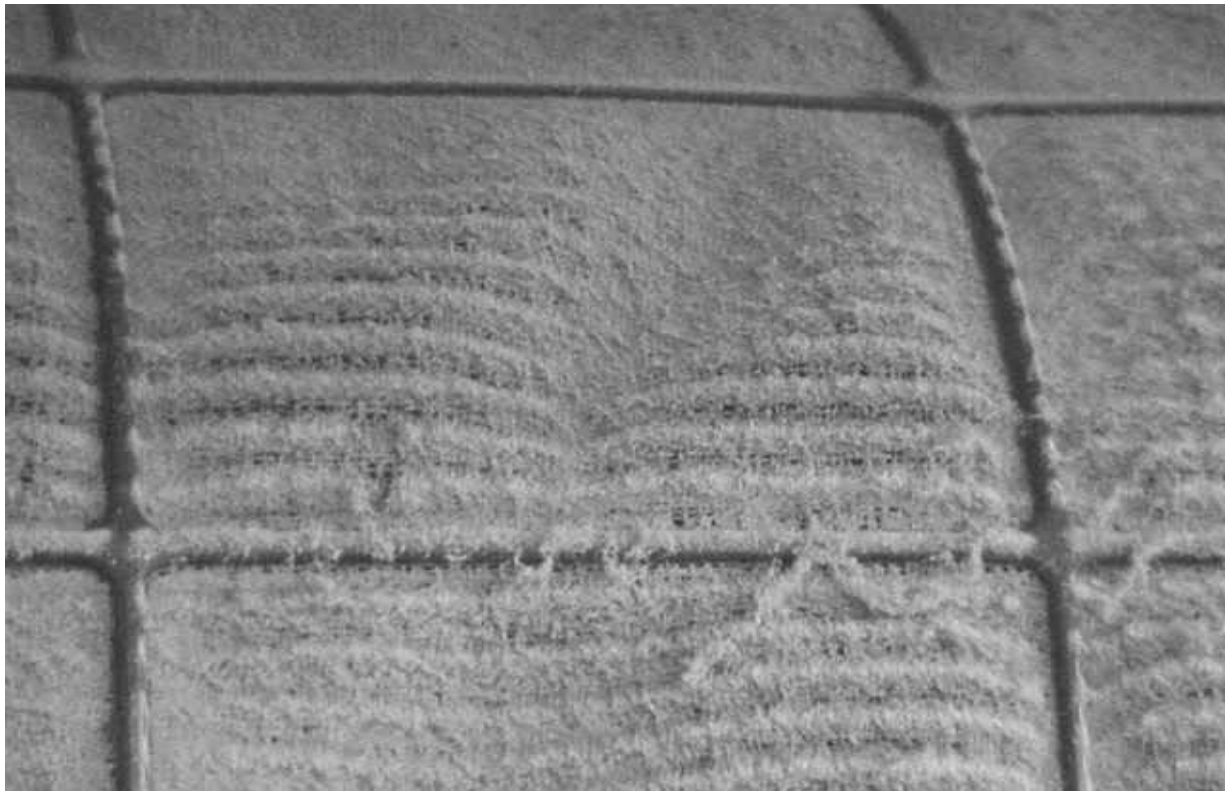
Picture 13

Close-Up of A/C Filter Note Filter Media Accumulated with Dirt, Dust and Debris

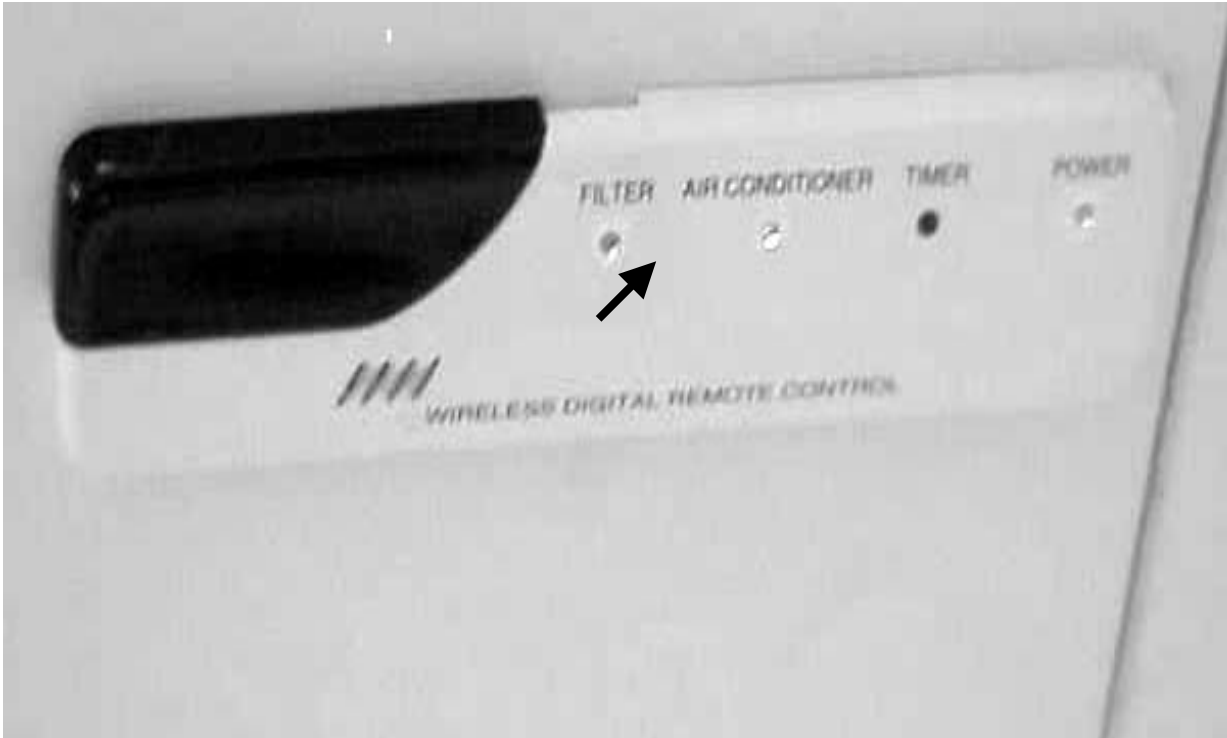
Picture 14

Indicator Lights Noted on Exterior Panel of A/C Unit Note Filter Indicator Light Was Red at the Time of the Assessment

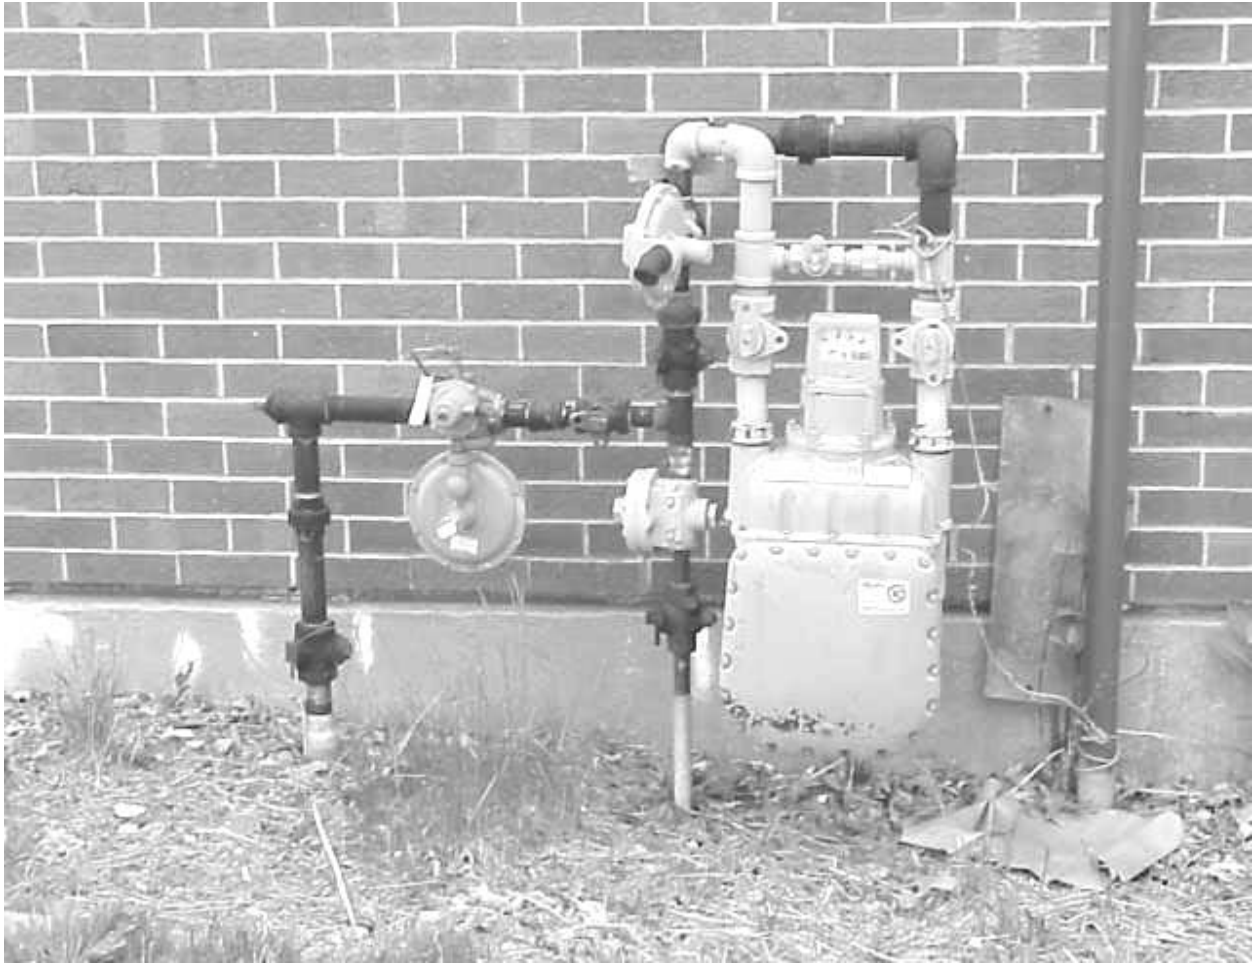
Picture 15

During a perimeter inspection of the building BEHA staff detected an odor of natural gas. A characteristic hissing sound was noted from the regulator directly outside of the welding shop (see Picture 15). BEHA staff alerted welding shop occupants and Ms. Bruneau, who in turn, notified Commonwealth Gas. BEHA staff called Ms. Bruneau, the following day to determine the status of the leak. Ms. Bruneau reported that Commonwealth Gas had responded, confirmed, the gas leak and corrected the problem.

Gas Regulator Noted Leaking on Exterior Eastside Wall

11. Monitor gas regulator outside of welding shop periodically; report any odors and/or leaks to Commonwealth Gas.
12. Activate wall fan in drive-thru to over pressurize the area to keep exhaust emissions from infiltrating. Post a sign requesting that vehicles shut off engines after five minutes as required by Massachusetts General Laws 90:16A.
