INDOOR AIR QUALITY ASSESSMENT

**William E. Welch, Sr. Elementary School
3 Swampscott Avenue
Peabody, Massachusetts**

Prepared by:
Massachusetts Department of Public Health
Bureau of Environmental Health Assessment
July, 2000

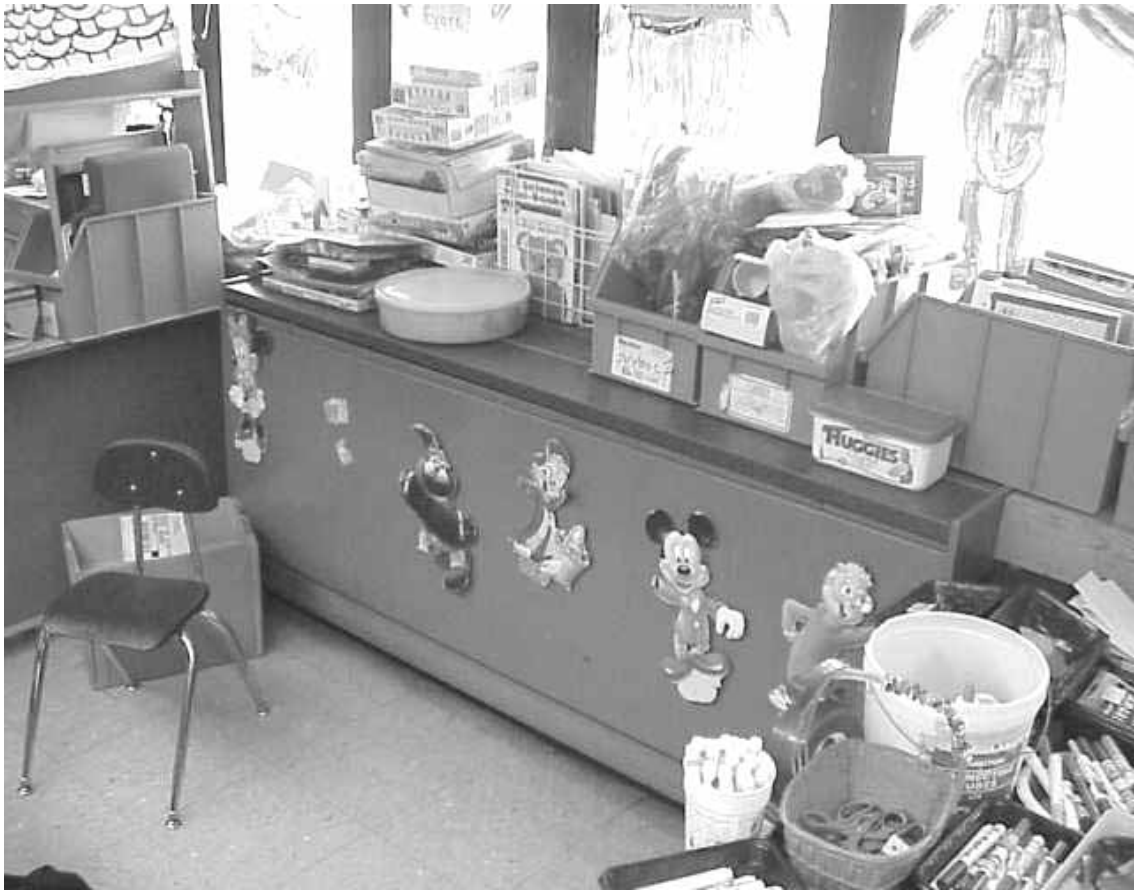
Picture 1

Obstructions to airflow, such as books, papers and posters on top of univents, as well as bookcases, tables and desks in front of univent returns, were seen in a number of classrooms (see Picture 1). To function as designed, univents and univent returns must

remain free of obstructions. Importantly, these units must be activated and allowed to operate during hours of school occupation.

Classroom Univent: Note Materials Obstructing Air Diffuser (Top of Unit)

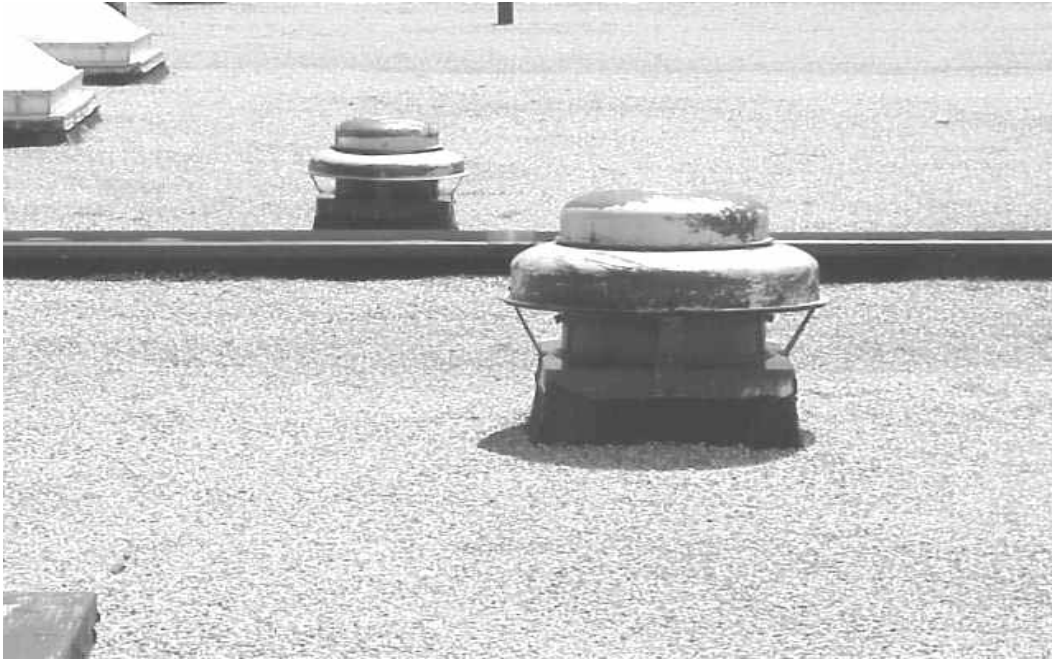
Picture 5

**Rooftop Exhaust Motors: Note that 17 of 22 of These Motors
Were Operating During the Assessment**

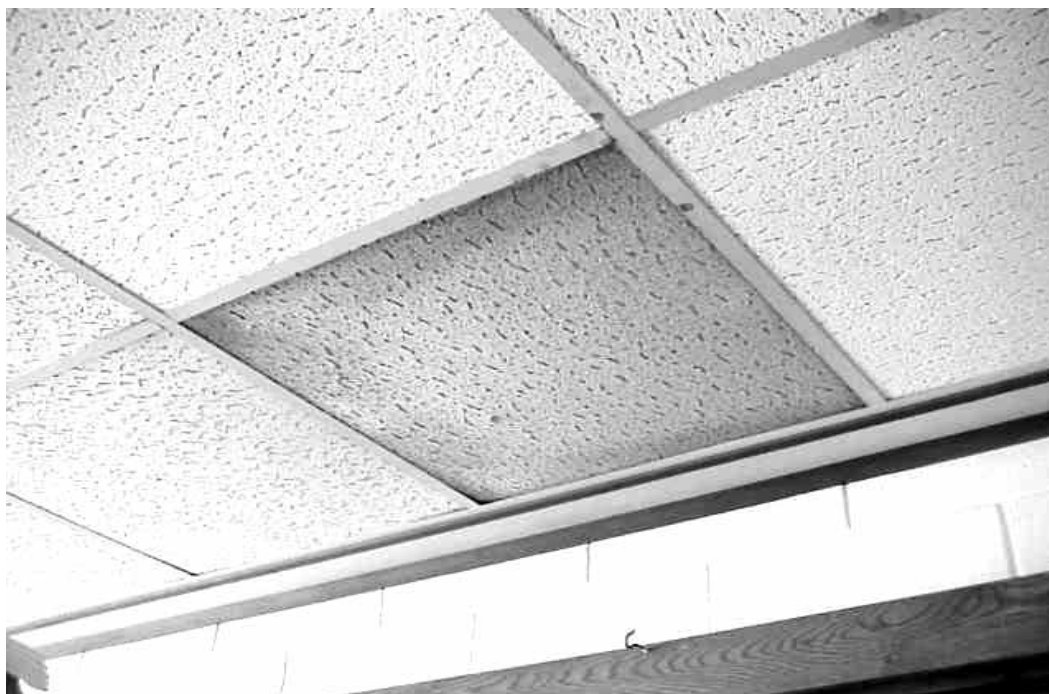
Picture 7

Several areas had water stained ceiling tiles (see Tables/Picture 7). Water-damaged ceiling tiles can provide a source of mold and mildew and should be replaced after a water leak is discovered and repaired. Mold can be an eye and respiratory irritant to certain sensitive individuals. Classroom 14 contained a water-stained ceiling tile with possible mold growth (see Picture 8).

Water-Stained Ceiling Tile in Classroom

8. Repair roof leaks and replace any water-stained ceiling tiles. Examine the area above and around these areas for mold growth. Disinfect areas of water leaks with an appropriate antimicrobial.

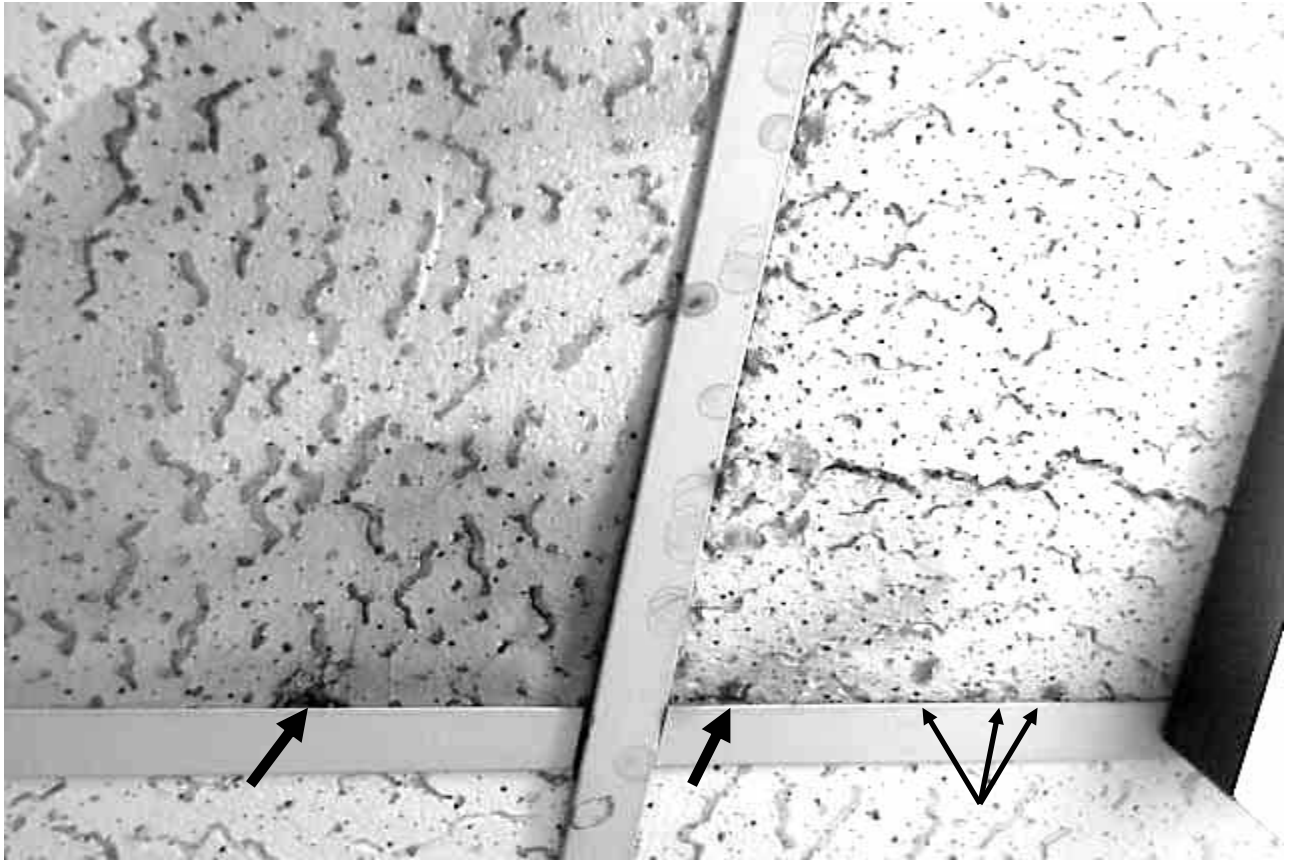
Picture 8

Possible Mold Growth on Classroom Ceiling Tile

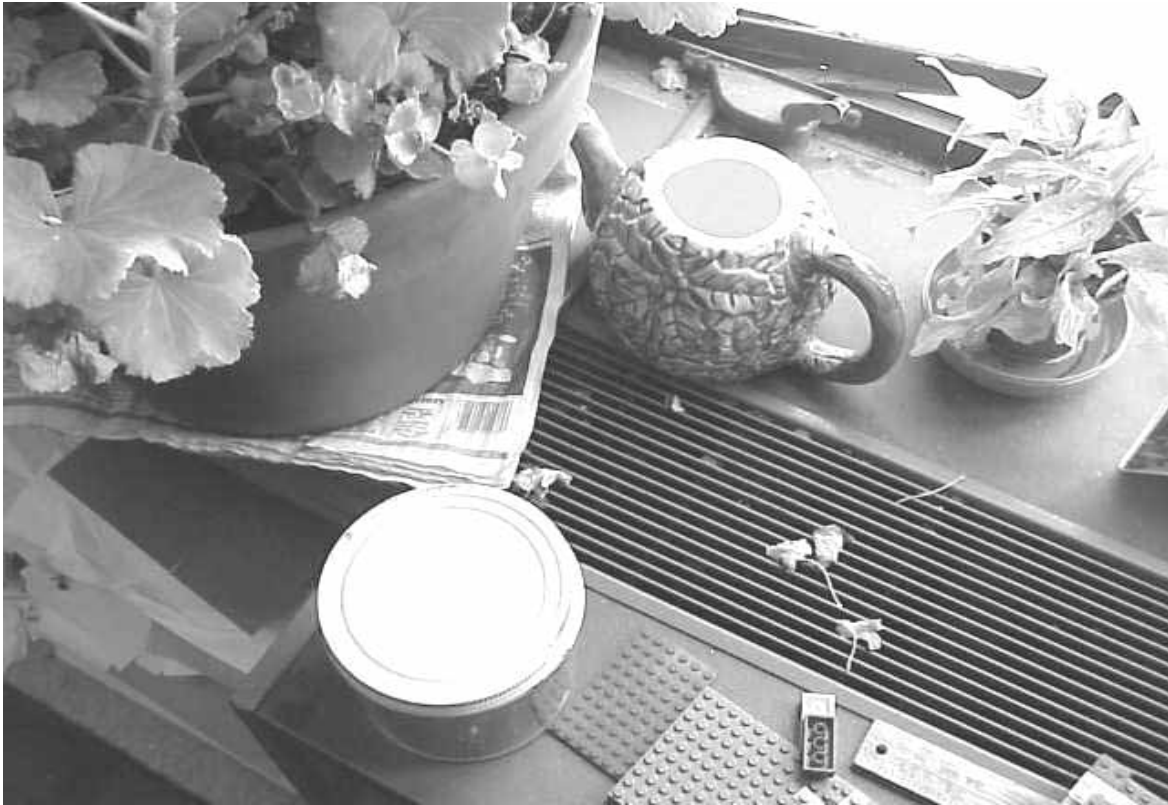
Picture 9

Plants were noted in several classrooms. Plants can be a source of pollen and mold, which can be a respiratory irritant to some individuals. Plants should be properly maintained and equipped with drip pans. Plants should also be located away from univents to prevent the aerosolization of dirt, pollen or mold (see Picture 9). Several classrooms contained plants in window planters. Window planters are designed to be mounted on the outside of windows and usually do not have drip pans. The lack of drip pans can lead to water pooling and mold growth on windowsills when used indoors. Windowsills have the potential to become colonized by mold growth and serve as a source of related odors. Several classrooms had plants without drip pans resting on

Plants and Other Materials on Classroom Univent

9. Repair/replace loose, missing or damaged window caulking building-wide to prevent water penetration through window frames.
10. Keep plants away from univents in classrooms. Ensure plants have drip pans, examine drip pans for mold growth and disinfect areas with an appropriate antimicrobial where necessary. Consider discontinuing the use of window planters inside the building.

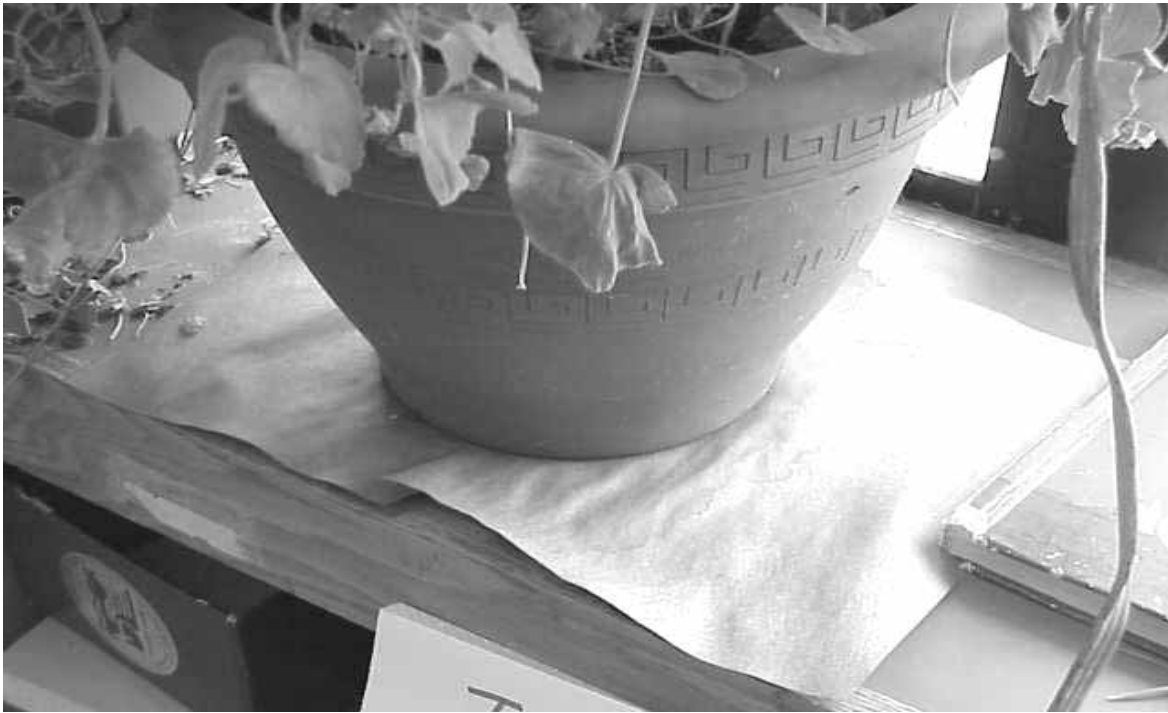
Picture 10

newspaper or other paper material (see Picture 10). If this material becomes wet repeatedly, it can also become colonized by mold.

Plant on Paper in Classroom: Note Plant is not Equipped With Drip Pan

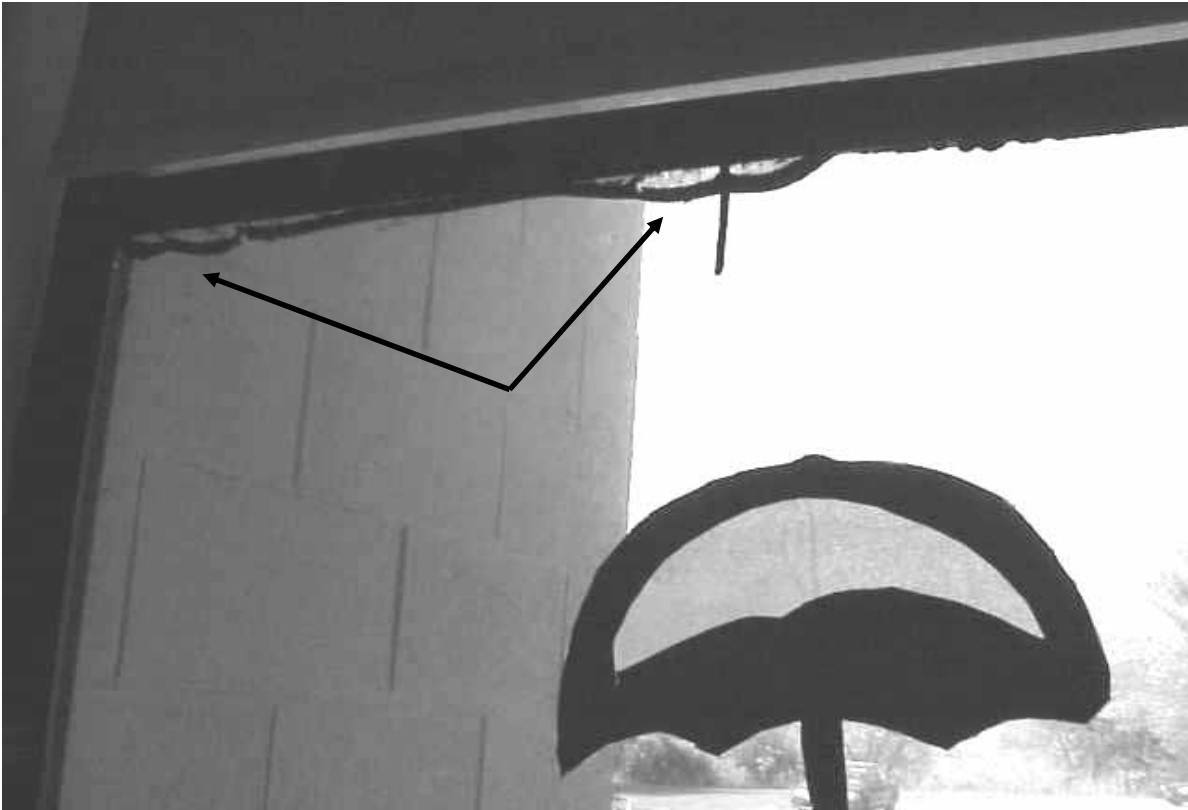
Picture 11

In a number of areas caulking around the interior and exterior windowpanes was loose, missing or damaged (see Pictures 11). Repairs of window leaks are necessary to prevent water penetration. Repeated water damage can result in mold colonization of window frames, curtains and items stored on or near windowsills.

Failing Window Caulking around Classroom Window

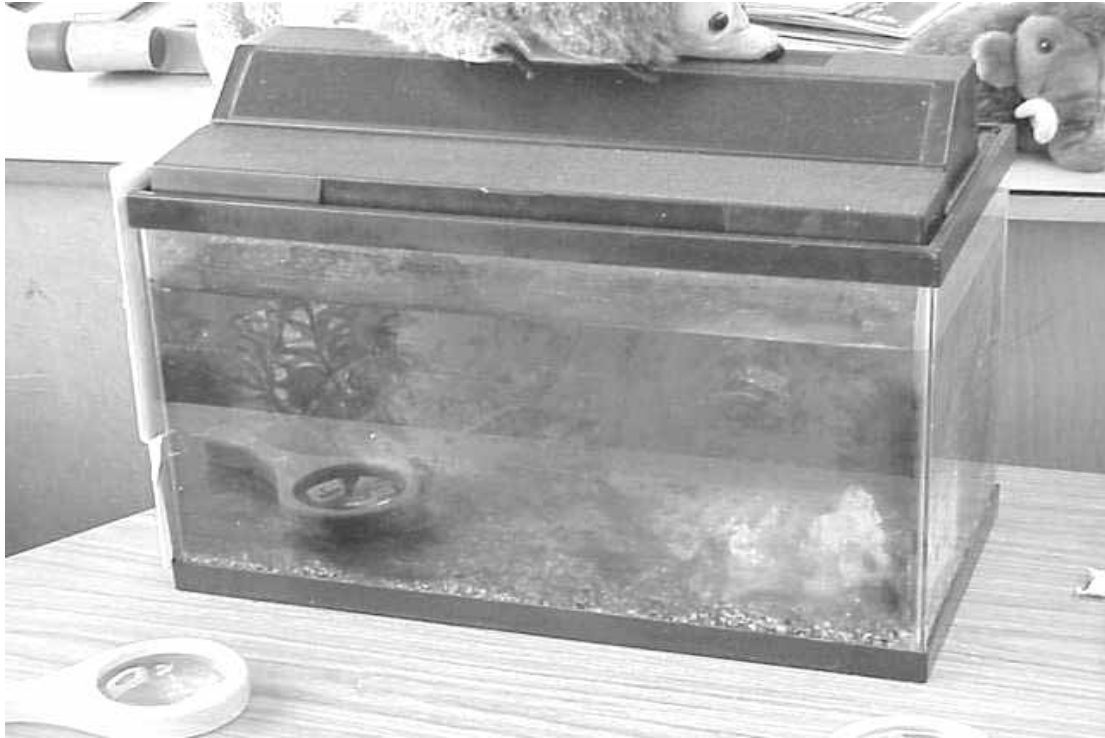
Picture 12

Room 14 contained a large fish tank that was green with algal growth (see Picture 12). Aquariums should be properly maintained to prevent microbial/algal growth as they can emit unpleasant odors into the classroom.

Aquarium with Algal Growth in Classroom 14

11. Clean and maintain aquariums to prevent bacterial/mold growth and associated odors.
12. Examine interior and exterior of multipurpose room for breaches of the building envelope and seal to prevent water penetration and subsequent damage and/or mold growth.

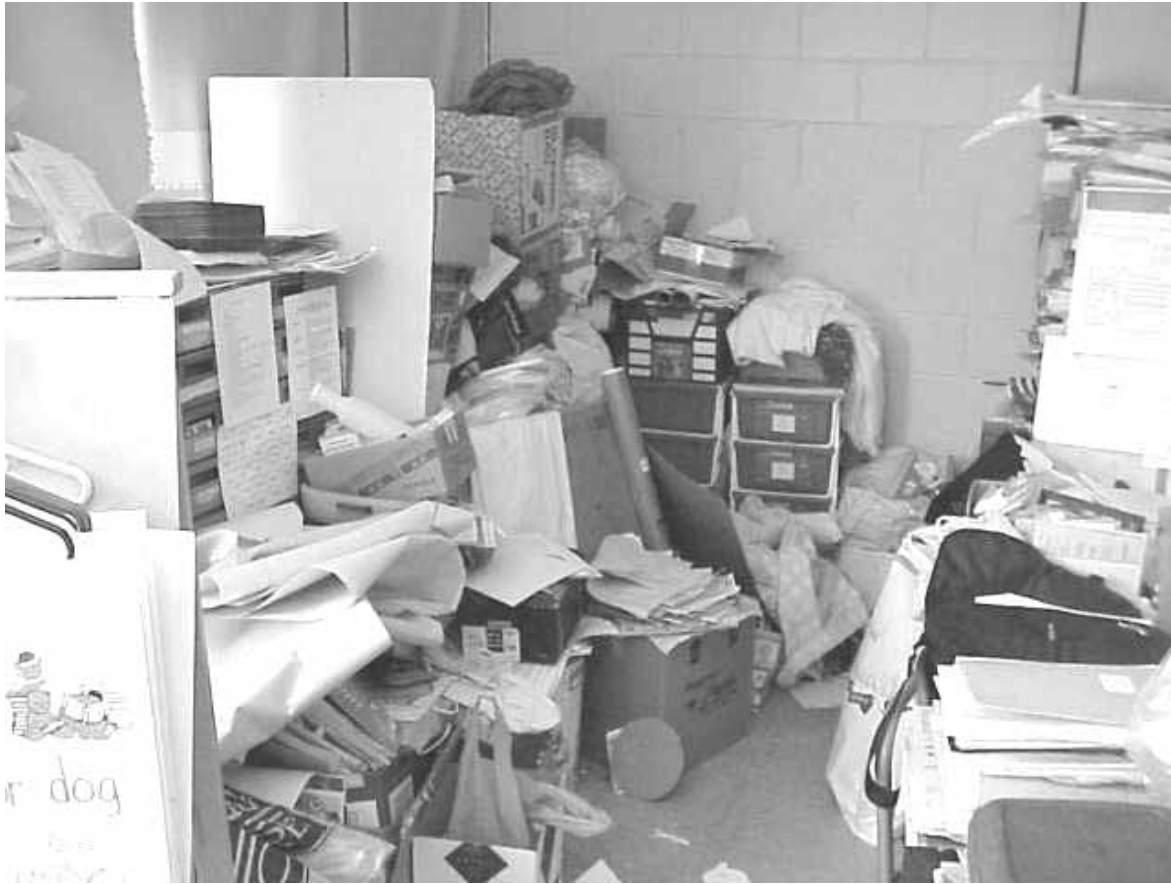
Picture 13

Also of note was the amount of materials stored inside classrooms (see Picture 13). In several areas, items were observed piled on windowsills, tabletops, counters, bookcases and desks. The large number of items stored in classrooms provides a source for dusts to accumulate. These items, (e.g., papers, folders, boxes, etc.) make it difficult for custodial staff to clean in and around these areas. Dust can be irritating to eyes, nose and respiratory tract. These items should be relocated and/or should be cleaned periodically to avoid excessive dust build up. In addition, a number of exhaust vents in classrooms were noted with accumulated dust. If exhaust vents are not functioning, backdrafting can occur, which can re-aerosolize household type dust particles.

Accumulated Materials in Classroom

20. Relocate or consider reducing the amount of materials stored in classrooms to allow for more thorough cleaning of classrooms. Clean items regularly with a wet cloth or sponge to prevent excessive dust build-up.

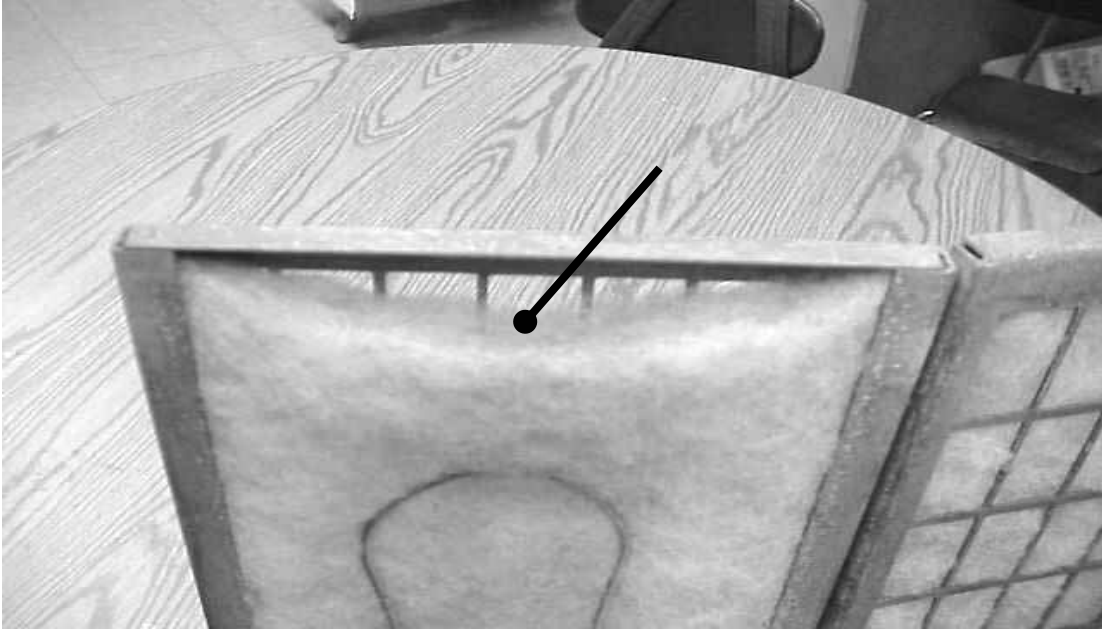
Picture 14

Univents were equipped with metal racks, into which filter materials are cut to fit (see Picture 14). The material used for filtering in these metal racks provides minimal filtration of respirable particulates that can be distributed by univents. Univents should be equipped with filters that strain particulates from airflow. In order to decrease

aerosolized particulates, disposable filters with an increased dust spot efficiency can be installed in univents. The dust spot efficiency is the ability of a filter to remove particulates of a certain diameter from air passing through the filter. Filters that have been determined by ASHRAE to meet its standard for dust spot efficiency of a minimum of 40 percent would be sufficient to reduce airborne particulates (MEHRC, 1997; ASHRAE, 1992). Note that increased filtration can reduce univent airflow through increased resistance. Prior to any increase of filtration, a ventilation engineer should be consulted as to whether univents can maintain function with more efficient filters.

Metal-Framed Univalent Filter: Note Spaces Allowing Materials to Bypass the Filter Media

14. Change or clean filters for univents as per the manufacturer's instructions or more frequently as needed to prevent the re-aerosolization of dirt, dust and particulate matter. Consider replacing metal grates for univents with disposable filters. Examine univents to ascertain whether filters with an increased dust spot efficiency that fit univent filter racks flush can be installed.

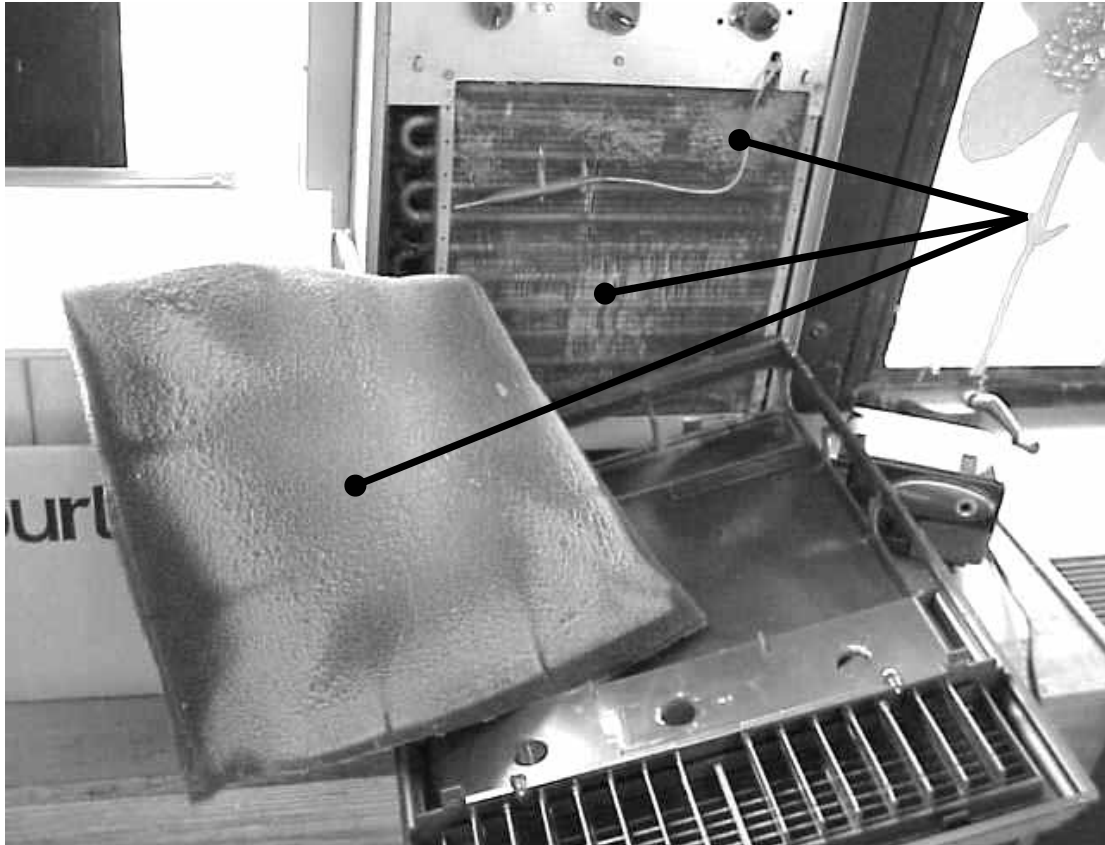
Picture 15

Several classrooms have window mounted air-conditioning units that are equipped with filters, which should be changed as per the manufacturer's instructions to avoid the build up and re-aerosolization of dirt, dust and particulate matter. The filter of the unit in classroom 9 was inspected by BEHA staff and had heavy dust accumulation (see Picture 15).

Accumulated Dirt and Dust on Air-Conditioner Filter and Cooling Vents

18. Clean chalkboards and trays regularly to prevent the build-up of excessive chalk dust.
19. Change filters in window-mounted air conditioners as per the manufacturer's instructions to prevent the re-aerosolization of dirt, dust and particulate matter.

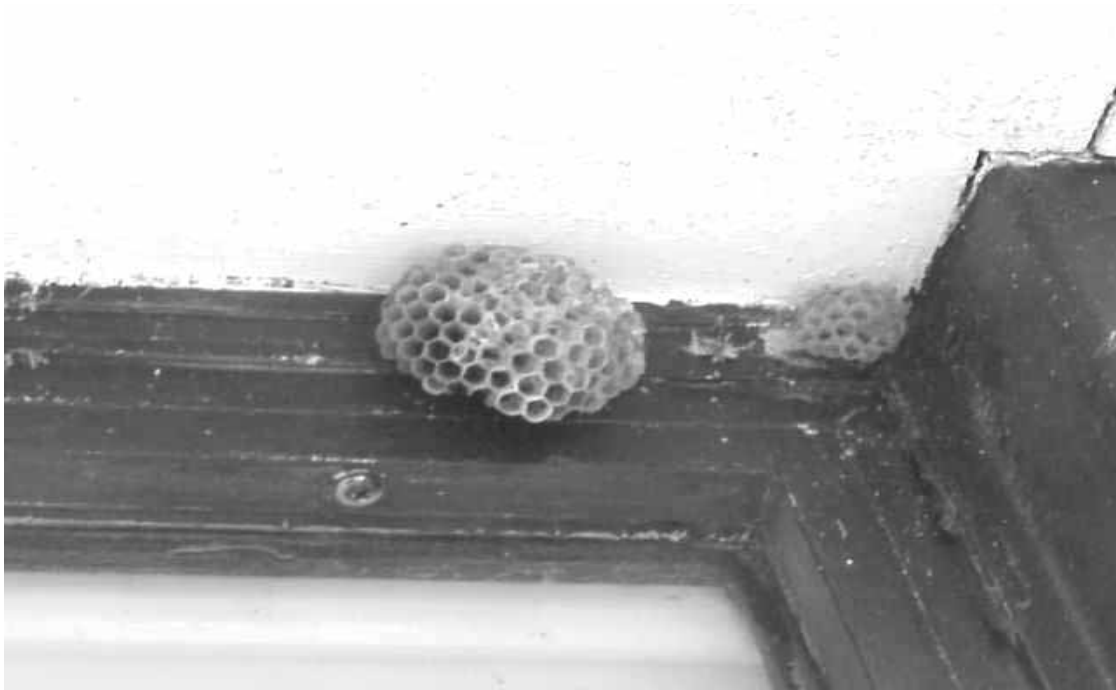
Picture 16

Several wasp and hornet's nests were noted outside of classroom 25 (occupational therapy) (see Picture 16). These items should be removed in a manner as to not introduce pests and/or pesticides into the school and its ventilation system.

Hornet's Nests Outside of the Occupational Therapy Room (Classroom 25)

17. Remove hornet/wasp's nests outside of classroom 25 in a manner as to not introduce pests and/or pesticides into the school and its ventilation system.

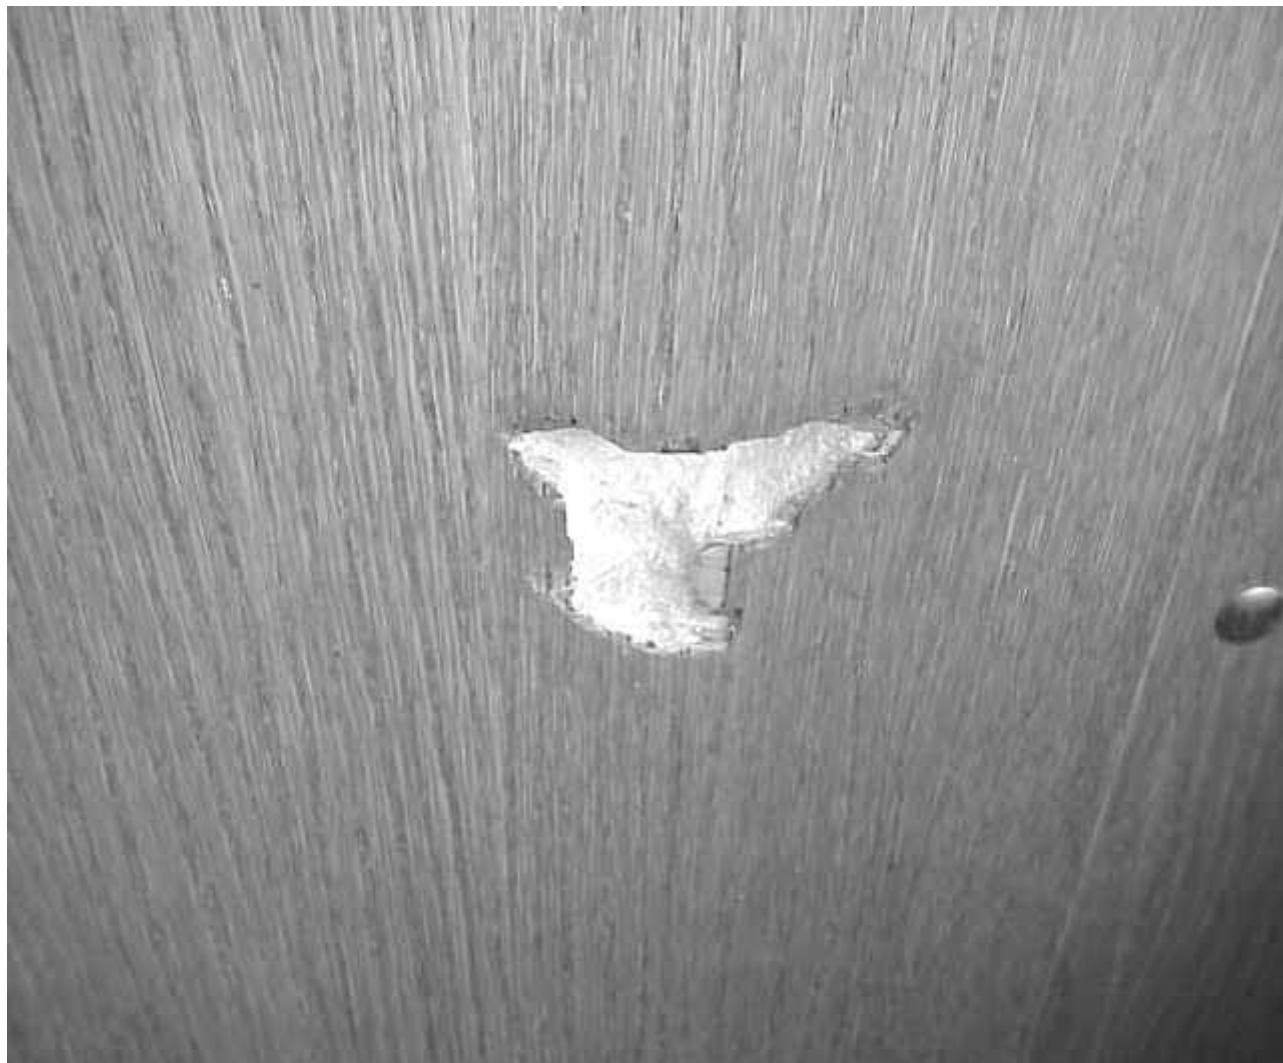
The hallway door noted in Picture 17 was damaged; the core appeared to consist of a white, chalky material, which may contain asbestos. Intact asbestos-containing materials do not pose a health hazard if they are not disturbed. If damaged, asbestos-containing materials can be rendered friable and become aerosolized. Friable asbestos is a chronic (long-term) health hazard, but will not produce acute (short-term) health effects (e.g., respiratory symptoms, headaches, etc.) that are associated with buildings that are believed to have indoor air quality problems. Pursuant to the Asbestos Hazard Emergency Response Act (AHERA), school systems are required to examine asbestos

containing materials on a three-year cycle for signs of friable dust or damage (US EPA, 1988). Where asbestos-containing materials are found damaged, they should be removed in a manner consistent with Massachusetts asbestos remediation laws (MDLI, 1993). To determine if this door contains asbestos, a review of the school's AHERA plan, blueprints, purchase orders or contacting the manufacturer is recommended.

Possible Asbestos-Containing Material in Damaged Door

21. Store chemicals and cleaning products properly and out of the reach of students.
22. Determine if hallway door in Picture 15 is made of asbestos-containing material. If found to contain asbestos, remediation must be done in a manner consistent with Massachusetts asbestos remediation and hazardous waste disposal laws.
