The Commonwealth of Massachusetts
Executive Office of Health and Human Services
Department of Public Health
Bureau of Environmental Health Assessment
250 Washington Street, Boston, MA 02108-4619

June 7, 2000

As you know, the Bureau of Environmental Health Assessment (BEHA) conducted an evaluation of the indoor air quality at the Welch Elementary School on May 12, 2000. Michael Feeney, Chief of Emergency Response/Indoor Air Quality (ER/IAQ), BEHA, and Cory Holmes, BEHA conducted this inspection. Concerns about sand migrating from the development of a golf course (see Picture 1) into classrooms prompted this evaluation.

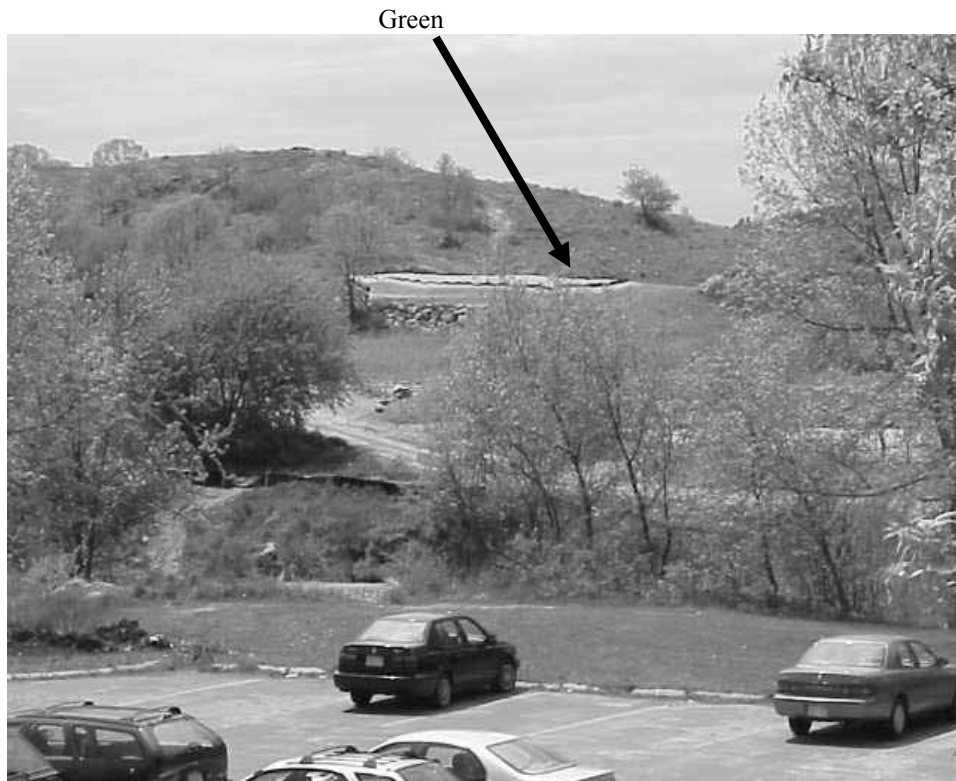
Picture 1

View from the Top of the Welch Elementary School Roof of Green under Construction on the Golf Course

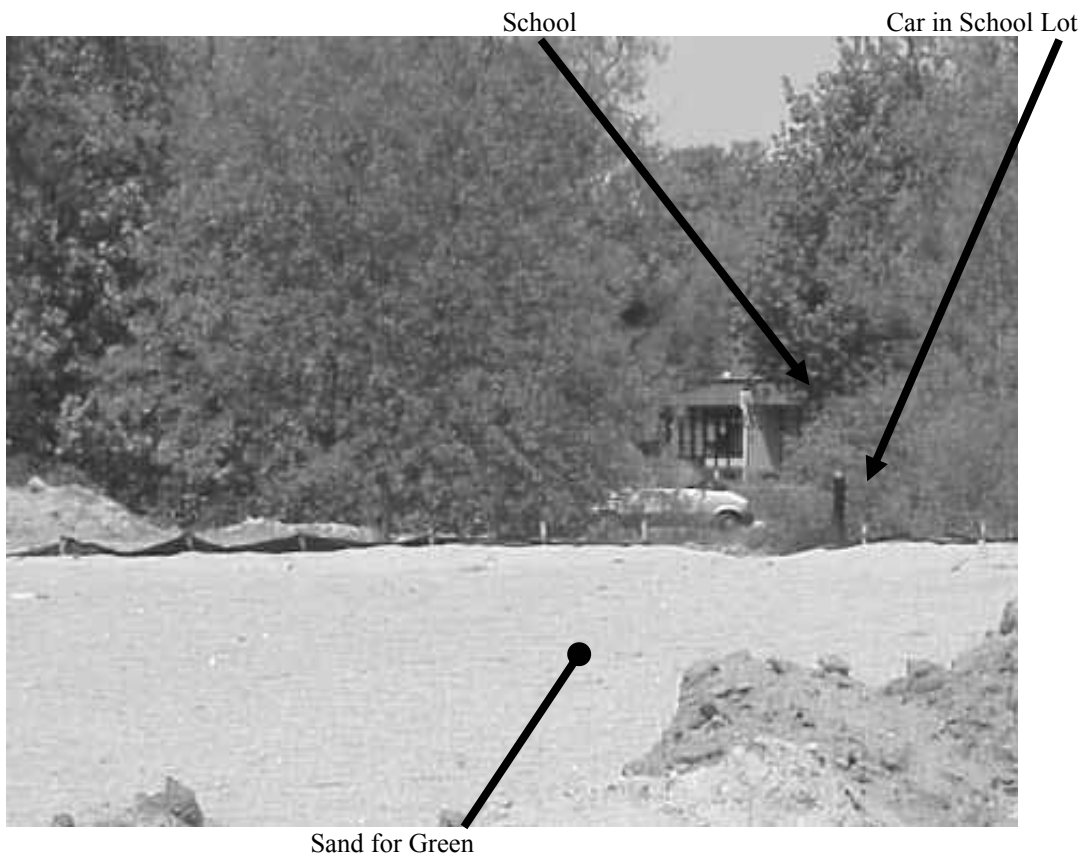
Picture 2

It appears that sand for leveling a green (see Picture 2) is located approximately 85 yards from the closest unit ventilator (univent) fresh air intake of this building and approximately 100 yards from the furthest univent fresh air intake. The sand is contained using a two-foot high barrier that appears to be made of felt (see Picture 3). This barrier seems to have been vandalized since the material is torn in a number of places.

Green under Construction and Its Proximity to School (~85 yards)

3. Wet the green sand twice a day (early morning and noon) to reduce aerosolization of sand.
4. Install a barrier made of a vandalism resistant material (such as nylon cloth used at construction sites) to contain sand. The barrier should be at least three feet in height and of sufficient length to block sand from migrating to the school building.

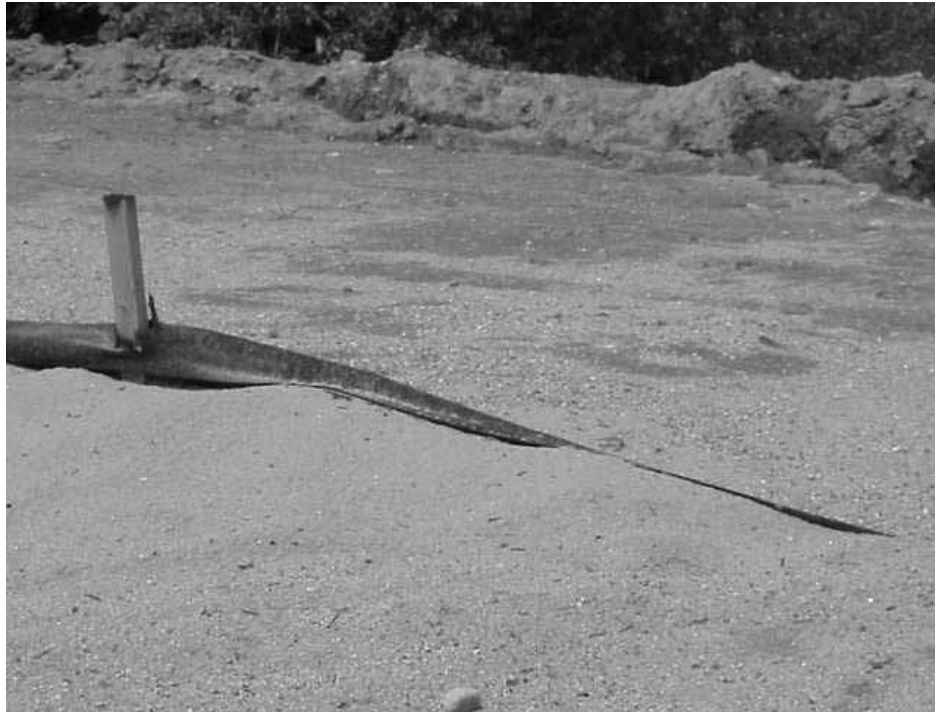
Picture 3

**Vandalized Felt Containment Barrier around Green under Construction,
Note the Height of the Wooden Stake and Tears in Felt**

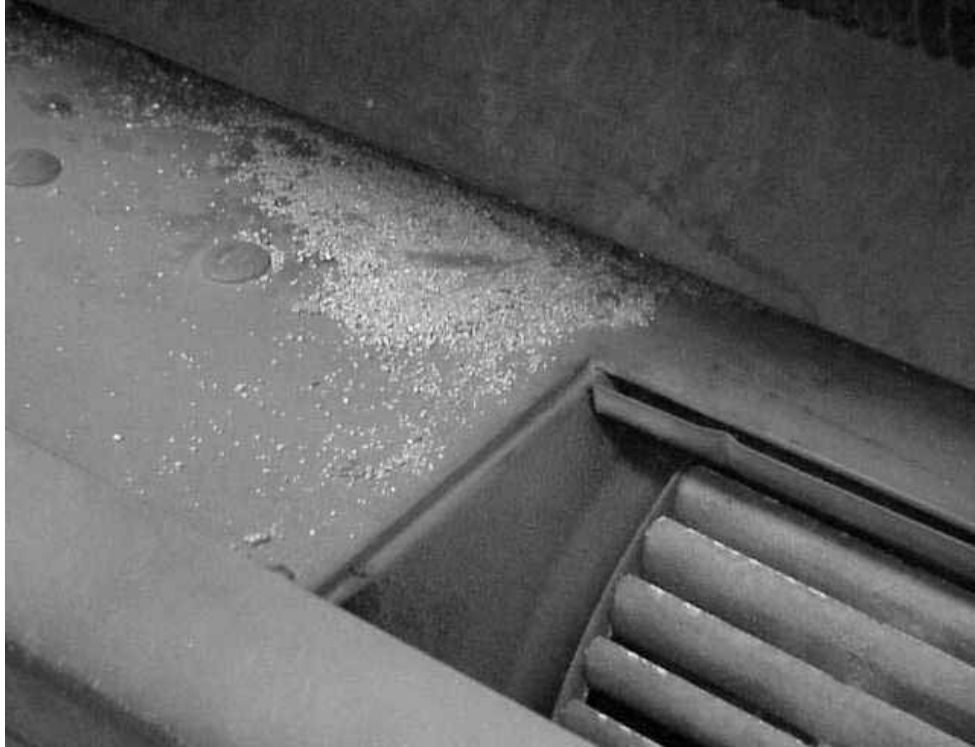
Picture 4

Univents in the classrooms facing the golf course under construction were opened and examined. One univent had an accumulation of sand inside the casing (see Picture 4). The filter rack in this univent appears to be damaged which results in the filter not fitting flush. This condition creates spaces around the filter that allows fresh air drawn into the univent to bypass filters. Particulates may also bypass the filter resulting in sand penetrating into the univent. The exterior grounds of the school do not appear to have sand of a similar color or texture near univent fresh air intakes (see Picture 5). The color and texture of the sand appears to match the sand used on the green under construction on the golf course (see Picture 6). Therefore, it appears that the containment used around the green is not sufficient to contain sand during weather with southwest winds. On dry days,

Sand inside Univent Casing above Fan, Indicating Air By-Pass of Filter

1. Examine and repair all filter racks in univents facing the golf course if filters do not fit flush.
2. Shutting down univents systems (when possible) during periods of heavy construction and demolition may be necessary to ensuring systems are isolated from entrain construction generated pollutants. Sealing ventilation openings with plastic and utilizing filters with a higher dust spot efficiency is recommended (SMACNA, 1995).

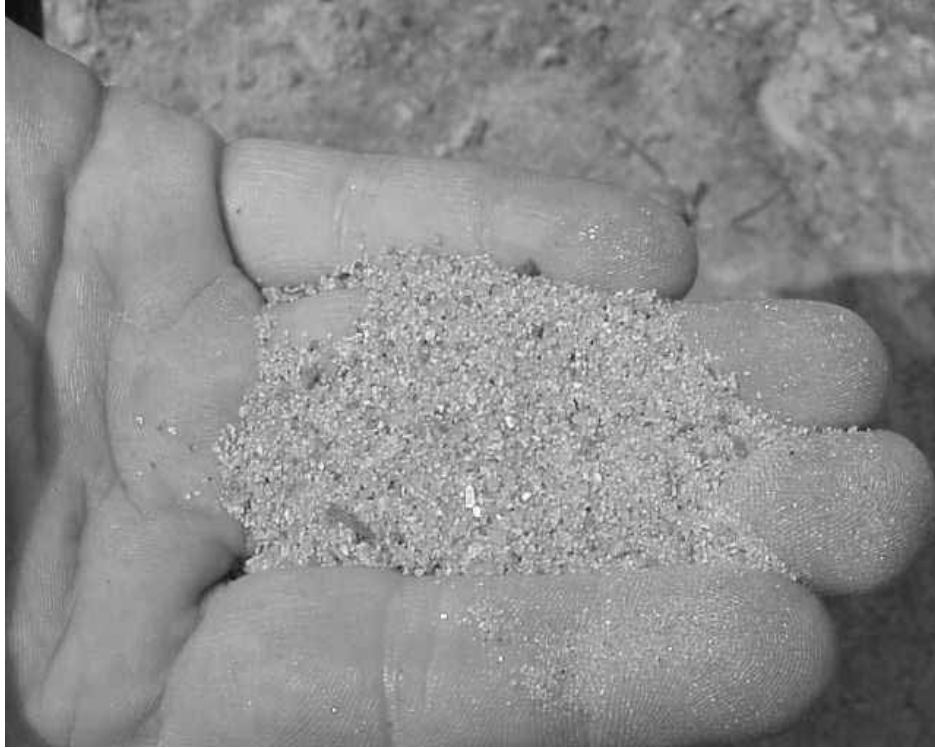
Picture 5

Sand from Green under Construction

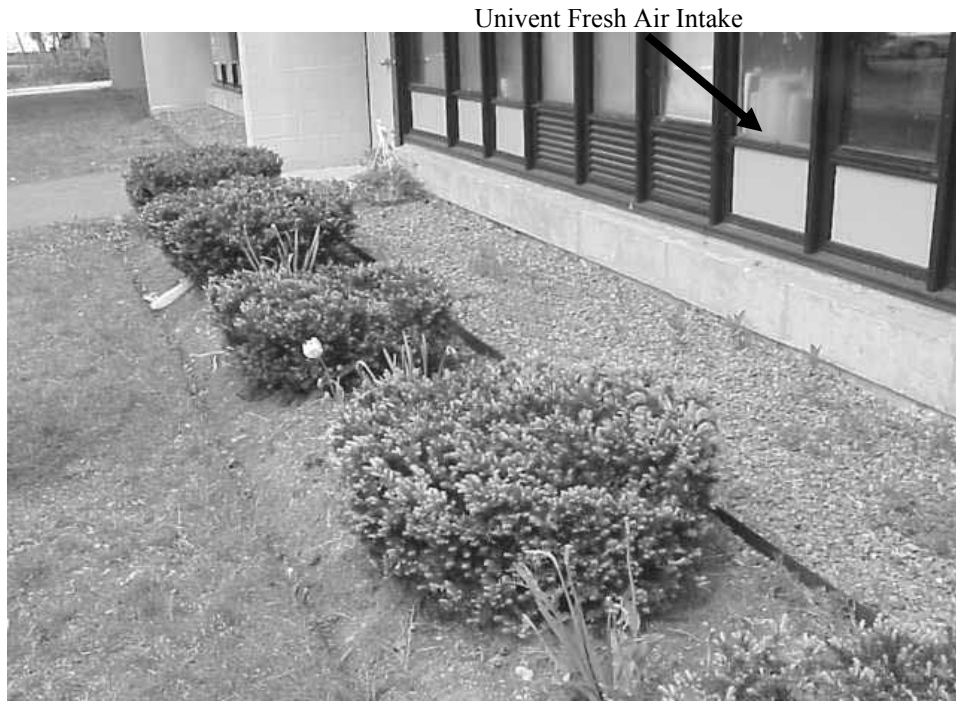
Picture 6

**Ground around Univent Fresh Air Intakes at the Front of the Building,
Note Lack of Loose Sand**
