# **INDOOR AIR QUALITY ASSESSMENT**

**Powder Mill Middle School  
94 Powder Mill Road  
Southwick, Massachusetts**

Prepared by:  
Massachusetts Department of Public Health  
Bureau of Environmental Health Assessment  
July, 2000

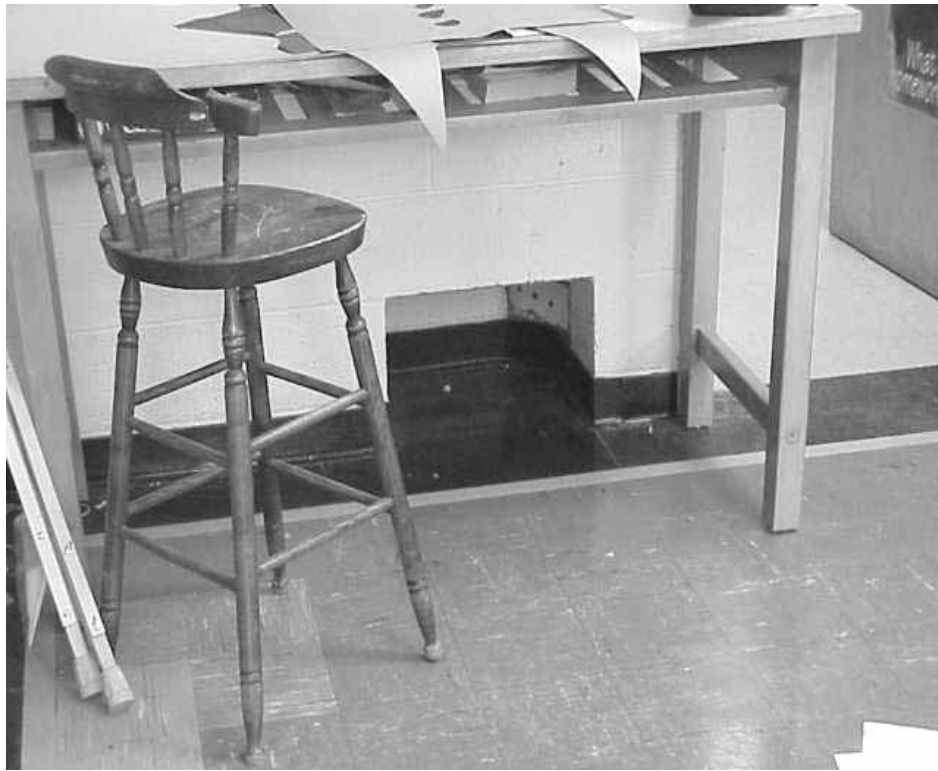
**Picture 1**

The school has two different types of exhaust ventilation systems. In the older section of the building, exhaust ventilation is provided by ungrated holes (see Picture 1) connected to rooftop exhaust vents (see Picture 2) by ductwork. Airflow is controlled by a flue, which is opened by a draw chain-pulley system. The flue is set at a desired angle by setting the draw chain in a locking mechanism. The interior of several of these vents appears to be sealed with fiberglass. These vents need to be free of obstructions in order to function as designed.

**Exhaust Vent in the Original Building**

1. Repair exhaust vent motors.
2. Examine exhaust vents in the original building for blockages. Restore the airflow controls for the exhaust ventilation system.
3. Remove blockages of the univents.

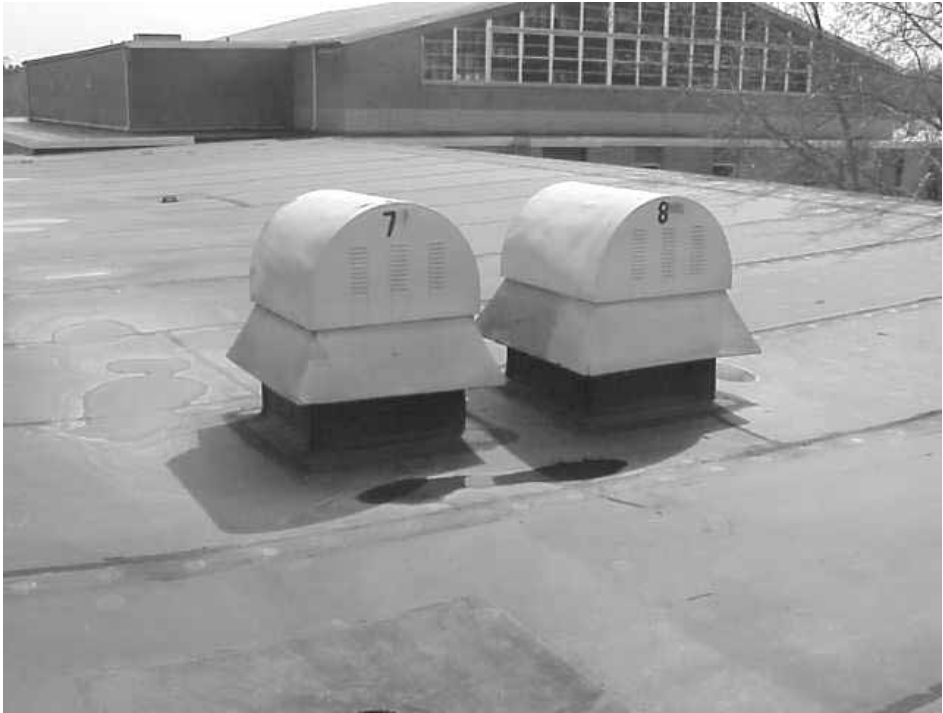
**Picture 2**

**Rooftop Exhaust Vents**

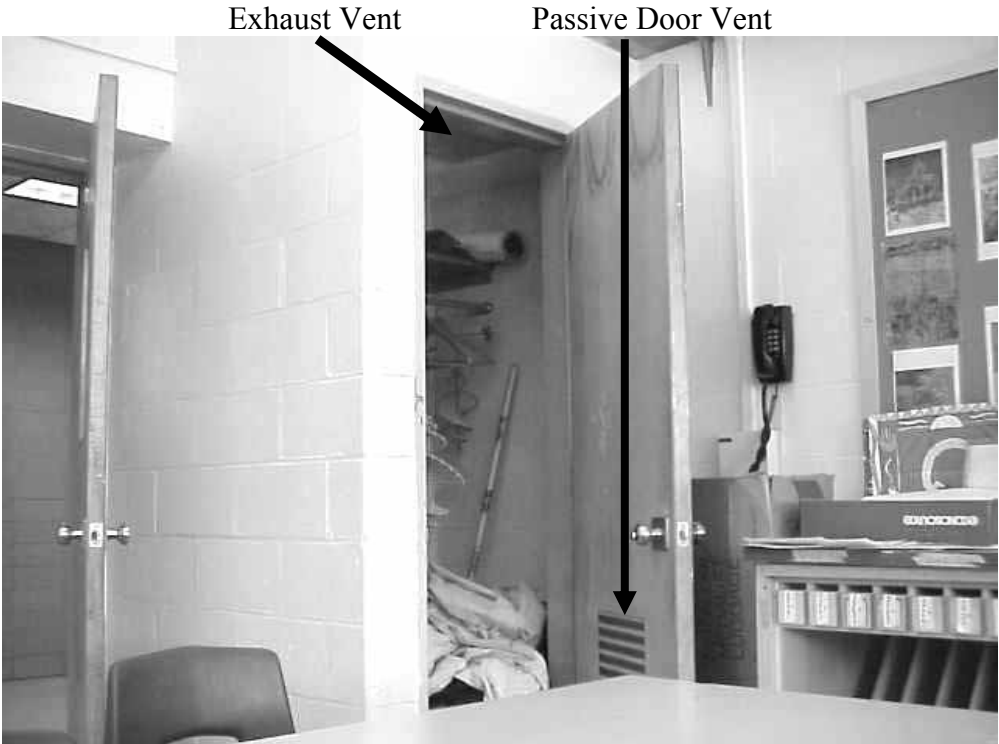
**Picture 3**

In the 1959 addition, exhaust ventilation is provided by a mechanical, ducted ventilation system. Exhaust vents are located in the ceiling of each classroom closet (see

Picture 3). Classroom air is drawn into the coat closet via a grate mounted on the front face of the closet. This design allows for these vents to be easily blocked by stored materials (see Picture 4). When blocked, exhaust air is drawn through the space between the closet door and doorframe. Confirming this condition is the heavy accumulation of dust along the closet door edge (see Picture 5). In order to function properly, these vents must be cleared and remain free of obstructions. Each classroom exhaust vent is connected to a rooftop motor. One third of the exhaust vent motors were deactivated (see Tables 5 and 6). Without active exhaust ventilation, normally occurring environmental pollutants can build up in the indoor environment.

**Exhaust Ventilation System in the 1959 Addition**

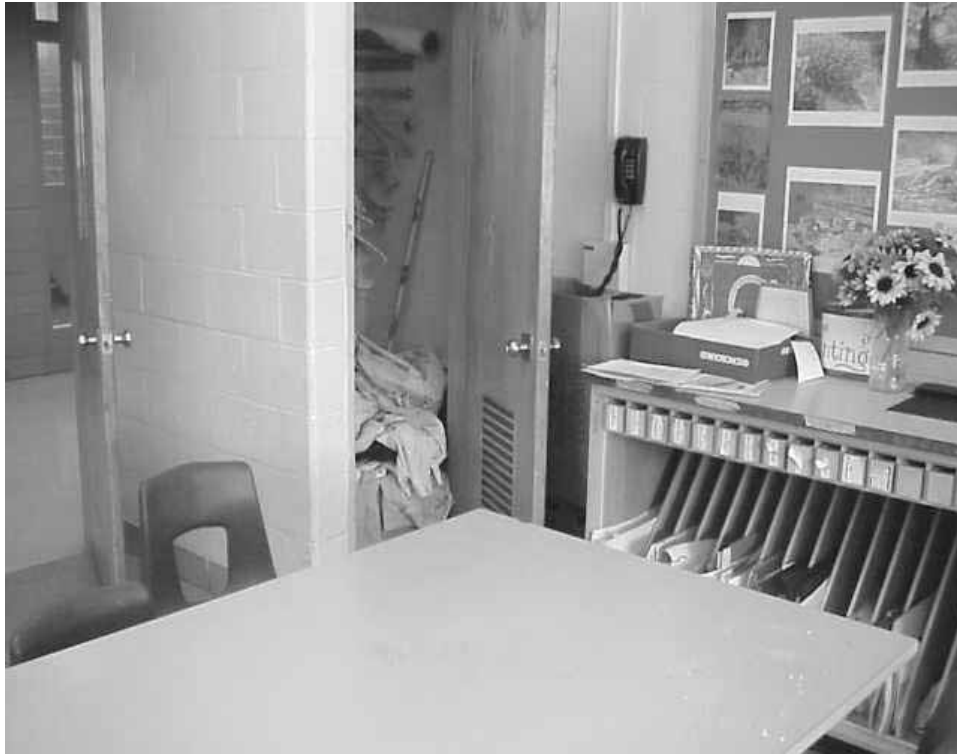
**Picture 4**

**Piled Materials Blocking Closet Passive Door Vent**

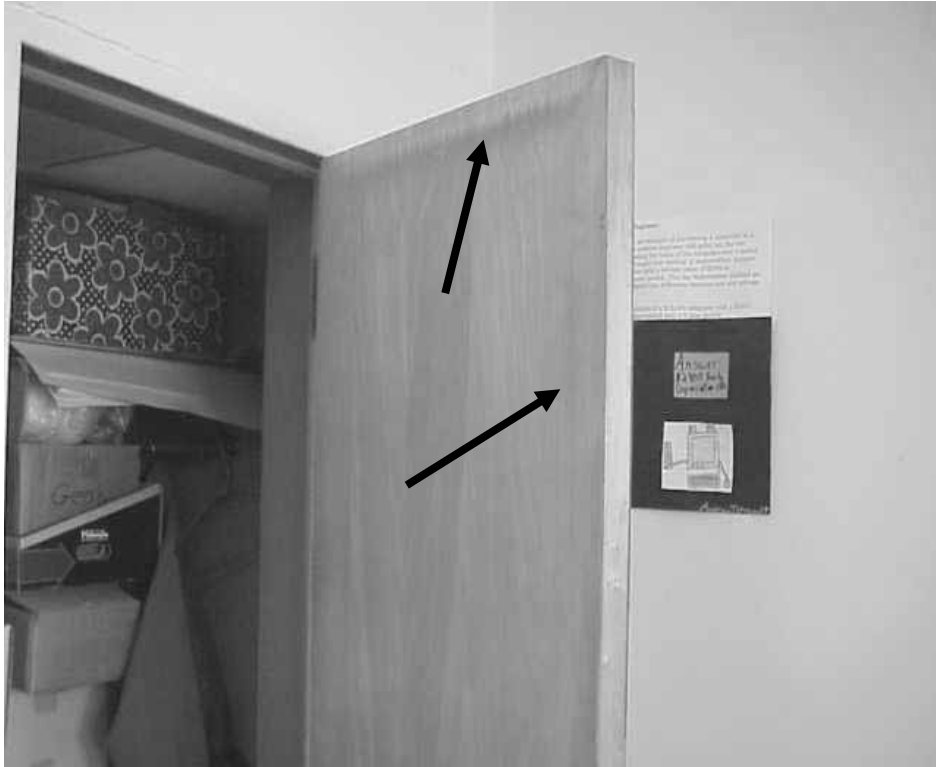
**Picture 5**

**Collected Dust on Edge of Classroom Door**

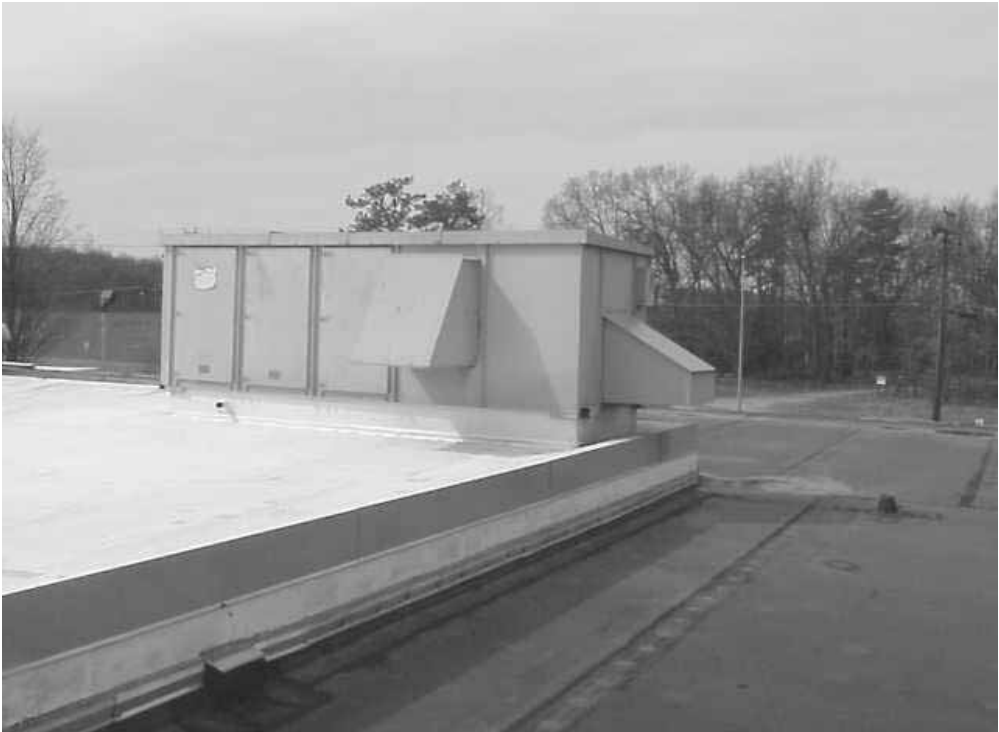
**Picture 6**

A rooftop air-handling unit (AHU) provides ventilation in the library. The fresh air intake is located on the roof (see Picture 6). This AHU is connected by ductwork to fresh air diffusers located in the ceiling of the library. Return air is drawn into a ceiling plenum through grates in the ceiling back to the rooftop AHU. The ceiling was missing one ceiling tile. In order to have the exhaust ventilation system function as designed, all ceiling tiles must remain intact in order to draw air through the ceiling tile system.

The rooftop AHU is installed with air filters that do not fit flush with their racks. Filters should be one piece that fits flush with the filter rack. If two filters are to be used, the filter rack must have the appropriate equipment to make each filter fit flush. Air drawn into the AHU will bypass filters through spaces between filters and racks. This can result in dust, dirt and other debris to be distributed by the ventilation system. Univents and AHUs are installed with filters that provide minimal filtration of respirable particulates. Both univents and AHUs are equipped with filters that strain particulates from airflow. In order to decrease aerosolized particulates, disposable filters with an increased dust spot efficiency can be installed. The dust spot efficiency is the ability of a filter to remove particulates of a certain diameter from air passing through the filter. Filters that have been determined by ASHRAE to meet its standard for a dust spot efficiency of a minimum of 40 percent would be sufficient to reduce airborne particulates (Thornburg, D., 2000; MEHRC, 1997; ASHRAE, 1992). Note that increased filtration can reduce airflow produced through increased resistance. Prior to any increase of filtration, each piece of air handling equipment should be evaluated by a ventilation engineer to ascertain whether it can maintain function with more efficient filters.

**Library AHU**

5. Obtain spacers for between air filters in the library AHU.
6. Ensure that the ceiling tile system in the library remains intact in order for the exhaust plenum ventilation system to work as designed.

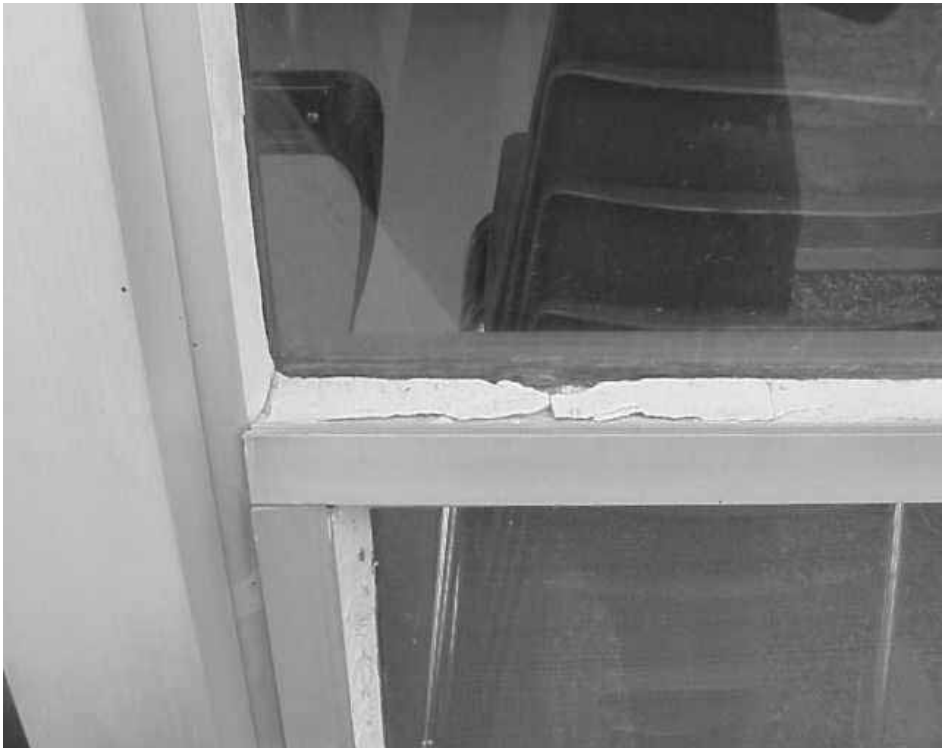
**Picture 7**

Caulking around windows appears to be missing, damaged or crumbling in a number of areas (see Pictures 7 and 8). Moss was observed growing on the seam of a window frame (see Picture 9). Moss growth can indicate substantial moisture exposure to these window frames. Moss growth can lead to damage to the frame seal. Windows should be properly sealed and broken windows should be replaced to prevent water intrusion and subsequent mold growth.

**Eroded Window Caulking**

12. Replace damaged window caulking.
13. For buildings in New England, periods of low relative humidity during the winter are often unavoidable. Therefore, implementation of scrupulous cleaning practices

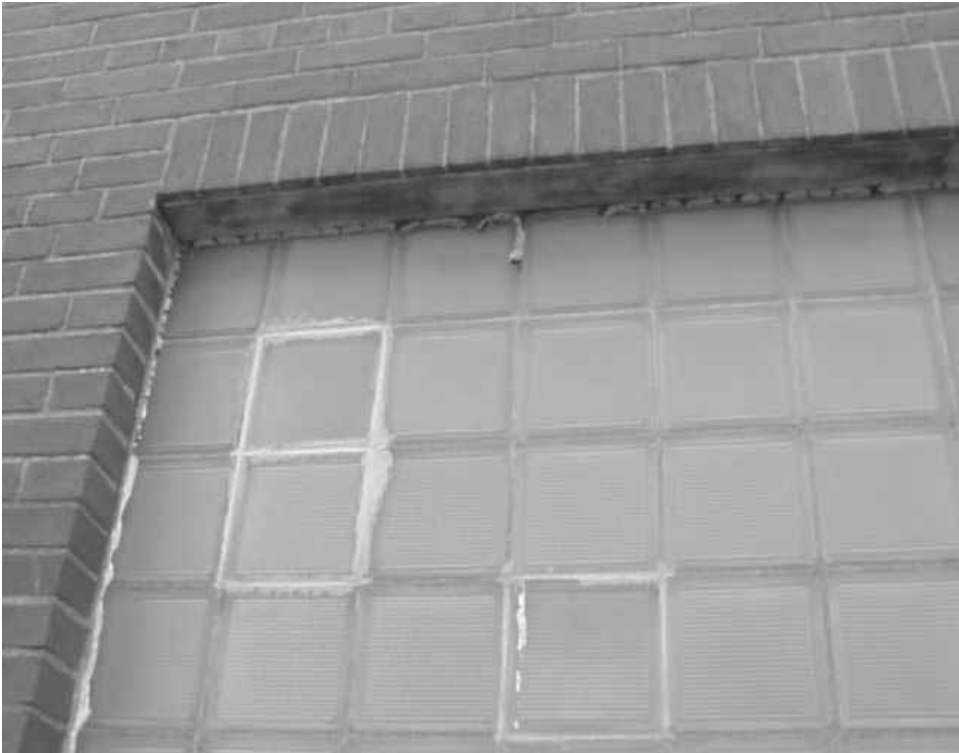
**Picture 8**

**Missing and Damaged Window Caulking**

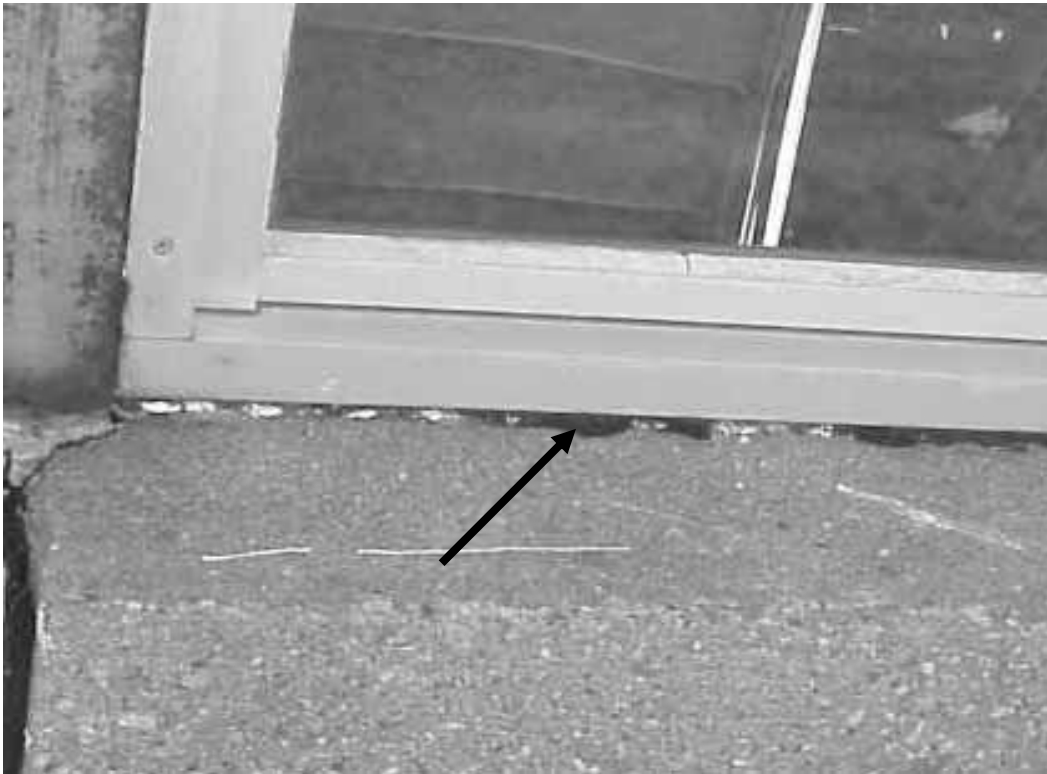
**Picture 9**

**Moss Growing in Window Frame Seam**

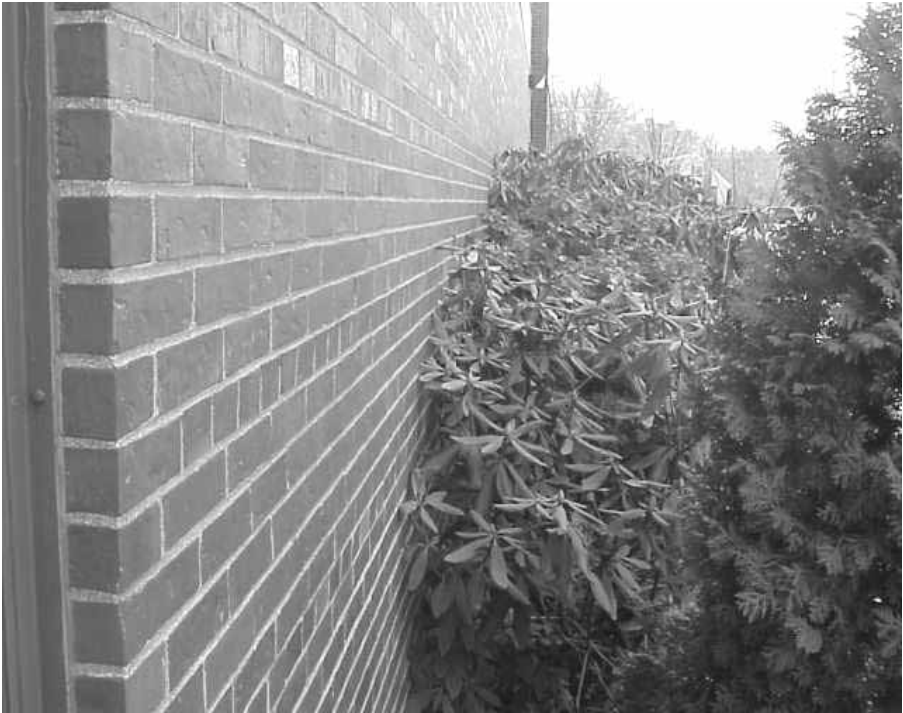
**Picture 10**

Shrubbery in direct contact with the exterior wall brick was noted in several areas around the building (see Picture 10). Shrubbery can serve as a possible source of water

impingement on the exterior curtain wall due to the location of plants growing directly against the building. Plants retain water and in some cases can work their way into mortar and brickwork causing cracks and fissures, which may subsequently lead to water penetration and possible mold growth.

**Shrubbery Growing against the School Exterior Wall**

14. Reduce/trim or remove plants that are growing against the exterior brick curtain wall.
  15. Seal abandoned drains or wet dry drain traps regularly to prevent odor migration into classrooms.

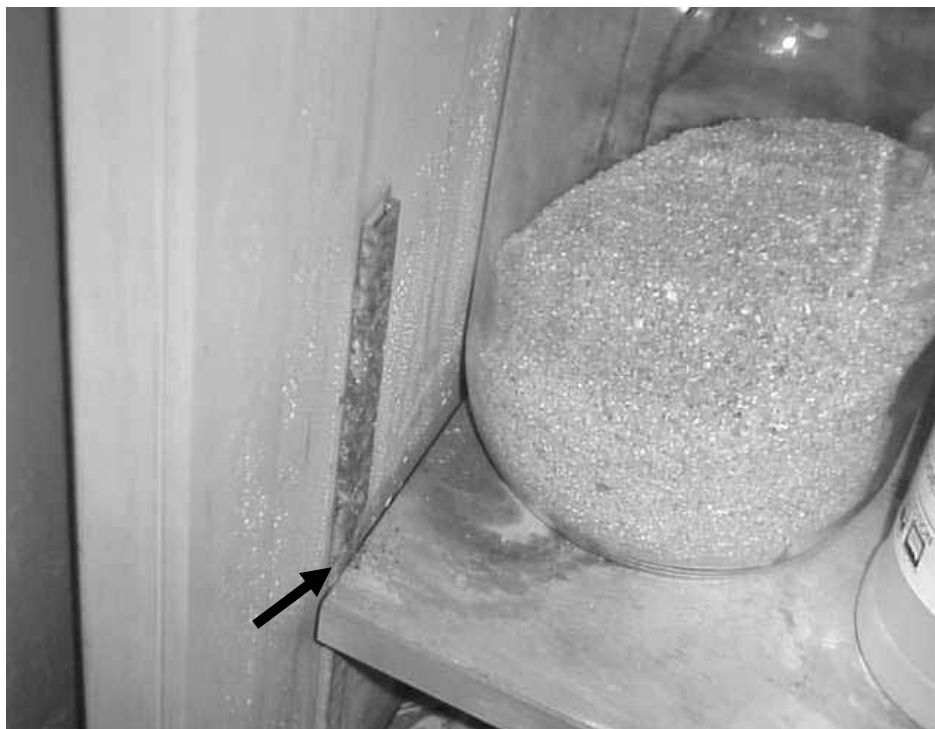
**Picture 11**

Several other conditions that can potentially affect indoor air quality were identified. Of note are the chemicals found in the science storeroom. Several other conditions of improperly stored materials were also found in this storeroom. The storage cabinet contains several acidic materials. This material is extremely corrosive. The storage caps on acid containing bottles have not been secured, as evidenced by corrosion to the shelf supports in this cabinet (see Picture 11). Corrosion of the metal can undermine the integrity of the shelf

supports and lead to shelf failure. Of note is the storage of plumbing torches stored beneath the acids. Welding torches should be stored in a separate storage area that is in compliance with state and local fire ordinances. It is highly recommended that a thorough inventory of chemicals in the science department be done to assess chemical storage and disposal in an appropriate manner consistent with Massachusetts' hazardous waste laws.

**Corrosion of Shelf Support from Exposure to Stored Acids**

17. Consider obtaining an acid resistant storage cabinet for the chemical storeroom.
  18. Clean chalkboards and chalk trays regularly to prevent the build-up of excessive chalk dust.

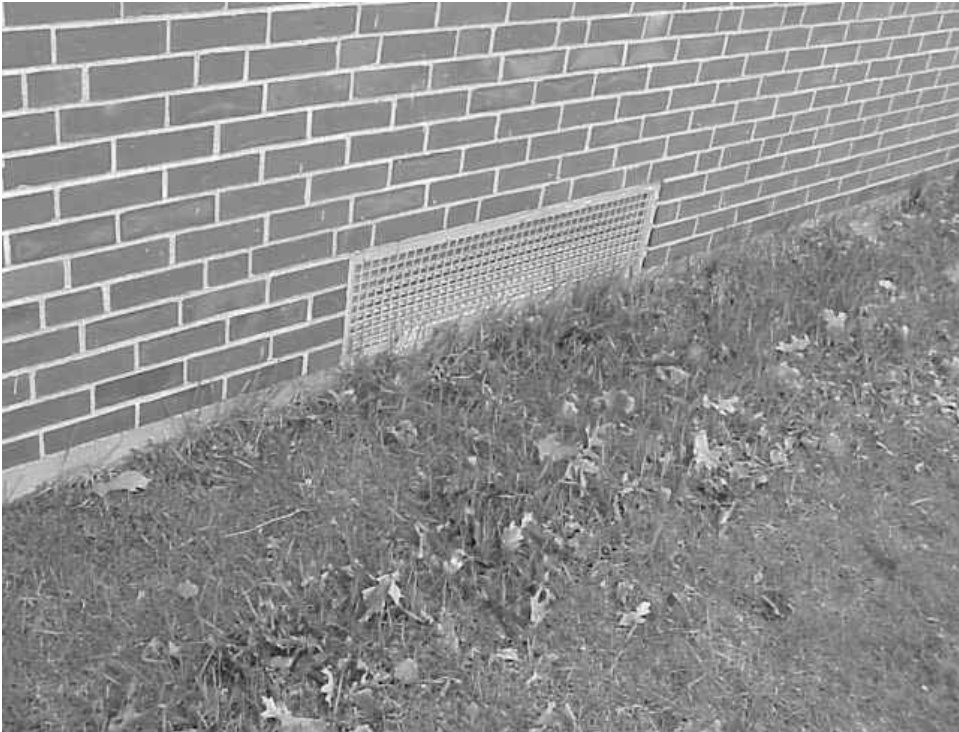
Picture 12

Some univent fresh air intakes are located at ground level (see Picture 12). These vents can be prone to drawing dust, dirt and pollen into univents as well as blockage with accumulated snow. In addition, grass cutting during school hours can introduce plant matter, dirt, dust and pollen into univent fresh air intakes.

**Univent Fresh Air Intake Note Lawn Growth against Air Intake**

7. Ensure that ground level fresh air intakes remain clear of blockages, particularly snow in winter. Avoid grass cutting during school hours.
8. Examine the filters in the univents and AHUs and change filters as recommended by the manufacturer or more frequently if needed. Consider increasing the dust spot efficiency of filters to increase the removal of particulates from the environment.
