INDOOR AIR QUALITY ASSESSMENT

**Department of Revenue
Child Support Enforcement Division
2 South Street
Pittsfield, Massachusetts**

Prepared by:
Massachusetts Department of Public Health
Bureau of Environmental Health Assessment
November, 2000

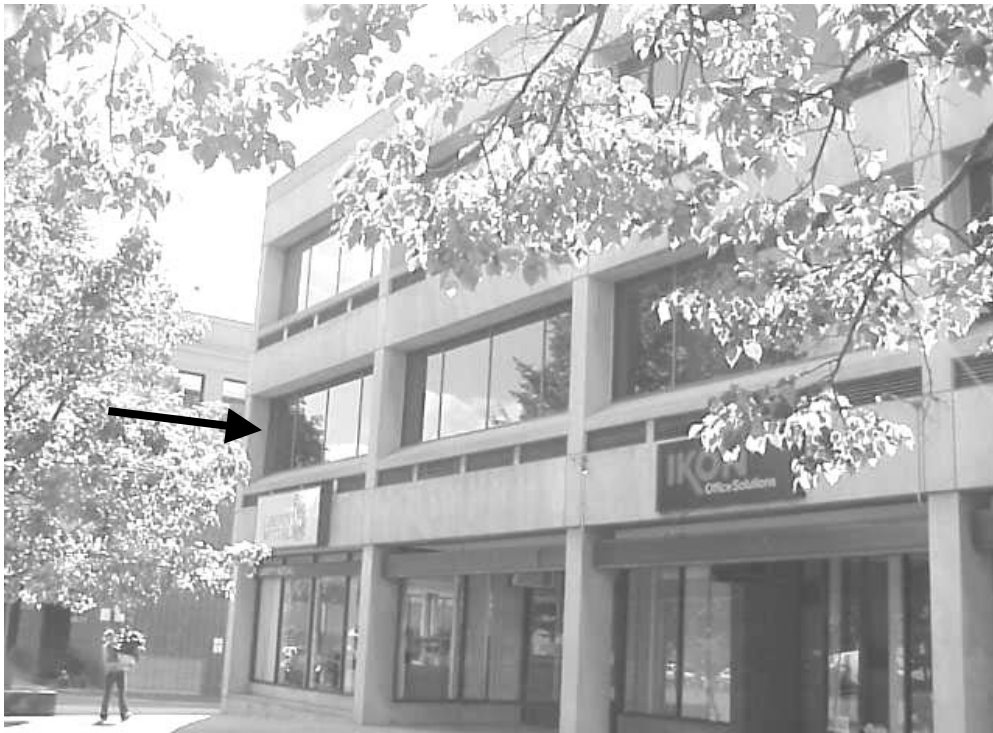
Picture 1

On September 14, 2000 a visit was made to this building by Michael Feeney, Chief of Emergency Response/Indoor Air Quality (ER/IAQ). The CSE office exists in a two-story cement and steel girder building (see Picture 1). The CSE has occupied this building since 1995. Their offices are located in the south section of the second floor of this building, which contains a number of businesses and offices in downtown Pittsfield. A penthouse on the roof contains the building's heating, ventilation and air conditioning (HVAC) equipment that services the CSE office. Windows in the building do not open.

DOR CSE Office Located on Second Floor of Building

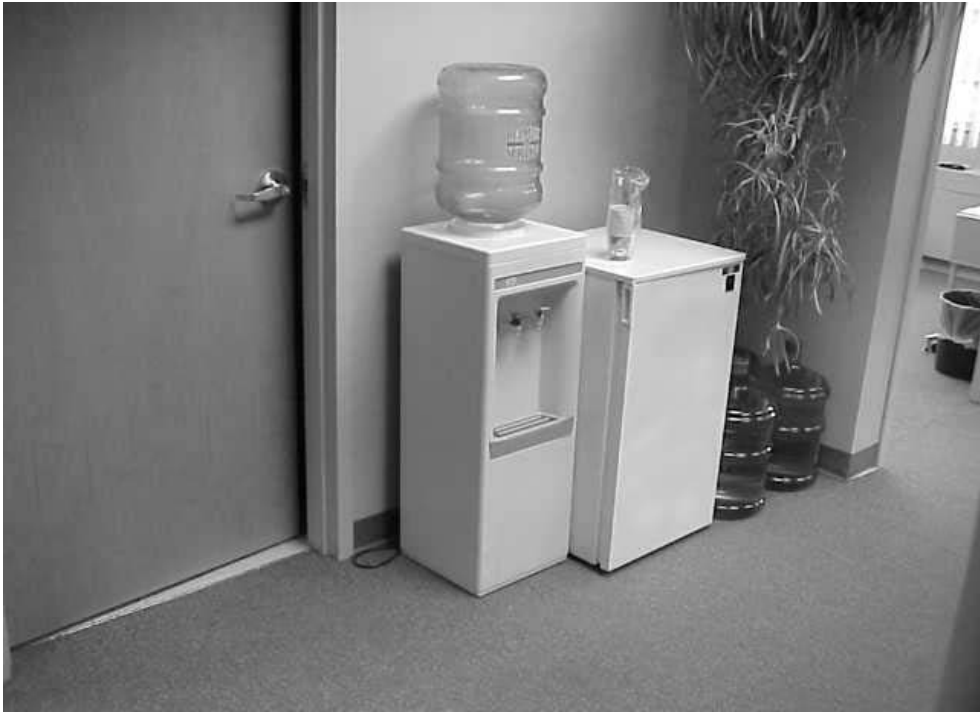
Picture 2

Plants were observed in various areas within the office space. Plants can be a source of pollen and mold, which can be a respiratory irritant to some individuals. Plants should be properly maintained and equipped with drip pans. Plants should also be located away from the air stream of mechanical ventilation to prevent aerosolization of dirt, pollen or mold. A water cooler was placed on carpeting (see Picture 2). This condition can result in the repeated moistening of carpeting, which can lead to mold growth.

Water Cooler on Carpet

5. Ensure all plants are equipped with drip pans. Examine drip pans periodically for mold growth and disinfect with an appropriate antimicrobial where necessary.

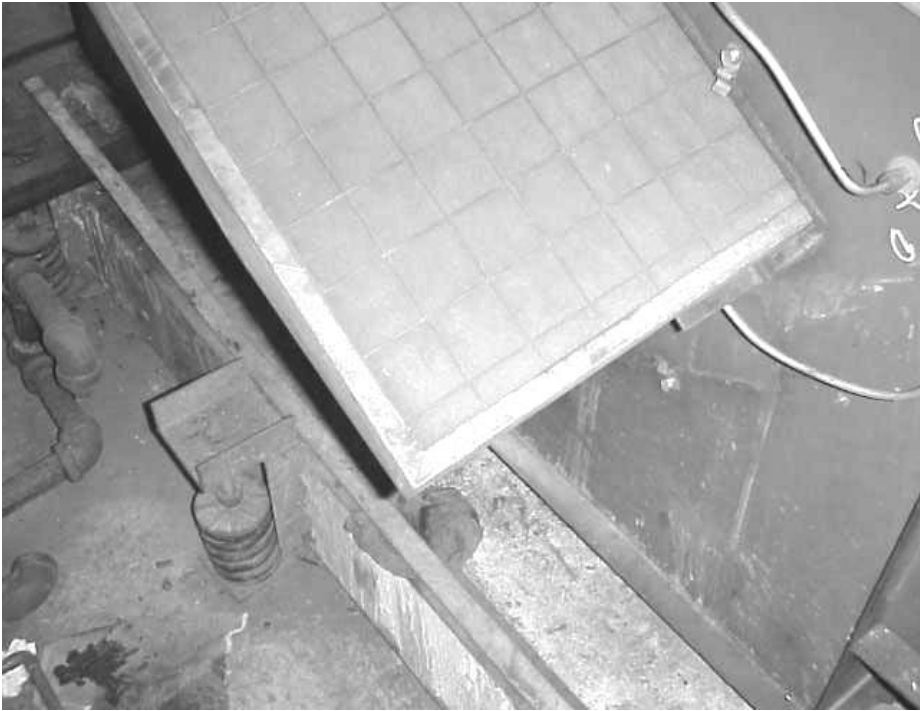
Picture 3

The AHU was equipped with a metal rack, into which the filter medium is cut to fit the filter rack (see Picture 3). This type of filter installation can result in the creation of spaces between the filter media and rack edge, which can allow for particulates to by-

Metal Rack Filter in AHU

1. Install replaced filters in univents.
2. In order to decrease aerosolized particulates, consider installing disposable filters with an increased dust spot efficiency in the AHU and univents. Note that increased filtration can reduce airflow by increased resistance (called “pressure drop”). Prior to any increase of filtration, each unit should be evaluated by a ventilation engineer to determine whether it can maintain function with more efficient filters.
3. Replace the water damaged ceiling tile.
4. For buildings in New England, periods of low relative humidity during the winter are often unavoidable. Scrupulous cleaning practices should be adopted to

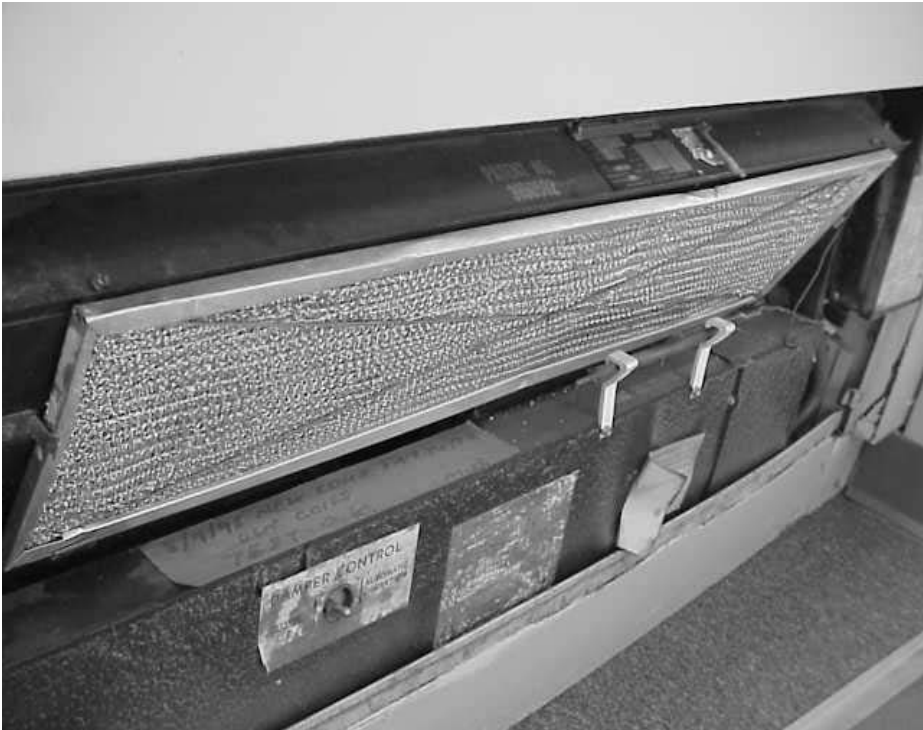
Picture 4

pass the filters. The interiors of two univents were examined. One univent had a metal filter, which provides minimal filtration of respirable dusts (see Picture 4). The second univent did not have a filter (see Picture 5). The filters provide filtration of respirable dusts. In order to decrease aerosolized particulates, disposable filters with an increased dust spot efficiency can be installed. The dust spot efficiency is the ability of a filter to remove particulates of a certain diameter from air passing through the filter. Filters that have been determined by ASHRAE to meet its standard for a dust spot efficiency of a minimum of 40 percent (Minimum Efficiency Reporting Value equal to 9) would be sufficient to reduce many airborne particulates (Thornburg, D., 2000; MEHRC, 1997; ASHRAE, 1992).

Univent with Metal Filter Installed in Univent

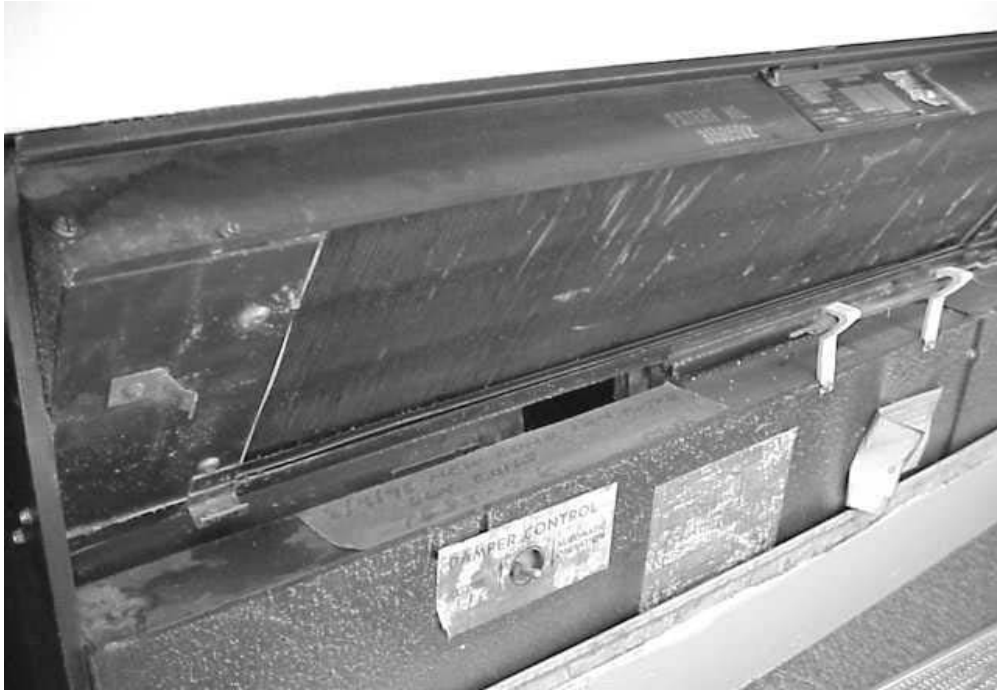
Picture 5

Univent without Filter
