INDOOR AIR QUALITY ASSESSMENT

**Department Social Services
Hyde Park Office
1530 River Street
Boston, Massachusetts**

Prepared by:
Massachusetts Department of Public Health
Bureau of Environmental Health Assessment
January, 2001

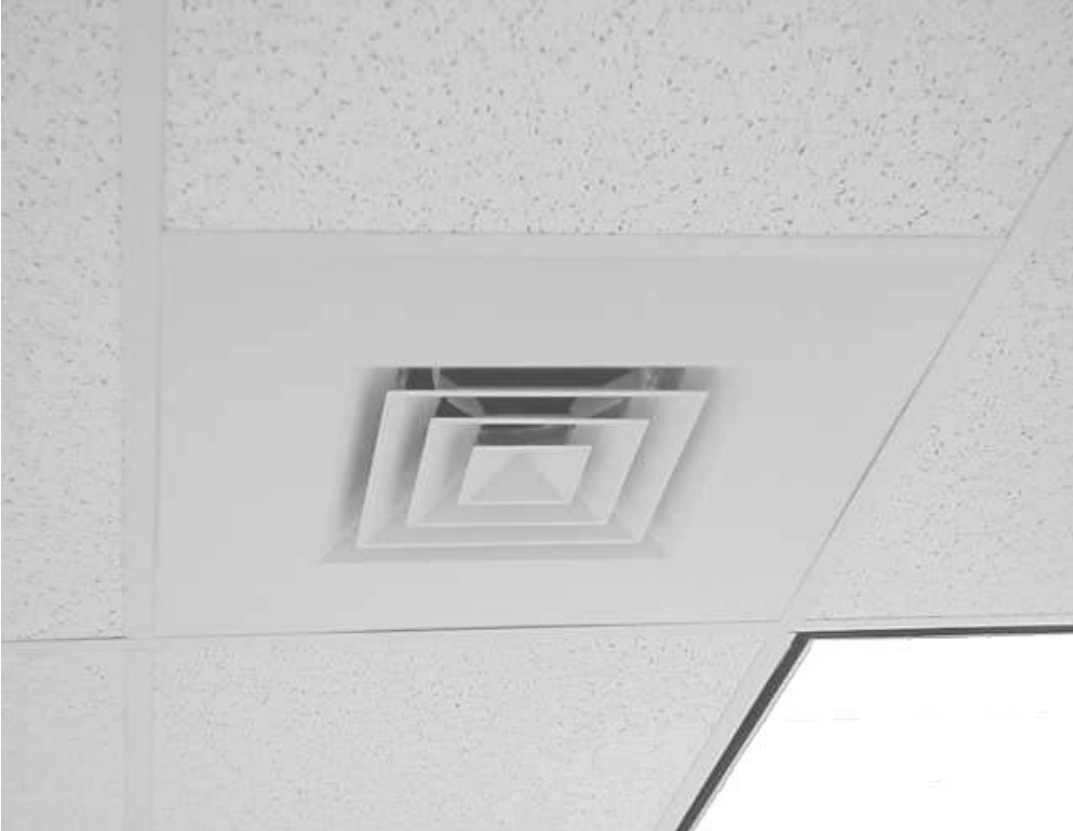
Picture 1

Ceiling-Mounted Multi-directional Air Diffuser

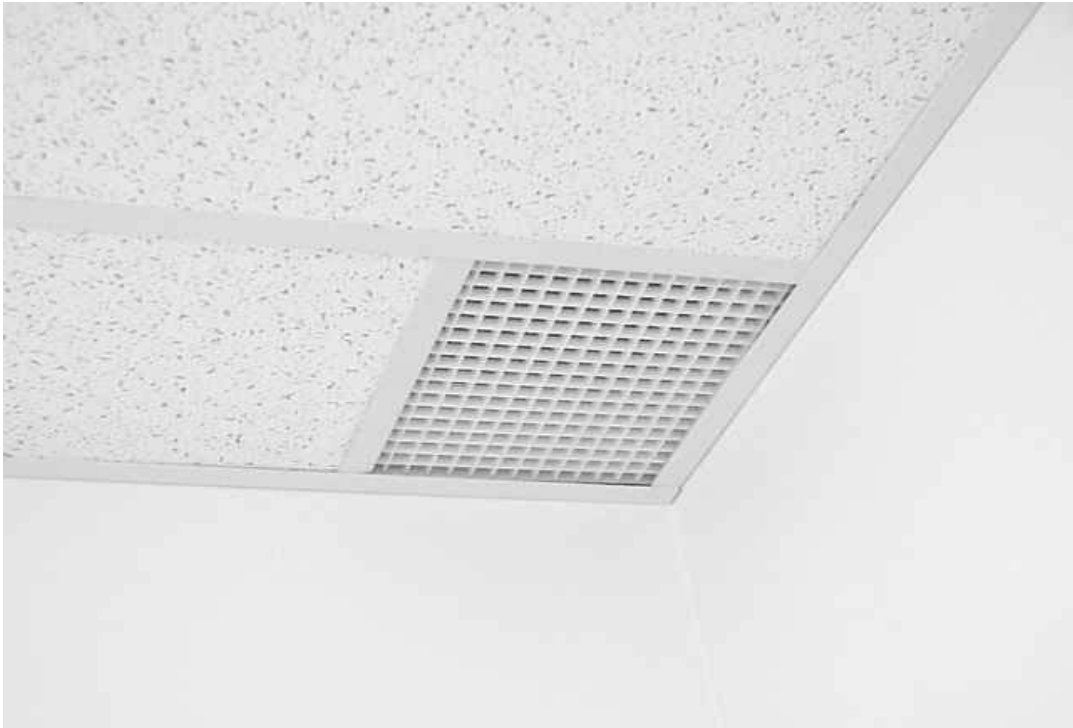
Picture 2

Ceiling-Mounted Exhaust/Return Grille

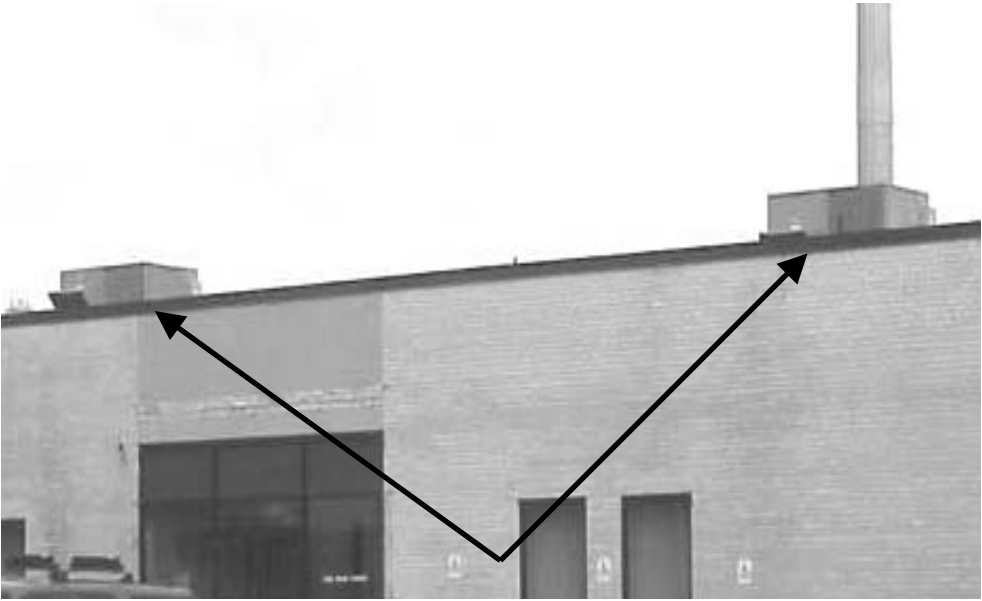
Picture 3

It can be seen from the tables that carbon dioxide levels were slightly above 800 parts per million parts of air [ppm] in four of forty-eight areas sampled throughout the building during the May 31 visit. The DSS building is divided into private offices and a large open work area that was subdivided into smaller work areas by floor dividers. Each work area contains fresh air supply diffusers and exhaust vents (see Pictures 1 & 2) that are connected to rooftop air handling units (AHUs), which provide fresh air (see Picture 3). Heating in the building is divided into zones controlled by thermostats. The

On return to this building on September 29, all areas tested (16 of 16) were above 800 ppm carbon dioxide. These 16 general areas were chosen to be reflective of the overall adequacy of fresh air supply throughout the office space, since each location tested on September 29 is supplied by the same rooftop AHUs as non-tested areas. Although the system was operating during both site visits, elevated levels of carbon dioxide were more prevalent during the September 29th visit, which may indicate that the outside air intake louvers on the AHUs were minimally opened or shut. BEHA staff were unable to gain access to the roof to observe the AHUs.

Rooftop Air-Handling Units

1. Inspect rooftop AHUs to ensure fresh air intake louvers are operable. Change filters for AHU equipment as per the manufacturer's instructions or more frequently if needed. Examine AHUs periodically for maintenance and function, repair/replace parts as necessary.

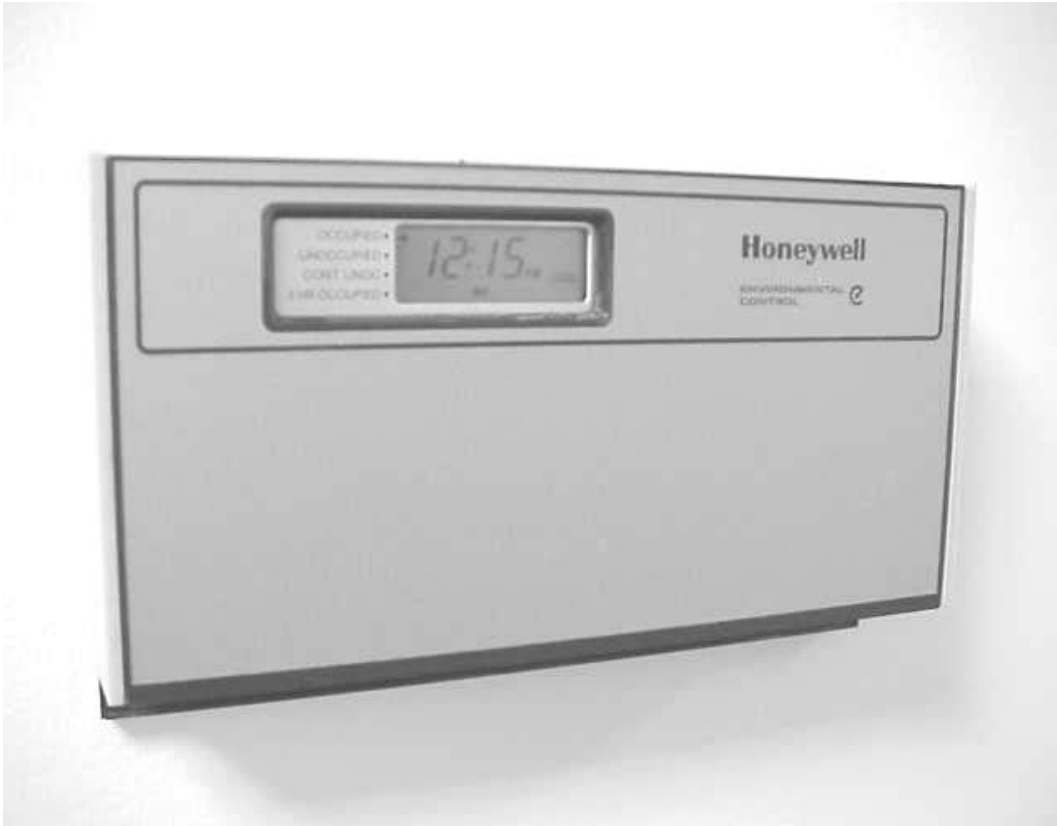
Picture 4

Temperature measurements were within the BEHA recommended comfort range for both visits. Temperature measurements ranged from 71° F to 77° F on May 31 and from 71° F to 73° on September 29. The BEHA recommends that indoor air temperatures be maintained in a range of 70° F to 78° F in order to provide for the comfort of building occupants. A number of complaints of uneven heating and cooling were expressed to BEHA staff. As previously mentioned, the building is divided into five thermostat zones and is adjusted by digital wall-mounted thermostats (see Picture 4). In many cases

Digital Wall-Mounted Thermostat

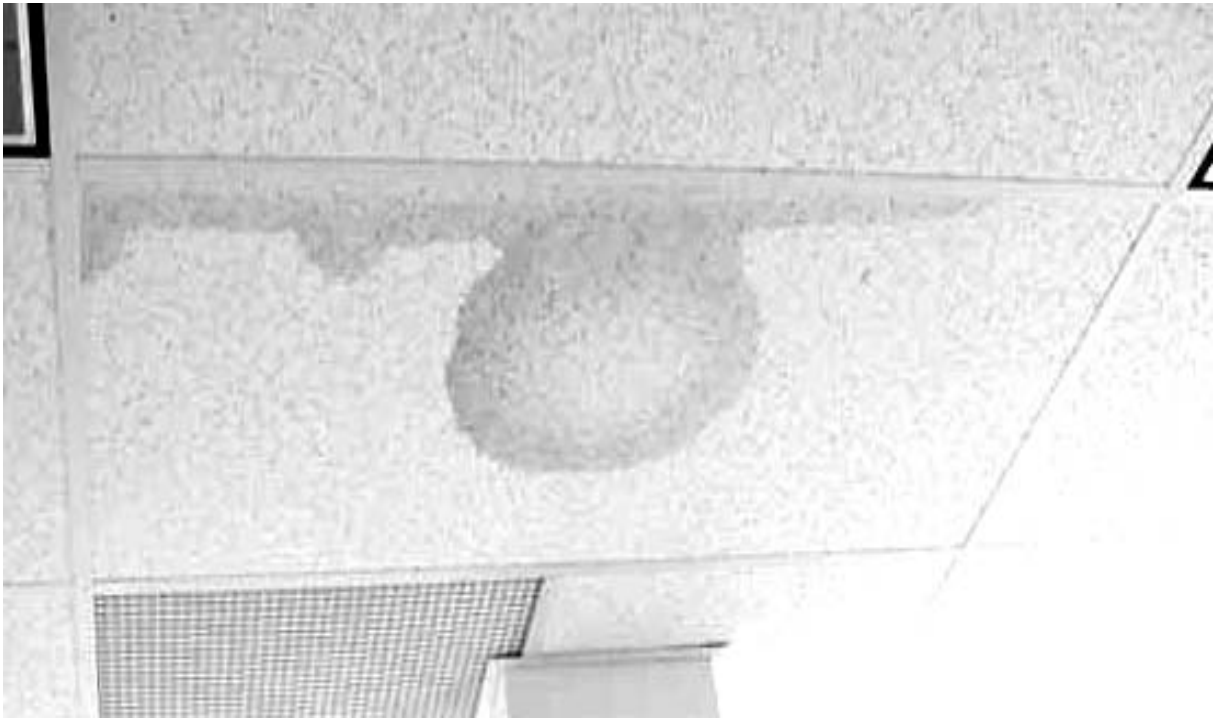
Picture 5

Several areas contained water-stained ceiling tiles (see Picture 5), which are evidence of historic roof or plumbing leaks. BEHA staff removed ceiling tiles in areas 30 and 31 (see Appendix A) to observe conditions within the ceiling plenum. Several plastic buckets were observed hanging from fixtures in the ceiling plenum apparently to collect rainwater from roof leakage (see Picture 6). Water-damaged ceiling tiles can provide a source of mold and mildew. If the roof leakage has been fixed, these buckets

Water-Damaged Ceiling Tile

should be removed; ceiling tiles should be inspected for mold growth and be replaced as necessary.

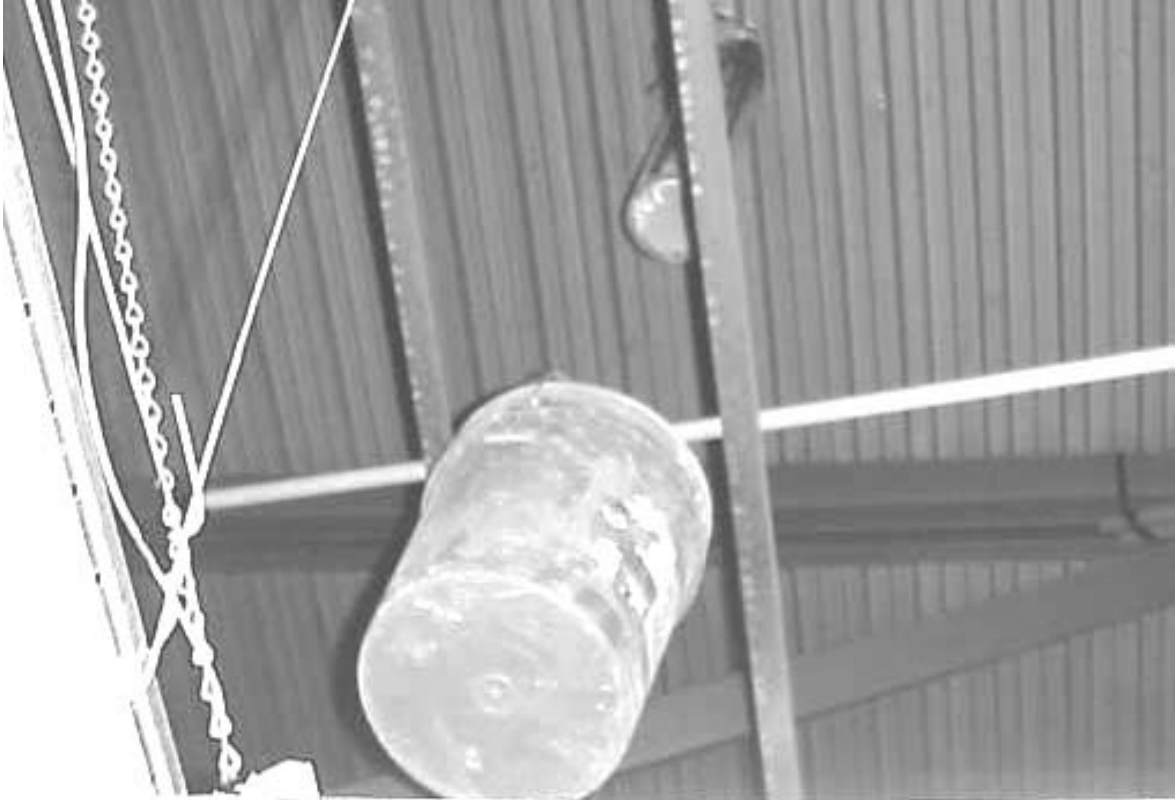
Picture 6

Plastic Bucket Stationed above Tiles in Ceiling Plenum

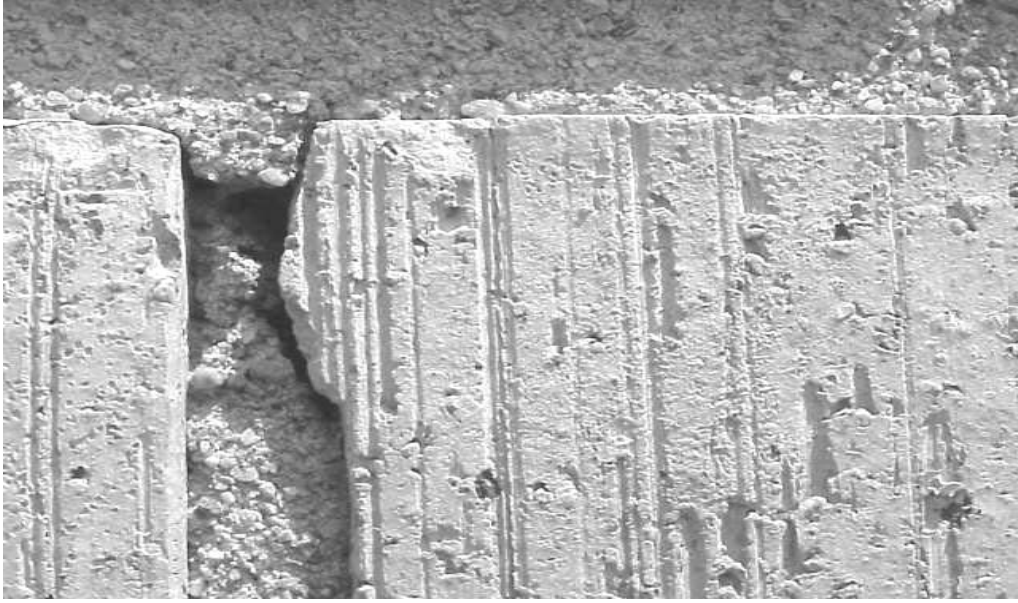
Picture 7

A number of cracks in the exterior brickwork were noted on the southwest (front) and southeast (parking lot) sides of the building (see Pictures 7 & 8). These conditions are breaches of the building envelope and can provide a means for water entry into the building. Repeated water penetration can result in the chronic wetting of building materials and the potential for mold growth.

Hole/Missing Mortar around Brickwork along Southwest (front) Side of Building

6. Repair cracks on the exterior wall/foundation of the building to prevent water penetration.
7. Remove plant growths against the building.
8. Repair any existing water leaks and replace any remaining water-stained ceiling tiles. Examine the areas above these tiles for mold growth. Disinfect areas of water leaks with an appropriate antimicrobial as needed.
9. Report any roof leaks or other signs of water penetration to building owner/manager for prompt remediation.
10. Ensure photocopiers are located in a well-ventilated area.
11. If possible, conduct painting during unoccupied periods or periods of low occupancy (e.g., Friday evenings, holidays, weekends, etc.). If not possible isolate area and vent paint odors to the outside using local exhaust.

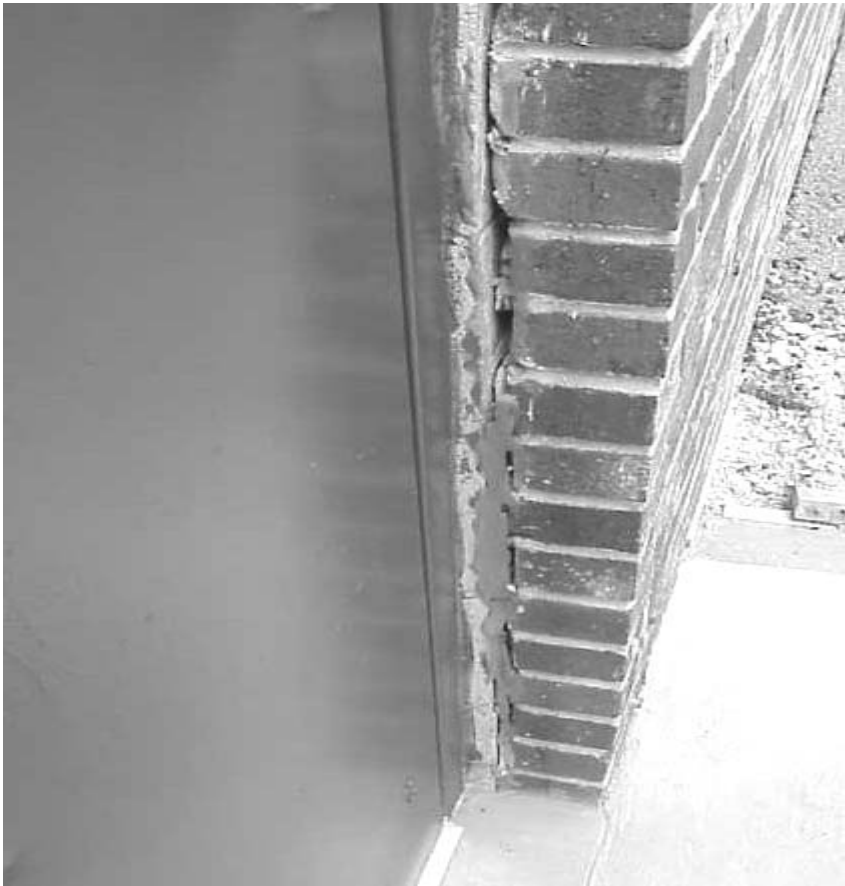
Picture 8

Spaces Noted between the Interior and Exterior Brick of Building

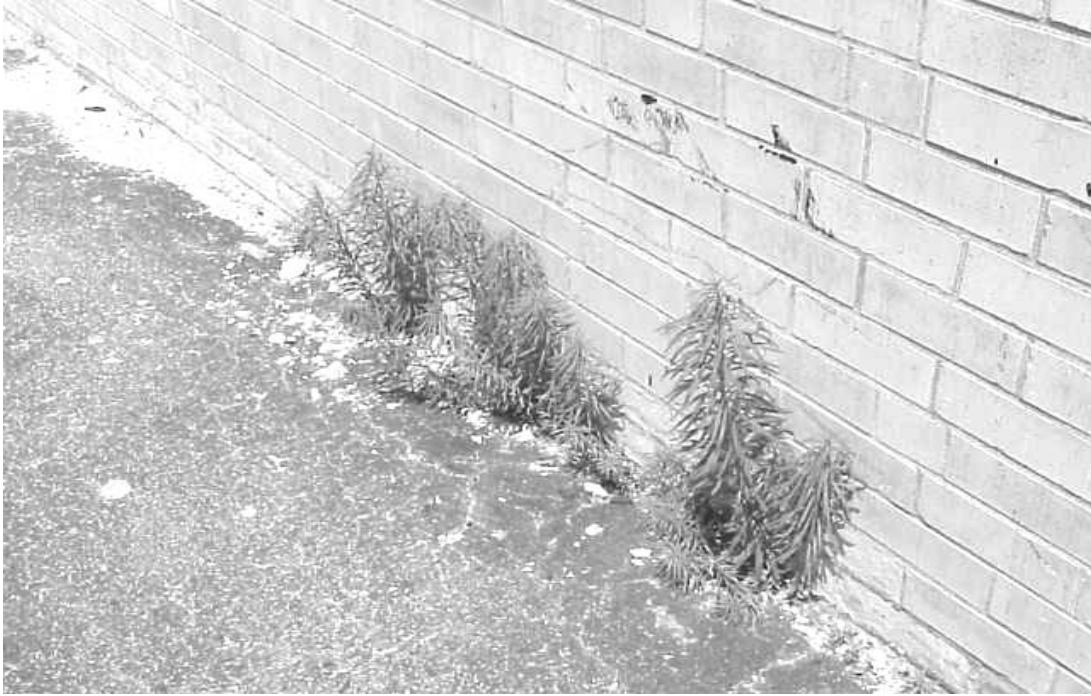
Picture 9

Also noted on the southwest (front) side of the building were plants growing between the tarmac and the foundation/exterior wall of the building (see Picture 9). The growth of plants against the exterior walls of the building can bring moisture in contact with wall brick and eventually lead to cracks and/or fissures in the foundation below ground level, which can subsequently breach the integrity of the building envelope.

Plants Growing between the Tarmac and Exterior Brick/Foundation of Building

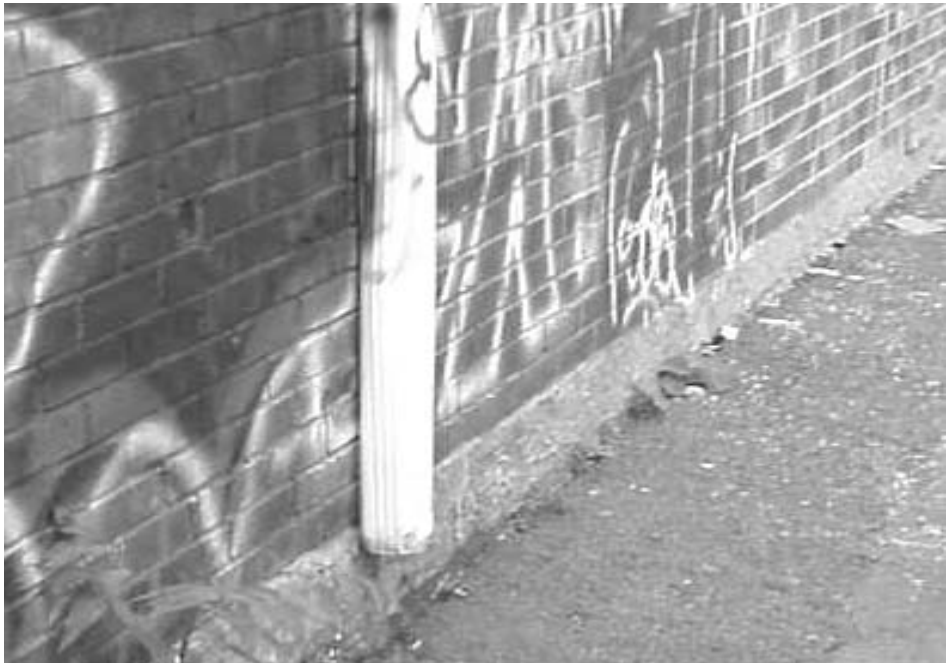
Building downspouts on the southeast walls were missing elbow extensions to divert rainwater away from the building. Picture 10 shows that the system empties approximately 10-12 inches above ground level, which allows back-splashing rainwater to impact on the ground below resulting in chronic wetting of the exterior wall. Downspouts should be designed to direct rainwater away from the base of the building to prevent the chronic wetting of exterior walls which can result in damaged brickwork and/or mold growth.

Downspout Missing Elbow Extension

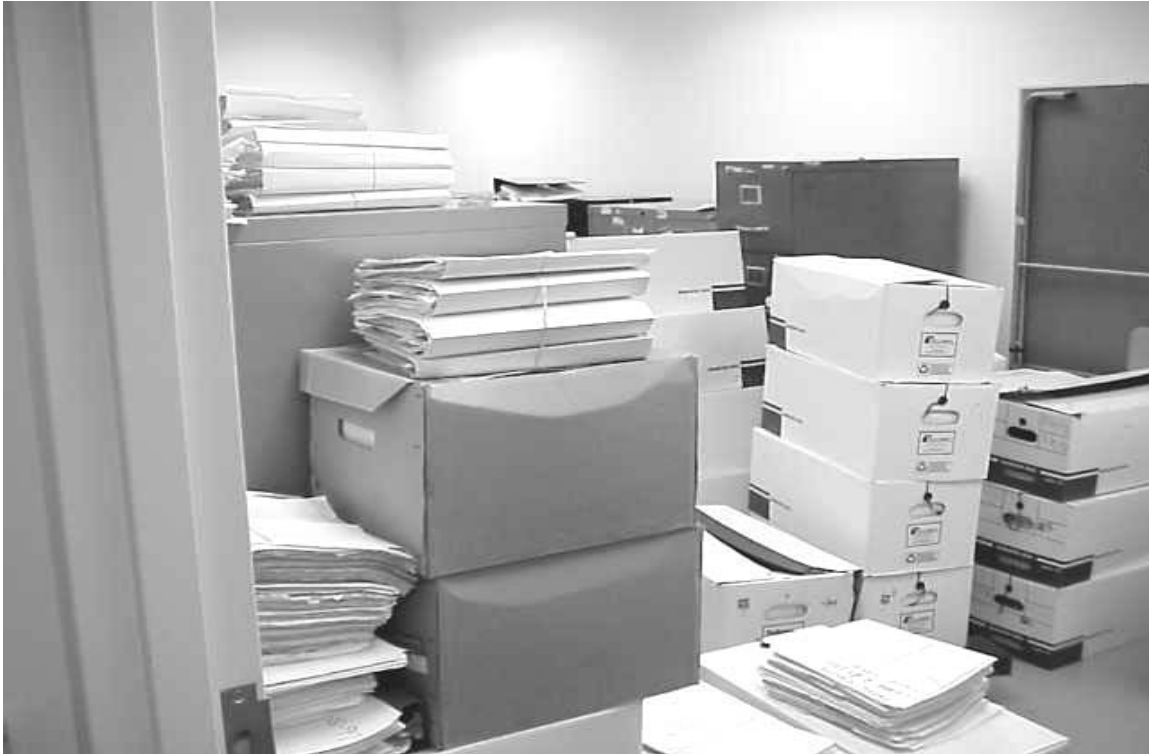
Picture 11

A cardboard odor was noted in the storeroom (area 21). The source of this odor appears to be from boxes containing DSS records (see Picture 11). The storage boxes were dry, however, new cardboard boxes contain glues that can emit odors. Office personnel should ensure that the mechanical ventilation in this area is operating to both dilute and remove odors that may be present.

Boxes in Storeroom Containing DSS Records
