# **INDOOR AIR QUALITY ASSESSMENT**

**North Andover Fire Department  
124 Main Street  
North Andover, Massachusetts**

Prepared by:  
Massachusetts Department of Public Health  
Bureau of Environmental Health Assessment  
June, 2001

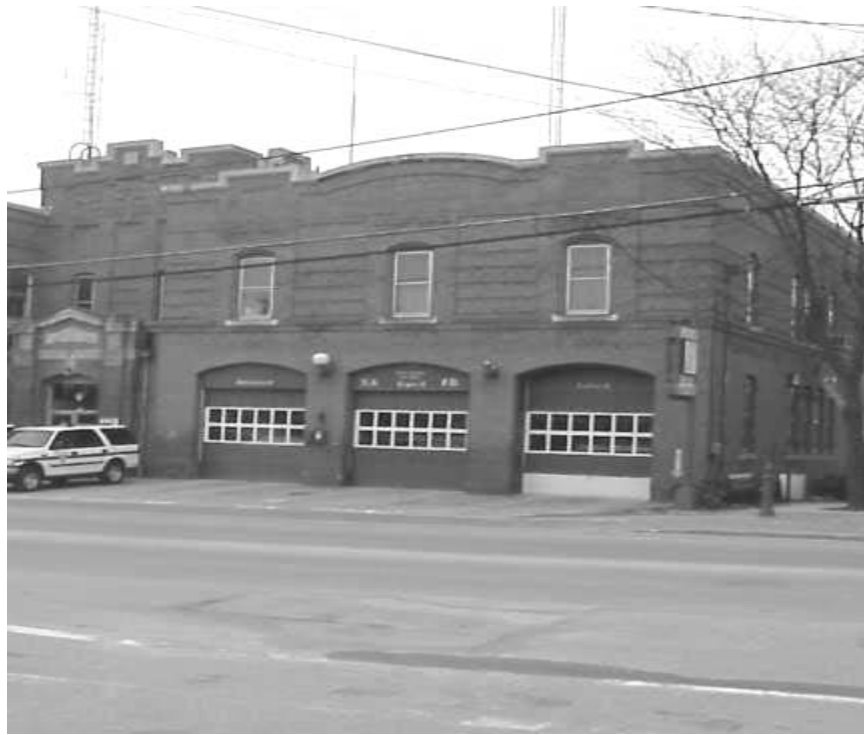
**Picture 1**

The firehouse is a two-story red brick building constructed in 1909 (see Picture 1). This building is joined to the North Andover Town Hall, which was built in the 1920's. The indoor air quality assessment for the North Andover Town Hall is subject of a separate report. The North Andover Fire Department second floor has offices, a meeting room, bunkroom and kitchen. The first floor contains three engine bays, reception and credit union office. The basement contains a workout room, furnace, equipment storage and garage used to store fossil fuel-powered equipment. Windows are openable and consist of single paned glass in wooden window frames. The front of the building has three garage doors that enclose the engine bays. Two stairwells connect the garage to rooms on the second floor.

**North Andover Fire Station**

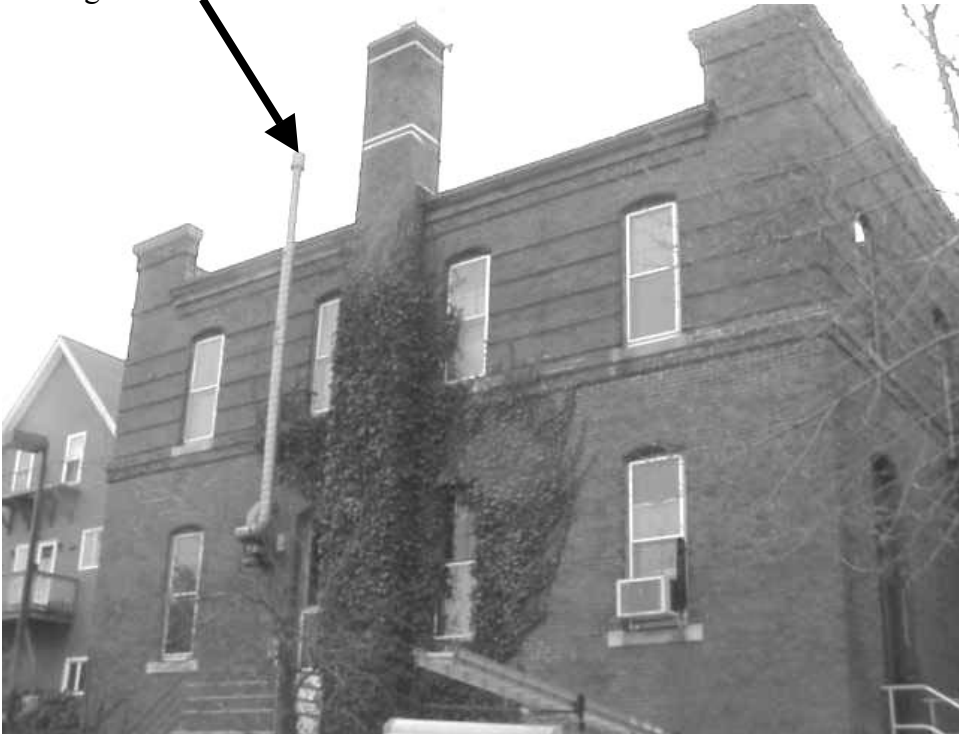
**Picture 2**

A mechanical exhaust ventilation system was installed in the engine bays to remove carbon monoxide and other products of combustion from vehicles. A flexible hose is connected to the tailpipe of each vehicle. Each flexible hose is connected to a motorized fan located on the rear of the building (see Picture 2). As motors operate, engine combustion products are drawn into the vent system and released into a chimney that terminates above the edge of the roof.

**Exhaust Vent for Fire Engines**

1. Operate the vehicle exhaust ventilation system on a continuous basis to create negative air pressure in the engine bays.
2. Seal utility holes in the ceiling of the engine bays. Continue with plans to seal the remaining fire pole hole. Caulk the seam around the plywood plugs placed over the fire pole holes.

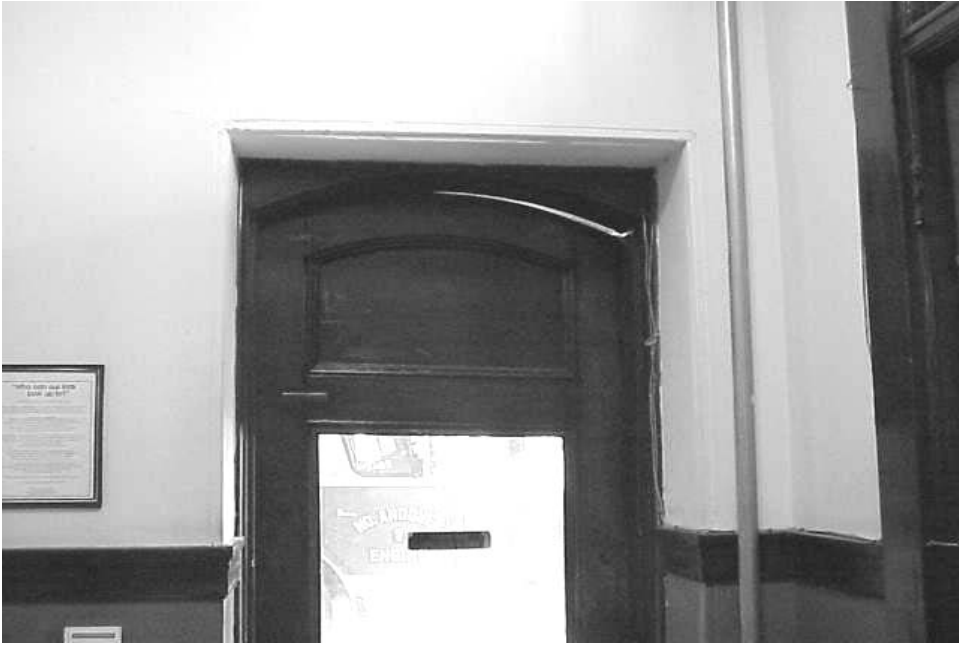
**Picture 3**

- The door to the front stairwell does not fit flush with its doorframe, resulting in the creation of spaces around the door (see Picture 3). The top door hinge appears to be worn, resulting in the door fitting loosely in the frame. The loosening of the door could have resulted from the hinge screws stripping the wood of the doorframe over time.
- The door to the rear stairwell also has spaces around the doorframe.
- Open seams in walls around the rear stairwell can allow air penetration (see Picture 4).
- Two fire pole holes exist in the ceiling of the engine bays. One fire pole hole has space around its door (see Picture 5).
- The ceiling of the engine bays is penetrated by holes for utilities. These holes are not sealed (see Picture 6).

**Space in Doorframe Adjacent to Engine Bays**

3. Refit the hinges of the front stairwell door. Install weather stripping along the doorframe and a door sweep on the underside of all doors that access the engine bays.

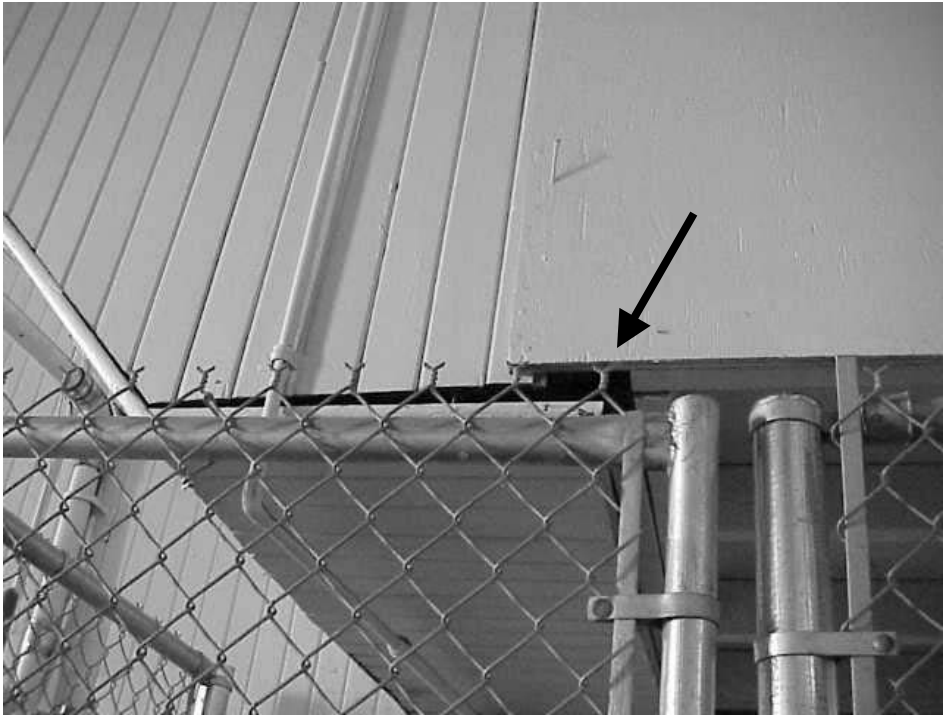
**Picture 4**

**Spaces in Wall around Back Stairwell Wall**

4. Render the walls along the back stairwell airtight. Installing gypsum wallboard over the original walls and sealing the seams with caulking may be the most cost-effective method to create an airtight barrier.

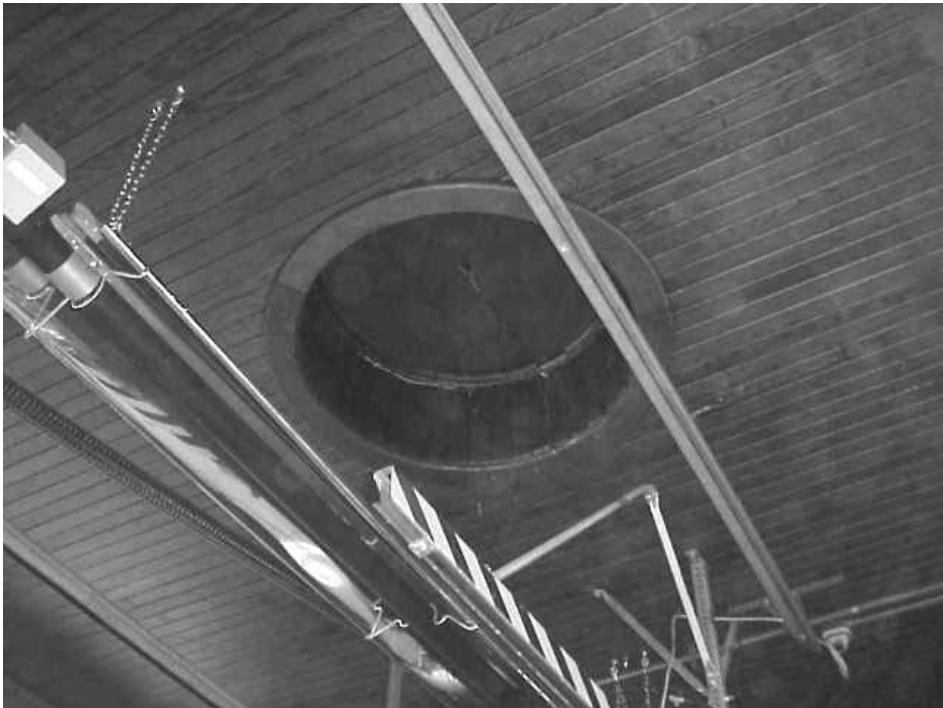
**Picture 5**

**Fire Pole Hole in Ceiling**

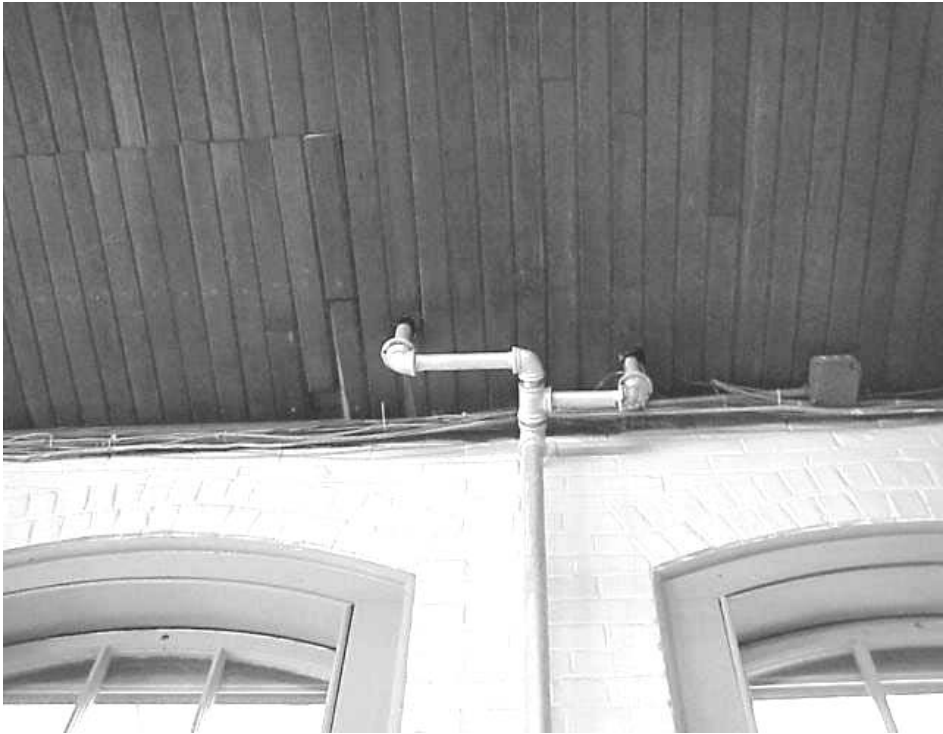
**Picture 6**

**Utility Holes in Ceiling of Engine Bays**

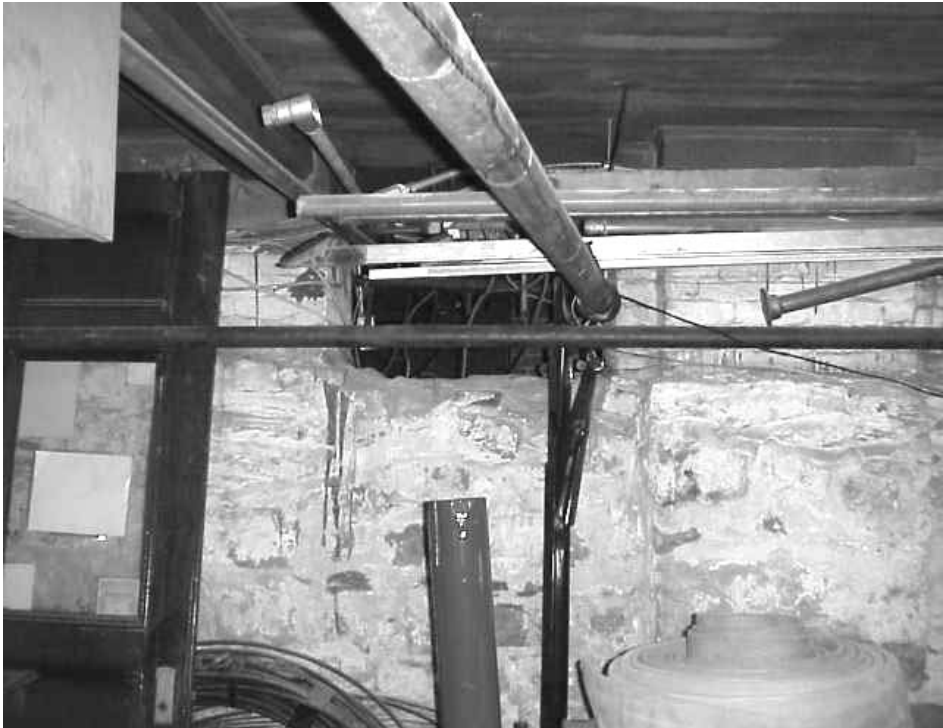
**Picture 7**

The fire station and the town hall share an adjoining wall. While the first and second floors appear to have minimal air pathways, a hole for access to a crawlspace beneath the town hall exists in the basement of the fire station (see Picture 7). Stored in the basement are several pieces of fossil fuel powered equipment, including the emergency electrical generator. The opening between the buildings can serve as a means for odors to move from the fire station basement into the town hall crawlspace. Once in the crawlspace, pollutants could potentially move into the ground and first floor through spaces in floor or walls.

**Hole in Fire Station/Town Hall Shared Wall**
