# **INDOOR AIR QUALITY ASSESSMENT**

**Holland Elementary School  
28 Sturbridge Road  
Holland, Massachusetts**

Prepared by:  
Massachusetts Department of Public Health  
Bureau of Environmental Health Assessment  
July, 2001

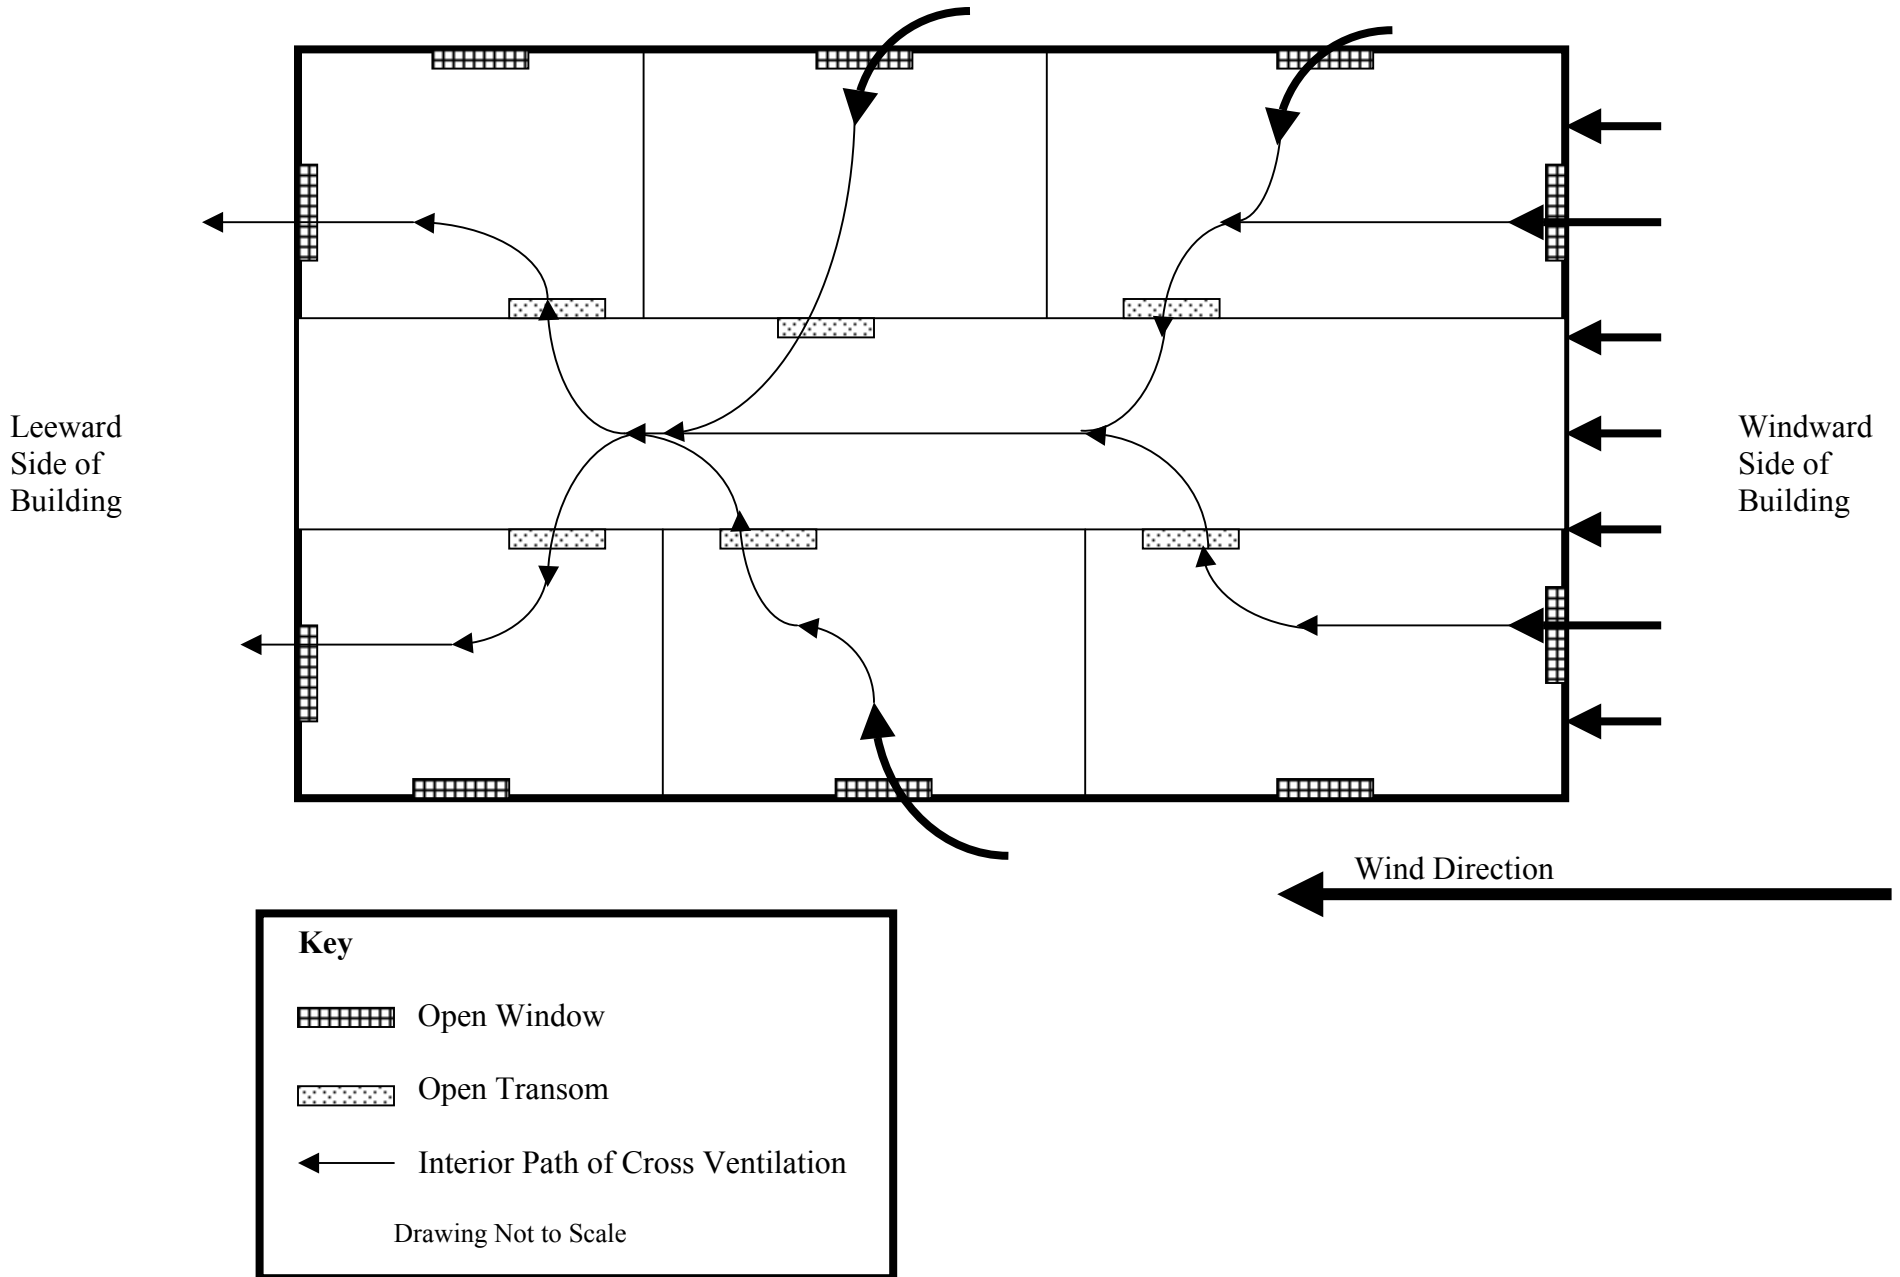
Figure 2

Cross Ventilation in a Building Using Open Windows and Transoms

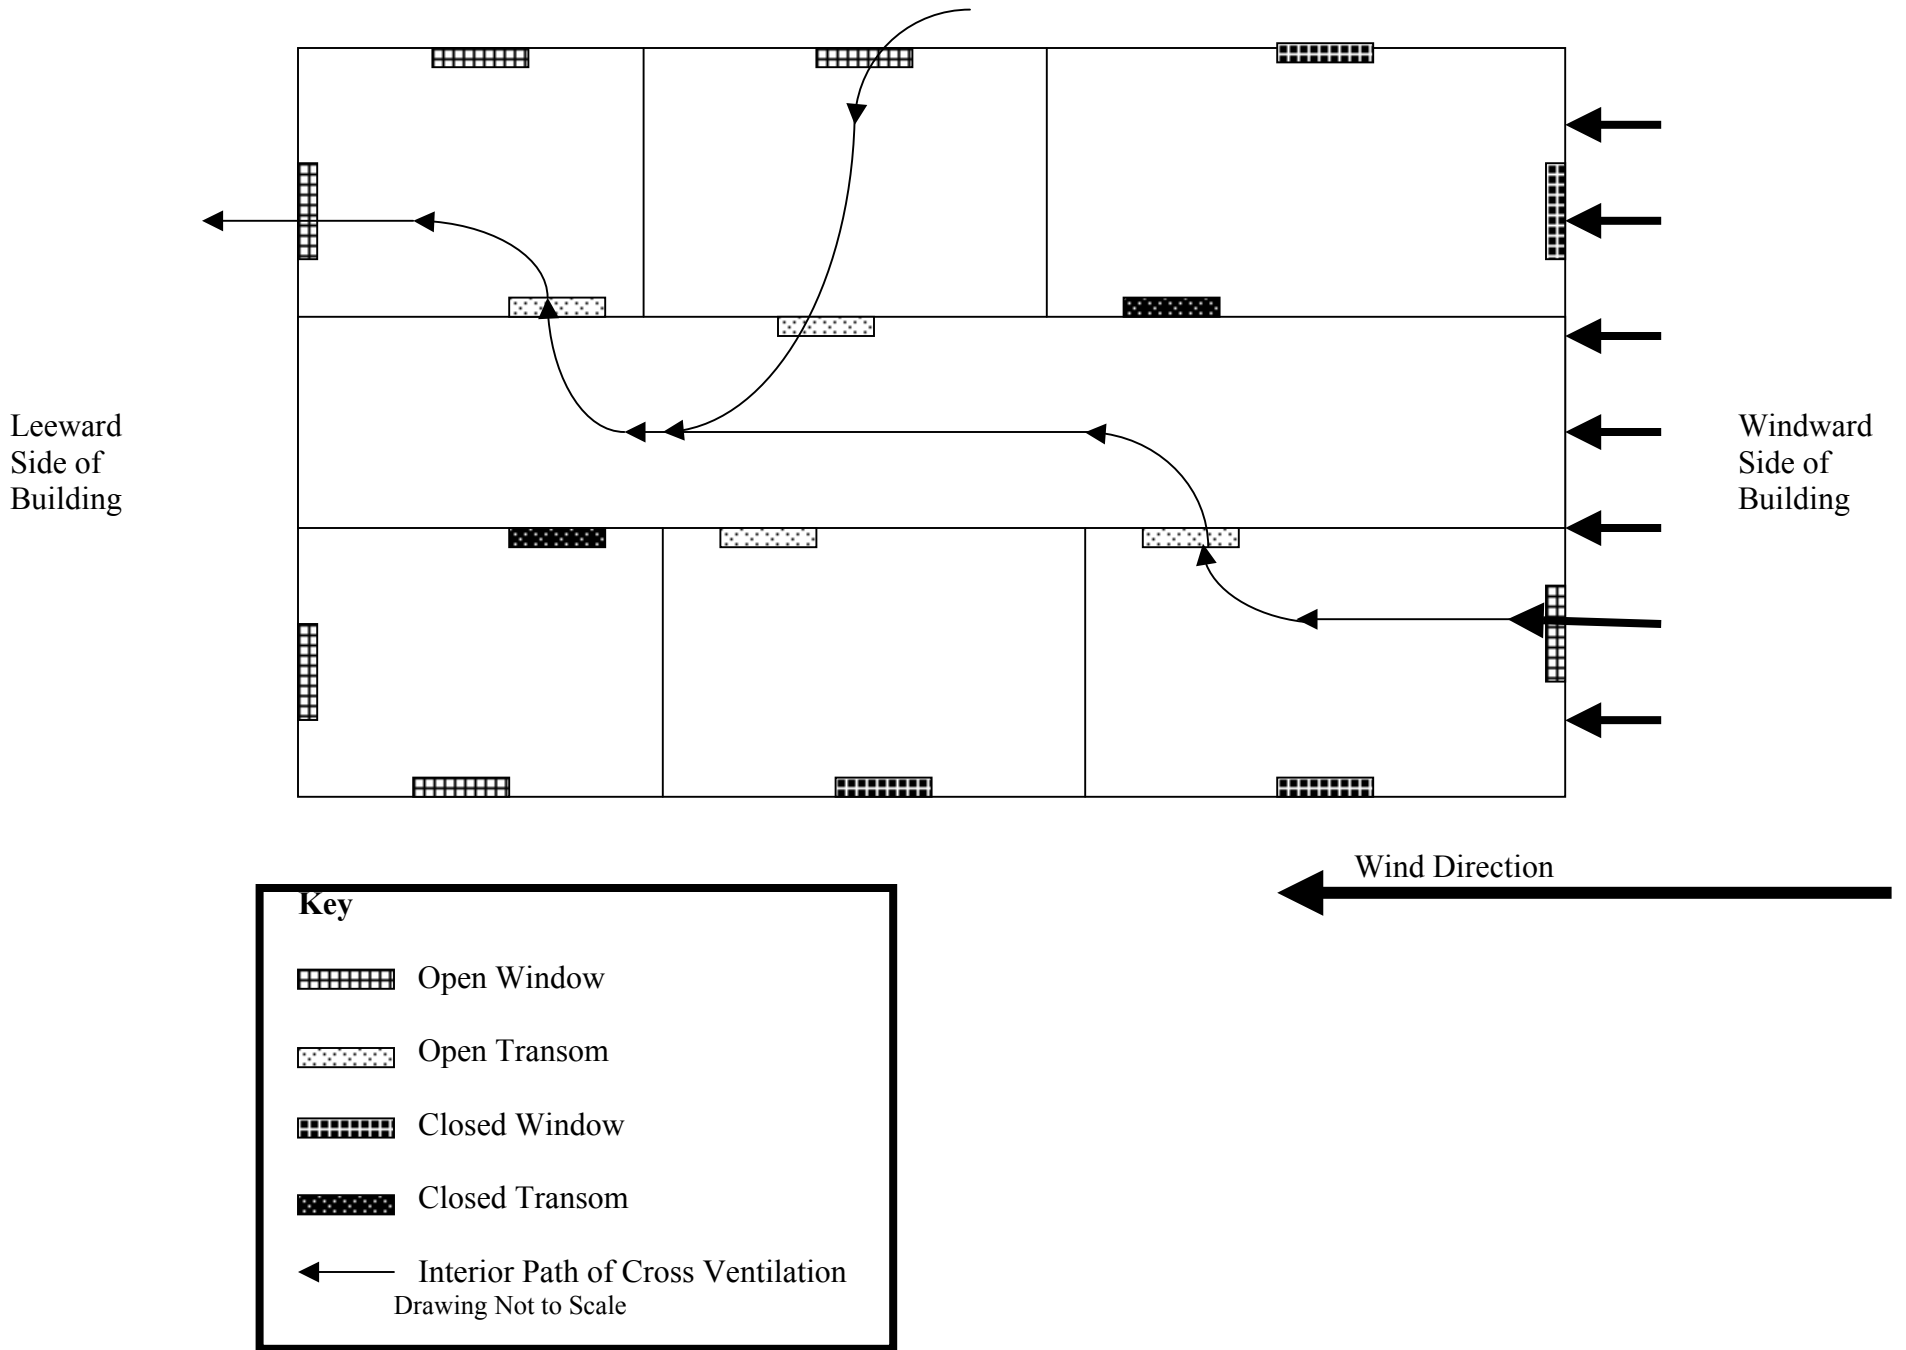
Figure 3

During summer months, ventilation in the school is controlled by the use of operable windows in classrooms. This section was configured in a manner to use cross-ventilation to provide comfort for building occupants. The building is equipped with windows on opposing exterior walls. In addition, the building has hinged windows located above the hallway doors. The hinged windows (called transoms) enable classroom occupants to close the hallway door while maintaining a pathway for airflow. This design allows for airflow to enter an open window, pass through a classroom and subsequently pass through the open transom. Airflow then enters the hallway, passing through the opposing open classroom transom, into the opposing classroom and finally exits the building on the leeward side (opposite the windward side) (see Figure 2). With all windows and transoms open, airflow can be maintained in a building regardless of the direction of the wind. This system fails if the windows or transoms are closed (see Figure 3). Most transoms in this wing were closed.

Inhibition of Cross Ventilation in a Building with Several Windows and Transoms Closed

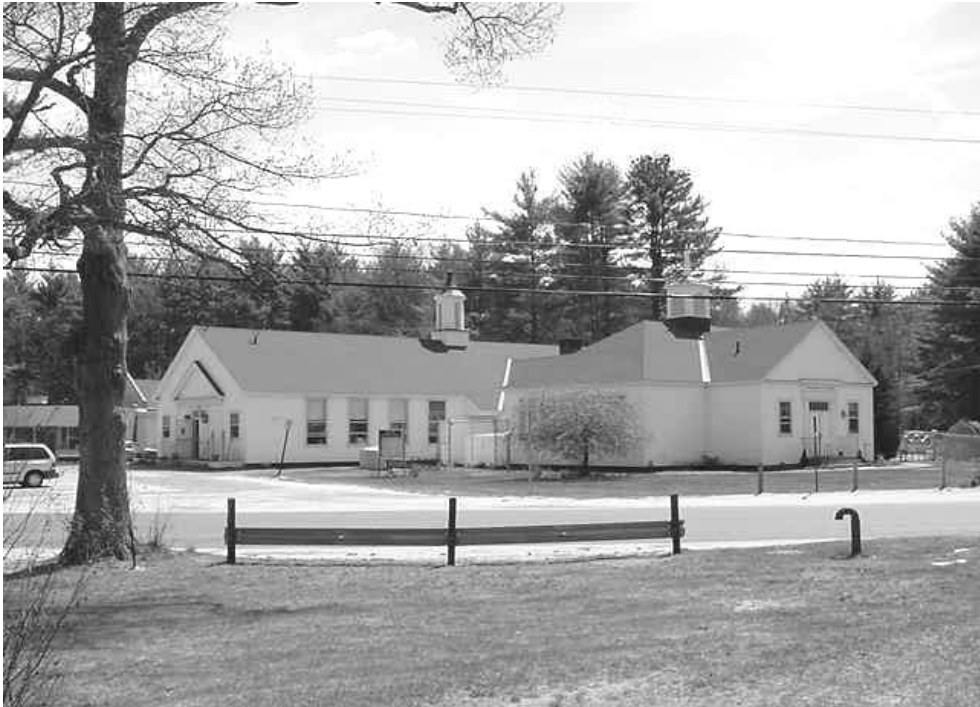
**Picture 1**

The school was built in 1947 as a wood frame structure (see Picture 1). A wood frame addition was constructed at the rear of the original building during the 1960s (see Picture 2). A brick and steel frame addition was added to the east wall of the 1960s addition in 1975 (see Picture 3). The school contains general classrooms, library, gymnasium/cafeteria, and various offices. Classroom windows are openable. The 1947 and 1960s wings underwent renovations to render these sections energy efficient, but the date of these renovations was not available. The original siding on the 1947 and 1960s wings was replaced with vinyl siding. It also appears that the original window frames were replaced with energy efficient models. The air volume of each classroom in each of these wings was reduced by the installation of a suspended ceiling. Reducing classroom volume decreases the energy needed to heat an area.

**1947 Wing**

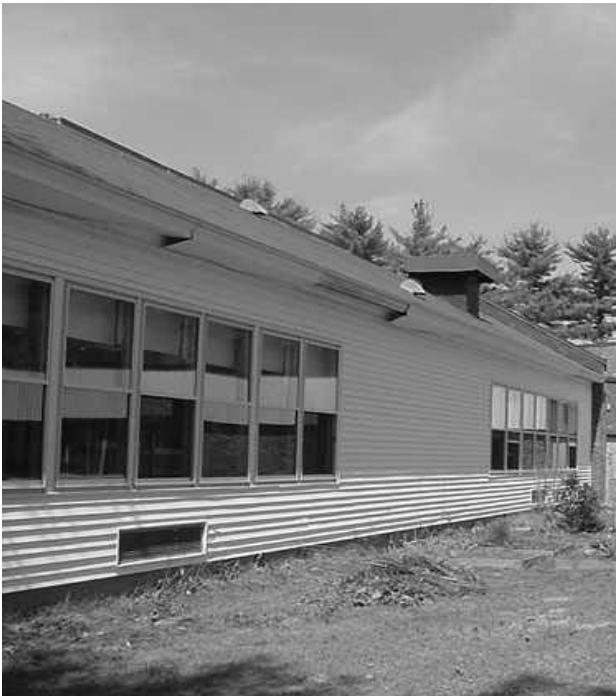
**Picture 2**

**1960s Wing**

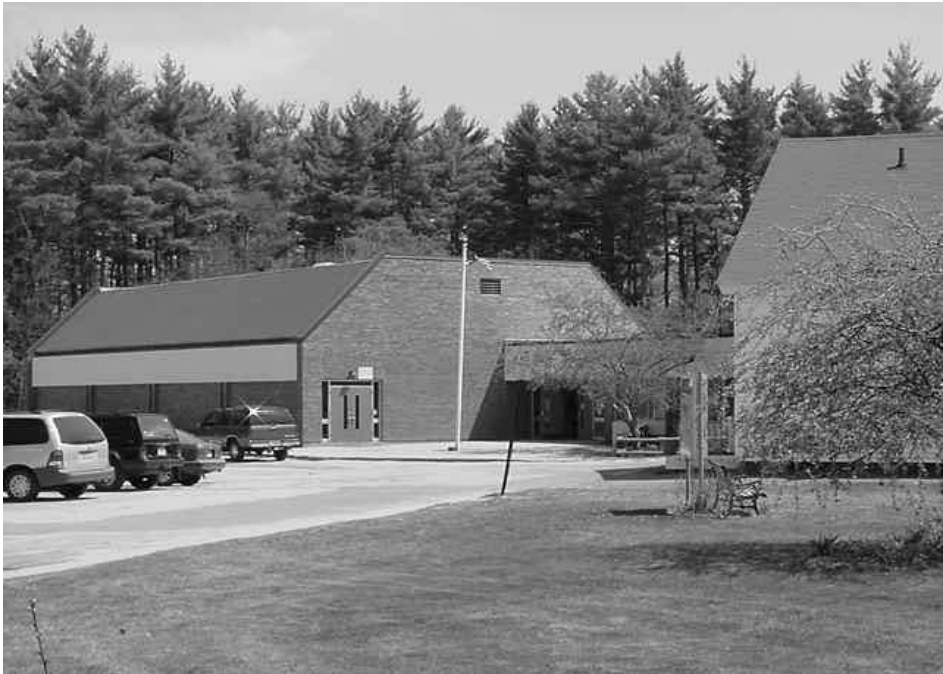
**Picture 3**

**1975 Wing**

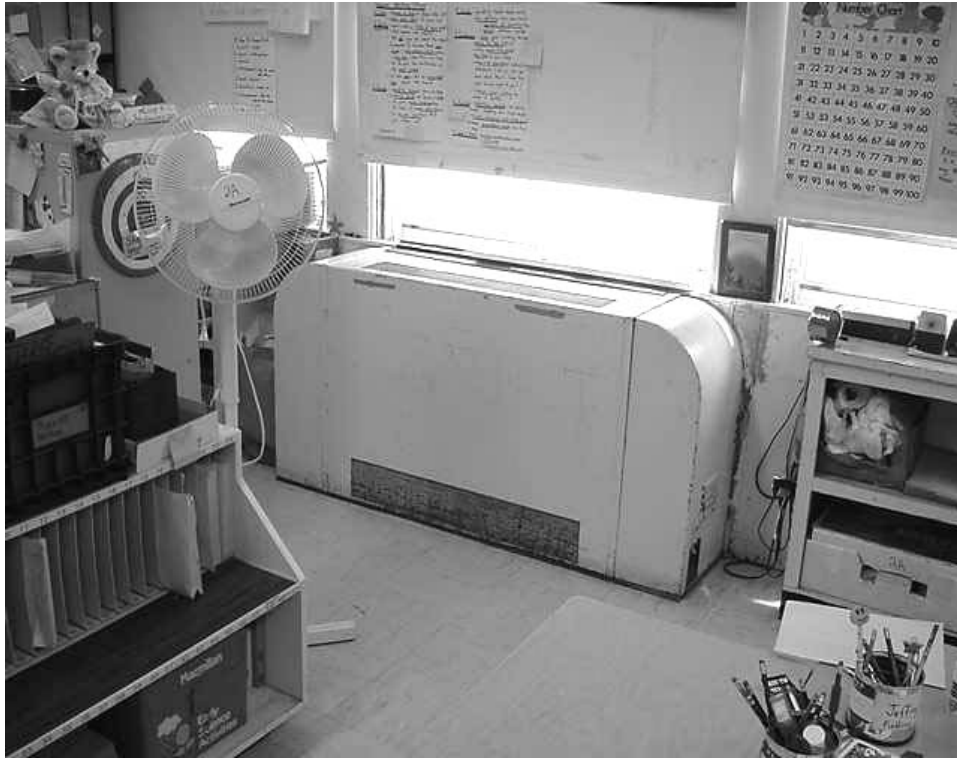
Picture 4

Univent in 1947 Wing

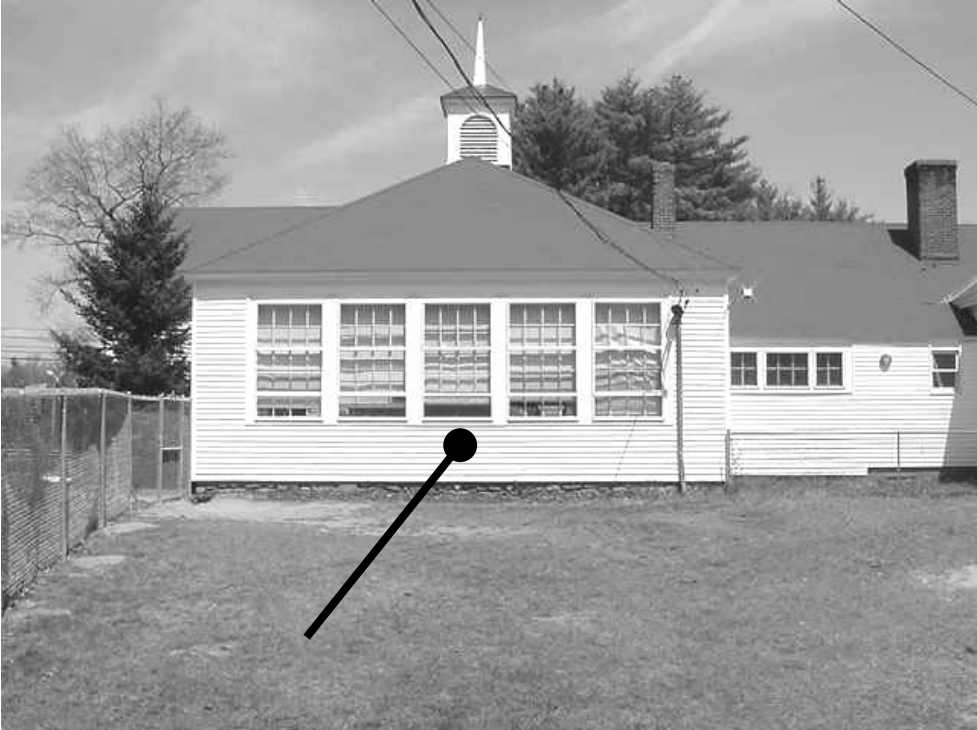
**Picture 5**

installation of vinyl siding on the exterior of this wing. Univent fresh air intakes for the rooms in the front of this wing were enclosed beneath the vinyl siding exterior (see Picture 5). Fresh air intakes for the library and classroom 106 were sealed with plywood (see Picture 6). Therefore, no fresh air can be provided for the areas using univents. Operation of univents would only serve as a radiant heat source. As univents operate, normally occurring indoor air pollutants would be entrained by each univent and reaerosolized, which can lead to pollutant build up. Sources of odors in each area would not be diluted and could be allowed to concentrate. Each room in this wing (with the exception of room 106) has exhaust vents. The exhaust vents were either drawing weekly or were blocked by boxes and other obstructions. The means to provide exhaust ventilation (either mechanically using fans or using rising, heated air) could not be determined, but are likely within cupolas located on the roof (see Picture 7). Since it appears that renovations to render this wing energy efficient were made, exhaust vents to the roof could either be blocked or deactivated in a manner similar to the univents. Roof exhaust vents were not examined because of difficulties in access to the peaked roof. Therefore, the sole means to creating airflow in this wing is through open windows. Rooms 105 (library) and 106 appear to be a former cafeteria/auditorium, which has been divided. Exhaust vents that serviced the entire original cafeteria/auditorium exist along the floor on the right side of the stage. The installation of the wall creating room 106 and the library separates room 106 from these exhaust vents. As configured, no means (with the exception

**General Location of Univent Fresh Air Intake Sealed Inside Vinyl Siding**

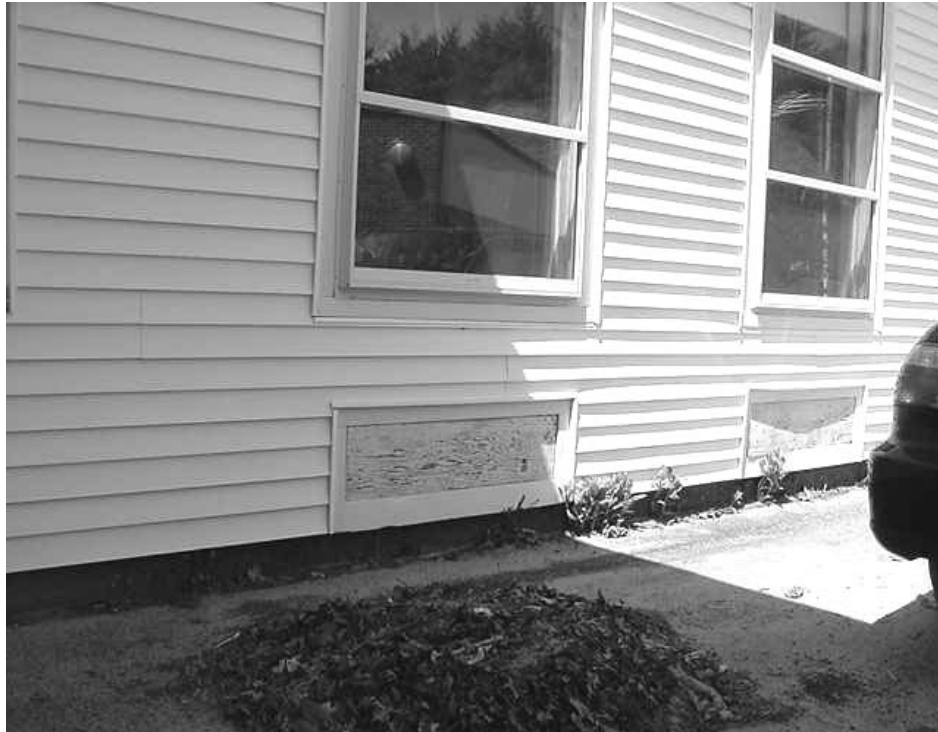
**Picture 6**

The library/room 106 univents sealed fresh air intakes are located next to a parking area. If these fresh air intakes are restored, vehicle exhaust can be entrained by the univents and distributed into these areas.

**Sealed Univent Fresh Air Intakes for Library and Room 106**

4. Consider consulting a building engineer to determine the most appropriate method to insulate and install a vapor barrier for the wing floor.
5. Consult a ventilation engineer to determine whether deactivated univents in the 1947 and 1960s wings can be repaired and restored to provide fresh air for classrooms. If not feasible, replacing the nonfunctioning univents should be considered.
6. Restore the fresh air intakes for the univents that were sealed by the vinyl siding installation after determining the feasibility of restoring the function of univents.
7. Examine the feasibility of providing exhaust ventilation for room 106.
8. Prohibit parking outside library/room 106 after fresh air intakes are restored to prevent vehicle exhaust entrainment.

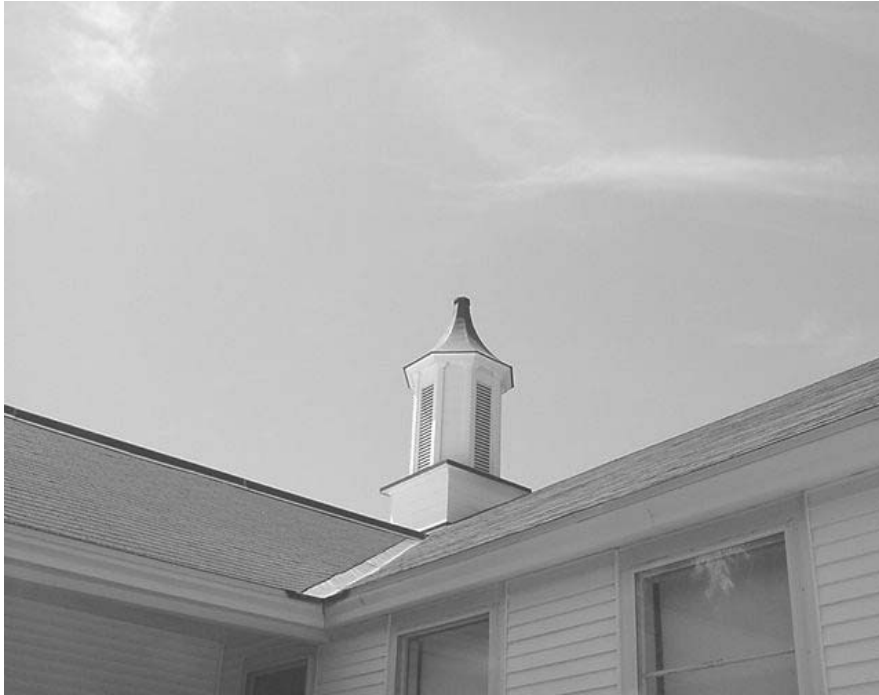
**Picture 7**

**Rooftop Cupola That May Contain Exhaust Vent Terminus**

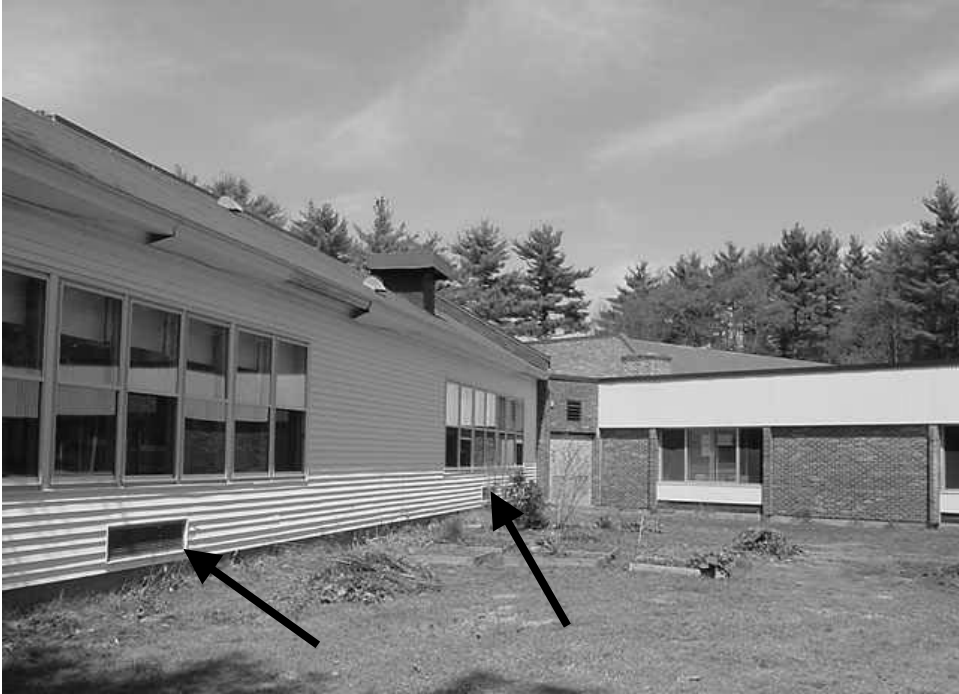
**Picture 8**

Fresh air is supplied by univents with open fresh air intakes that were installed through the vinyl siding (see Picture 8). Univents were deactivated. Exhaust ventilation is provided by ceiling mounted exhaust grilles. These exhaust vent grilles appear to be connected by ductwork to two exhaust vent fans on the roof (see Picture 9). Exhaust vents of this configuration typically are mechanical.

**1960s Wing Univent Fresh Air Intake**

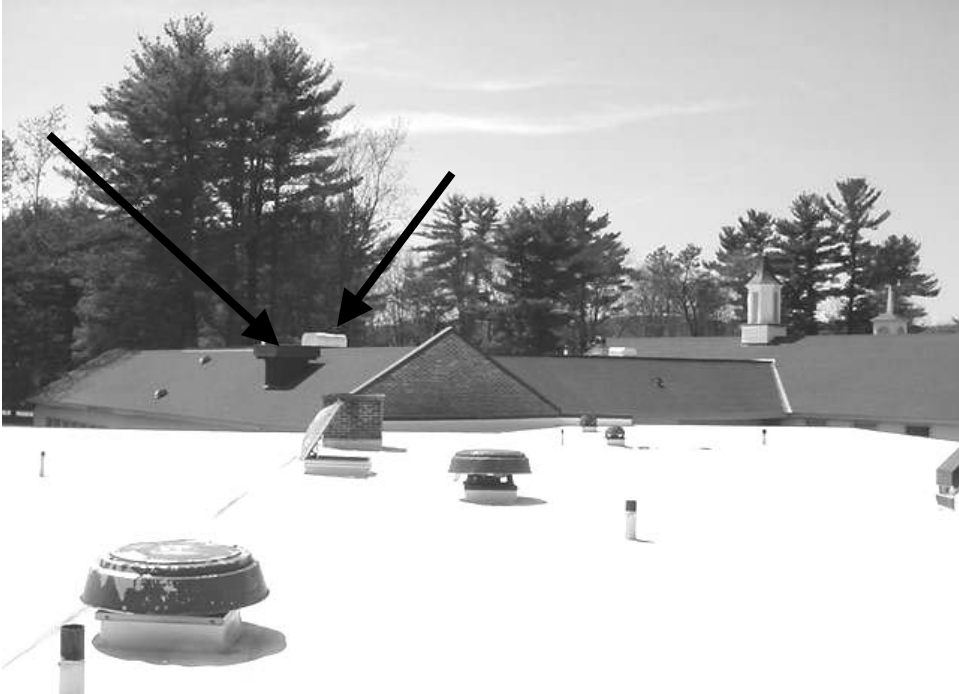
Picture 9

1960's Wing Rooftop Exhaust Vent Termini

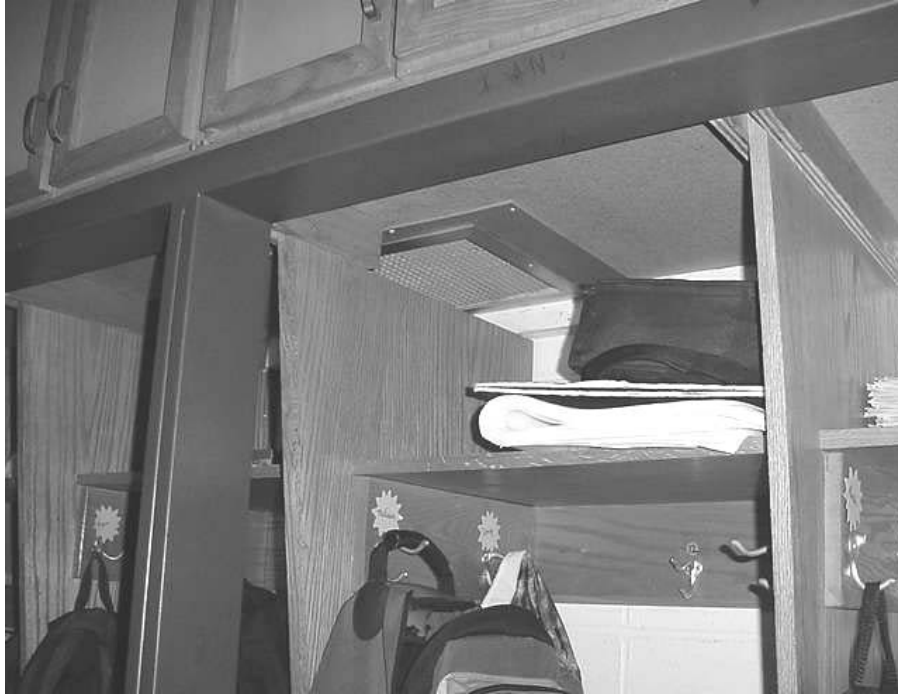
**Picture 10**

**Exhaust Vent Grilles Located in Ceiling of Closet in 1975 Wing**

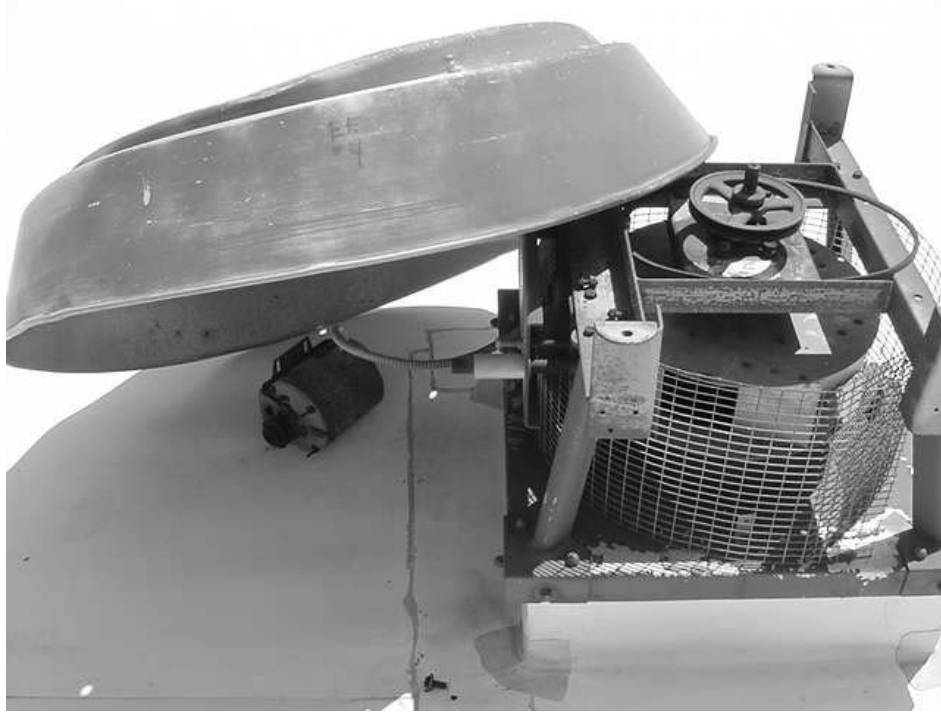
**Picture 11**

**Disassembled Exhaust Vent Motor On 1975 Wing Roof**

2. Repair exhaust vent fan motors. Operate exhaust vents during school hours.
3. Remove all blockages from univents and exhaust vents to facilitate airflow. Clear a three-foot space around all exhaust vents where feasible and reduce stored materials in classroom closets such that airflow is not impeded. Exhaust ventilation is necessary to remove pollutants from the interior of classrooms. If exhaust ventilation cannot be run continuously, adjust exhaust unit ventilator to have exhaust run to the extent that the equipment will allow.

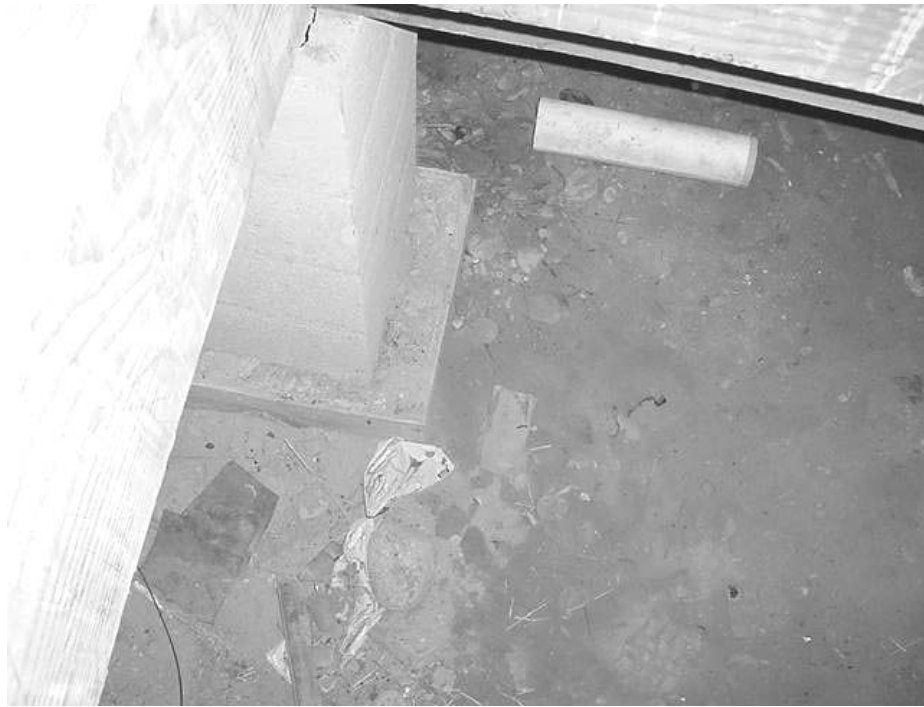
**Picture 12**

During the course of this assessment, BEHA staff did *not* detect musty/mold odors in any areas of this building. The 1947 and 1960s wing are built over a crawlspace. The floor of the crawlspace beneath the classrooms is dirt (see Picture 12). One passive air vent is located on the west foundation wall at ground level. This wing is covered with a peaked, shingled roof. It did not appear that the edges of either side of the roof were outfitted with rain gutters or downspouts (see Pictures 13 and 14). As a result, rainwater runs off the roof onto the ground at the base of the building. Over the years, this runoff has created a trench parallel to the base of the wall, which allowed rainwater and melting snow to pool against the foundation and the exterior wall of this wing. Pooling rainwater has accumulated in this area and has entered into the building through the crawlspace passive air vent. Several entrances to the crawlspace are located in these wings. A slight, musty odor was noted emanating from the crawlspace upon removal of a floor plug. A number of materials observed in the crawlspace can support mold growth, including its dirt floor (see Picture 12). It appears that no vapor barrier was installed on the wing floor. Air pathways from the crawlspace exist in both the 1947 and 1960s wings. Floor plug access doors and holes through the floor for plumbing and univents have spaces that can allow air and pollutants to migrate from the crawlspace into occupied areas. Elimination of these pathways would prevent musty odors reported in these wings.

**Floor Of Crawlspace beneath 1947 Wing**

6. Examine building structural materials beneath the newer wing floor for mold colonization. Examine floorboards and joists for mold growth and disinfect with an appropriate antimicrobial. Remove debris from the floor of the newer wing crawlspace.

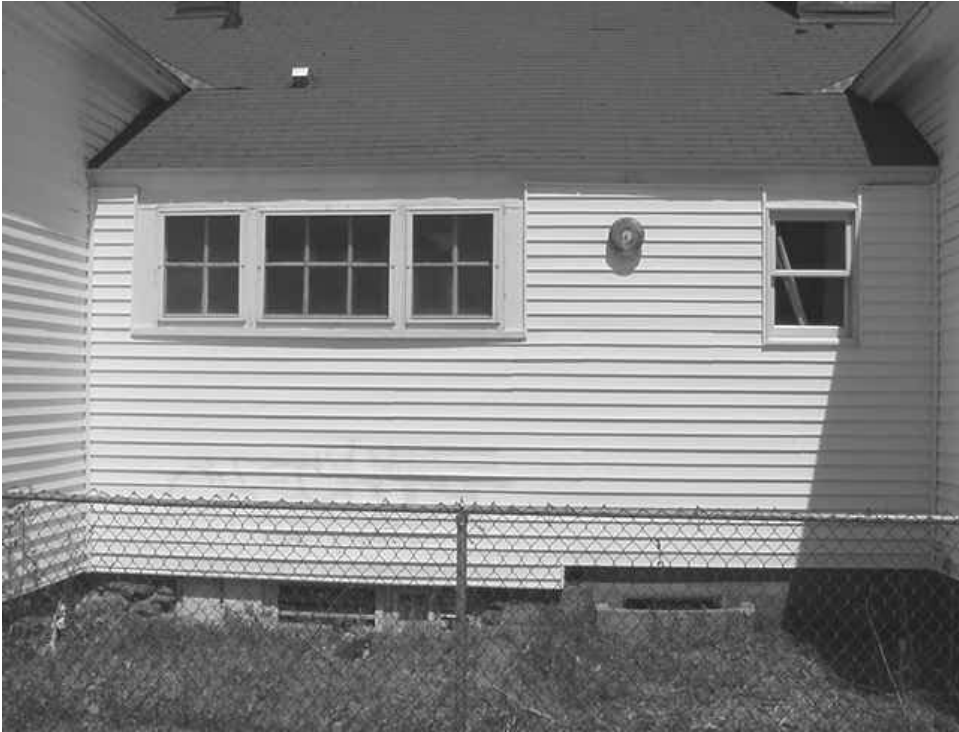
**Picture 13**

**Edge Of Roof Missing Gutters over Crawlspace Vents**

1. Consider installing a gutter/downspout system on the edge of the 1947 and 1960 wings' peaked roofs to direct water away from the base of each wing and its crawlspace vents. The installation of a drainage system may also be necessary to direct water away from the base of the foundation.

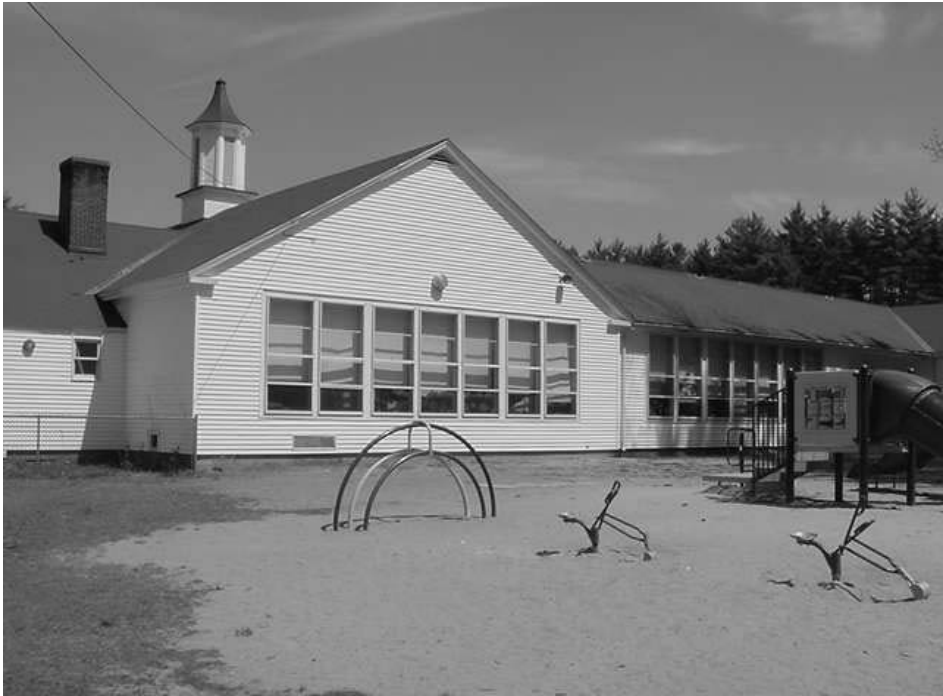
**Picture 14**

**Edge Of Roof Missing Gutters**

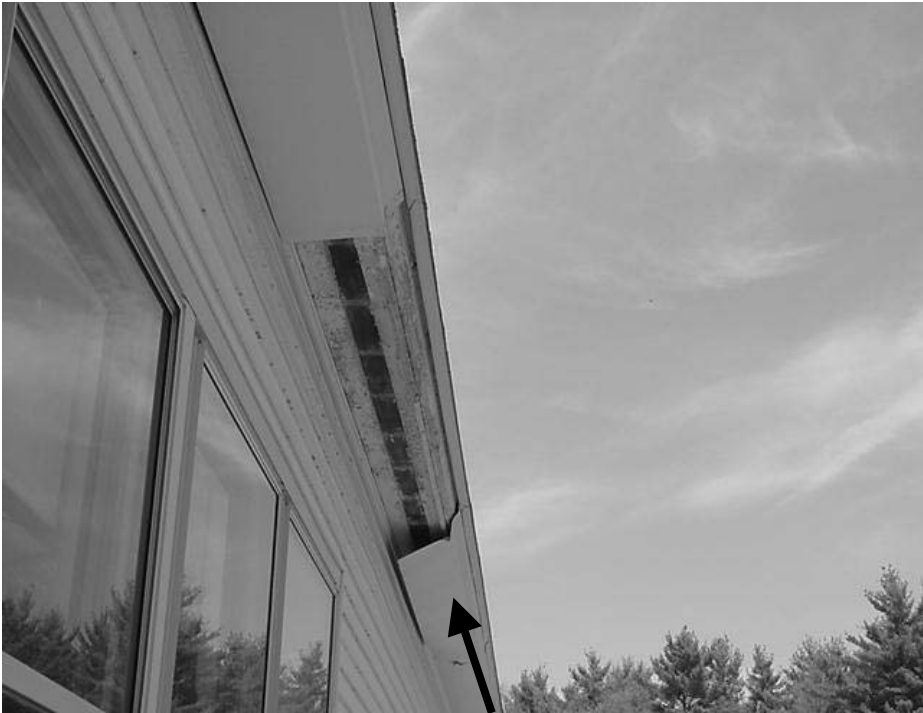
Picture 15

Vinyl Siding Soffit

**Open Section of Vinyl Siding That Reveals Sealed Soffit Vents**

2. Restoration of the soffit vents sealed by the installation of the vinyl siding should be considered to remedy chronic creation of ice dams. The insulation in the crawlspace that has become moistened should be replaced with fresh insulation of a sufficient R-value that will prevent heat loss. Each ridge vent should be examined and repaired if necessary. Please note that any restoration effort must render the vinyl siding installation intact to prevent water penetration between the exterior siding and the original siding. Water accumulation behind vinyl siding can result in mold growth in building materials.

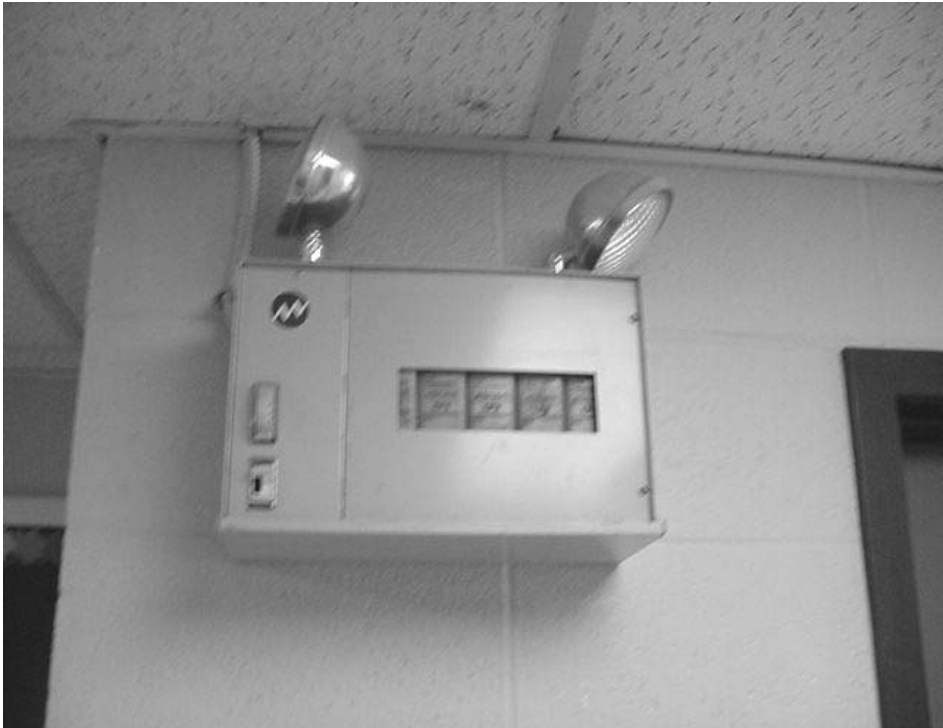
Picture 16

An emergency light was observed in the general library wing hallway (see Picture 16). A battery that requires periodic refilling to maintain its charge powers this emergency light. The battery solution would be expected to be a dilute sulfuric acid solution. This mixture evaporates over time and can form a vapor of sulfuric acid and water. Dilute sulfuric acid can be irritating to the eyes, nose and throat.

**Emergency Light Powered By Acid Battery**

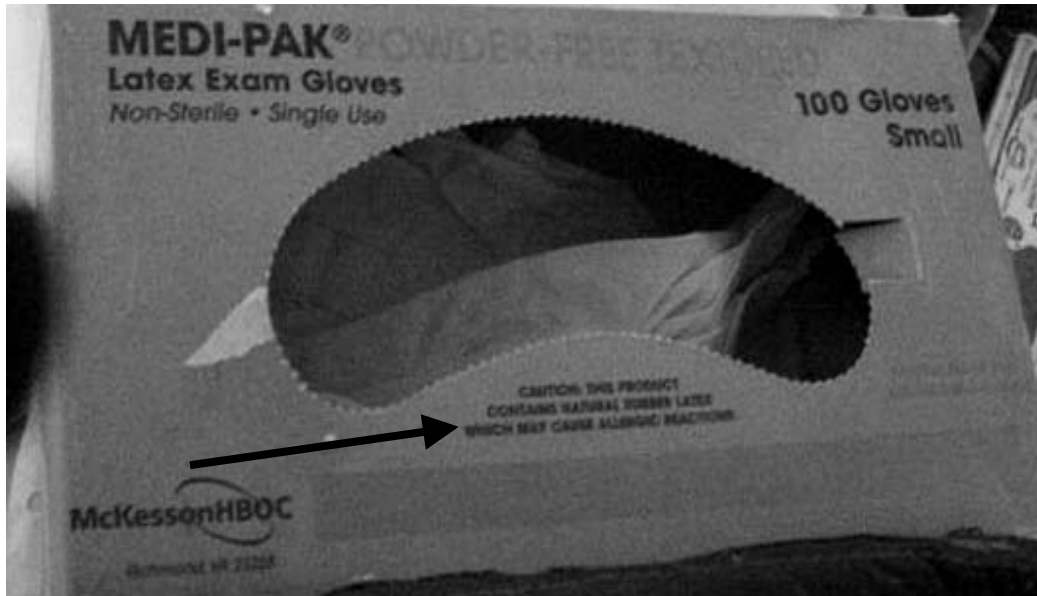
Picture 17

Natural rubber latex gloves were observed in use in the school (see Picture 17). The use of latex gloves aerosolizes proteins that are in glove powder. It is recommended that workers be provided with nonlatex gloves where there is little potential for contact with infectious materials (NIOSH, 1997). A question and answer sheet concerning latex allergy is attached as Appendix A.

Box Of Latex Gloves, Note Warning
