INDOOR AIR QUALITY ASSESSMENT

**Martha M. Burnell Campus School
66 Hooper Street
Bridgewater, Massachusetts**

Prepared by:
Massachusetts Department of Public Health
Bureau of Environmental Health Assessment
December, 2001

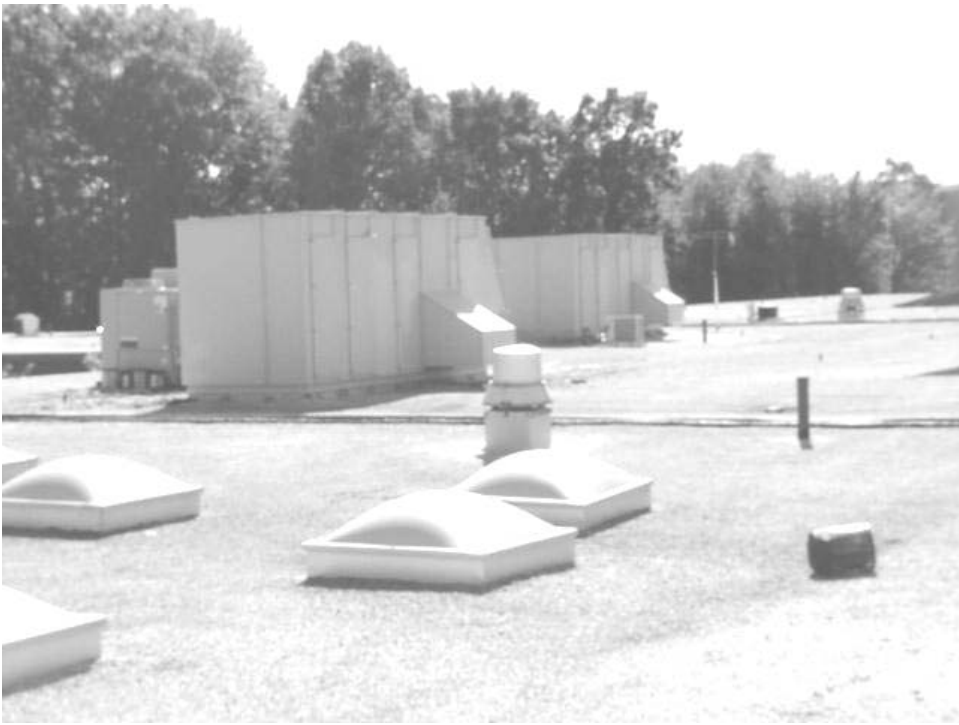
Picture 1

Mechanical ventilation is provided by rooftop air handling units (AHUs), which are ducted to slot air diffusers installed in the drop ceiling to the rear of classrooms (see Pictures 1 & 2). Air is returned to the units via ceiling mounted return grills connected by ducts back to the units. Classrooms are also equipped with a second return vent attached to a variable air volume (VAV) box, which recirculates classroom air once a pre-set temperature is read by the thermostat. Complaints of poor airflow, temperature extremes and stuffiness were reported in the music room, which can indicate a mechanical problem with thermostatic control and/or operation of the VAV box. Rooms 128 A, D and I have fresh air supplies, but no exhaust vents. Lack of exhaust ventilation can result in accumulation of indoors environmental pollutants in these rooms.

Rooftop AHUs

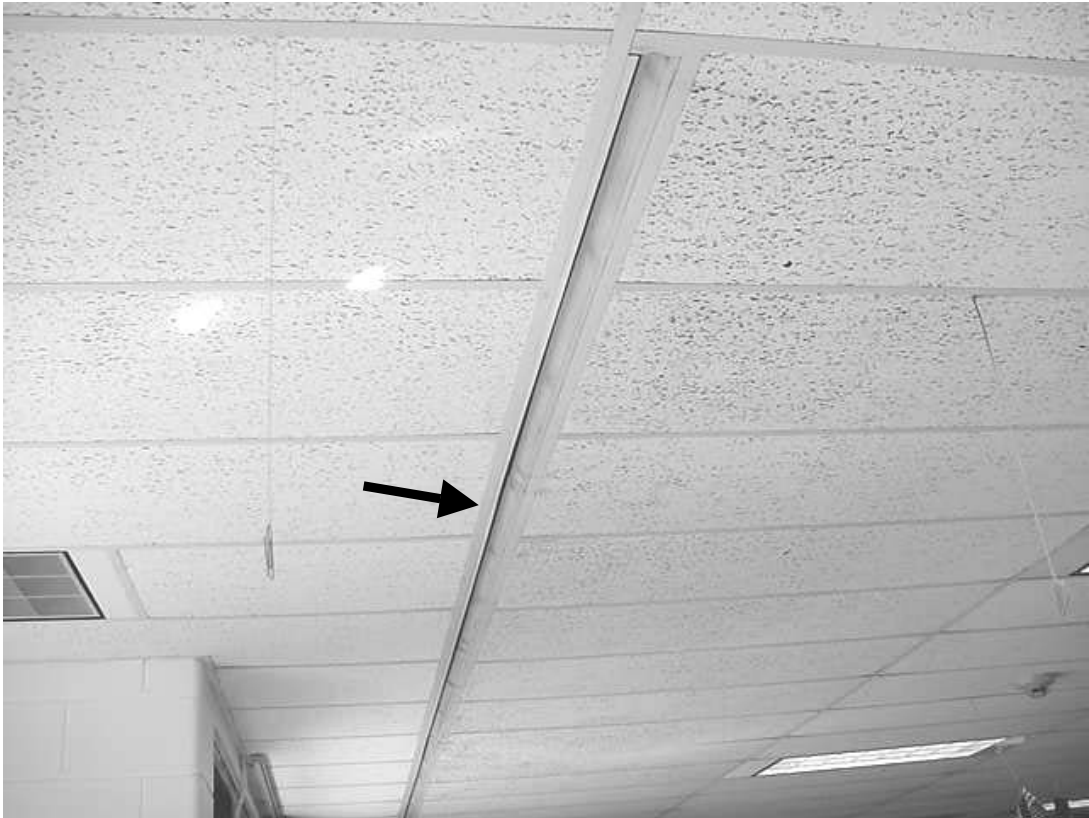
Picture 2

Slotted Air Diffuser in Classroom

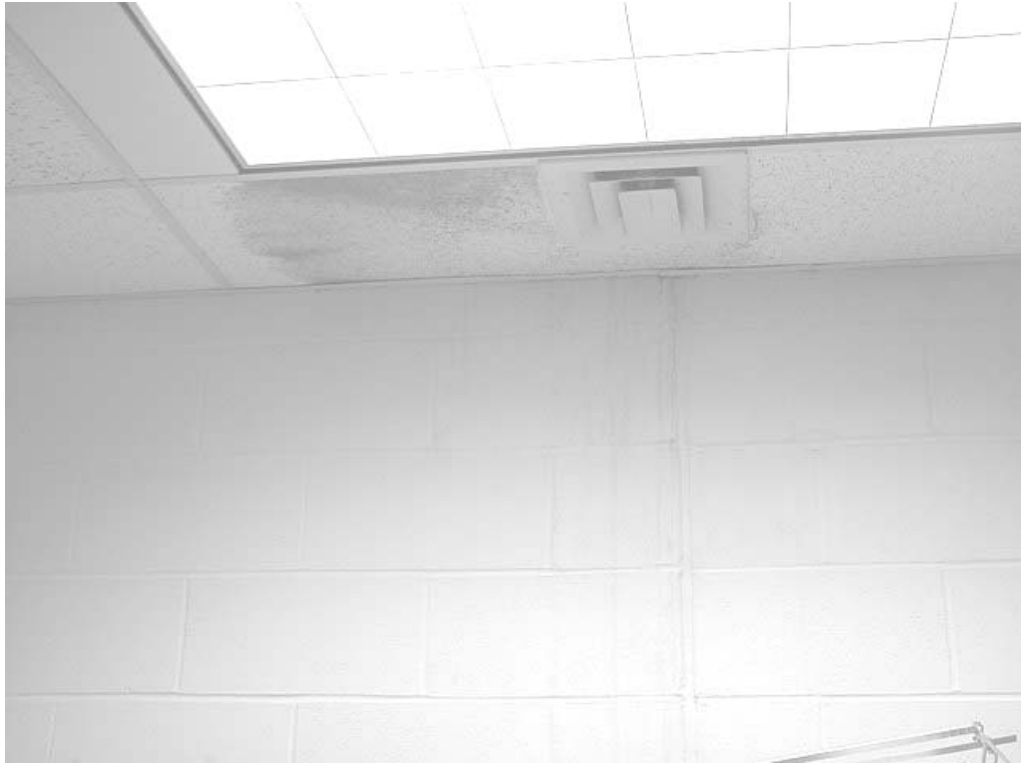
Picture 3

The building has experienced historical roof leaks. Several areas had water damaged ceiling tiles. On-going leaks were reported in the Dean's office file room (128-I) (see Picture 3). Possible mold growth was observed on a ceiling tile in classroom 122 (see Picture 4). Stained ceiling tiles and efflorescence (e.g., mineral deposits) (see Picture 5) in the library also indicate water penetration. Efflorescence is a characteristic

Water Damage Ceiling Tiles in area 128-I Dean's Office File Room, Note Water Stains on Wall

| Location | Carbon Dioxide *ppm | Temp. °F | Relative Humidity % | Occupants in Room | Windows Openable | Ventilation | | Remarks |
|---|---|---|---|---|---|---|---|---|
| Room 128I | 752 | 70 | 31 | 0 | No | Yes | No | Reported roof leak-down wall, carpeting, ductwork reinsulated |

5. Continue to work with roofing contractor to identify and isolate leaks. Once repaired, replace any remaining water-stained ceiling tiles. Examine the areas above and behind these tiles for mold growth. Disinfect areas of water leaks with an appropriate antimicrobial, wipe surfaces with soap and water.

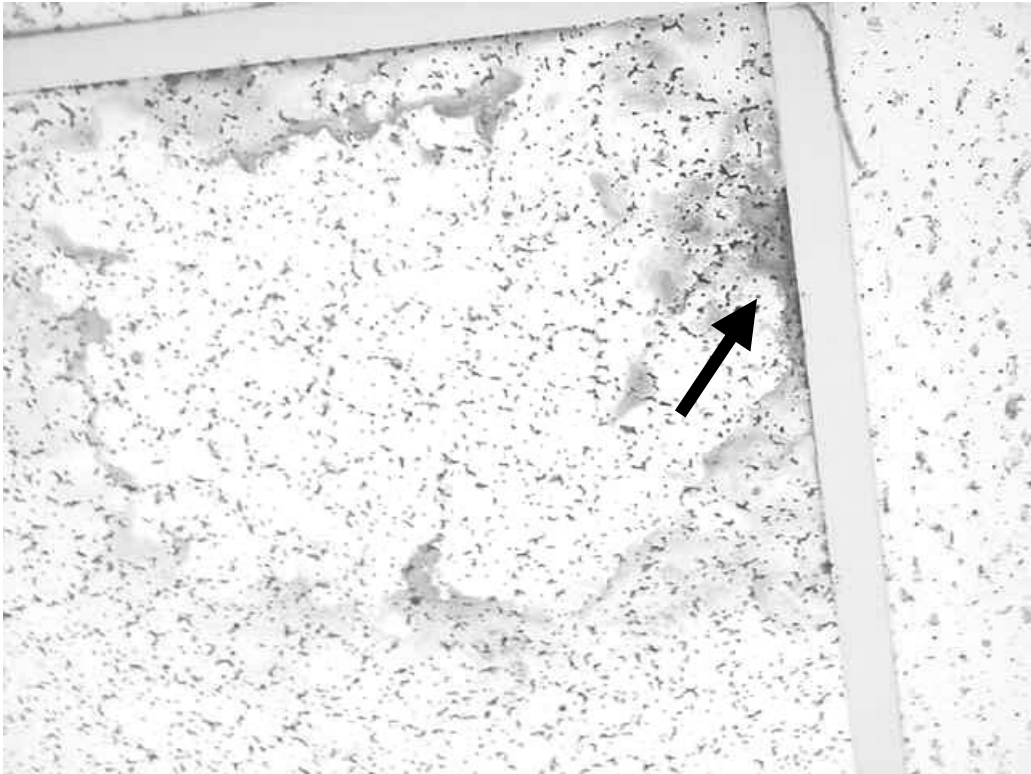
Picture 4

Water Stained Ceiling Tile with Possible Mold Growth in Classroom 122

| Location | Carbon Dioxide *ppm | Temp. °F | Relative Humidity % | Occupants in Room | Windows Openable | Ventilation | | Remarks |
|---|---|---|---|---|---|---|---|---|
| Classroom 122 | 472 | 73 | 25 | 3 | Yes | Yes | Yes | Dehumidifier (full), 2 water damaged CT-possible mold growth, door open |

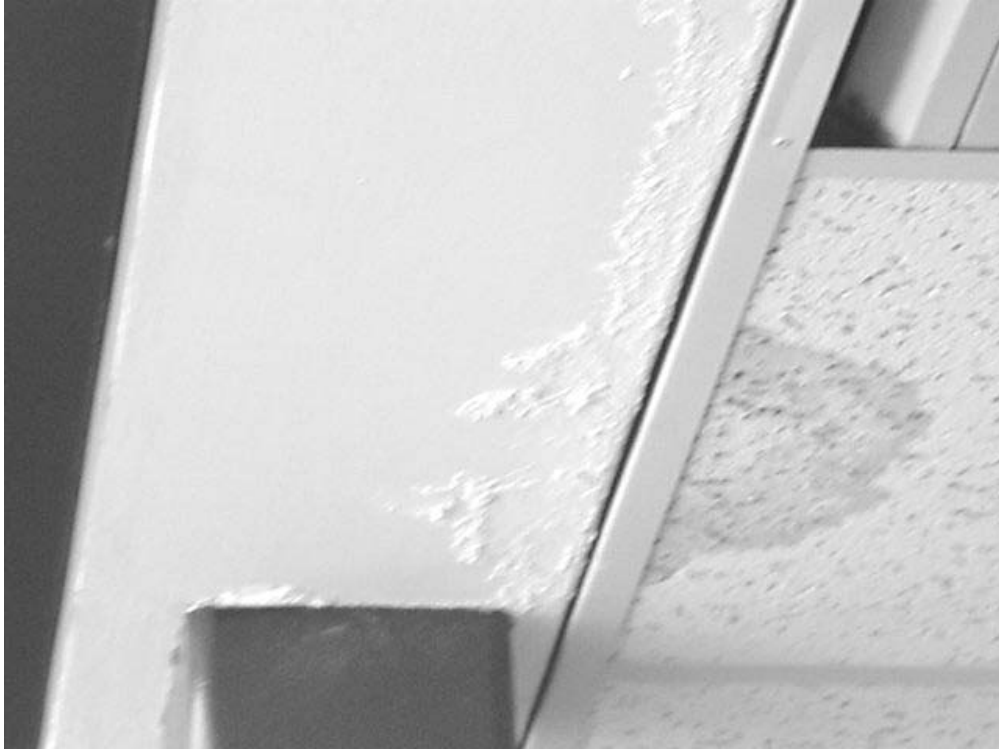
Picture 5

sign of water damage to building materials such as brick or plaster, but it is not mold growth. As moisture penetrates and works its way through mortar around brick, water-soluble compounds in bricks and mortar dissolve, creating a solution. As the solution moves to the surface of the brick or mortar, water evaporates, leaving behind white, powdery mineral deposits. Water-damaged ceiling tiles, wallboard and other porous building materials can provide a source of mold and mildew and should be replaced after a water leak is discovered. Mold can be an eye and respiratory irritant to sensitive individuals.

Efflorescence (e.g., mineral deposits) and Stained Ceiling Tile in Library

| Location | Carbon Dioxide *ppm | Temp. °F | Relative Humidity % | Occupants in Room | Windows Openable | Ventilation | | Remarks |
|---|---|---|---|---|---|---|---|--|
| Library | 613 | 74 | 26 | ~20 | Yes | Yes | Yes | Several water damaged CT, efflorescence near support beam |

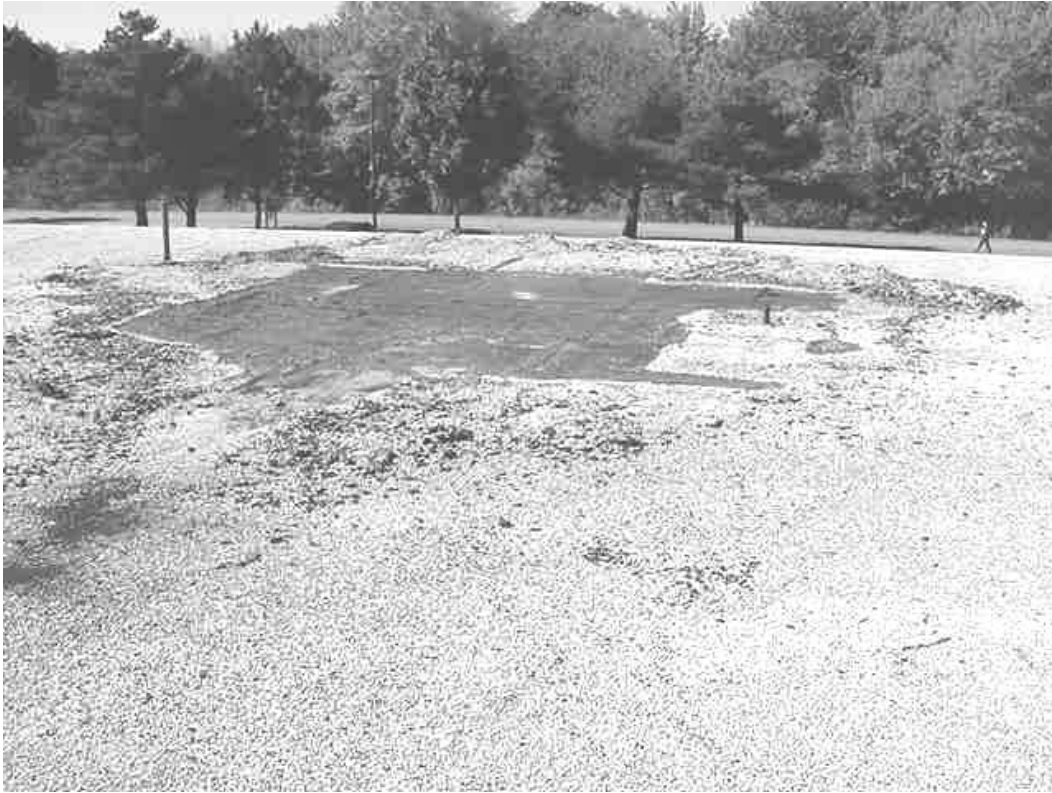
Picture 6

Reportedly, once roof/ceiling leaks are identified, the building's roofing contractor is contacted by building maintenance personnel to determine the origin of and repair the leak. Once leaks are identified and repaired, ceiling tiles are replaced by campus maintenance staff. BEHA staff examined conditions on the roof. Two areas had roof ballast/gravel removed to identify and isolate current leaks (see Picture 6). Replacement of the roof is reportedly on the BSCs deferred maintenance list for future consideration.

Area on Roof Cleared Away to Isolate and Repair Leak

6. Continue with plans for future roof replacement to maintain building envelope integrity.
7. Keep plants away from vents in classrooms. Ensure plants have drip pans and examine drip pans for mold growth. Disinfect areas with an appropriate antimicrobial where necessary.

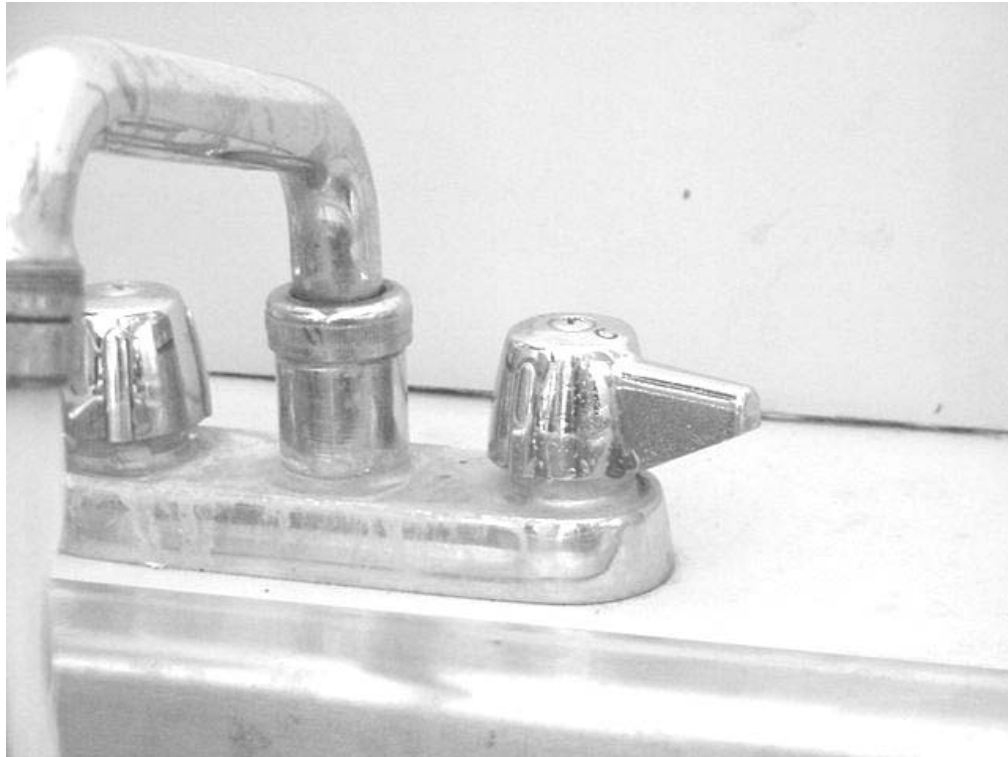
Picture 7

In a number of classrooms, spaces between the sink countertop and backsplash were noted (see Picture 7). Repeated leakage or improper drainage/overflow can lead to water penetration of countertop wood, the cabinet interior and behind cabinets. Like other porous materials, if these materials become wet repeatedly they can provide a medium for mold growth. A pungent odor was noted upon opening the cabinet beneath the sink in classroom 105, emanating from water-damaged contact paper that was

Spaces between Backsplash and Sink Countertop

9. Seal areas around sinks to prevent water-damage to the interior of cabinets and adjacent wallboard. Inspect wallboard for water-damage and mold/mildew growth, repair/replace as necessary. Disinfect areas of microbial growth with an appropriate antimicrobial as needed. Wipe surfaces with soap and water.

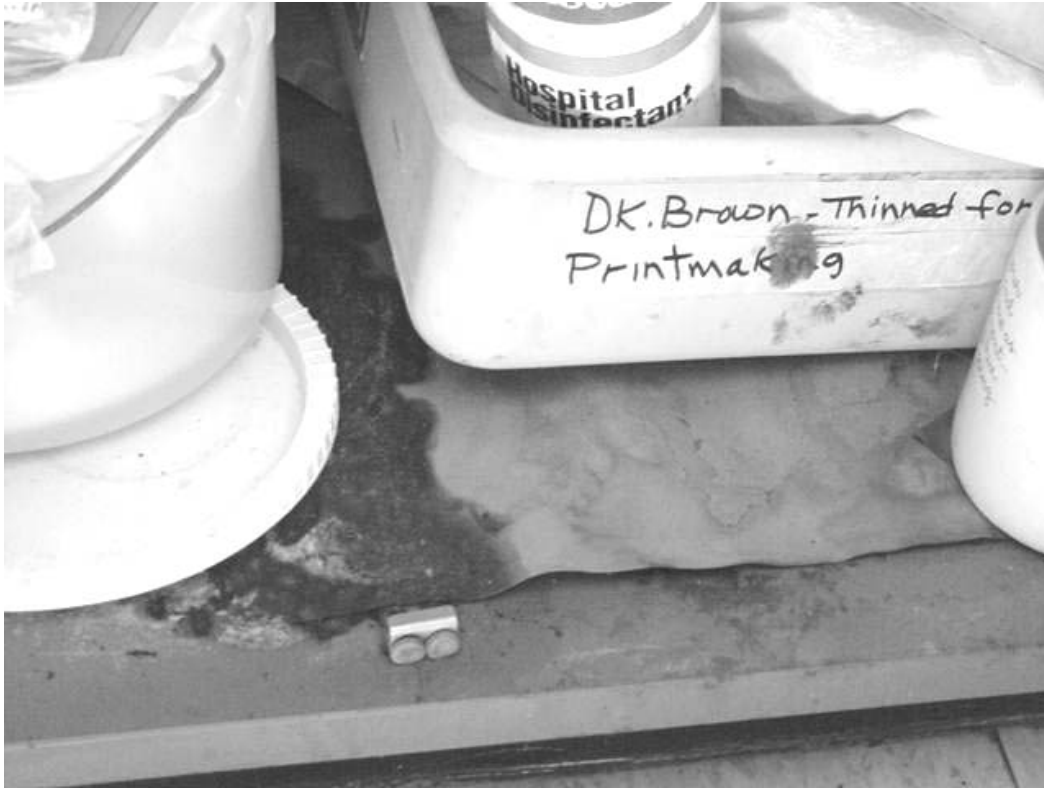
Picture 8

colonized with mold growth (see Picture 8). Porous items (e.g., cardboard and paper) should not be kept beneath sinks. These types of materials should be removed and discarded if moldy.

Mold Colonized/Water-Damaged Contact Paper under Sink in Classroom

| Location | Carbon Dioxide *ppm | Temp. °F | Relative Humidity % | Occupants in Room | Windows Openable | Ventilation | | Remarks |
|---|---|---|---|---|---|---|---|---|
| Classroom 105 | 726 | 72 | 29 | 28 | Yes | Yes | Yes | Water damaged/moldy contact paper under sink, unlabeled spray cleaning product, 3 water damaged CT-corner near hallway door, door open |

8. Remove and discard water-damaged/mold colonized materials beneath sinks in classrooms (e.g., classroom 105). Relocate porous items to a dry environment. Disinfect areas of water leaks with an appropriate antimicrobial, wipe surfaces with soap and water.

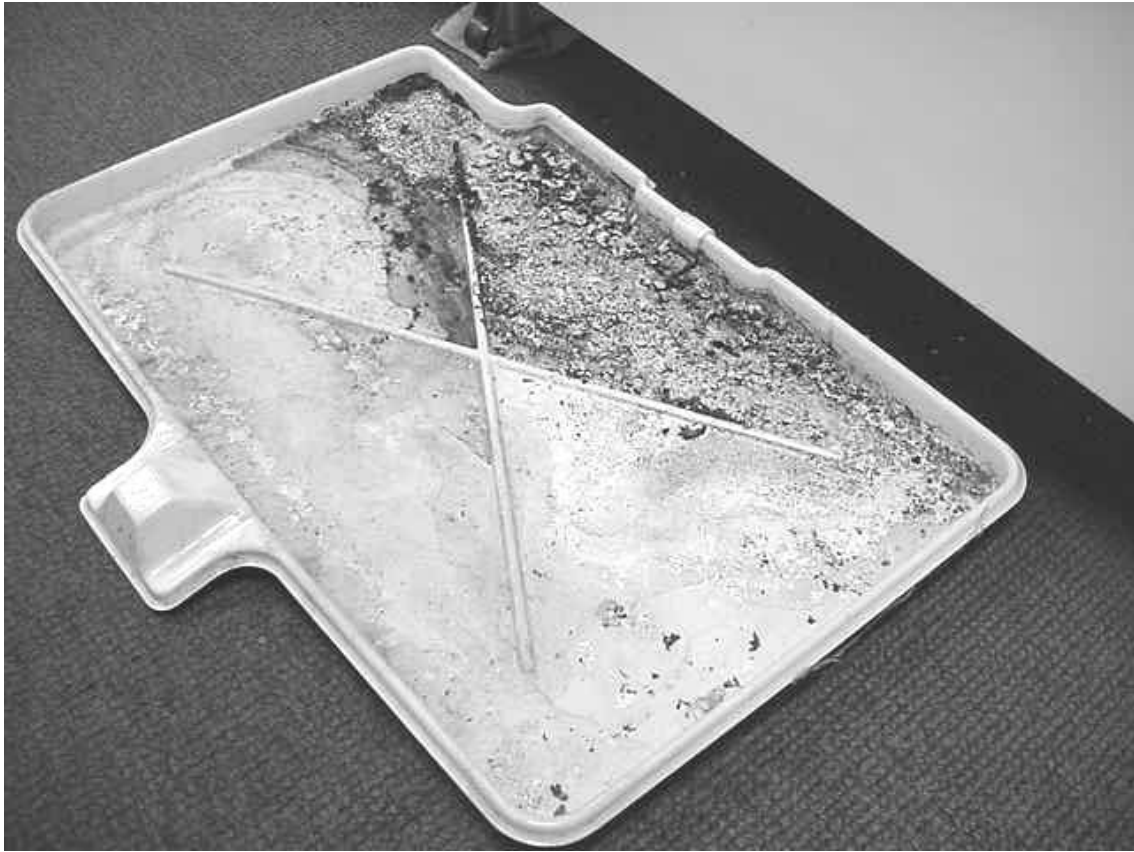
Picture 9

The teacher's lounge contains a refrigerator equipped with a drip pan to catch condensation. BEHA staff removed the drip pan for inspection and found it coated with debris and possible mold growth (see Picture 9). Drip pans should be emptied and cleaned regularly to avoid bacterial/microbial growth and associated odors.

Mold Colonized Refrigerator Drip Pan in Teacher's Lounge

| Location | Carbon Dioxide *ppm | Temp. °F | Relative Humidity % | Occupants in Room | Windows Openable | Ventilation | | Remarks |
|---|---|---|---|---|---|---|---|---|
| Teacher’s Lounge | 660 | 73 | 28 | 0 | No | Yes | | Refrigerator drip pan-dirty/debris/possible mold growth |

12. Clean refrigerator drip pans regularly to prevent microbial growth.
13. Store chemicals and cleaning products properly and out of the reach of students. Ensure all containers are properly labeled for identification in the event of an emergency.

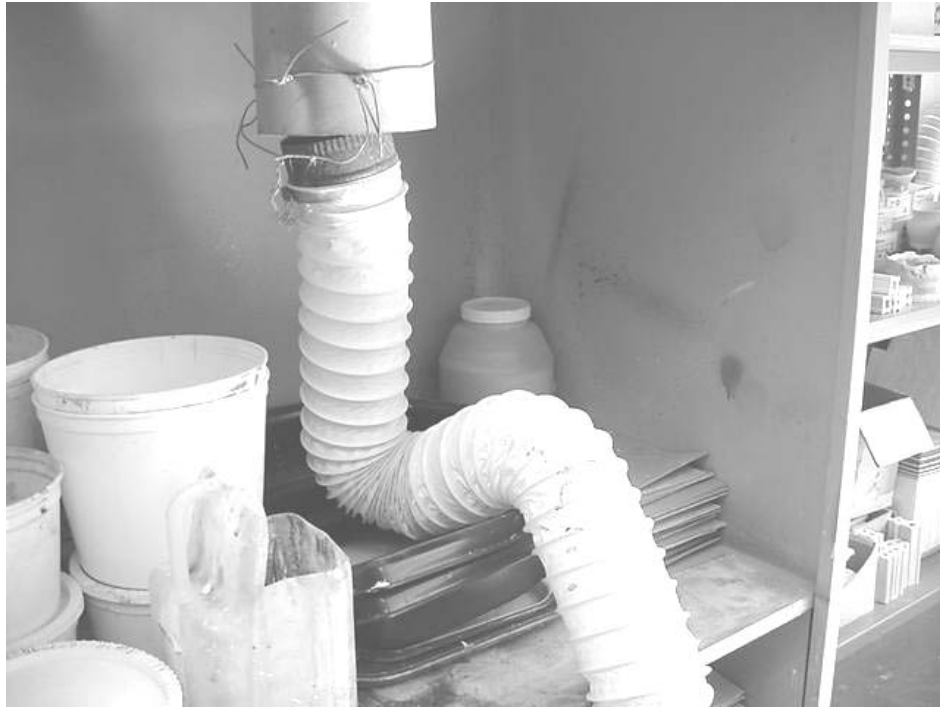
Picture 10

A number of other conditions were noted during the assessment, which can effect indoor air quality. The art room contained a pottery kiln, which was connected to a laboratory vent hood by flexible hose. Pottery kilns can produce carbon monoxide and sulfur dioxide, which can cause respiratory symptoms in exposed individuals. Flexible ductwork connecting the kiln to the vent hood was found pinched at one end (near the vent hood) and damaged at the point where it connects to the kiln (see Pictures 10 & 11).

Operating the kiln with the ductwork in this condition can allow kiln-generated pollutants to enter the classroom.

“Pinched” Flexible Ductwork Venting Kiln out of Laboratory Vent Hood

| Location | Carbon Dioxide *ppm | Temp. °F | Relative Humidity % | Occupants in Room | Windows Openable | Ventilation | | Remarks |
|---|---|---|---|---|---|---|---|---|
| Art Room 123 | 485 | 74 | 24 | 0 | Yes | Yes | Yes | Kiln-flex-ducted into lab hood-flex duct hanger on floor-“pinched” |

14. Discontinue use of pottery kiln until damaged flexible ductwork is replaced.
15. Use IPM to remove pests from the building. A copy of the IPM recommendations is included with this report as Appendix A (MDFA, 1996). Activities that can be used to eliminate pest infestation may include the following activities.

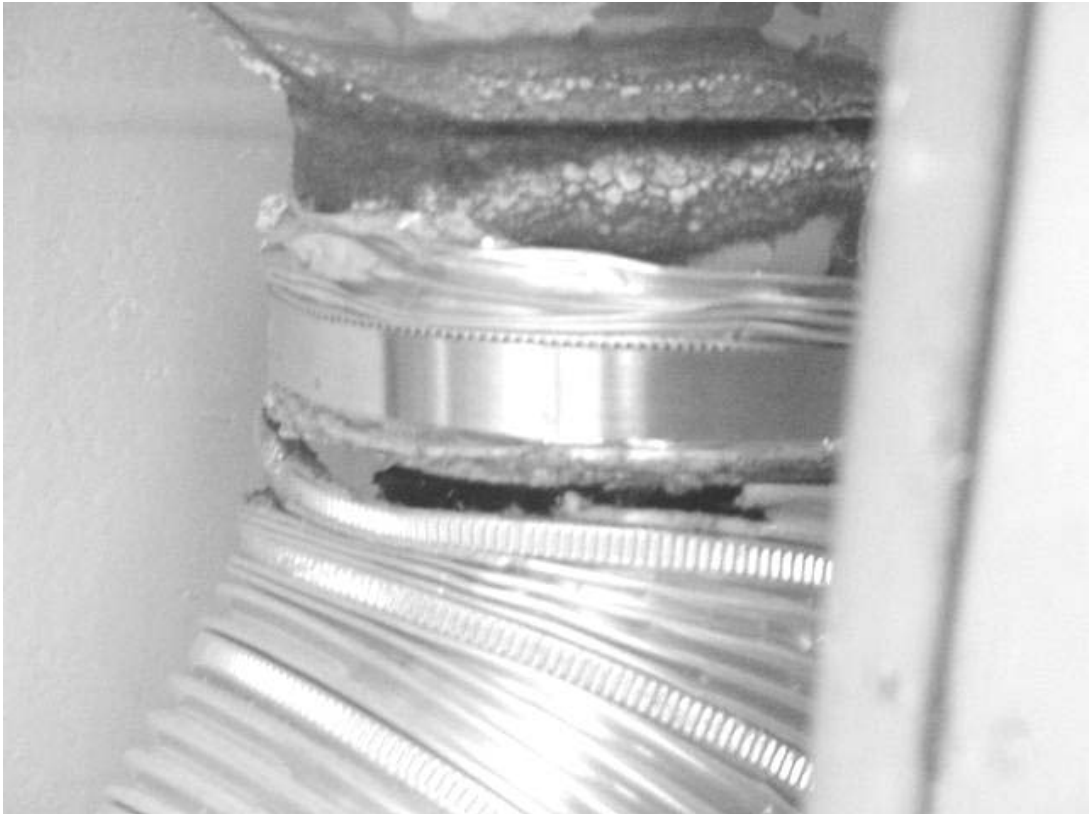
Picture 11

Damaged Ductwork to Kiln

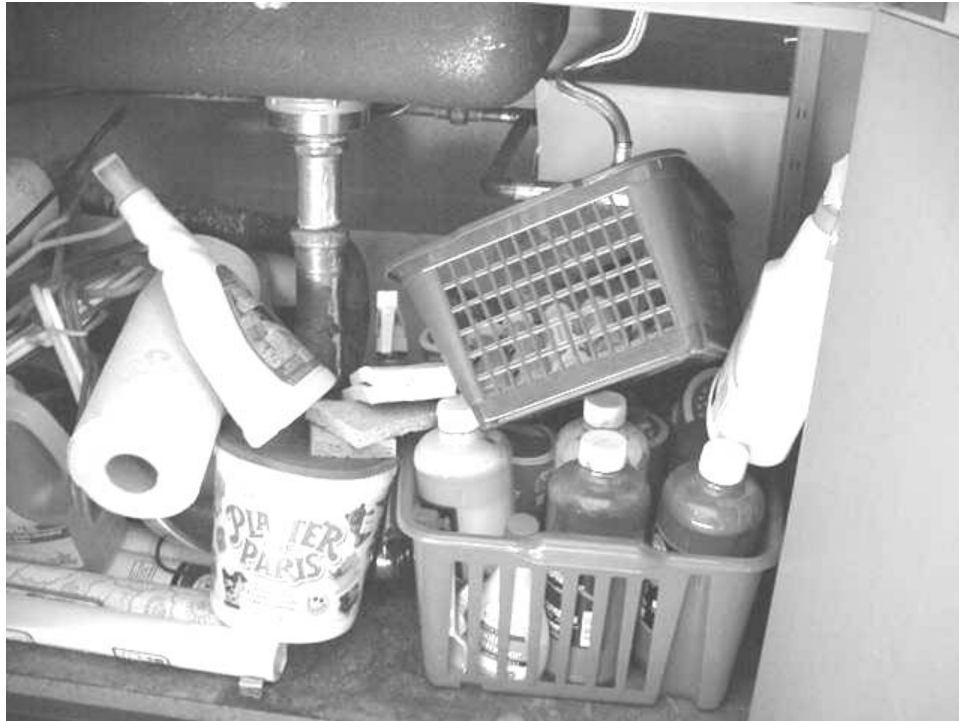
Picture 12

Several classrooms contained dry erase boards and dry erase board markers. Materials such as dry erase markers and dry erase board cleaners may contain VOCs, such as methyl isobutyl ketone, n-butyl acetate and butyl-cellulose (Sanford, 1999). Cleaning products, nail polish remover and other spray products were found on counter tops and underneath sinks in a number of classrooms (see Picture 12). These items should be stored properly and out of reach of students. Cleaning products, dry erase markers and dry erase board cleaners can contain chemicals, which can be irritating to the eyes, nose and throat.

Spray Cleaning Products and Nail Polish beneath Sink in Classroom
