INDOOR AIR QUALITY ASSESSMENT
Supplemental Relative Humidity/Water Penetration Evaluation

Virginia Blanchard Elementary School
65 East Hartford Street
Uxbridge, Massachusetts

Prepared by:
Massachusetts Department of Public Health
Bureau of Environmental Health Assessment
April, 2002

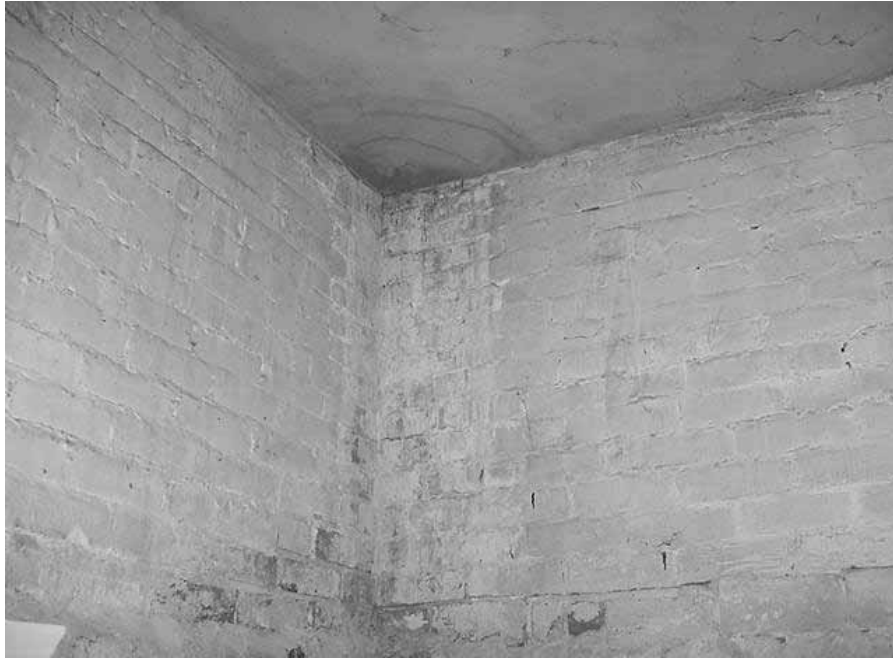
Picture 3

non-detectable. Water damage was noted in foundation wall brickwork in a number of areas of the basement (see Picture 3). Corners of foundation walls have signs of brick deterioration and efflorescence (i.e., mineral deposits), which indicates water penetration. Efflorescence is a characteristic sign of water intrusion. As moisture penetrates and works its way through mortar around brick it leaves behind these characteristic mineral deposits. With moisture entering the basement, porous materials can become wet and serve as growth media for mold. Each of the areas of brick and mortar damage corresponds to the termini of gutter downspouts on the exterior of the building (see Picture 4).

Damaged Brickwork in Storeroom at Southeastern Corner of Building

1. Seal holes in tarmac around the exterior walls
2. Install means to direct rainwater from the base of the building.
3. Repair water damaged mortar and brickwork in the basement.

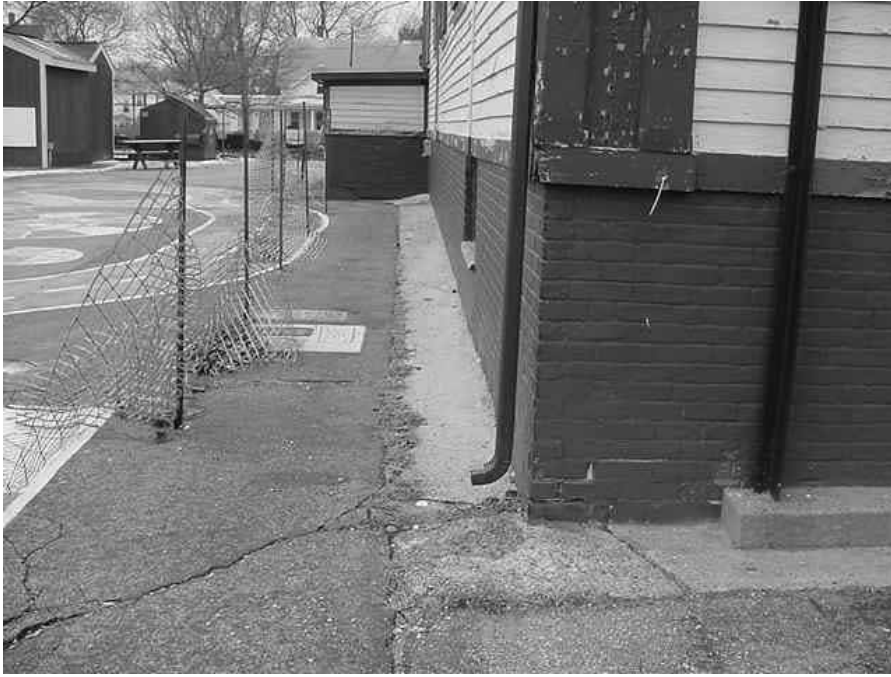
Picture 4

As noted in the previous BEHA assessment, a possible pathway exists for water to penetrate through foundation walls from inadequately drained rainwater. In several areas, downspouts from roof gutters empty at the base of the building into dirt or cracks in pavement. The freezing and thawing action of water during winter months can create cracks and fissures in the foundation. Over time, this process can undermine the integrity of the building and provide a means of water entry into the building through capillary action through foundation concrete and masonry (Lstiburek, J. & Brennan, T; 2001).

Downspout on the Southeastern Corner of Building, Note Cracks in Concrete and Tarmac

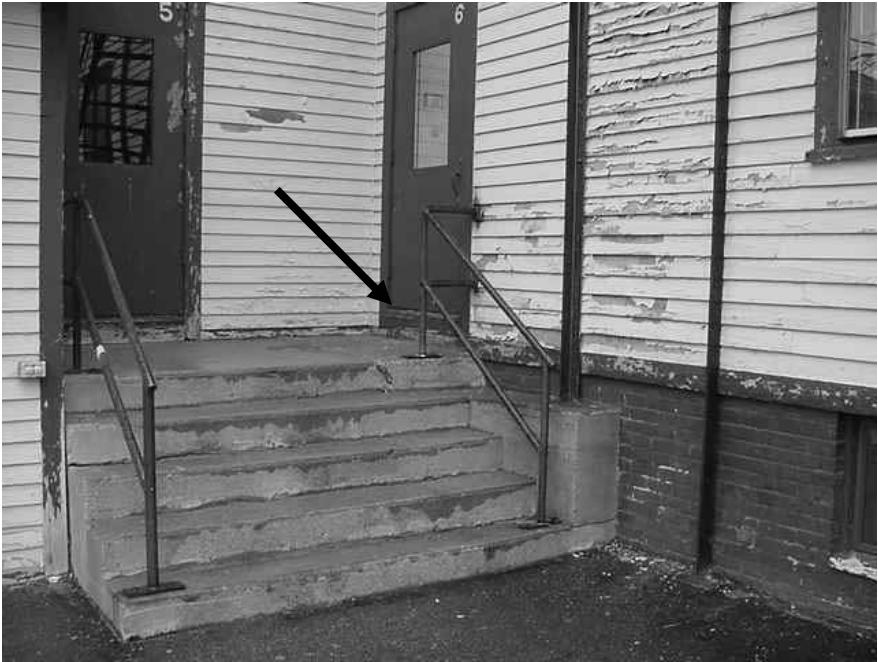
Picture 5

Signs of possible water penetration exist at the top of wood stairs in the back of the building (see Picture 5). These stairs face southwest, which would subject this corner of the building to wind-driven rain during summer months. Wind driven rain can penetrate the wood stair seam and penetrate into the foundation wall.

Water Damaged Wood Threshold
