INDOOR AIR QUALITY ASSESSMENT

**Community Action Head Start
Friends Meeting House
124 Friend Street
Amesbury, Massachusetts**

Prepared by:
Massachusetts Department of Public Health
Bureau of Environmental Health Assessment
June, 2002

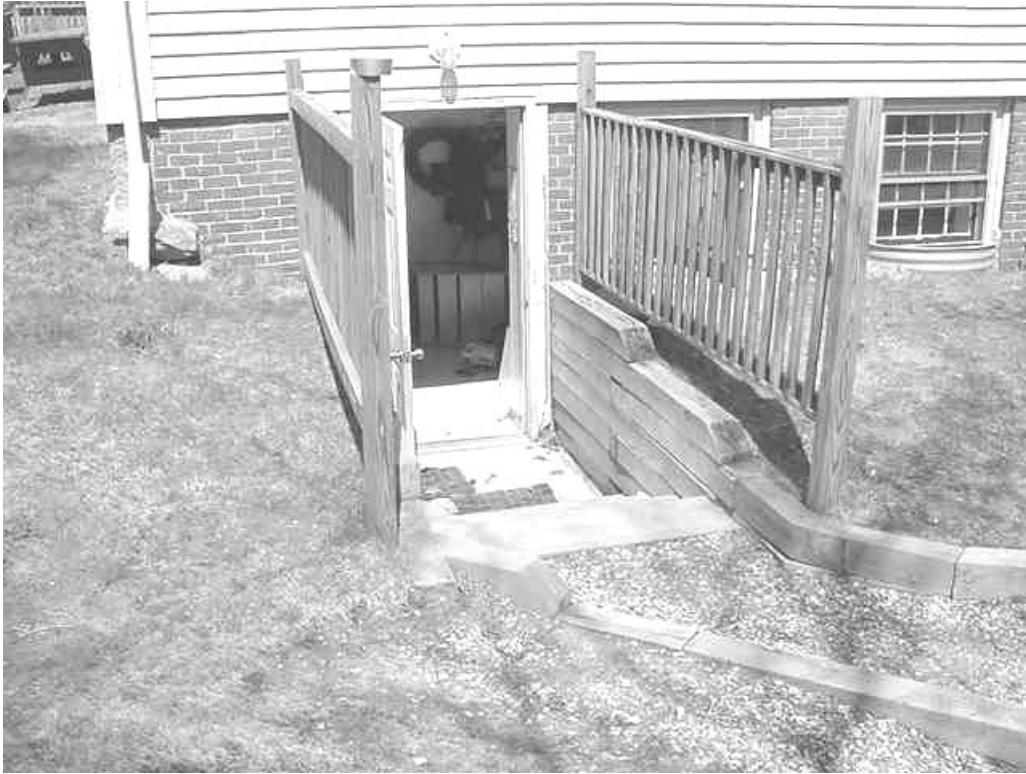
Picture 1

As reported by Mr. Lynch, the basement was flooded as a result of heavy rainfall (approximately 3-4 years ago). A contractor was hired to clean and dry the carpeting. Shortly after, a french drain was installed in the stairwell directly in front of the basement door (see Pictures 1 & 2) to prevent flooding. No flooding has been reported since the drain was installed. Although work was conducted to clean and dry carpeting, gypsum wallboard (GW) remained wet, resulting in mold growth in the mechanical room.

Entrance to Basement Head Start, Where Flooding Occurred

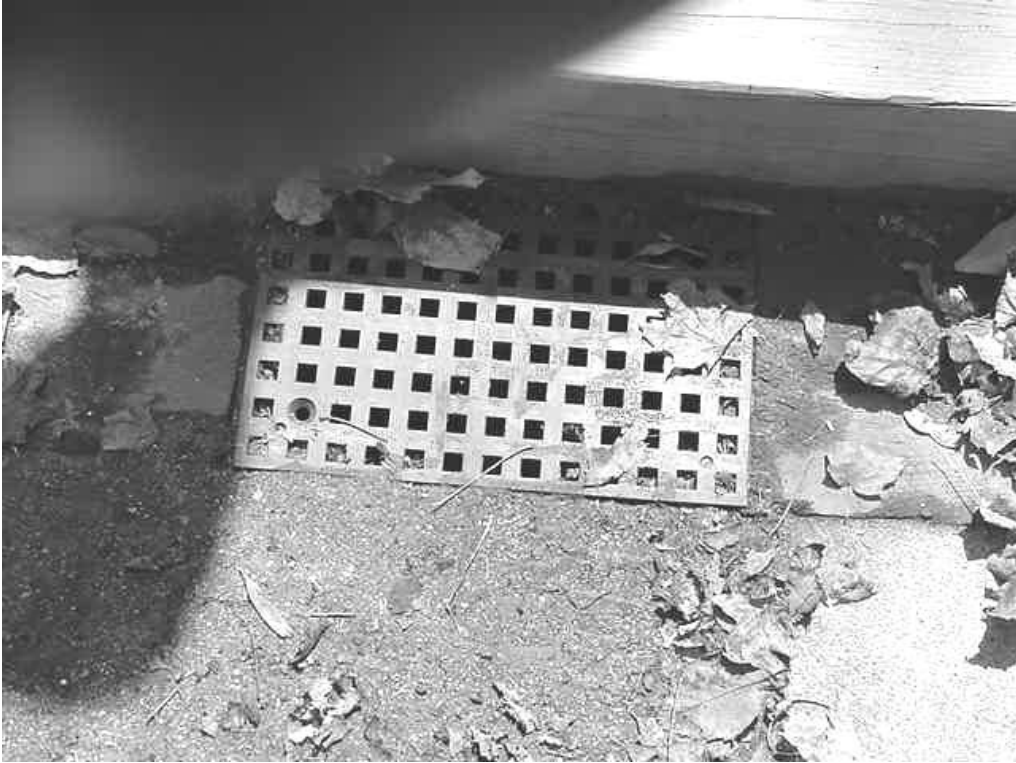
Picture 2

French Drain Installed to Prevent Flooding of Basement

4. Once mold contaminated GW is removed from the interior of the mechanical room, examine the interior of the wall cavity for water damaged building materials and mold growth. If additional water damaged building materials are colonized with microbial growth, remove. Disinfect areas of water leaks/microbial growth with an appropriate antimicrobial.
5. Once repairs are completed, change filters and operate mechanical ventilation system 48-72 hours prior to reoccupation.
6. Continue to monitor drainage system for proper function, report any flooding/water damage to building owner for prompt remediation

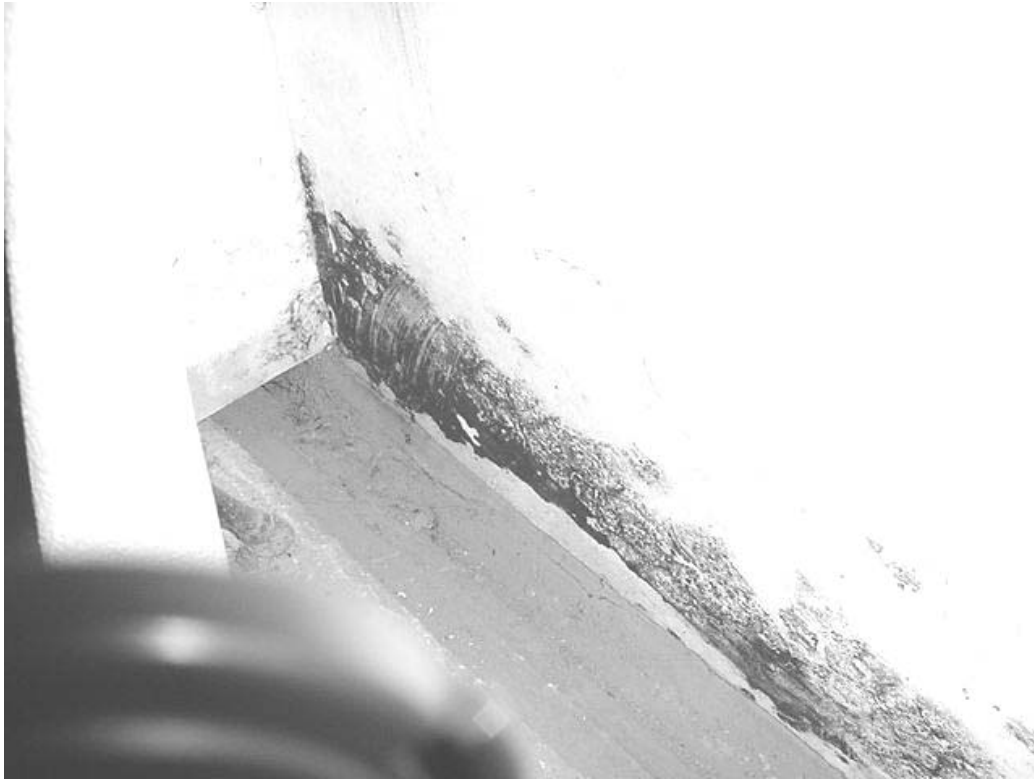
Picture 3

A number of moisture measurements were taken of GW at varying heights (i.e. three feet, two feet, and six inches above the floor respectively), as well of baseboards/wooden wall trim near floor level. Visual inspection suggested substantial mold growth of GW inside the mechanical room approximately 6-12 inches above the floor on all four walls (see Picture 3). (As indicated by written correspondence from John Cuneo, the microbial growth was sampled by a consultant and verbally reported as *Stachybotrus* [CAI, 2002]).

Visible Mold Colonies on GW in Mechanical Room

1. Remove and replace all mold contaminated GW in the mechanical room as well as mold colonized/water damaged wooden trim along floors in the entrance hallway. This measure will remove actively growing mold colonies that may be present. This work should be conducted at a time when occupants are not present in the area. Contain the area where contaminated materials are removed to prevent the spread of dust and mold spores. It is recommended that the AHU in the mechanical room as well as the hallway door leading into the classroom be sealed with plastic sheeting and duct tape; and that local exhaust ventilation be employed to place the mechanical room under negative pressure to prevent mold spores and associated materials from migrating into adjacent areas.

2. Once work is completed, ensure that the area is thoroughly cleaned and disinfected with an appropriate antimicrobial. Dust and particulates resulting from renovation efforts should be vacuumed with a high efficiency particulate arrestance (HEPA) filtered vacuum cleaner.

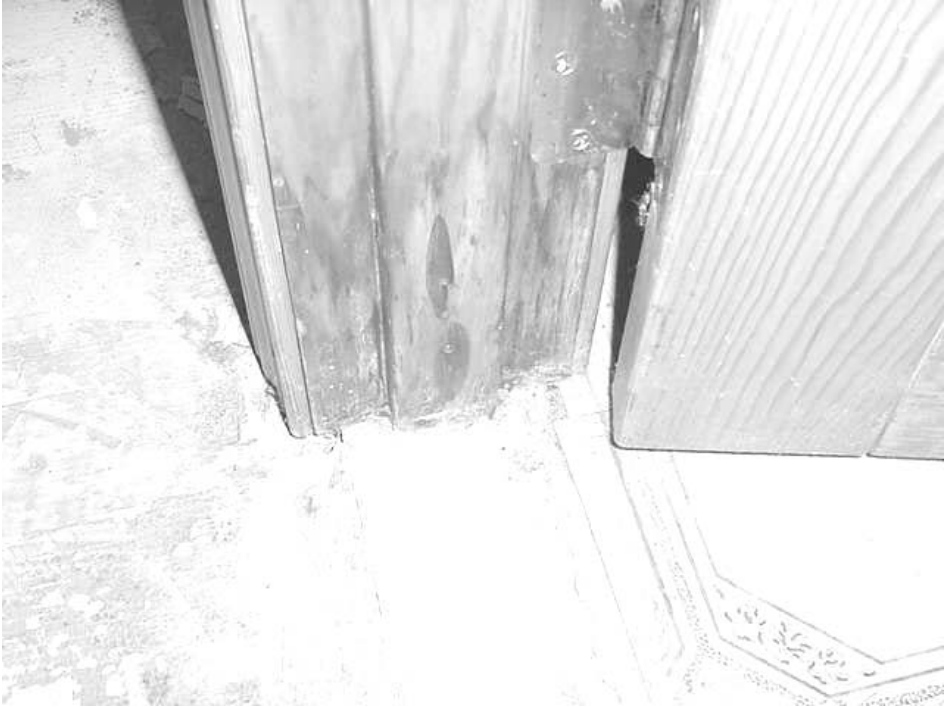
Picture 4

in the fall of 2001. Wood trim at floor level had dark staining in a number of areas (see Pictures 4 & 5), which appeared to be water damage and/or possible mold growth. In addition, the mechanical room was being used for storage of a number of porous items such as tissue paper and cardboard boxes (see Picture 6), which if wet can also provide mediums for microbial growth.

Water Damaged Wood Trim

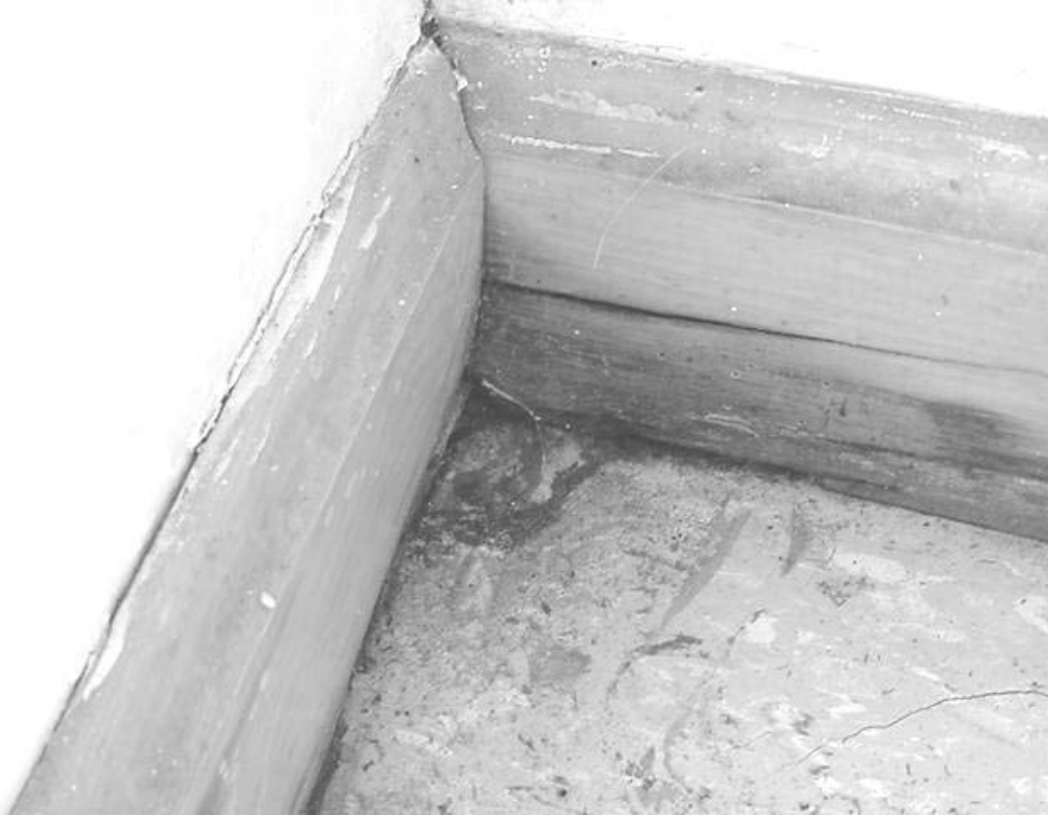
Picture 5

Water Damaged Wood Trim

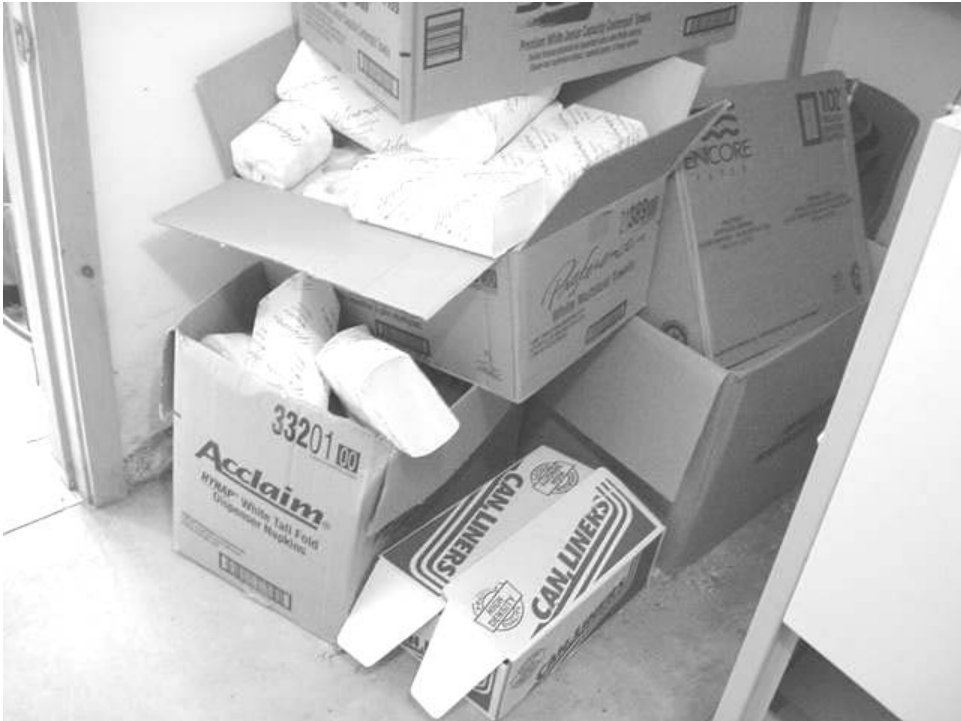
Picture 6

Porous Materials Stored in Mechanical Room

3. Inspect porous items stored in the mechanical room and discard if moldy.
