INDOOR AIR QUALITY ASSESSMENT

**Lunenburg Town Hall
17 Main Street
Lunenburg, Massachusetts**

Prepared by:
Massachusetts Department of Public Health
Bureau of Environmental Health Assessment
Emergency Response/Indoor Air Quality Program
January 2003

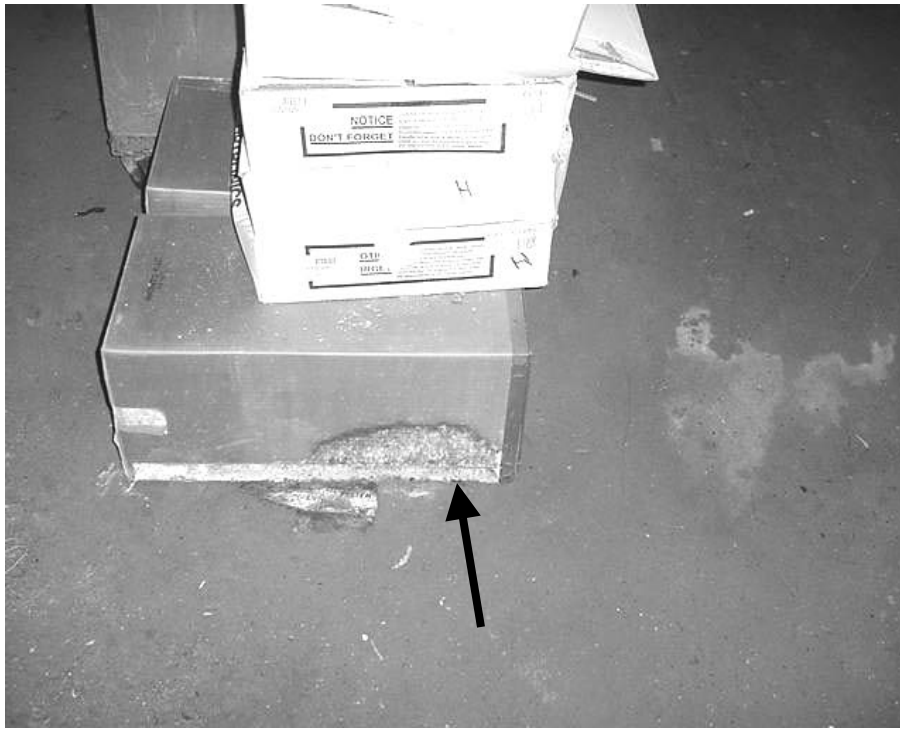
Picture 1

The basement is used for storage of large amounts of materials, including cardboard and paper products. If these materials are subjected to high relative humidity conditions without drying for several days, these materials can become colonized by fungi (mold). Some materials were stored in cardboard boxes that were placed on the dirt floor. This method of storage resulted in mold contamination of the boxes (see Picture 1) and most likely, the stored contents. As noted previously, relative humidity measurements in the basement were 24 percent higher than the relative humidity measured outdoors (49%). Increased temperature indoors, as measured in this building, would be expected to have lower relative humidity compared to outdoors. The increase in relative humidity may indicate that a moisture source exists in the building. Several possibilities were examined:

Basement with Dirt Floor, Note Mold Colony on Box

1. Seal the vent to the basement AHU. Consider installing fresh air supply ductwork for this AHU.
2. Seal all spaces around utility pipes.
3. Do not store porous materials on the dirt floor of the cellar.

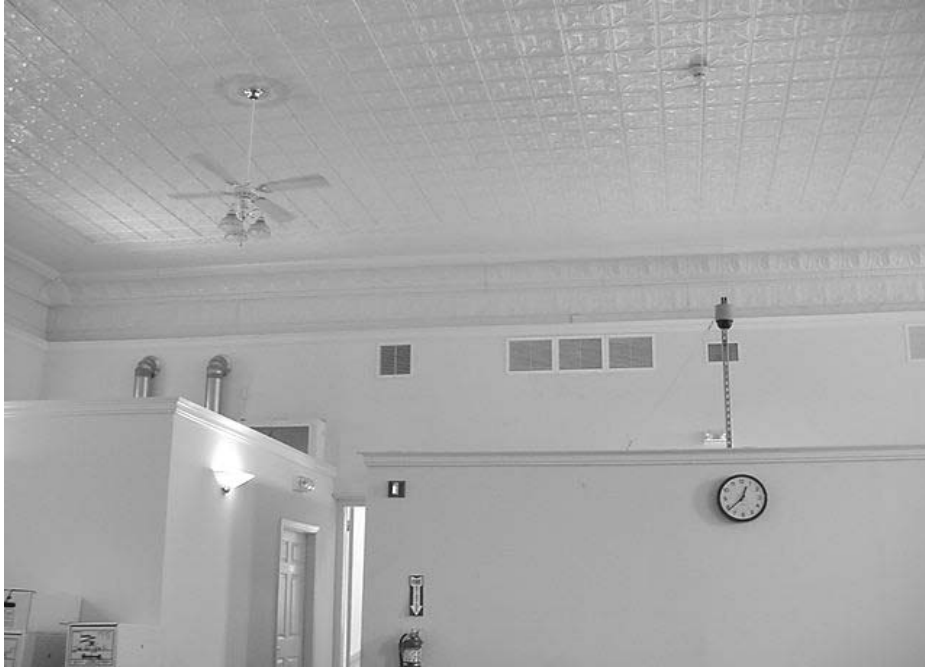
Picture 2

Air is supplied to the second floor by an air handling unit (AHU) located in the attic. The attic AHU provides conditioned air to offices and the auditorium by a combination of ceiling and wall-mounted air diffusers connected via ductwork (see Picture 2). Air returns to the AHU through wall-mounted exhaust grilles via ductwork. The first floor is provided with ventilation from an AHU located in the basement. The attic AHU does not appear to be designed to have mechanical ventilation that will exhaust air from the second floor. This system appears to recirculate air within the LTH second floor. With the lack of exhaust ventilation, pollutants that exist in the interior space will not be diluted and will build up and remain inside the office.

Second Floor Fresh Air Supply Vents

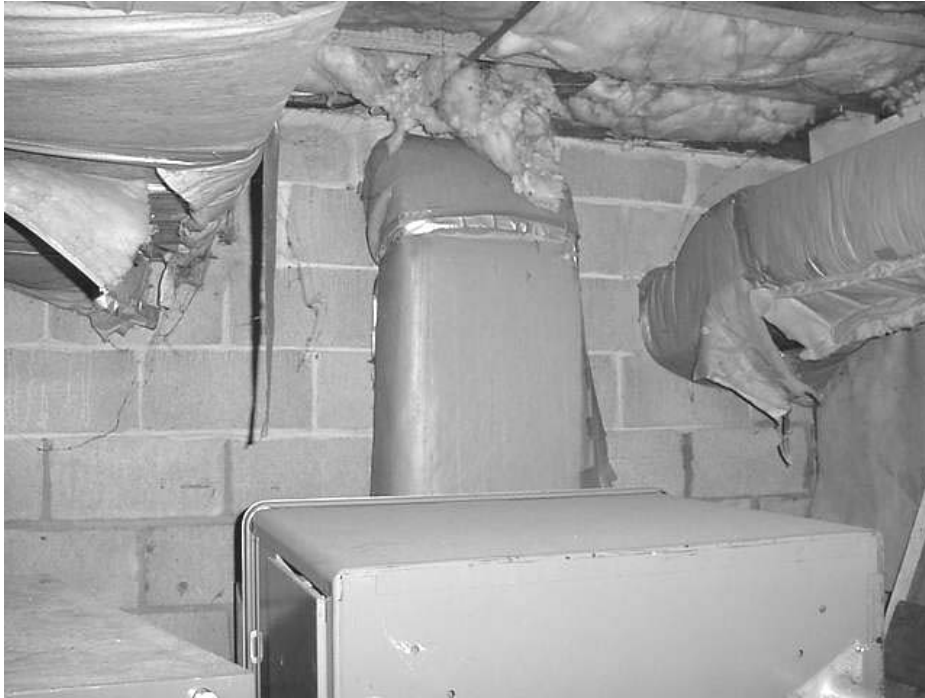
Picture 3

AHU through wall-mounted exhaust grilles via ductwork. This AHU appeared to be deactivated during the assessment. The basement AHU also does not appear to be designed to have mechanical ventilation that will provide fresh air or to exhaust air from this office space. A duct appears to draw air from another duct located behind file cabinets (see Picture 3). With the lack of a fresh air supply, pollutants that exist in the interior space will not be diluted and will build up and remain inside the office. In addition, pollutants *from the basement* may be captured by this AHU and distributed into occupied areas.

Air Intake for Basement AHU Located behind File Cabinet in Basement

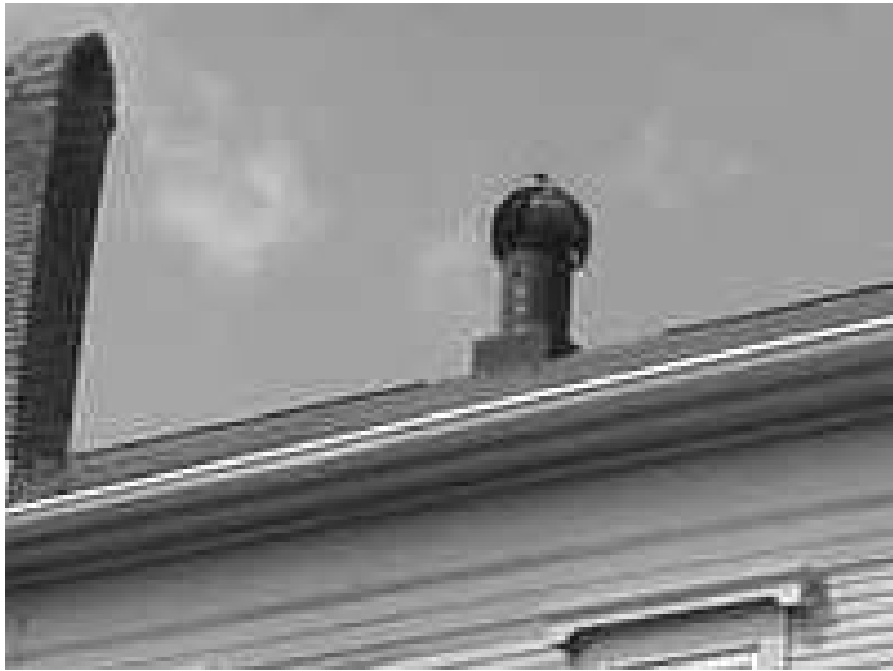
Picture 4

Exhaust ventilation ductwork was identified in the attic, which appear to be connected to a turbine vent on the roof of the LTH (see Picture 4). These ducts are likely connected to wall mounted grilles on the first floor. A louver located inside the duct controls airflow. A heating element is usually located above the louver that creates airflow via rising heat called “the stack effect”. Under these circumstances, it appears that the building does not have a functioning exhaust ventilation system. Without exhaust ventilation, normally occurring environmental pollutants can build up and lead to air quality/comfort complaints.

Turbine Exhaust Vent On Roof

1. Consideration should be given to repairing the original exhaust ventilation system for the first floor. Consult a ventilation engineer to determine whether existing ductwork can be restored.
2. Consider installing a gutter/downspout system on the edge of the peaked roofs of the addition to direct water away from the base of the building.

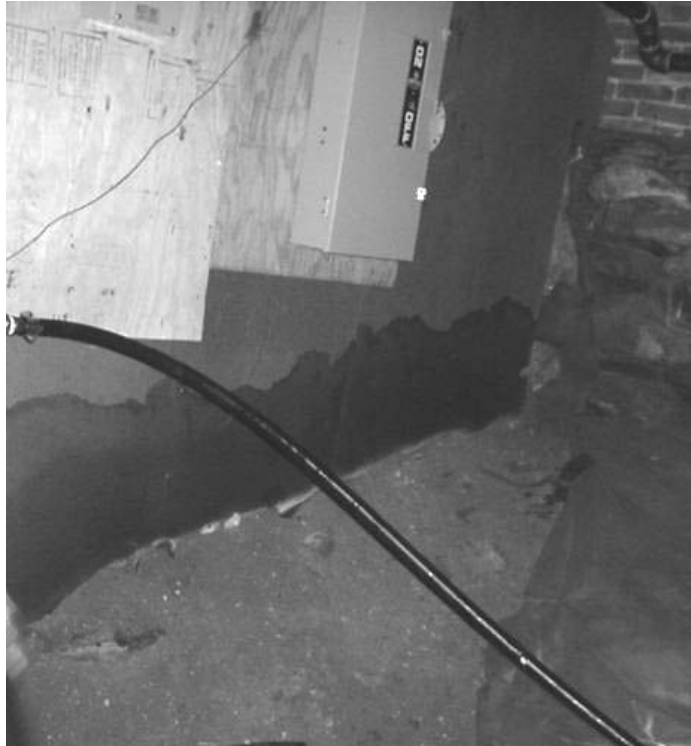
Picture 5

2. No means exists for venting the basement to remove water vapor. If water penetrates through the foundation, moisture may accumulate in the basement. In an effort to improve energy efficiency, fiberglass insulation was affixed to the foundation walls, sealed within a wall material (See Picture 5, note the large water stain on the base of the wall). It appears the purpose of the insulation is to prevent air penetration and heat loss through the foundation. The paper on the insulation can support mold growth if wetted. The installation of insulation also prevents natural ventilation of the crawlspace that can lead to the accumulation of water vapor.

Wall Material Enclosing Fiberglass Insulation on Foundation, Note Size of Water Stain

9. Consider removing the stained wall material and fiberglass insulation along foundation. Remove this material a manner consistent with US EPA recommendations for mold remediation (US EPA, 2001).

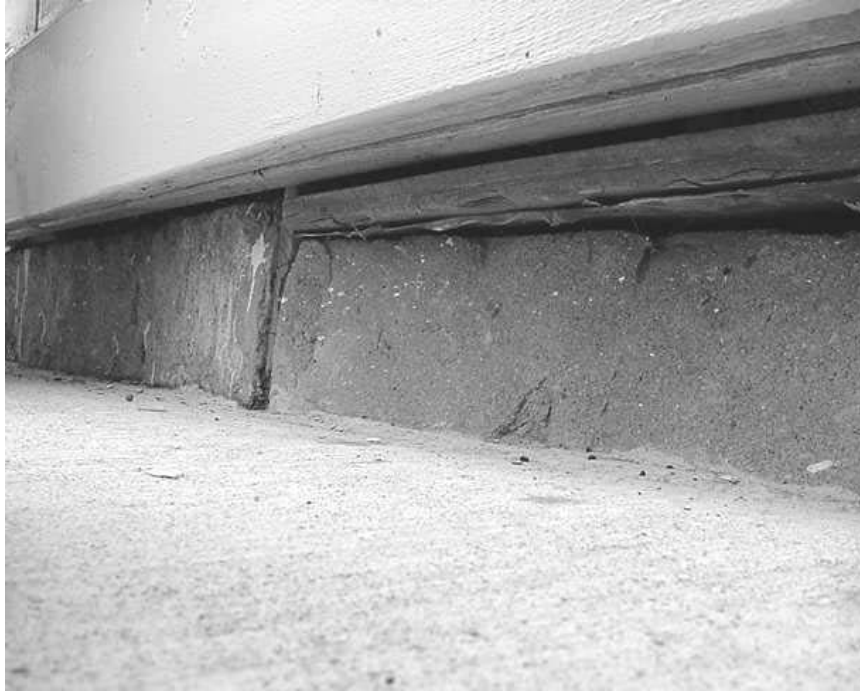
Picture 6

3. An unsealed opening in the foundation exists at sidewalk level (see Picture 6), which is likely an abandoned coal chute opening. The cellar showed signs of repeated water penetration (see Picture 7). It is likely that wet weather systems with an easterly wind will drive water against the foundation and through this opening.

Opening In Foundation along Sidewalk

4. Keep the door to the basement closed. Install weather stripping and a door sweep on this door to create an airtight barrier.
5. Seal the former coal chute to prevent further water damage.

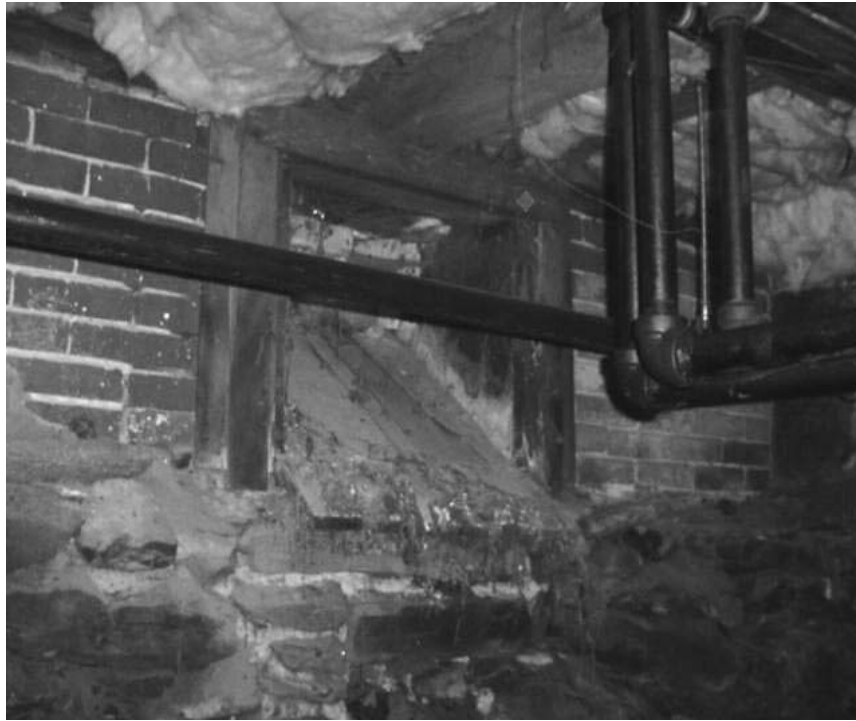
Picture 7

Interior View of Former Coal Chute, Note Heavy Water Damage

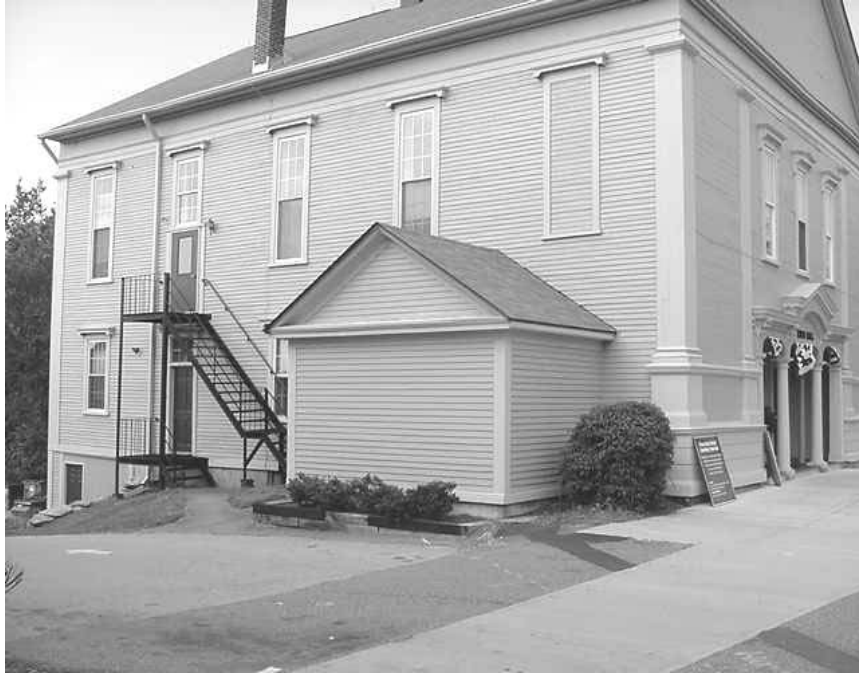
Picture 8

4. Enhancing water pooling is the addition to the south wall of the LTH (see Picture 8). The vault has a peaked roof. No gutter or downspout system exists on the edge of this peaked roof. Rainwater runs off the roof onto the ground at the base of the building. This runoff has created a trench parallel to the base of the front wall of the vault, which allows rainwater and melting snow to pool against the

- foundation and the exterior wall of this wing. Excessive exposure to water can result in water penetration into the cellar along the addition slab.
5. Shrubbery exists in close proximity to the foundation walls (see Picture 8). The growth of roots against the exterior walls can bring moisture in contact with wall brick and eventually lead to cracks and/or fissures in the foundation below ground level. Over time, this process can undermine the integrity of the building envelope and provide a means of water entry into the building through capillary action through foundation concrete and masonry (Lstiburek, J. & Brennan, T.; 2001).

The Addition, Note Shrubbery and Lack of Gutters/Downspout of Roof Edge

8. To prevent moisture penetration into the basement, the following actions should be considered:
 - a) Move foliage to no less than five feet from the foundation.

- b) Improve the grading of the ground away from the foundation at a rate of 6 inches per every 10 feet (Lstiburek, J. & Brennan, T.; 2001).
 - c) Install a water impermeable layer on ground surface (clay cap) to prevent water saturation of ground near foundation (Lstiburek, J. & Brennan, T.; 2001).

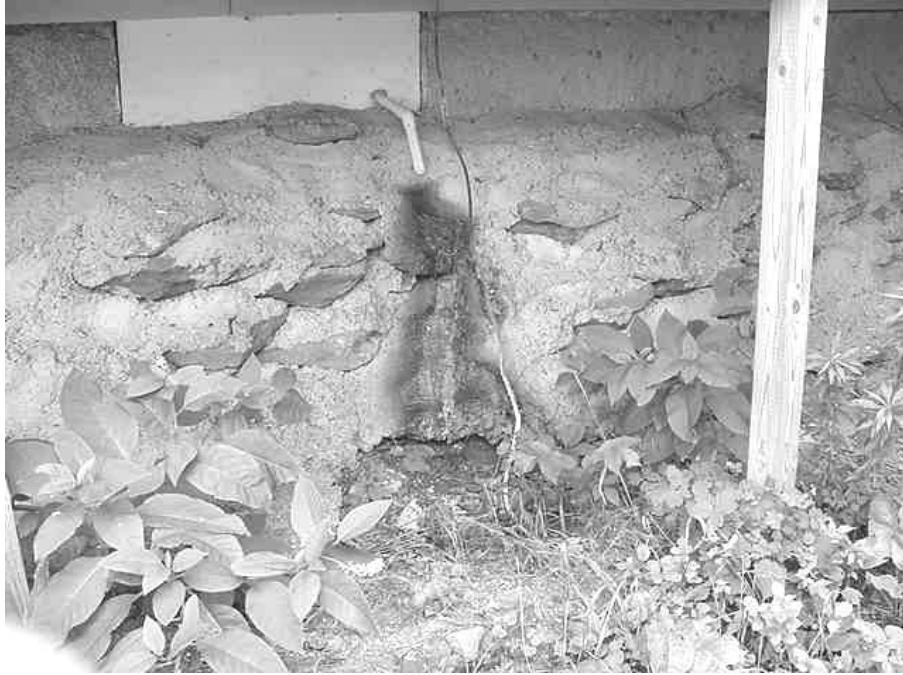
Picture 9

6. A condensation drain for the building empties onto the foundation wall (see Picture 9). This configuration moistens masonry, which may then penetrate through the wall into the basement.

Condensation Drain That Empties onto Foundation

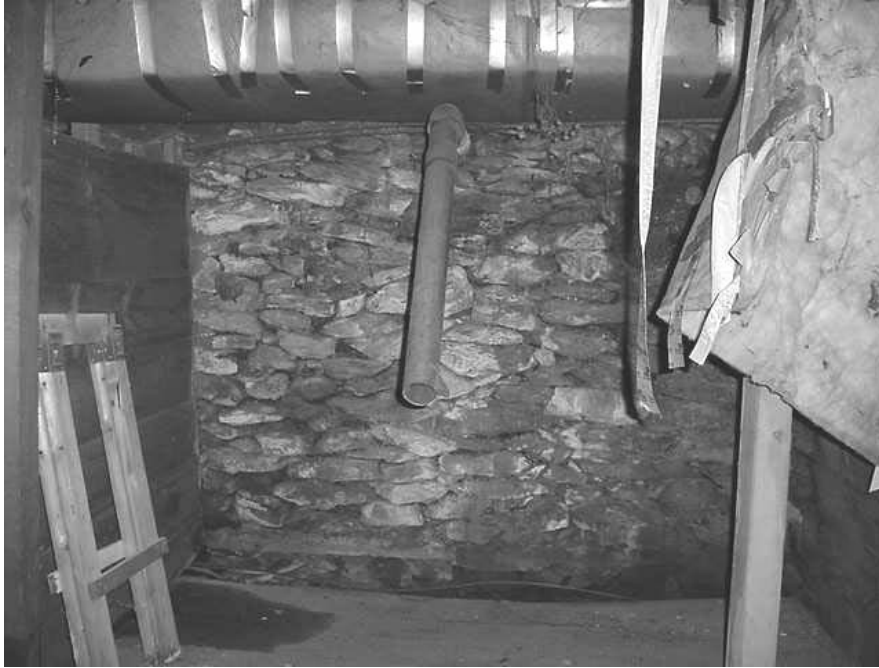
Picture 10

7. A former gutter downspout pipe was identified in the slab of the addition. It could not be determined where this pipes is connected. Several open-ended pipes exist in the basement (see Pictures 10 and 11). The purpose of these pipes could not be determined, nor whether each is connected to a former rainwater drainage system.

Open Pipe in Basement

10. Seal the former gutter drain hole in the addition slab.
11. During a rainstorm, determine if rainwater drains from the pipes shown in Pictures 10 and 11. If these pipes drain rainwater, a system of water collection

- and pumping from the cellar should be considered. If these pipes do not drain rainwater, seal/cap these and all other drain pipes in the basement.
12. Remove mold colonized materials stored from the basement where practical. Disinfect non-porous surfaces with an appropriate antimicrobial.
 13. For buildings in New England, periods of low relative humidity during the winter are often unavoidable. Therefore, scrupulous cleaning practices should be adopted to minimize common indoor air contaminants whose irritant effects can be enhanced when the relative humidity is low. To control for dusts, a high efficiency particulate arrestance (HEPA) filter equipped vacuum cleaner in conjunction with wet wiping of all surfaces is recommended. Avoid the use of feather dusters. Drinking water during the day can help ease some symptoms associated with a dry environment (throat and sinus irritations).

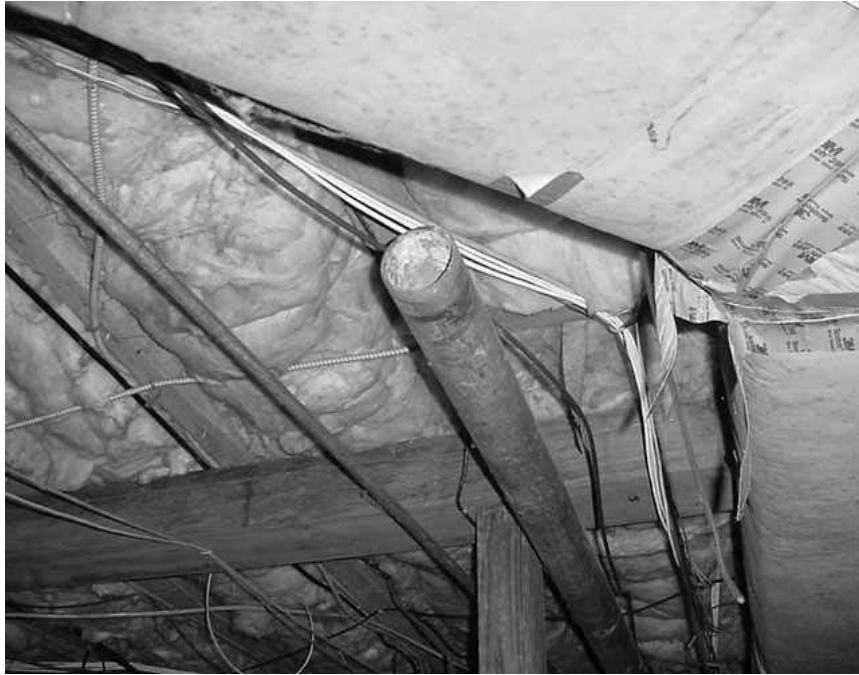
Picture 11

Another Open Pipe in the Basement

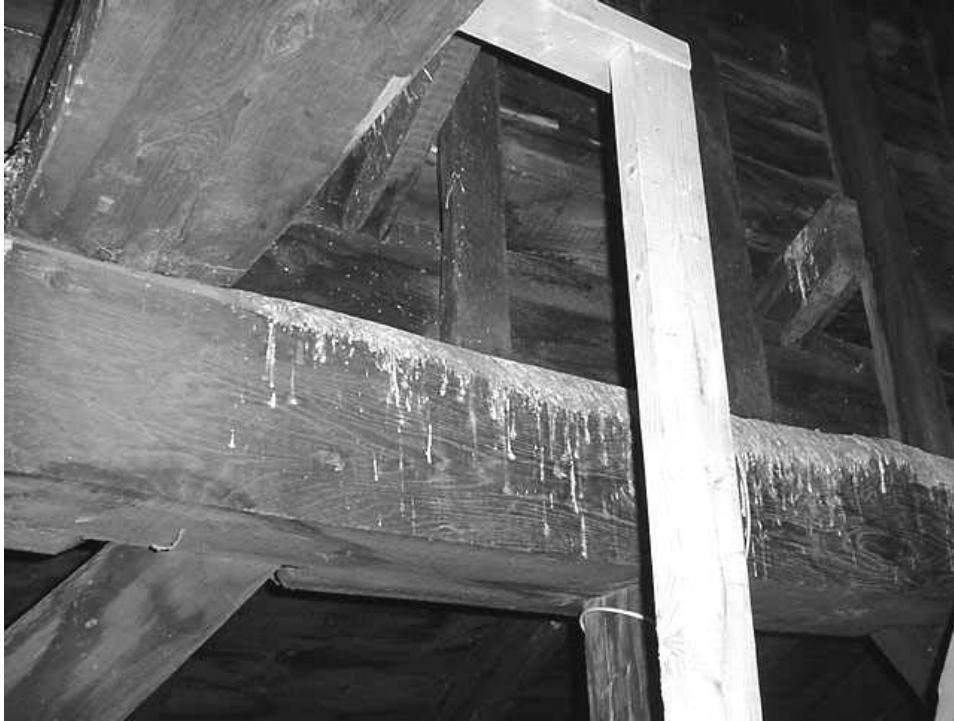
Picture 12

As reported by Mr. Londa, the attic became a pigeon roost, resulting in a large deposition of bird waste. Efforts were made to clean this area, however significant amounts of bird waste residue exists on beams (see Picture 12), plaster lathe (see Picture 13) and other surfaces (see Picture 14). Birds in a building raise concerns over diseases that may be caused by exposure to bird wastes. These conditions warrant clean up of bird waste and appropriate disinfection. Certain molds (*Histoplasma capsulatum*) are associated with bird waste (CDC, 2001; NIOSH, 1997) and are of concern for immune compromised individuals. Diseases of the respiratory tract may also result from exposure to bird waste. Exposure to bird wastes is thought to be associated with the development of hypersensitivity pneumonitis in some individuals. Psittacosis (bird fancier's disease) is another condition closely associated with exposure to bird wastes in bird raising and other occupational settings. While immune compromised individuals have an increased risk of health impacts following exposure to the materials in bird wastes, these impacts may also occur in healthy individuals exposed to these materials.

Bird Waste on Beams in Attic

6. Have bird waste cleaned from attic in a manner consistent with that described in the **Other Concerns** section of this report.
7. Install properly sized filters for all AHUs. Examine the feasibility of increasing the efficiency of AHU filters. Prior to any increase of filtration, each piece of air handling equipment should be evaluated by a ventilation engineer as to whether it can maintain function with more efficient filters.

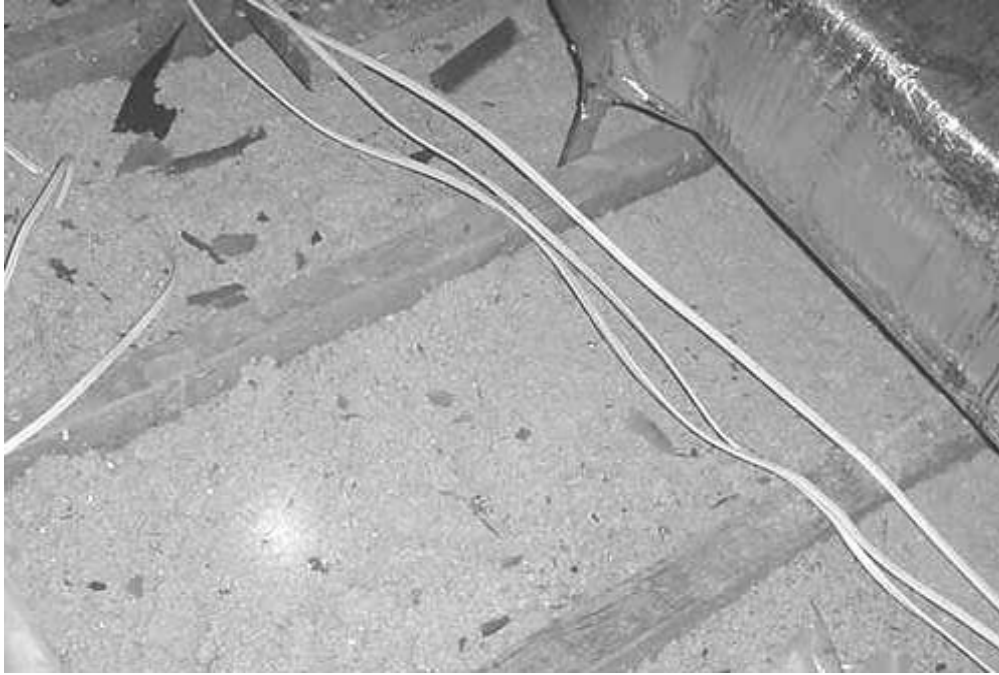
Picture 13

Bird Waste on Insulation in Attic

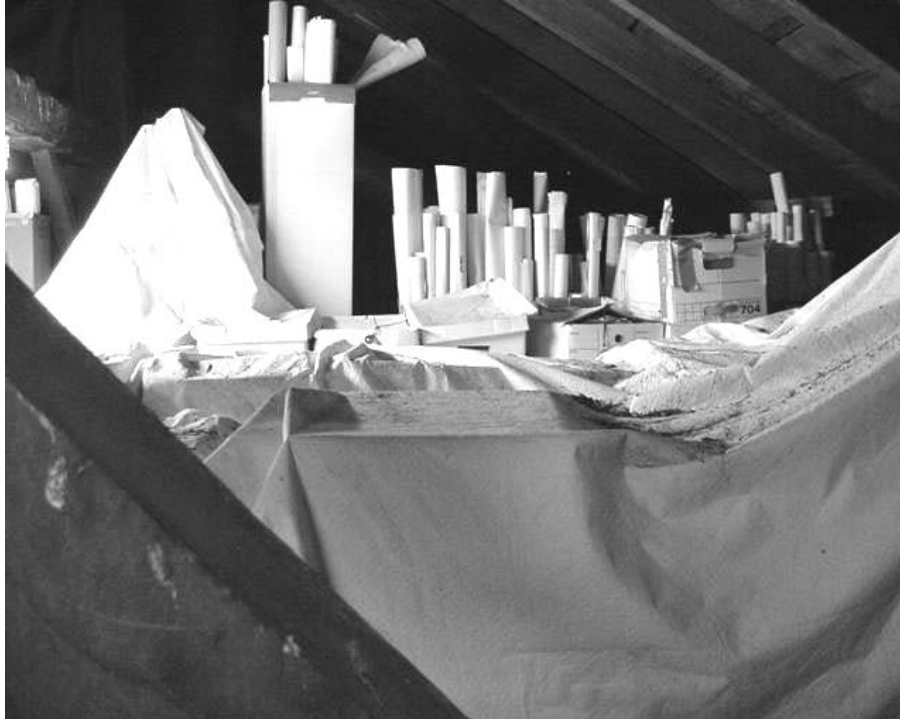
Picture 14

Bird Waste on Sheets in Attic

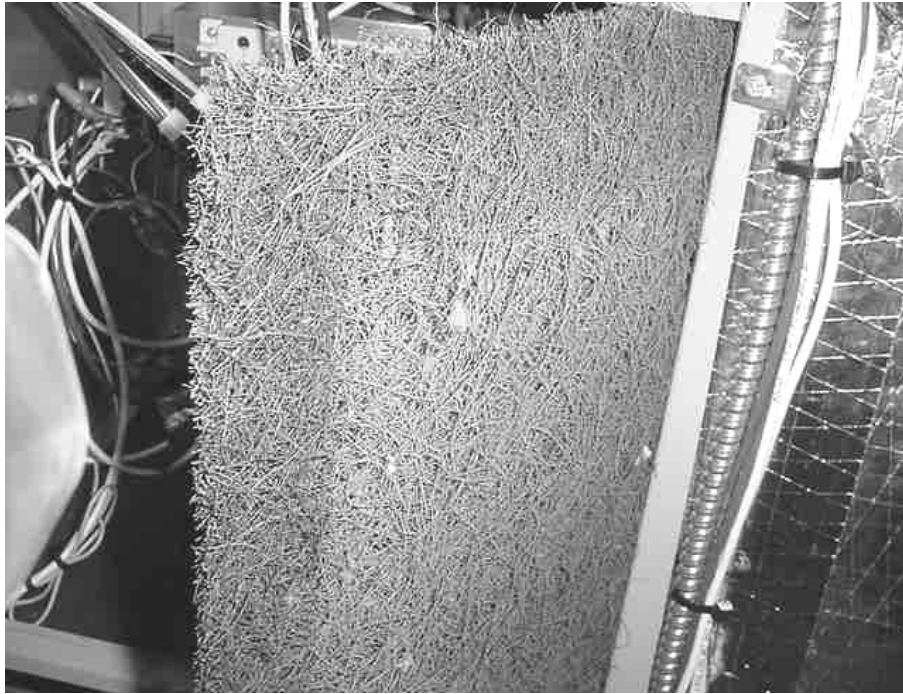
Picture 15

Finally, AHUs are equipped with filters that strain particulates from airflow. It appears that filters were installed that were larger than the filter frame for each AHU. Filters were found cut (see Picture 15) to fit into each rack in attic AHUs. Cutting of frames and filter medium creates space by which air drawn into the AHU can by-pass the filter, resulting in the potential distribution of pollutants into occupied areas. In addition, filters installed in AHUs appear to be of a type that will provide minimal filtration of respirable particles. In order to decrease aerosolized particulates, disposable filters with an

Cut Filters in Attic AHU
