# **INDOOR AIR QUALITY ASSESSMENT**

**Chicopee Public Safety Building  
Fire Department Headquarters  
80 Church Street  
Chicopee, Massachusetts**

Prepared by:  
Massachusetts Department of Public Health  
Bureau of Environmental Health Assessment  
Emergency Response/Indoor Air Quality Program  
March 2003

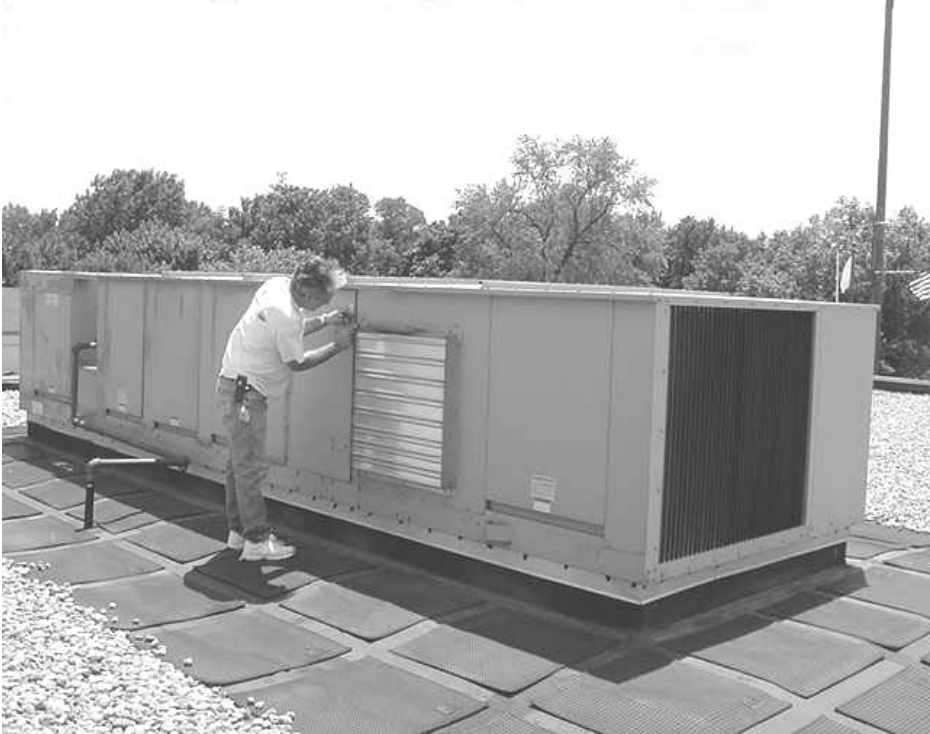
**Picture 1**

The fire station has a rooftop air-handling unit (AHU) designed to supply fresh air (see Picture 1). The AHU appears to provide fresh air supply and/or exhaust ventilation for multiple areas on multiple floors of the building. Shower areas/restrooms have local dedicated exhaust vent systems. The first floor has a specially designed exhaust ventilation system for operating fire engines and related vehicles (see Picture 2). The ground floor repair shop also has specially designed exhaust fans (see Picture 3) that were not activated during the assessment.

**Rooftop AHU**

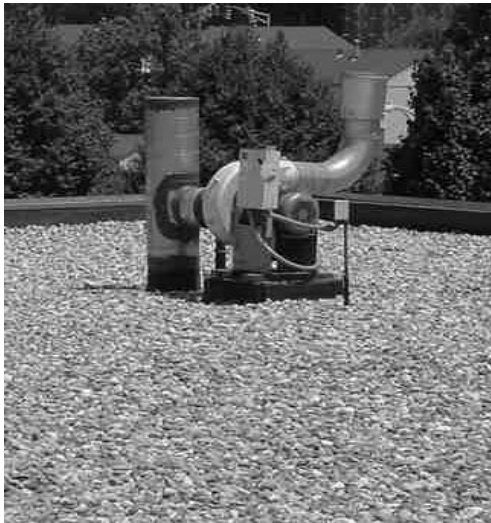
**Picture 2**

**Special Design Vehicle Exhaust Removal System for Operating Fire Engines and Related Vehicles**

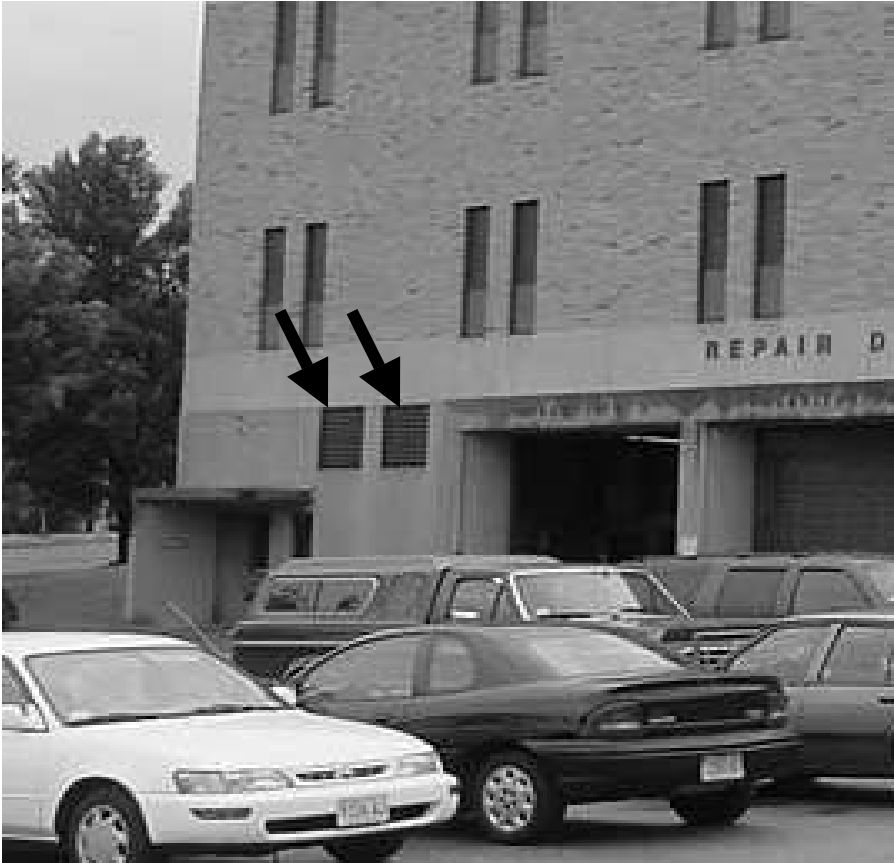
Picture 3

Ventilation System for Repair Shop

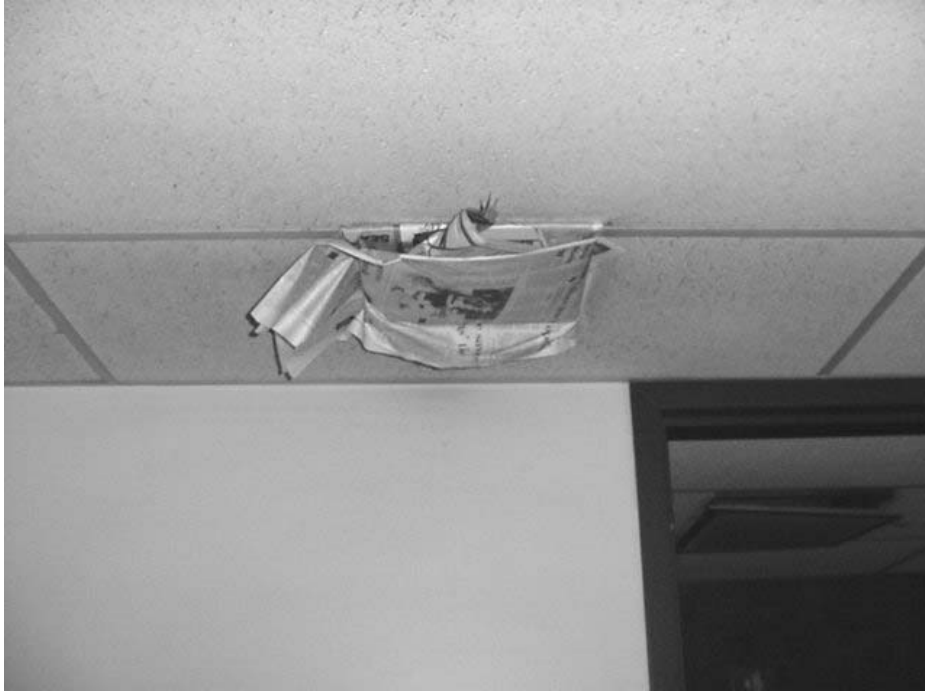
**Picture 4**

The Trane<sup>®</sup> AHU is connected by ductwork to wall or ceiling-mounted fresh air diffusers. Many fresh air diffusers in bunkhouse rooms were sealed with cardboard or newspaper (see Picture 4), indicating either poor temperature control or that drafts from the fresh air diffusers were directed onto individuals sleeping in the room. Since each bunkhouse room is serviced by the AHU by common ductwork, the sealing of one fresh air diffuser results in an *increase* of air delivery to other bunkhouse rooms, creating an imbalance in the ventilation system.

**Fresh Air Diffusers in Bunkhouse Sealed with Cardboard or Newspaper**

1. Examine the feasibility of installing a protective hood over the AHU exhaust vent to prevent flapping and to limit uncontrolled fresh air entrainment.
2. Avoid sealing fresh air diffuser in the bunkhouse. Consider repositioning beds or installing alternatively designed fresh air diffusers to direct the air stream away from sleeping occupants.

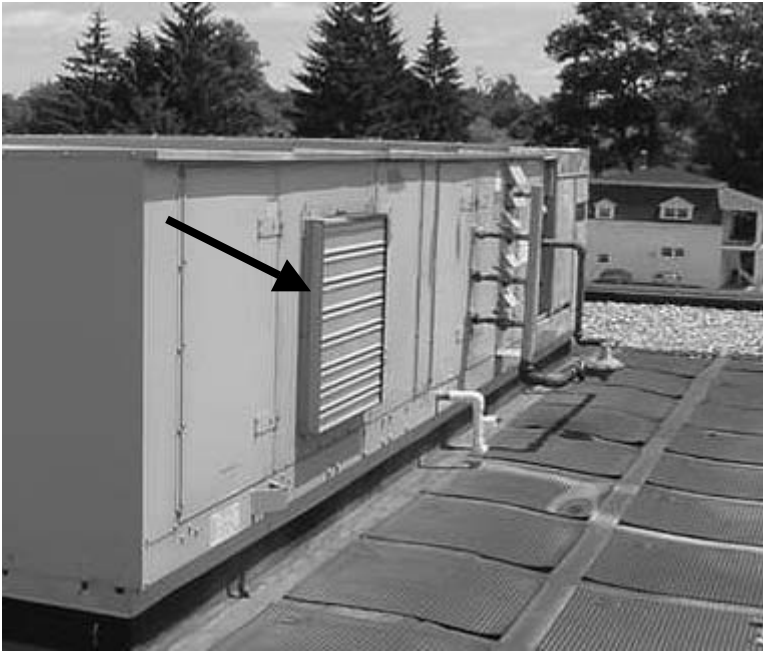
**Picture 5**

The orientation of the Trane<sup>®</sup> AHU can produce conditions that allow for uncontrolled entrainment of cold air during winter through the passive exhaust vent. The passive exhaust vents face north and south. Prevailing winter winds are generally of a northwestern orientation. As NW winds blow across the face of the Trane<sup>®</sup> AHU, this airflow can lift the edge of the passive vents and force air in an uncontrolled manner into the return air chamber. The condition is enhanced by lifting of the exhaust vent louvers when return vent louvers restrict airflow. Adjustment to increase fresh air intake would be expected to result in the exhaust vent louvers flapping in a westerly breeze. In the winter this condition can introduce cold air that may result in the AHU coils freezing.

**AHU Passive Louver Vents**

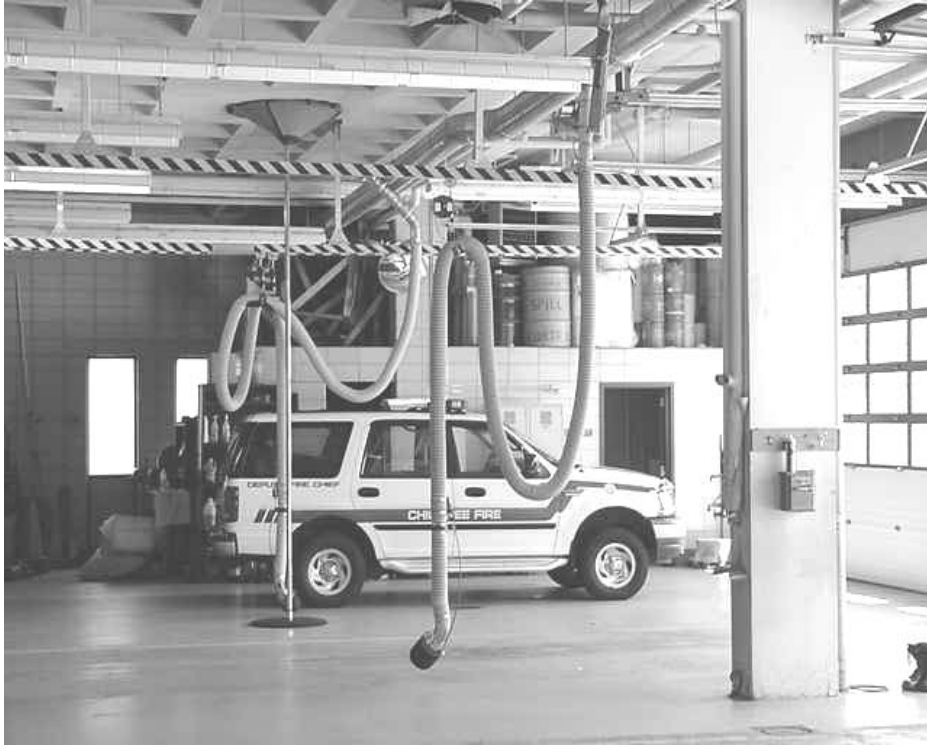
**Picture 6**

Of particular importance is vehicle exhaust. The firehouse is equipped with a mechanical exhaust system to remove exhaust from the engine bays during vehicle idling. Each fire engine is connected to the mechanical ventilation exhaust system by using a flexible hose (see Picture 6). As the mechanical exhaust vent system operates, vehicle exhaust is drawn to a fan motor. A number of pathways exist for odors and other pollutants from the first floor engine bay into the offices and second floor.

**Flexible Hose for Vehicle Exhaust Removal System**

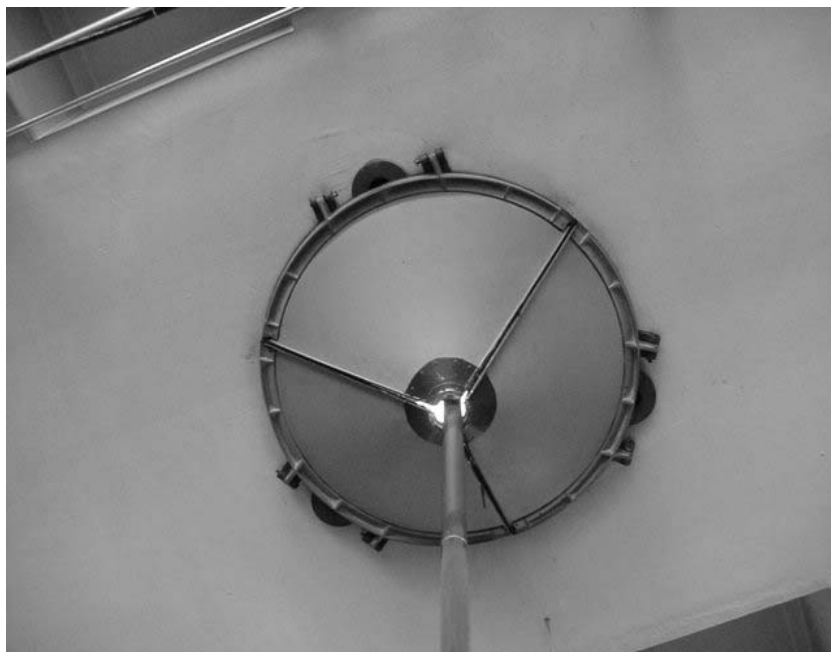
**Picture 7**

- The doors between the engine bays and reception office have spaces in the doorframe when closed.
- The gaskets on the clamshell doors that seal around the fire pole in the ceiling has spaces when closed. (see Picture 7).
- The ceiling of the engine bays is penetrated by holes for utilities (see Picture 8). These holes are not sealed.

**Clamshell Door Does Not Seal Around the Fire Pole**

5. Repair firepole clam shell doors to form as airtight a seal as possible.
6. Install weather stripping along the doorframe and a door sweep on the underside of all doors that access the first floor engine bays and ground floor garage.

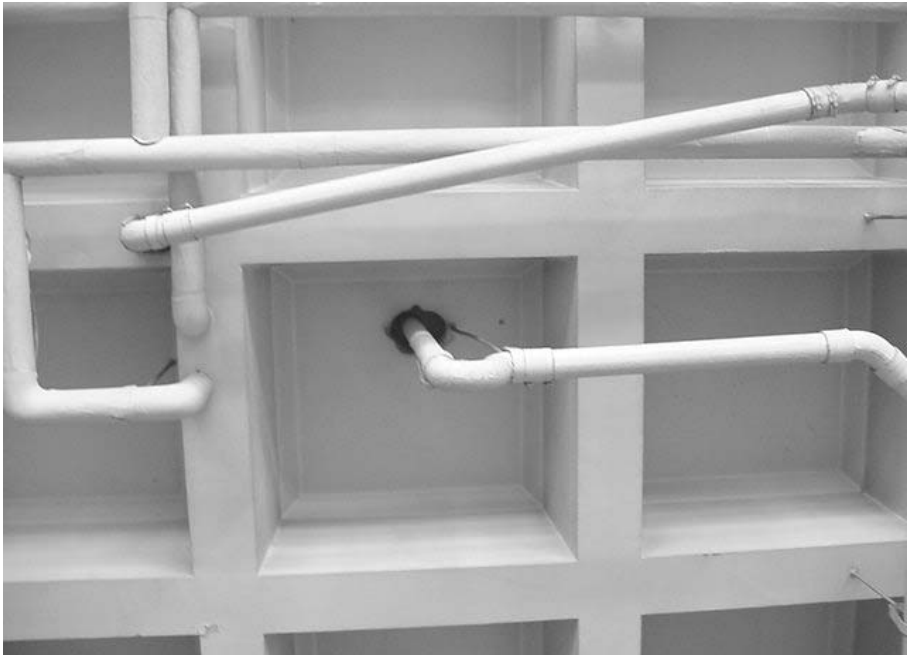
**Picture 8**

**Ceiling of the Engine Bays Is Penetrated By Holes for Utilities**

3. Repair exhaust vents on roof if necessary. Operate exhaust ventilation in all areas of the building.
4. Seal utility holes in the walls and ceiling of the engine bays.

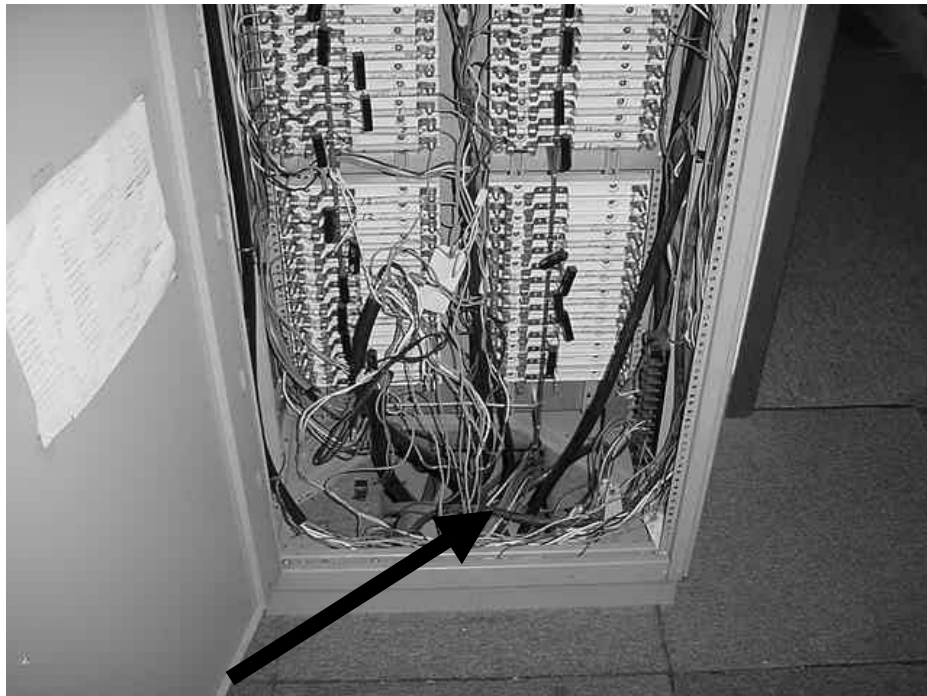
**Picture 9**

Periodic odors are reported in and around the alarm room area. A cabinet containing electrical wire exists in the alarm storeroom (see Picture 9). This electrical wire penetrates into the floor cavity. A similar hole exists in the ceiling of the former oxygen cylinder filling room locate near the rear of the ground floor garage (see Picture 10). In order to explain how odor generated in the garage may be migrating into the

**Cabinet Containing Electrical Wire In the Alarm Storeroom, Note Hole in Floor**

8. Render the hole in the floor of the alarm room storeroom airtight.
9. For buildings in New England, periods of low relative humidity during the winter are often unavoidable. Therefore, scrupulous cleaning practices should be adopted to minimize common indoor air contaminants whose irritant effects can be enhanced when the relative humidity is low. Drinking water during the day can help ease some symptoms associated with a dry environment (throat and sinus irritations).

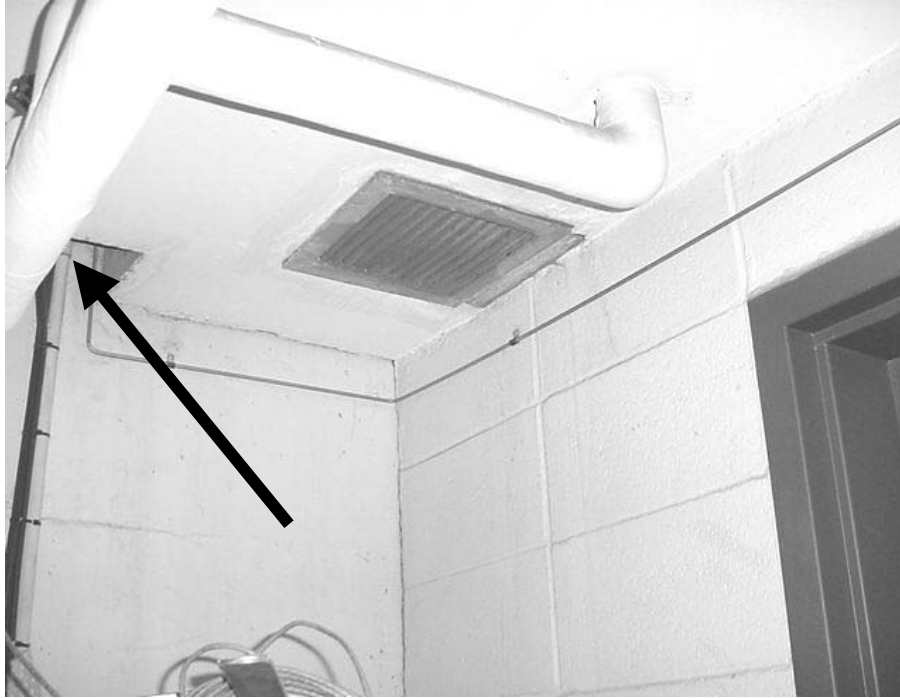
**Picture 10**

Each of these concepts has influence on the movement of odors from the garage into the alarm room. The opening in the box within the alarm room and in the ceiling of the former oxygen cylinder filling room forms a pathway within the internal wall space for garage air and odors to travel upward into the building interior. This pathway may allow for garage odors to penetrate through seams or hole interior walls in upper floors, particularly through large openings in the floor like that shown in Picture 9. The exhaust vent in the oxygen cylinder room was not drawing air. If this exhaust vent was operating, then the migration of odor upwards through the ceiling hole may be reduced.

**Hole in the Ceiling of the Former Oxygen Cylinder Filling Room on Garage Level**

7. Render airtight the hole in the ceiling of the former oxygen cylinder filling room to prevent garage odors from penetrating into the building interior wall space.

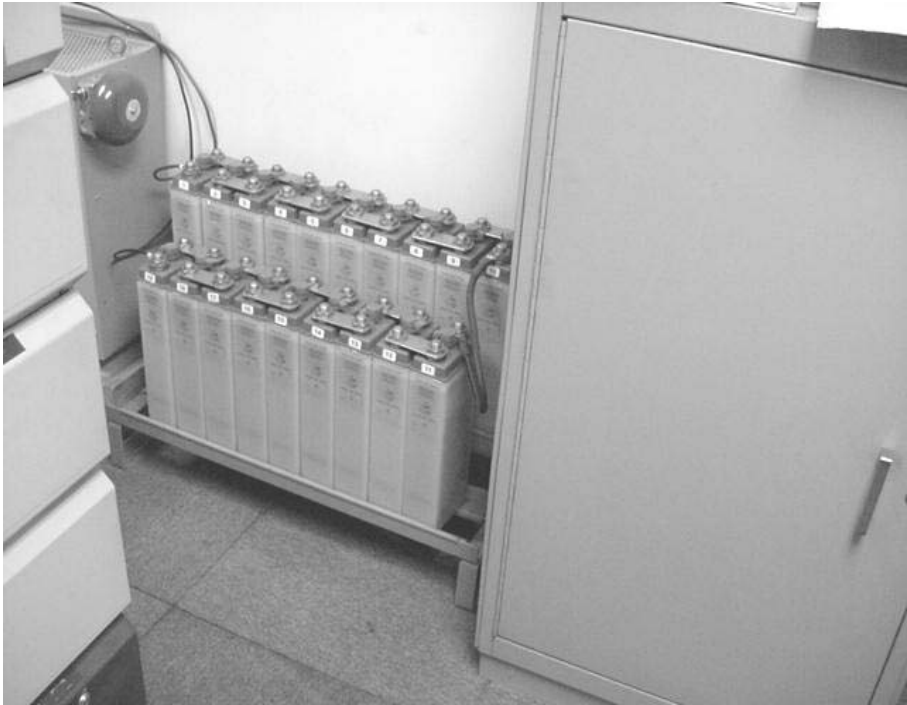
**Picture 11**

The alarm room storeroom has a carpeted floor. Located on the floor of this room is a rack of acid batteries used for backup power for electrical systems (see Picture 11). Carpeting in battery storerooms is ***not recommended*** as a floor covering for several health and safety reasons. Of important note is the possibility of the carpet becoming contaminated by chemical spills. A carpet contaminated with chemicals may also serve as a reservoir for off-gassing of irritating substances. Once contaminated with chemicals, cleaning of the carpet is not a viable option. At sufficient levels, contaminated surfaces of the carpet would be considered as a hazardous waste, requiring disposal in a manner consistent with Massachusetts hazardous waste laws and regulations. Of further concern is the interaction of spilled chemicals with the constituent materials of the carpet itself. Frequently, carpet consists of man-made materials (i.e., synthetic fibers). If contaminated with an organic solvent or strong acid, synthetic fiber may breakdown into its constituent chemicals, resulting in the release of hazardous materials. Some chemicals may react violently with synthetic materials resulting in fire. For these reasons a smooth, nonporous, nonflammable floor covering is preferred in a battery storeroom.

**Acid Batteries in Alarm Storeroom**
