INDOOR AIR QUALITY ASSESSMENT

**Shelburne Town Hall
51 Bridge Street
Shelburne, Massachusetts 01370**

Prepared by:
Massachusetts Department of Public Health
Bureau of Environmental Health Assessment
Emergency Response/Indoor Air Quality Program
April 2003

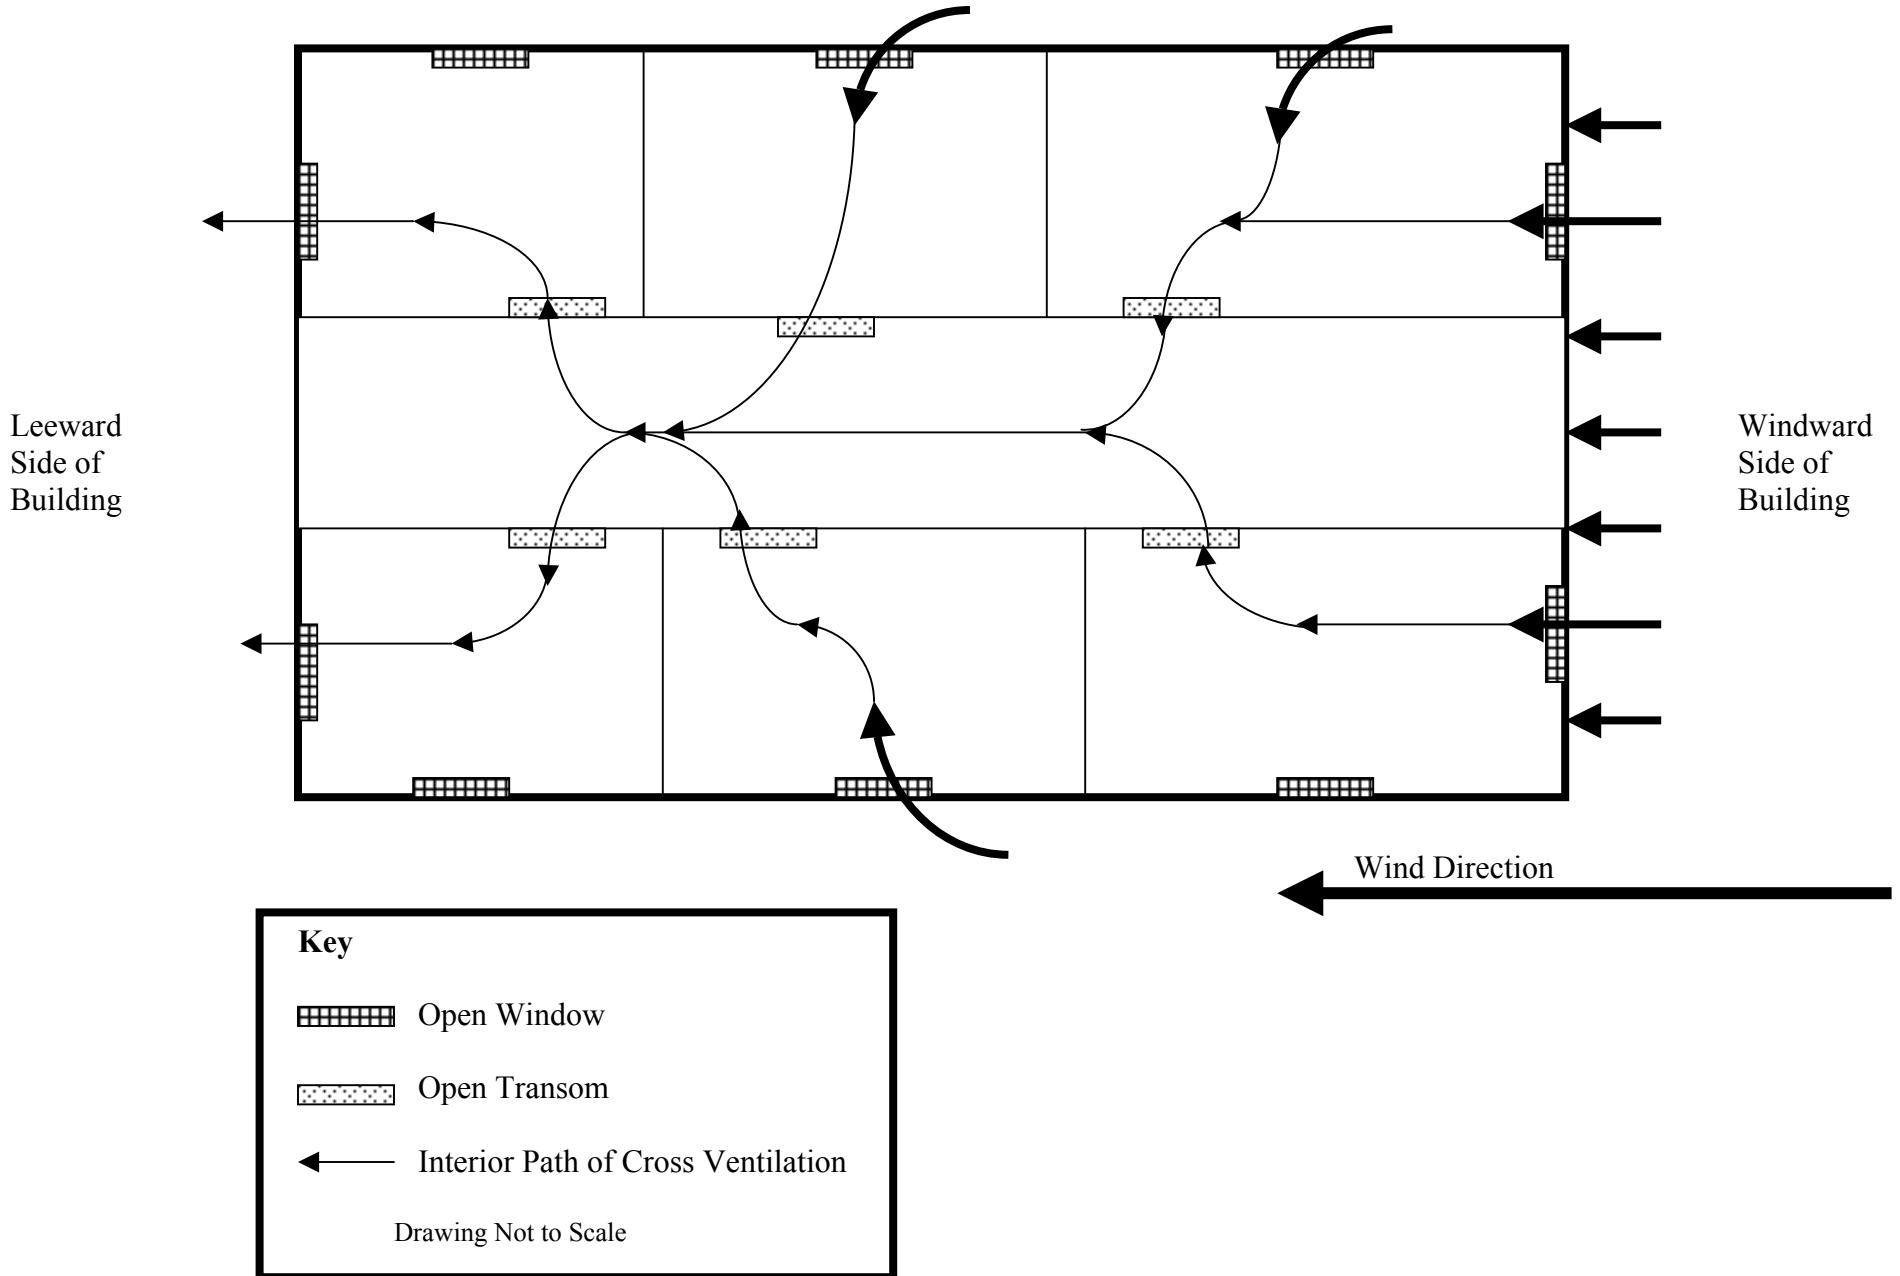
Figure 1

The town hall was configured in a manner to use cross-ventilation to provide comfort for building occupants. The building is equipped with windows on opposing exterior walls. This design allows for airflow to enter an open window (windward side), pass through the interior and exit the building on the leeward side (opposite the windward side) (see Figure 1). With all windows open, airflow can be maintained in a building regardless of the direction of the wind. This system fails if the windows are closed (see Figure 2). In the case of the STH building, the erection of interior walls to form offices prevents the utilization of cross ventilation when hallway doors are closed. This natural ventilation system was replaced with the installation of window-mounted air conditioners

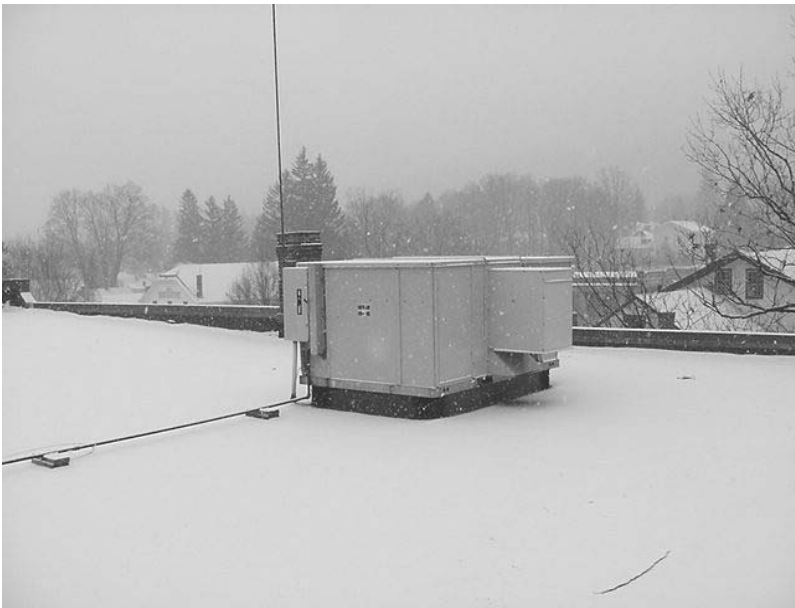
Picture 1

The second floor auditorium contains ceiling-mounted fresh air diffusers connected to a rooftop air handling unit (AHU) (see Picture 1). Town employees report that this unit is used for heating only when the auditorium is occupied.

AHU for Auditorium

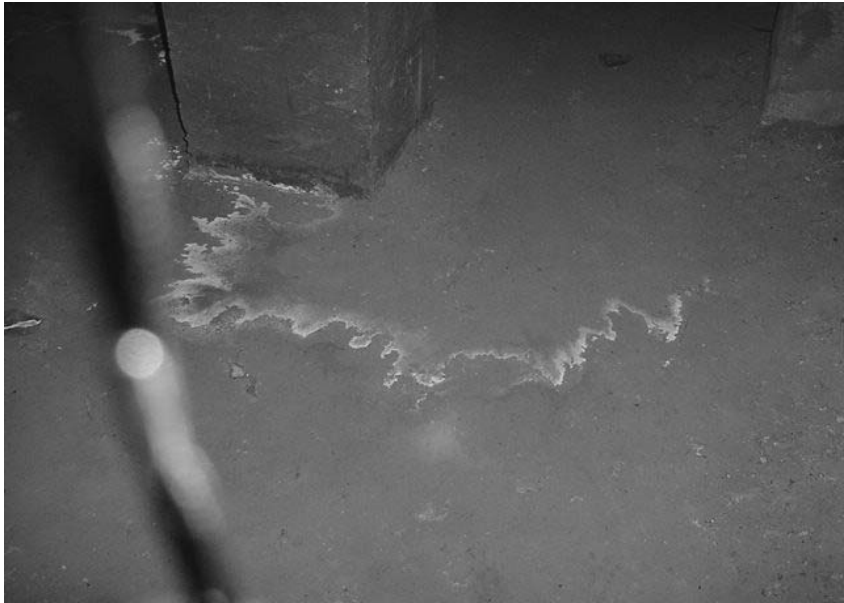
Picture 2

The basement has a dirt floor (see Picture 2). A number of moisture sources exist along the exterior of the building. A major source of water penetration into the basement appears to be water runoff from a peaked roof on a house immediately adjacent to the town hall (see Picture 3). The alleyway between the town hall and house is covered by dirt (see Picture 4). The roof does not have a gutter/downspout system, which results in rainwater collecting on the ground between buildings. No drain appears to exist in the alleyway. Collected water in the alleyway may then penetrate into the basement. Confirming this moisture pathway is the presence of efflorescence along exterior walls of

the foundation along the alleyway. Efflorescence is a characteristic sign of water damage to brick and mortar, but it is not mold growth. As moisture penetrates and works its way through mortar around brick, water-soluble compounds in bricks and mortar dissolve, creating a solution. As the solution moves to the surface of the brick or mortar, the water evaporates, leaving behind white, powdery mineral deposits.

Basement Dirt Floor, Note Efflorescence

- 7) Do not store porous materials on the dirt floor of the cellar.
- 8) Examine the feasibility of having a downspout/gutter system installed on the peaked roof building to direct water away from the alleyway.

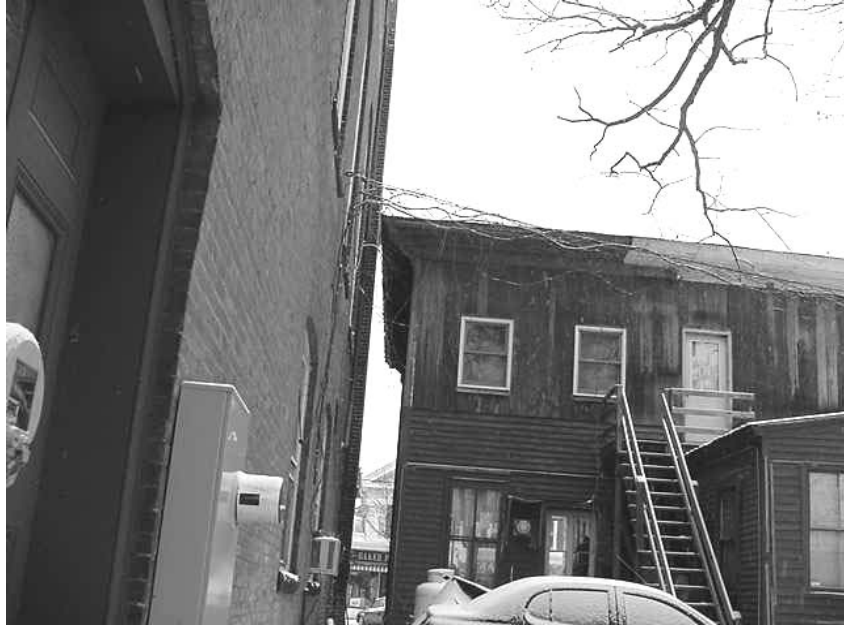
Picture 3

Peaked Roof Building Immediately Adjacent to the Town Hall

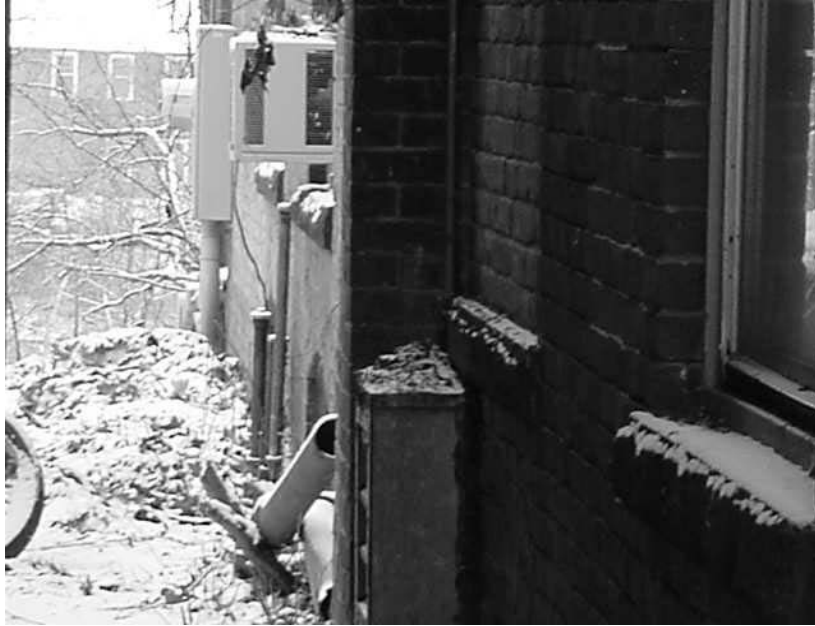
Picture 4

Dirt Floor Alleyway

- 9) Improve the grading of the ground away from the foundation at a rate of 6 inches per every 10 feet (Lstiburek, J. & Brennan, T.; 2001).
- 10) Install a water impermeable layer on ground surface (clay cap) to prevent water saturation of ground near foundation (Lstiburek, J. & Brennan, T.; 2001).

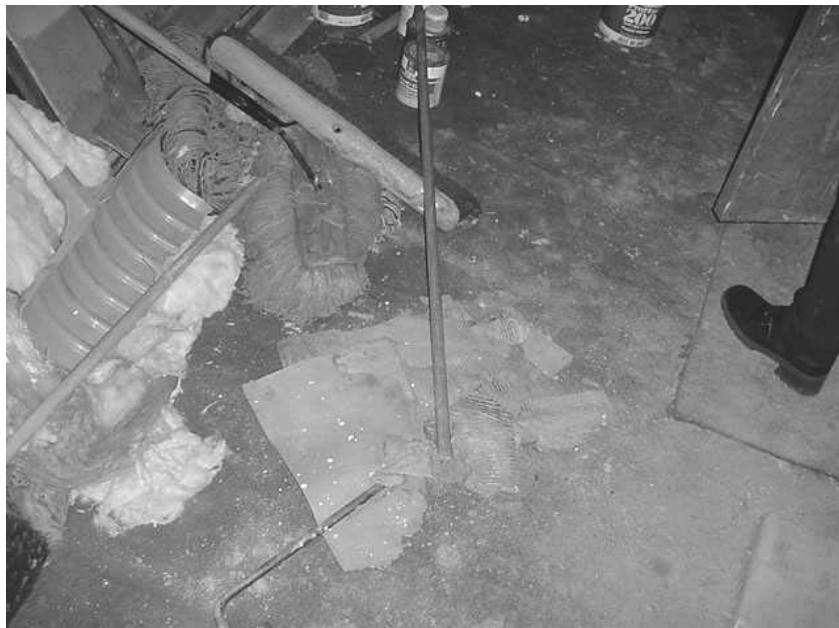
Picture 5

The basement is used for storage of large amounts of materials on the dirt floor, including carpeting, cardboard and paper products (see Picture 5). If these materials are subjected to high relative humidity conditions without drying for several days, these materials can become colonized by fungi (mold). Some materials were stored in cardboard boxes that were placed on the dirt floor. This method of storage resulted in mold contamination of the boxes and most likely, the stored contents. No means exist for venting the basement to remove water vapor. If water penetrates through the foundation, moisture may accumulate in the basement.

Materials Stored in Basement, Note Carpeting On Dirt Floor

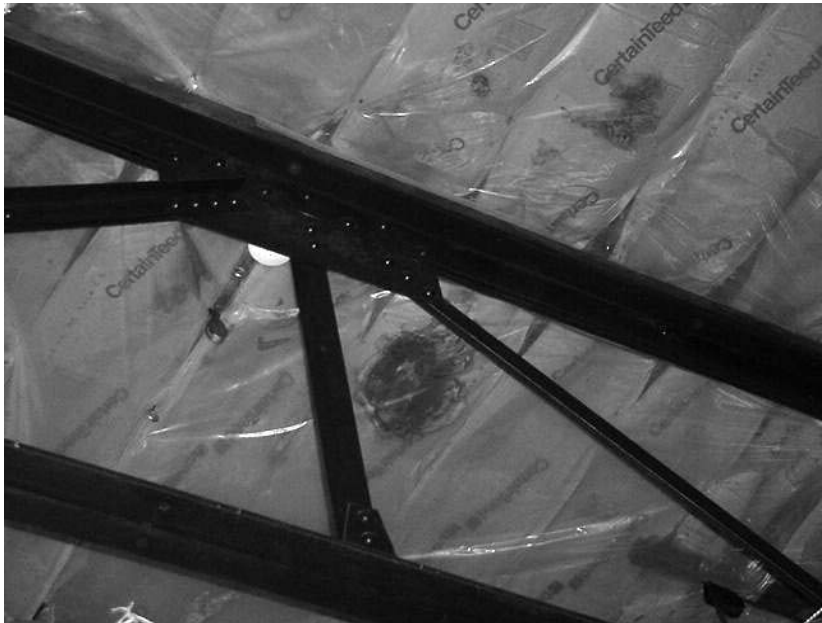
Picture 6

It appears that the roof has experienced water leaks, as demonstrated by the amount of water-damaged insulation within the auditorium (see Picture 6). Insulation paper and ceiling tiles are porous materials that can be prone to mold growth if repeatedly moistened.

Water Damaged Insulation Behind Plastic in Ceiling above the Auditorium Stage

- recommended. Drinking water during the day can help ease some symptoms associated with a dry environment (e.g., throat and sinus irritations).
- 12) Consideration should be given to removing water-damaged insulation and ceiling tiles within the auditorium.

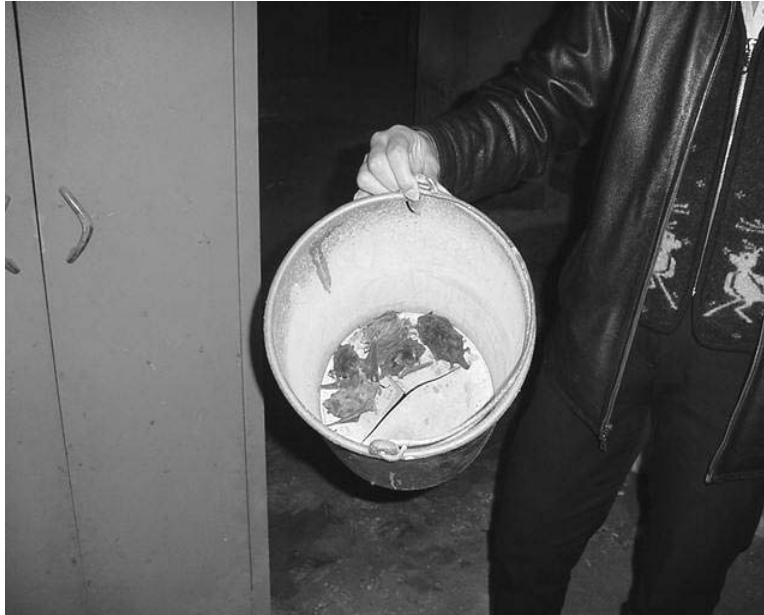
Picture 7

A number of other conditions were noted. While assessing conditions in the basement, a bucket was noted containing several bodies of dead bats (see Picture 7). It appears that bats can access the basement through the elevator shaft. The rooftop opening for the elevator shaft that provides pressure equalization during its operation does not have a bird screen (see Picture 8). Examination of the interior of the building found bird waste accumulation on flat surfaces of the STH and window-mounted air conditioners (see Picture 9). Bird screens were installed on eaves of the peaked roof building next to the STH. Ledges of sealed windows of the STH appear to provide enough purchase for pigeons to land (see Picture 10). While the bird wastes are on the exterior of the building, this air conditioner has the ability to introduce fresh air from outdoors. As air is drawn into the air conditioner, bird waste particulate can be entrained into the air stream and introduced into the interior of the building. Birds and bats in a building raise concerns over diseases that may be caused by exposure to their wastes. These conditions warrant clean up of waste materials and appropriate disinfection. Certain molds (*Histoplasma capsulatum*) are associated with bird/bat waste (CDC, 2001; NIOSH, 1997) and are of concern for immune compromised individuals. Diseases of the respiratory tract may also result from exposure to bird/bat waste. While immune compromised individuals have an increased risk of health impacts following exposure to the materials in bird/bat wastes, these impacts may also occur in healthy individuals exposed to these materials.

Dead Bats in Basement

- 5) Install anti roosting devices on all flat exterior surfaces to prevent bird roosting as was done on select windowsills of the building.
- 6) Remove bats from basement. Install bird screens on the elevator pressure equalization vent.

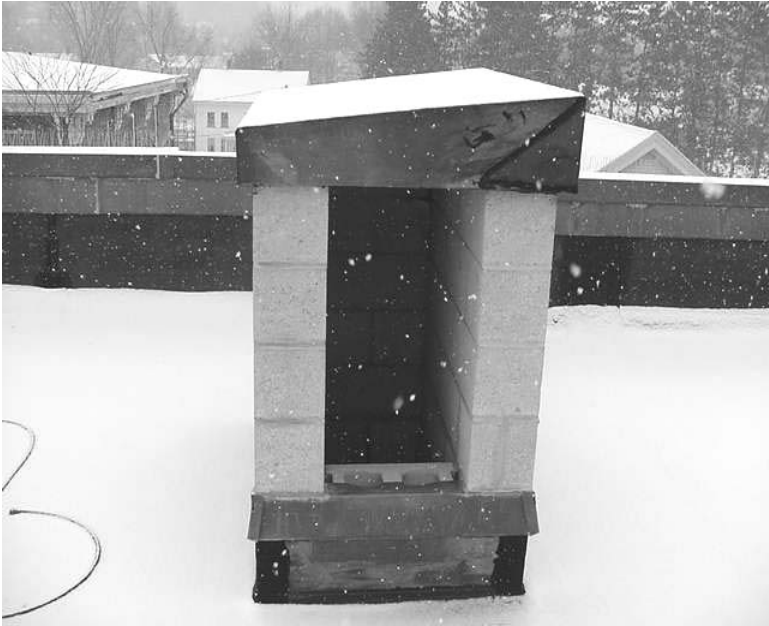
Picture 8

Elevator Shaft Pressure Equalization Vent, Note Lack of Bird Screen

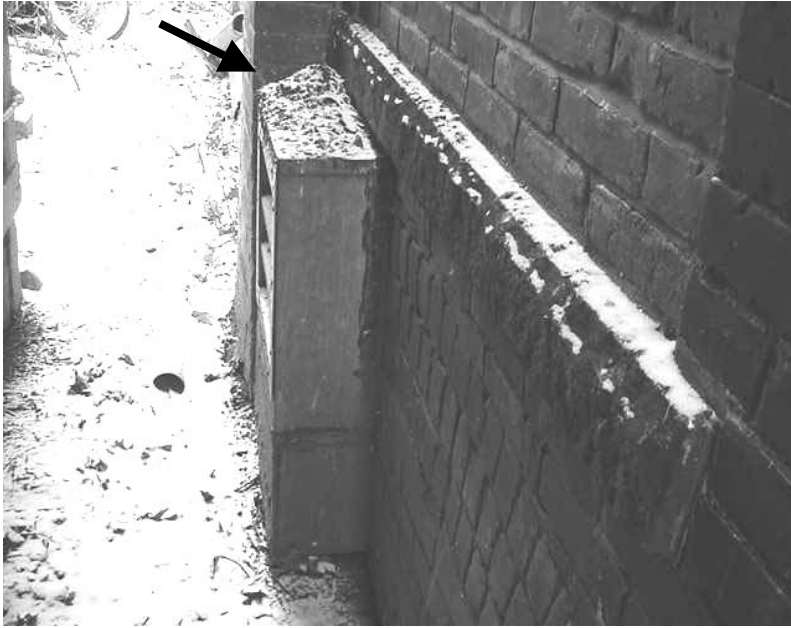
Picture 9

Accumulated Bird Waste in Alleyway

- 2) Seal hole in the furnace vent pipe.
- 3) Render the access door to the auditorium attic crawl space airtight with weather-stripping.
- 4) Remove bird waste from the exterior of the building a manner consistent with CDC recommendations.

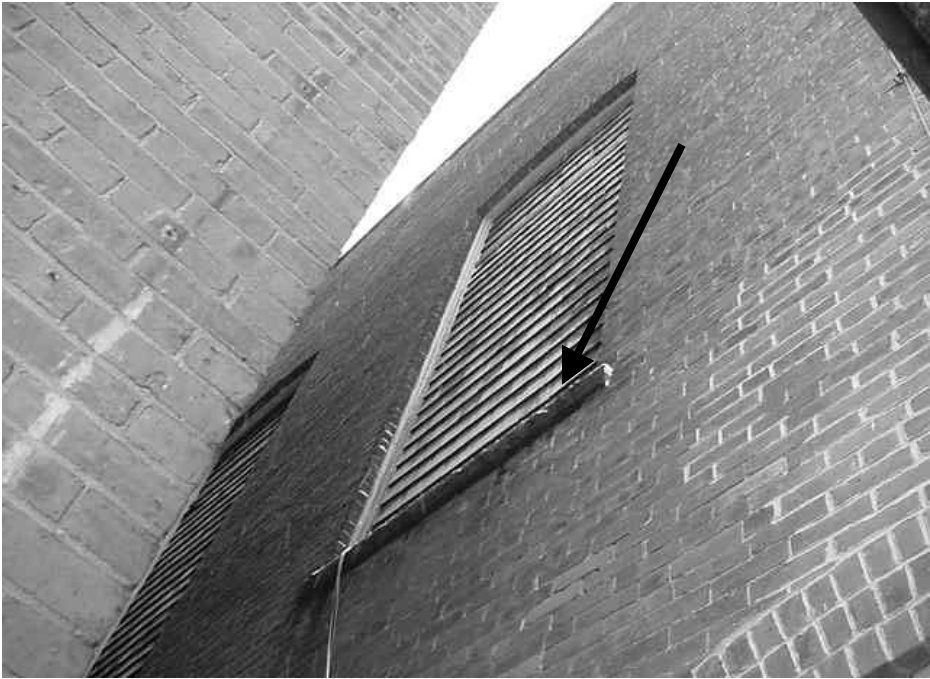
Picture 10

Flat Ledges along Building Exterior

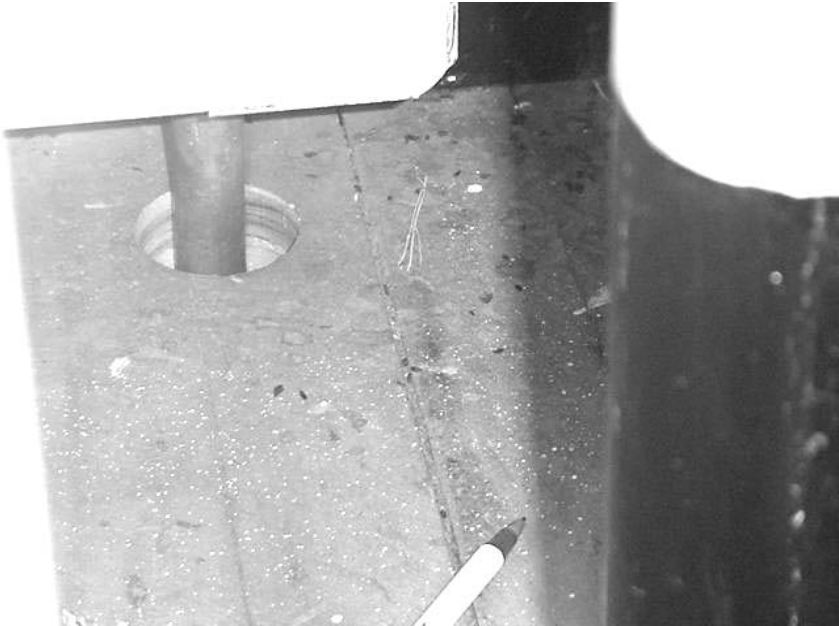
Picture 11

The building also shows signs of rodent infestation. Mouse droppings were noted behind the refrigerator in the kitchen (see Picture 11). Rodent infestation can result in indoor air quality related symptoms due to materials in their wastes. Mouse urine is known to contain a protein that is a known sensitizer (US EPA, 1992). A sensitizer is a material that can produce symptoms in exposed individuals (e.g., running nose or skin rashes). A three-step approach is necessary to eliminate rodent infestation:

Mouse Droppings in Basement

- removal of the rodents;
- cleaning of waste products from the interior of the building; and
- reduction/elimination of pathways/food sources that are attracting rodents.

To eliminate exposure to allergens, rodents must be removed from the building. Please note that removal, even after cleaning, may not provide immediate relief since allergens can exist in the interior for several months after rodents are eliminated (Burge, H.A., 1995). A combination of cleaning, increase in ventilation and filtration can serve to reduce rodent associated allergens once the infestation is eliminated.

- 13) Use IPM to remove pests from the building. Activities that can be used to eliminate pest infestation may include the following activities.
 - a) Consult a licensed pesticide applicator on the most appropriate method to end infestation.

- b) Reduction/elimination of pathways/food sources that are attracting pests.
 - c) Reduce harborages (plants/cardboard boxes) where pests may reside (MDFA, 1996).

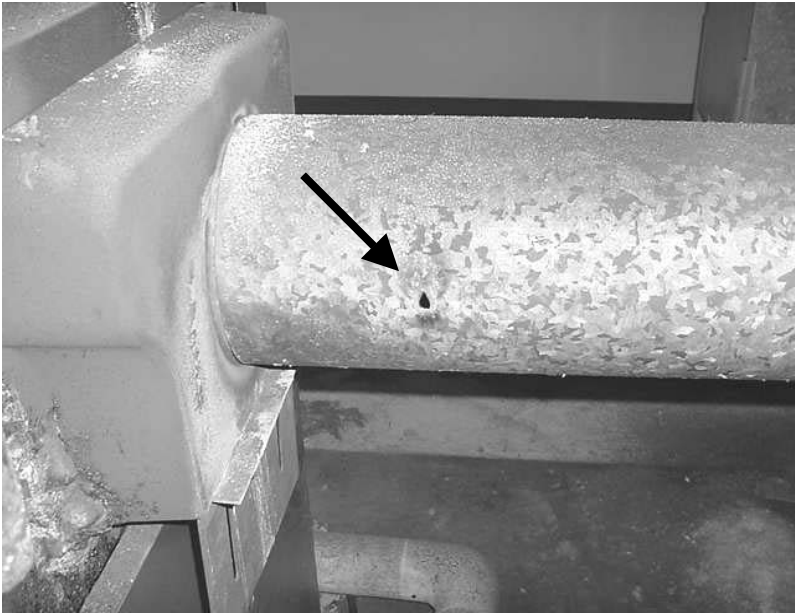
Picture 12

Finally, a vent connecting the furnace to the chimney had a hole (see Picture 12). This breach may result in the release of furnace emissions, particularly carbon monoxide, into the basement. Carbon monoxide is a health hazard and must be vented appropriately outdoors to prevent injury to building occupants.

Hole in Furnace Vent Pipe
