INDOOR AIR QUALITY REASSESSMENT

**Johnson Elementary School
290 Castle Road
Nahant, Massachusetts**

Prepared by:
Massachusetts Department of Public Health
Bureau of Environmental Health Assessment
Emergency Response/Indoor Air Quality Program
August 2003

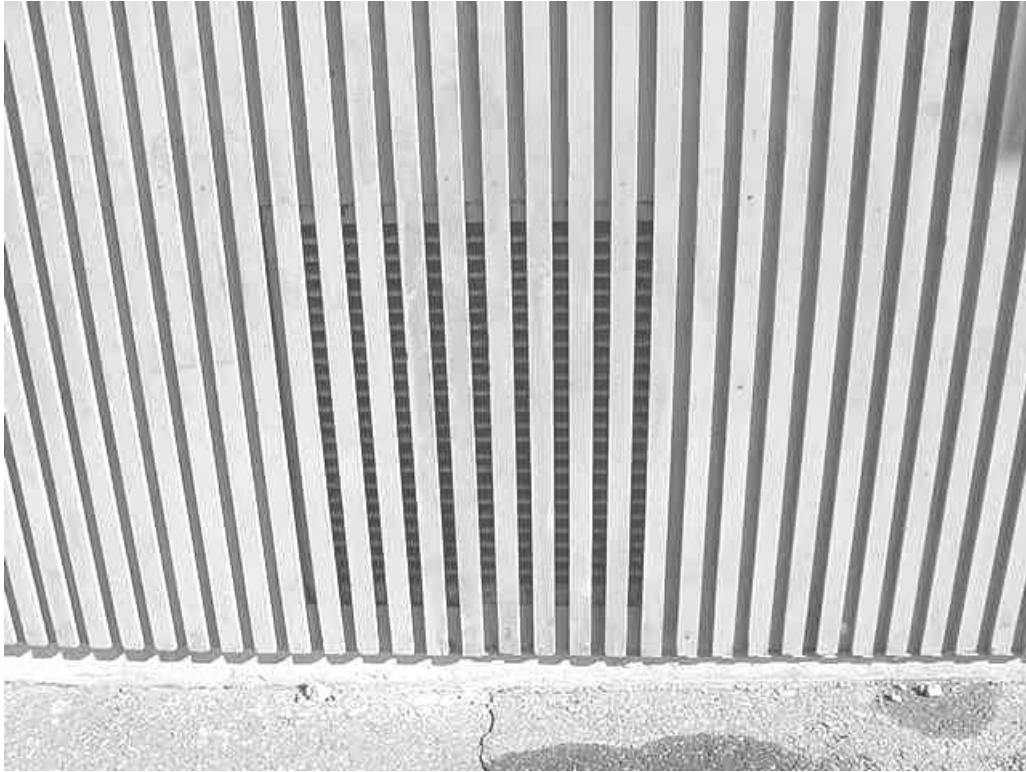
Picture 1

Fresh air in classrooms is supplied by a unit ventilator (univent) system. Univents draw air from outdoors through a fresh air intake located on the exterior walls of the building covered by vertical slats (see Picture 1). Return air is provided through an air intake located at the base of each unit. The mixture of fresh and return air is drawn through a filter and a heating coil, and is subsequently expelled from the univent by

Univents do not run continuously but are activated by thermostats once room temperatures drop below a set level called “cycling”. When the room temperature exceeds the thermostat setting, univents deactivate (off-cycle). Without mechanical ventilation running continuously, fresh air cannot be introduced into classrooms on a consistent basis. Further, in order for univents to provide fresh air as designed, air intakes and diffusers must remain free of obstructions. Obstructions to airflow, such as paper and boxes stored on univent air diffusers and desks in front of univent return vents, were noted in classrooms (see Picture 2). The efficiency of air intake by univents can also be limited by the vertical slats decreasing surface area by almost fifty percent.

Univent Fresh Air Intake Covered by Vertical Slats

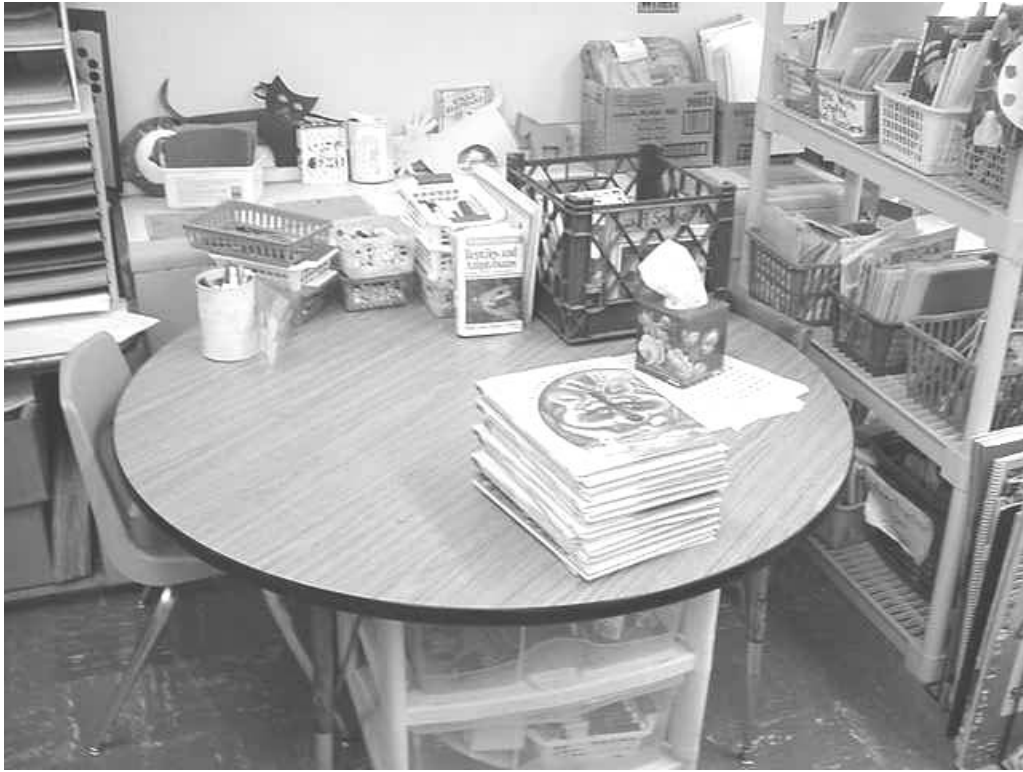
Picture 2

Univent Obstructed by Items on and in Front of Unit

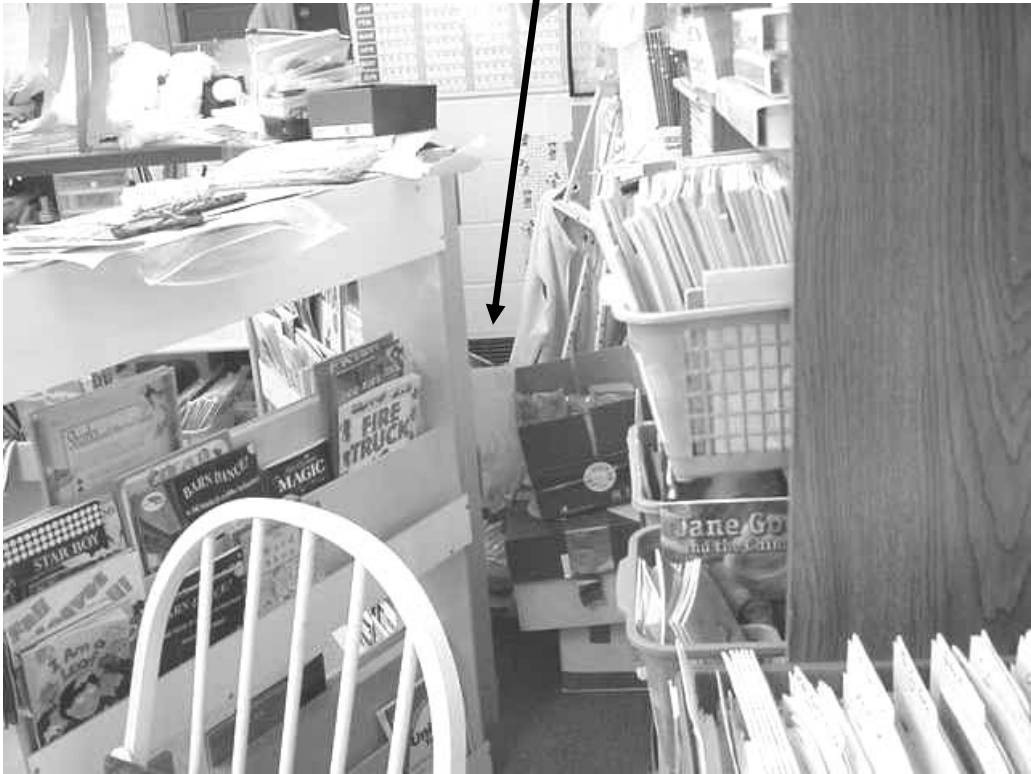
Picture 3

The mechanical exhaust ventilation system in each classroom consists of ducted, grated wall vents powered by rooftop exhaust motors. A number of vents were deactivated and backdrafting in classrooms, indicating exhaust motors were off or non-functional. As with the univents, a number of exhaust vents were obstructed by tables, chairs, boxes and other items (see Picture 3). Without adequate exhaust ventilation, excess heat and environmental pollutants can build up and lead to indoor air complaints.

Classroom Exhaust Vent Blocked by Various Items

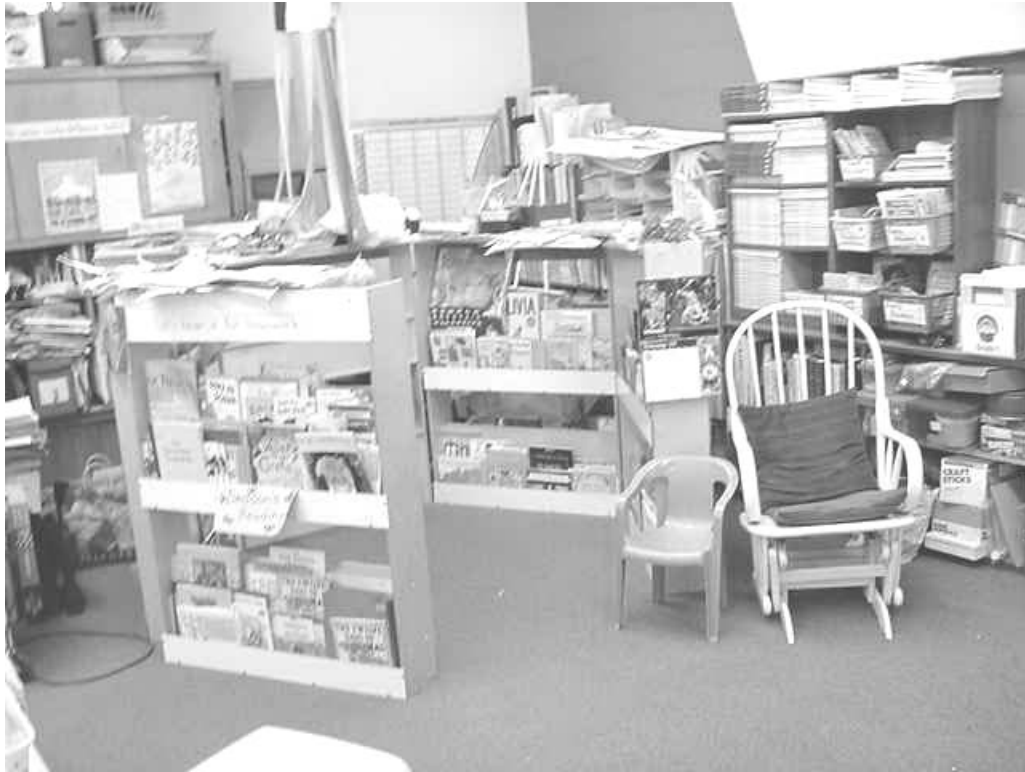
Picture 4

Of note was the amount of materials stored inside classrooms. In several areas, items were observed piled on windowsills, tabletops, counters, bookcases and desks. The large number of items stored in classrooms provides a source for dusts to accumulate. These items (e.g. papers, folders, and boxes) make it difficult for custodial staff to clean in and around these areas. Dust can be irritating to the eyes, nose and respiratory tract. Items should be relocated and/or cleaned periodically to avoid excessive dust build up. In addition, a number of exhaust vents in classrooms were noted with accumulated dust (see Picture 4). If exhaust vents are not functioning, backdrafting can occur, which can re-aerosolize accumulated dust particles.

Accumulated Items in Classroom
