INDOOR AIR QUALITY ASSESSMENT

**Ware District Court
70 South Street
Ware, Massachusetts**

Prepared by:
Massachusetts Department of Public Health
Center for Environmental Health
Emergency Response/Indoor Air Quality Program
May 2005

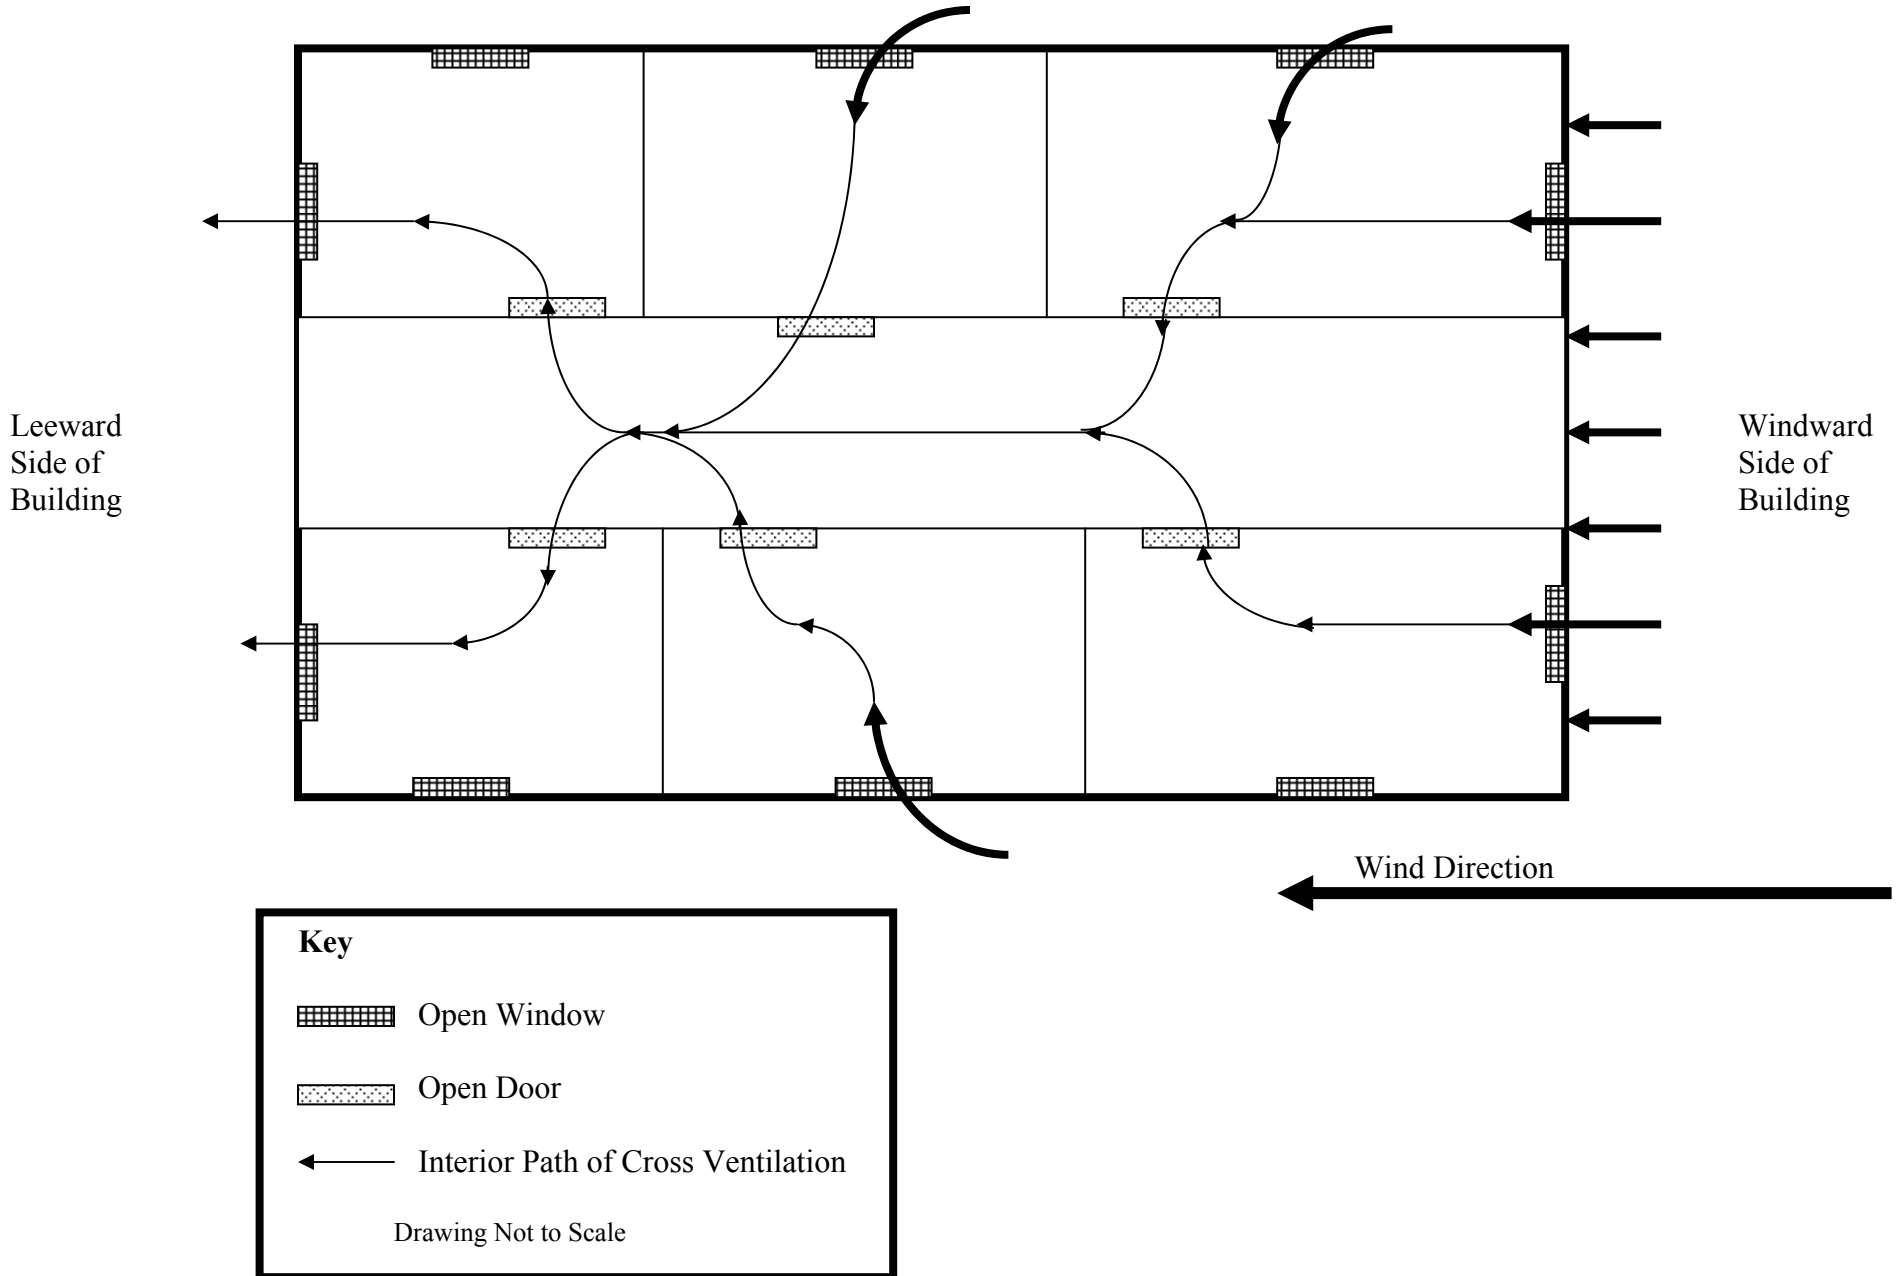
Figure 2

The building was originally designed to use cross-ventilation in the summer to provide comfort for building occupants. The WDC is equipped with windows on opposing exterior walls. This design allows for airflow to enter an open window, pass through a room, pass through the open door, enter the hallway, pass through the opposing room door and exit the building on the leeward side (opposite the windward side) (Figure

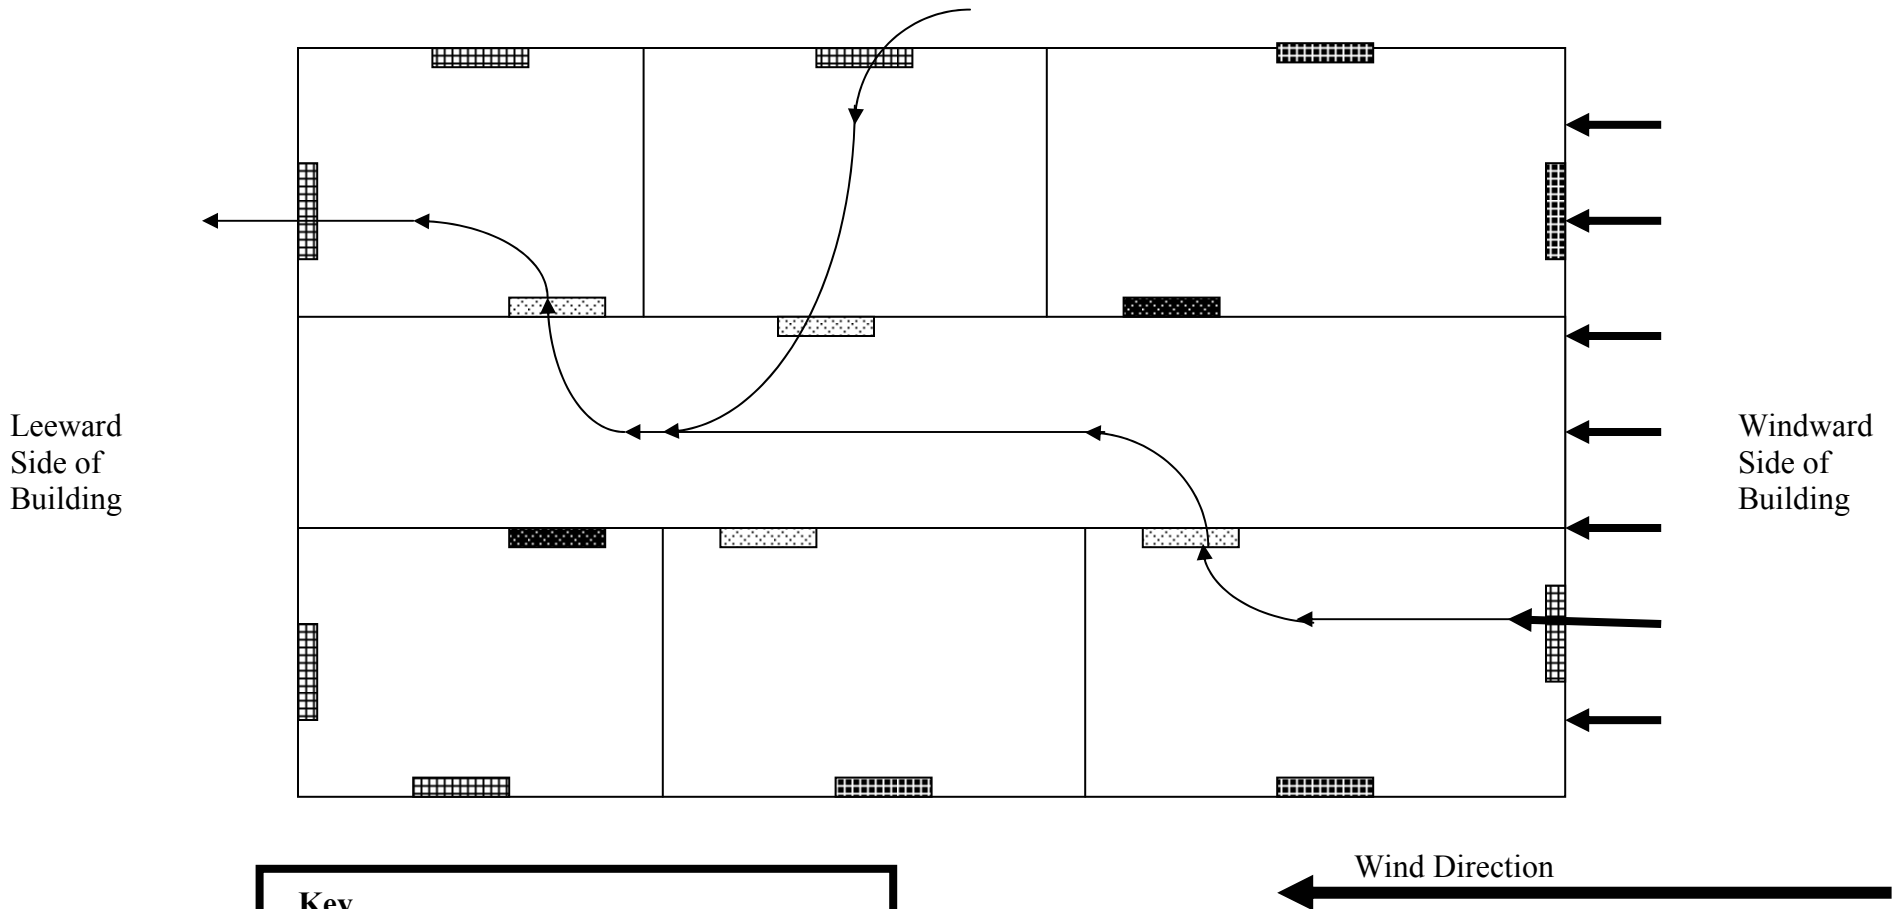
Figure 3

- 2). With all windows and doors open, airflow can be maintained in a building regardless of the direction of the wind. The system fails if the windows or doors are closed (Figure 3).
- 3). Windows and doors were closed in most areas closed during the assessment, which can inhibit airflow.

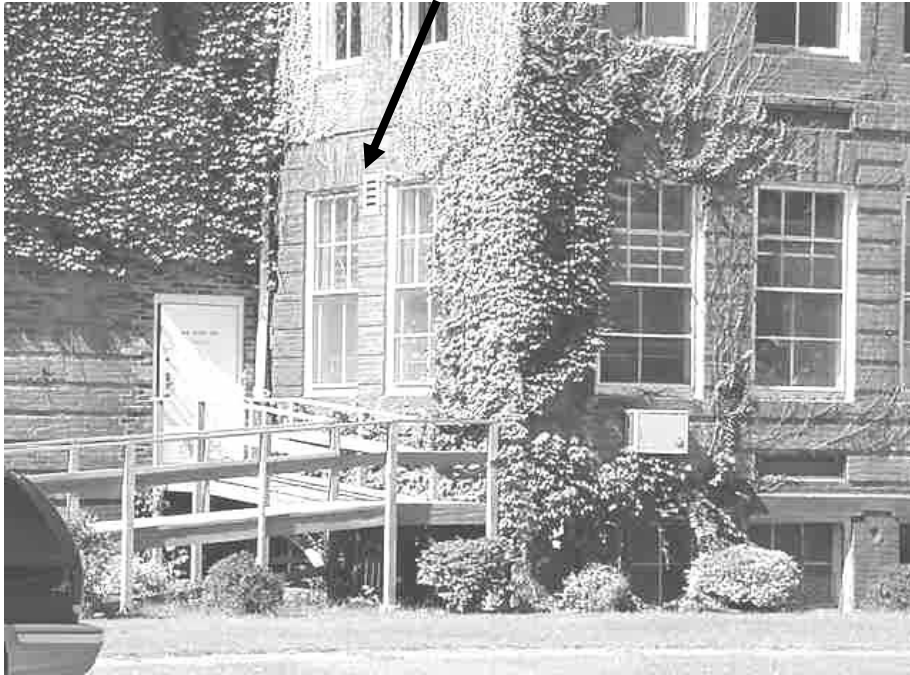
Picture 1

On September 22, 2004 Michael Feeney, Director of BEHA's Emergency Response/Indoor Air Quality (ER/IAQ) Program, visited the WDC. The WDC was constructed as a school at sometime prior to 1940. The red-brick building consists of three floors with an occupied basement. The WDC moved into the building in 1983. It appears that the first floor and basement were renovated to accommodate court activities. Mechanical ventilations systems, separated office spaces and suspended ceilings were installed in first floor areas. Offices and a holding area were constructed in the basement. An access ramp was installed on the exterior of the building, above the holding area (Picture 1). Windows are openable throughout the building.

Exhaust Vent

Access Ramp Was Installed On the Exterior of the Building, Immediately Outdoors above the Holding Area, and Note Exhaust Vent for First Floor

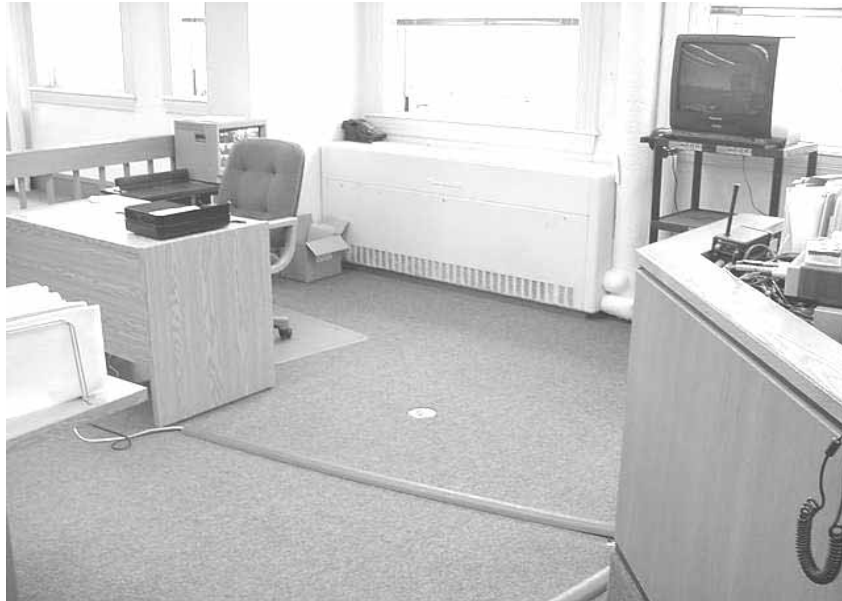
Picture 2

The WDC has a number of mechanical heating, ventilating, air-conditioning systems/components. Fresh air in rooms throughout the building is provided by unit ventilators (univents) ([Figure 1](#), Picture 2). Univents draw air from outdoors through a fresh air intake located on the exterior walls of the building and return air through an air intake located at the base of each unit. The mixture of fresh and return air is drawn through a filter and heating coil and is then provided to the room from the univent by motorized fans through an air diffuser on the top of the unit. Univents were obstructed and/or deactivated in a number of areas during the assessment. To function as designed, univent diffusers and returns must remain free of obstructions. Importantly, these units must be activated and allowed to operate.

Univent

- 10) Change filters in WACs as per the manufacturer's instructions to prevent the re-aerosolization of dirt, dust and particulate matter.
 - 11) Install filters in univents.

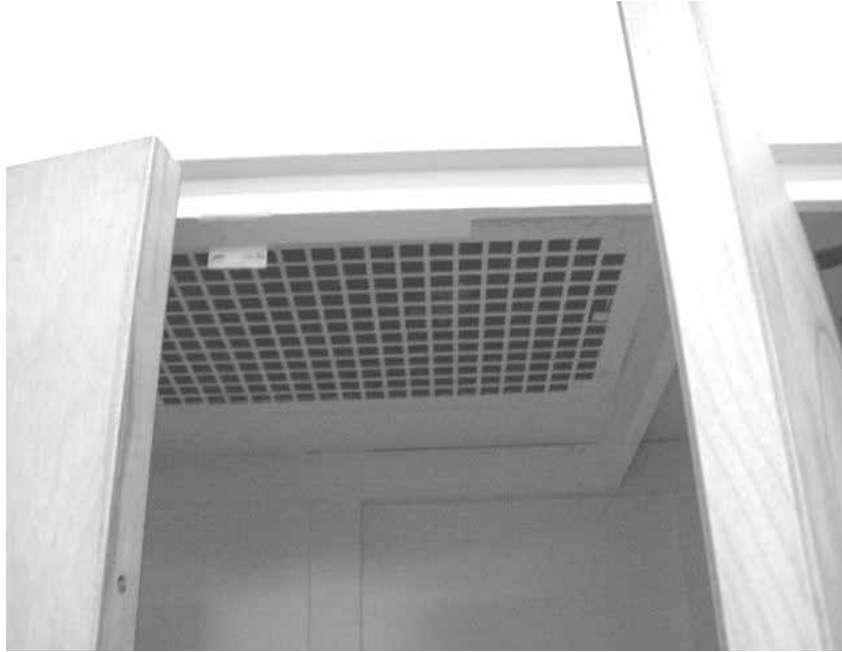
Picture 3

A mechanical exhaust ventilation system was installed to remove stale air from the building when originally constructed. The exhaust vent in each room is located in a coat closet (Picture 3). It appears that this system is not in use. The upper floors are not occupied and the vent in the clerk's office was sealed with plastic to prevent cold air

backdraft. If not activated, air can backdraft through these exhaust vents into the building, depending on wind and weather conditions. Drafts can also introduce any particulates that may have accumulated in the airshaft into the building. Since an alternate exhaust system appears to have been retrofitted into the first floor court areas (see below), sealing these vents would be appropriate.

Original Exhaust Vent System in Closets

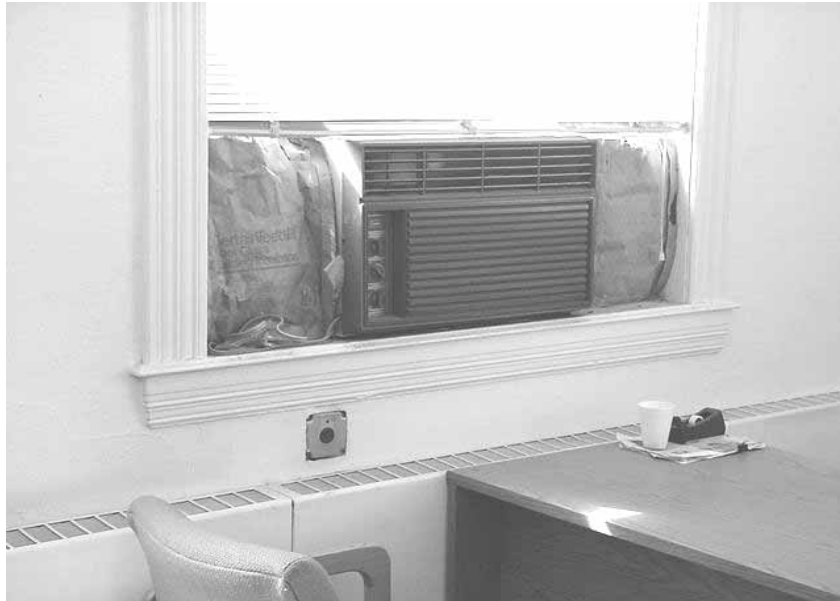
Picture 4

Window Mounted Air-Conditioner

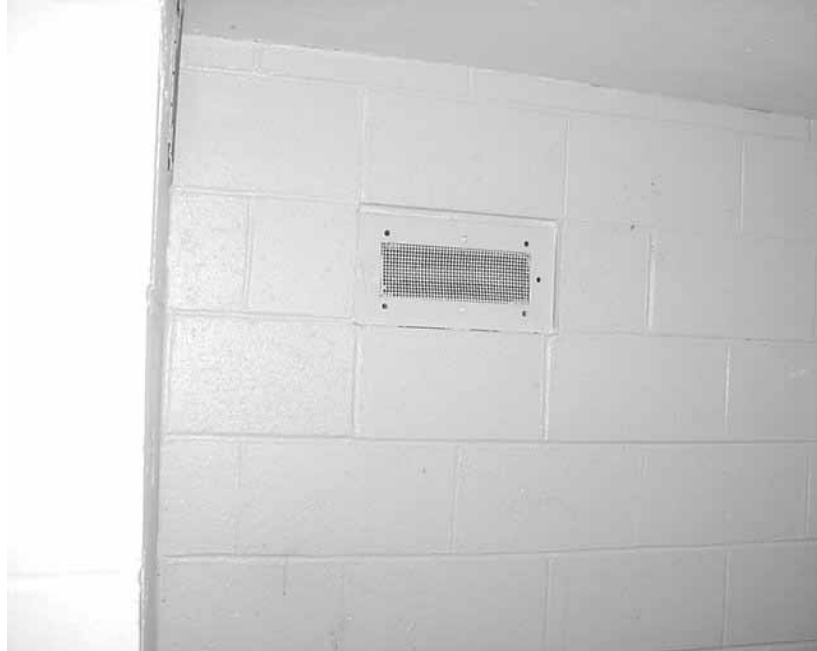
Picture 5

It appears that an exhaust fan was installed in the holding cell to remove odors (Picture 5) when the holding area was built. No transfer vents or undercuts exist in the doors to allow for the draw of air. Without a means to draw air from another area, the exhaust vent efficiency is reduced, resulting in a lack of air exchange, which can result in lingering odors.

Exhaust Vent, Holding Cell

- 1) Continue with plans to replace roof. Roof repair should include repair of holes.
- 2) Install passive vents or undercut doors in the holding area by at least 1-inch to provide transfer air.
- 3) Operate the retrofitted exhaust ventilation system during hours of operation. Install a timer to activate/deactivate this ventilation system.
- 4) Seal the closet exhaust vents to prevent backdrafting.
- 5) Consider the following actions as a means to prevent moisture penetration into the basement:
 - a) Repair/replace water damaged doors and plywood plugs in windows.
 - b) Install gutters along the access and downspouts to direct rainwater at least five feet away from the foundation.
 - c) Remove plastic beneath mulch along the edge of the building.
 - d) Remove mulch and accumulated debris to a level below basement windowsills.

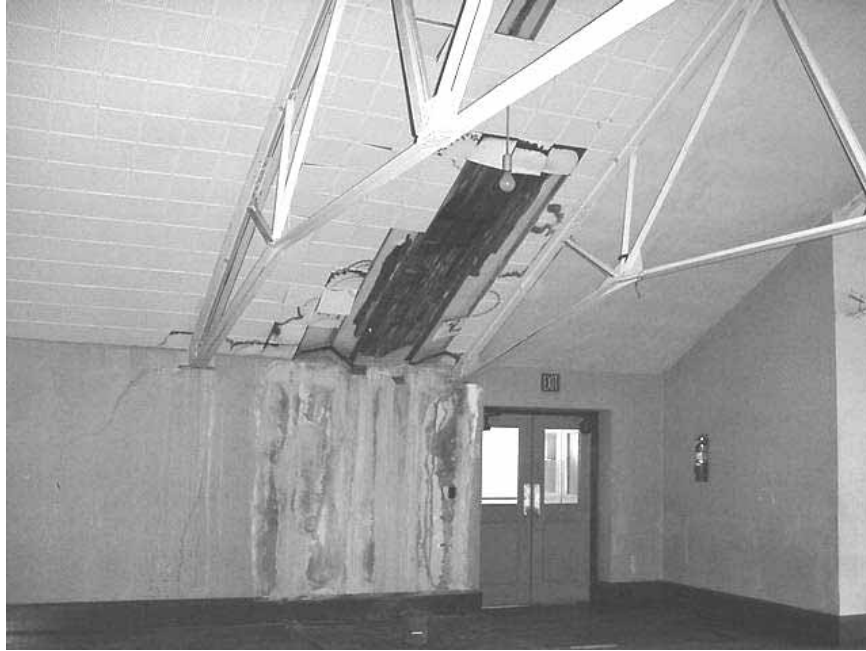
Picture 6

The WDC has a history of water penetration problems. Water damage was evidenced by third and second floor ceiling materials (Picture 6), walls (Picture 7) and flooring (Pictures 8 and 9), which have been attributed to roof leaks. A small amount of water damage to ceiling tiles was observed in the clerk's office, possibly attributed to these roof leaks. While the water damage to the second and third floors is extensive, it does not appear to be causing the problem that prompted the assessment (e.g., water pooling in the holding area). According to AOTC staff, funding was obtained for roof repairs and action was pending by the Town of Ware.

Water Damage to Ceiling, Third Floor

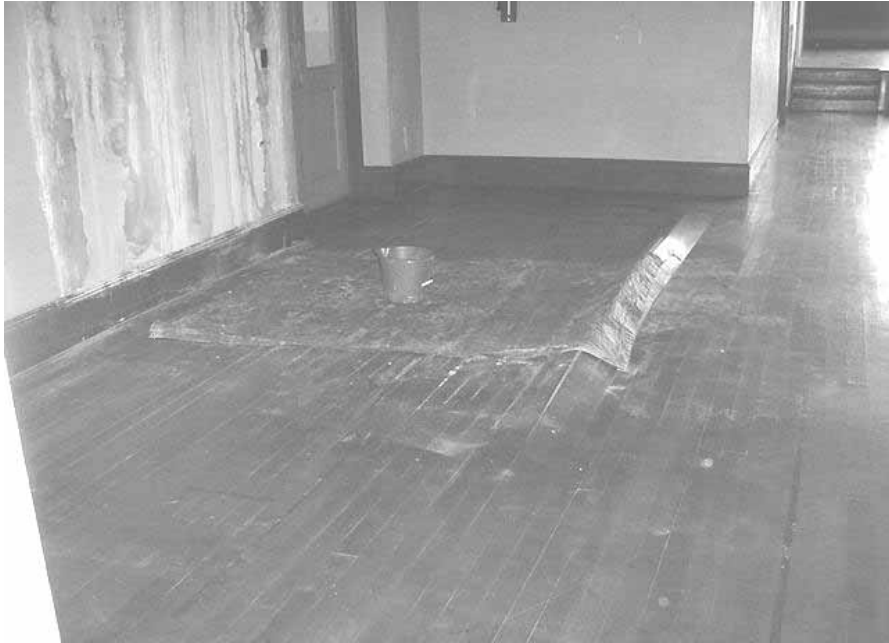
Picture 7

Water Damaged Floor, Third Floor

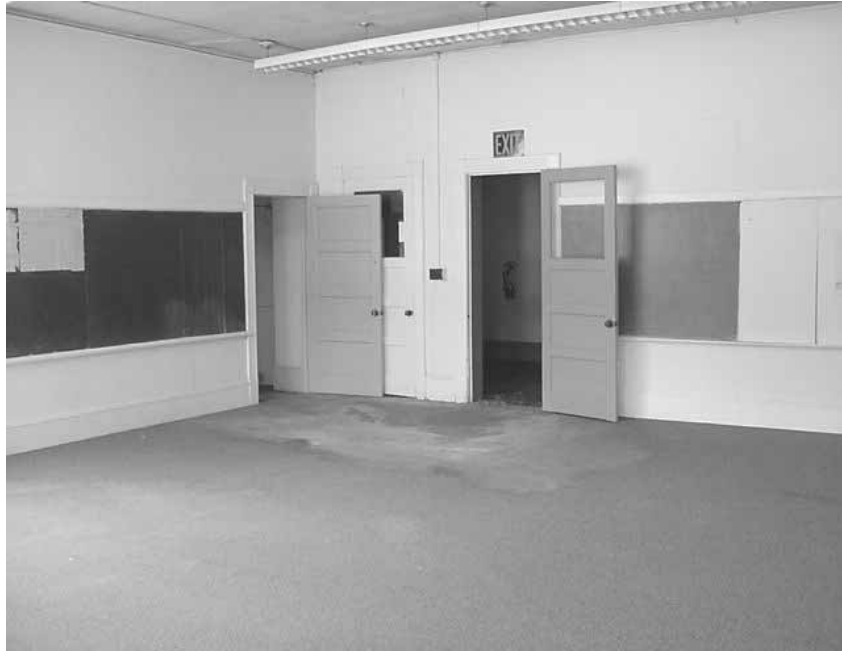
Picture 8

Water Damaged Carpet, Second Floor

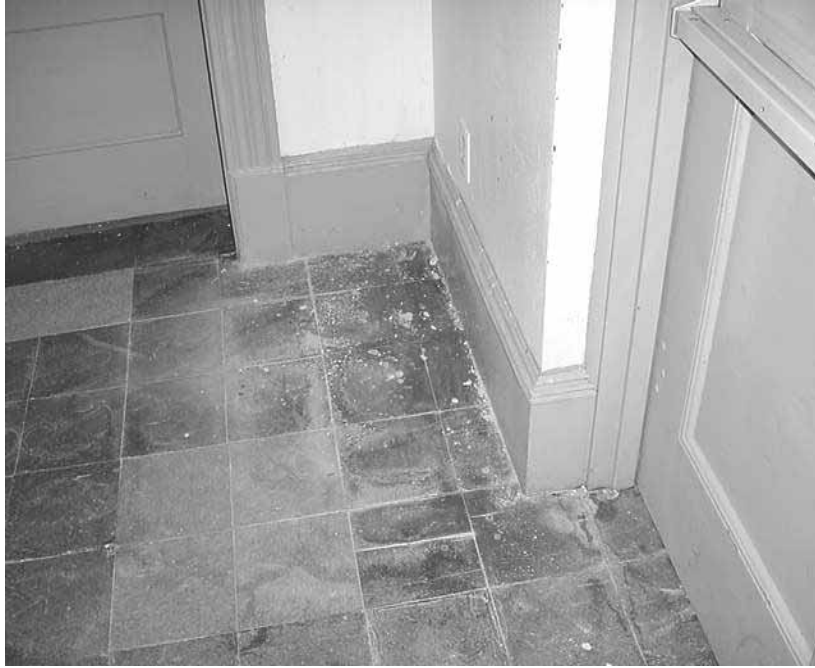
Picture 9

Water Damage Floor Tile in Hallway, Second Floor

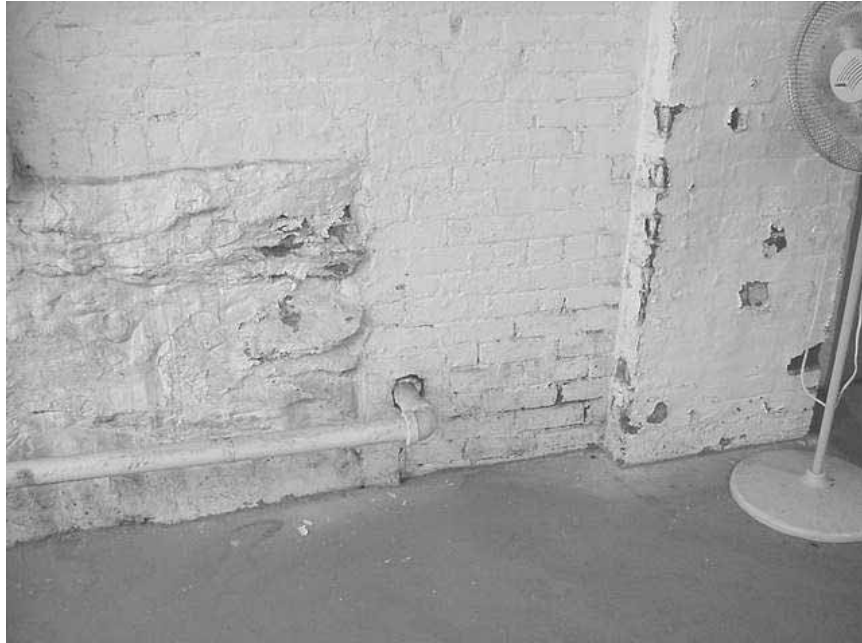
Picture 10

The holding cell area was reported to accumulate standing water after rainfall. An examination of the holding area indicates that water most likely penetrates through the foundation (Picture 10). The roof is unlikely to be the source of water in the holding cells due to the absence of water staining on the walls and floors of the office immediately above this area. These areas would be stained if the leak originated from the roof that is three stories above the holding area. The following conditions indicate that the most likely source of water pooling in the holding cells is through the foundation:

- The water damage to the wall where the pooling begins is near the floor/wall junction. This type of pattern is typical of water penetration through the foundation rather than a roof leak. If a roof leak were the source, water damage would be likely creating stains from the origin of the leak to the basement.

Water Damage to Holding Area Base of Wall, In an Area of the Foundation below Grade

Based on these observations, ensuring appropriate drainage outside the holding areas and re-establishing the integrity of the sealed windows and access door frame should prevent further water penetration.

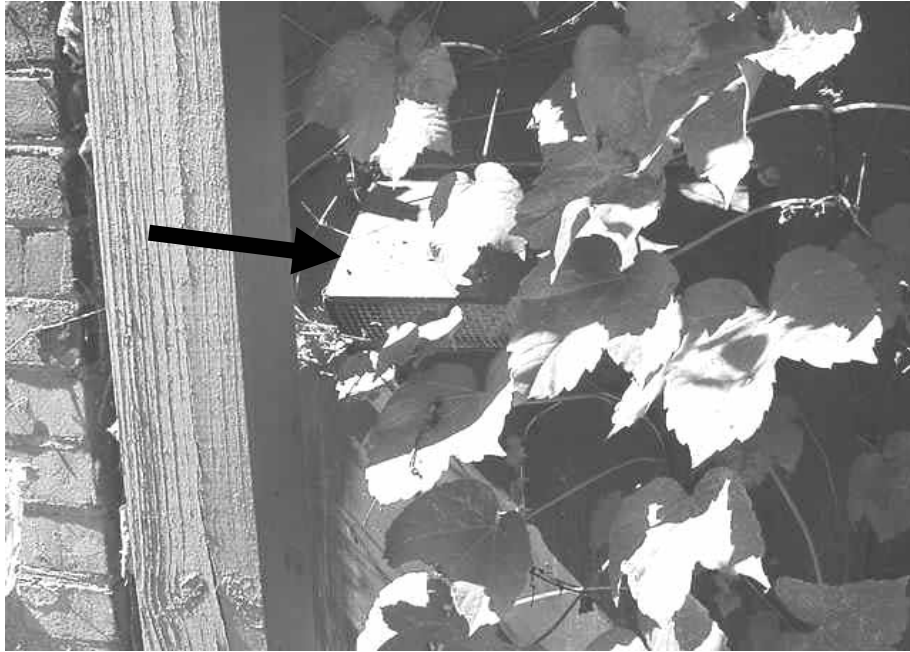
Picture 11

- Two windows in the holding area were sealed externally with plywood (Picture 11). The plywood appeared to be heavily water damaged and splaying. In this condition, water can easily penetrate between the window frame and plywood.

Basement Windows Sealed With Plywood, Note Holding Cell Exhaust Vent

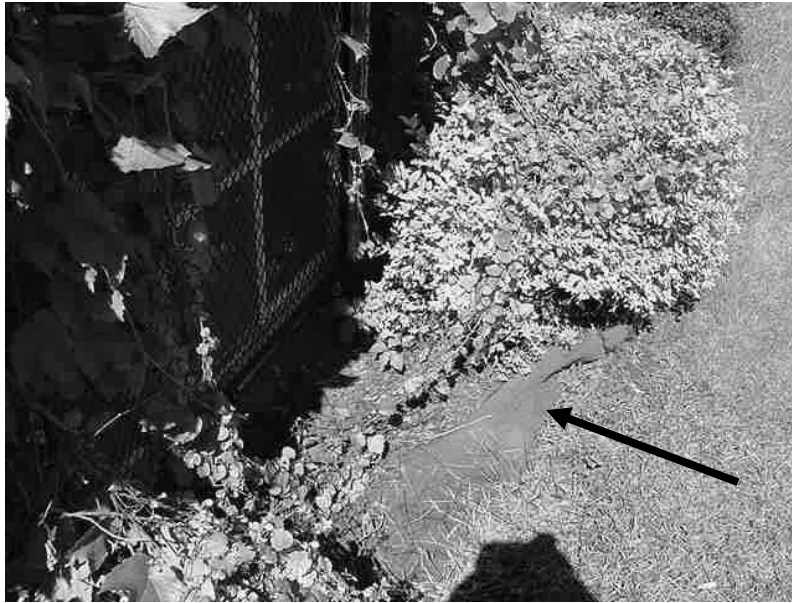
Picture 12

- The access ramp provides a water impermeable surface that under wind driven rain conditions, can direct water towards the foundation.
- A plastic material was placed under mulch outside this area to keep the soil moist, therefore keeping the ground next to the foundation wet. (Picture 12).

Plastic Material beneath Wood Chips

- e) Remove foliage to no less than five feet from the foundation.
 - f) Improve the grading of the ground away from the foundation at a rate of 6 inches per every 10 feet (Lstiburek & Brennan, 2001).

- g) Install a water impermeable layer on ground surface (clay cap) to prevent water saturation of ground near foundation (Lstiburek & Brennan, 2001).

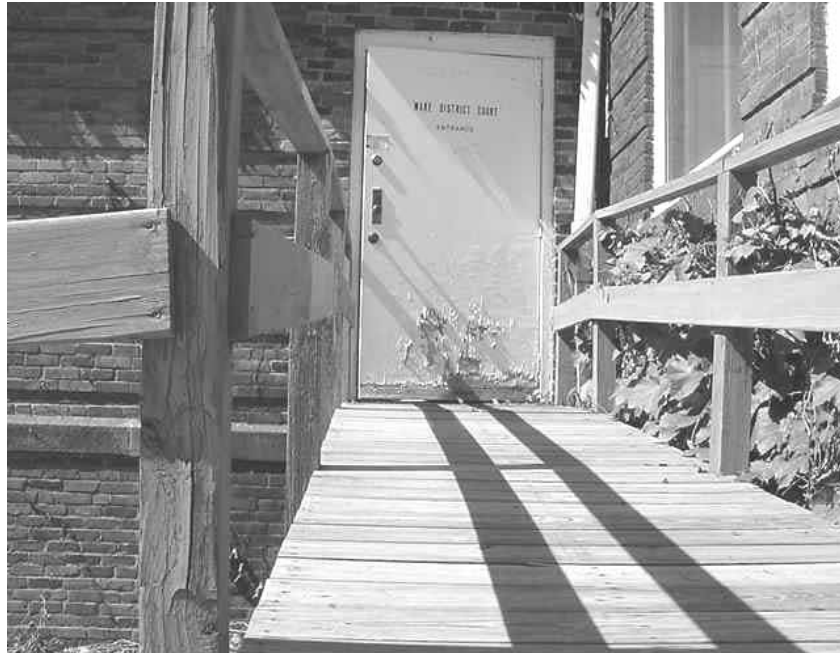
Picture 13

- The door for the access ramp was severely water damaged at its base (Picture 13).
This condition indicates that rain-driven water has penetrated through the door/threshold.

Water Damage to Access Ramp Door, Above the Holding Cell

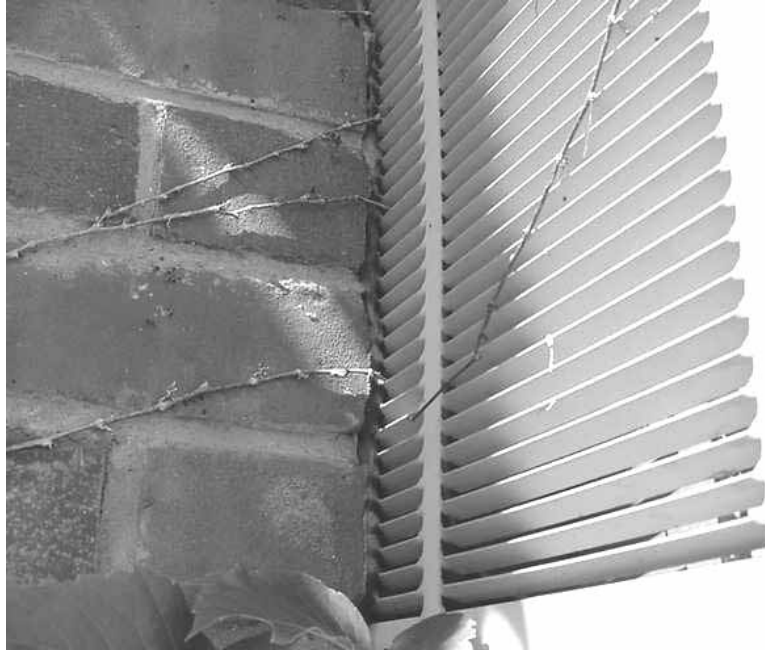
Picture 14

Installation of window mounted air conditioners (WACs) can also provide a possible means for water penetration into the building. A number of WACs were installed through exterior walls (Picture 14). It appears that the casing for some of these units are not of sufficient width, since fixed vent vanes used to cool the WAC compressor are partially enclosed by the exterior brick wall. In this condition, rainwater may pass around the sealant installed over the fixed vanes. Spaces were also seen around materials used to install WACs in windows (Picture 15), which can allow water, outdoor pollutants and insects into the building.

Air Conditioner Cabinet with Fixed Louvers Inside Building Envelope

- 9) Replace WAC cases with casings that extend vent louvers for the compressor beyond the exterior brick wall. Establish water tight installation for WACs.

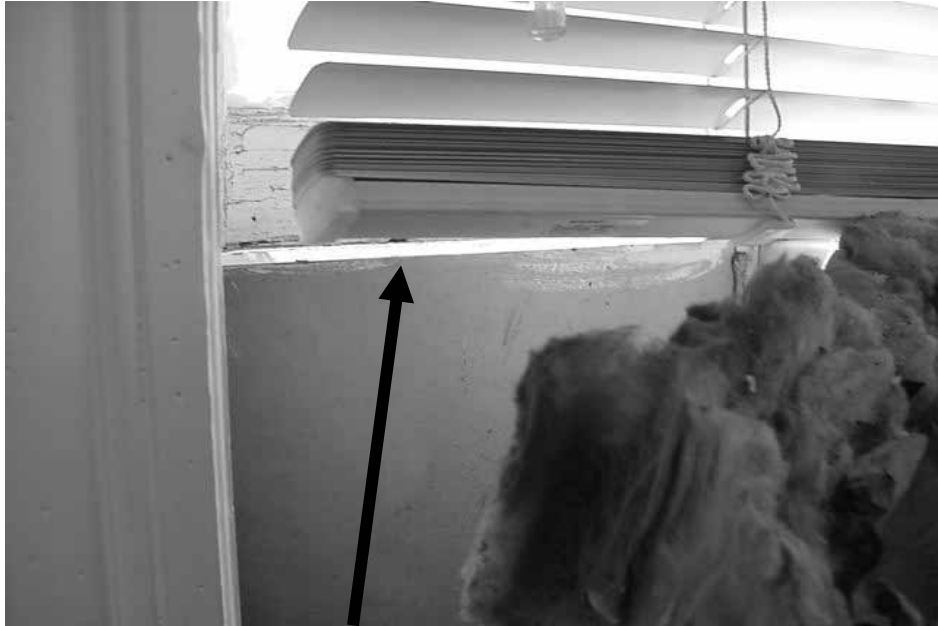
Picture 15

Spaces around WAC

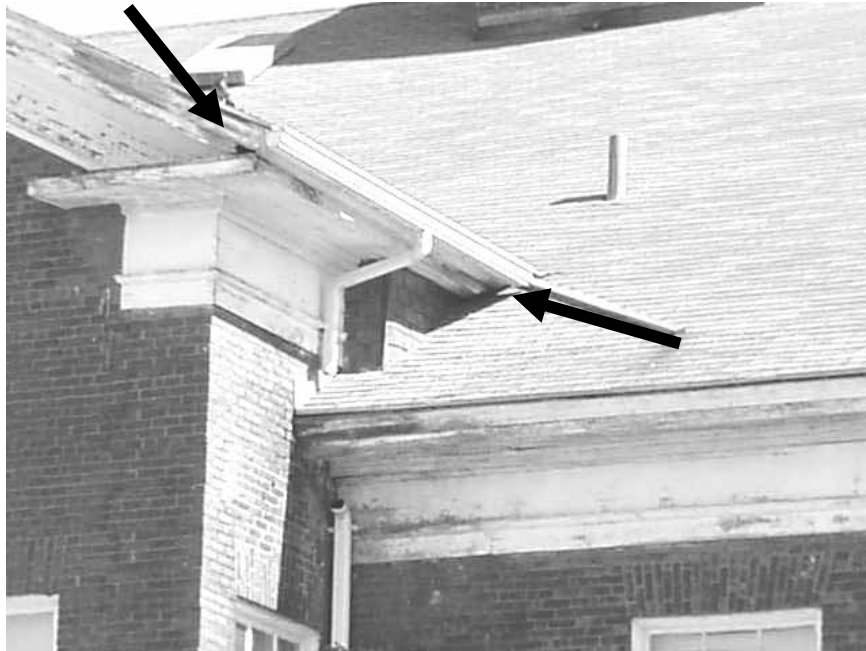
Picture 16

An examination of the attic found animal wastes on flat surfaces, which is an indication of bat and/or bird infestation. CEH staff observed birds entering holes in the west gable and soffit of the roof (Pictures 16 and 17). Animal wastes and dander can be a source of disease. Roosting of bats and/or birds inside the building should be prevented.

Holes in Gable of WDC, West Roof

- 12) Have the attic examined by a licensed pest control company in order to ascertain whether a bat and/or bird infestation exists. Seal all means of ingress/egress into the attic to prevent bat infestation. Clean bat and bird waste from attic space.
- 13) Refer to resource manuals and other related indoor air quality documents for further building-wide evaluations and advice on maintaining public buildings. These materials are located on the MDPH's website at <http://www.state.ma.us/dph/beha/iaq/iaqhome.htm>.

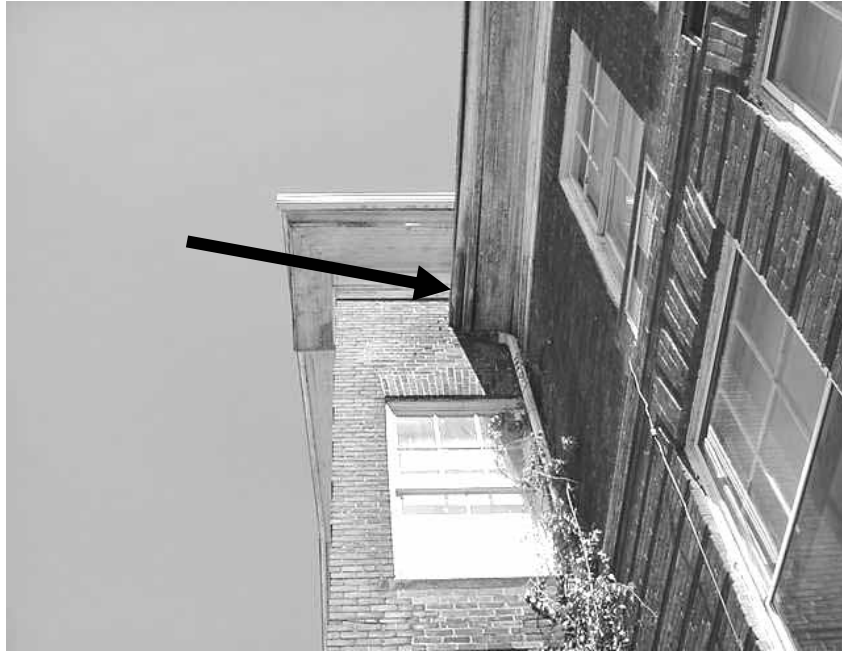
Picture 17

Hole in Soffit of WDC, West Roof
