# **INDOOR AIR QUALITY ASSESSMENT**

**Malden Government Center  
200 Pleasant Street  
Malden, Massachusetts**

Prepared by:  
Massachusetts Department of Public Health  
Center for Environmental Health  
Emergency Response/Indoor Air Quality Program  
September 2005

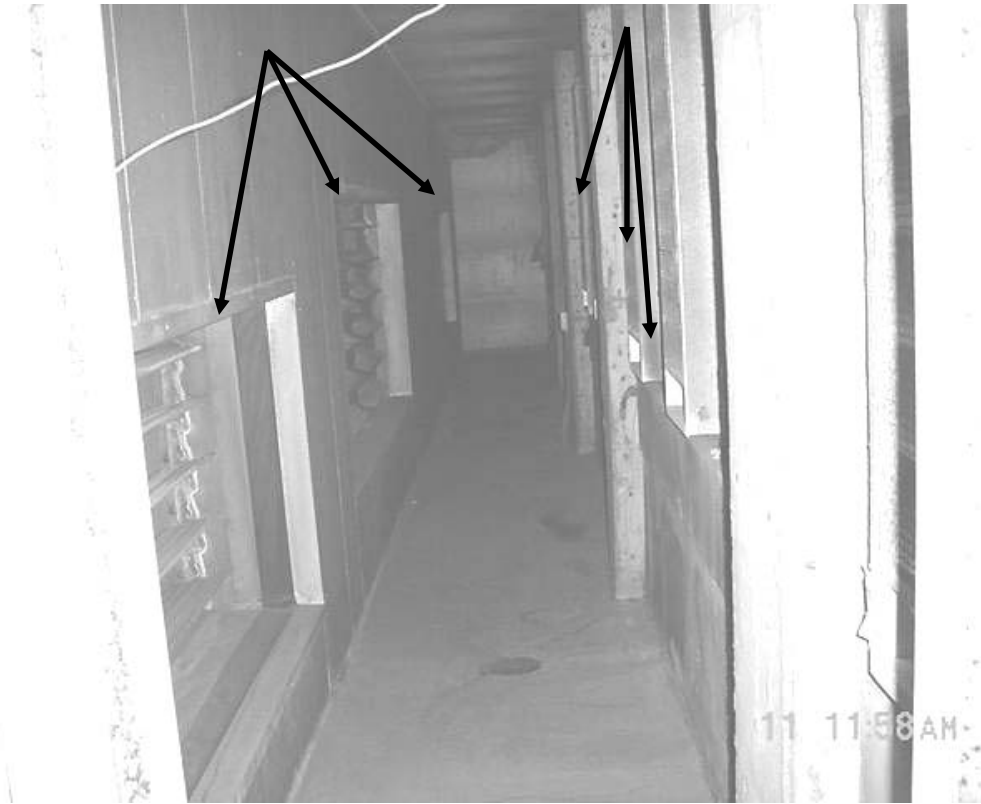
**Picture 1**

Ventilation is provided by a heating, ventilation and air-conditioning (HVAC) system. Air handling units (AHUs) located in a mechanical room on the sixth floor provide fresh conditioned air. The AHUs draw air from the outside through an air intake (Picture 1). Air is then filtered, heated or cooled then supplied to occupied areas through round floor vents or air diffusers (Pictures 2 and 3) located around the perimeter of the building. Return air is drawn into a ceiling plenum through slots around lighting fixtures (Picture 4) and drawn back to the AHUs via ductwork.

**AHU Fresh Air Intake Vents**

**Outside Air Intake Vents**

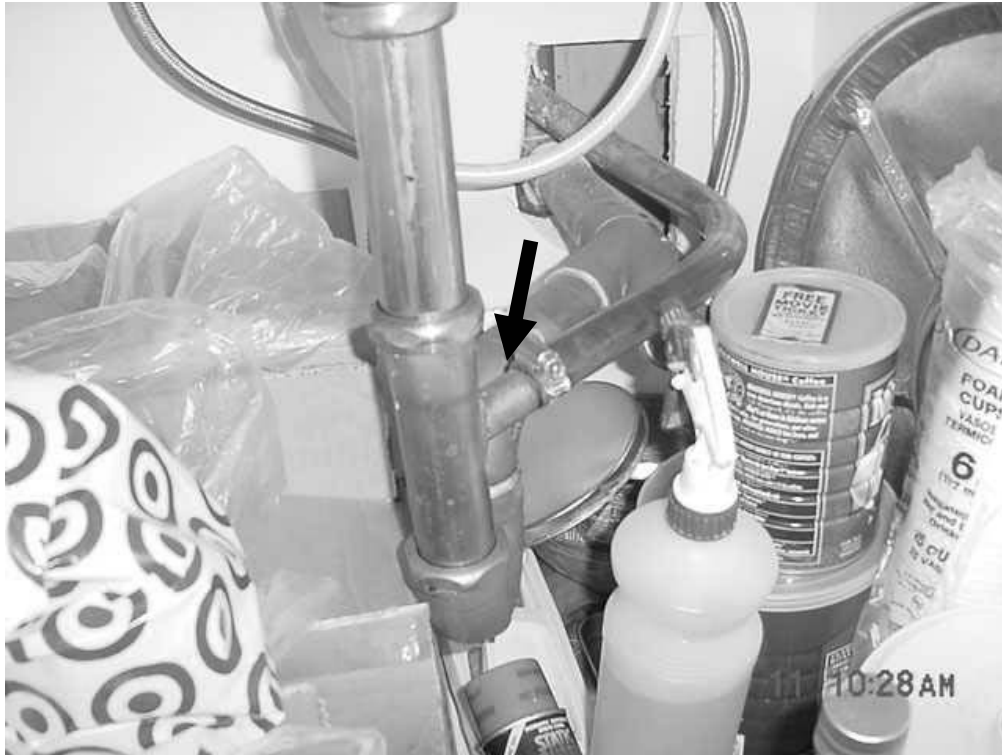
**Picture 7**

personnel/retirement area appears to be an area of reoccurring water damage through the building exterior. To collect incoming water a drain/gutter was installed above the ceiling tile system, which drains into the sink in the break room (Pictures 6 and 7). What appeared to be visible mold growth was observed growing inside the clear drainage tube (Picture 8).

**Temporary Drainage System above Ceiling Tiles in the Personnel/Retirement Area, Note Drain at Bottom of Gutter**

10. Consult with an architect and or general contractor regarding the integrity of the building envelope, primarily concerning water penetration in the personnel/retirement area.

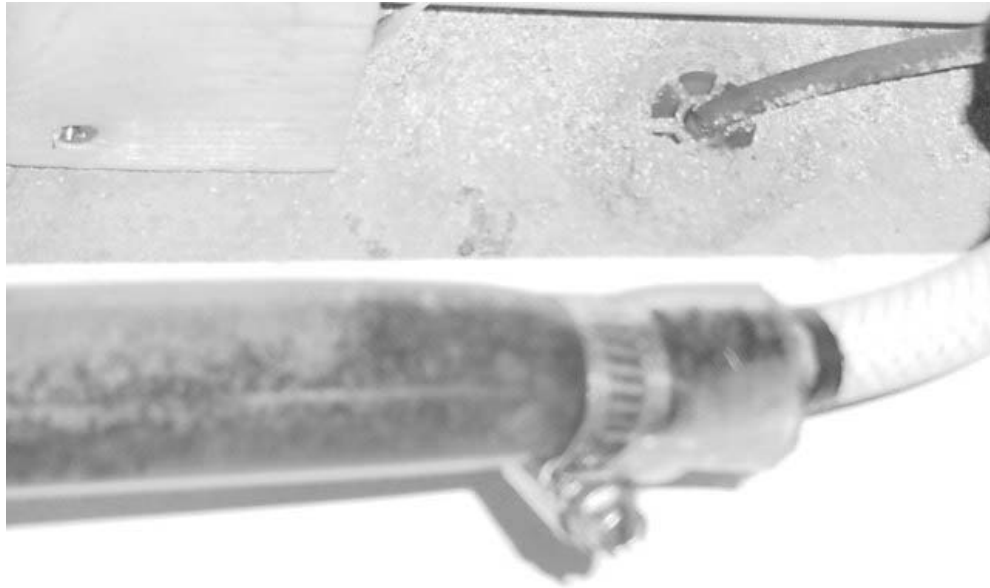
**Picture 8**

**Terminus of Hose from Temporary Drainage System in Previous Picture**

11. Change tubing for temporary drainage system in the personnel/retirement area. Inspect periodically for microbial growth.
12. For buildings in New England, periods of low relative humidity during the winter are often unavoidable. Therefore, scrupulous cleaning practices should be adopted to minimize common indoor air contaminants whose irritant effects can be enhanced when the relative humidity is low. To control for dusts, a high efficiency particulate arrestance (HEPA) filter equipped vacuum cleaner in conjunction with wet wiping of all surfaces is recommended. Avoid the use of feather dusters. Drinking water during the day can help ease some symptoms associated with a dry environment (throat and sinus irritations).

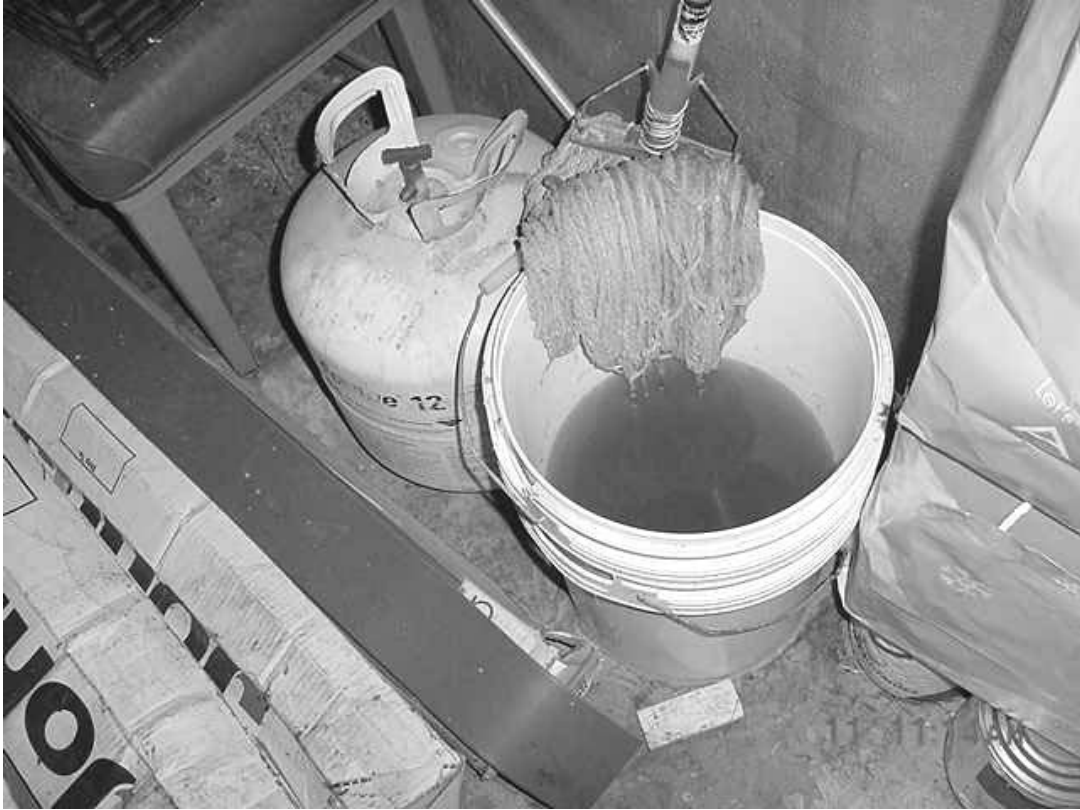
**Picture 12**

Several other conditions were noted during the assessment, which can affect indoor air quality. Exposed insulation that may contain asbestos was observed on pipes in the mechanical room near the kitchen (Pictures 11). Upon discovery, MDPH staff recommended that the material be inspected by a licensed asbestos inspector as soon as practicable. Also noted in this mechanical room were mop buckets with stagnant water, which can provide a source of unpleasant odors, and a propane tank which is a flammable material that should be stored in accordance with National Fire Prevention Agency (NFPA) recommendations (Picture 12).

**Exposed Insulation Material in Mechanical Room near Kitchen**

1. Ascertain whether the pipe insulation in the basement and sub-basement contains asbestos and encapsulate or remove in conformance with Massachusetts asbestos abatement laws.
2. Change filters for HVAC equipment as per the manufacturer's instructions or more frequently if needed.
