# INDOOR AIR QUALITY ASSESSMENT

**Oaklandvale Elementary School  
226 Main Street  
Saugus, Massachusetts 01906**

Prepared by:  
Massachusetts Department of Public Health  
Center for Environmental Health  
Emergency Response/Indoor Air Quality Program  
August 2006

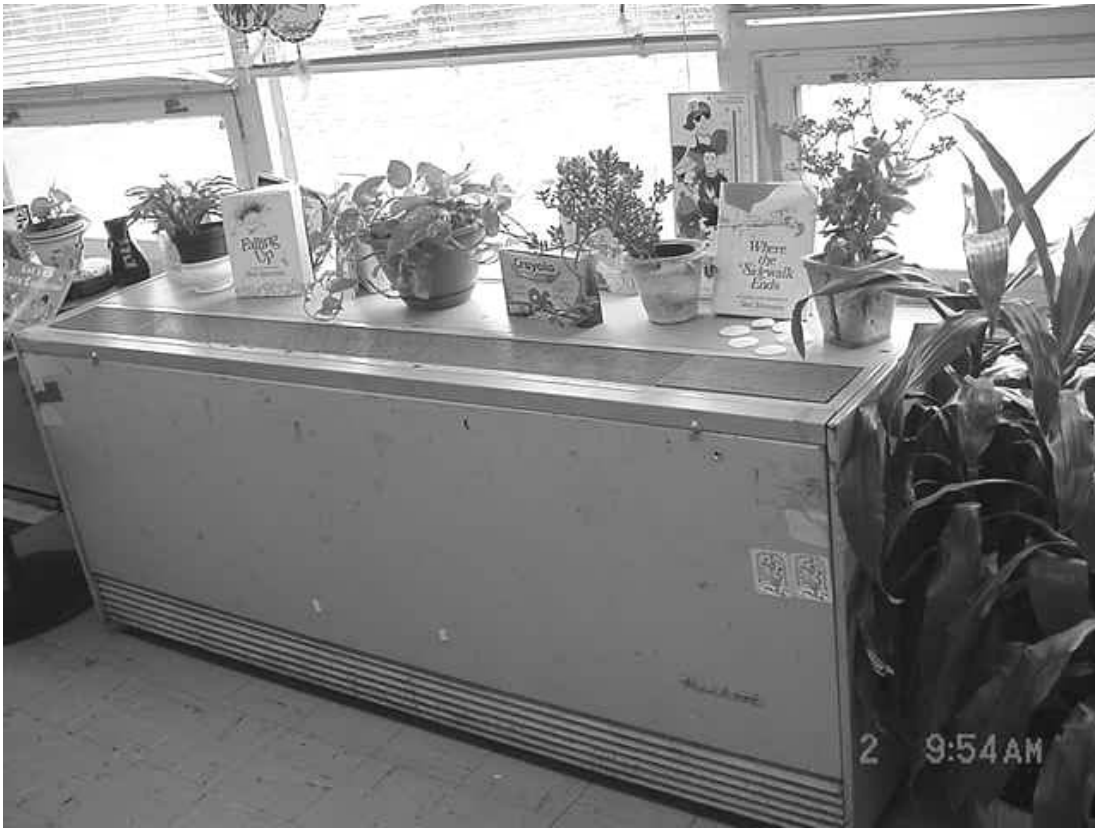
**Picture 1**

**Classroom Univent, 1960s Vintage, Note Plants near Air Diffuser**

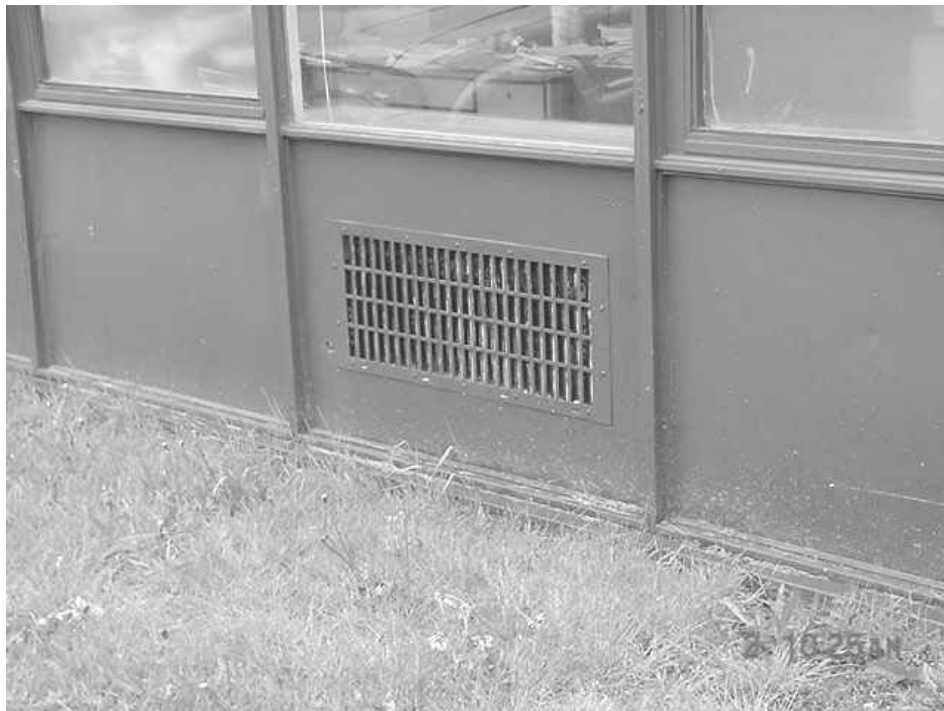
**Picture 2**

**Univent Fresh Air Intake**

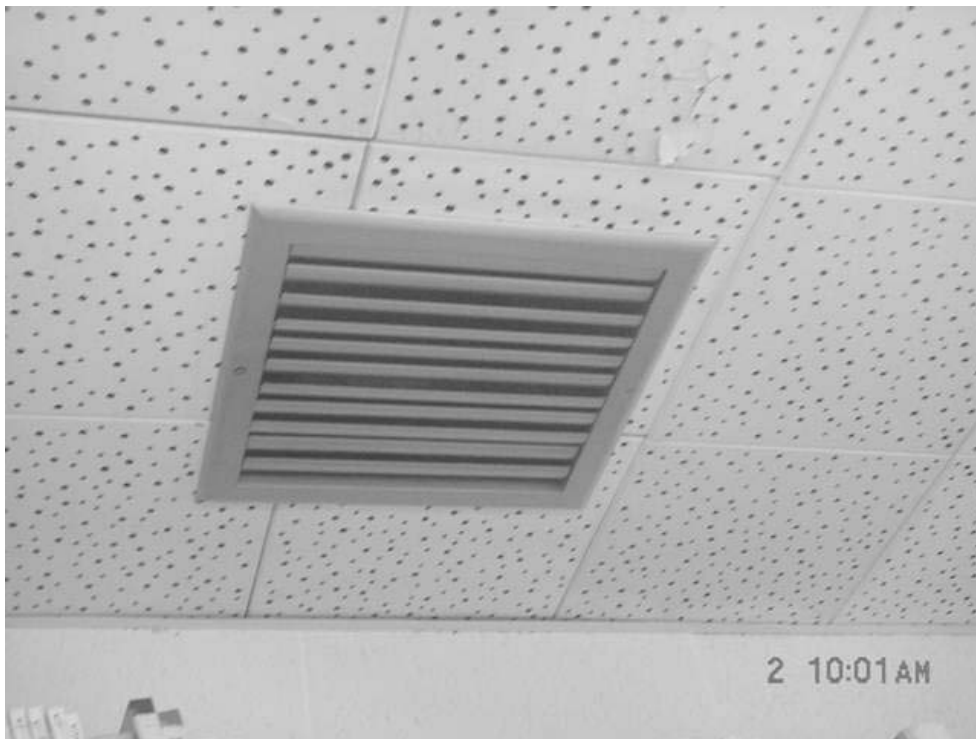
**Picture 3**

**Ceiling-Mounted Univent Louvers**

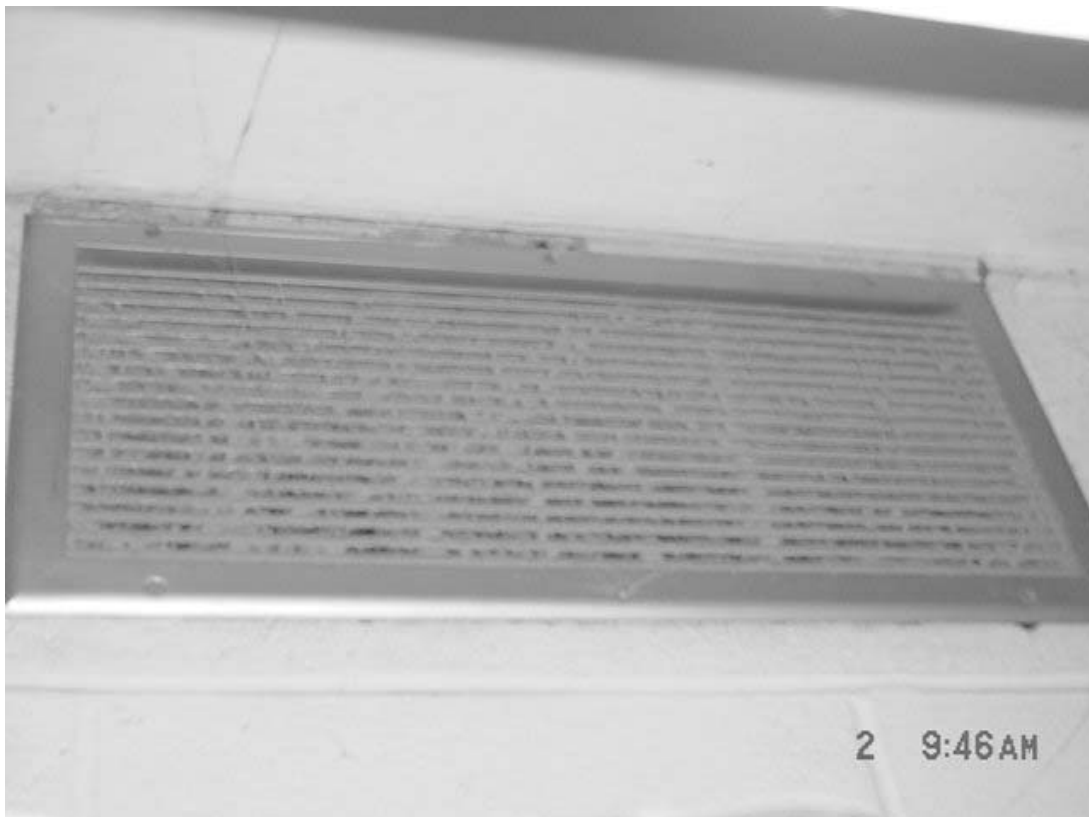
**Picture 4**

Exhaust ventilation is provided by vents located in the ceilings of coat closets (Picture 4) and are powered by rooftop motors. Air is drawn into the coat closet from the classroom via undercut closet doors (Picture 5). MDPH staff did not detect any draw of air from the exhaust vents at the time of the assessment. A call was made to the town electrician who determined that exhaust ventilation in these areas was inadvertently deactivated by a wall panel (Picture 6). The location of the closet vents also allows them to be easily blocked by stored materials (Picture 7). However, it appears that an attempt was made to increase airflow into the coat closet by installing small passive vents in the front of the coat closets (Picture 8). In order to function properly, exhaust vents must be activated and remain free of obstructions.

A number of exhaust/return vents and personal fans had accumulated dust (Pictures 4 and 16). If exhaust vents are not functioning, backdrafting can occur, which can re-aerosolize dust particles. Missing ceiling tiles were observed in a few areas (Picture 17). Missing ceiling tiles can serve as a means for odors, dusts and particulates to migrate into occupied areas.

**Exhaust Vent in Top of Classroom Coat Closet, Note Dust Build-Up**

18. Clean exhaust vents periodically to prevent excessive dust build-up.
19. Consider discontinuing the use of tennis balls on walker legs to prevent latex dust generation. Alternative “glides” can commonly be purchased from office supply stores, see Picture 19 for an example.
20. Consider adopting the US EPA document, “Tools for Schools” (US EPA, 2000b), to maintain a good indoor air quality environment on the building. This document can be downloaded from the Internet at:  
<http://www.epa.gov/iaq/schools/index.html>.
21. Refer to resource manuals and other related indoor air quality documents for further building-wide evaluations and advice on maintaining public buildings. These materials are located on the MDPH’s website at  
<http://www.state.ma.us/dph/CEH/iaq/iaqhome.htm>.

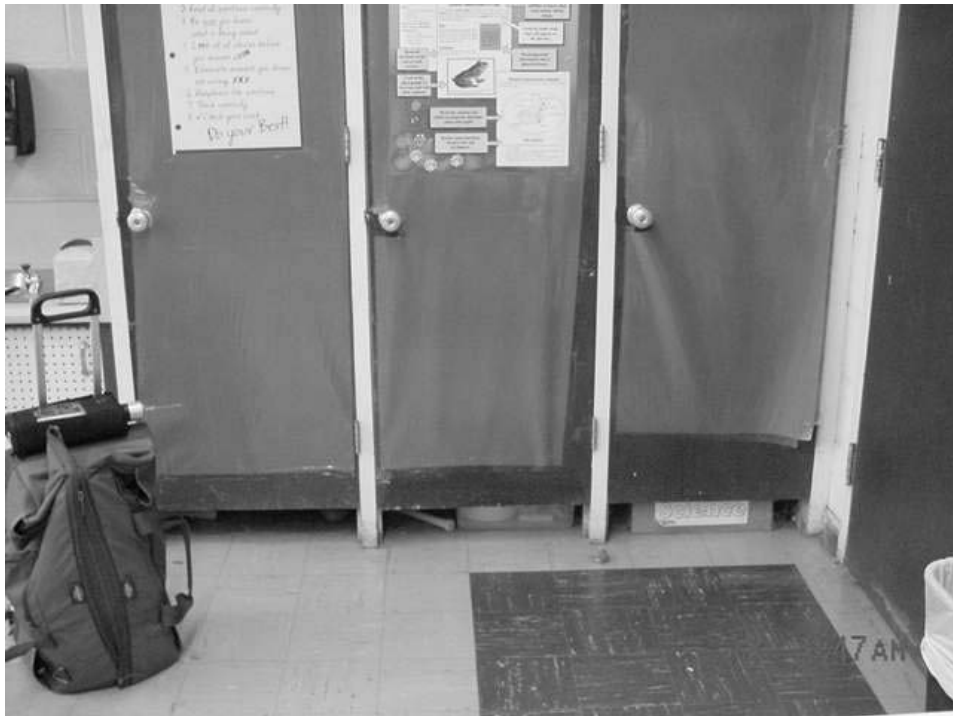
**Picture 5**

**Long-View of Undercut Coat Closet, Note Materials at Bottom Obstructing Airflow**

6. Remove all blockages from the vicinity of coat closet exhaust vents to ensure adequate airflow.
7. Consider having ventilation systems re-balanced every five years by an HVAC engineering firm.

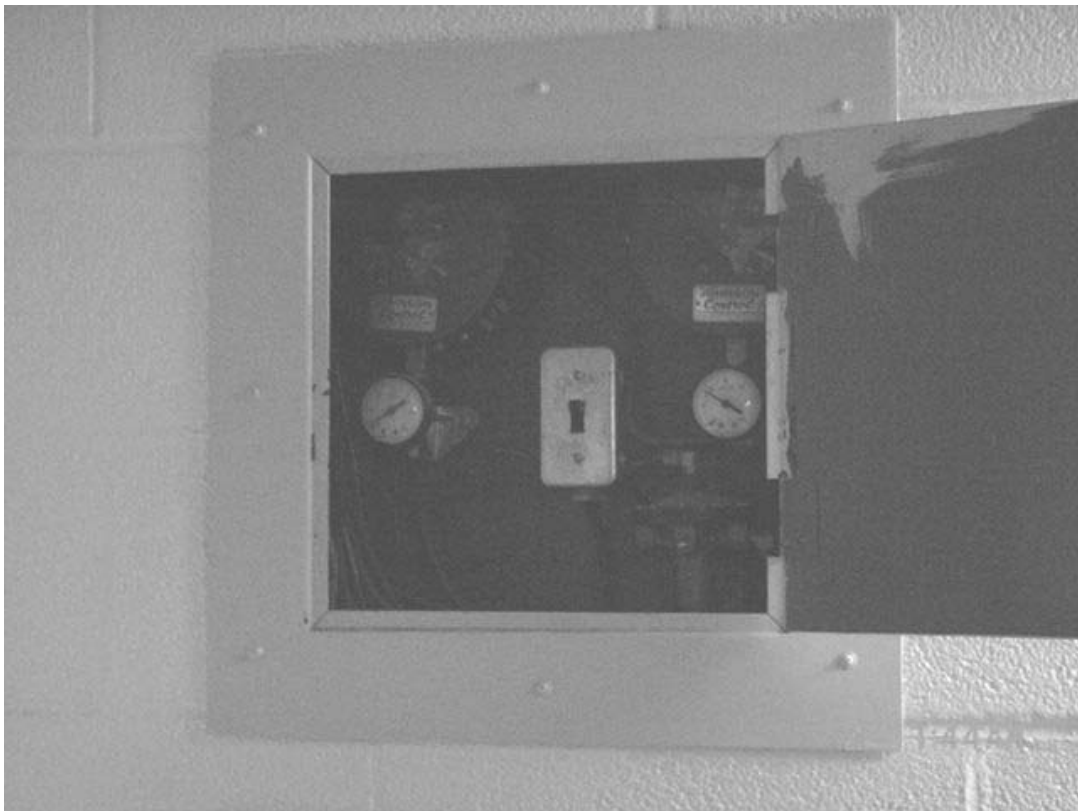
**Picture 6**

**Wall Panel Deactivating Coat Closet Exhaust Vents**

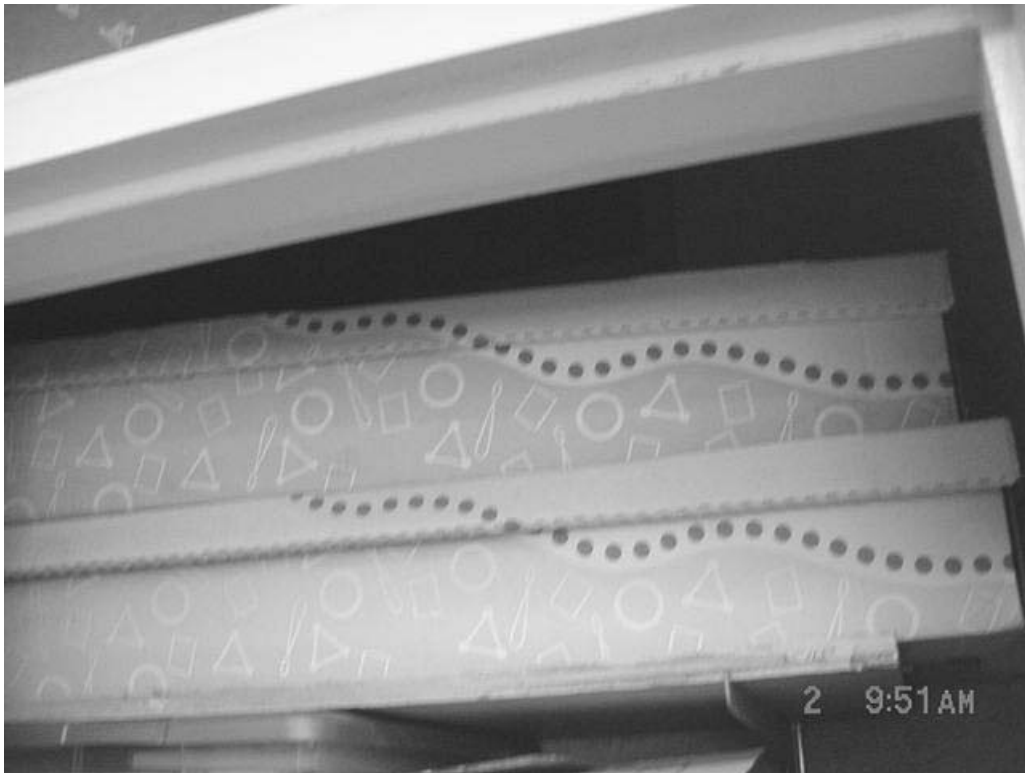
**Picture 7**

**Boxes on Top Shelf of Coat Closet Obstructing Airflow into Coat Closet Exhaust Vent**

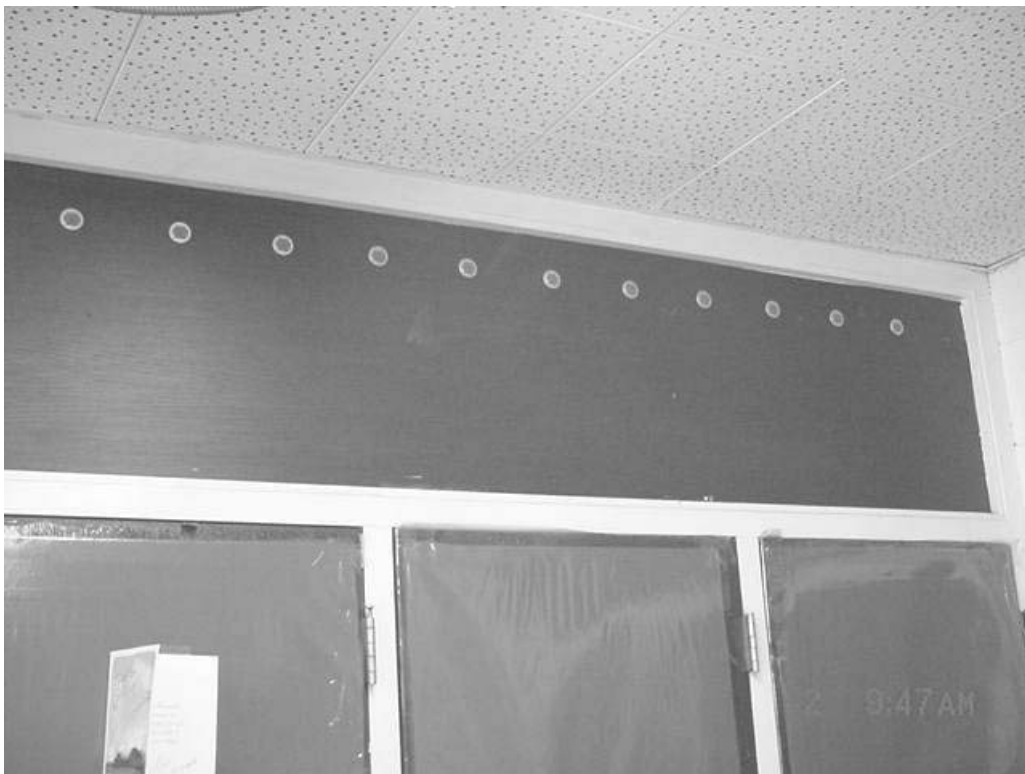
**Picture 8**

**Small Round Vents Installed in an Attempt to Increase Airflow into Coat Closet Vents**

4. Consider installing ducted exhaust grills to the face of coat closets to improve air exchange.
5. Remove all blockages from univents to ensure adequate airflow.

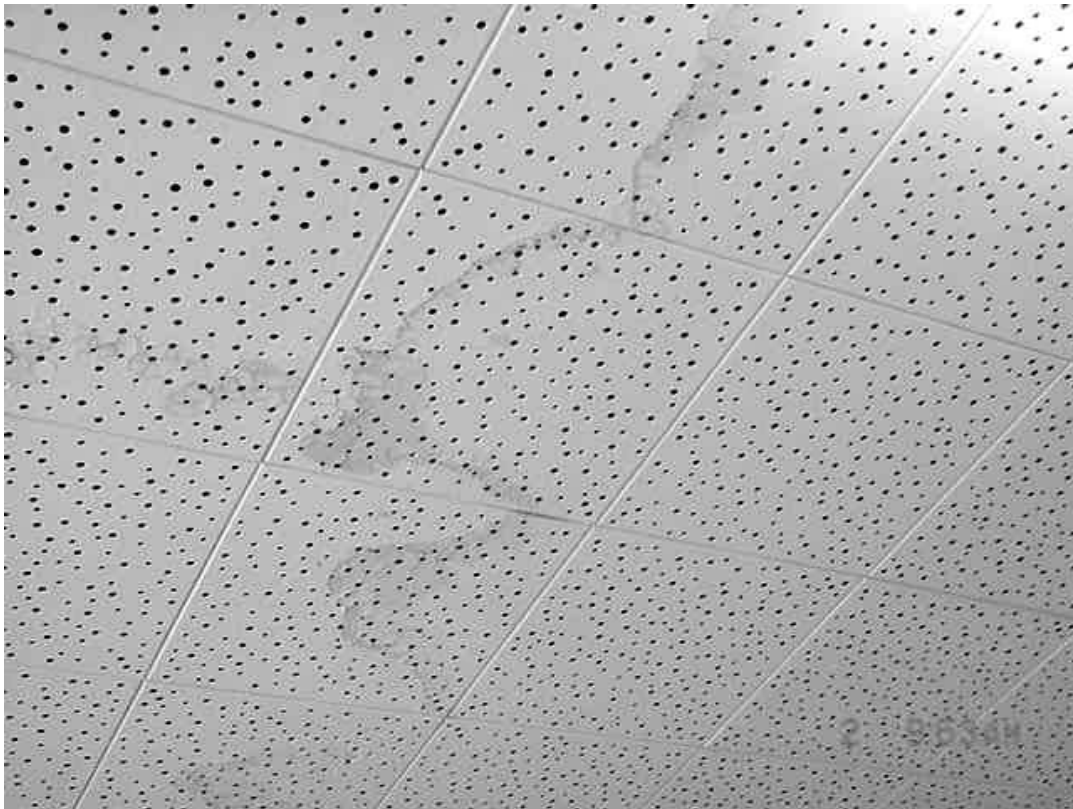
**Picture 9**

Water damaged ceiling tiles were observed in a number of areas (Picture 9), indicating evidence of historic leaks. The assessment occurred during a period of moderate to heavy rainfall; no leaks were reported or observed at that time. Water damaged ceiling tiles can provide a source of mold and should be replaced after a water leak is discovered and repaired.

**Water Damaged Interlocking Ceiling Tiles**

10. Relocate bird feeders away from univent air intake.
11. Ensure roof and /or plumbing leaks are repaired and replace any remaining water-stained ceiling tiles.

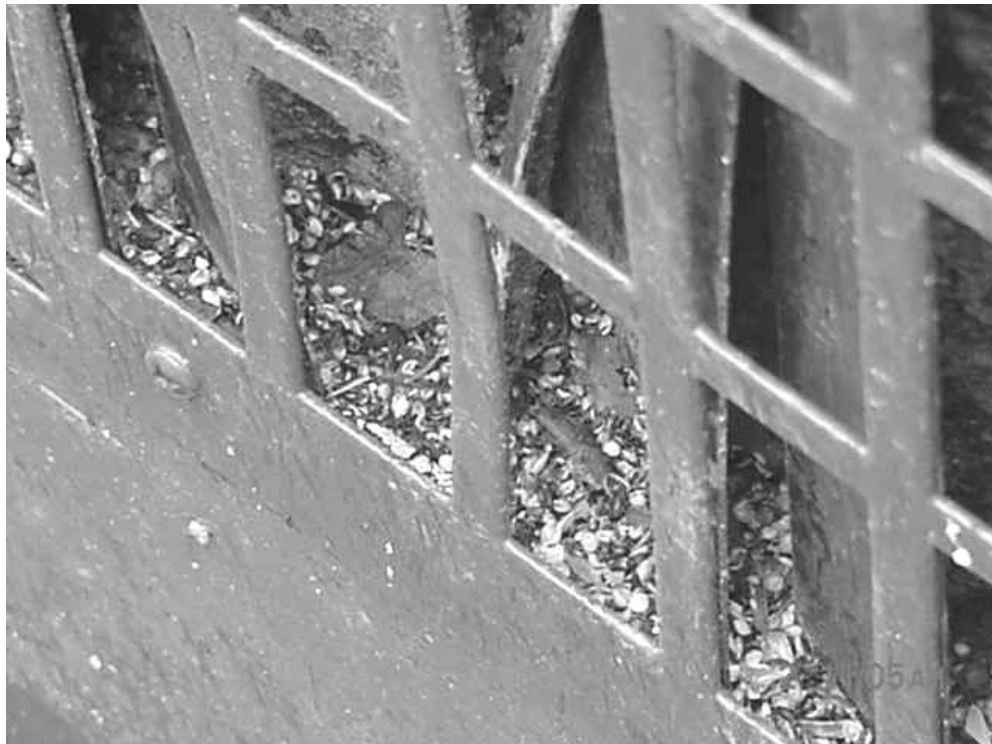
**Picture 10**

Plant debris (and bird seed from a feeder outside of room 18) was observed on the inner lip of univent air intakes (Picture 10) on the exterior of the building. The design of the fresh air intakes allows for debris to accumulate inside the grilles. If wetted repeatedly, this can create conditions for mold growth, which can in turn be drawn into univents and distributed into occupied areas.

**Plant Debris and Bird Seed in Univent Air Intake outside of Classroom 18**

12. Seal spaces around exterior window frames and wall panels.
13. Seal/repair cracks in brickwork.
14. Clean and disinfect univent fresh air intakes regularly. Consider replacing univent fresh air intake grills with an alternative design to prevent the accumulation of debris.

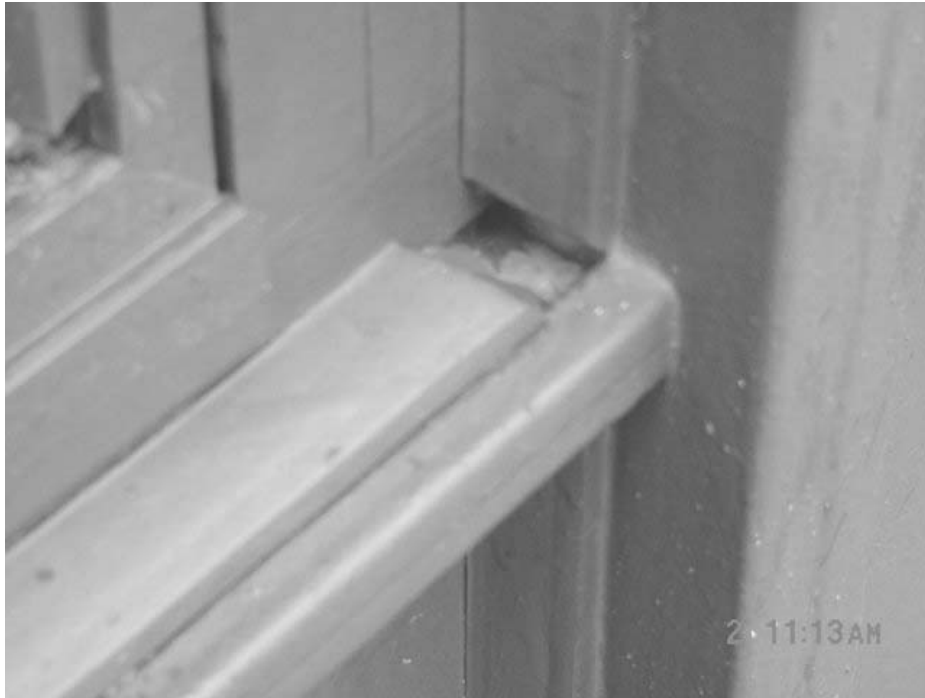
**Picture 11**

Several other potential pathways for moisture to enter the building were identified. CEH staff observed spaces between wall/window panels in exterior walls (Pictures 11 and 12) and cracks in brickwork toward the rear of the building (Pictures 13). Repeated water penetration can result in the chronic wetting of building materials, which can potentially lead to microbial growth. In addition, these breaches in the building envelope can provide a means of egress for pests/rodents into the building.

**Spaces between Exterior Wall Panels (see Picture 13 for Comparison)**

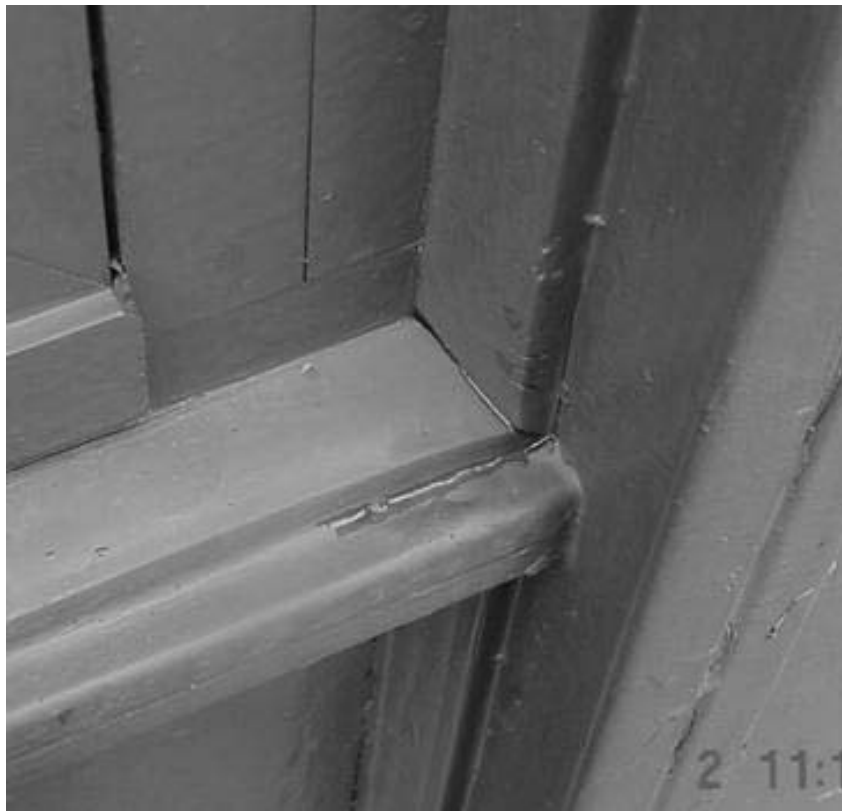
**Picture 12**

**Exterior Wall Panel Sealed**

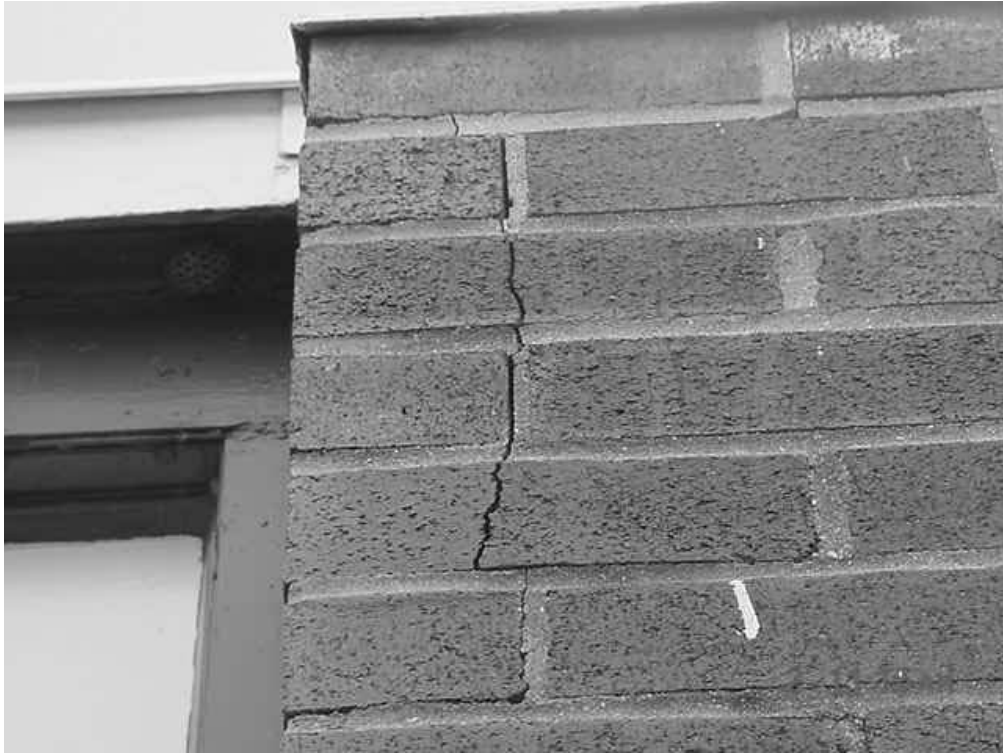
**Picture 13**

**Exterior Wall Crack on Rear of Building**

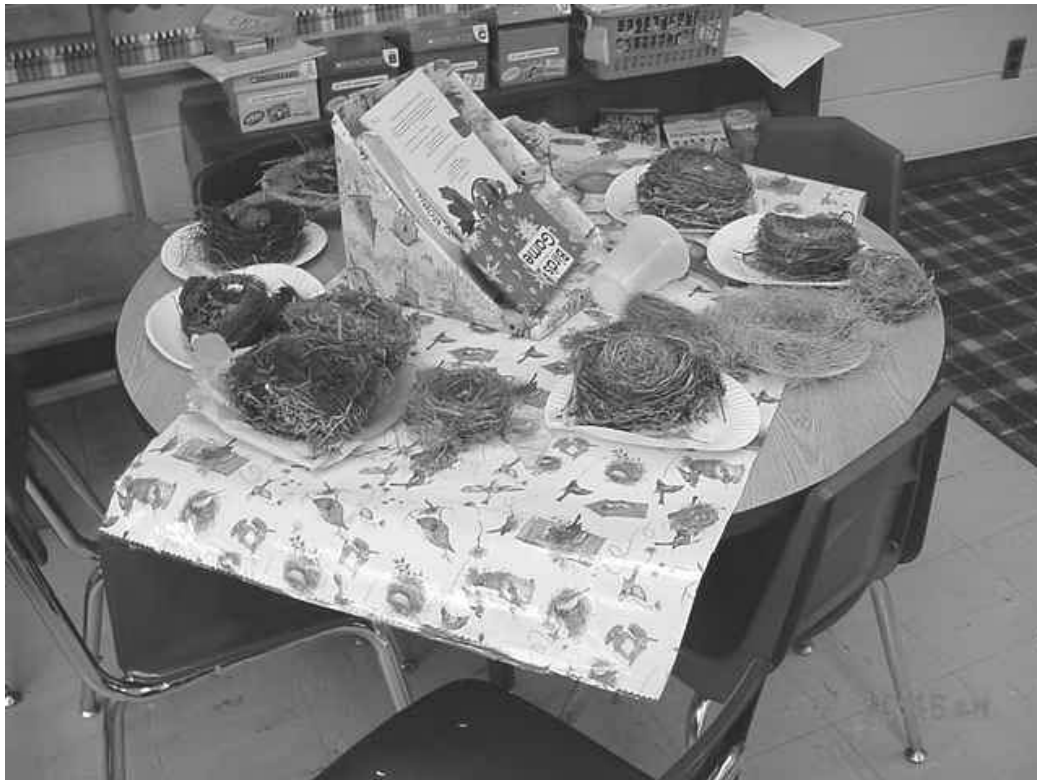
**Picture 14**

Inactive bird's nests were seen in a few classrooms (Picture 14). Nests can contain bacteria and may be a source of allergenic material. Nests should be placed in resealable bags to prevent aerosolization of allergenic material.

**Bird's Nests in Classroom**

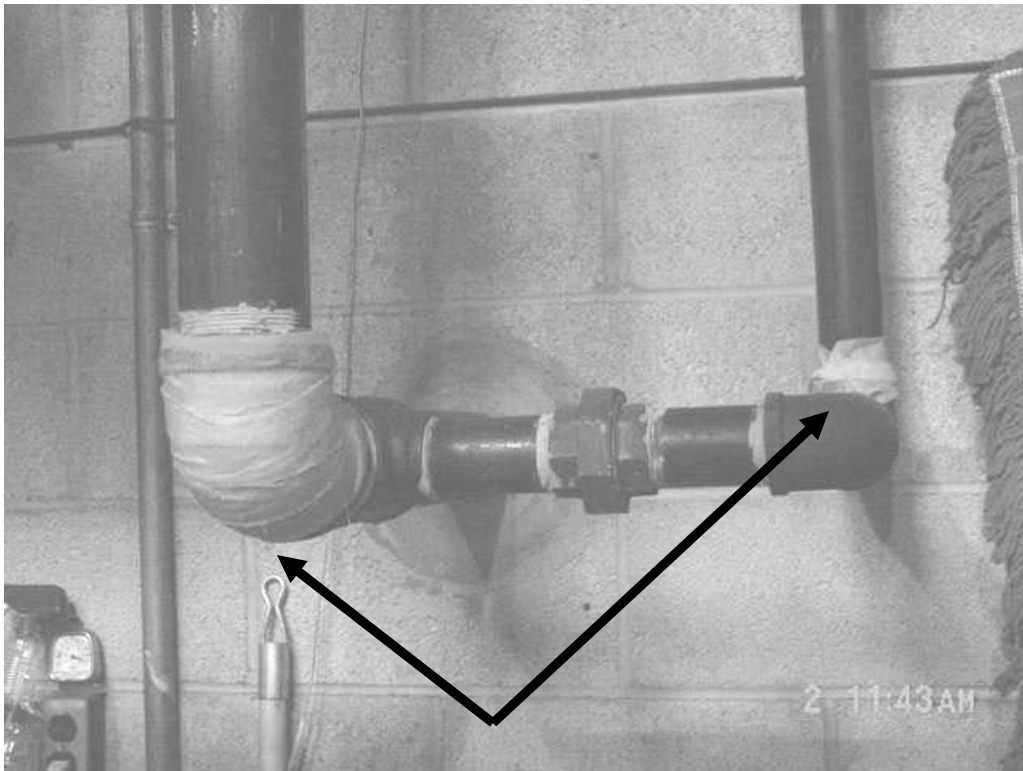
**Picture 15**

Several other conditions that can affect indoor air quality were noted during the assessment. A slight natural gas odor was detected in the boiler room. CEH staff reported this finding to Mr. Materissi, who contacted the school's utility company, Keyspan. A Keyspan representative arrived shortly after and identified two small hairline fissures in the natural gas piping, which were subsequently sealed by the Saugus Building Department staff member under the direction of Keyspan (Picture 15).

**Natural Gas Pipes Sealed by Saugus Building Department**

1. Make permanent repairs to gas pipes in boiler room.
2. Continue with plans to have an HVAC engineering firm evaluate the mechanical ventilation systems. Examine each univent for function. Survey classrooms for univent function to ensure the calibration/function of univent fresh air control dampers throughout the building.

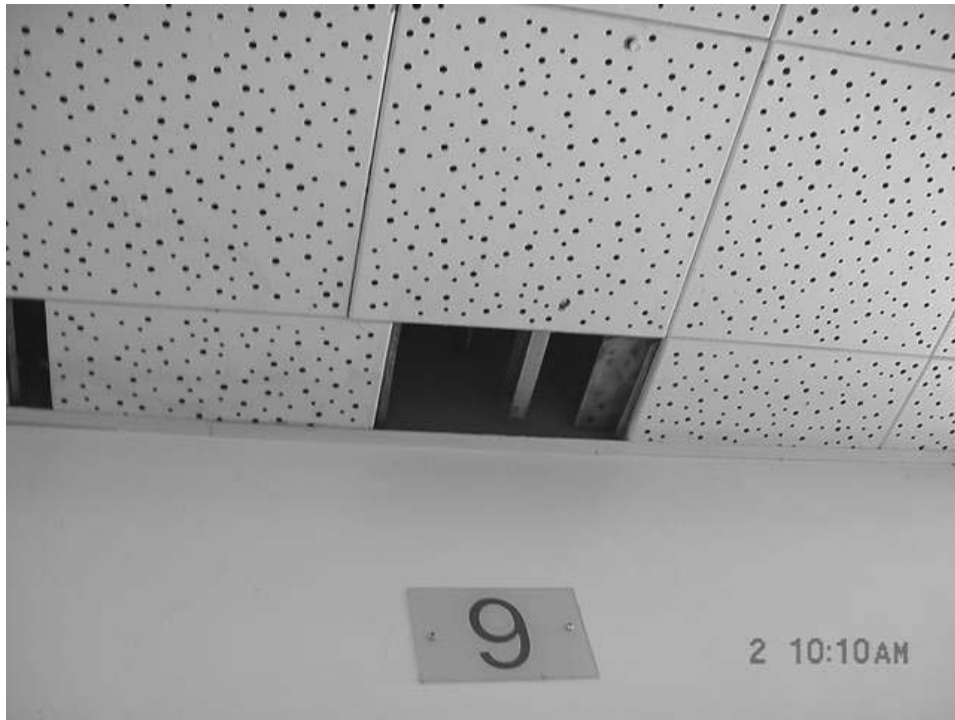
**Picture 17**

**Missing Ceiling Tiles**

17. Replace missing ceiling tiles.

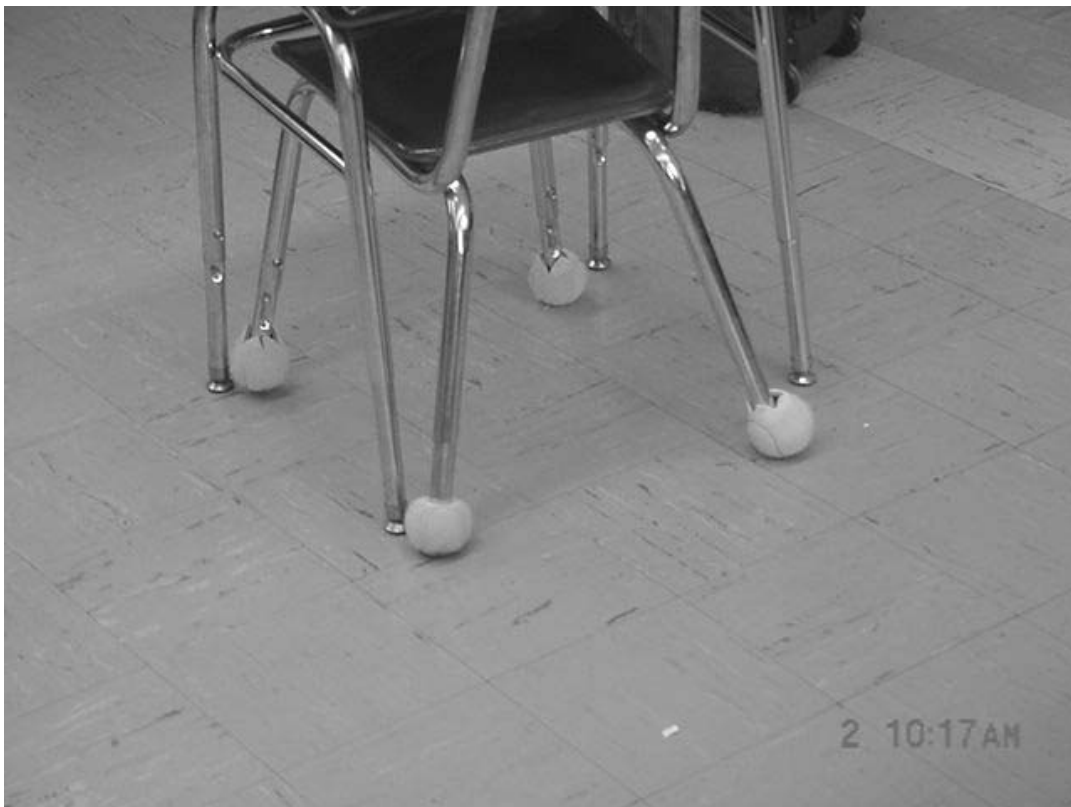
**Picture 18**

In an effort to reduce noise from sliding chairs, tennis balls had been sliced open and placed on chair legs (Picture 18). Tennis balls are made of a number of materials that are a source of respiratory irritants. Constant wearing of tennis balls can produce fibers and off-gas TVOCs. Tennis balls are made with a natural rubber latex bladder, which becomes abraded when used as a chair leg pad. Use of tennis balls in this manner may introduce latex dust into the school environment. Some individuals are highly allergic to latex (e.g., spina bifida patients) (SBAA, 2001). It is recommended that the use of materials containing latex be limited in buildings to reduce the likelihood of symptoms in sensitive individuals (NIOSH, 1997). A question and answer sheet concerning latex allergy is attached as [Appendix B](#) (NIOSH, 1998).

**Tennis Balls on Chair Legs**

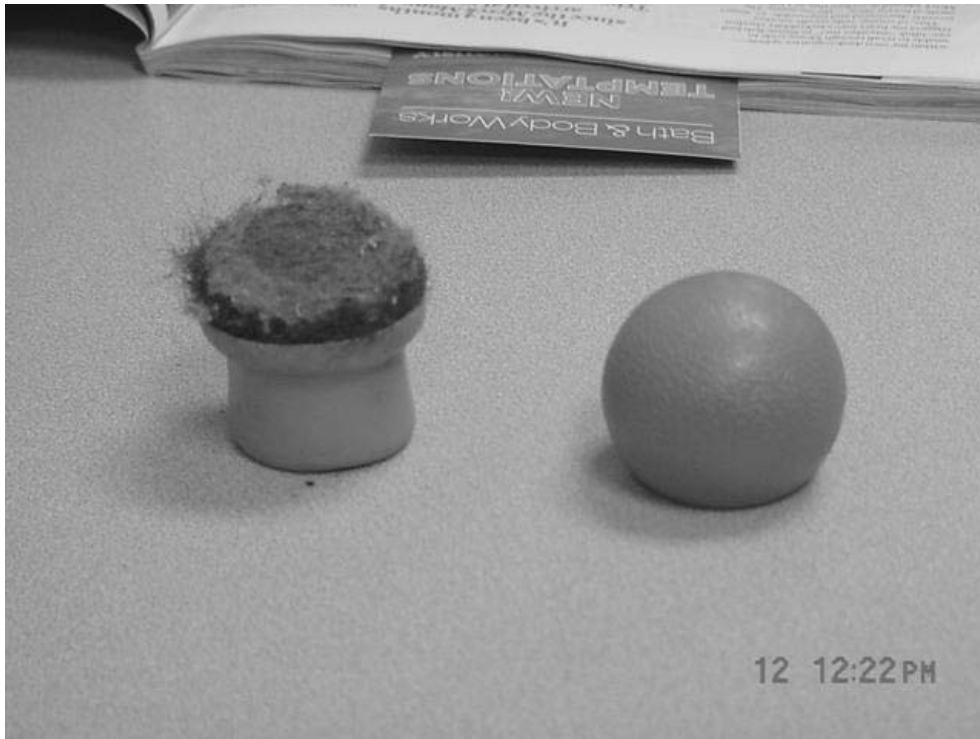
Picture 19

**“Glides” for Chair Legs that can be used as an Alternative to Tennis Balls**
