# **INDOOR AIR QUALITY ASSESSMENT**

**Newbury Town Hall  
25 High Road  
Newbury, Massachusetts**

Prepared by:  
Massachusetts Department of Public Health  
Center for Environmental Health  
Emergency Response/Indoor Air Quality Program  
September 2006

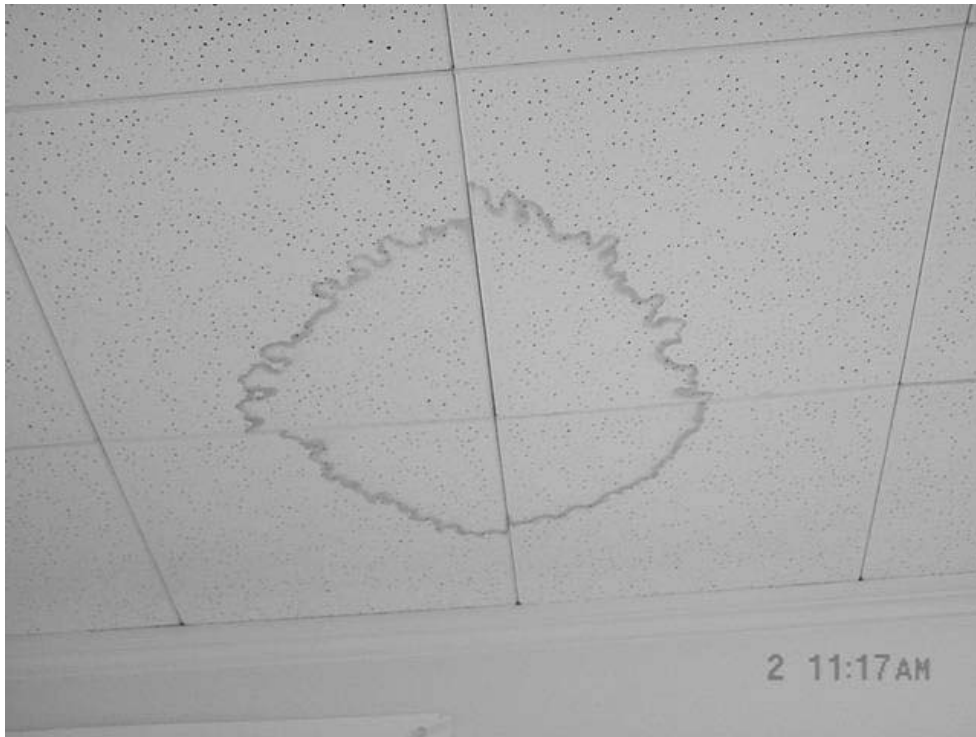
**Picture 1**

A few areas had water-damaged ceiling tiles (Picture 1). Water-damaged ceiling tiles can provide a source of mold and should be replaced after a moisture source or leak is discovered and repaired. The US Environmental Protection Agency (US EPA) and the American Conference of Governmental Industrial Hygienists (ACGIH) recommends that porous materials be dried with fans and heating within 24 to 48 hours of becoming wet (US EPA, 2001; ACGIH, 1989). If porous materials are not dried within this time frame, mold growth may occur. Water-damaged porous materials cannot be adequately cleaned to remove mold growth. The application of a mildewcide to moldy porous materials is not recommended.

**Water Damaged Ceiling Tiles**

3. Ensure roof leaks are repaired, and replace any remaining water-damaged ceiling tiles. Examine the space above and around these areas for mold growth. Disinfect areas of water leaks with an appropriate antimicrobial.

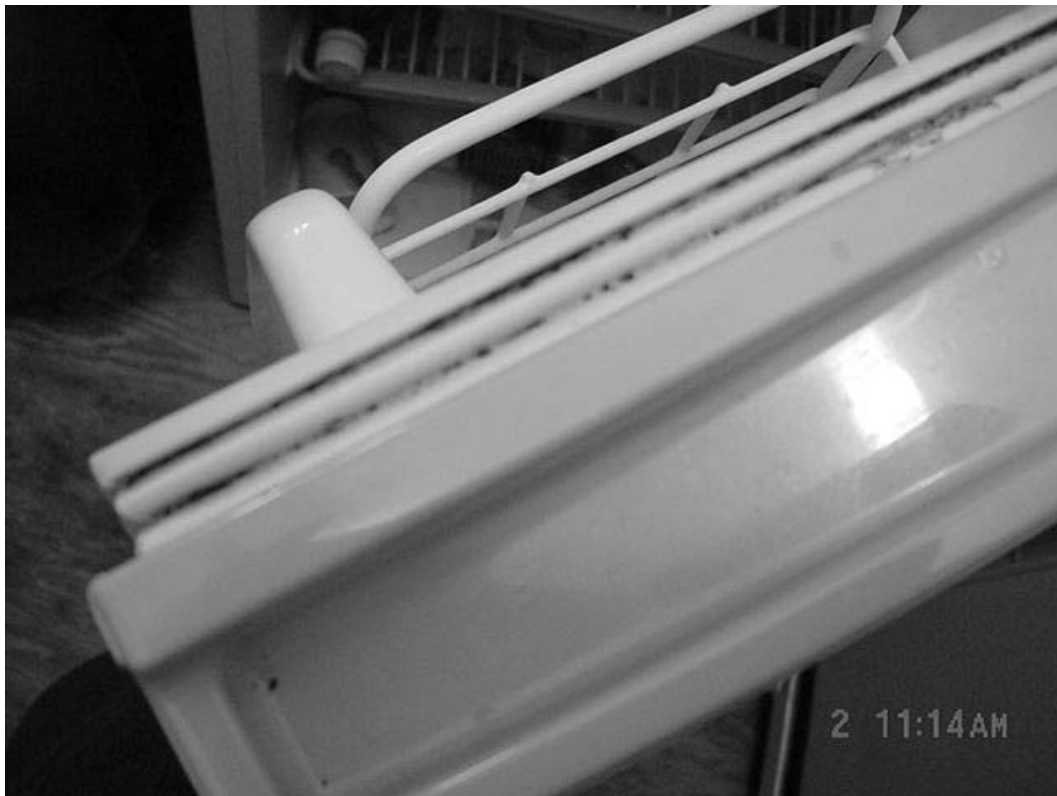
**Picture 2**

Occupants reported musty odors in the pantry/kitchen area. Upon examination, CEH staff observed mold growth along the gasket of the refrigerator (Picture 2). At the time of the assessment, CEH staff recommended that the gasket be cleaned and disinfected with an appropriate antimicrobial.

**Mold Growth (as Indicated by Black Areas) along Refrigerator Gasket**

4. Clean and disinfect refrigerator gasket with an appropriate antimicrobial. Clean afterwards with soap and water.
5. Ensure windows are closed during hot, humid weather to maintain indoor temperatures and avoid condensation problems.

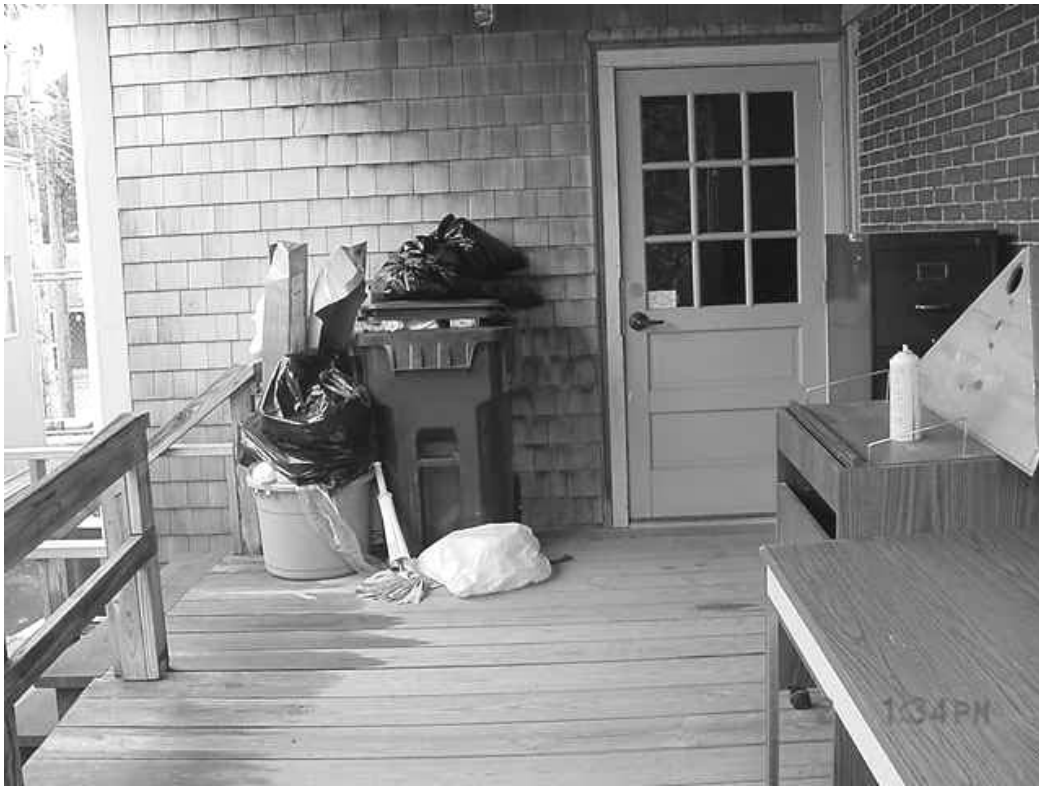
**Picture 3**

EPA, 1992). A sensitizer is a material that can produce symptoms readily in sensitive individuals. CEH staff observed trash being stored directly against the building near the rear entrance of the town hall (Picture 3), which can attract rodents. The reduction/elimination of attractants (i.e., trash) as well as any pathways of egress into the building (Picture 4) should be the first steps taken to eliminate infestation.

**Refuse Stored Outside Town Hall Rear Entrance**

10. Encapsulate insulation around portable air conditioners.
11. Store trash away from building. Consider obtaining a dumpster to collect trash.
12. Relocate or consider reducing the amount of materials stored to allow for more thorough cleaning. Clean items regularly with a wet cloth or sponge to prevent excessive dust build-up.

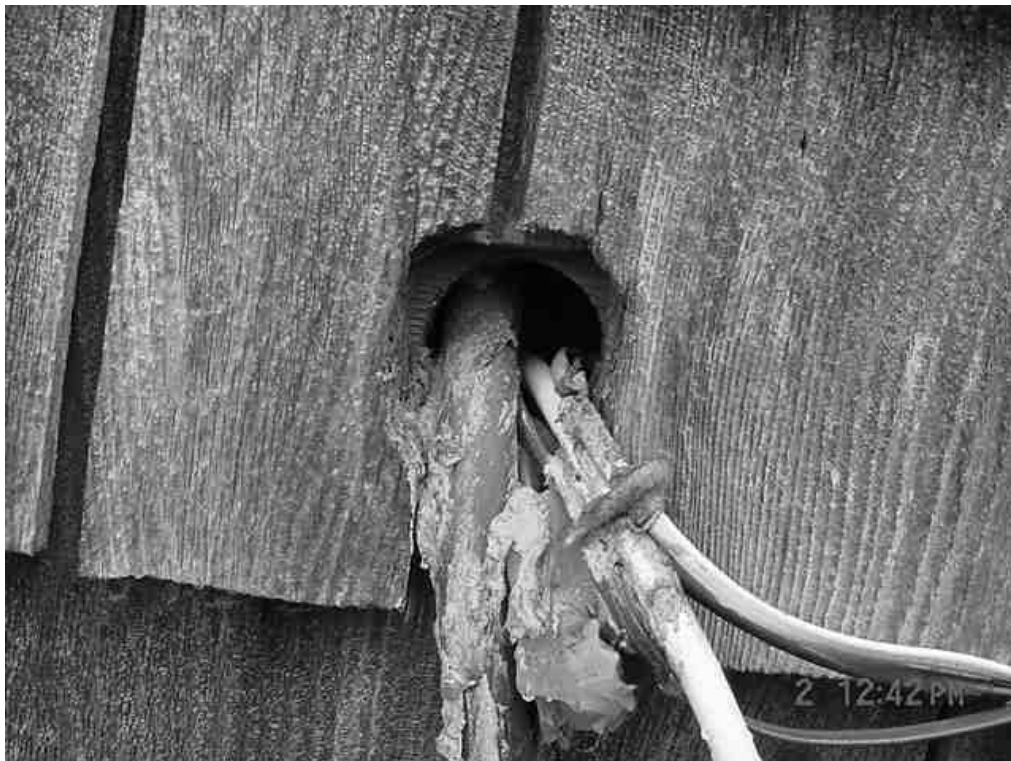
**Picture 4**

**Open Utility Hole/Egress for Pests/Rodents into Building**

8. Seal spaces around portable ACs, breaches in the building exterior (e.g., utility holes, foundation cracks) to prevent pest entry.
9. Clean/change filters for ACs as per the manufacture's instructions or more frequently if needed.

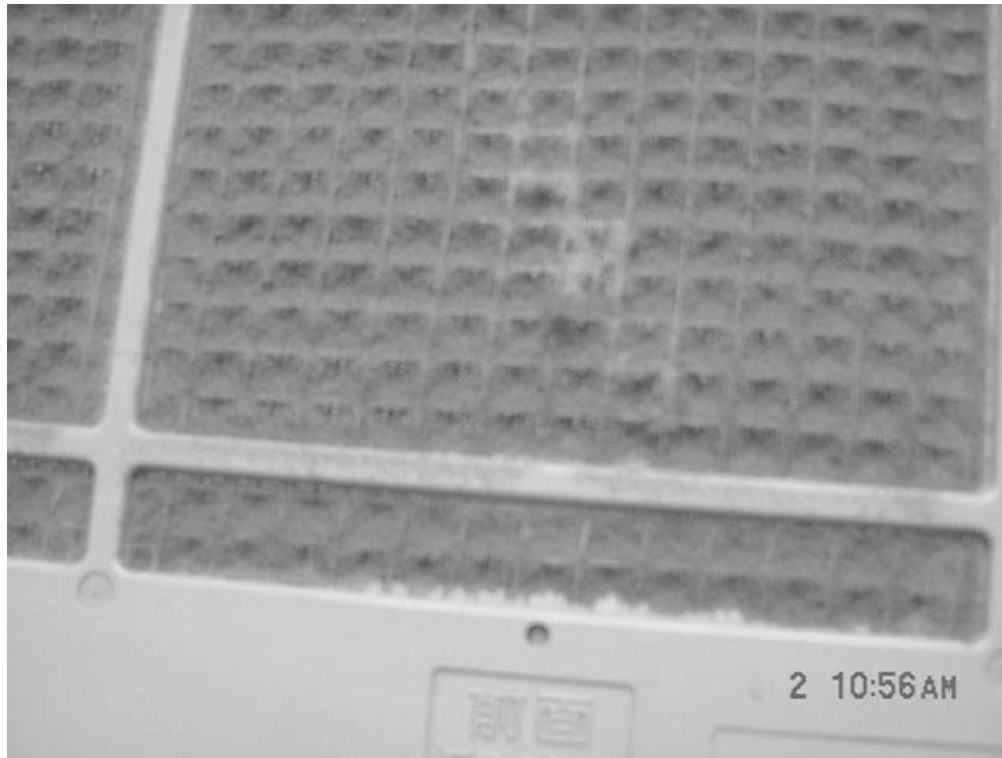
**Picture 5**

Window-mounted ACs are normally equipped with filters, which should be cleaned or changed as per manufacturer's instructions to avoid the build-up and re-aerosolization of dirt, dust and particulate matter. CEH staff examined filters within AC units and found them occluded with dust and debris (Picture 5). In addition, exposed fiberglass insulation was observed around window mounted ACs (Picture 6). Fiberglass insulation can provide a source of skin, eye and respiratory irritation.

**Accumulated Dust on AC Filter**

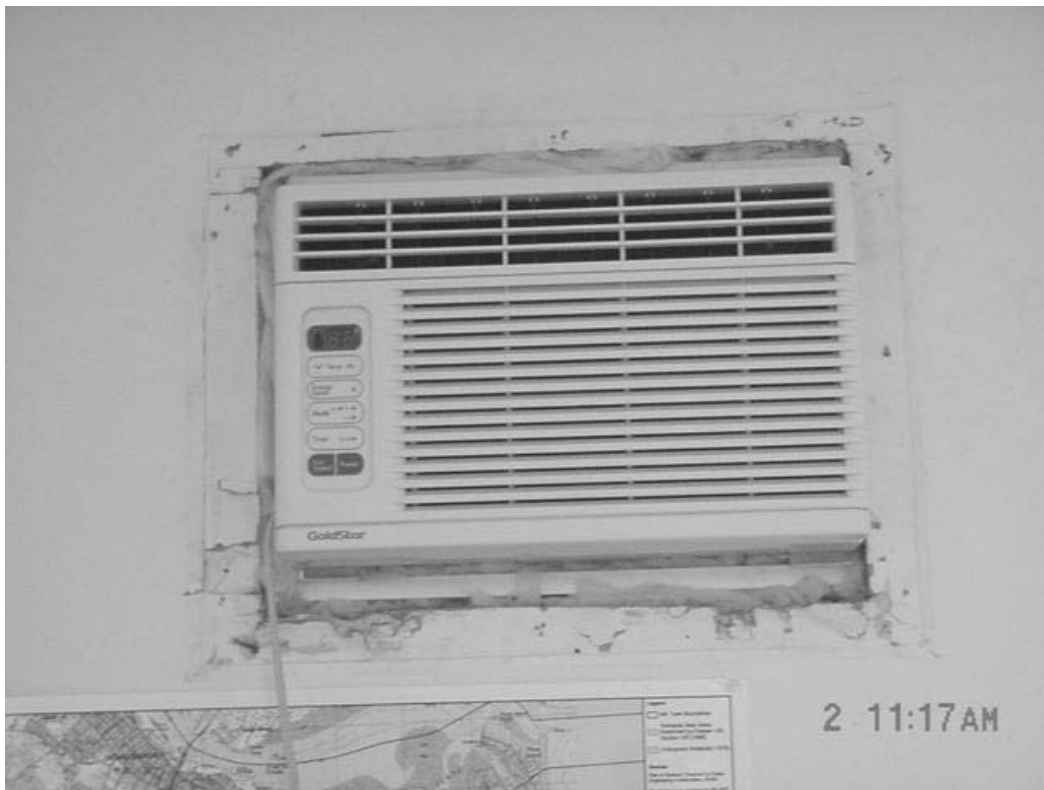
**Picture 6**

**Exposed Fiberglass around AC Unit**

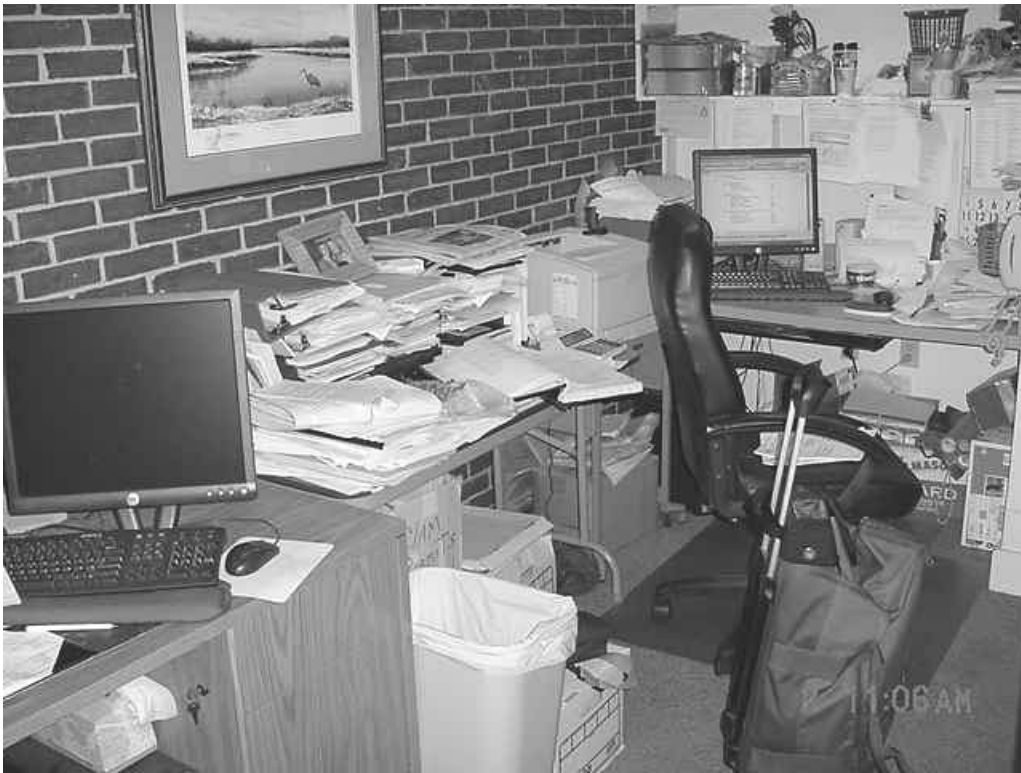
**Picture 7**

Also of note was the amount of materials stored inside offices (Picture 7). In areas throughout the building, items were observed on windowsills, tabletops, counters, bookcases and desks. The large number of items stored provides a source for dusts to accumulate. These items (e.g., papers, folders, boxes) make it difficult for custodial staff to clean. Several had accumulated dust (Pictures 8 and 9). Dust can be irritating to eyes, nose and respiratory tract. Items should be relocated and/or be cleaned periodically to avoid excessive dust build up.

**Accumulated Items Stored in Office**

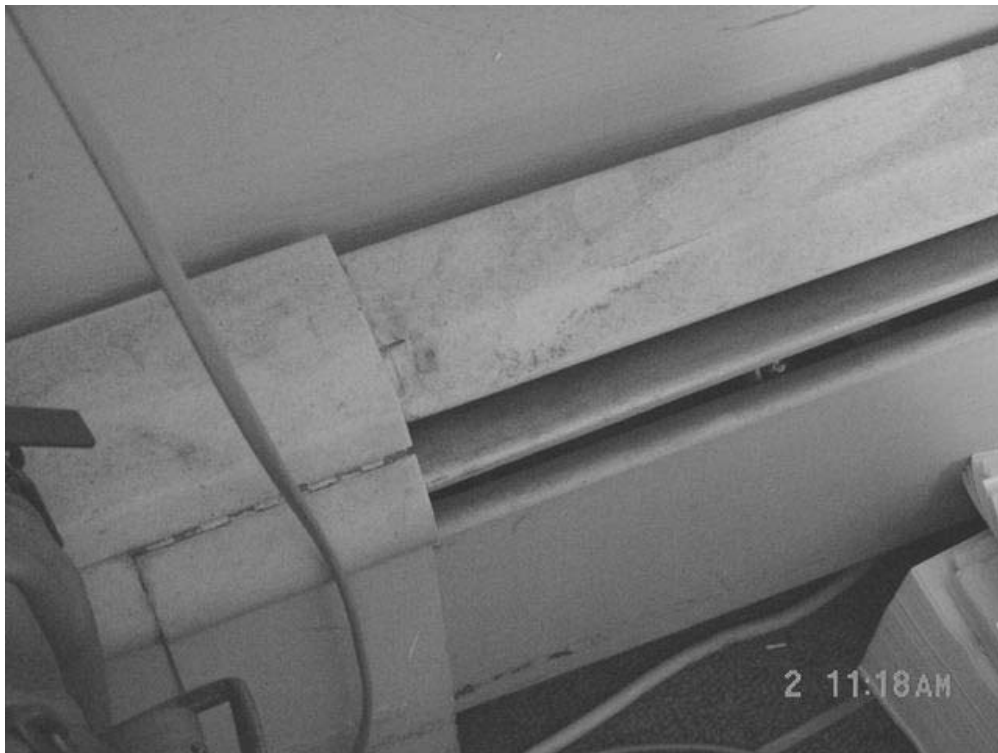
**Picture 8**

**Dust Accumulation on Baseboard Heater**

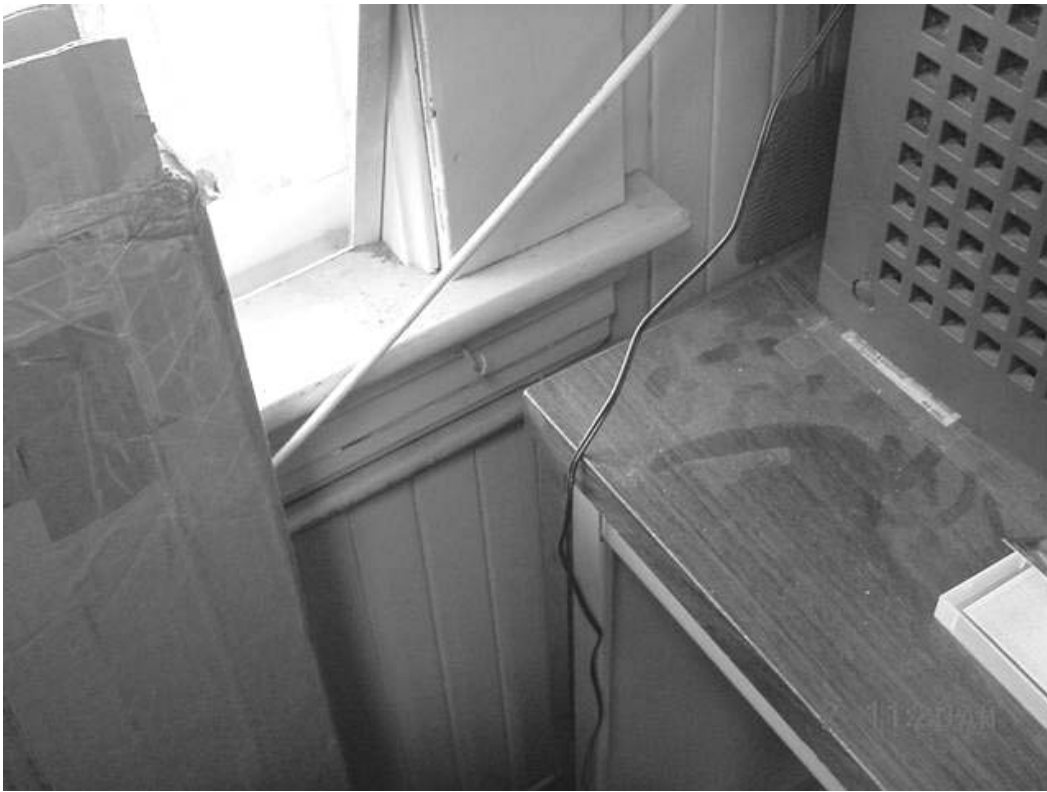
**Picture 9**

**Dust Accumulation on Flat Surfaces in Office**

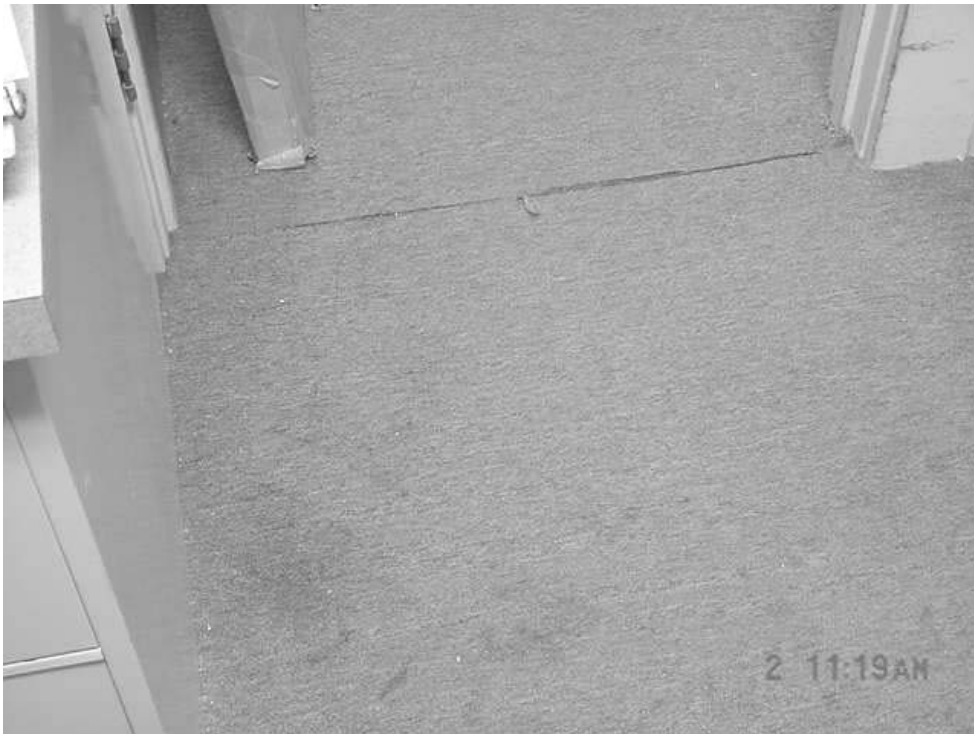
**Picture 10**

Finally, carpeting in several areas was extremely worn and damaged (Picture 10). Disintegrating textiles can be a source of particulates, which can be irritating to the eyes, nose and throat.

**Worn/Stained Carpeting**

13. Consider replacing old/stained/worn carpeting. If not feasible, clean existing carpeting annually (or semi-annually in soiled high traffic areas) as per the recommendations of the Institute of Inspection, Cleaning and Restoration Certification (IICRC). Copies of the IICRC fact sheet can be downloaded at:  
[http://www.cleancareseminars.com/carpet\\_cleaning\\_faq4.htm](http://www.cleancareseminars.com/carpet_cleaning_faq4.htm) (IICRC, 2005)
