INDOOR AIR QUALITY ASSESSMENT

**Office of the Chief Medical Examiner
720 Albany Street
Boston, MA**

Prepared by:
Massachusetts Department of Public Health
Center for Environmental Health
Emergency Response/Indoor Air Quality Program
April 2007

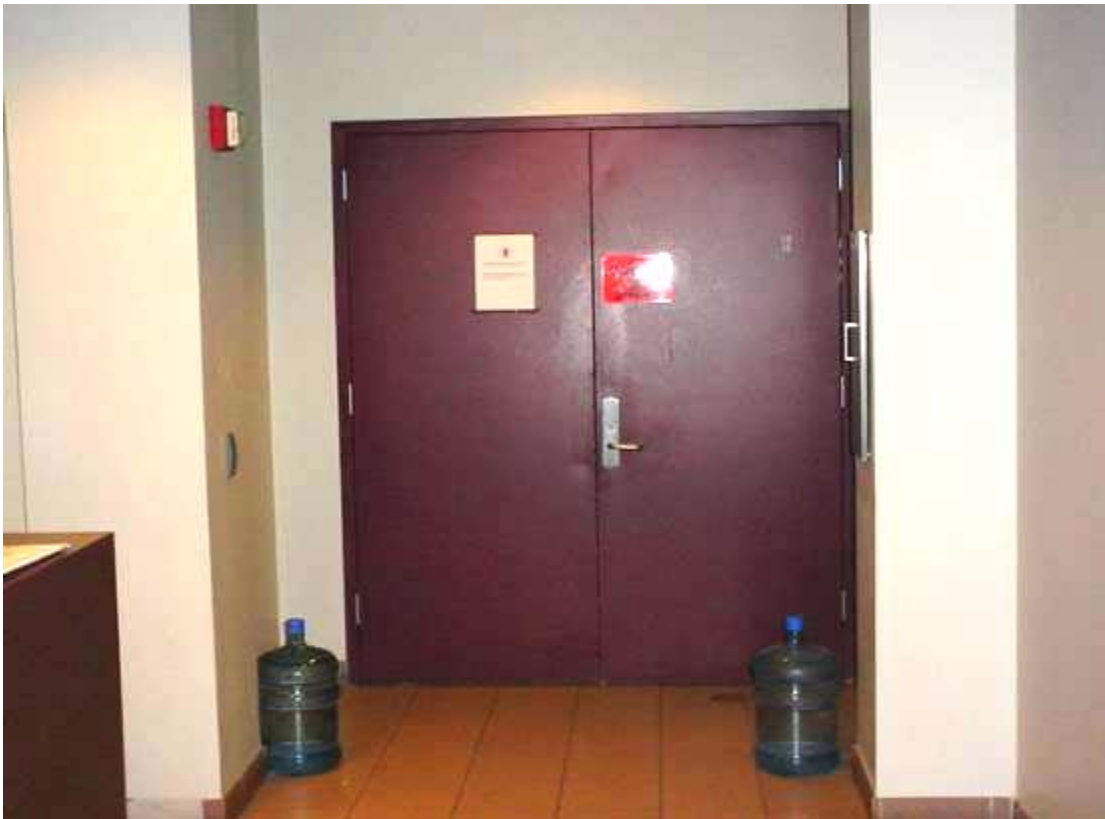
Picture 1

Police offices are also located on the first floor at the front of the building. The first floor reception area is separated from the autopsy suite by a single set of double doors (Picture 1). Stairwells providing access to second floor offices are located at the front and back of the building. An elevator is adjacent to the stairwell at the front of the building. At the rear of the building is a three bay garage and a semi-enclosed parking lot surrounded by a ten-foot high brick wall.

A set of swinging doors separates the autopsy suite from the elevator/front stairwell/reception area. These swinging doors are not airtight, with spaces beneath and between the doors that allows for air from the autopsy suite hallway to readily penetrate into employee/publicly occupied areas.

Double Door Separating Autopsy Suite from Elevator Lobby

6. Install weather-stripping and door sweeps on the hallway door between the autopsy suite and the elevator/stairwell/reception area.
7. Reposition the fresh air diffuser near the waiting room door in the elevator lobby so that air is directed towards the autopsy suite doors.
8. Render the window in the garage airtight to prevent air penetration (Picture 7).
9. Refer to resource manuals and other related indoor air quality documents for further building-wide evaluations and advice on maintaining public buildings. Copies of these materials are located on the MDPH's website: http://mass.gov/dph/indoor_air.

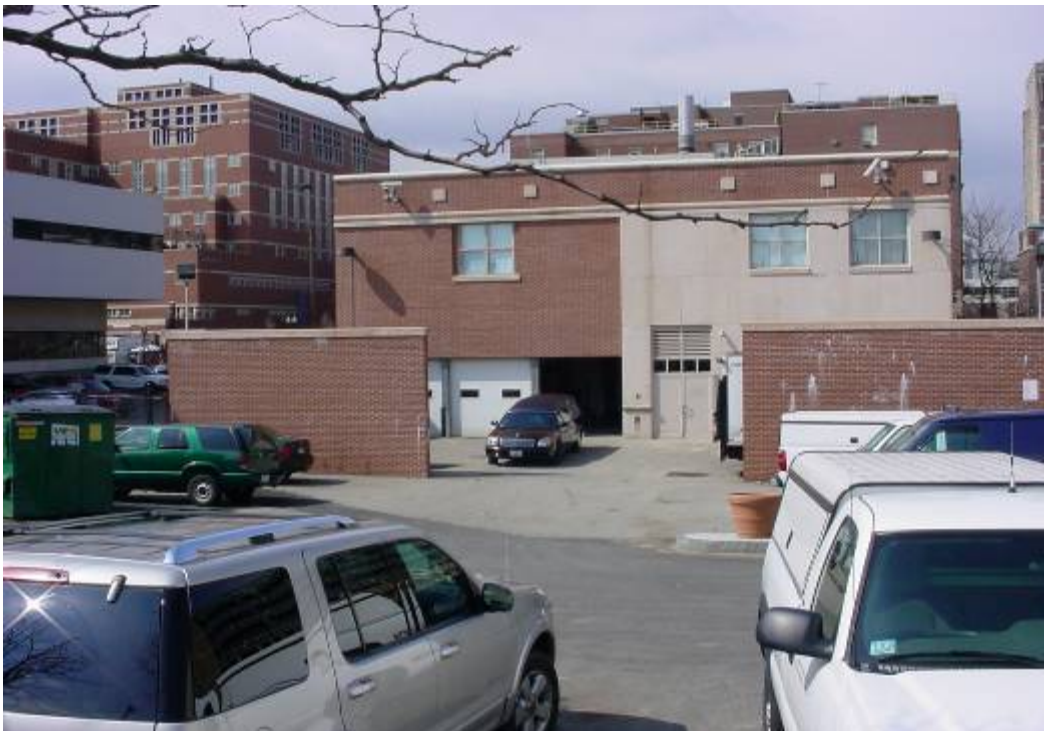
Picture 2

With this door open, the garage becomes pressurized, forcing air into the hallway that runs through the center of the first floor autopsy suite. This pressurization then forces air/odors out from the autopsy suite through breaches and spaces in/around doors. Odor pathways include: (1) the doors to the stairwell at the rear of the building (2) the hallway doors that separate the autopsy suite from the elevator/front stairwell lobby/reception desk and (3) the door to the elevator machine room. Once beyond the autopsy suite, odors can be distributed throughout the building via the elevator and stairway.

OCME garage

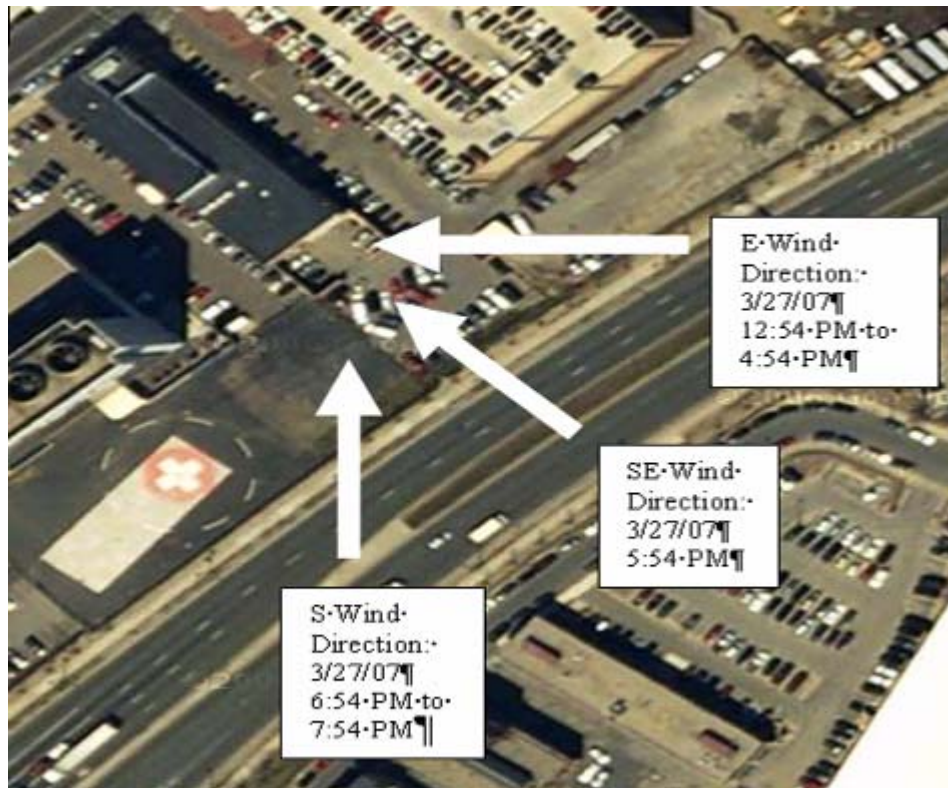
Picture 3

At the rear of the building are three garage doors. The garage doors are located on the southeast-facing side of the building (Picture 3). One of the garage doors is an automatic accordion style door, which is left open for the duration of the work day to allow transport of case studies between the autopsy suite and transport vehicles. During the afternoon of the assessment, wind in Boston was steady (~4-12 mph/gusts up to 17), with a shift in wind

direction from the east to south over a seven-hour period (Table 2). Given that the building faces the southeast and the wind was in an east to south direction, the open door allowed a direct flow of air from the outdoors.

Wind Direction on March 27, 2007 around the OCME

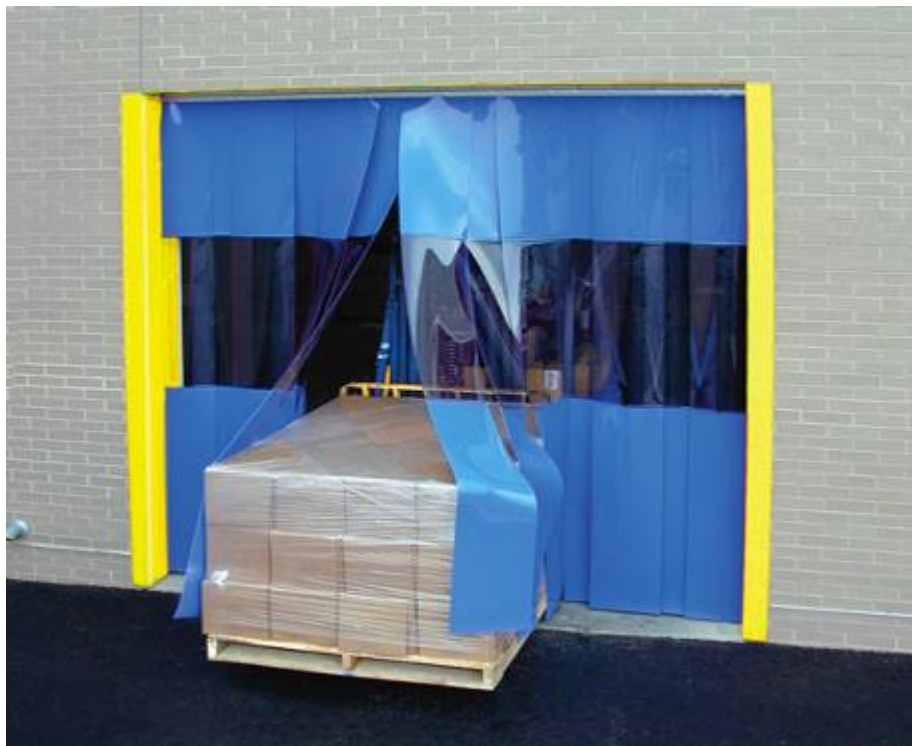
Picture 4

Example of Strip Door

3. Install industrial strip doors in the garage areas as recommended in this report.
4. Connect the elevator shaft pressurization equalization vent in the elevator mechanical room to ductwork that draws air outdoors or a location outside the autopsy suite.

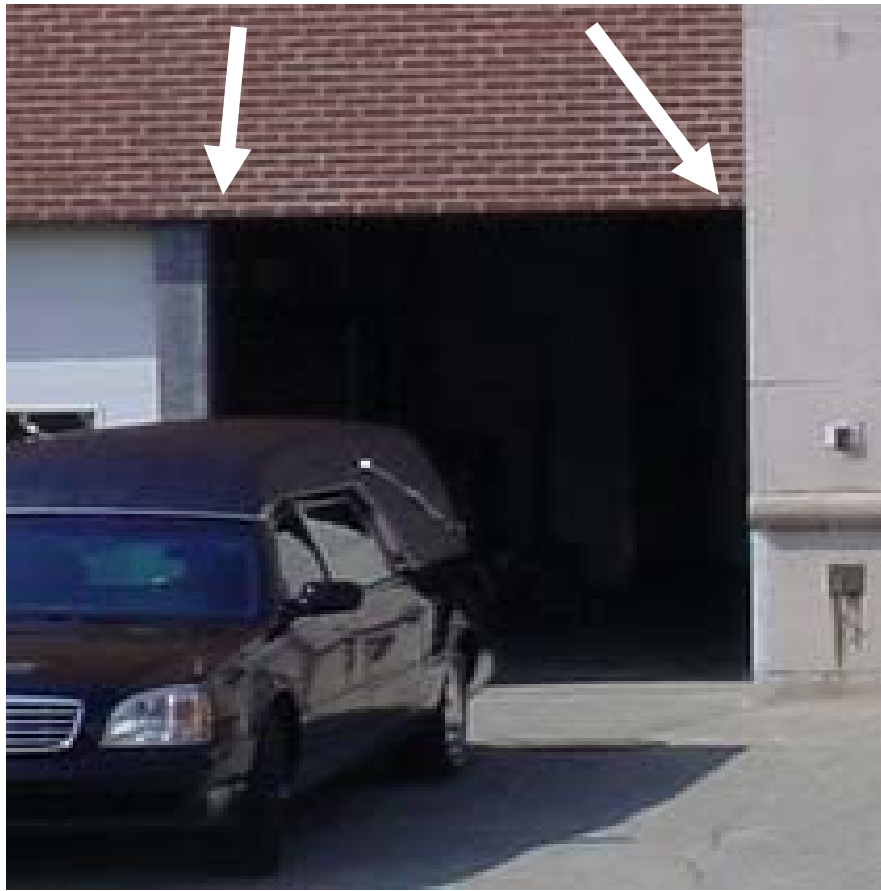
Picture 5

Location Where Strip Door Should Be Attached on Outside Of Building (see arrows)

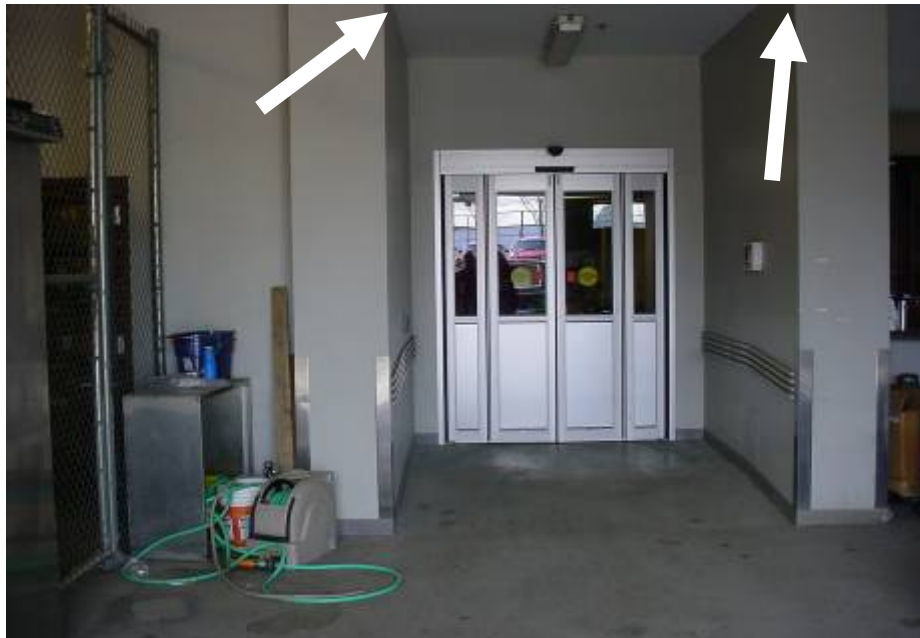
Picture 6

Location Where Strip Door Should Be Attached inside the Garage (see arrows)

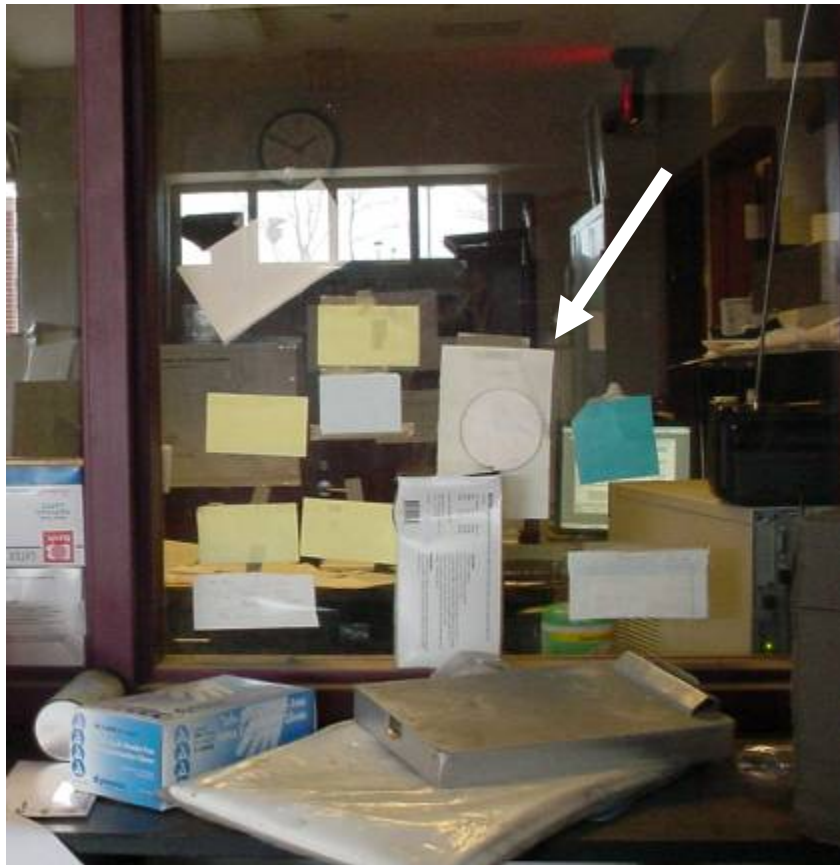
Picture 7

Former Check-in Window in Garage, Note Circular Opening Sealed with a Piece of Paper and Tape
