# INDOOR AIR QUALITY REASSESSMENT

**Lillian M. Jacobs Elementary School  
180 Harbor View Road  
Hull, Massachusetts 02405**

Prepared by:  
Massachusetts Department of Public Health  
Bureau of Environmental Health  
Emergency Response/Indoor Air Quality Program  
June 2007

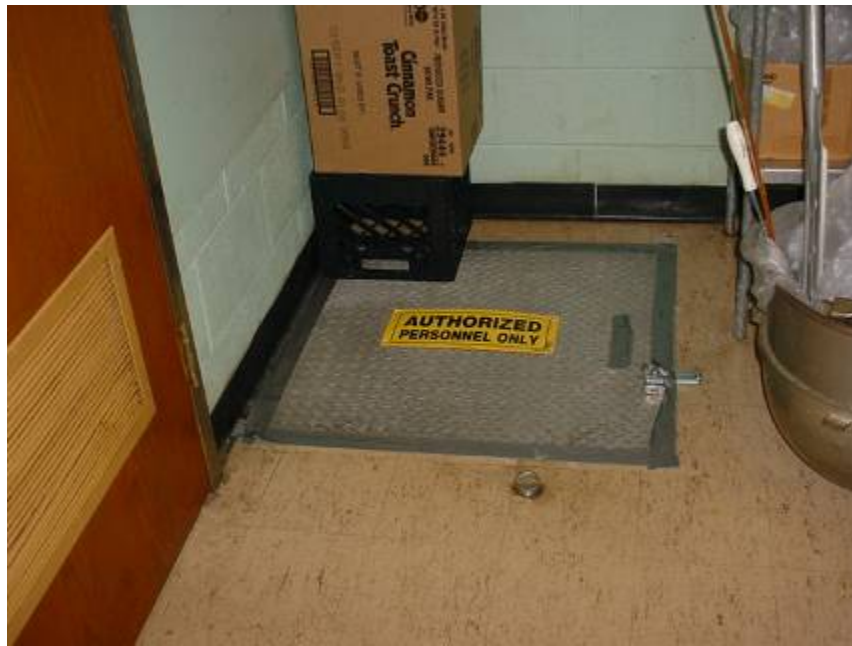
**Picture 1**

It was reported by Mr. Twombly that occupants had previously raised concerns of potential mold growth in a crawlspace located beneath the kitchen. BEH staff examined the access hatch to the crawlspace and found that it was sealed and that no discernable pathways were identified for mold spores or associated odors to migrate into occupied areas (Picture 1).

**Crawlspace Access Hatch in Kitchen Sealed with Duct Tape**

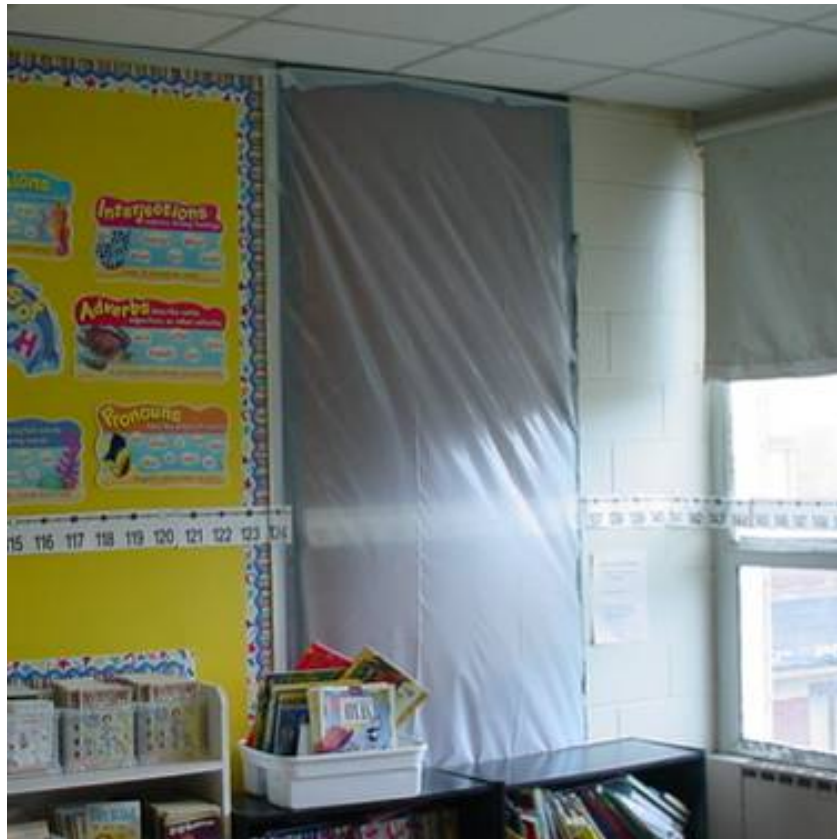
**Picture 2**

BEH staff inspected construction barriers to identify and reduce/prevent pollutant pathways. The plastic barrier in classroom 33 was observed to be “bowed” *towards* the occupied classroom, which would indicate that the pressurization is not performing appropriately (Picture 2). BEH staff examined the room directly adjacent to classroom 33 and found that the room was pressurized due to the removal of a portion of the exterior wall near

**“Bowed” Plastic on Door in Classroom 33 Indicating that Construction area is *Pressurized* in Relation to Classroom**

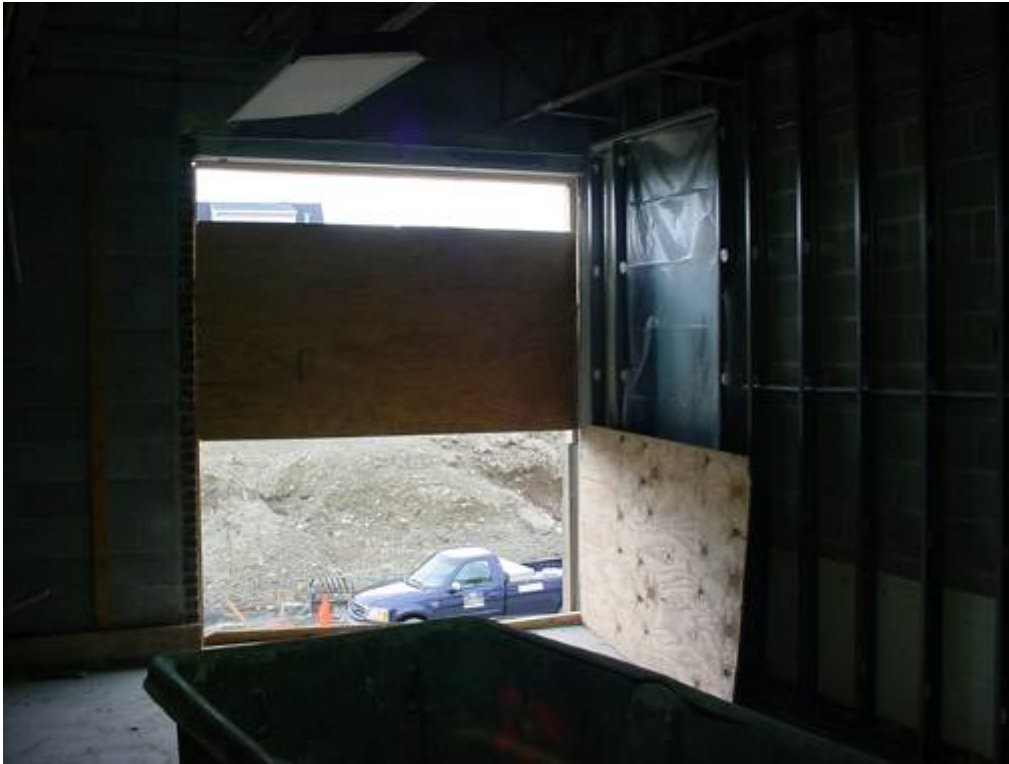
**Picture 3**

this door allowing uncontrolled outside air into the space (Picture 3). It appeared likely that the section of wall was removed so that construction personnel could discard materials into a dumpster, which was stationed outside, directly below this area. The pressurization of construction areas directly adjacent to occupied areas can force airborne odors and pollutants through any breaches in containment. In several other areas plastic sheeting on the construction side had areas that were loose or torn (Pictures 4 and 5). These findings were also reported to school officials at the time of the assessment with the recommendation to relocate the dumpster.

**Section of Wall Removed in Construction Area Directly Adjacent to Classroom 33 Door Shown in Preceding Picture**

2. Relocate dumpster and seal exterior wall in construction area adjacent to classroom 33 if this has not already been done.
3. Test and replace carbon monoxide detectors as per the manufacture's recommendations to ensure proper working order.

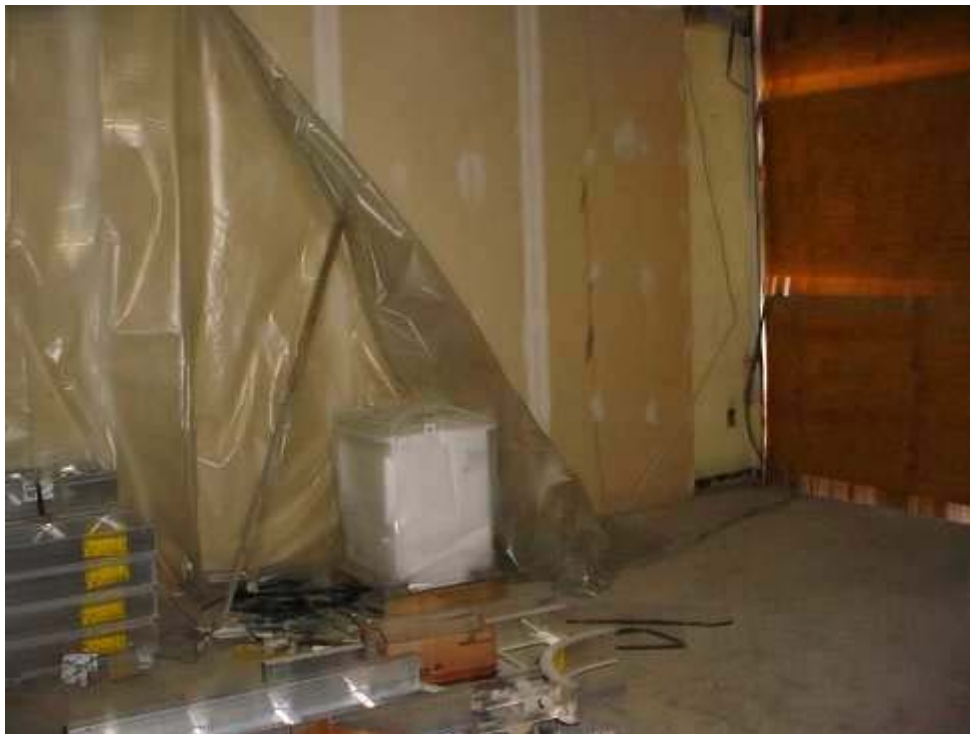
**Picture 4**

**Failing Plastic Sheeting on Construction Side of Barriers**

6. Continue to implement all applicable recommendations listed in the previous MDPH reports particularly those regarding the integrity of construction barriers and

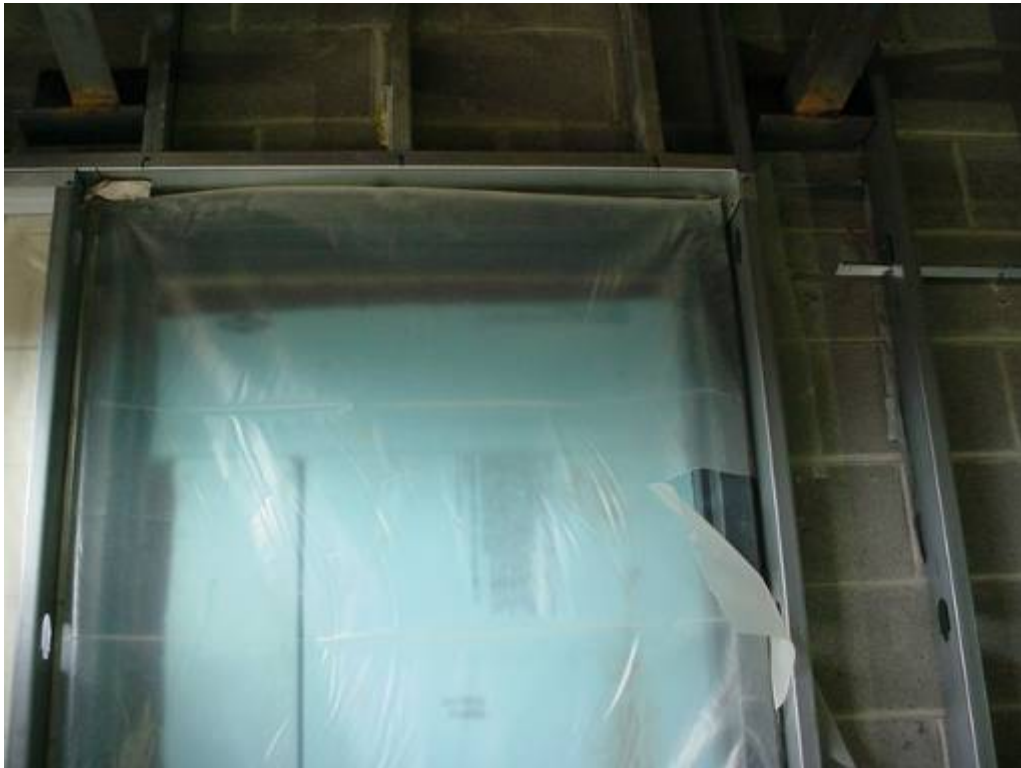
**Picture 5**

**Torn Plastic Sheeting on Construction Side of Classroom Door**

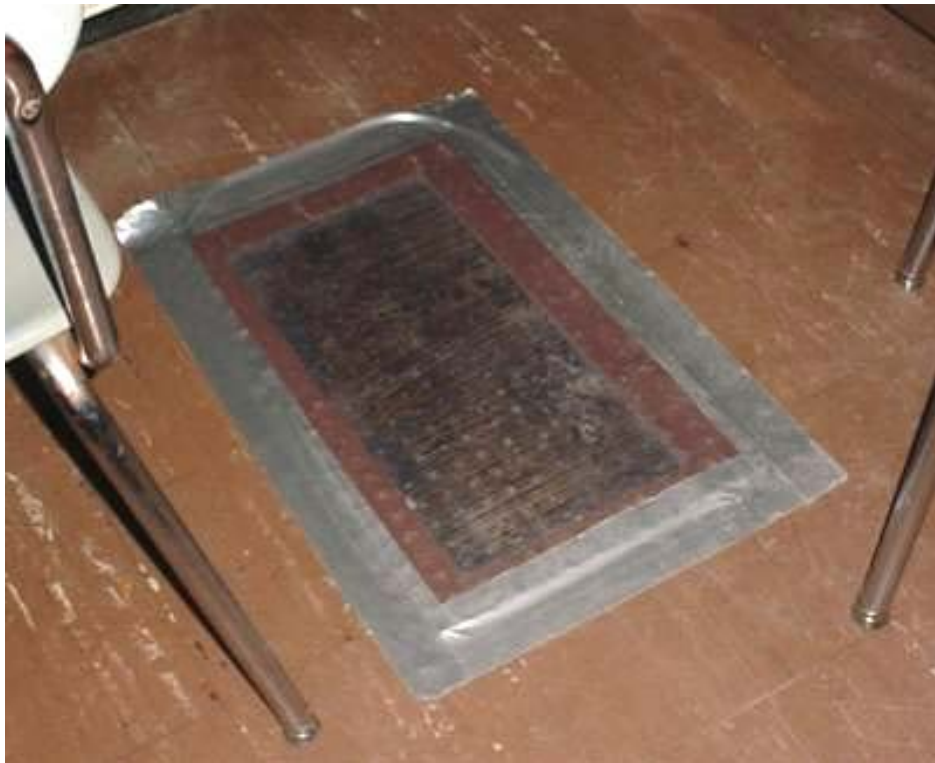
**Picture 6**

Lastly, damaged floor tiles containing asbestos were observed in several areas of the building. Mr. Twombly reported that at the recommendation of their remediation contractor, these tiles were identified and sealed with plastic and duct tape until they can be physically removed during subsequent phases of construction (Pictures 5 and 6).

**Damaged Asbestos-Containing Floor Tiles Sealed with Plastic and Duct Tape**

4. Clean/change filters for portable air purifiers as per the manufacturer's instructions or more frequently if needed.
5. Remediate damaged asbestos with Massachusetts asbestos remediation and hazardous waste disposal laws. For further questions regarding the proper remediation of asbestos-containing materials contact the Massachusetts Division of Occupational Safety's Asbestos Program at <http://www.mass.gov/dos/asbestos/index.htm> or by calling (617) 969-7177.

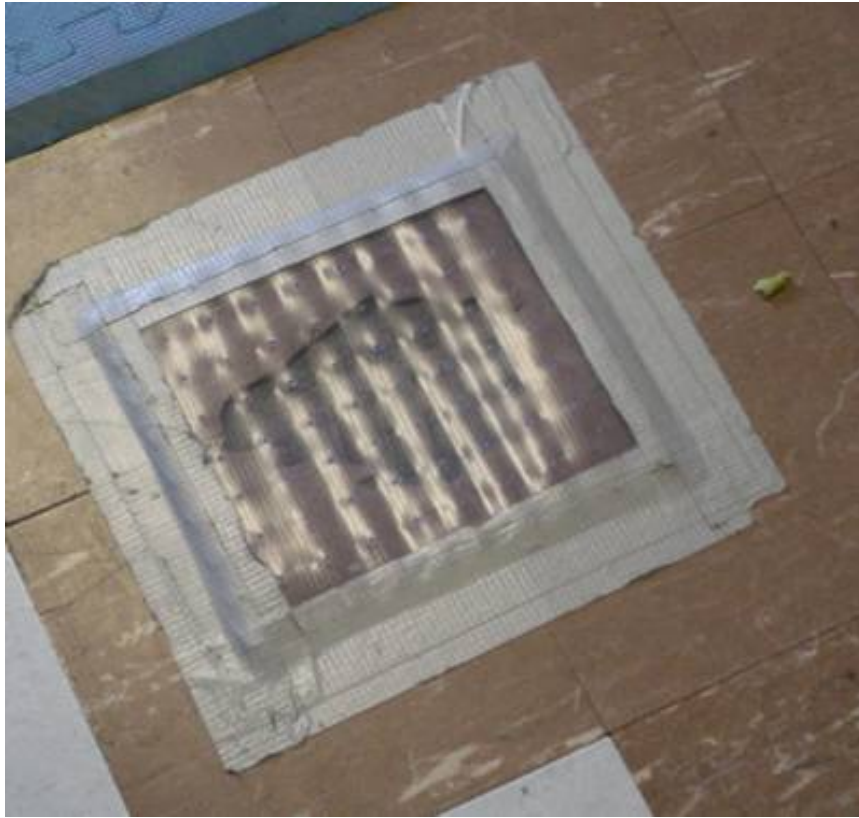
**Picture 7**

**Damaged Asbestos-Containing Floor Tiles Sealed with Plastic and Duct Tape**
