PRELIMINARY ASSESSEMENT

**East Junior High School
464 Centre Street
Brockton, MA 02302**

Prepared by:
Massachusetts Department of Public Health
Bureau of Environmental Health
Indoor Air Quality Program
April 2008

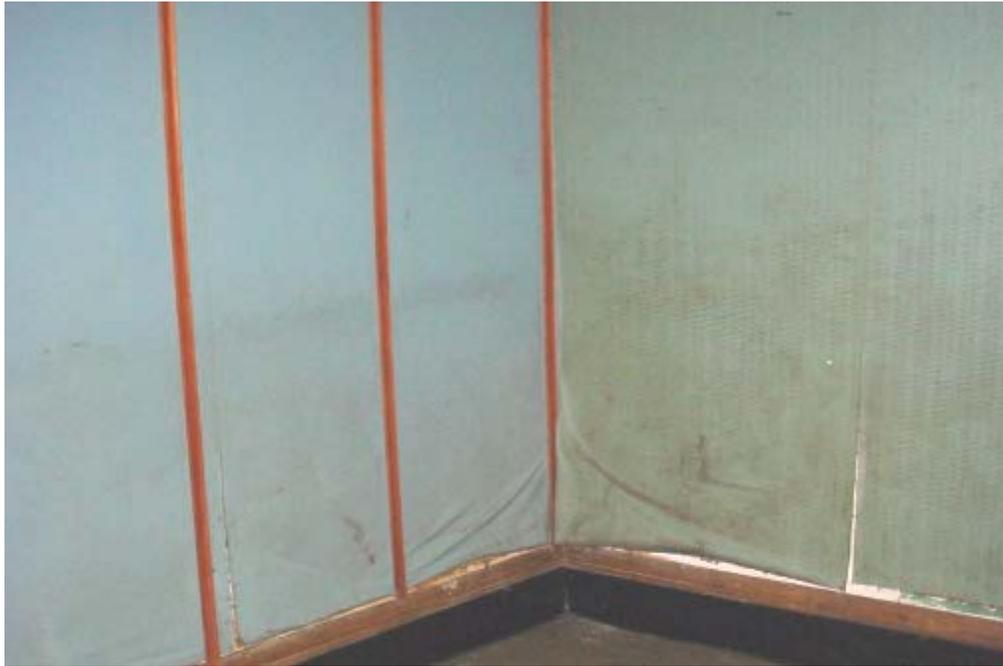
Picture 1

Water Damaged/Peeling Vinyl Wall Covering in Auditorium (Stage Side Right)

1. Consider consulting a professional remediation specialist for mold remediation.
Remove/replace water-damaged/mold colonized porous materials in auditorium (e.g., ceiling tiles, GW, vinyl wall covering). This measure will remove actively growing mold colonies that may be present. It is recommended that this work be conducted at a time when building occupants are *not* present in the area. Once work is completed, ensure that the area is thoroughly cleaned and disinfected with an appropriate antimicrobial. Dust and particulates generated from remediation should be vacuumed with a high efficiency particulate arrestance (HEPA) filtered vacuum cleaner.

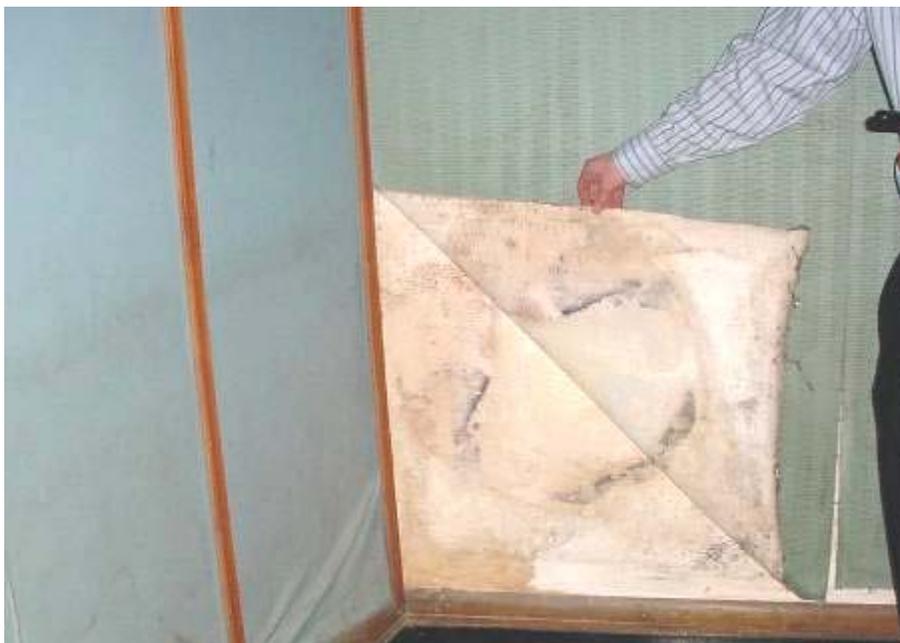
Picture 2

growth and water damaged building materials (ceiling/wall tiles, plaster ceiling/walls) were observed in the auditorium. BEH staff conducted moisture testing of materials in a number of areas likely impacted by water damage. Plaster and ceiling/wall tiles in this area were found to have low (i.e., normal) moisture content at the time of the assessment (Table 1), indicating they were dry. However, elevated (i.e., saturated) moisture content and visible mold growth was observed on gypsum wallboard (GW) behind vinyl wall covering along the right side of the auditorium (Pictures 1 through 3). Vinyl wallpaper is a water impermeable material that can “trap” moisture. In addition, one ceiling tile in the gymnasium hallway had visible mold growth at the time of the assessment (Picture 4), which should also be removed/replaced.

Water Damaged/Mold Colonized Gypsum Wallboard behind Vinyl Wall Covering in Auditorium (Stage Side Right)

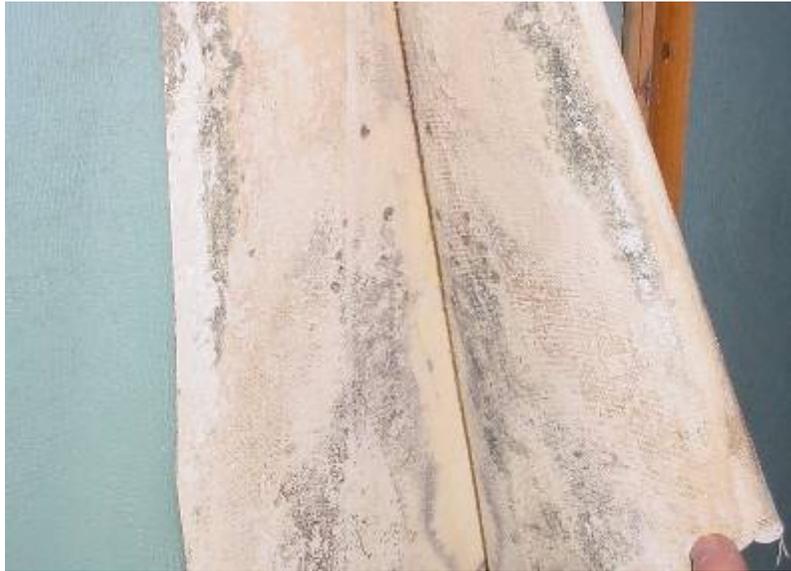
Picture 3

Close-Up of Visible Mold (Accumulated Dark Material) behind Vinyl Wall Covering in Auditorium (Stage Side Right)

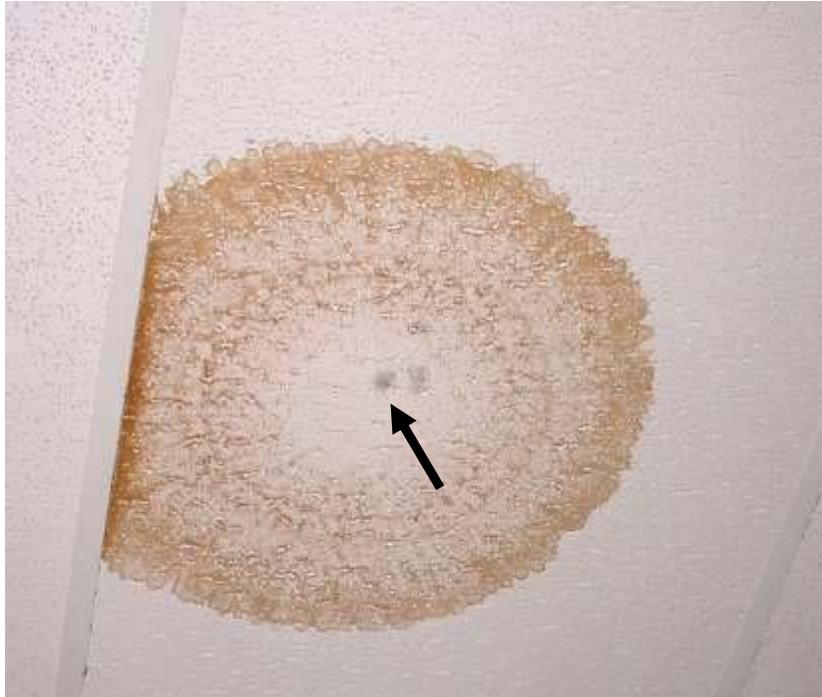
Picture 4

Visible Mold (Accumulated Dark Material) on Water Damaged Ceiling Tile in Gymnasium Hallway

3. Ensure that the general mechanical ventilation system is deactivated and/or sealed (i.e., supply and return vents) in areas of remediation.
4. Remove and replace water damaged/mold colonized ceiling tile(s) in gymnasium hallway.
