# **Mold/Water Damage Investigation**

**Massachusetts Department of Social Services  
Coastal Area Office  
541 Main Street  
South Weymouth, Massachusetts**

Prepared by:  
Massachusetts Department of Public Health  
Bureau of Environmental Health  
Indoor Air Quality Program  
June 2008

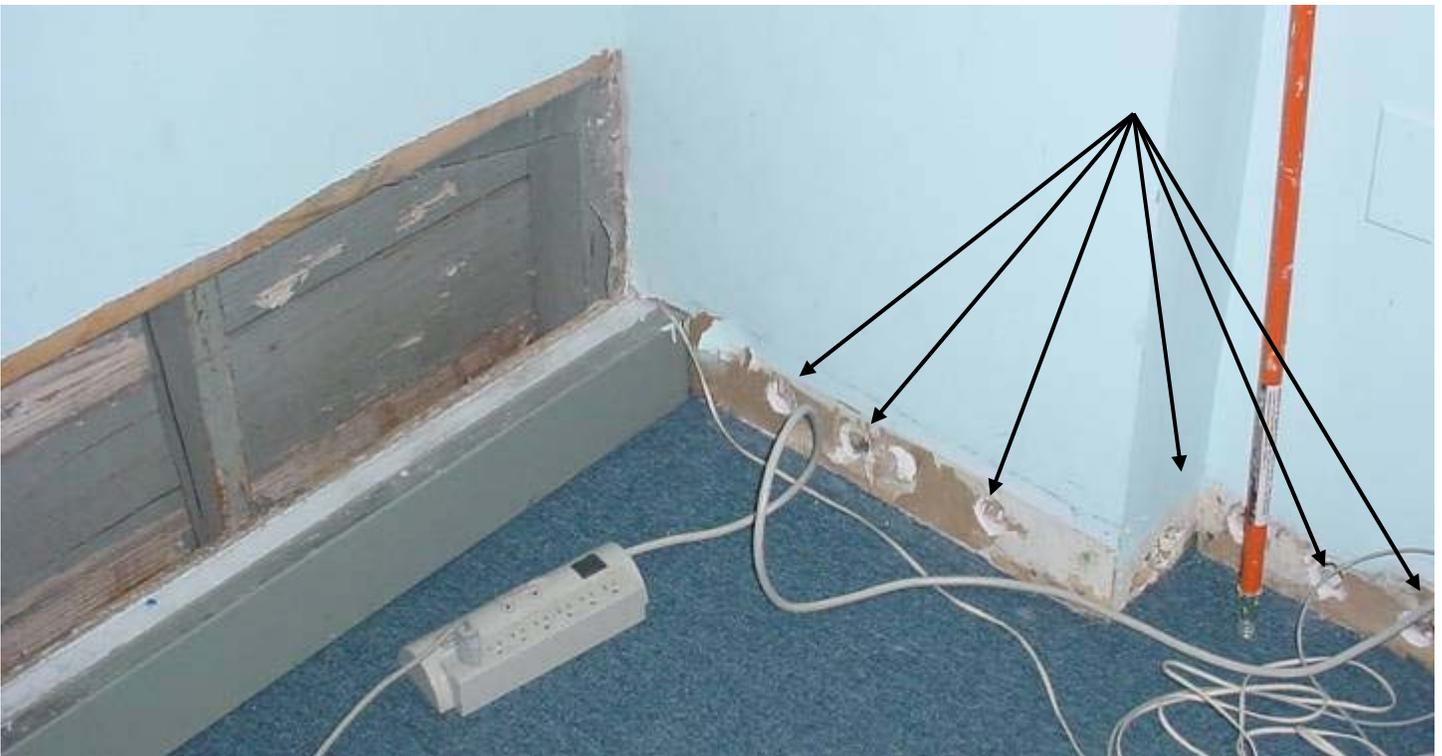
**Picture 1**

According to DSS officials the building management responded immediately by contacting a professional flood restoration firm and were reportedly on-scene within hours of the incident. Remediation included removal of sections of GW and vinyl baseboard coving to help dry GW and vent wall cavities (Pictures 1 to 3). In addition, staff were temporarily relocated and a moving company was hired to pack and remove all furniture and personal items in order to conduct drying and cleaning of carpeting.

**Vinyl Baseboard Coving Removed/Sections of Gypsum Wallboard (GW) Removed and Holes cut into GW (arrows) to Facilitate Drying of Wall Cavities**

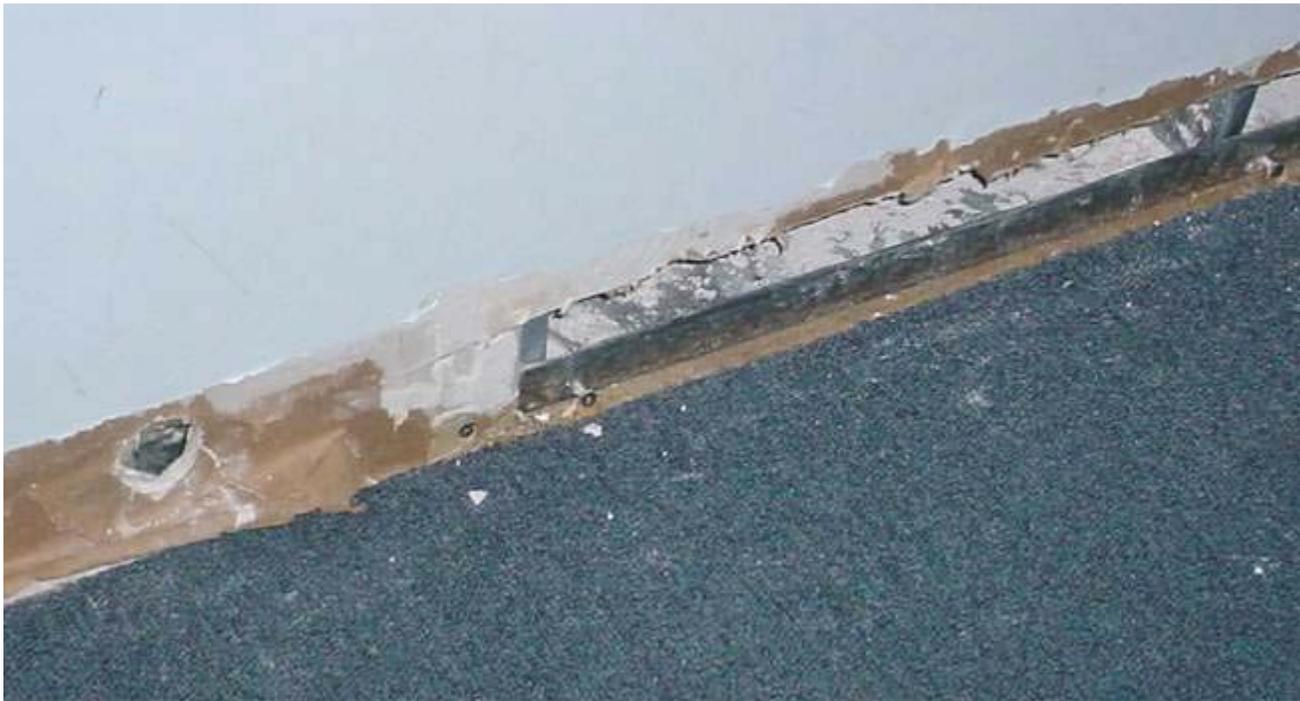
**Picture 2**

**Vinyl Baseboard Coving Removed/Sections of Gypsum Wallboard (GW) Removed and Holes cut into GW to Facilitate Drying of Wall Cavities**

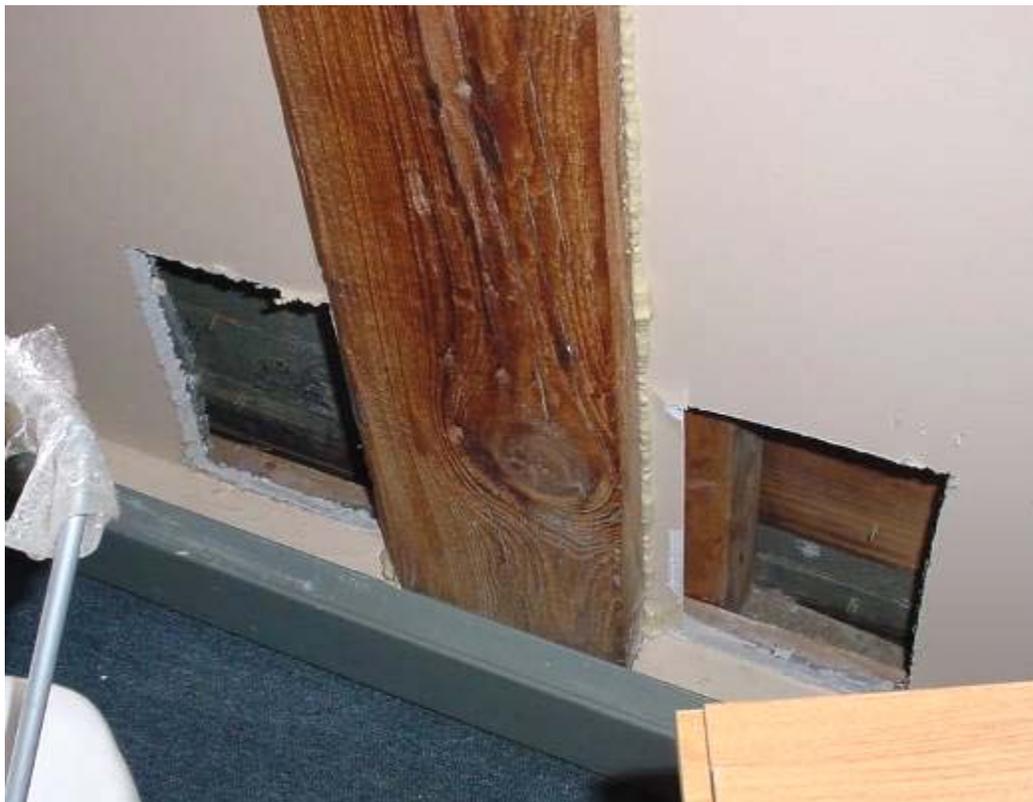
**Picture 3**

**Sections of Gypsum Wallboard (GW) Removed to Facilitate Drying of Wall Cavities**

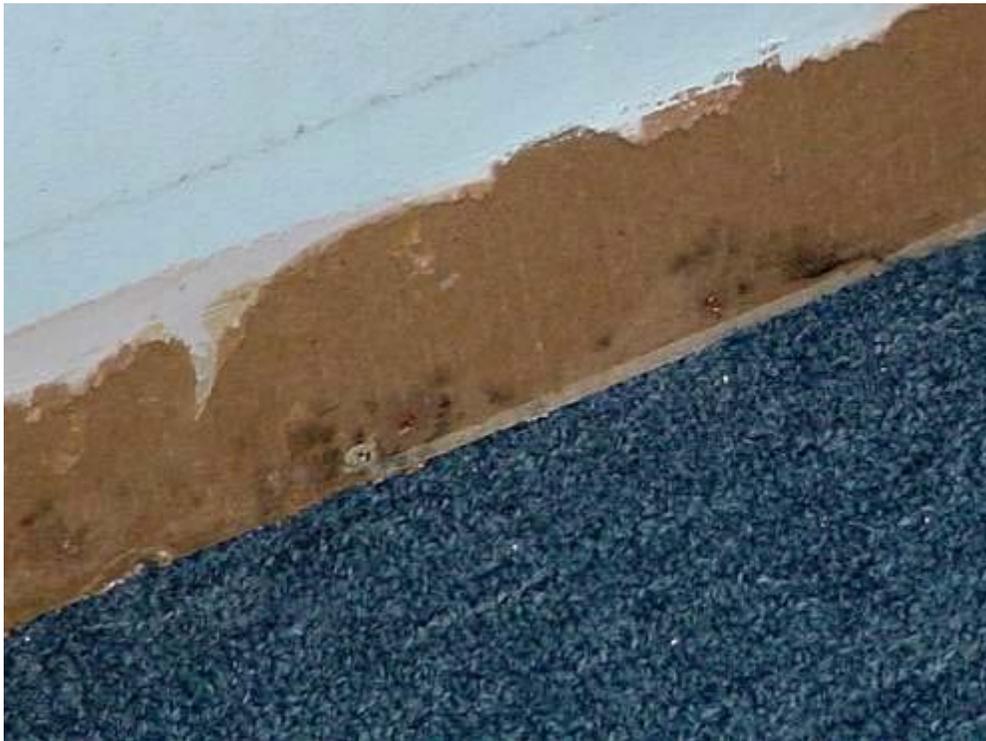
**Picture 4**

BEH staff observed small sections of visible mold growth on the surface of GW in two areas (Michaelle's office and the third floor hallway) (Pictures 4 and 5). These two areas were pointed out to Mr. Carroll with a recommendation to have the building's contractor remove these sections of GW. At the time of the assessment, a few areas were still undergoing remediation and were sealed off from occupied areas via plastic polyethylene sheeting (Picture 6).

**Visible Mold on Surface of GW (as Indicated by Dark Spots) in Office**

Michaelle's Office	ND	12	70	26	Small area of "light" mold growth on surface of GW (behind desk/near floor)-recommended removal

1. Continue with plans to complete remediation. Remove sections of GW in 3<sup>rd</sup> floor hallway and Michaelle's office with visible mold growth (Pictures 4 and 5). This work should be done while these areas are unoccupied.
2. Once work is completed, clean any dust and particulates generated by renovation using a high efficiency particulate air filter (HEPA) equipped vacuum cleaner in conjunction with wet wiping.
3. If odorous materials (e.g., adhesives) are used during the reinstallation of vinyl baseboard coving this work should be done during unoccupied periods with sufficient curing time to prevent odor complaints.
4. For more information on mold consult "Mold Remediation in Schools and Commercial Buildings" published by the US Environmental Protection Agency (US EPA, 2001). This

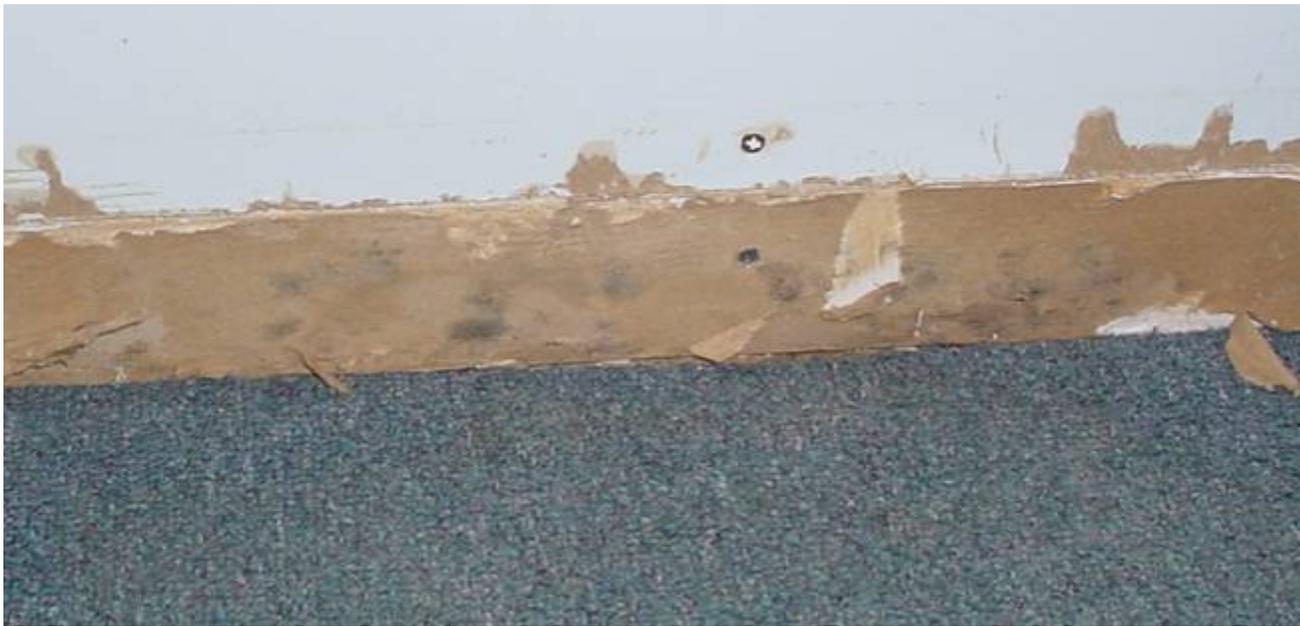
**Picture 5**

**Visible Mold on Surface of GW (as Indicated by Dark Spots) in 3<sup>rd</sup> Floor Hallway**

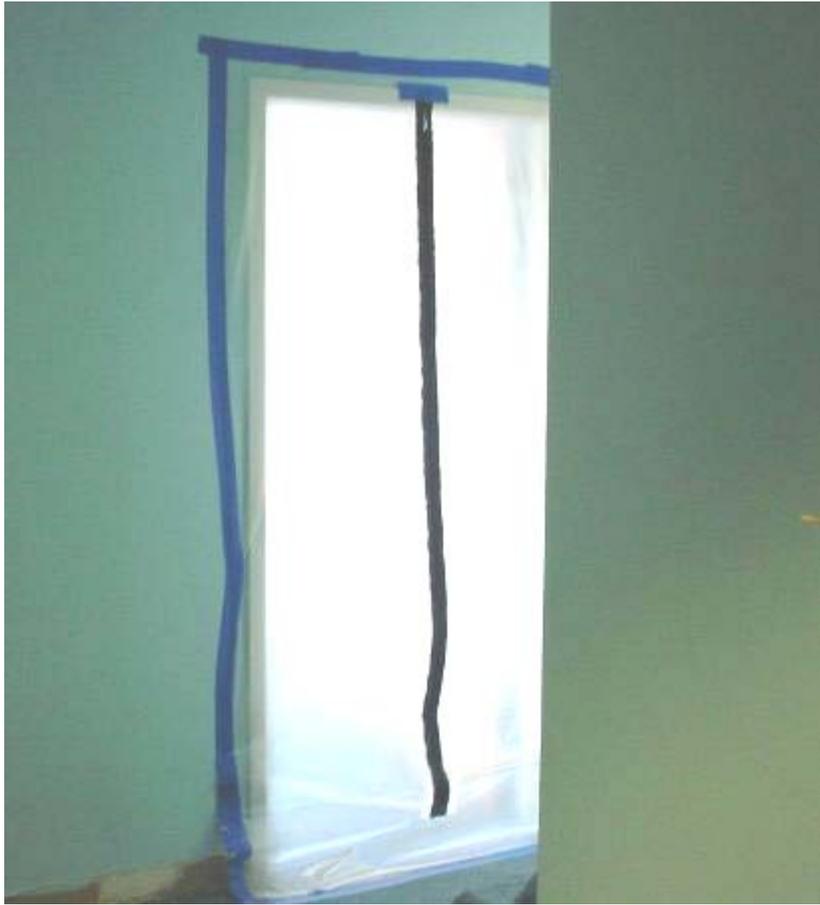
**Picture 6**

**Remediation Area Sealed With Plastic Polyethylene Sheeting**

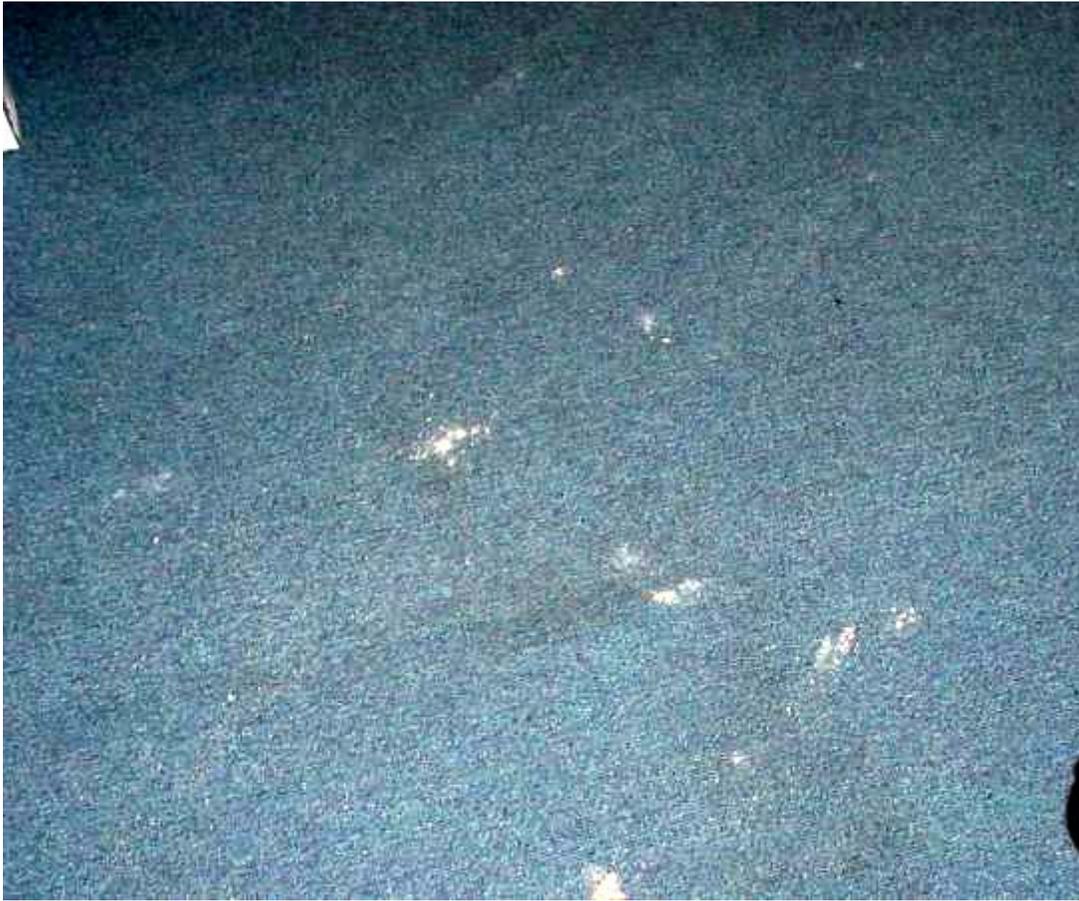
**Picture 7**

Outdoor PM<sub>2.5</sub> concentrations at the time of the assessment were measured at 13 µg/m<sup>3</sup> (Table 1). PM<sub>2.5</sub> levels within the DSS ranged from 8 to 19 µg/m<sup>3</sup>. Indoor and outdoor PM<sub>2.5</sub> levels were below the NAAQS of 35 µg/m<sup>3</sup> (Table 1). Frequently, indoor air levels of particulates can be at higher levels than those measured outdoors. A number of mechanical devices and/or activities that occur indoors can generate particulates during normal operation. Sources of indoor airborne particulate may include but are not limited to particles generated during the operation of fan belts in the HVAC system, cooking and microwave ovens; use of photocopiers, fax machines and computer printing devices, operating an ordinary vacuum cleaner and heavy foot traffic indoors. While some dust/debris was observed on carpeting and flat surfaces in a few areas, these particles are of a large size and are not likely to become airborne (Pictures 7 and 8).

**Dirt, Dust and Debris on Carpet**

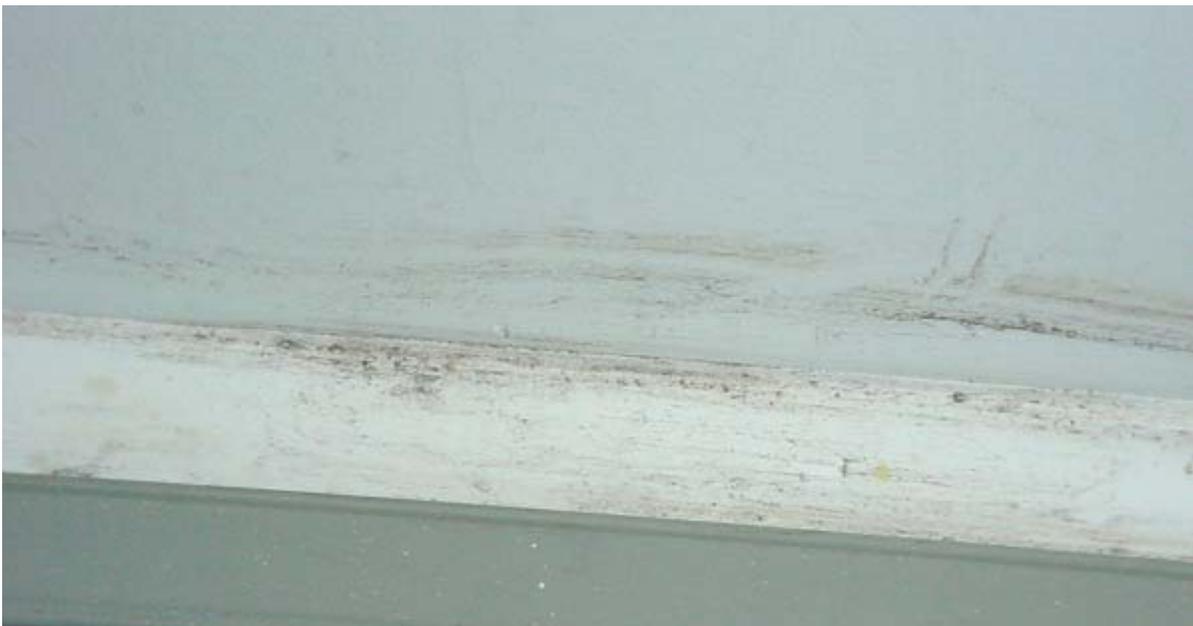
**Picture 8**

**Dirt, Dust and Debris on Wall/Base in Office**
