# **INDOOR AIR QUALITY ASSESSMENT**

**Tewksbury Police Department  
918 Main Street  
Tewksbury, MA 01876**

Prepared by:  
Massachusetts Department of Public Health  
Bureau of Environmental Health  
Indoor Air Quality Program  
June 2008

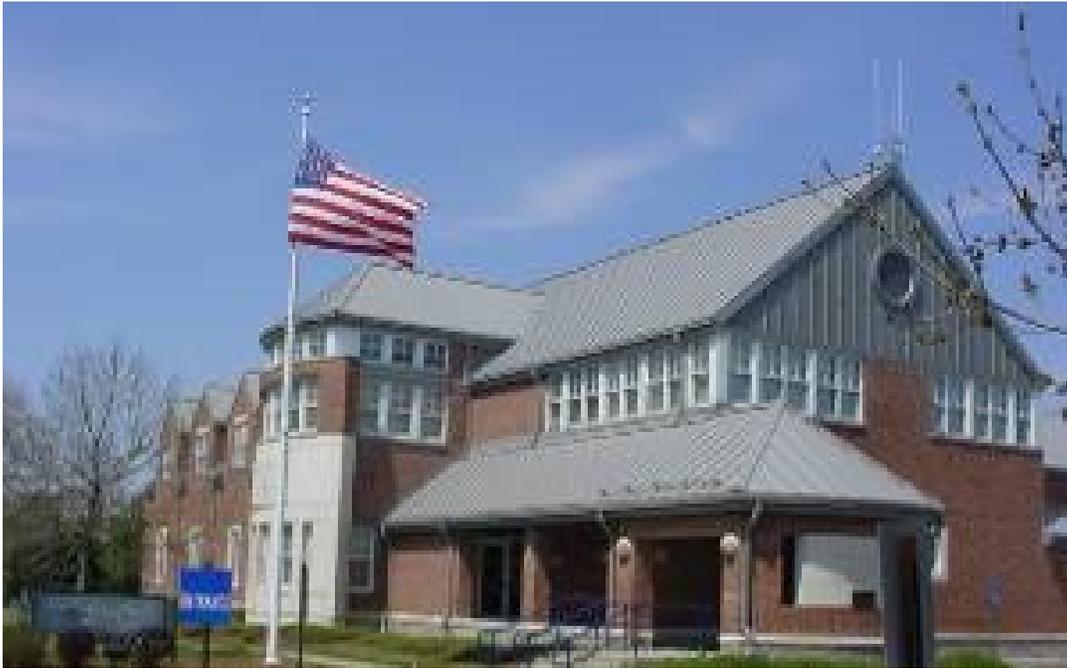
**Picture 1**

The TPD is a two-story, multi-level, brick building with a metal roof that was constructed in 1997 (Picture 1). The ground floor contains the dispatch area, offices and conference rooms; the second floor contains offices, conference rooms, a mechanical room and computer room; the basement contains a two bay police vehicle garage, cell area, evidence store room, boiler room and locker rooms. Windows are openable throughout the building, and the facility is equipped with central air conditioning.

**Tewksbury Police Department**

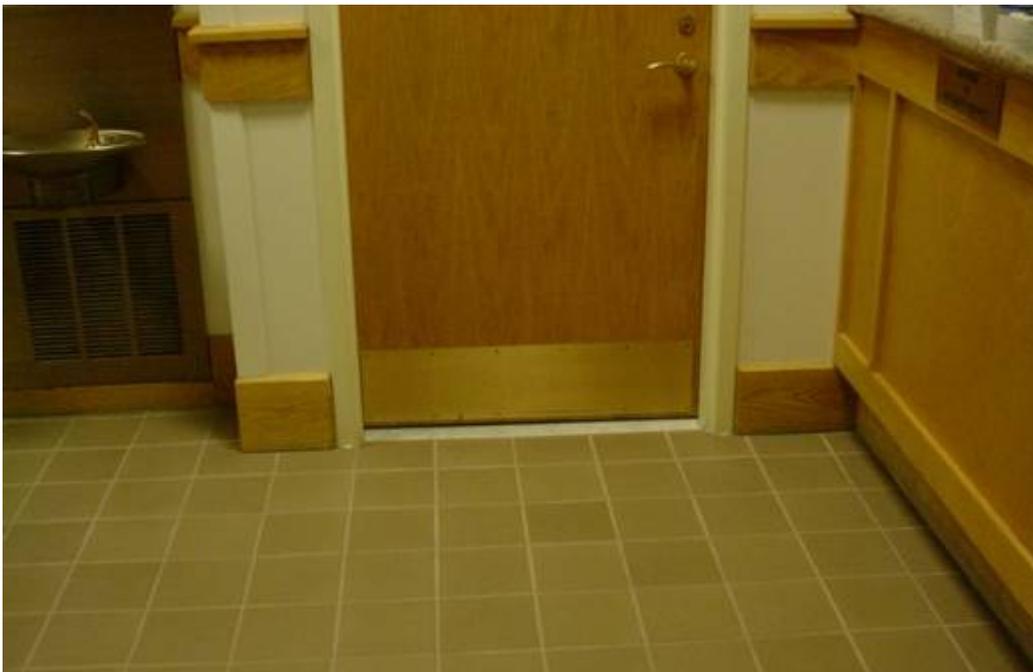
**Picture 2**

Several areas in the TPD building (including the dispatch area) are designed to have air exhausted through return vents located in the restrooms. However, restroom doors are not undercut and did not have passive vents. Therefore, air is not allowed to flow freely (Picture 2). BEH staff found restroom vents deactivated at the time of the assessment.

**Restroom Door**

1. Undercut all restroom doors by at least 1 inch in order to provide adequate transfer air for restroom exhaust vents to operate.
2. Ensure that all restroom vents are operating to provide exhaust ventilation.

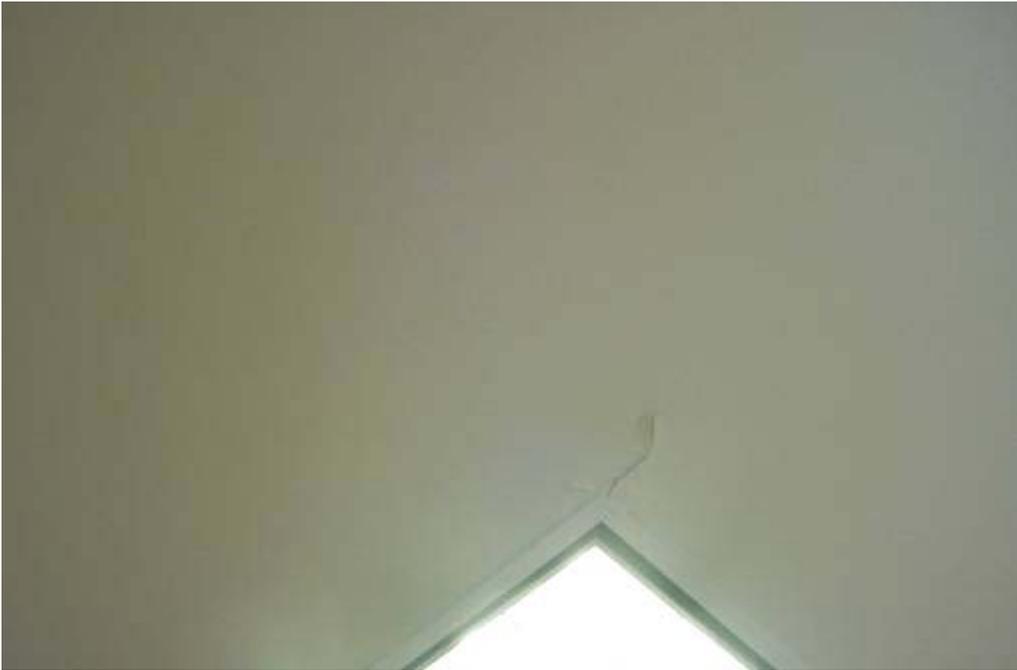
**Picture 3**

building interior has caused paint to peel in numerous areas (Picture 3). Several areas had water-damaged ceiling tiles which can indicate sources of water penetration (Picture 4). Water-damaged ceiling tiles can provide a source of mold and should be replaced after a water leak is discovered and repaired.

**Peeling Paint**

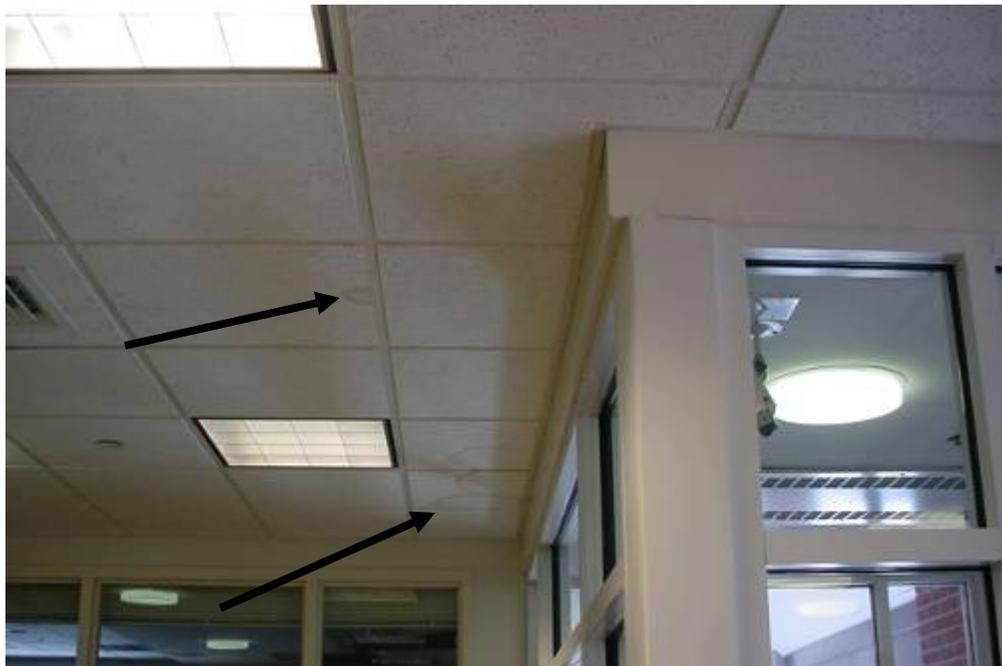
**Picture 4**

**Water Damaged Ceiling Tiles, Front Foyer**

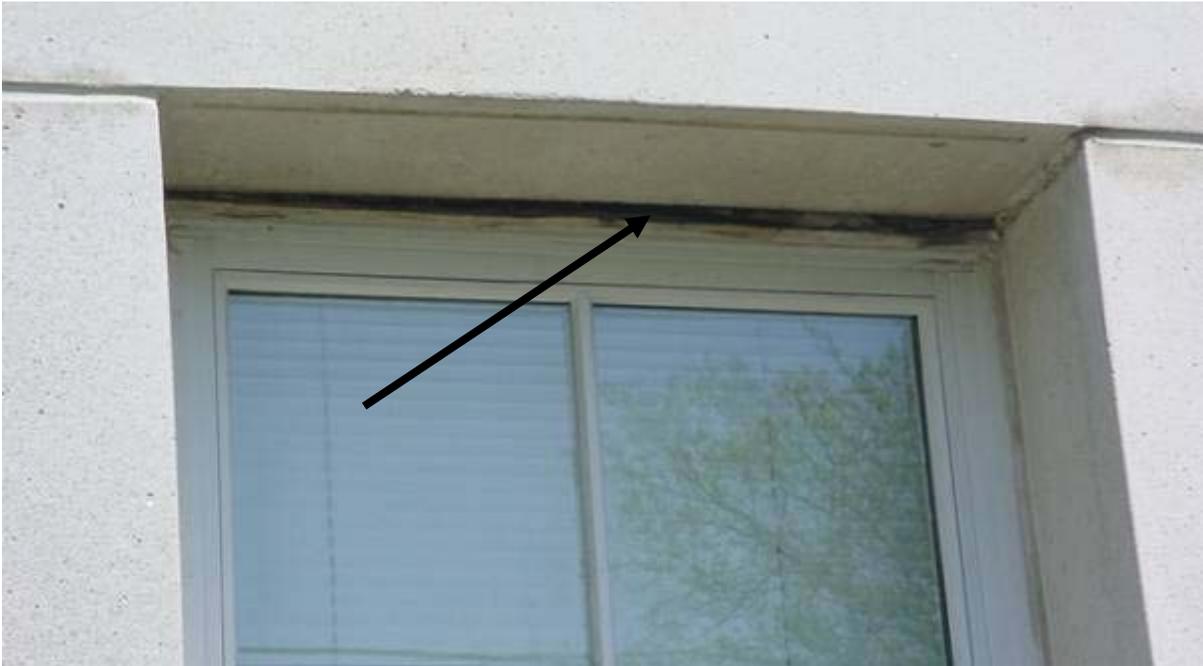
**Picture 5**

Throughout the building, caulking around the interior and exterior windowpanes was crumbling, missing or damaged (Picture 5). Air infiltration was noted around windows, which can result in water penetration through the window frames. Water penetration through window frames can lead to mold growth under certain conditions. Repairs of window leaks are necessary to prevent further water penetration.

**Damaged Caulking Around Windows**

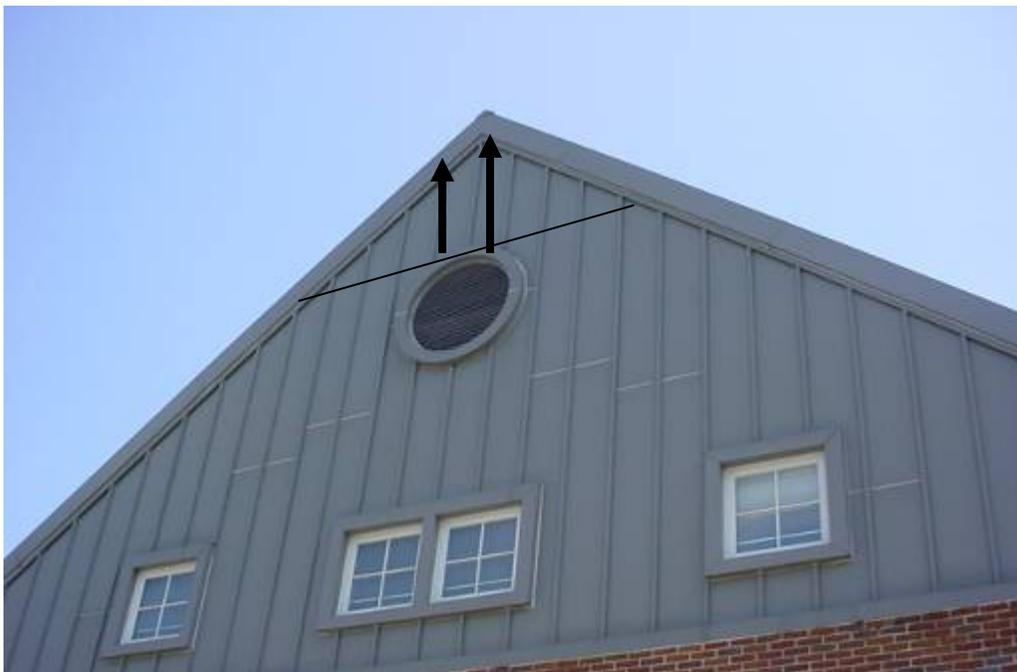
**Picture 6**

Vents were observed in the attic (Picture 6); however, these appear to be louvers which will not readily remove heated air unless appropriate wind conditions exist. Another likely confounding problem is the moistening of insulation from ice dams. The ability of insulation to prevent temperature transfer is reduced if the material becomes moistened. The loss of temperature control can result in more heat transfer into the attic space, creating larger ice dams and causing more water penetration.

**Attic Vent, Note Space Above Vent Where Heat May Accumulate**

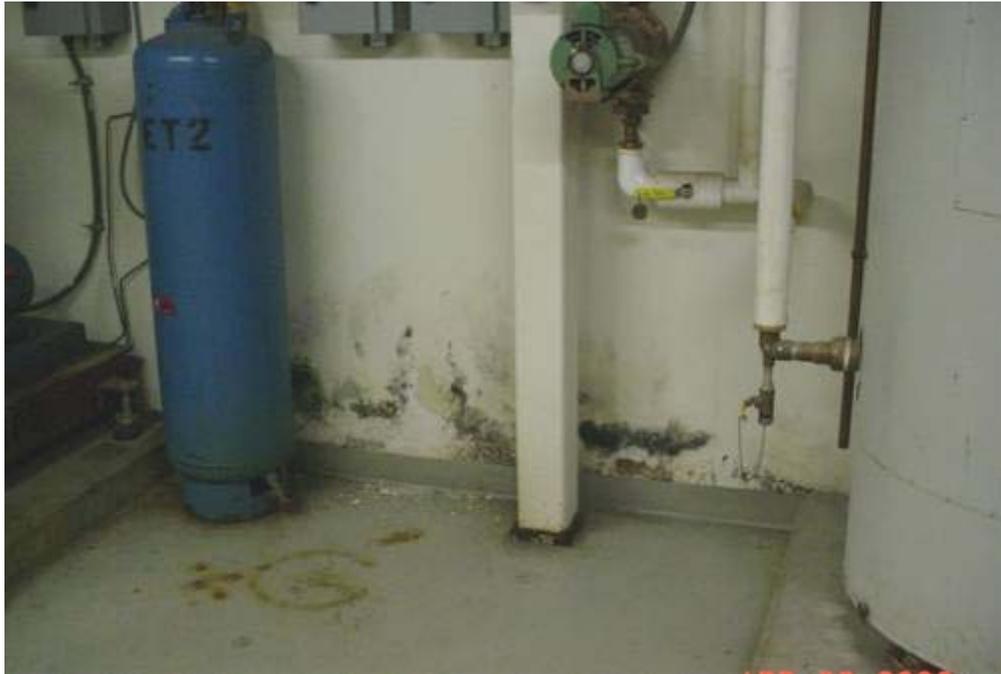
**Picture 7**

BEH staff noted visible mold growth on gypsum wallboard in the basement boiler room (Picture 7). A malfunctioning/undersized sump pump has caused flooding of the basement and repeated moistening of the gypsum wallboard. Coving at the base of the wall holds moisture against the gypsum wallboard, preventing the wall from drying. In addition, BEH staff found standing water on the floor of the evidence store room that was adjacent to the basement boiler room.

**Mold Growth in Basement Boiler Room**

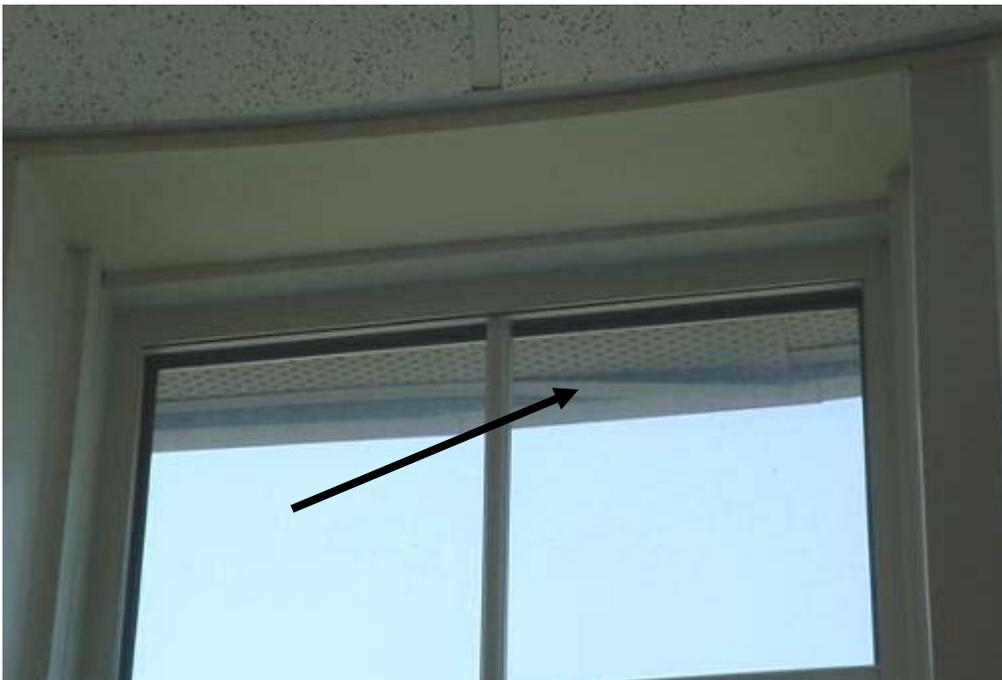
**Picture 8**

The outside of the building is infested with hornets. The most likely path for hornets to gain entrance to the building is through the soffit vents. Sections of the soffit vents and metal roof were displaced, and gaps were noted in the sealant of several windows (Pictures 5, 8 and 9). Under current Massachusetts law (effective November 1, 2001) the principles of integrated pest management (IPM) must be used to remove pests in state buildings (Mass Act, 2000). Although not a state building, the principals of IPM can be used in any facility. Pesticide use indoors can introduce chemicals into the indoor environment that can be sources of eye, nose and throat

**Damaged Soffit Vent**

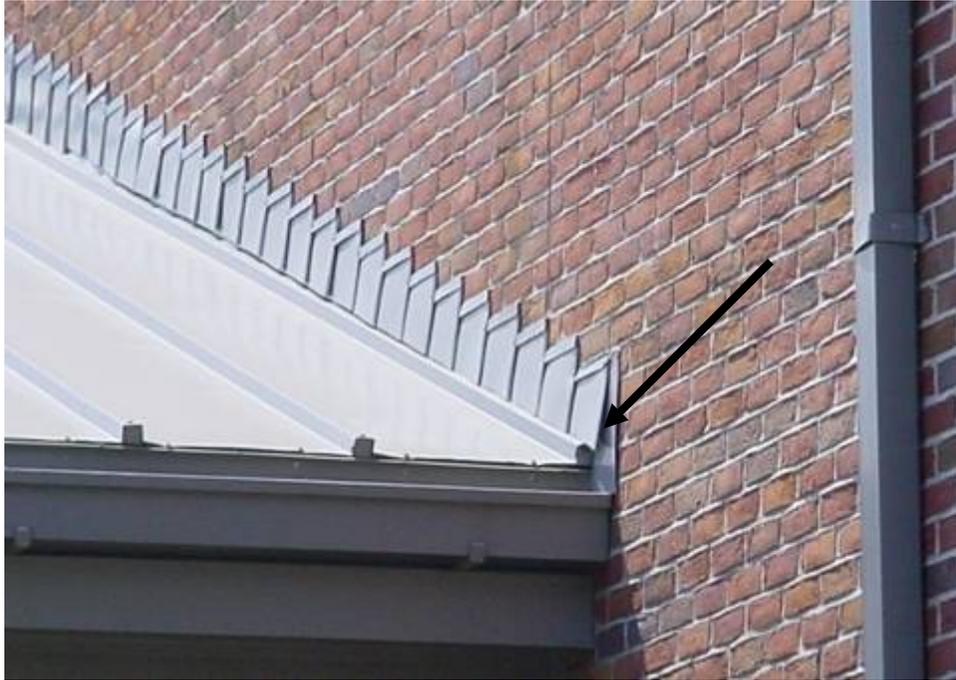
**Picture 9**

**Unsealed Gap in Flashing on Side of Metal Roof**

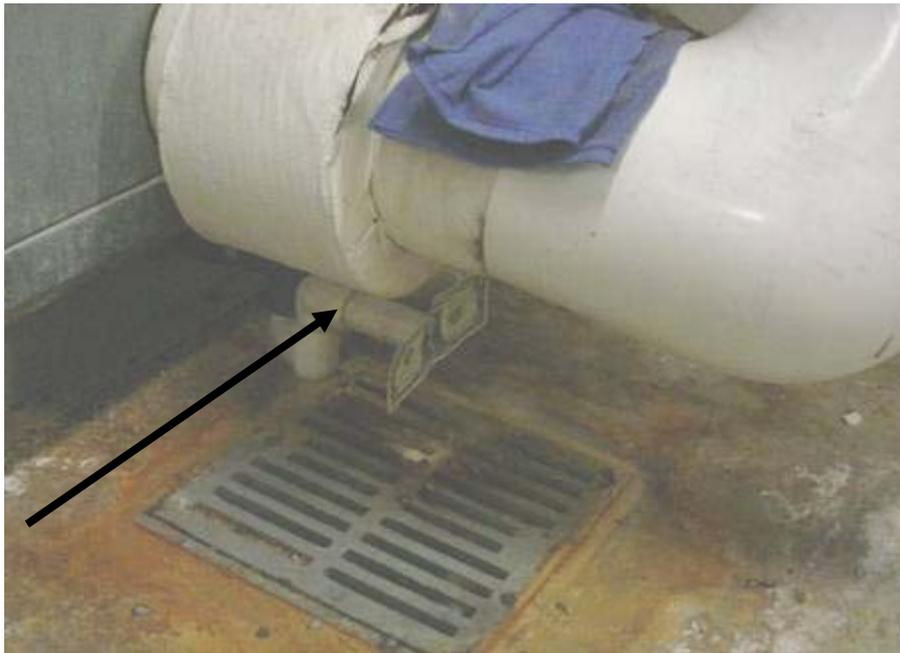
**Picture 10**

The AHU at the TPD provides air-conditioning throughout the building during warm months. AHUs that provide air-conditioning require the installation of condensation drains to prevent water build up inside the casing and ductwork. The condensation drains for these units terminate above a floor drain that is connected to the building's drainage system (Picture 10). Both condensation and floor drains are usually designed with traps to prevent sewer odors/gases from penetrating into occupied spaces. When water enters a drain, the trap fills and forms a watertight seal. Without periodic input of water (e.g., every other day), traps can dry out, breaking the watertight seal. Odors or other material can travel up the drain and enter the occupied space if traps are not wet. At the time of the assessment, the AHU in the second floor mechanical room was found to be drawing air into the unit through the condensation drain (Picture 10). This condition occurs, especially during the heating season because the AHU is not producing condensation which normally creates a watertight seal in the drain. With the condensation drain acting as a vacuum, odors from the floor drain can be drawn into the AHU and be distributed to occupied areas in the building.

**Condensation Pipe Located Above Floor Drain**

**Note Dollar Bill, Air is Drawn Into Pipe**
